**Final
Hazardous, Toxic, and Radioactive Waste (HTRW)
Site Inspection Report
DERP-FUDS Site IO2PR006800
Former Lower Camp Debris Site
Culebra Island, Puerto Rico**

July 2012

Final
Hazardous, Toxic, and Radioactive Waste (HTRW)
Site Inspection Report
at DERP-FUDS Site IO2PR006800

Former Lower Camp Debris Site
Culebra Island, Puerto Rico

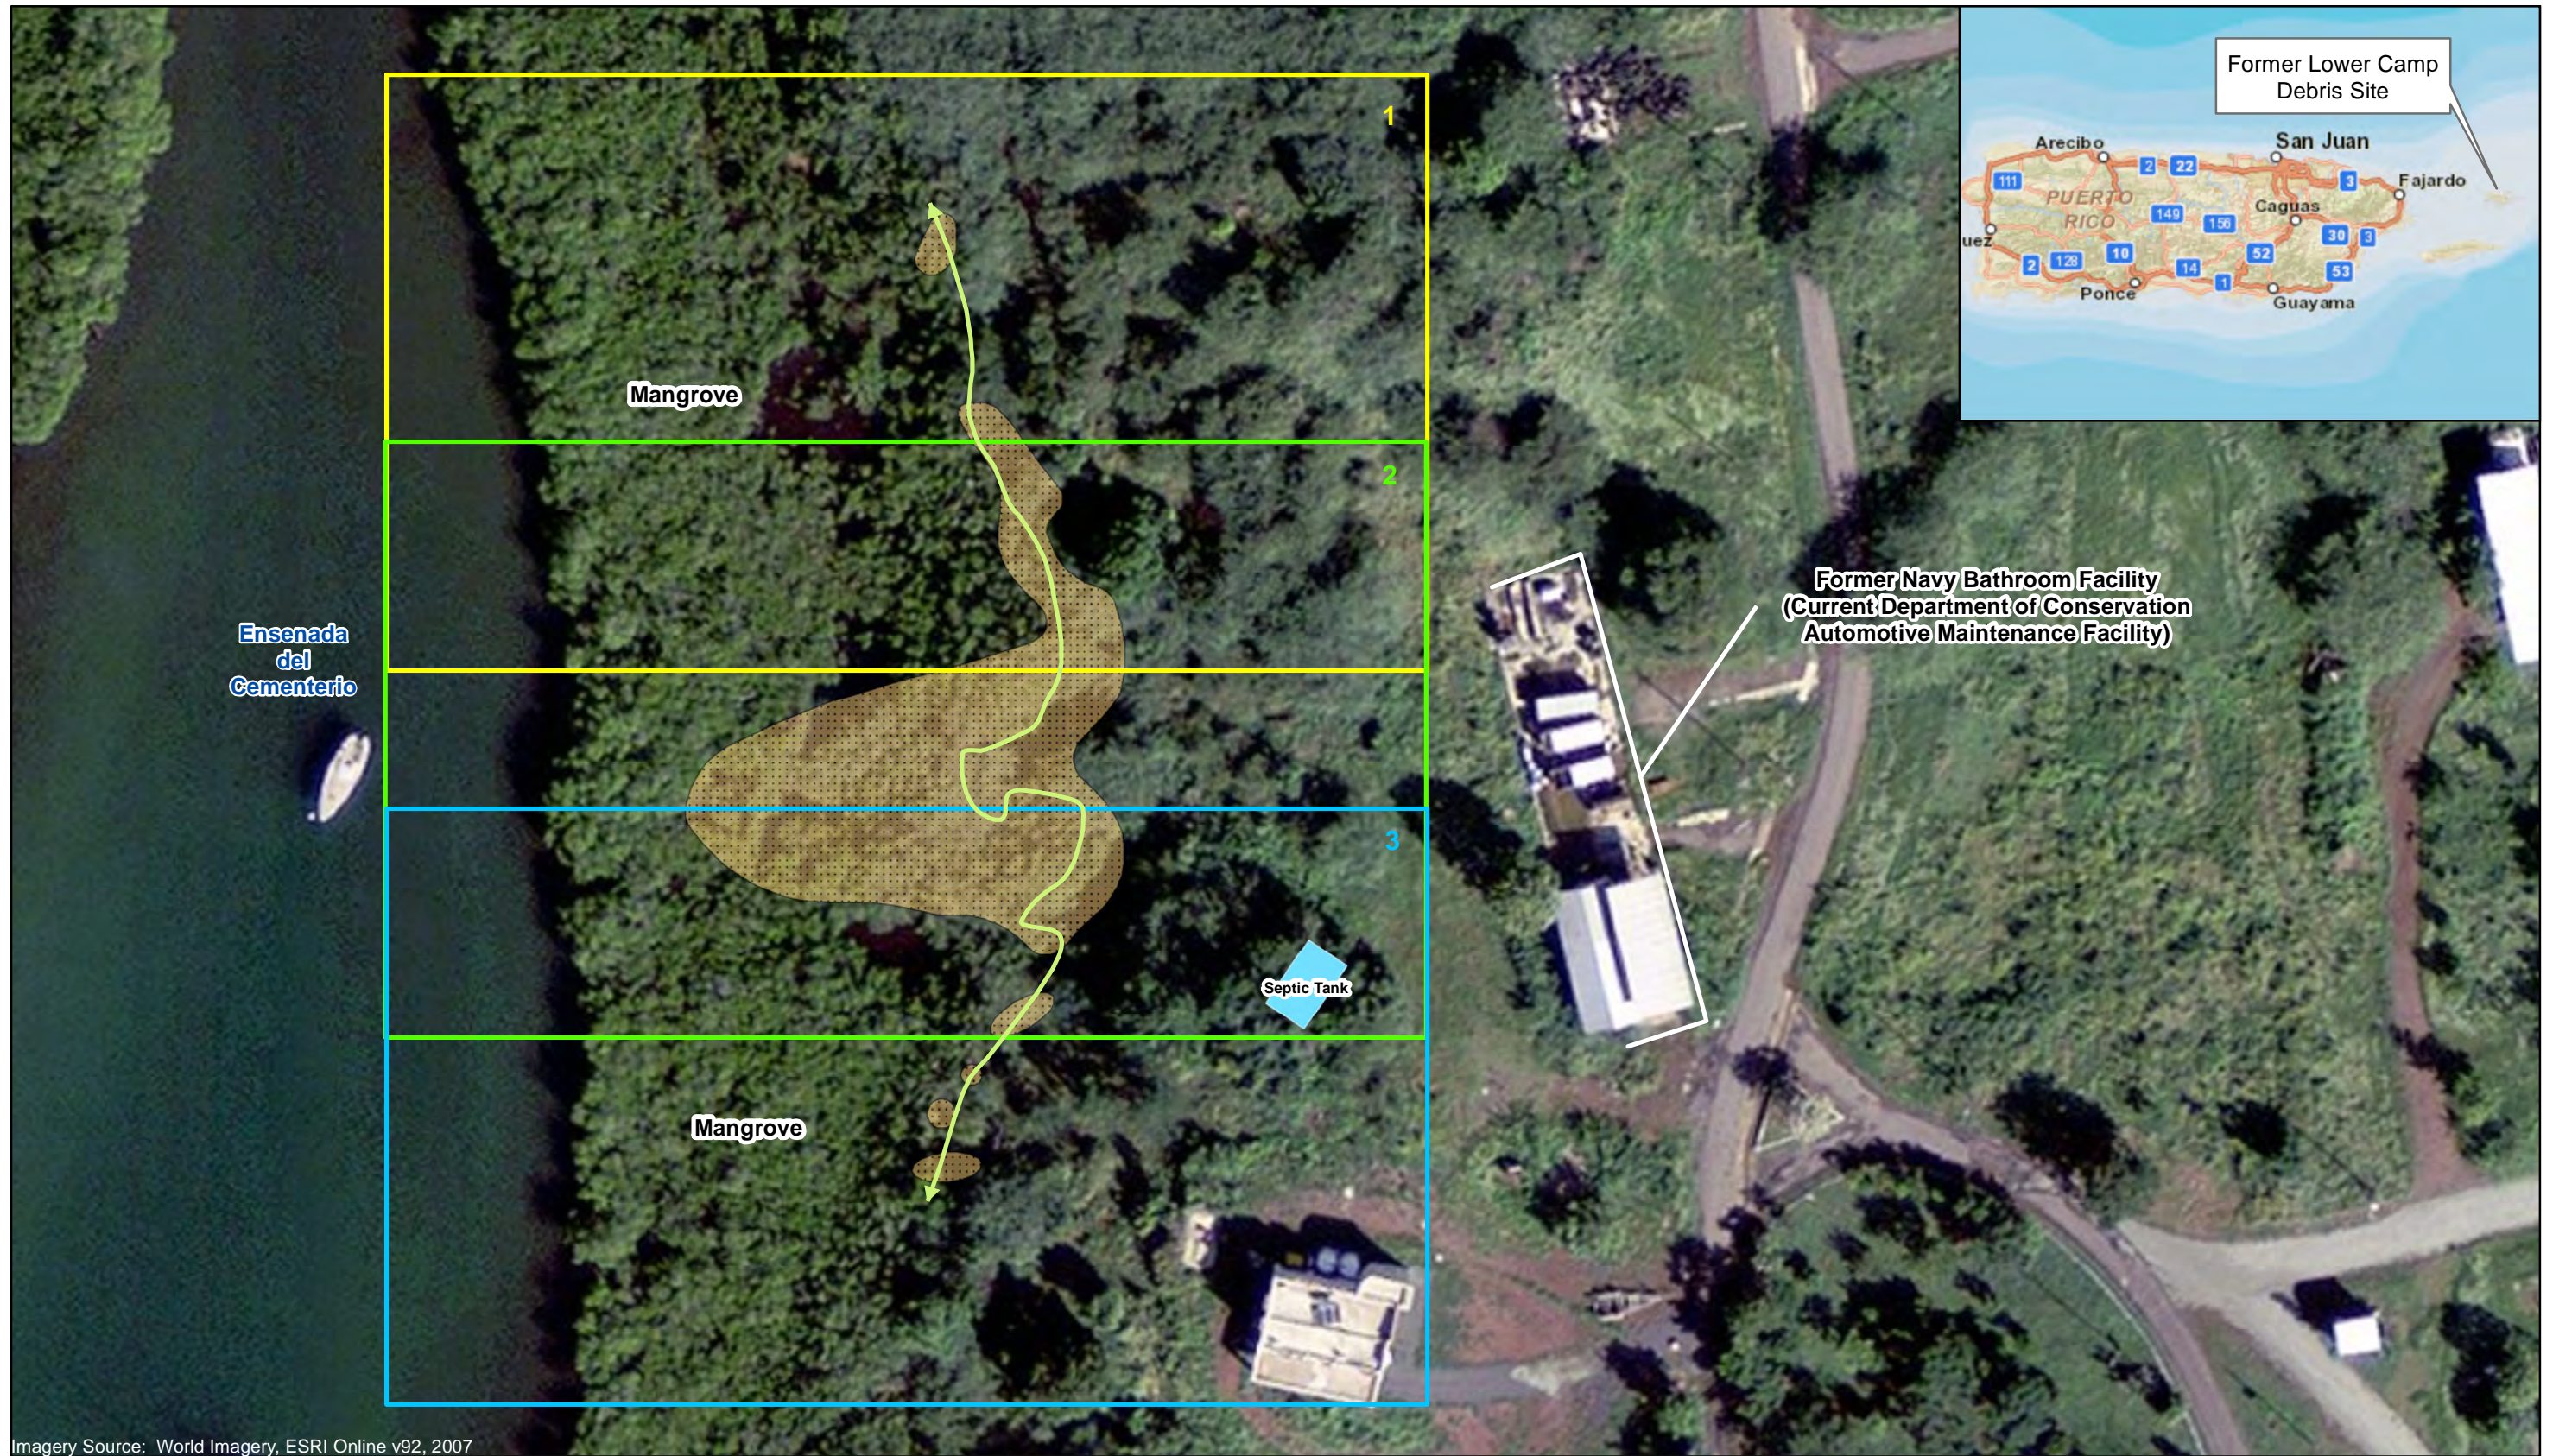
FIGURE 3-1
Site Inspection Location Map
 Former Lower Camp Debris Site
 Culebra, Puerto Rico

The estimated extent of debris is located in a total area of 15,070 ft² (0.35 acre), and extends a distance of 350 feet from the southernmost to the northernmost tip of the debris field (**Figure 3-1**). The widest point of the debris field is approximately 165 feet. The debris consisted of broken bottles, building materials (i.e., bricks both broken and whole and mortar), highly deteriorated oxidized metal (i.e., pipes, beams, rods/rebar, bolts, mattress springs, cables, water valves, and cans), rusted metal walkway sheets, rusted refrigerator type appliance, rusted corrugated metal sheets, concrete stormwater pipes, old vehicle engines, a battery, tires, axles, transmissions, body frames, and broken porcelain..

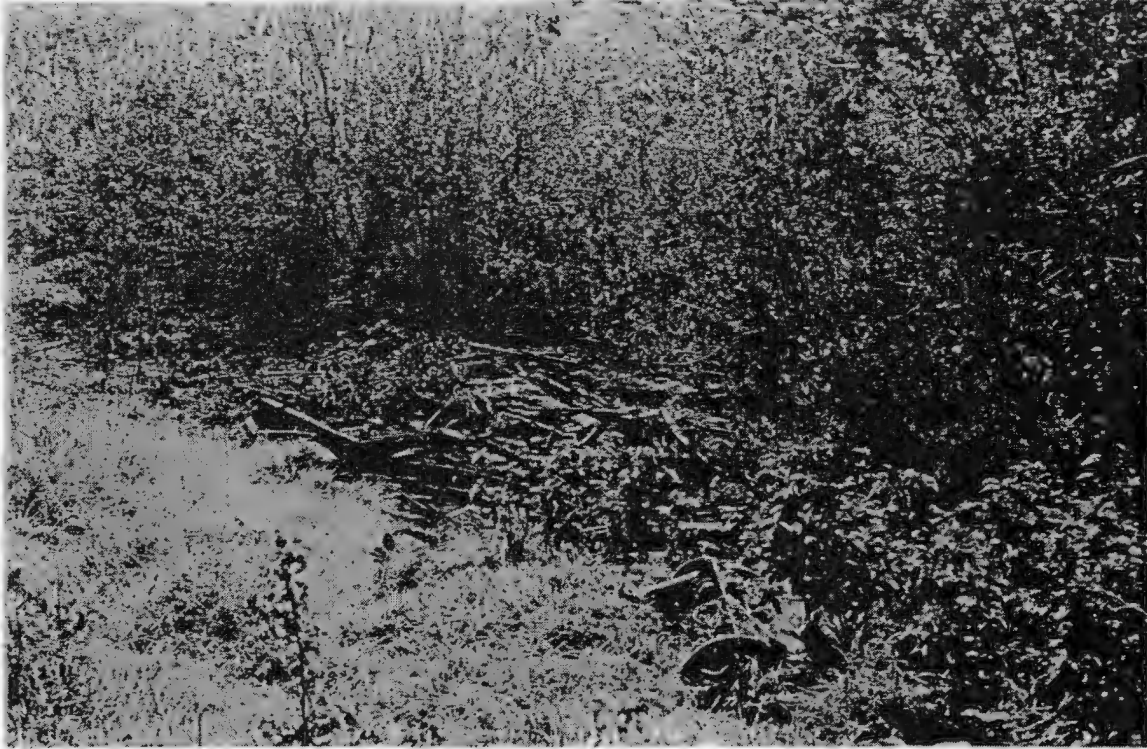
3. Culebra Island NWR (metal debris in wetland area)

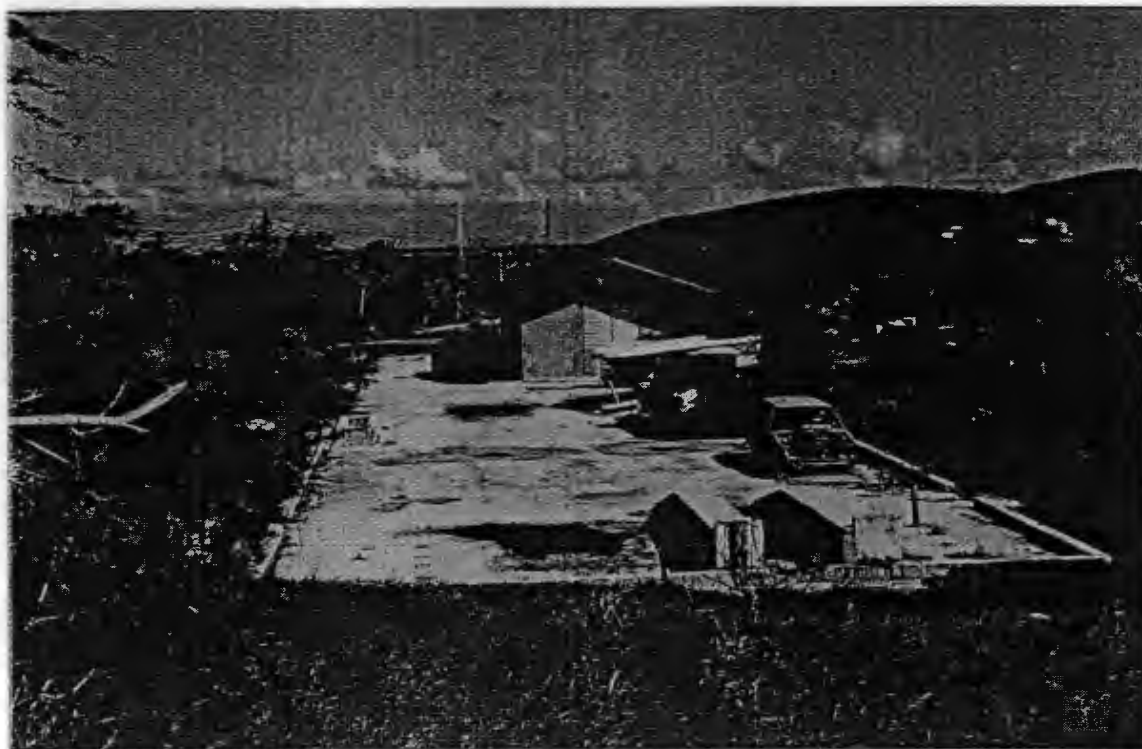
2. Culebra Island NWR (former bathroom foundation and auto shop)

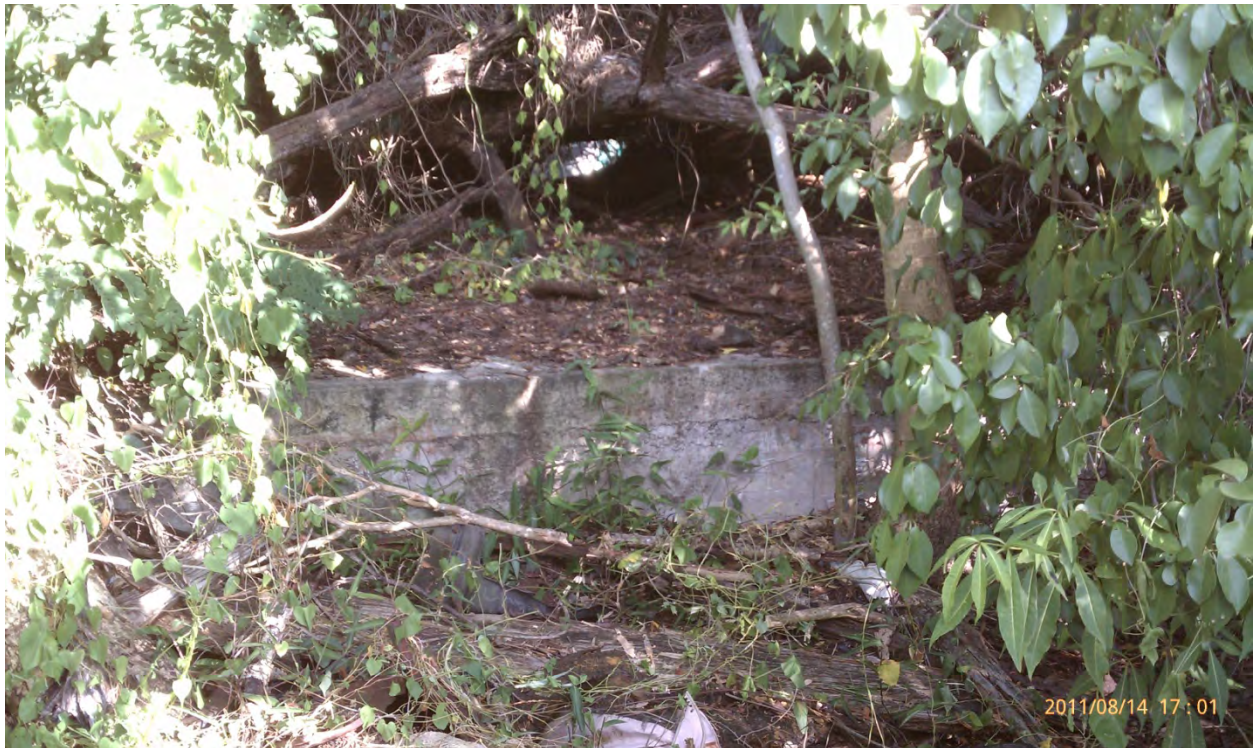
Photograph #1

The septic tank is concrete with a flat, aboveground top 18.5 feet wide by 28 feet long and located approximately 75 feet west of the concrete pad used for the former Navy restroom facility. No outfall could be visually observed. A photograph of the septic tank is included in **Appendix C**.

Septic Tank:

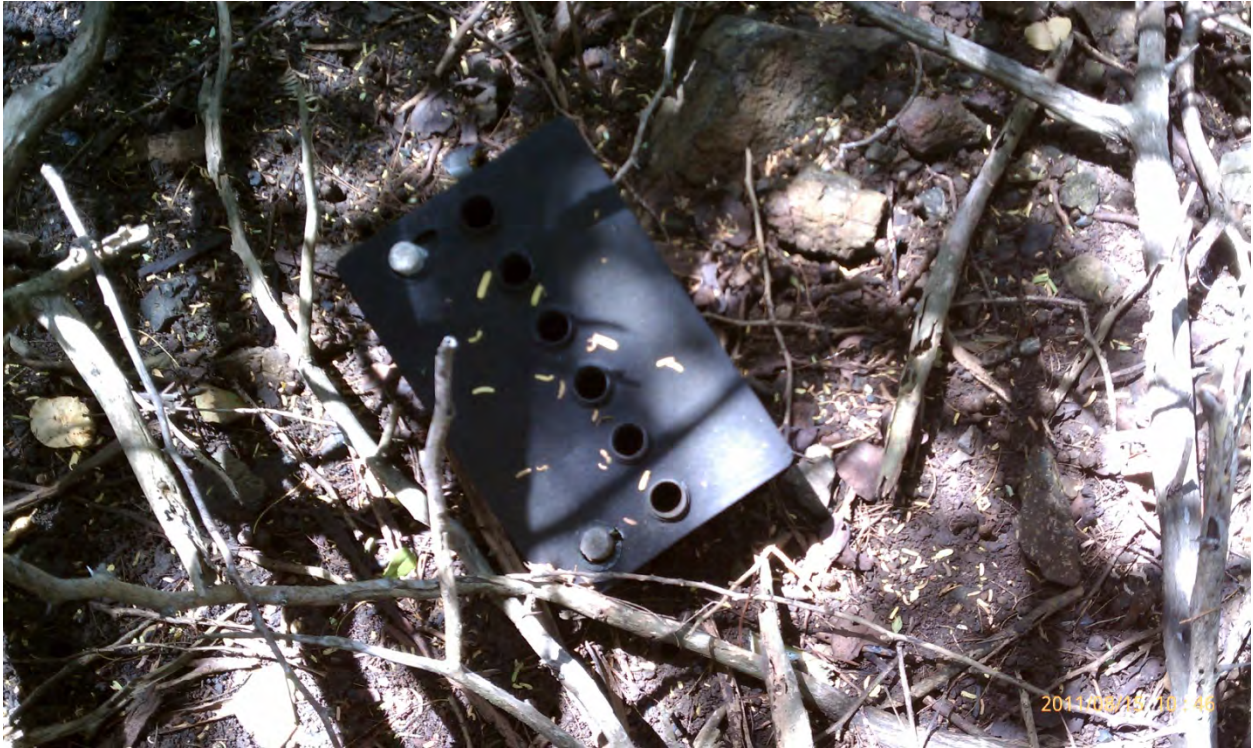
Photograph #2

Battery:

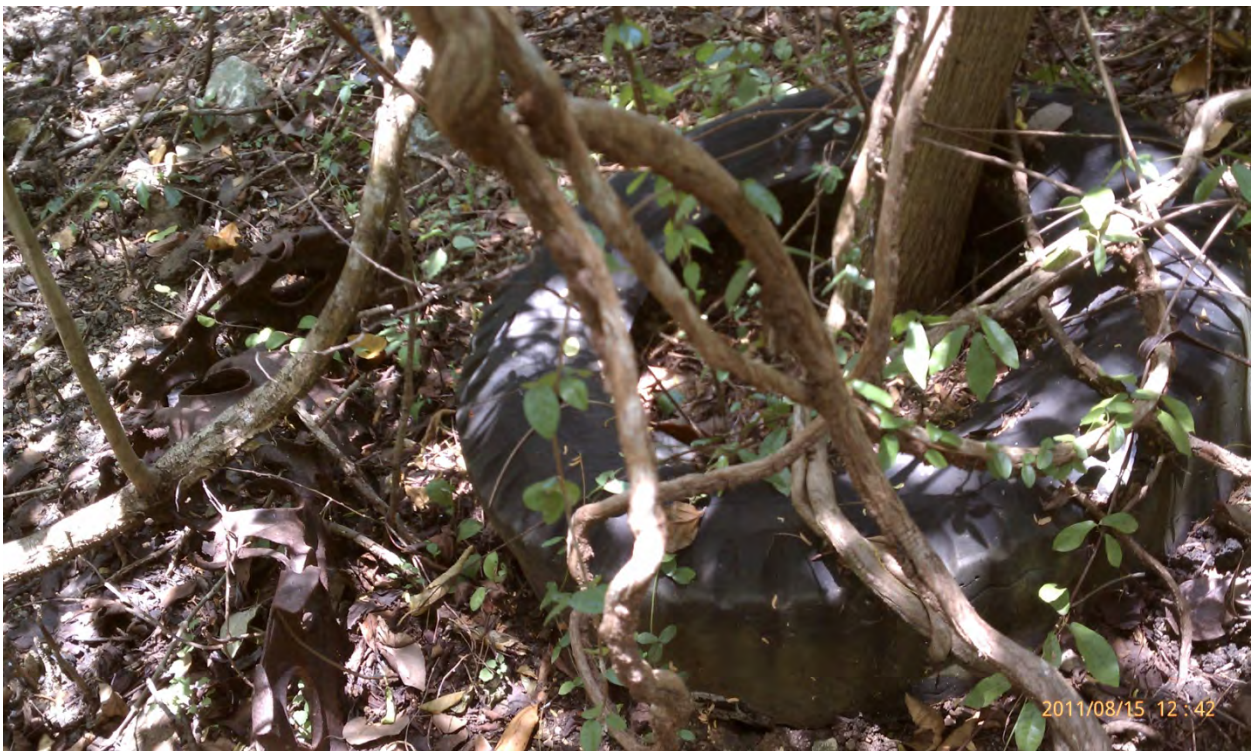
Photograph #3

Old Tires:

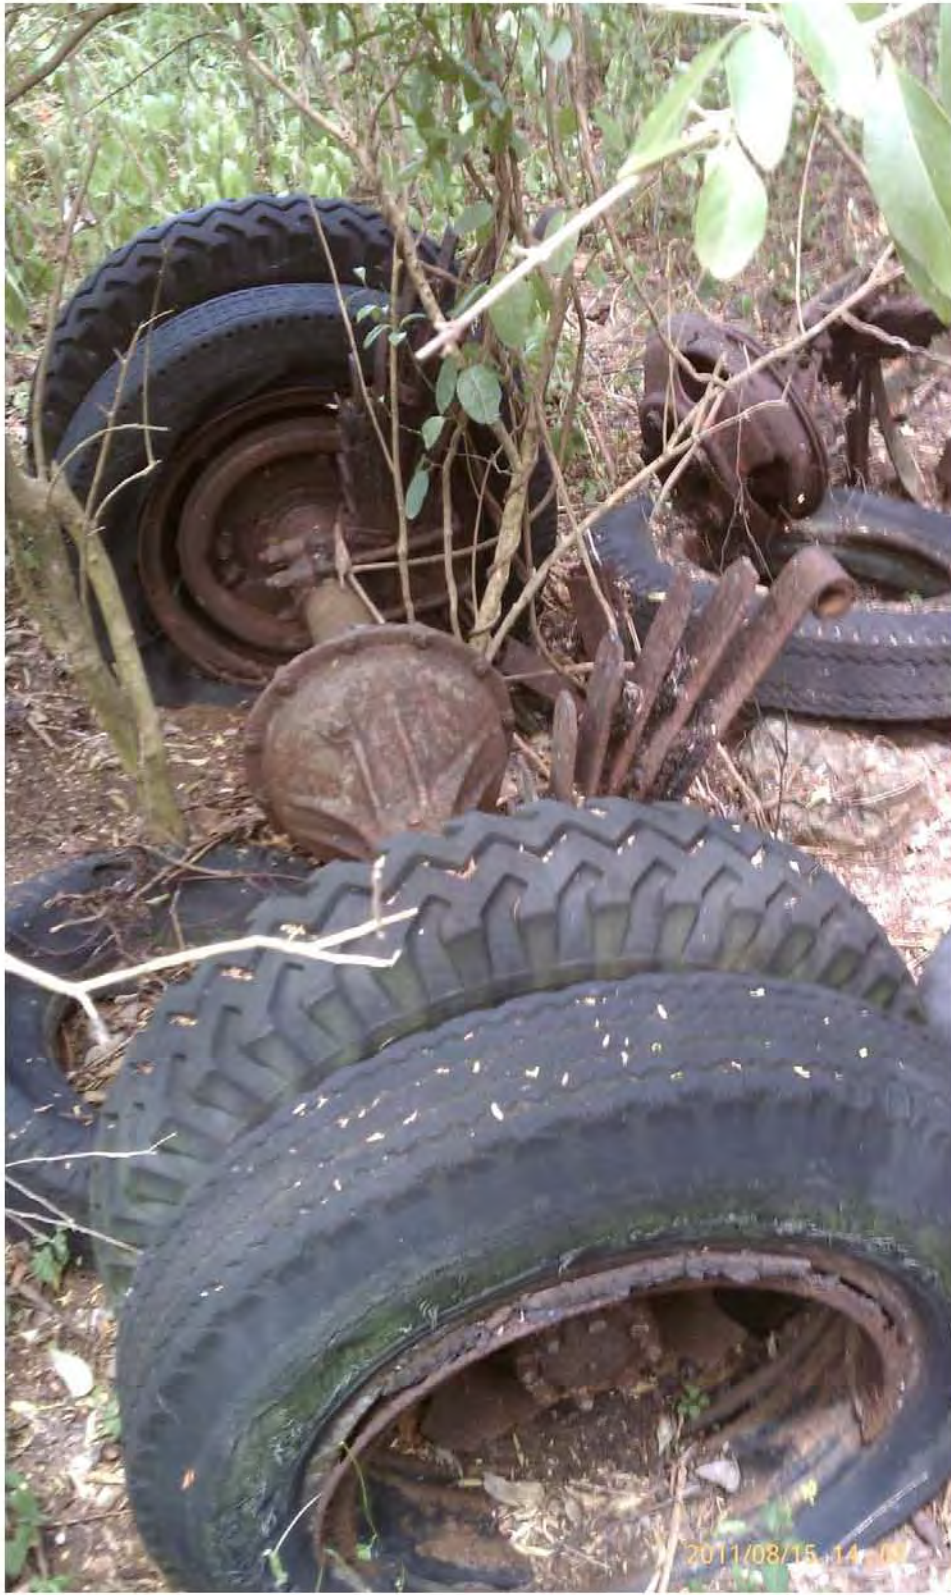
Photograph #4

Vehicle Axle and Tires:

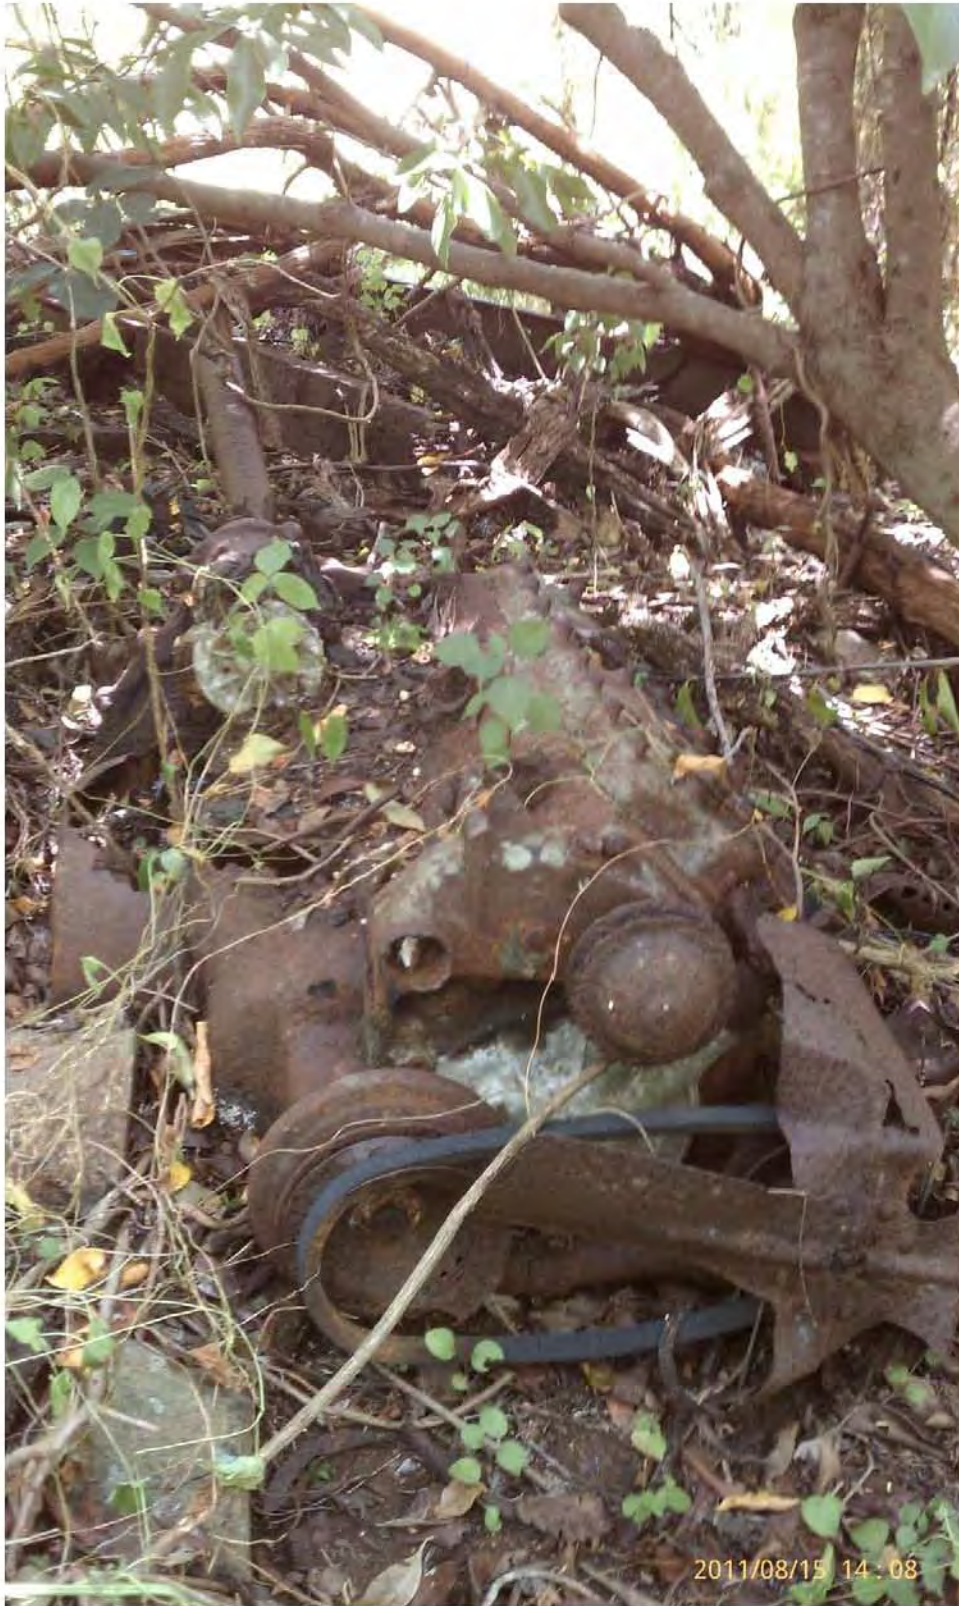
Photograph #5

Vehicle Engine, Transmission, and Frame:

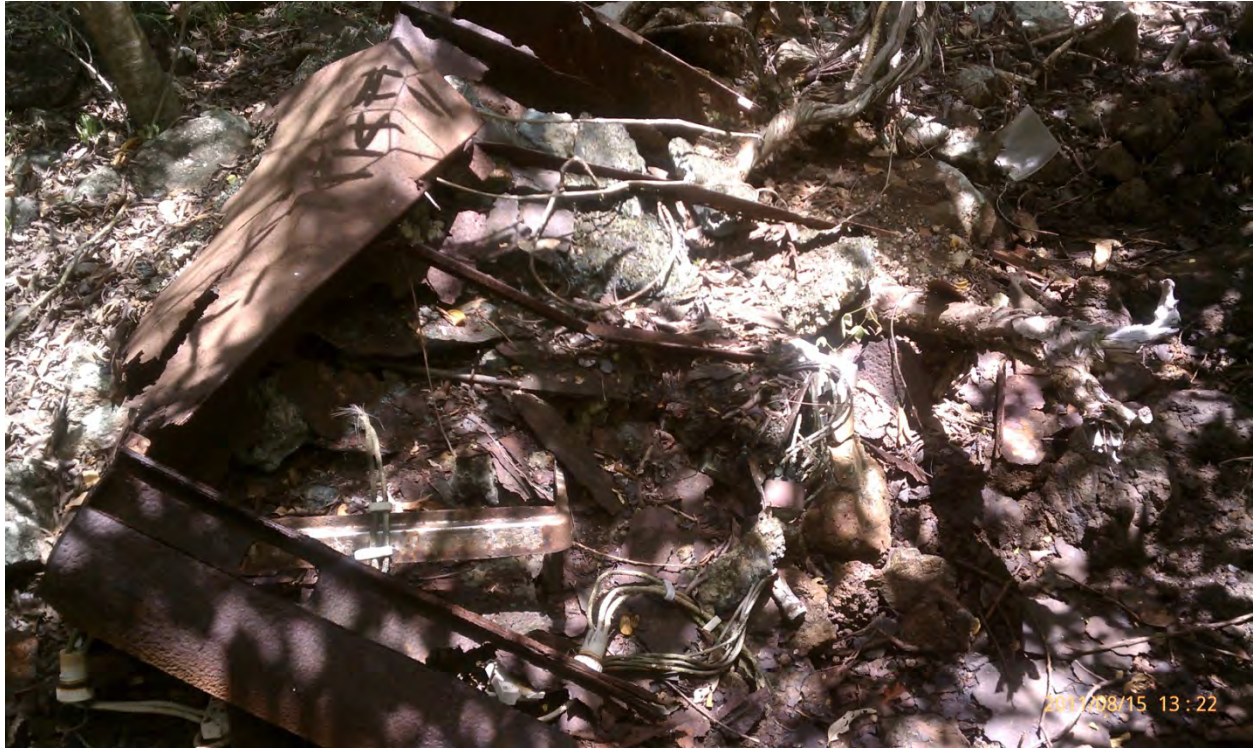
Photograph #6

Refrigerator or Other Type Appliance:

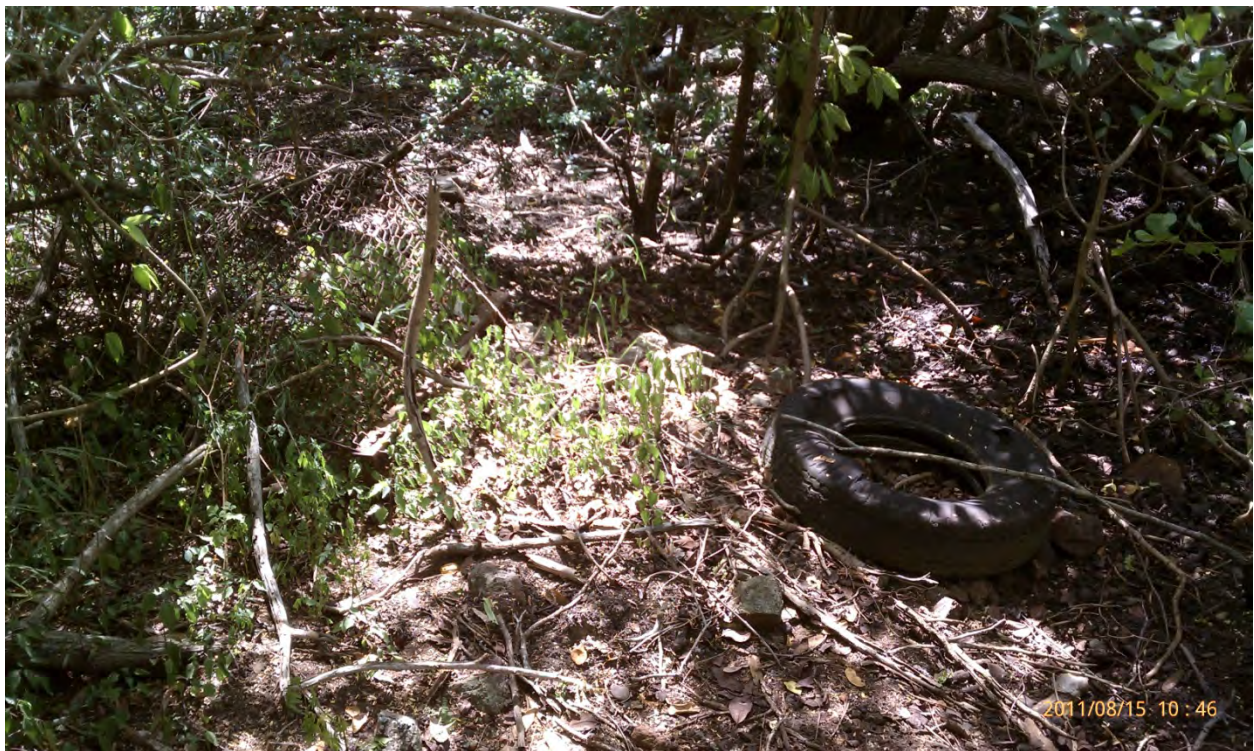
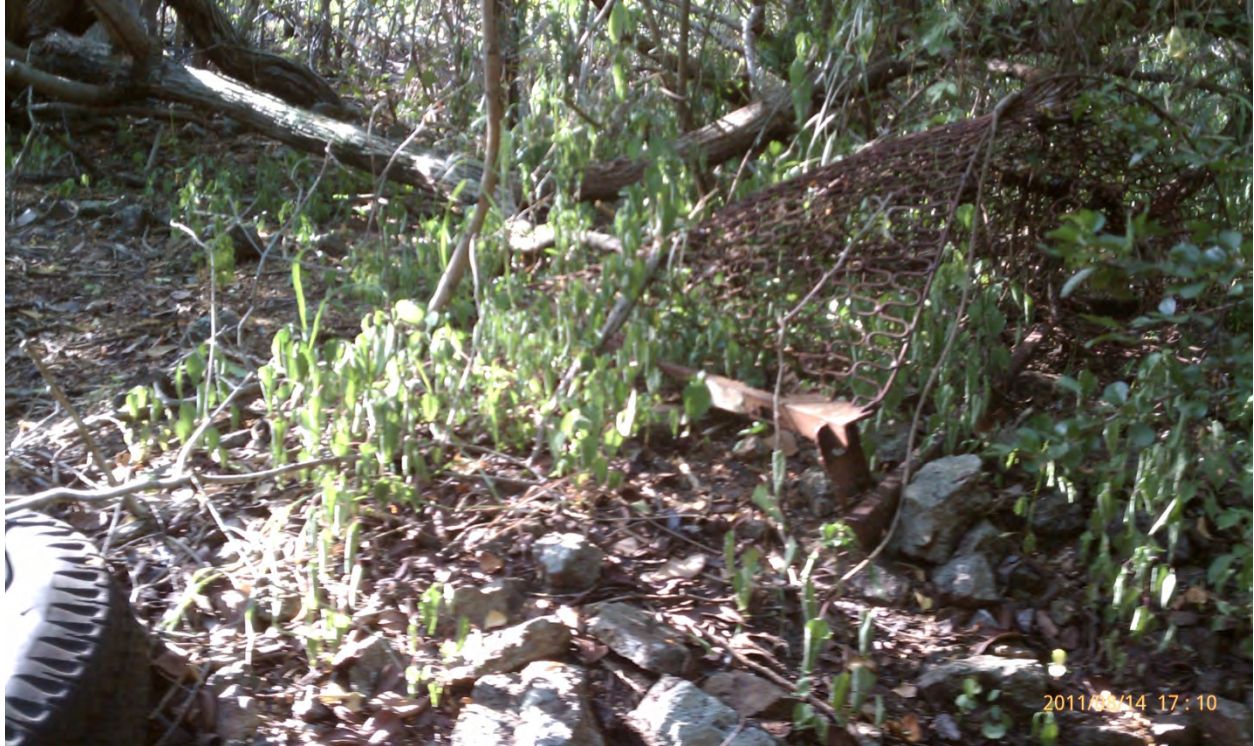
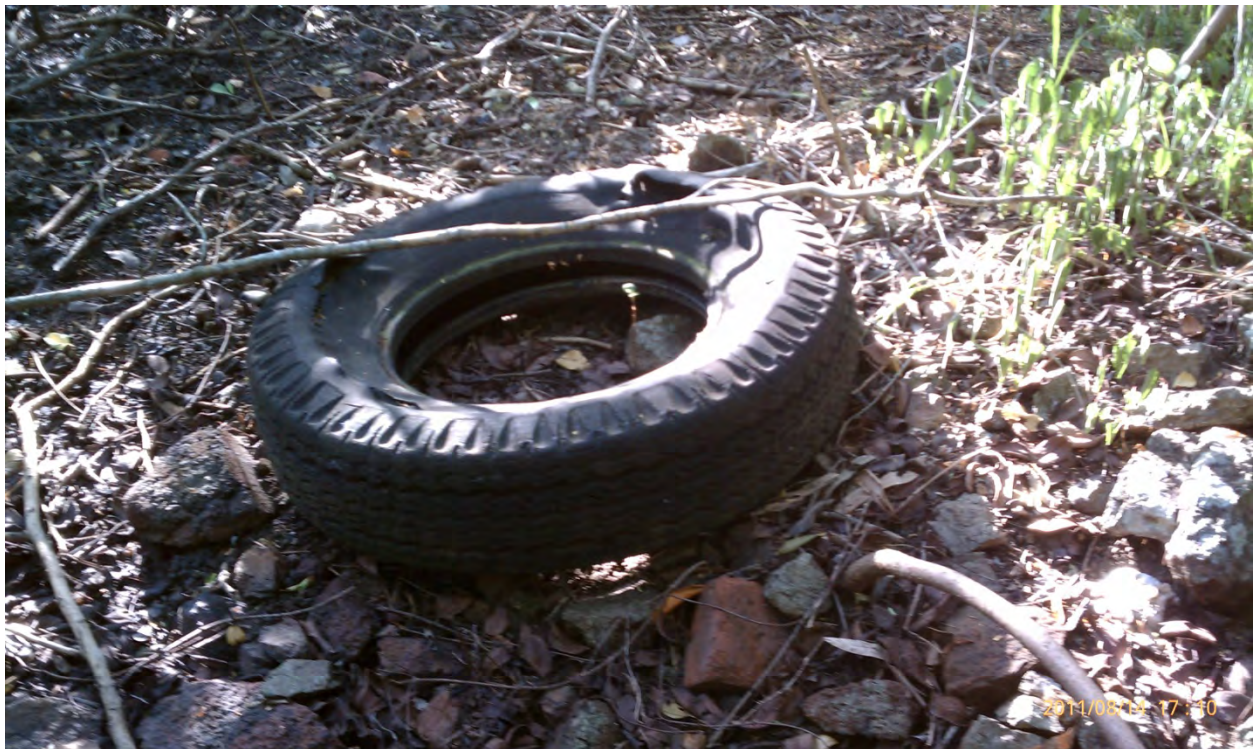
Old Tire, Mattress Spring, Building Material:

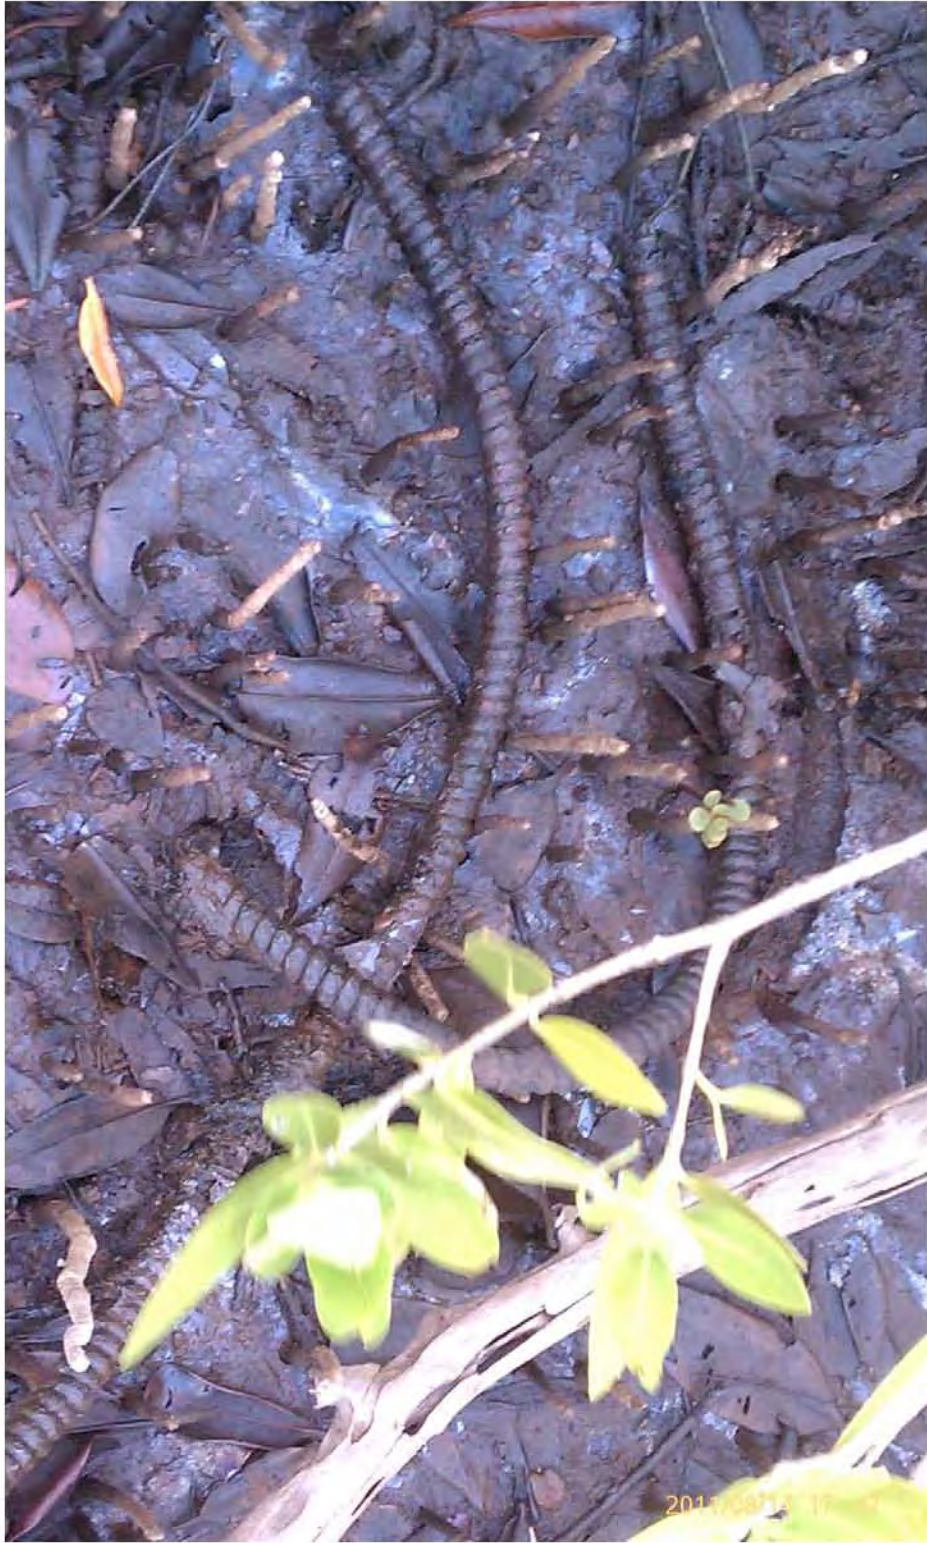
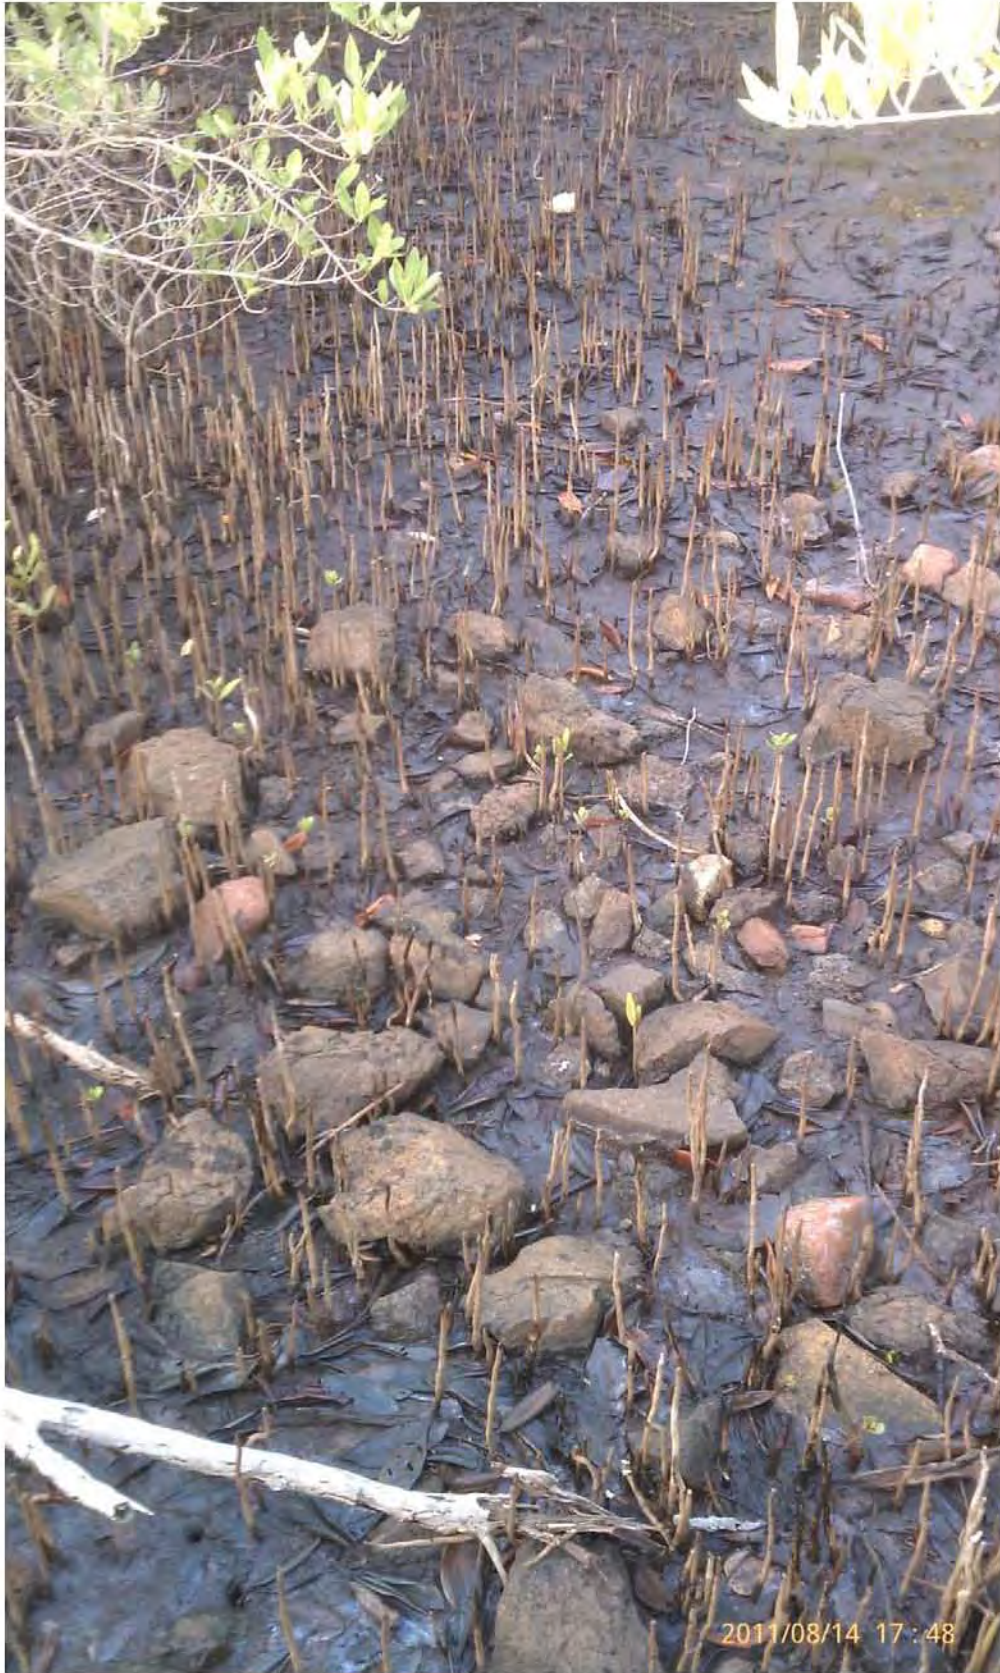
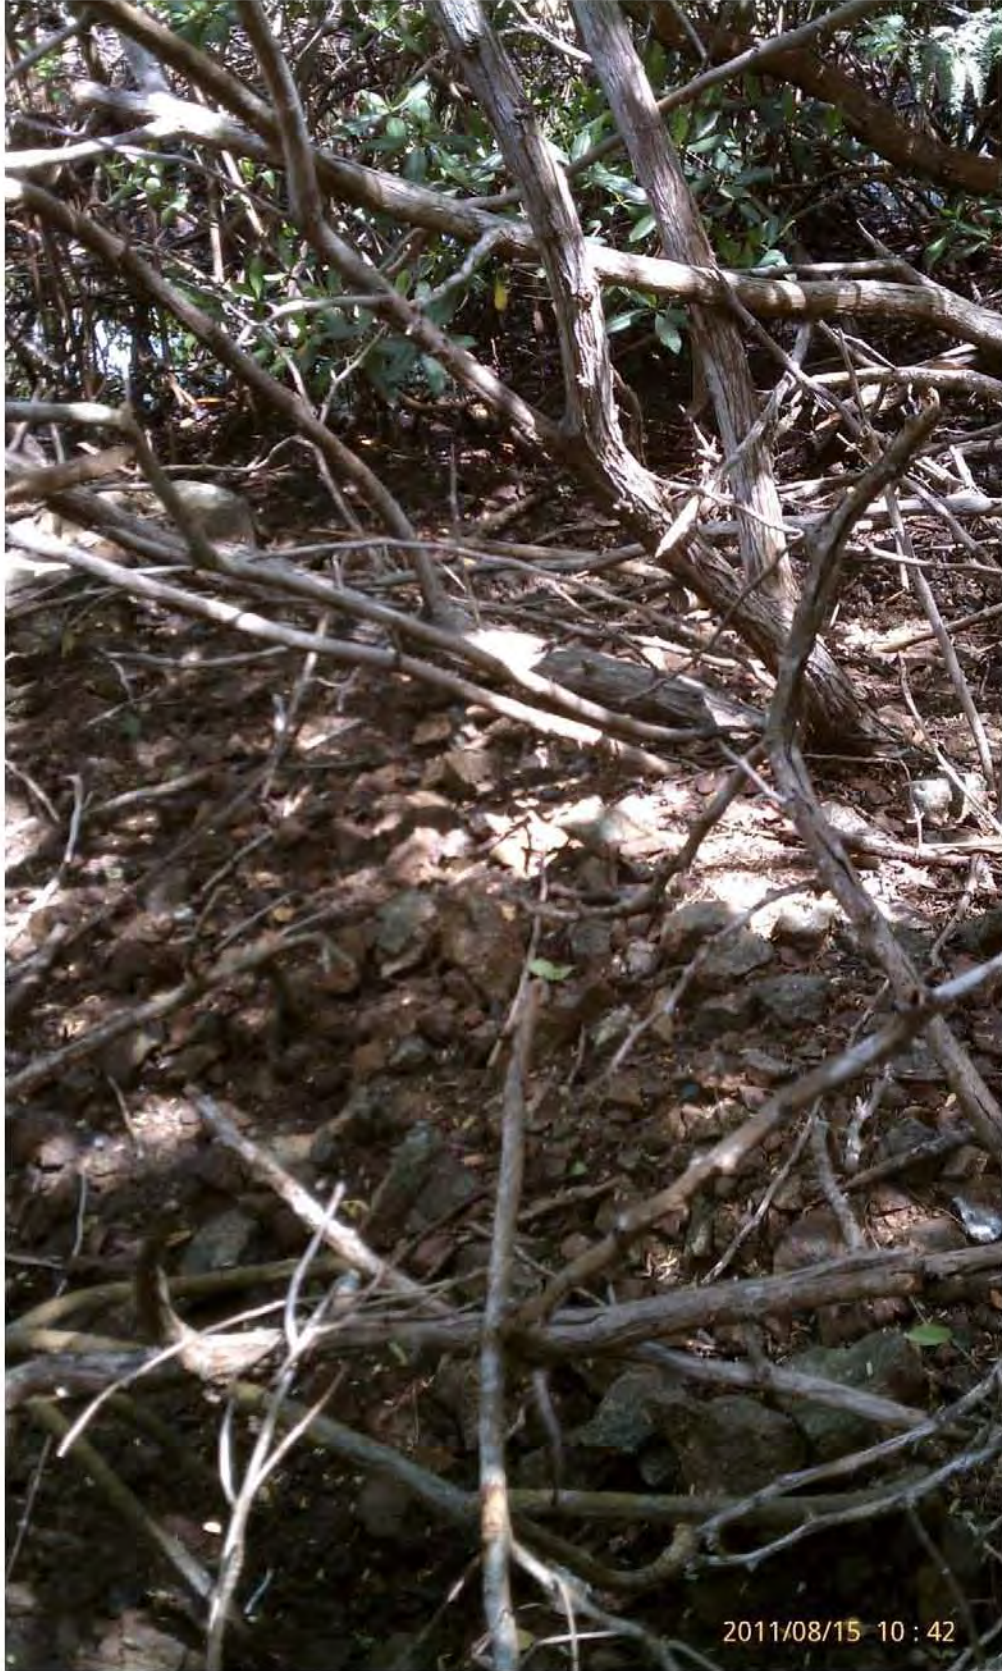
Building Materials:

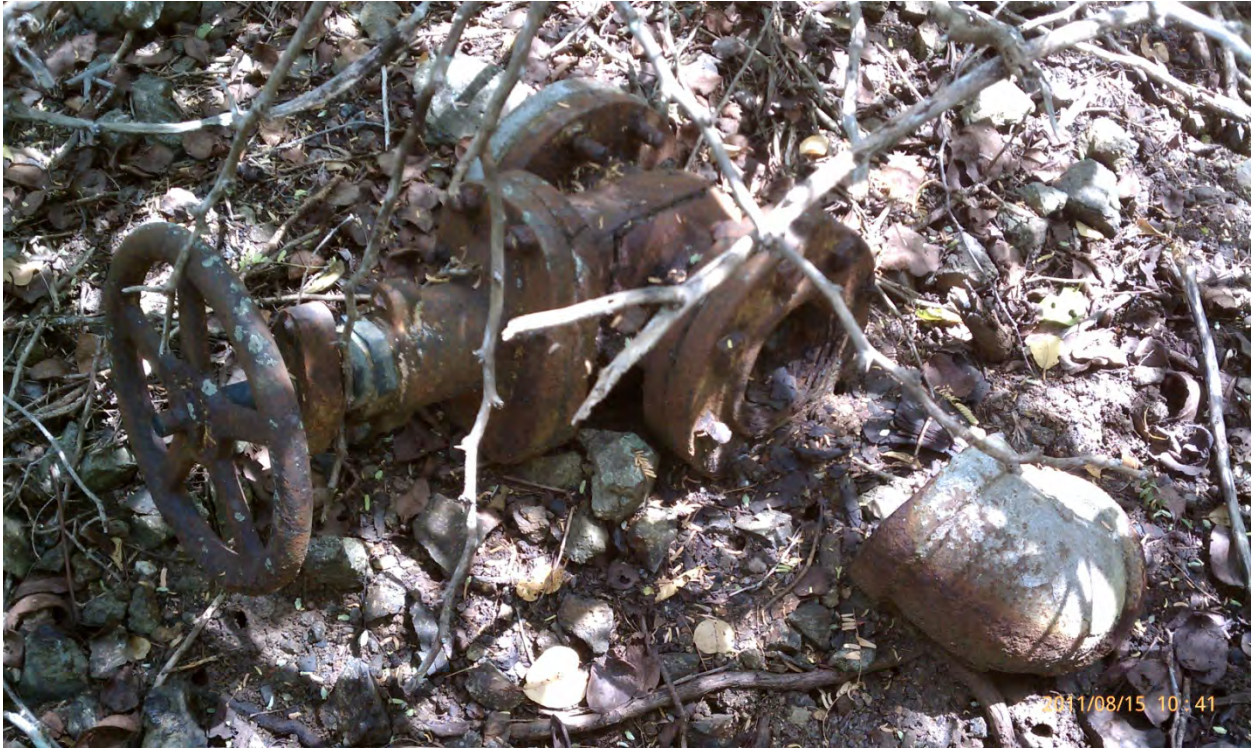
Photograph #13

Water Valve:

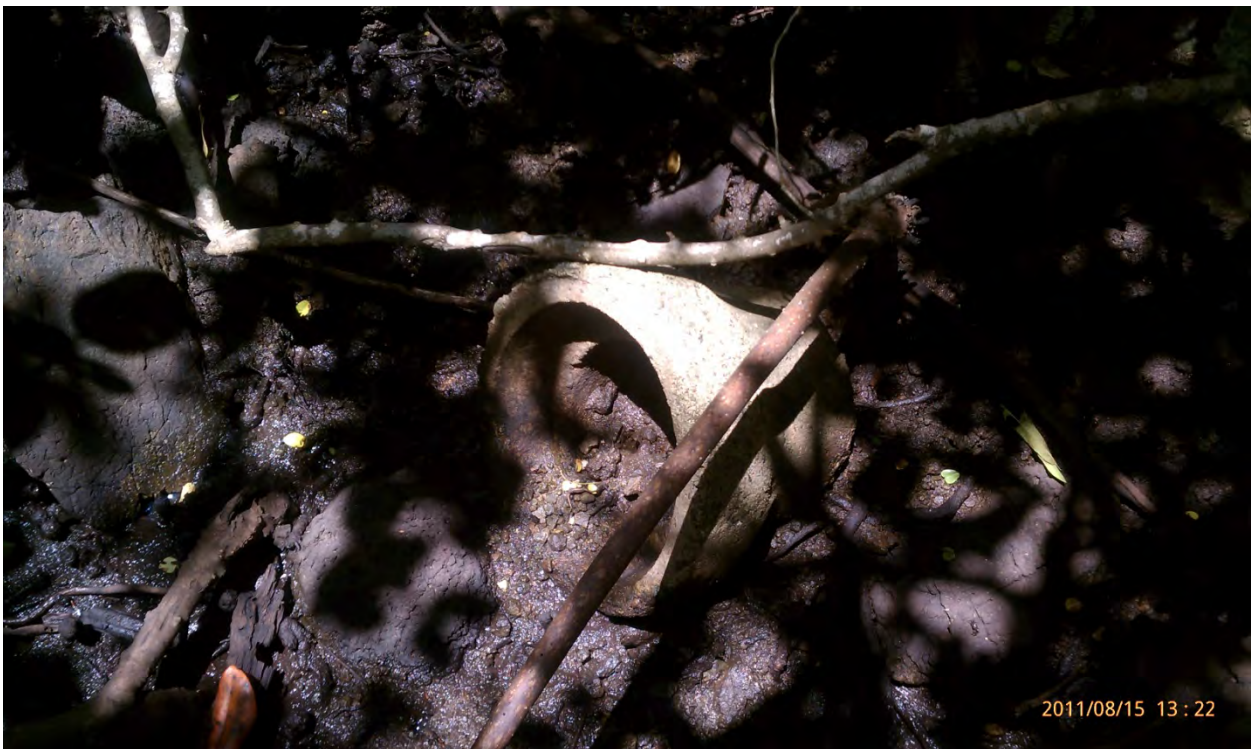
Photograph #14

Concrete Pipe:
