**Final
Hazardous, Toxic, and Radioactive Waste (HTRW)
Site Inspection Report
DERP-FUDS Site IO2PR006800
Former Lower Camp Debris Site
Culebra Island, Puerto Rico**

July 2012

Final
Hazardous, Toxic, and Radioactive Waste (HTRW)
Site Inspection Report
at DERP-FUDS Site IO2PR006800

Former Lower Camp Debris Site
Culebra Island, Puerto Rico

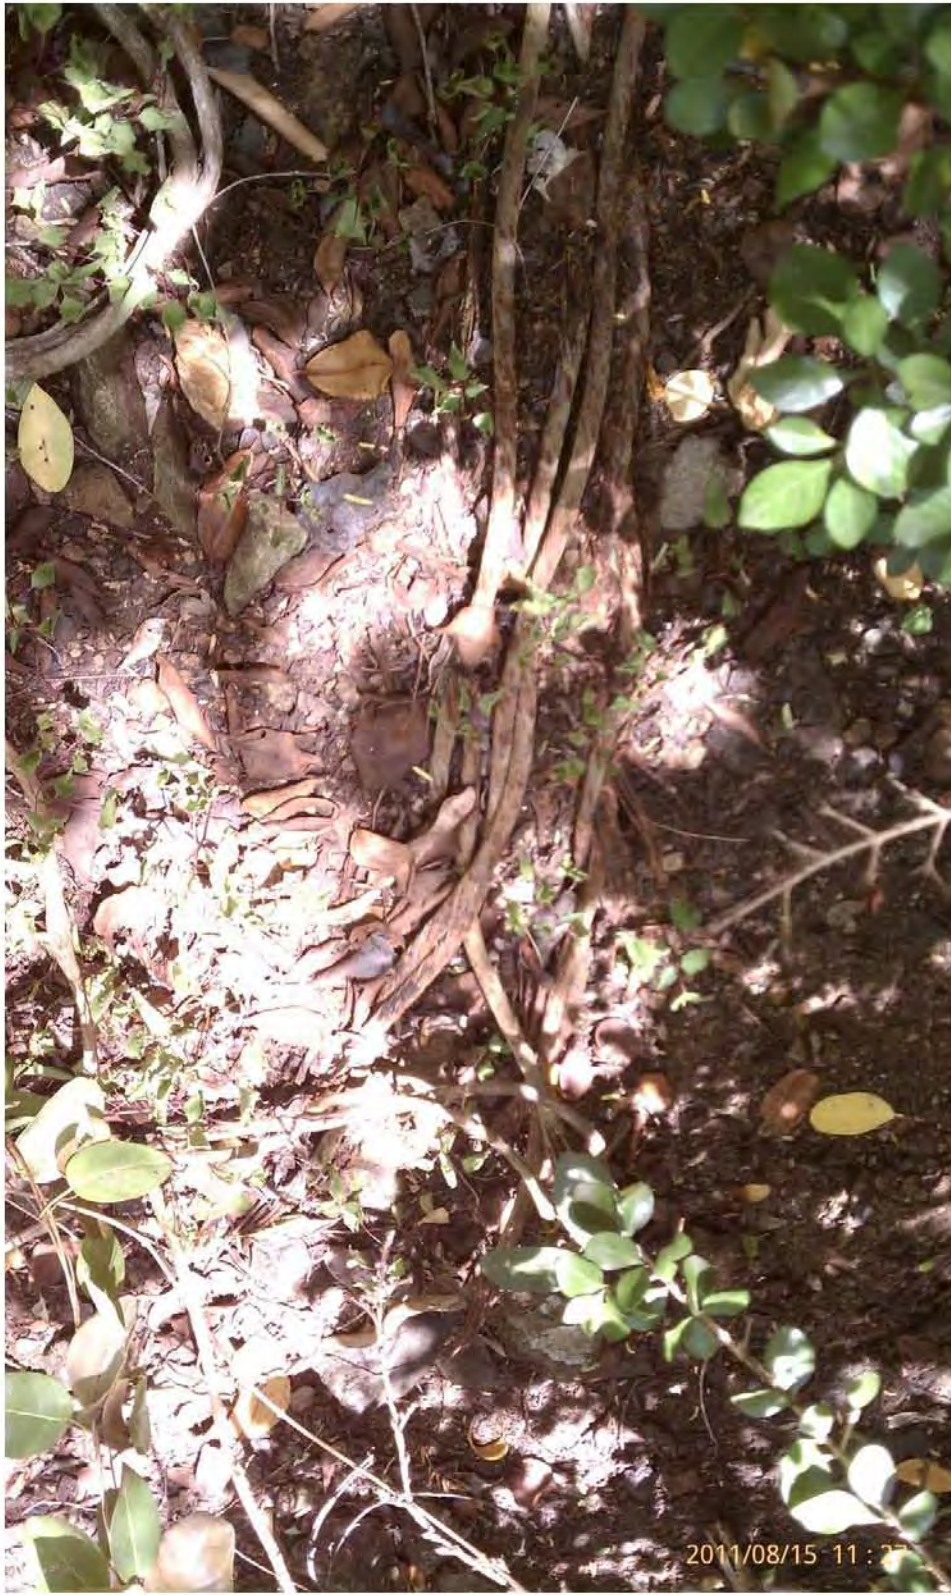
Photograph #15

Metal Braided Cables:

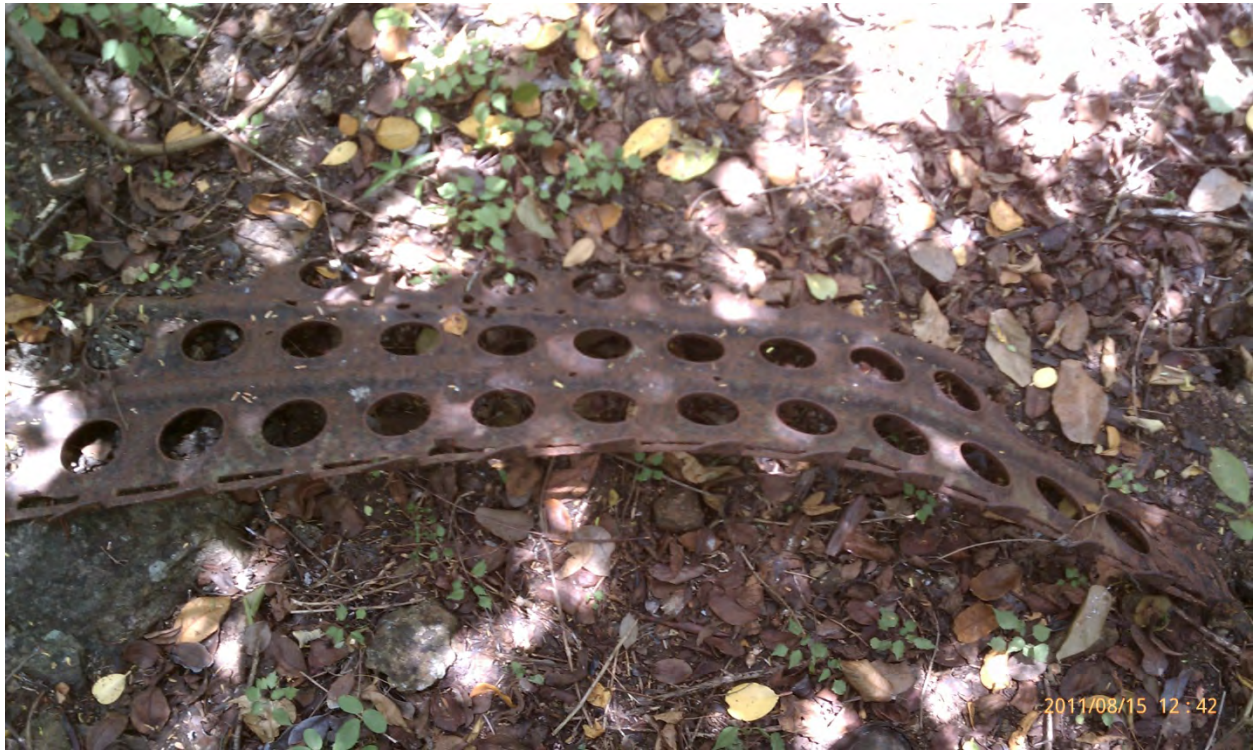
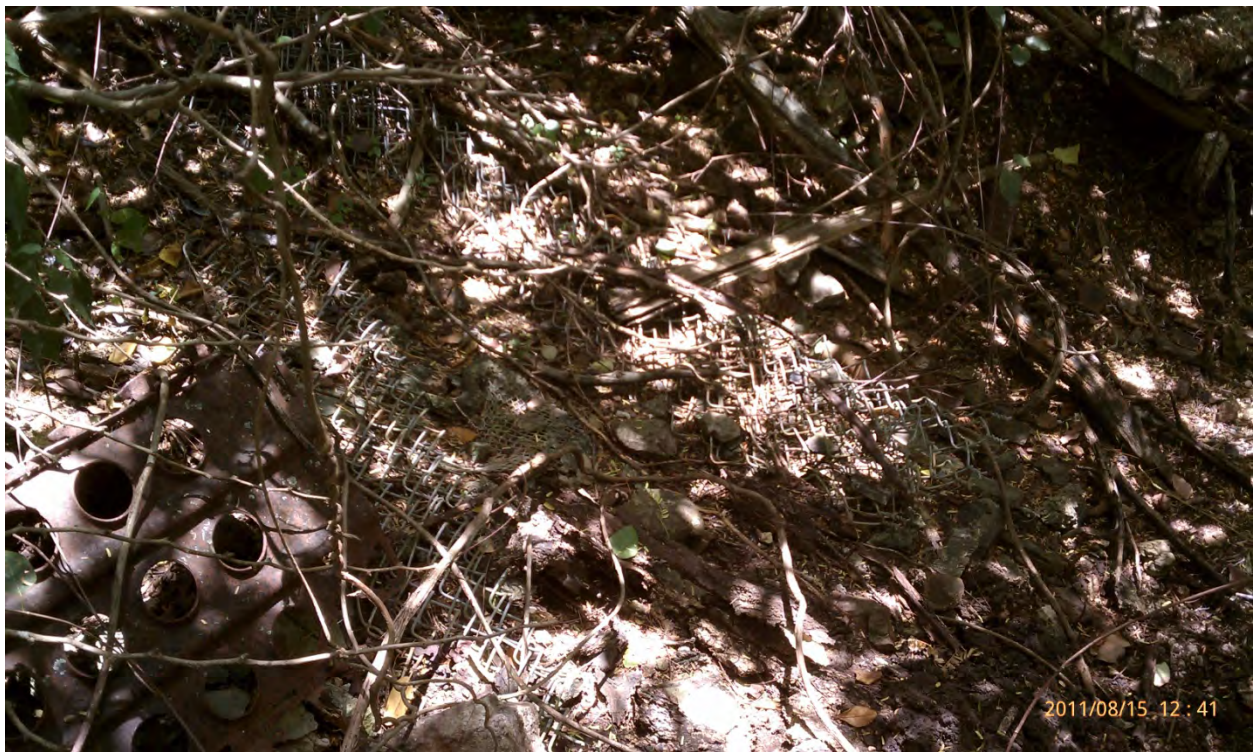
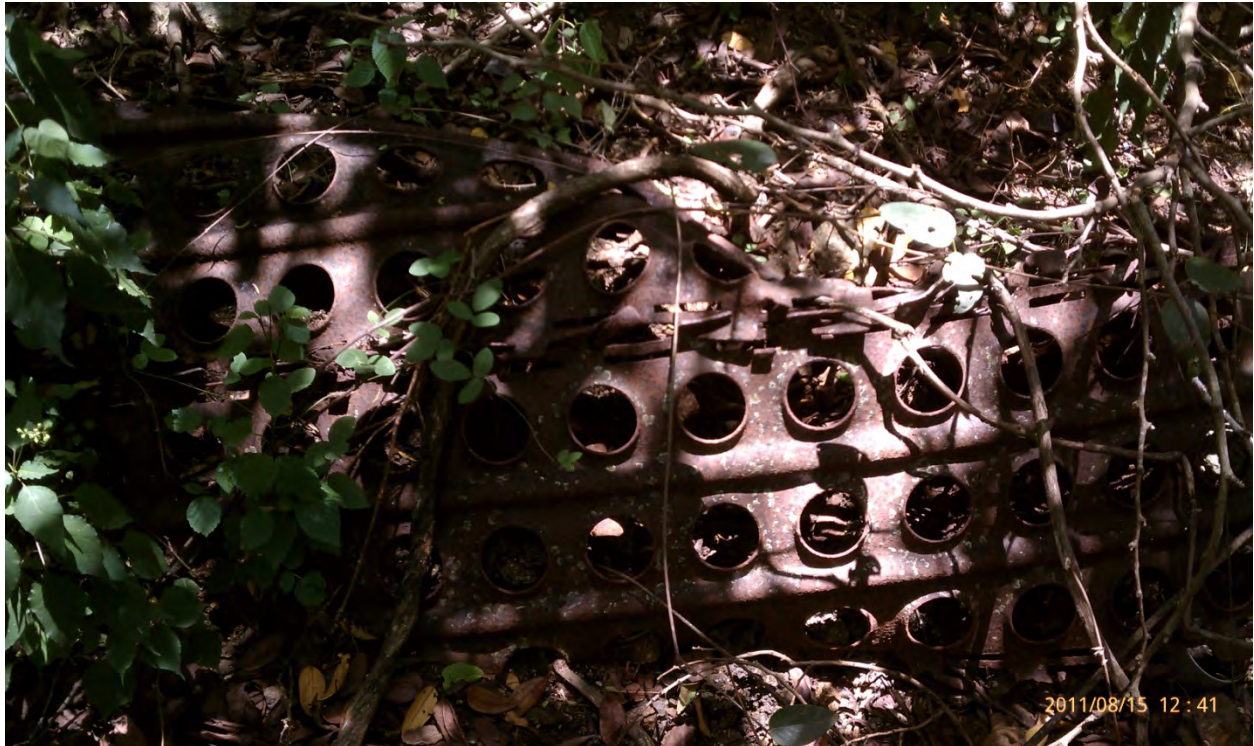
Metal Walkway:

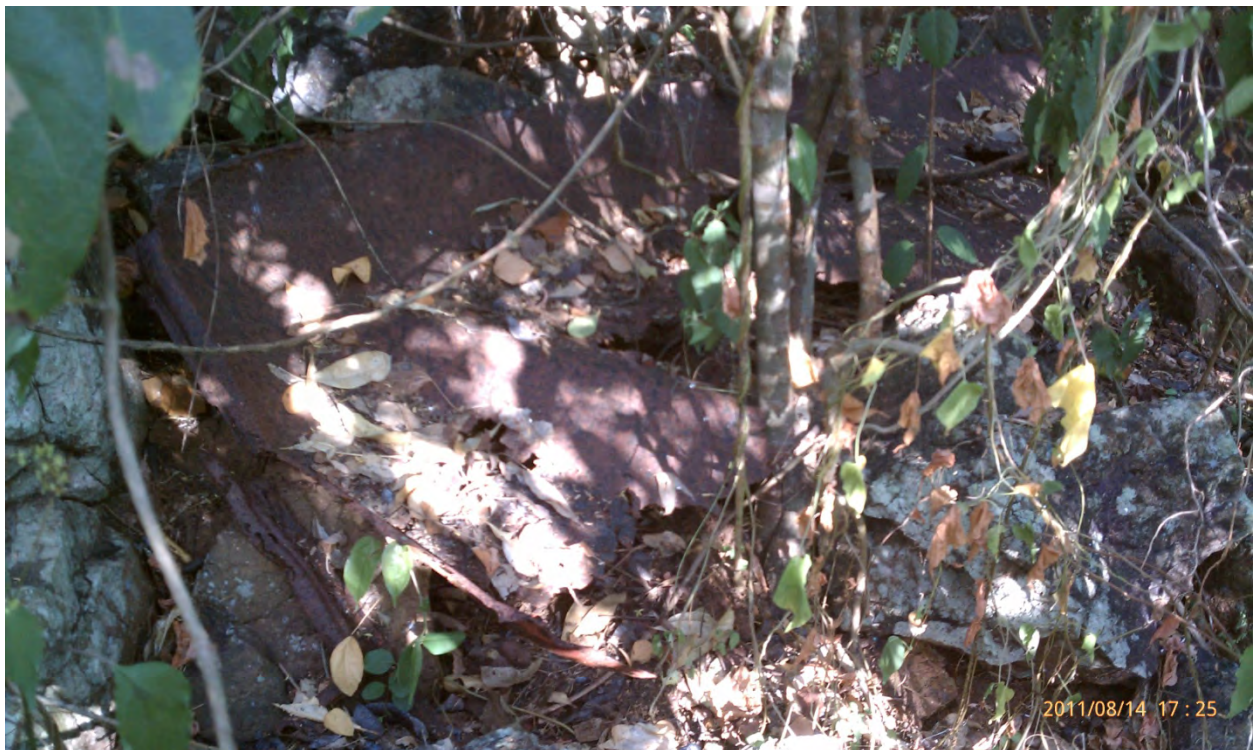
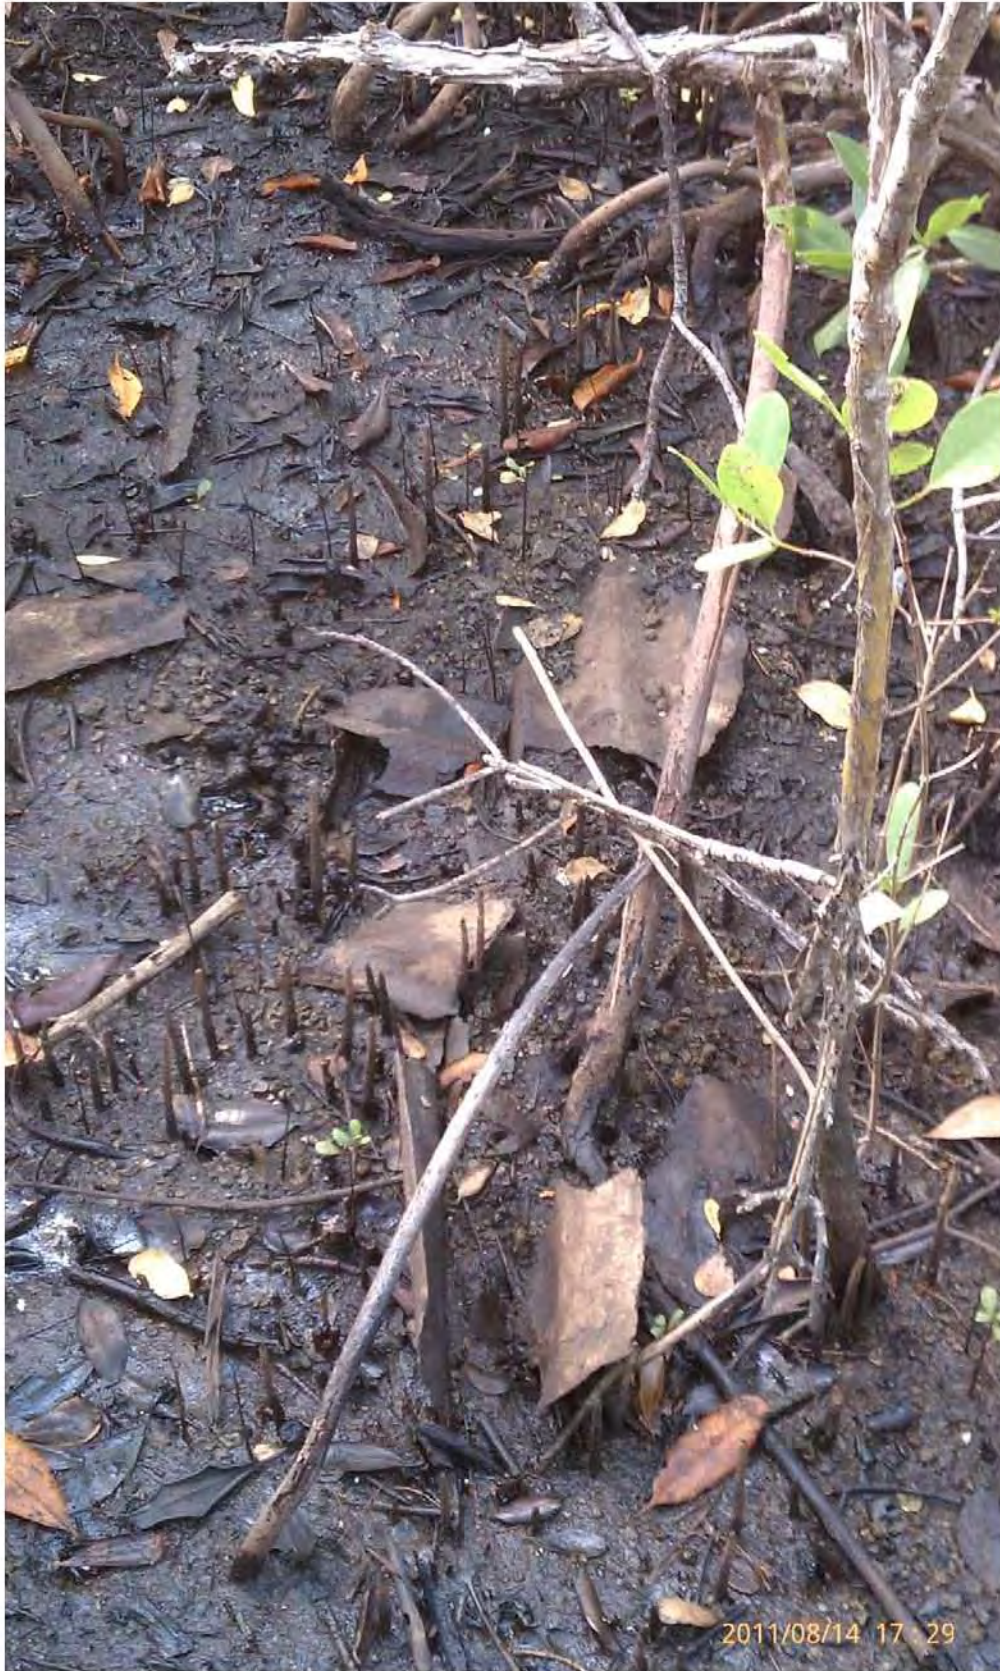
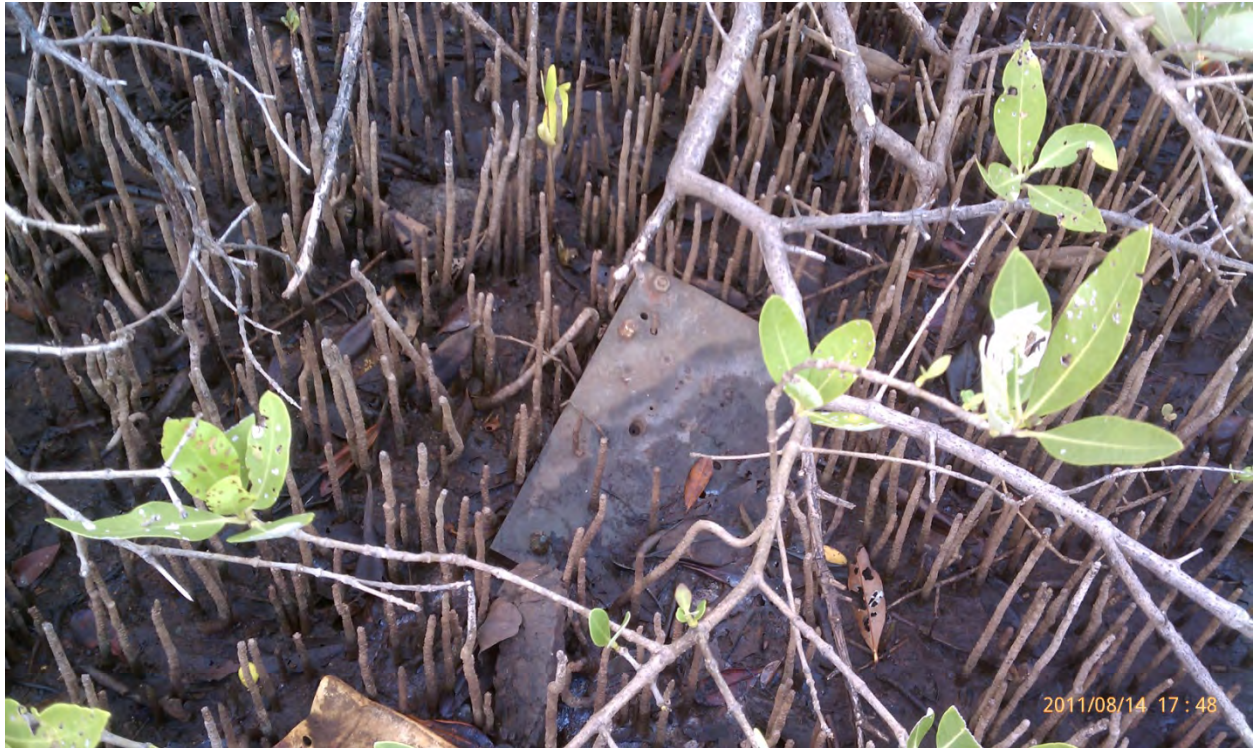
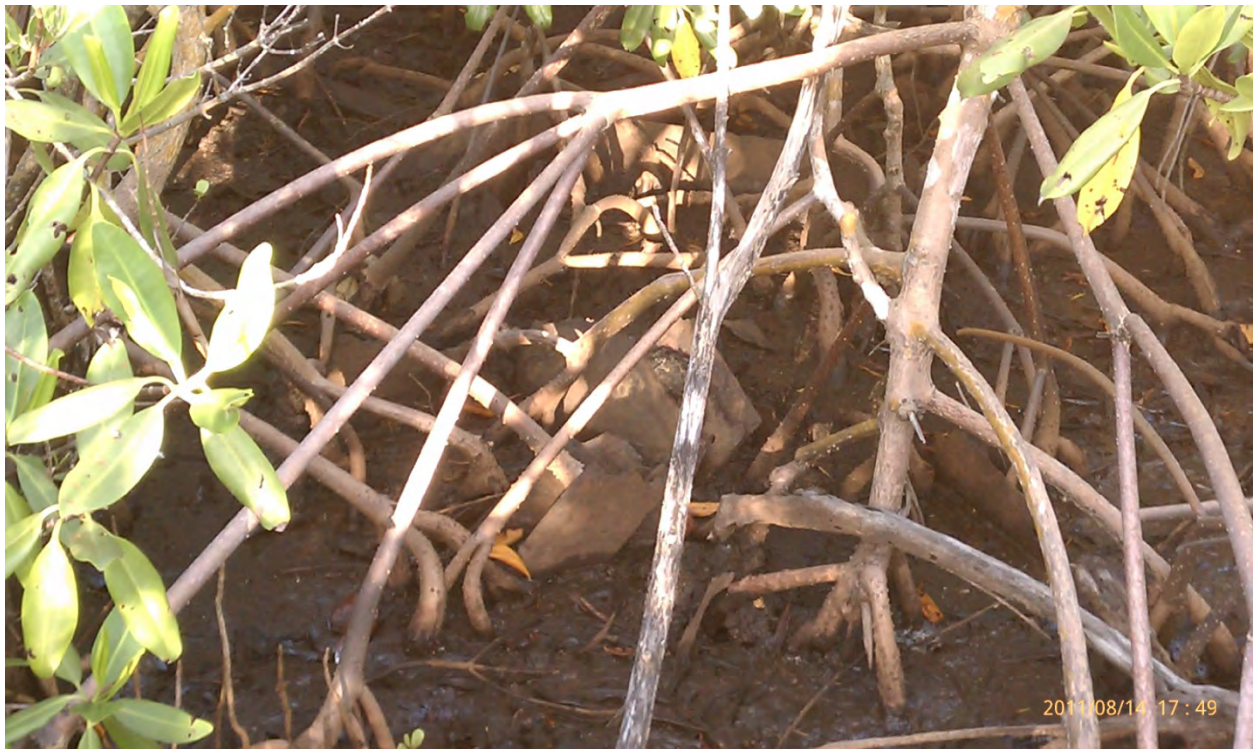
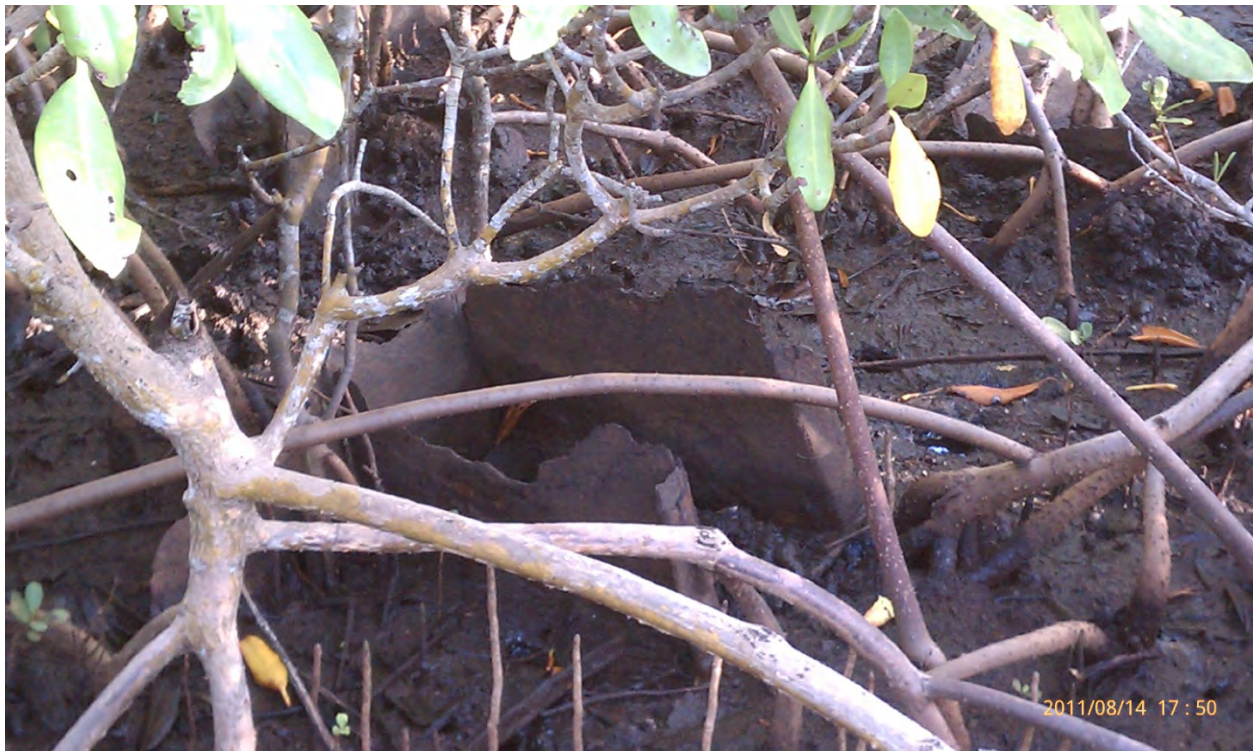
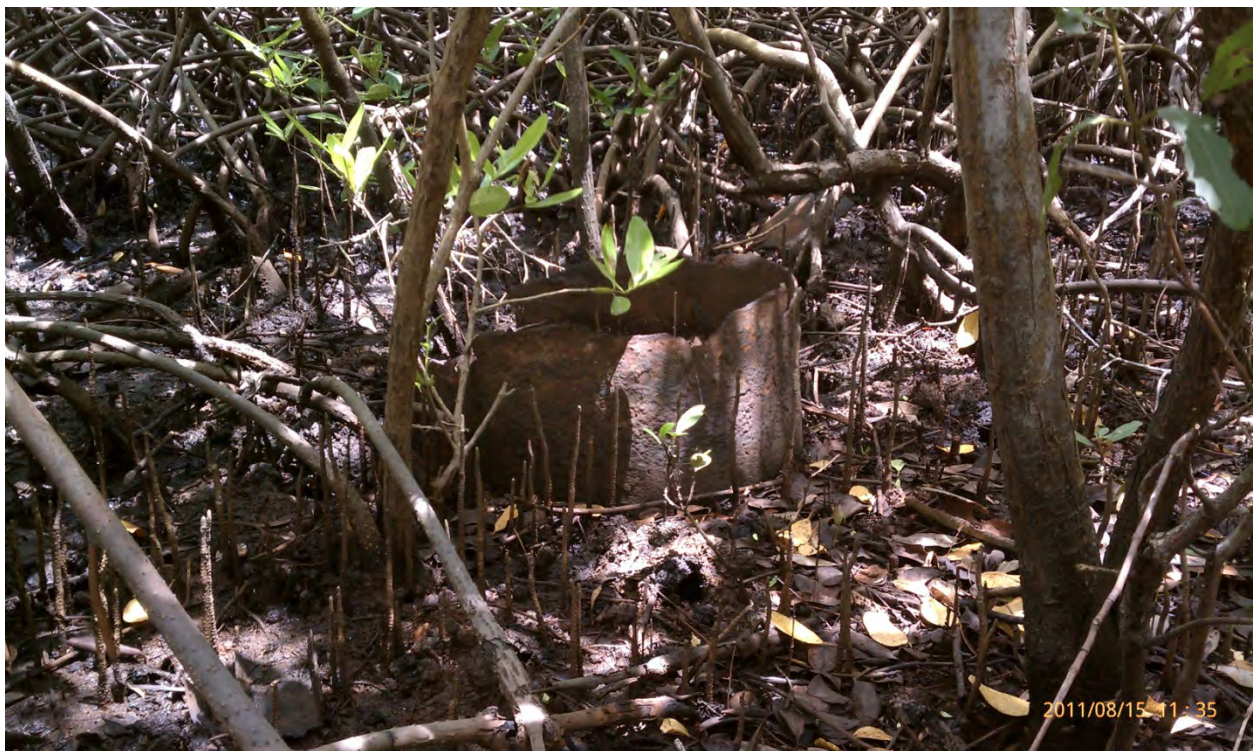
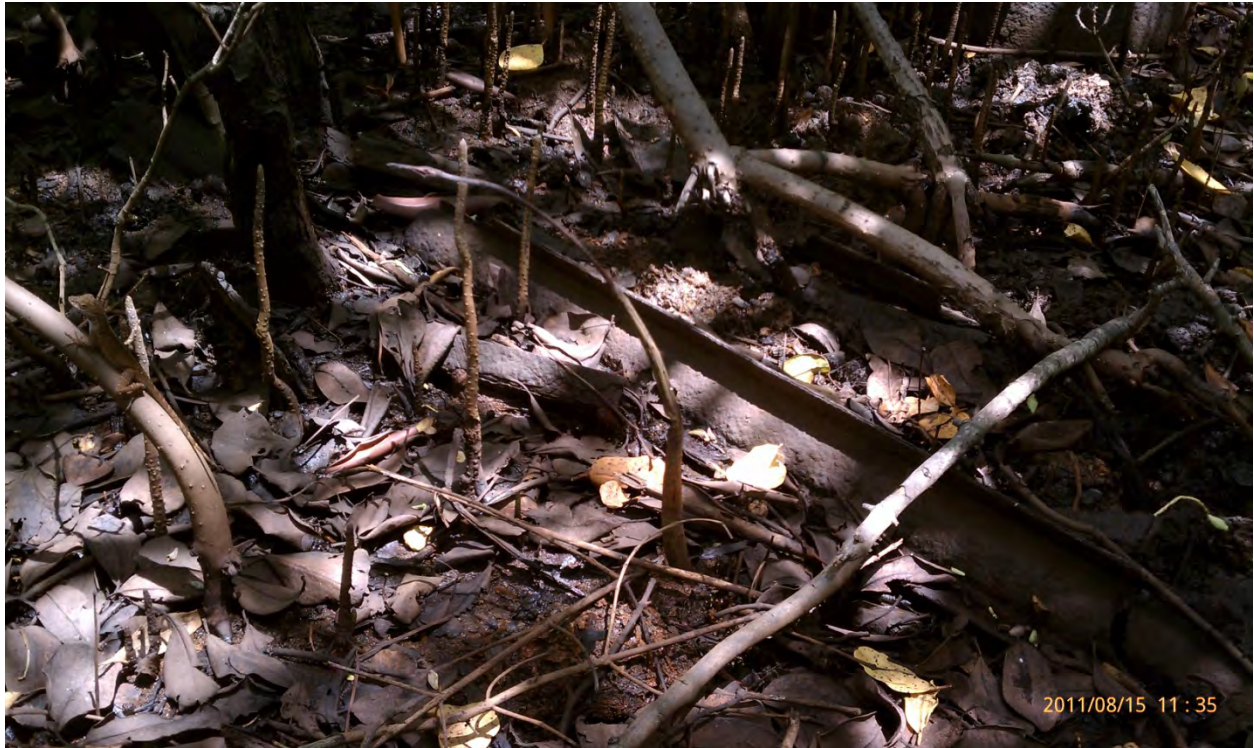
Highly Deteriorated Oxidized Metal:

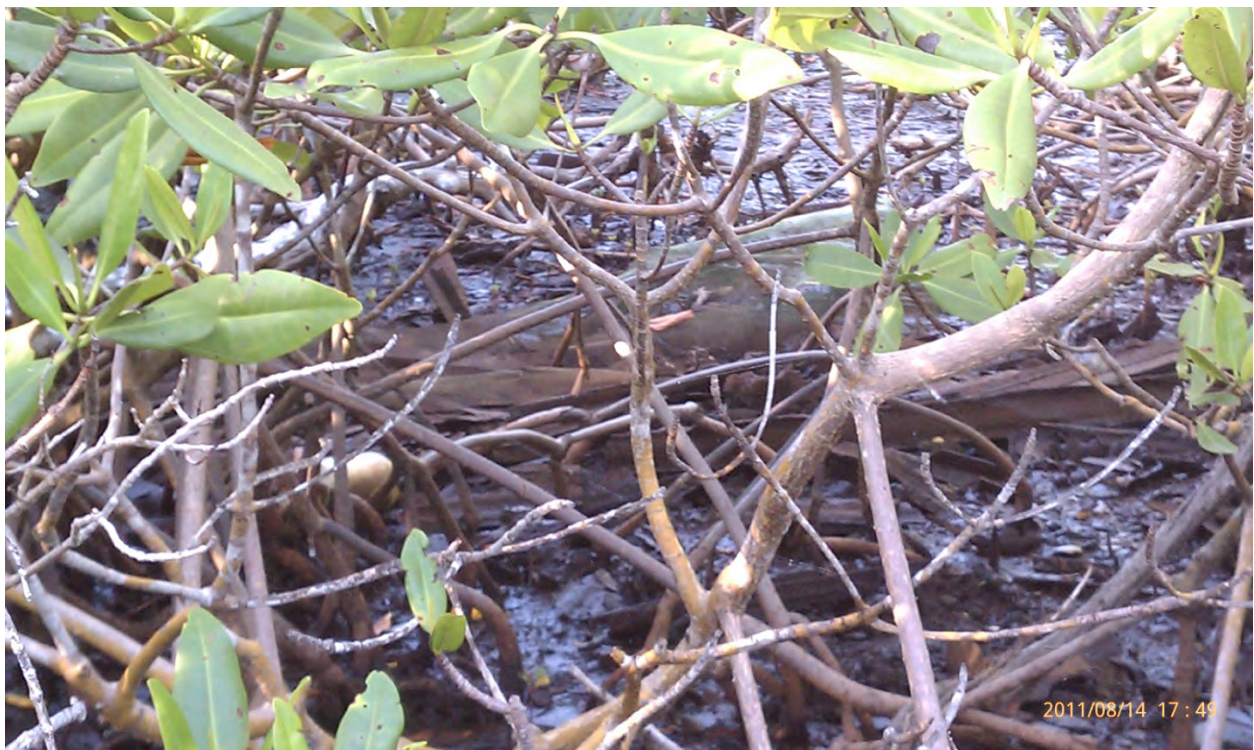
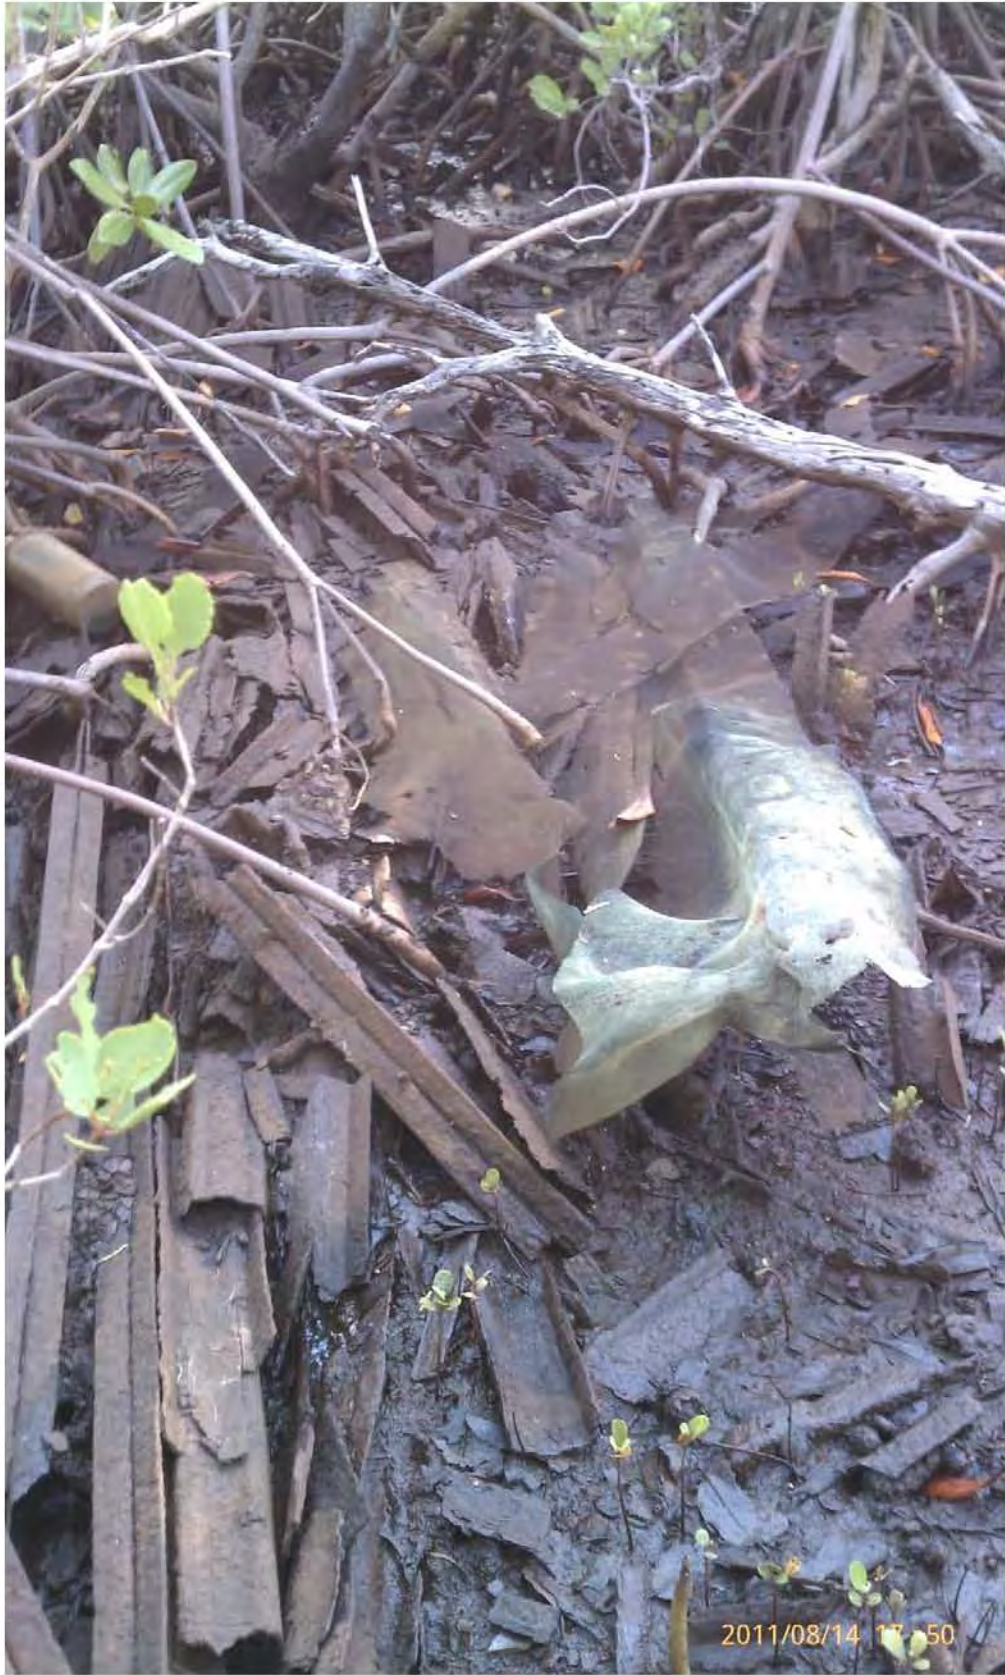
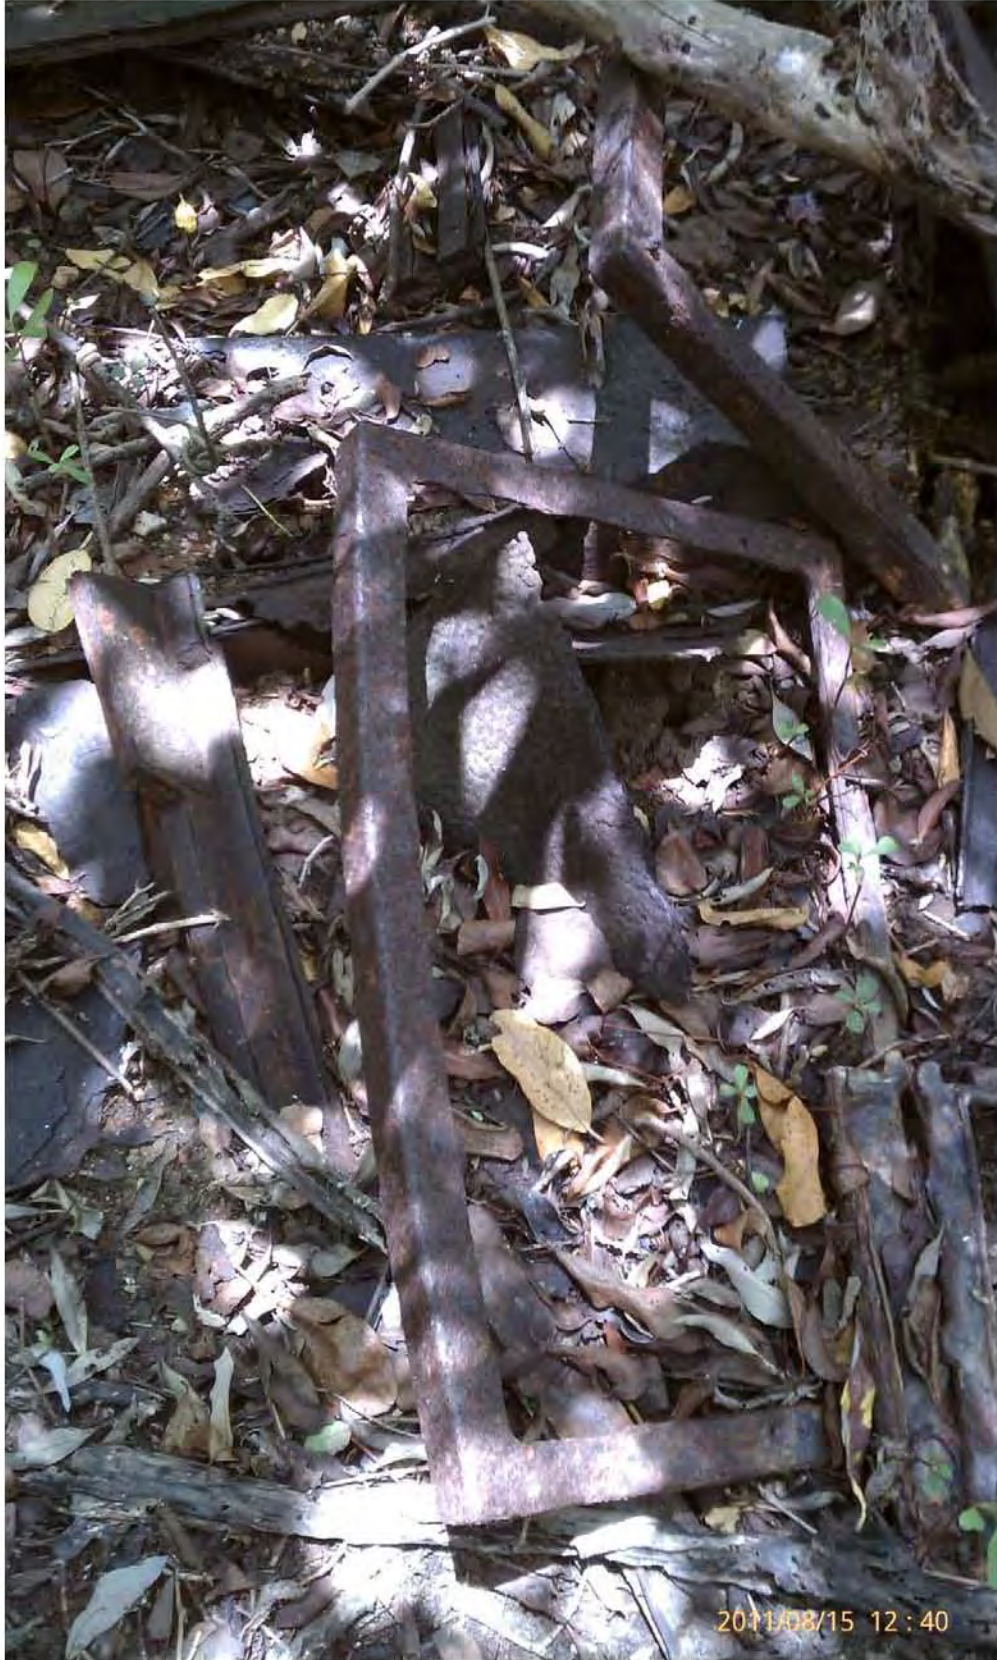
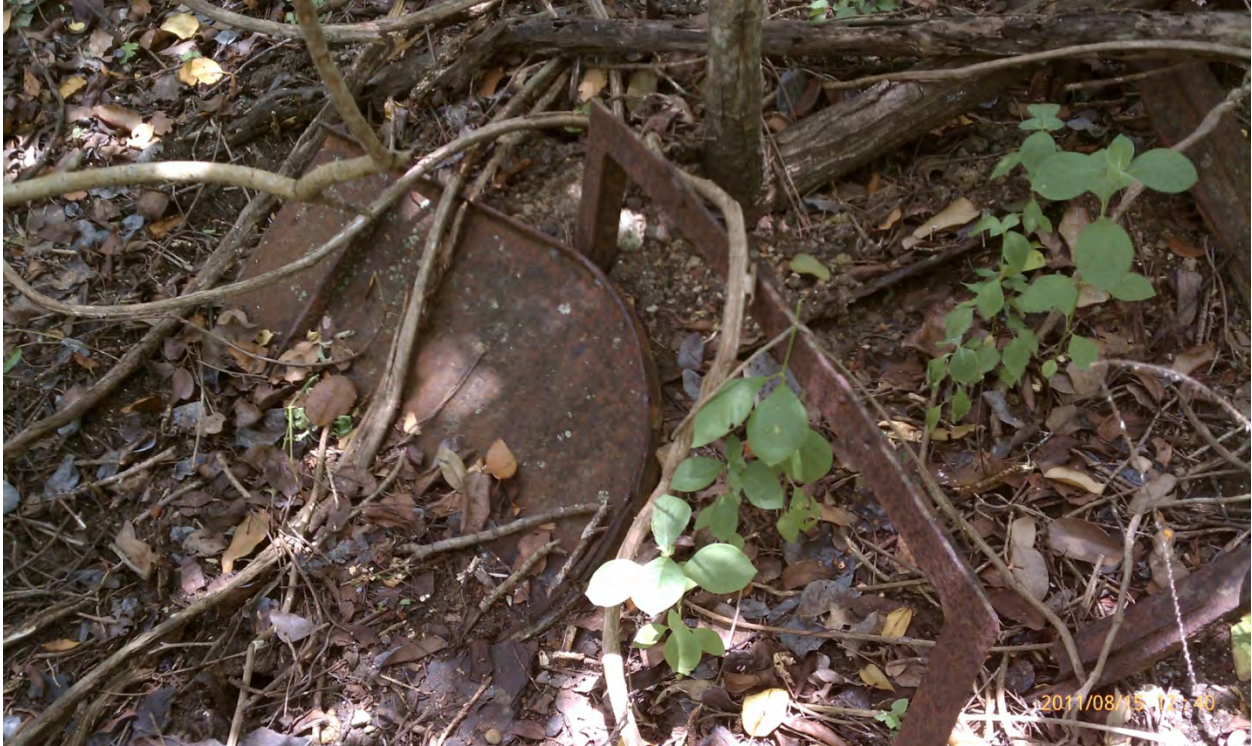
Highly Deteriorated Oxidized Metal Pile:

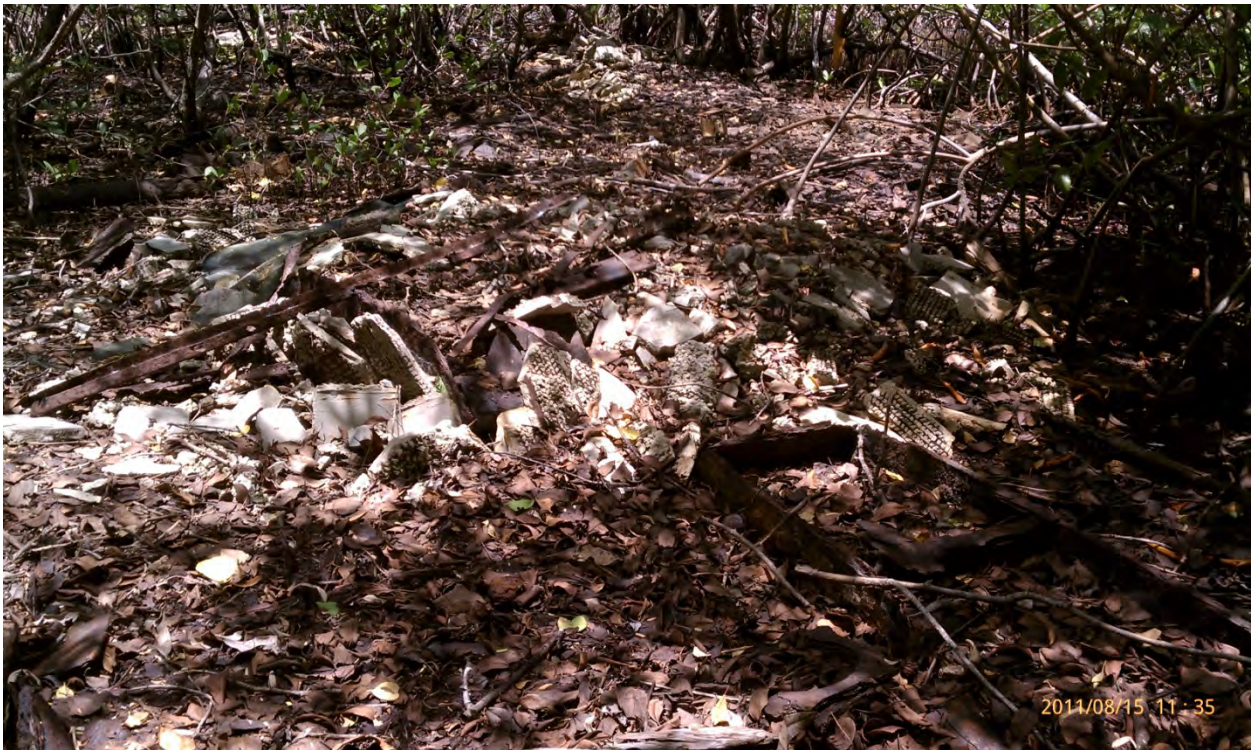
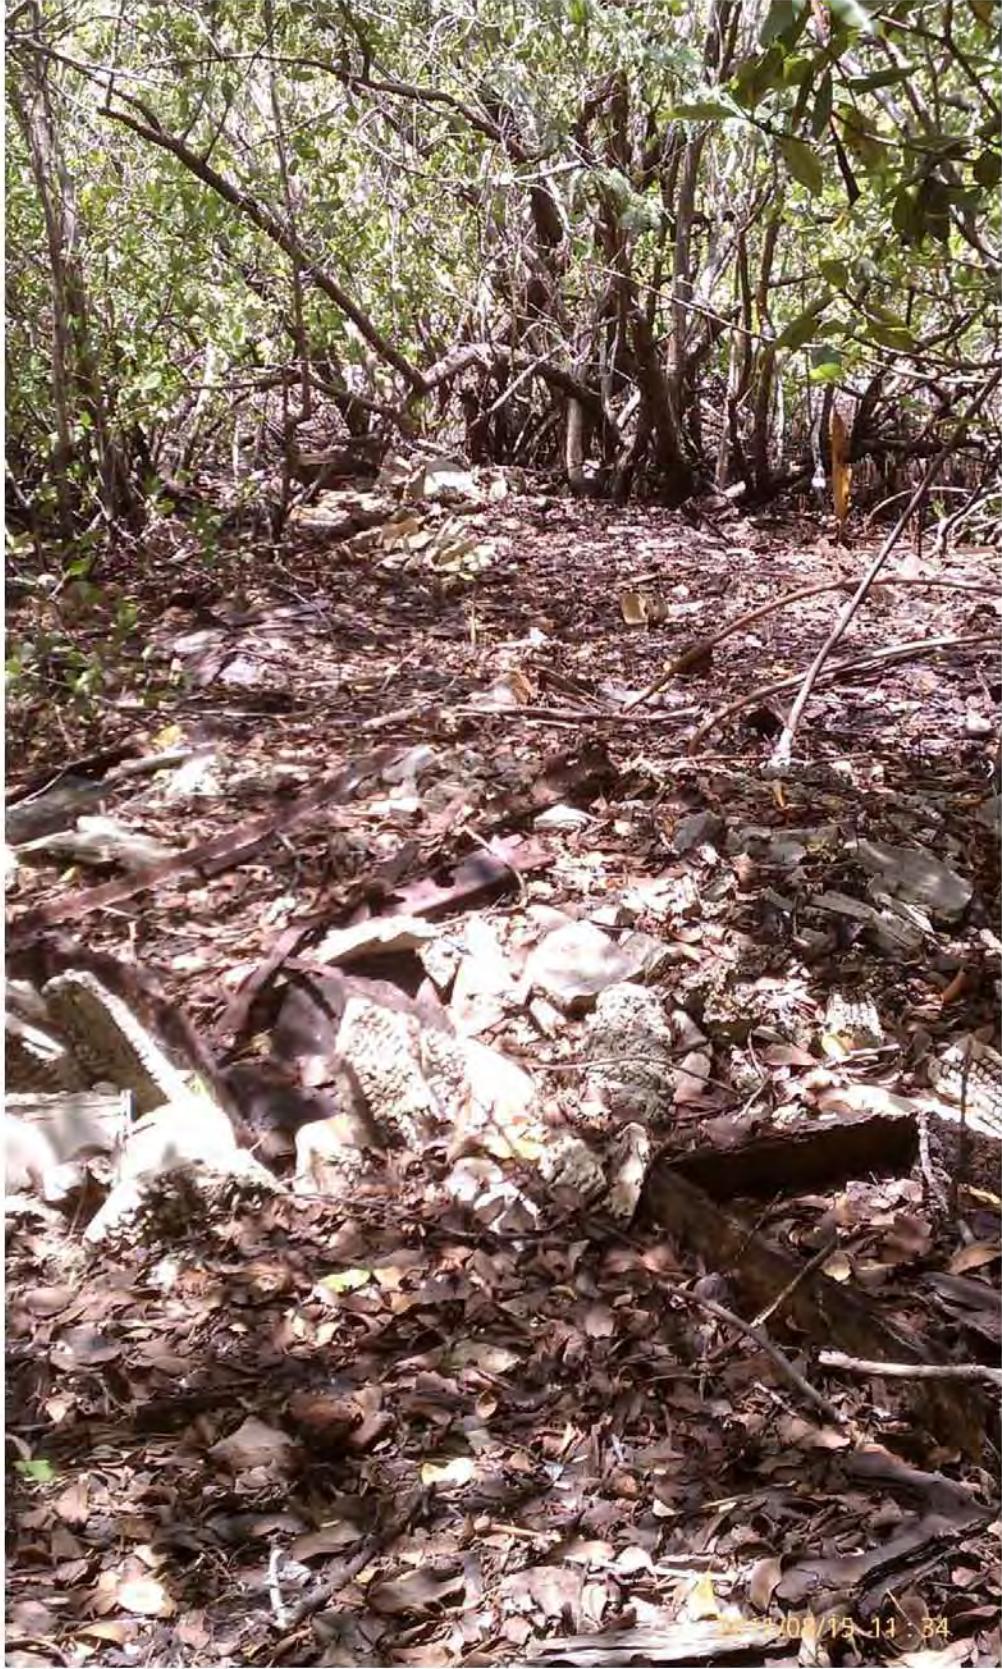
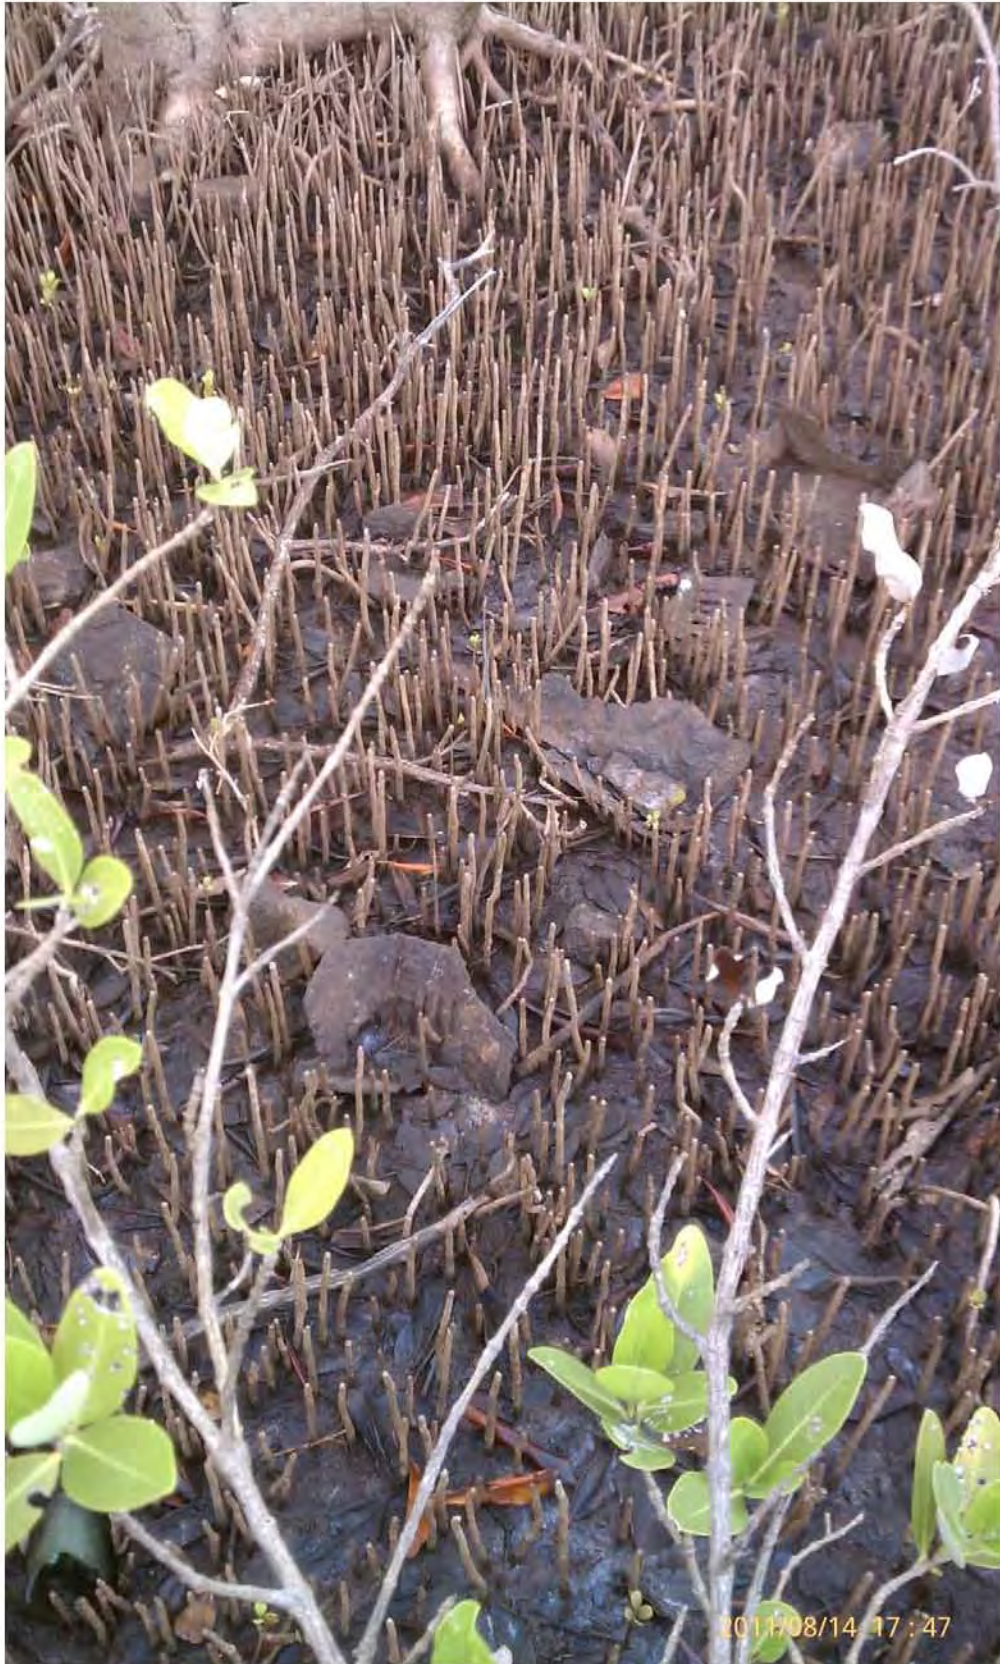
Highly Deteriorated Oxidized Metal and Building Material:

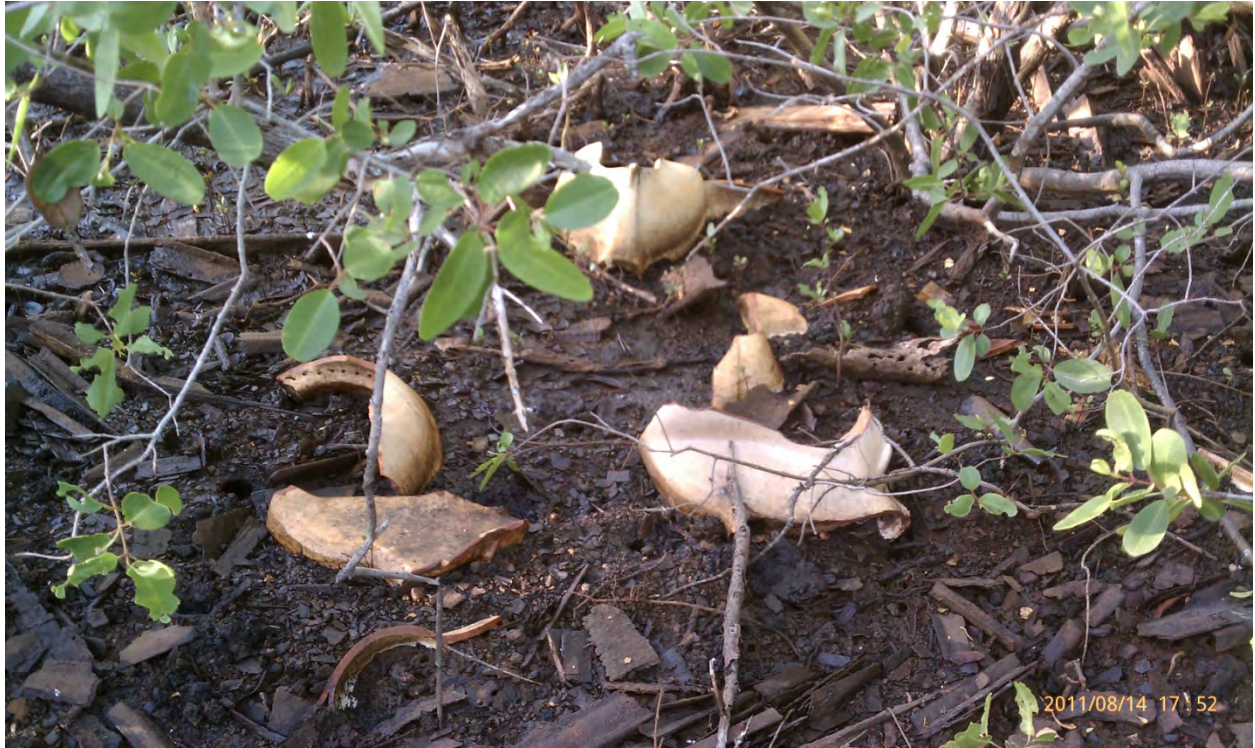
Photograph #35

Broken Porcelain and Highly Deteriorated Oxidized Metal:
