**Final
Hazardous, Toxic, and Radioactive Waste (HTRW)
Site Inspection Report
DERP-FUDS Site IO2PR006800
Former Lower Camp Debris Site
Culebra Island, Puerto Rico**

July 2012

Final
Hazardous, Toxic, and Radioactive Waste (HTRW)
Site Inspection Report
at DERP-FUDS Site IO2PR006800

Former Lower Camp Debris Site
Culebra Island, Puerto Rico

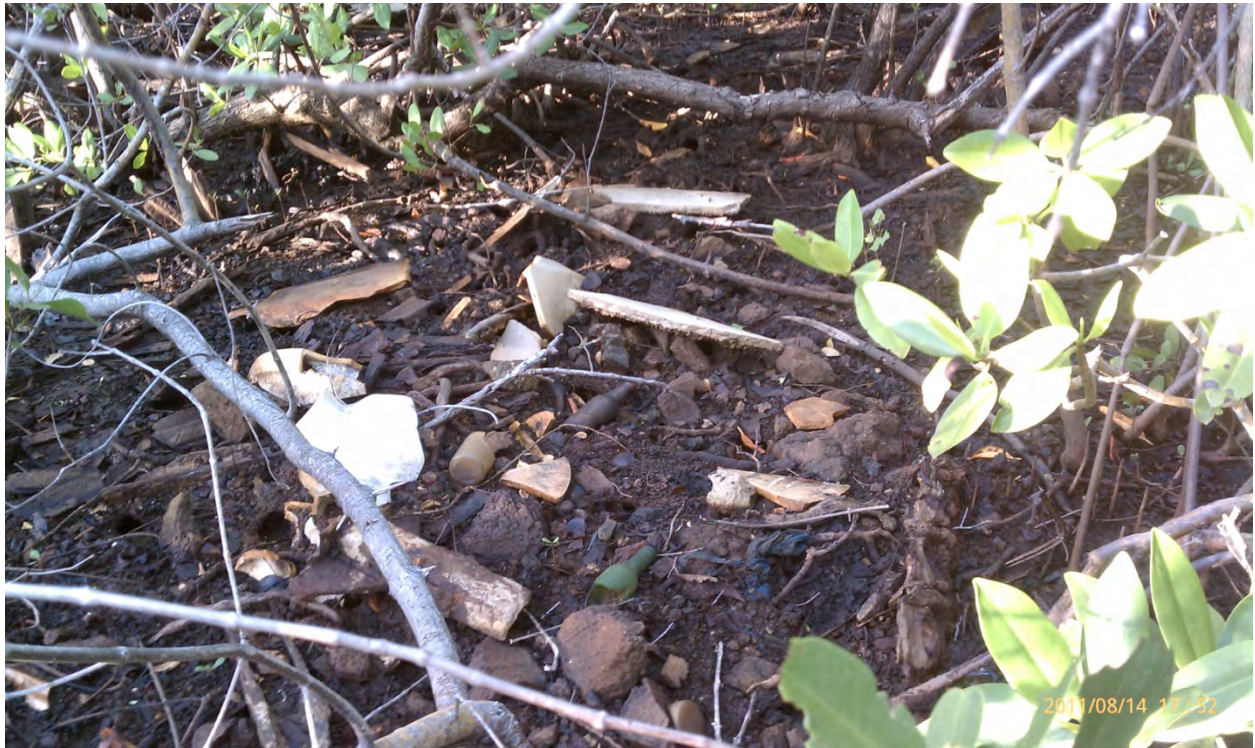
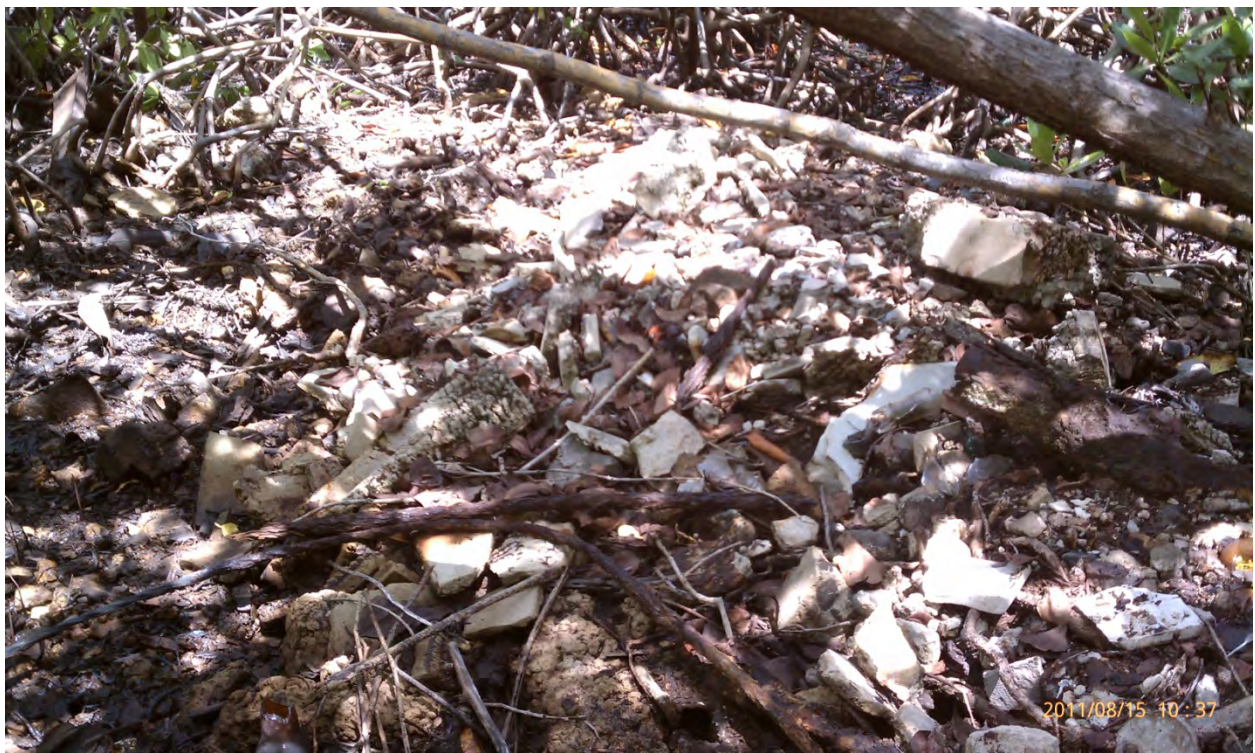
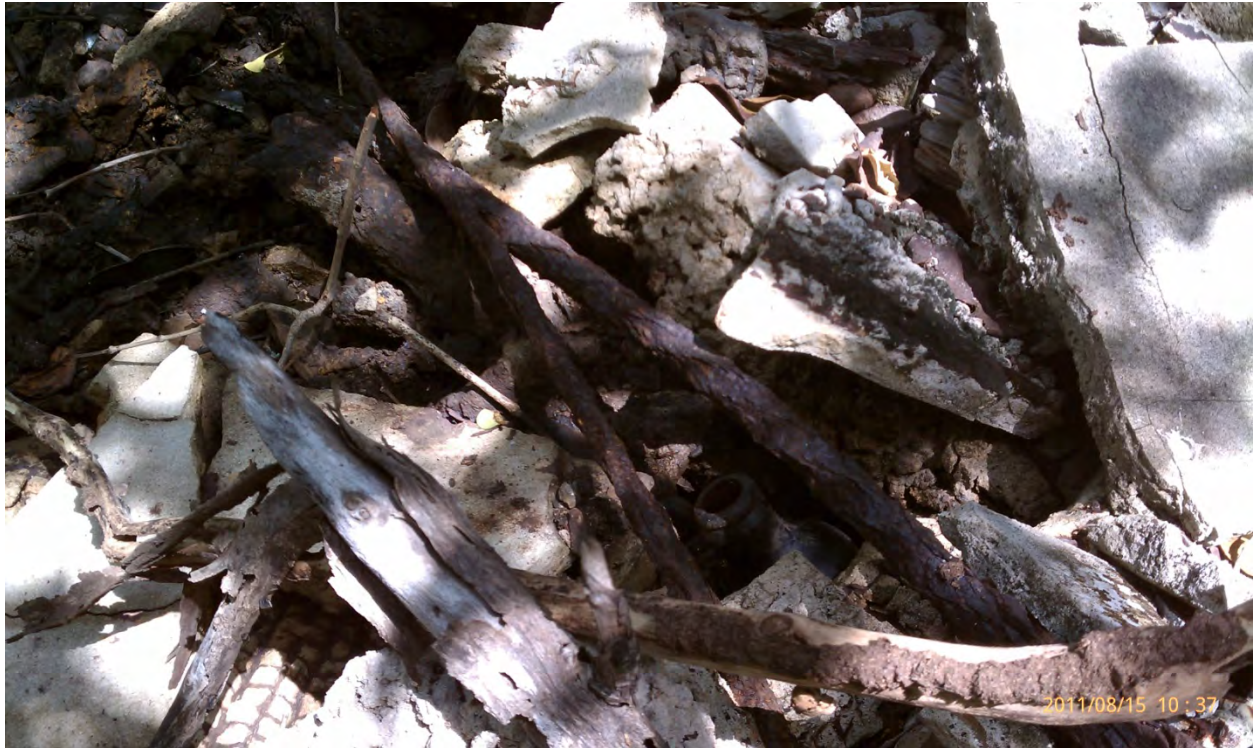
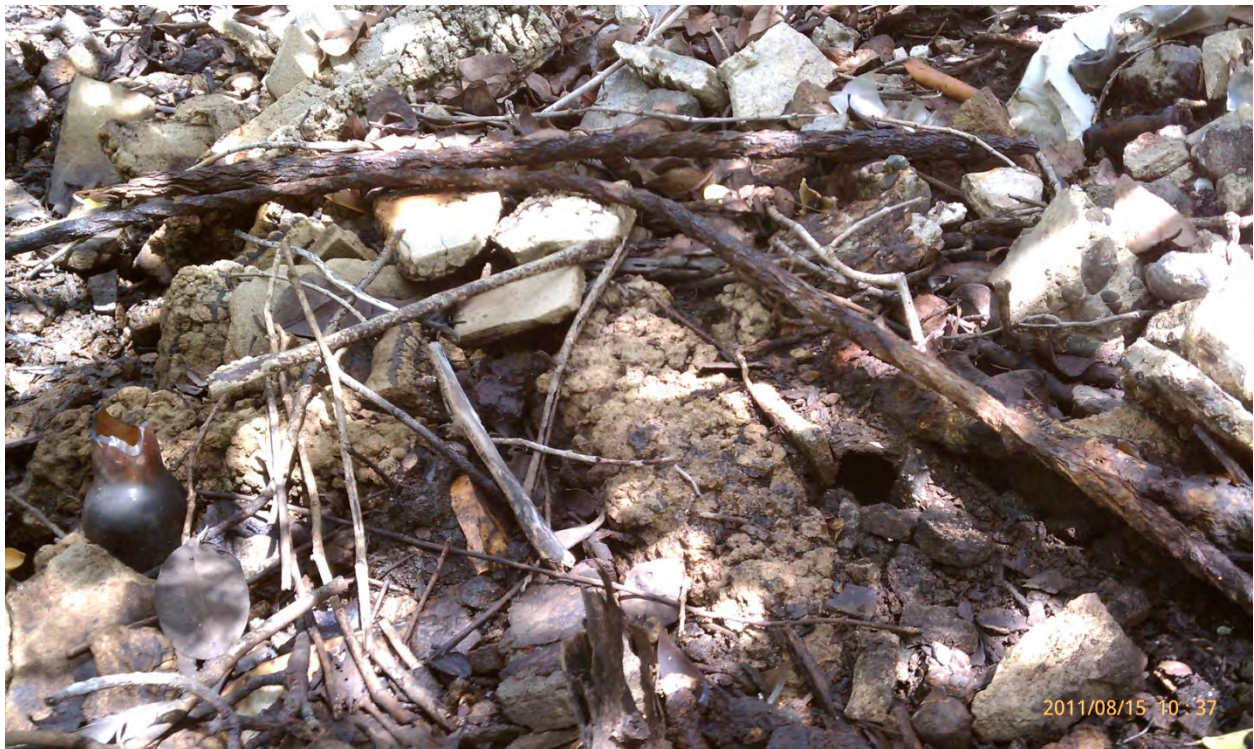
Broken Porcelain, Highly Deteriorated Oxidized Metal, Building Materials, and Broken Bottles:

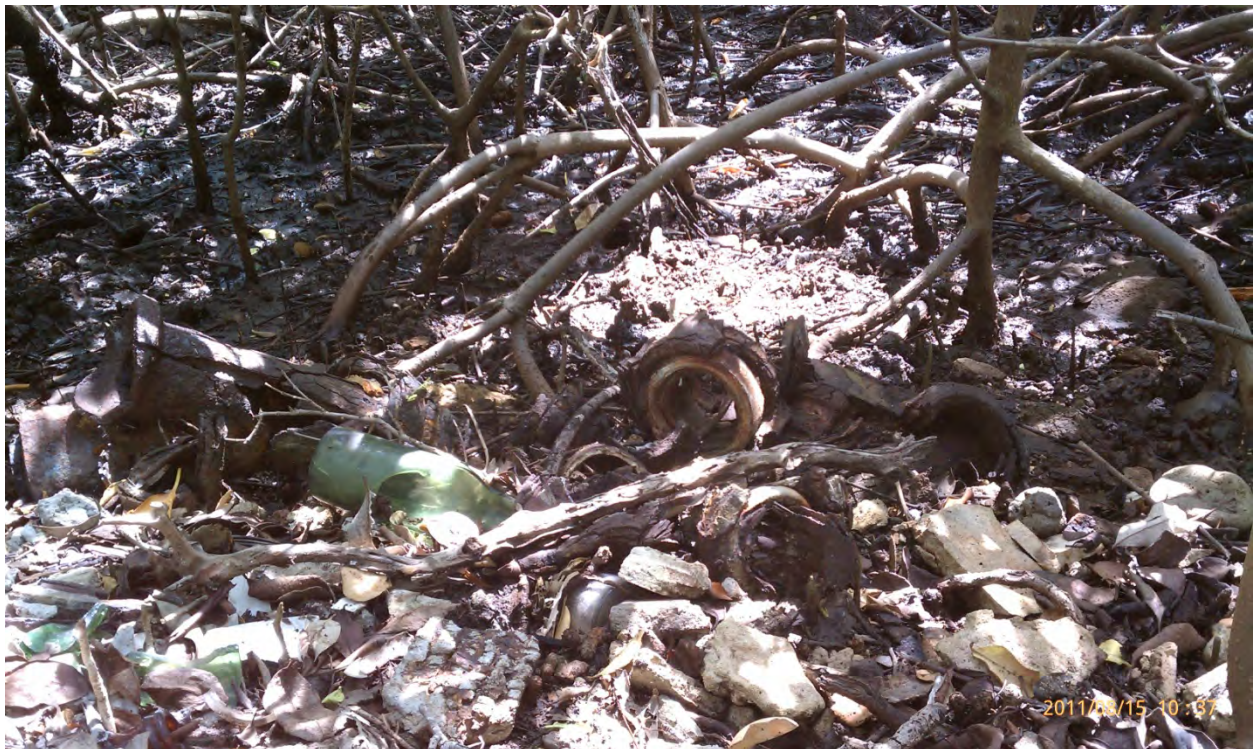
Photograph #41

Metal Pipes:

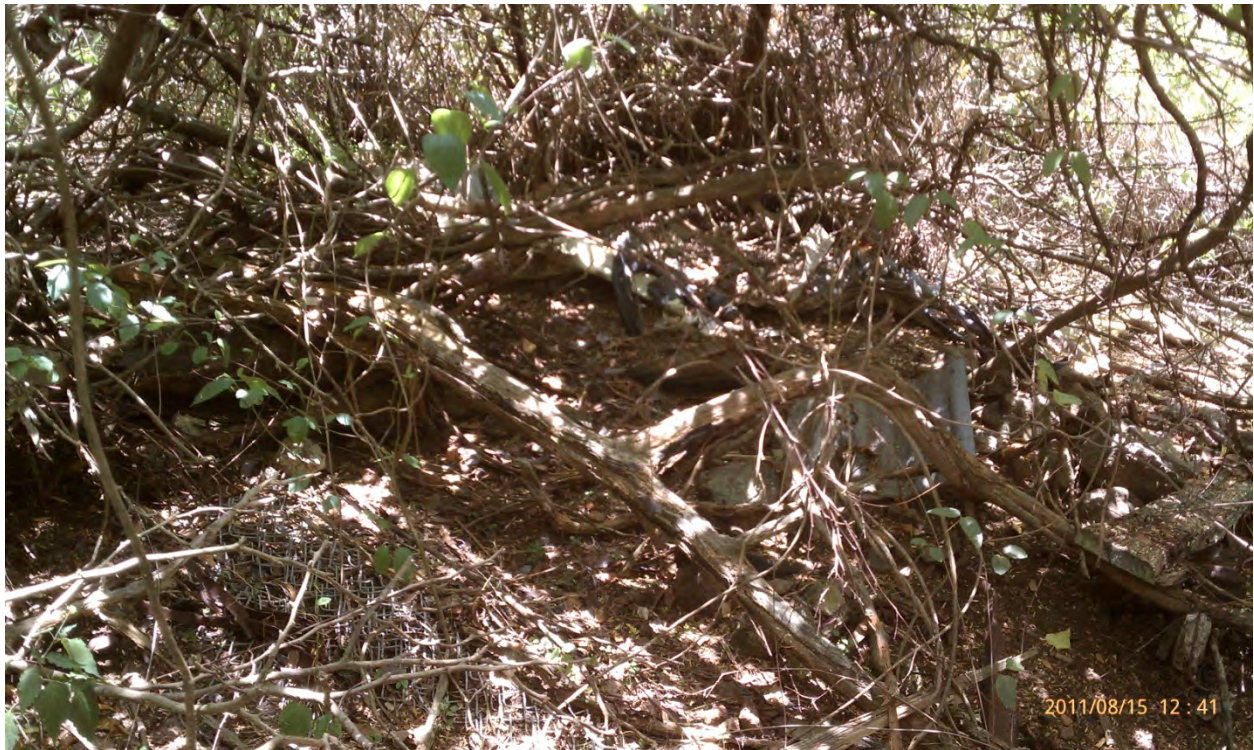
Photograph #43

Metal Chain Linked Fencing, Corrugated Sheets, Building Materials:

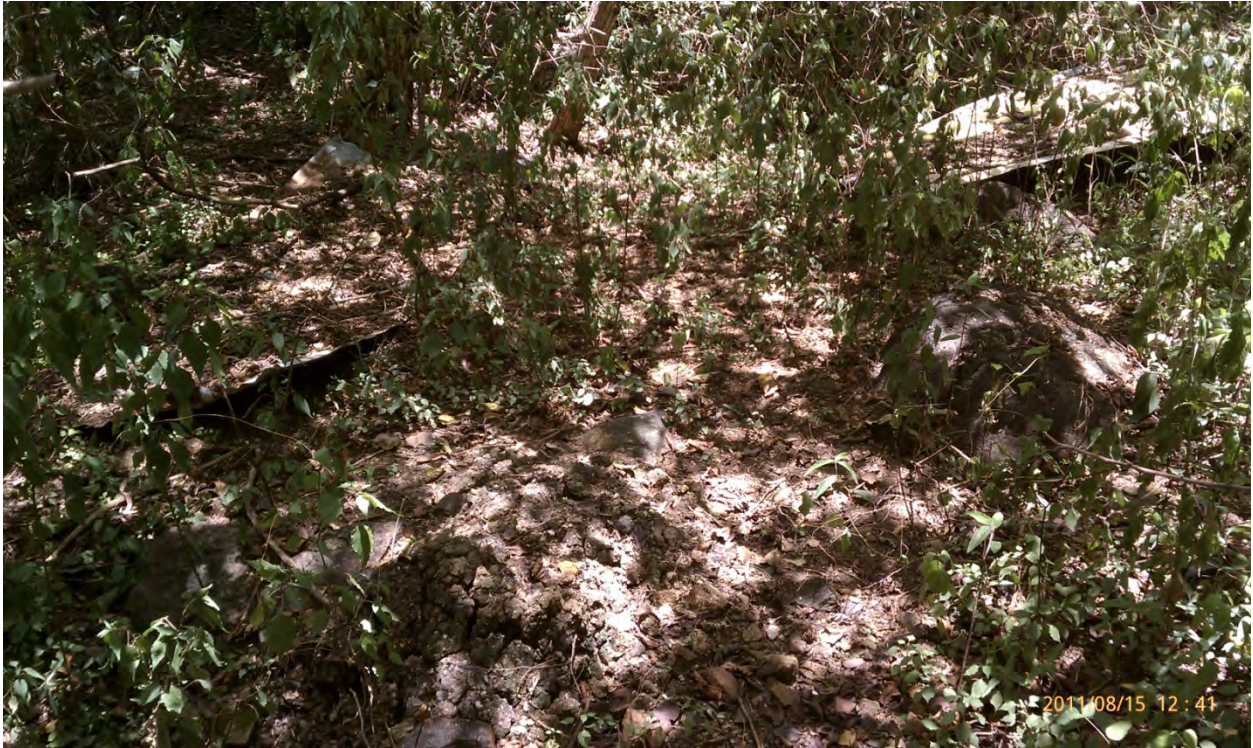
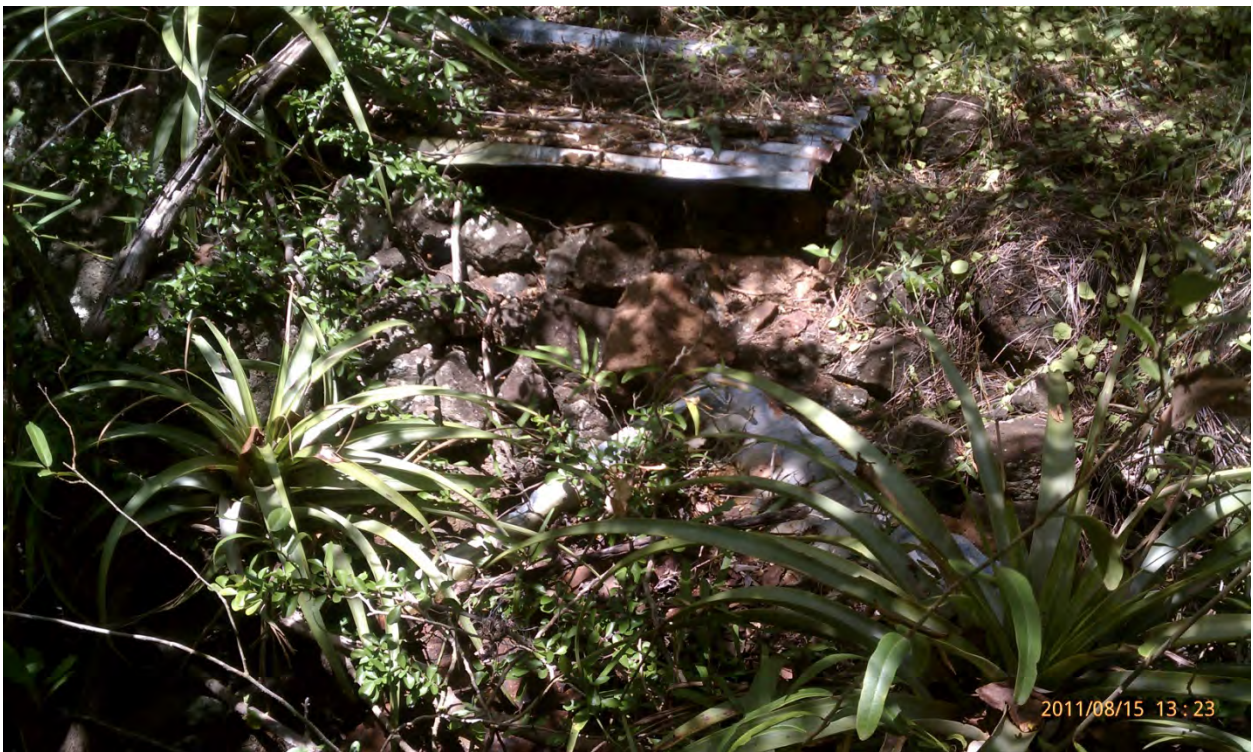
Corrugated Sheet and Building Material:

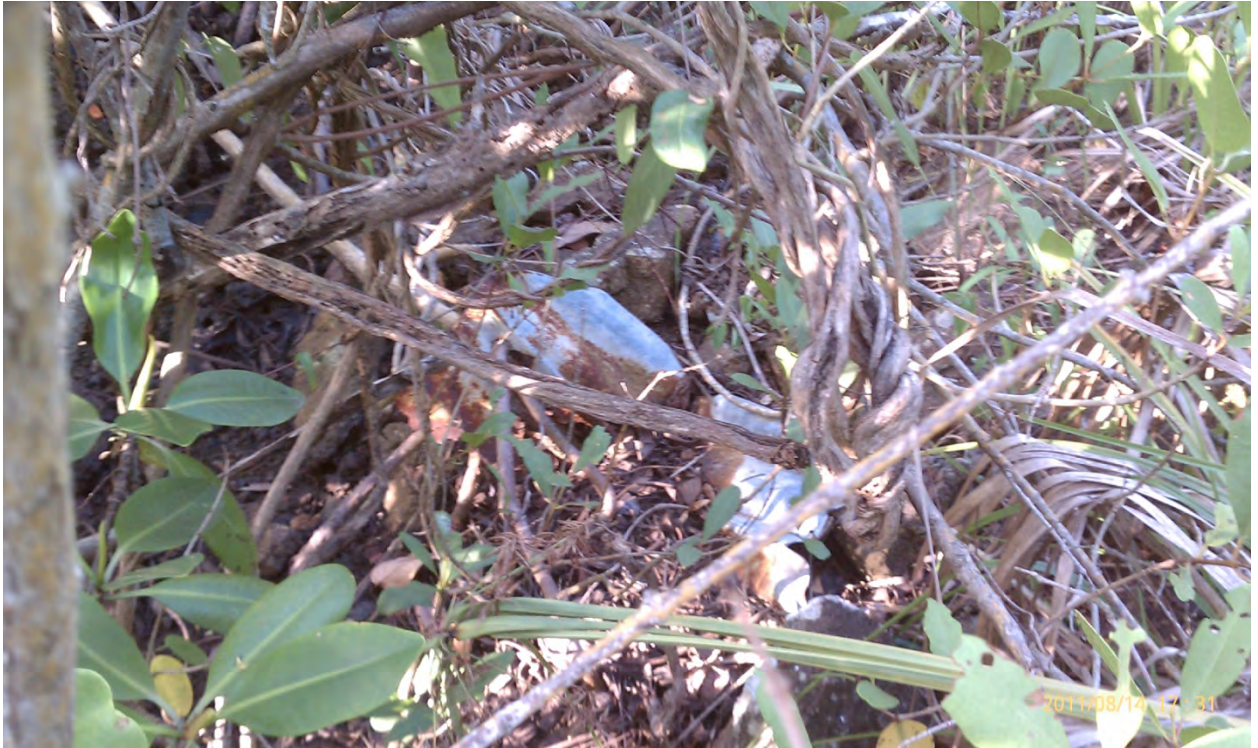
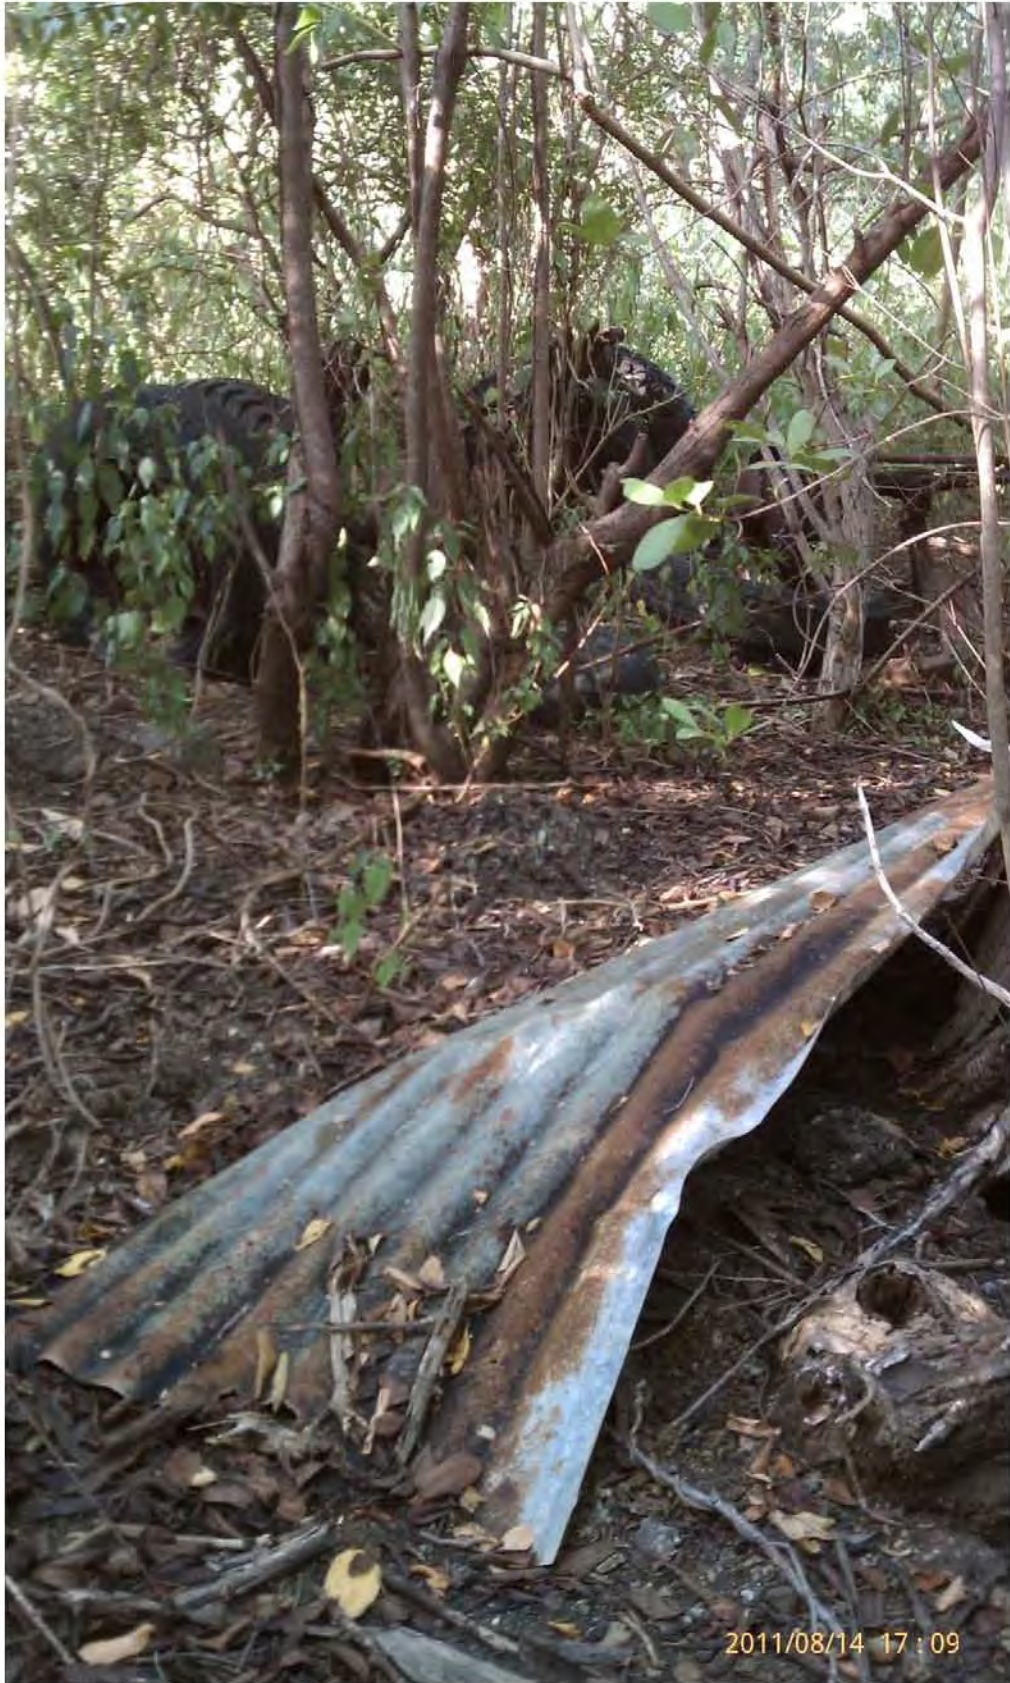
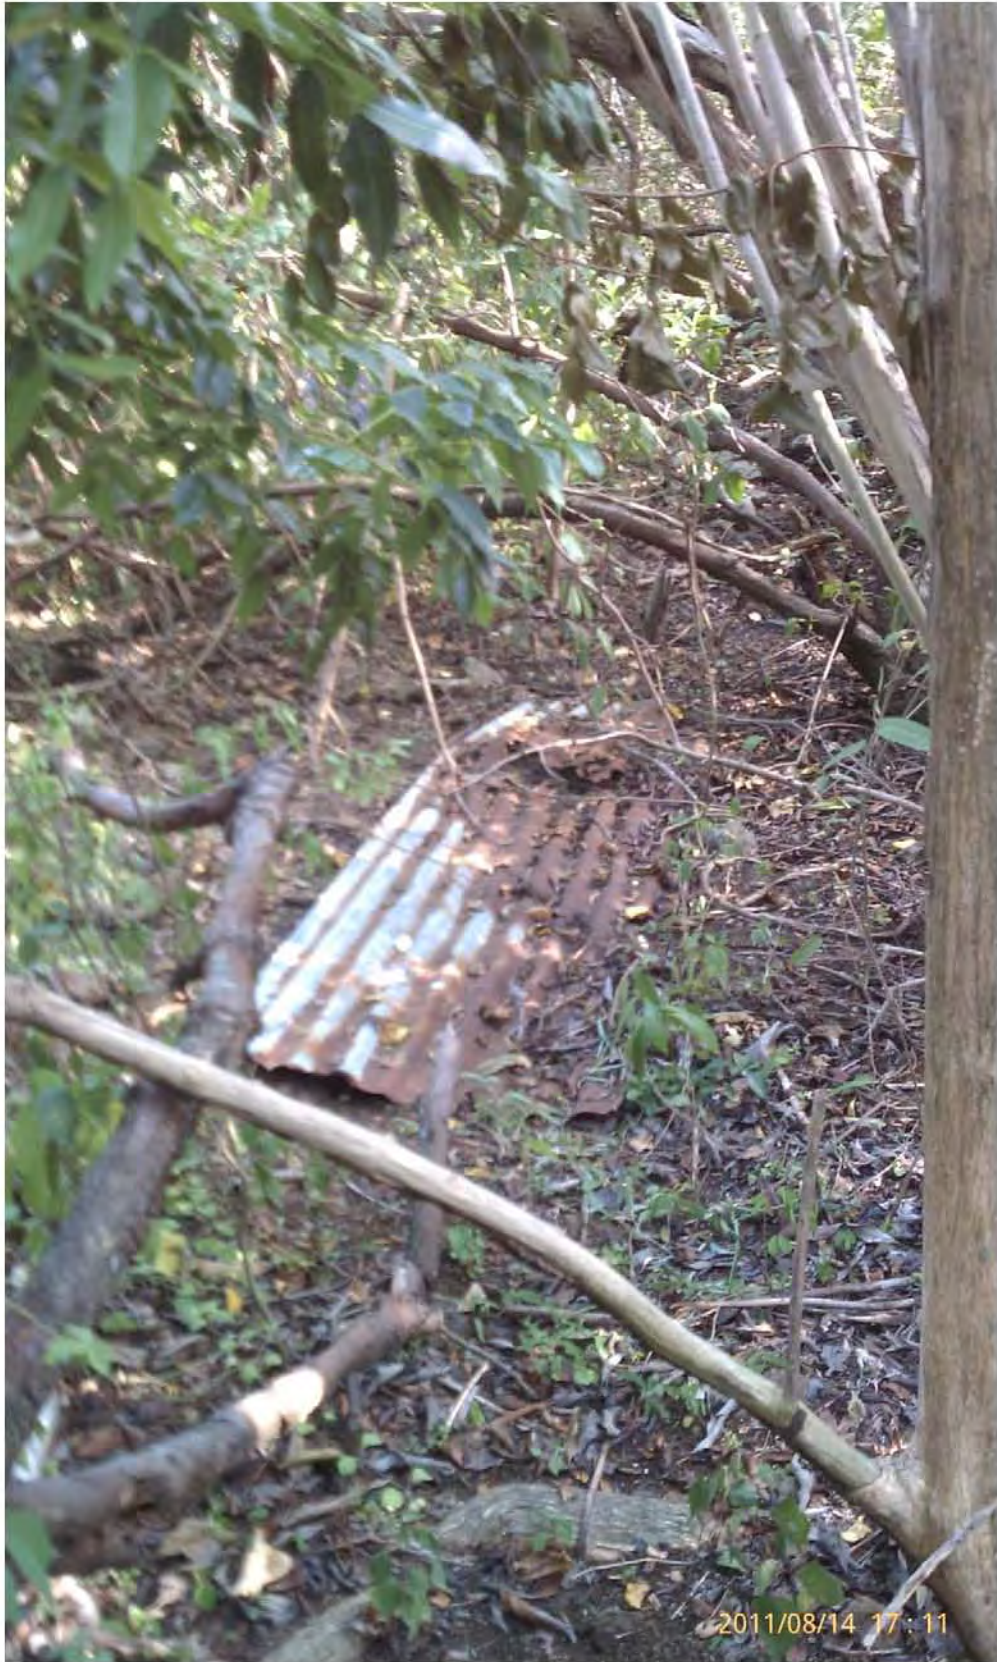
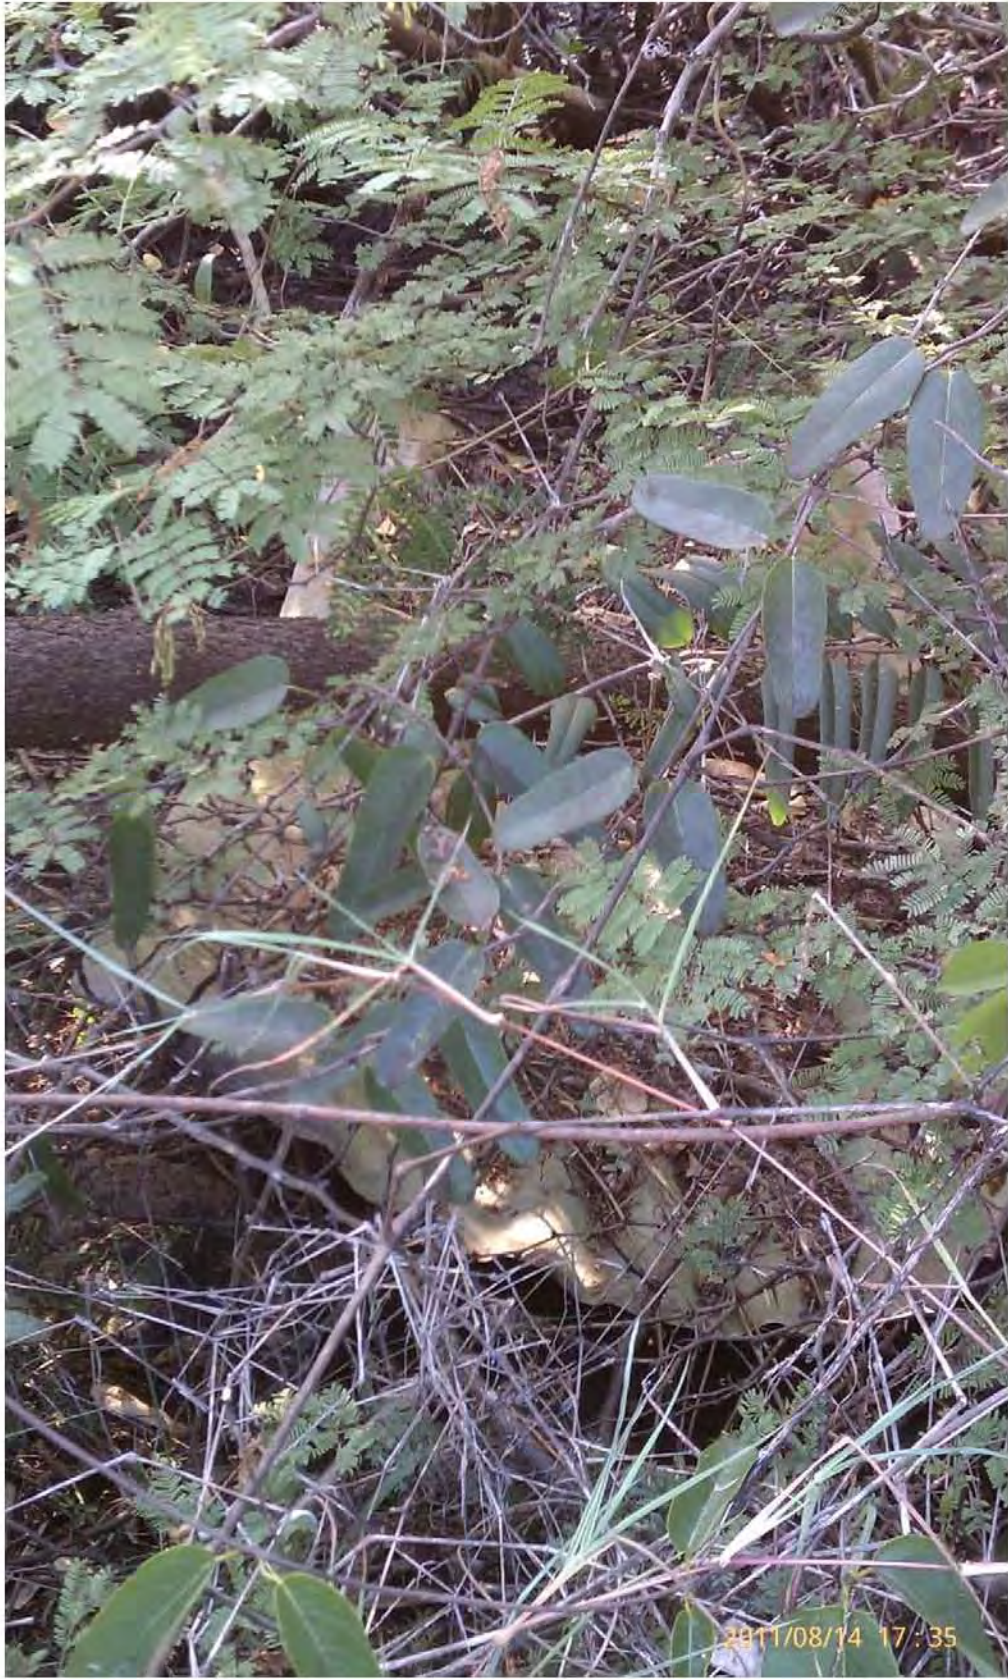
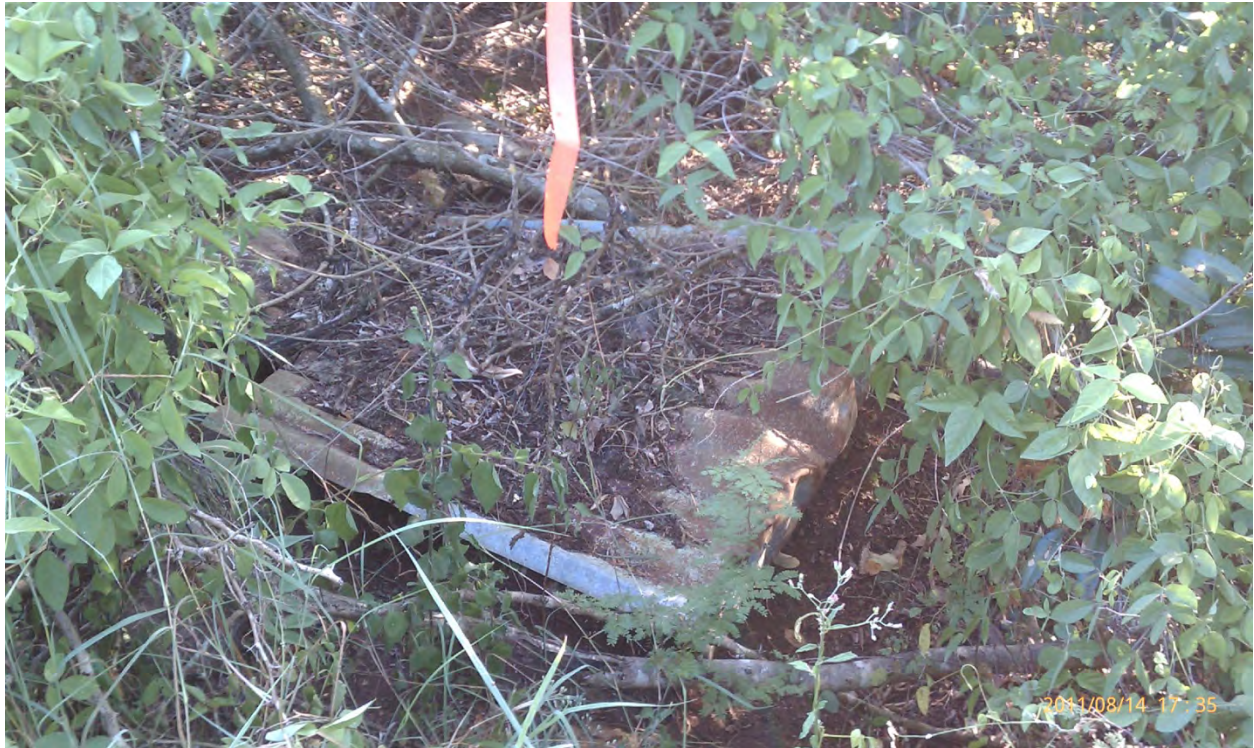
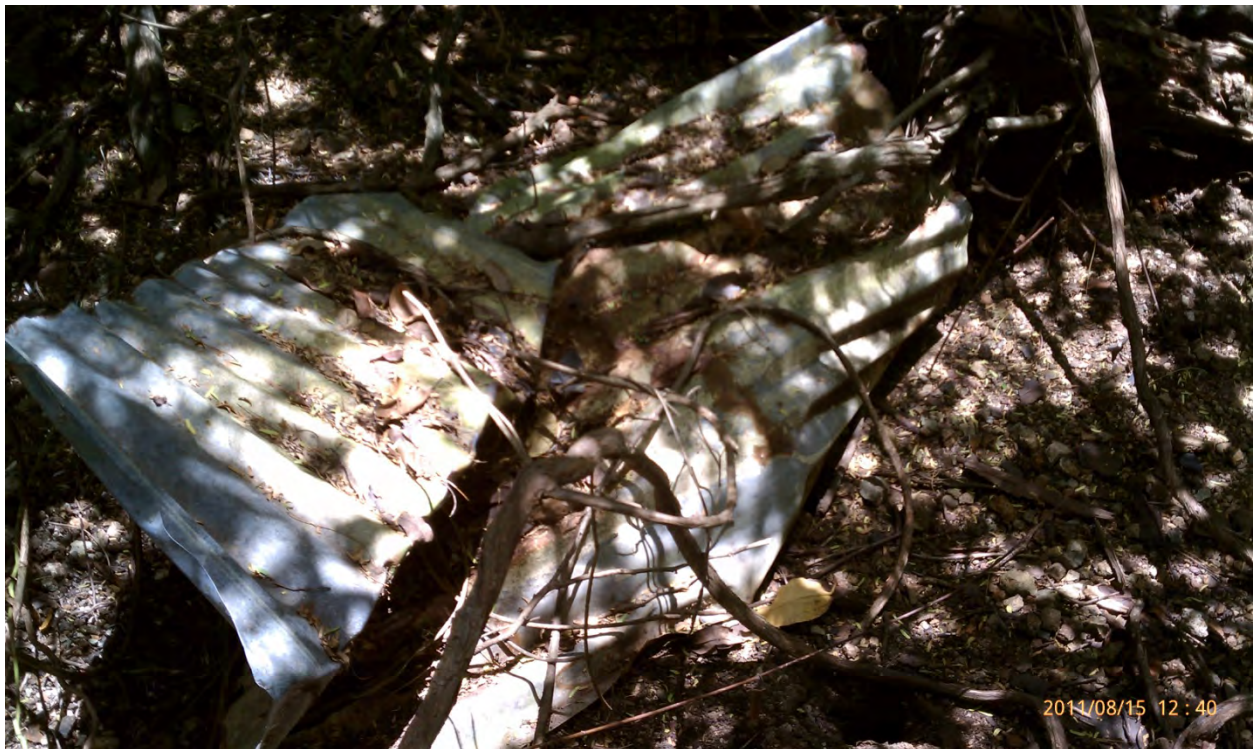
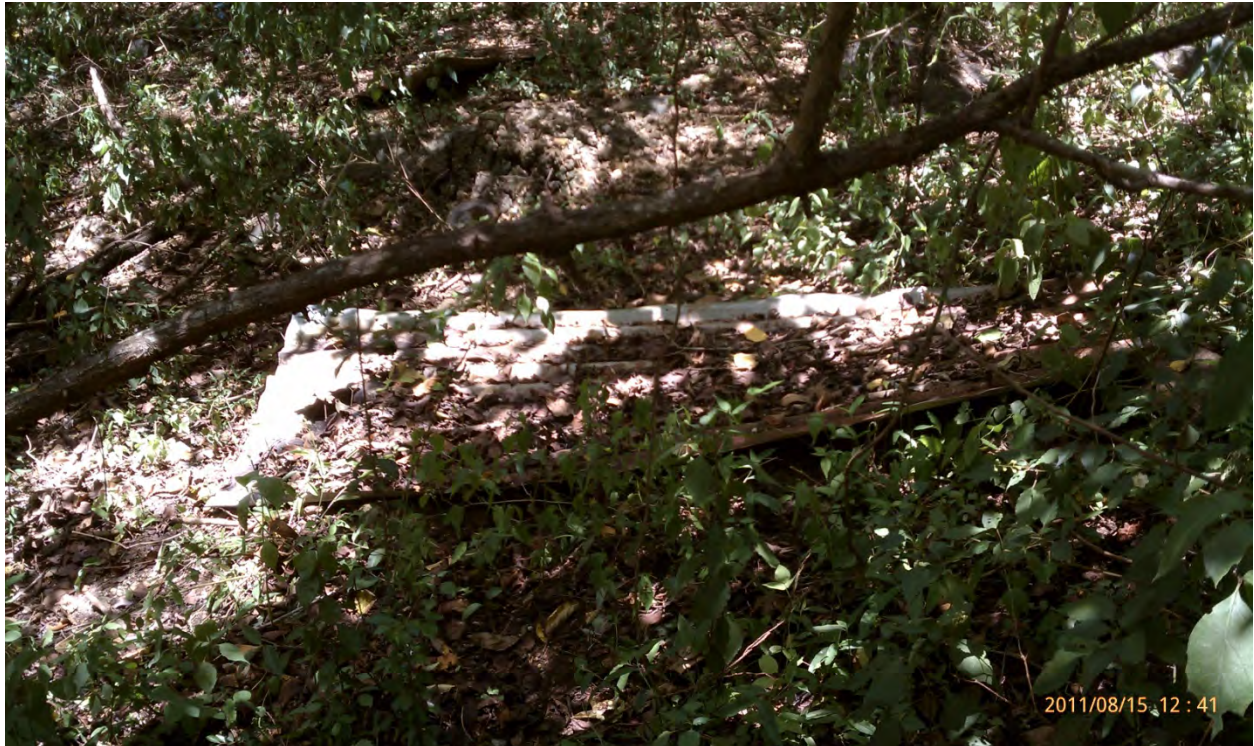
Corrugated Sheet:

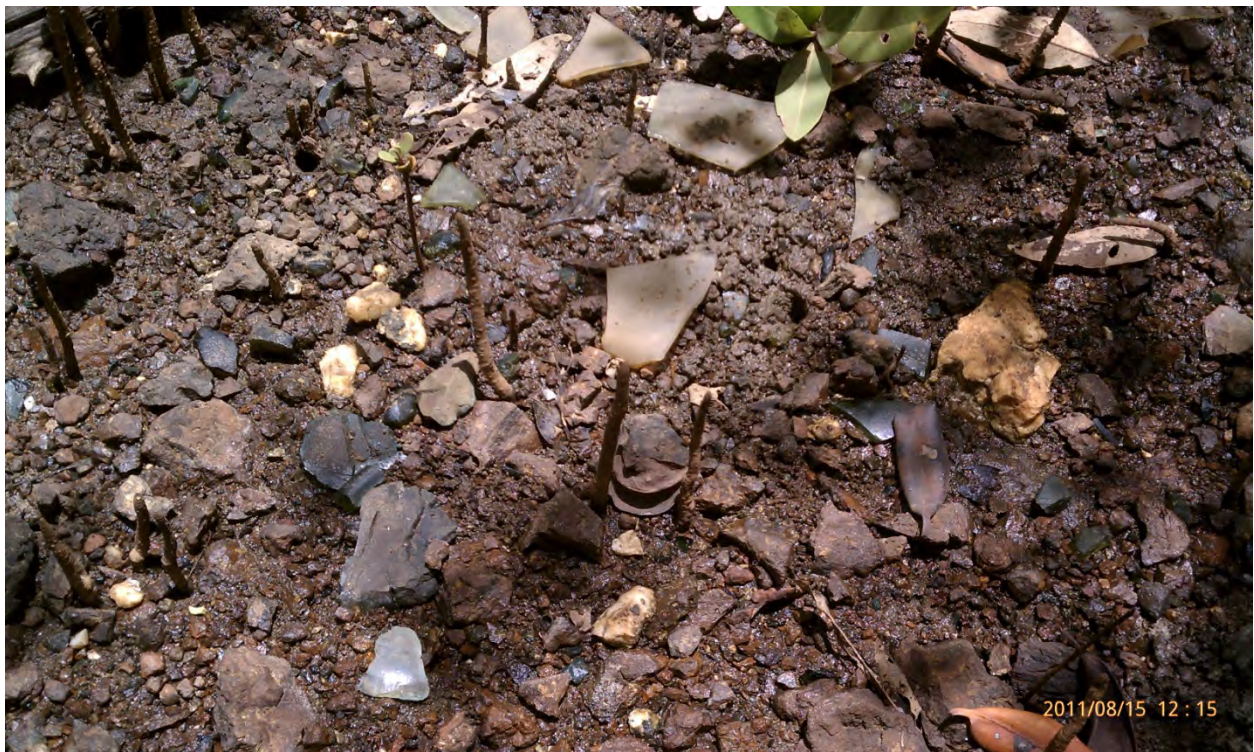
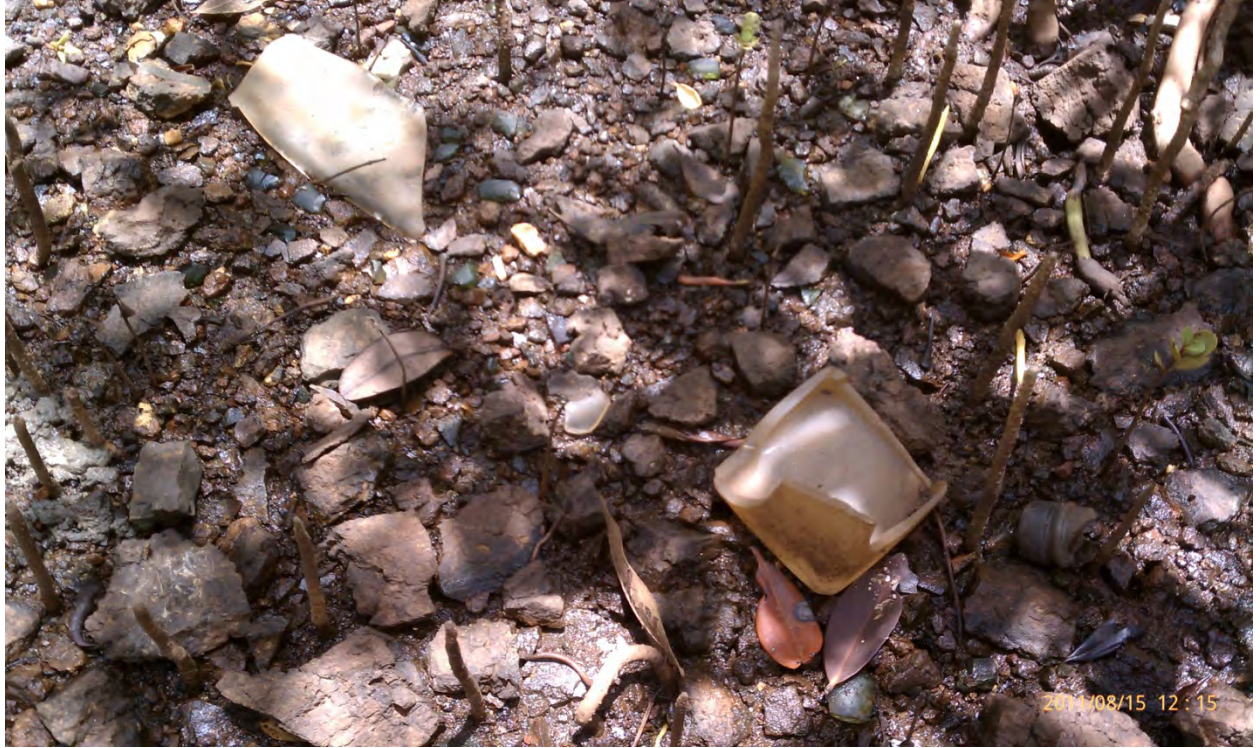
Broken Glass:
