**Hazardous, Toxic, and Radioactive Waste (HTRW)  
Site Inspection Report  
DERP-FUDS Site IO2PR006800**

**Former Lower Camp Debris Site  
Culebra Island, Puerto Rico**

December 2011

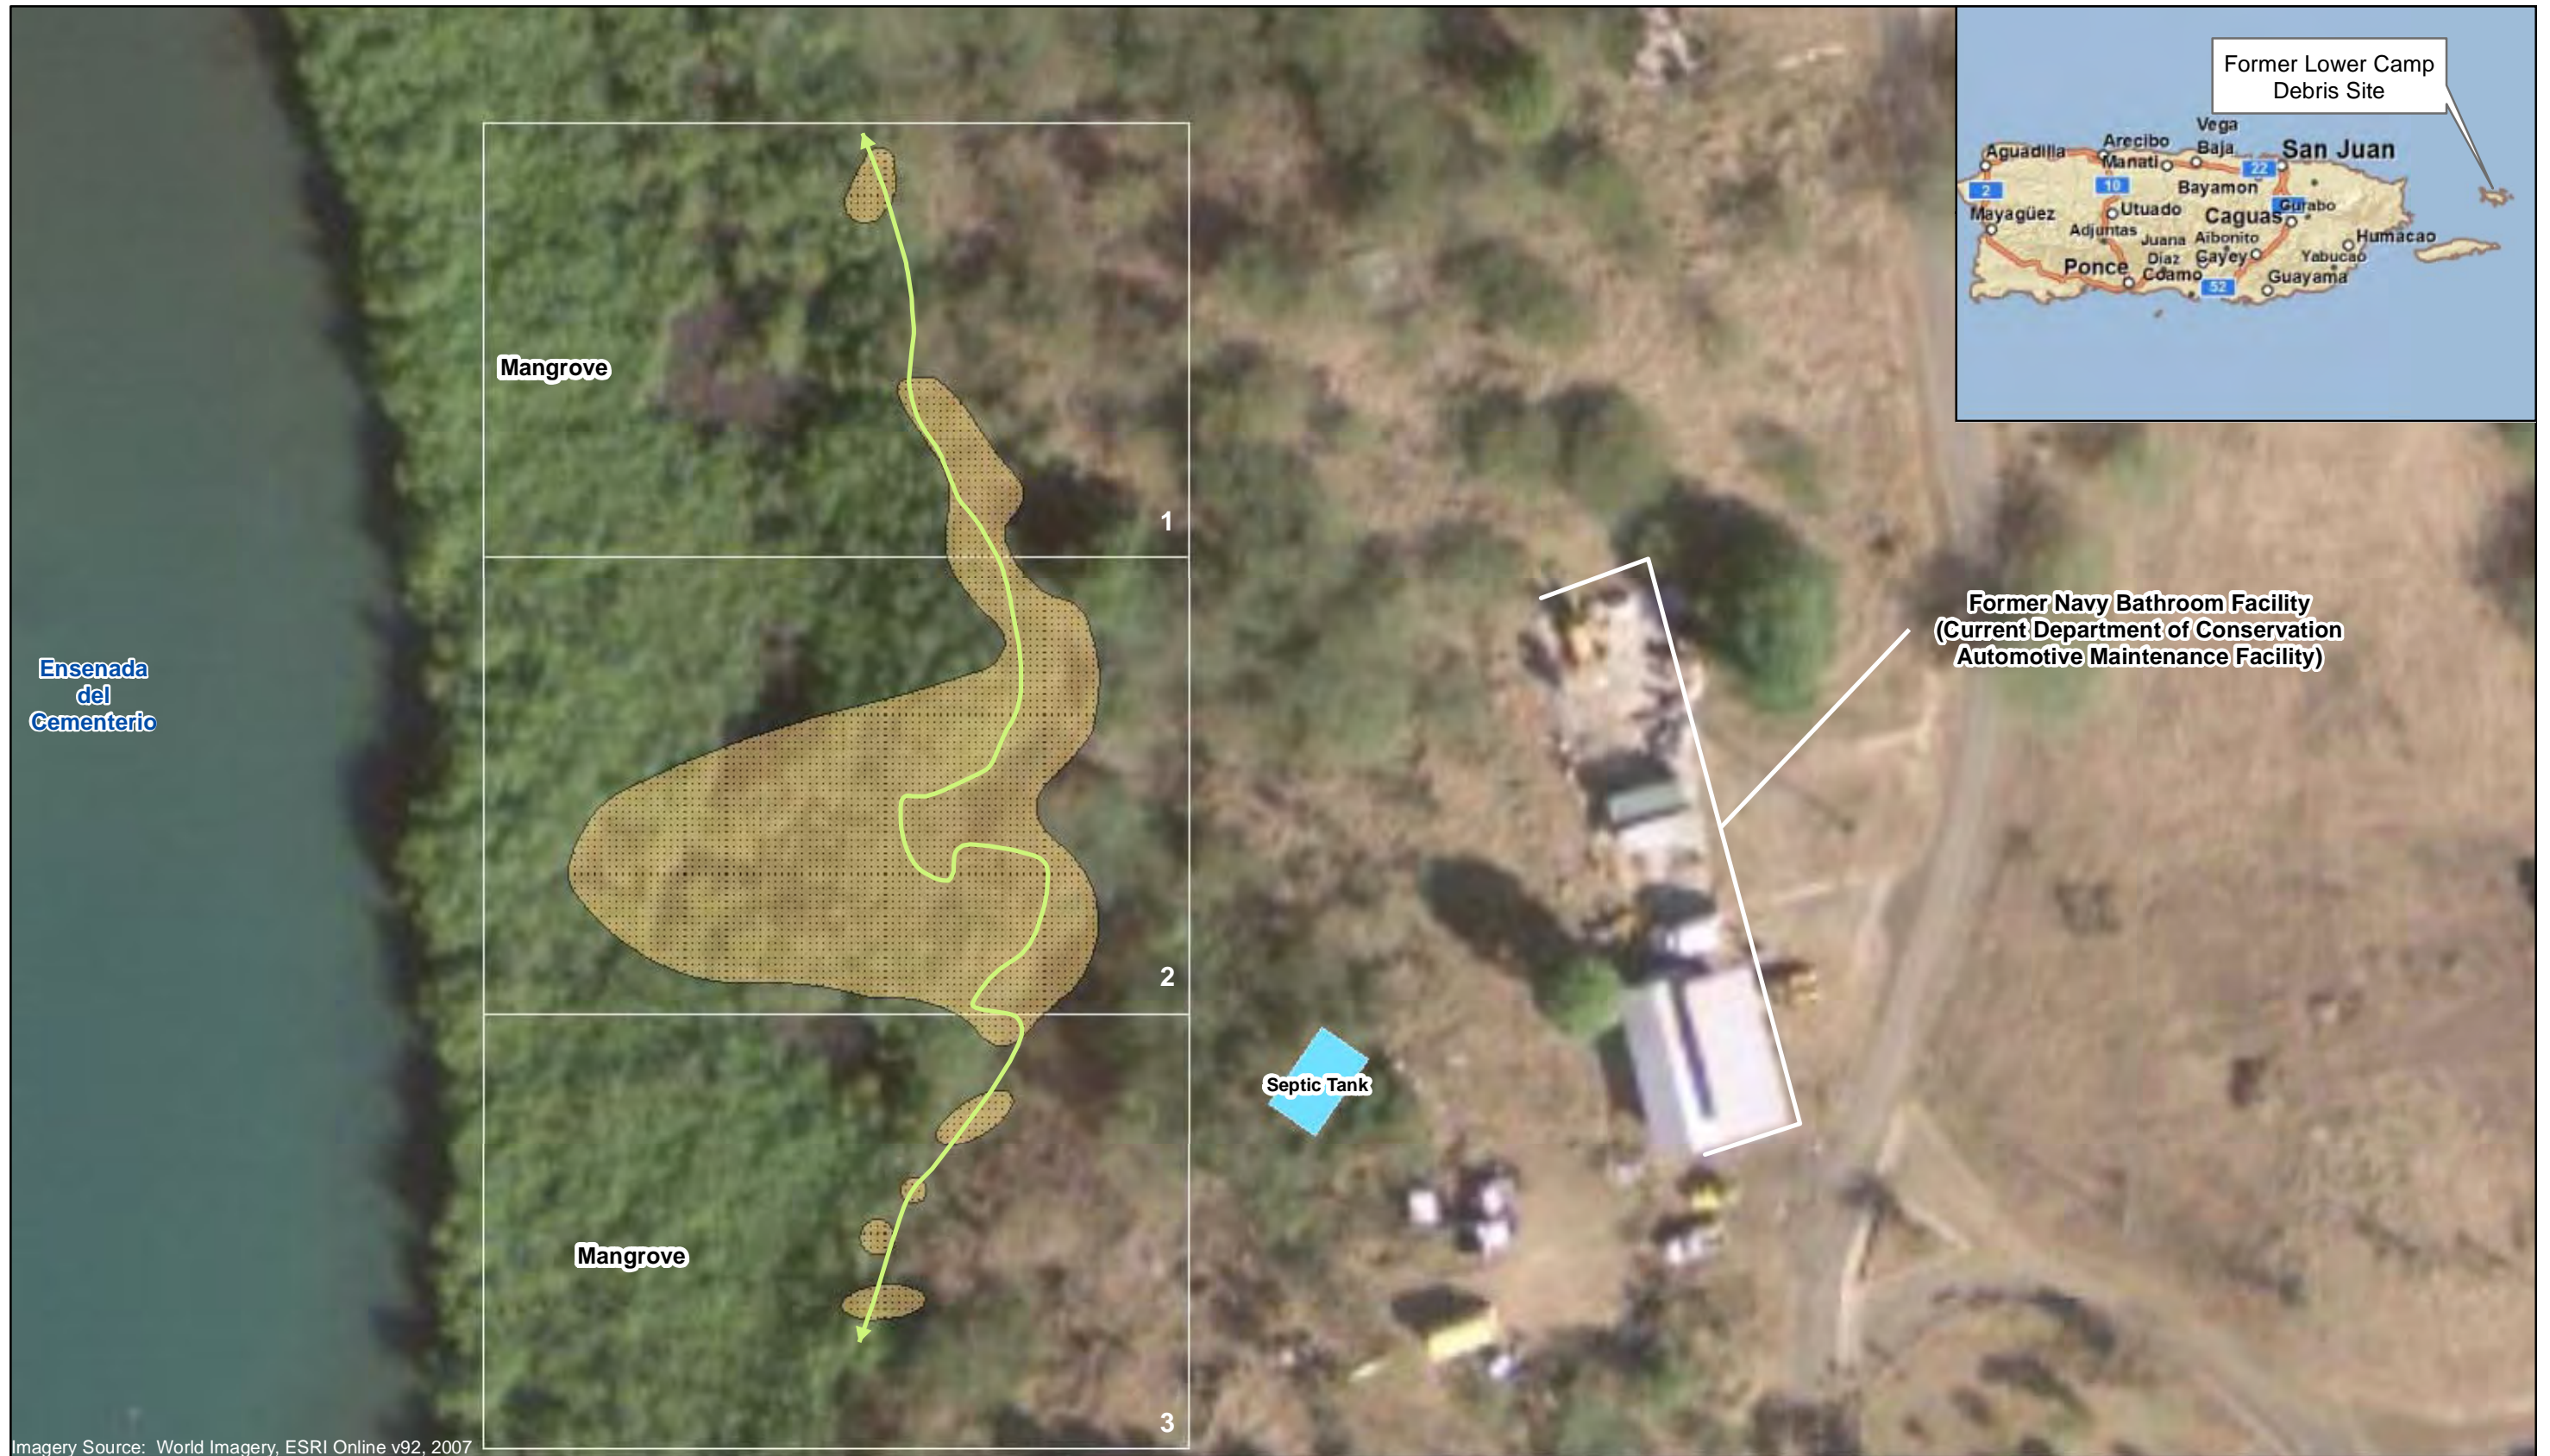
**FIGURE 3-1**  
**Site Inspection Location Map**  
 Former Lower Camp Debris Site  
 Culebra, Puerto Rico

The estimated extent of debris is located in a total area of 15,070 ft<sup>2</sup> (0.35 acre), and extends a distance of 350 feet from the southernmost to the northernmost tip of the debris field (**Figure 3-1**). The widest point of the debris field is approximately 165 feet. The debris consisted of broken bottles, building materials (i.e., bricks both broken and whole and mortar), highly deteriorated oxidized metal (i.e., pipes, beams, rods/rebar, bolts, mattress springs, cables, water valves, and cans), rusted metal walkway sheets, rusted refrigerator type appliance, rusted corrugated metal sheets, concrete stormwater pipes, old vehicle engines, a battery, tires, axles, transmissions, body frames, and broken porcelain..

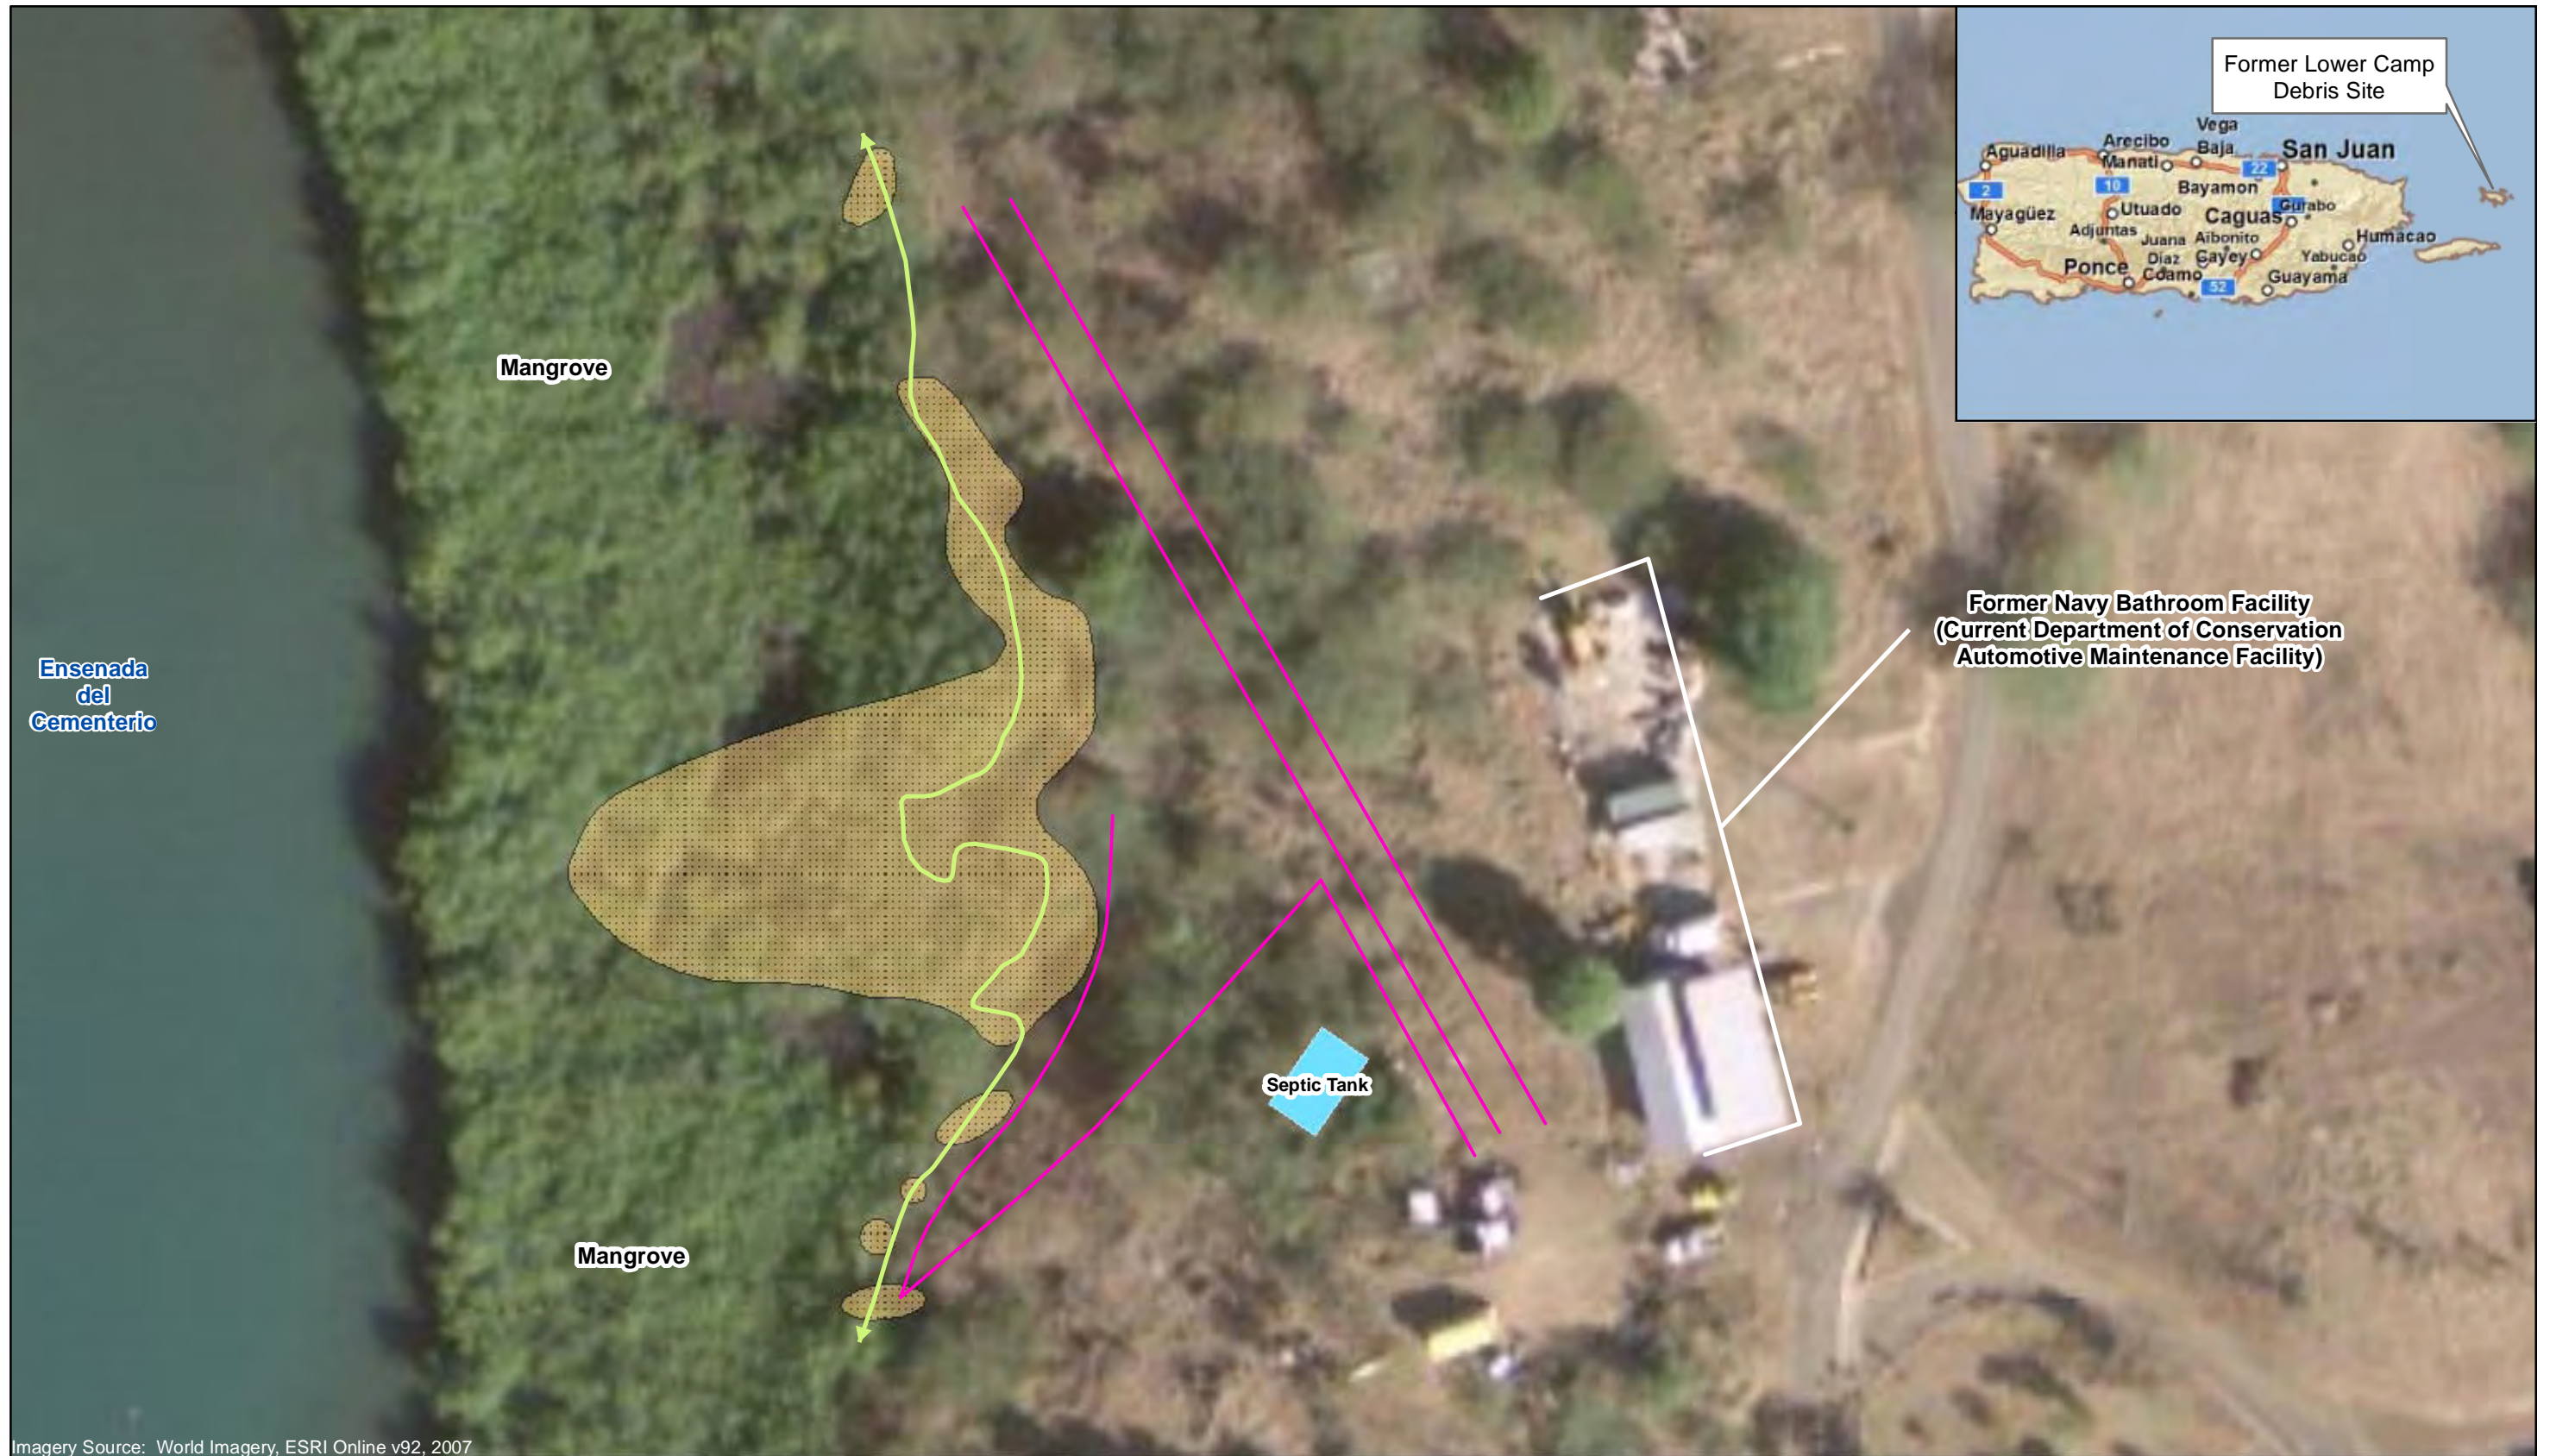
**FIGURE 3-5**  
**Geophysical Screening Map**  
 Former Lower Camp Debris Site  
 Culebra, Puerto Rico

Electromagnetic scans were performed inductively to search for buried debris and utilities exiting the former Navy restroom facility in accessible areas between the visible debris piles and the former restroom facility. GPR scans were also performed to determine soil conditions, and to locate a tailout line leaving the septic tank area (**Figure 3-5**).

mangroves did not reveal any anomalies inconsistent with site soil conditions. The geophysical screening report by OneVision Utility Services is provided in **Appendix D**.

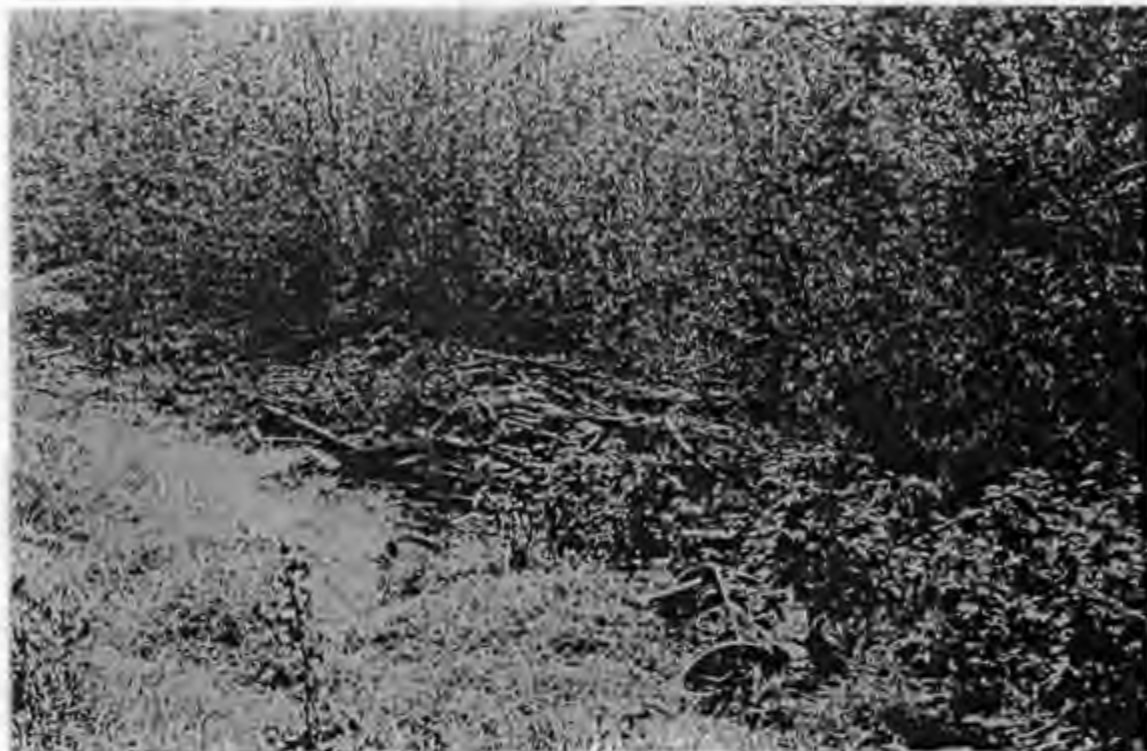
3. Culebra Island NWR (metal debris in wetland area)

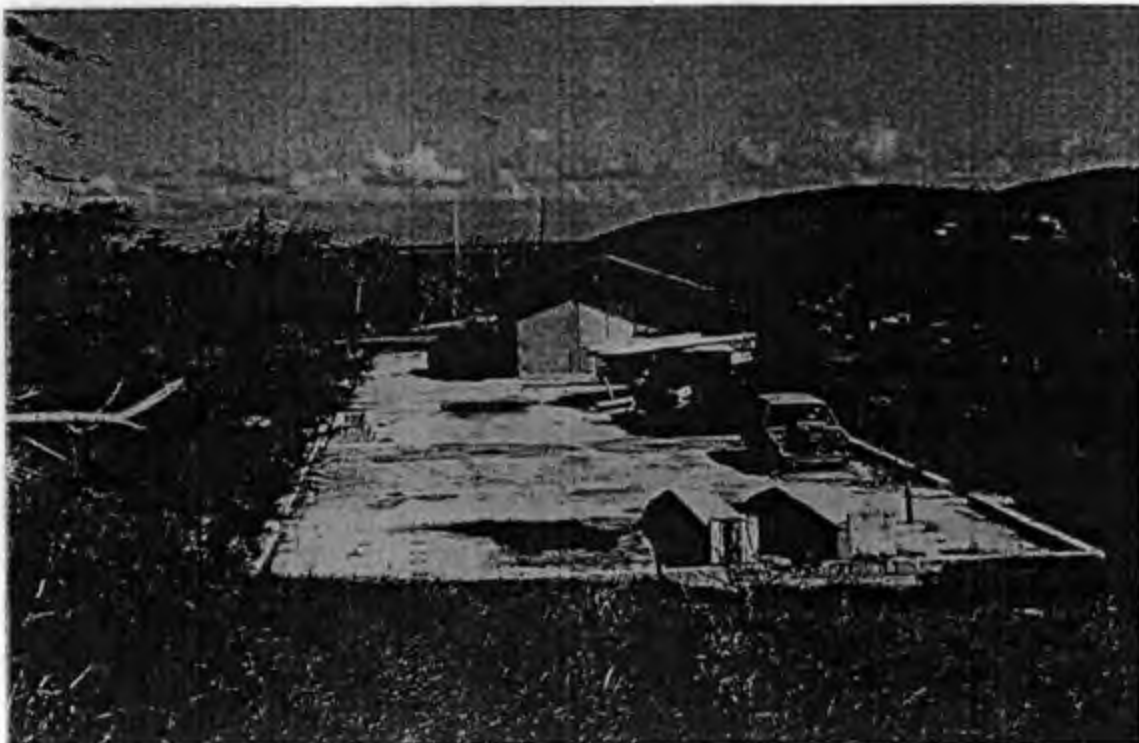
2. Culebra Island NWR (former bathroom foundation and auto shop)

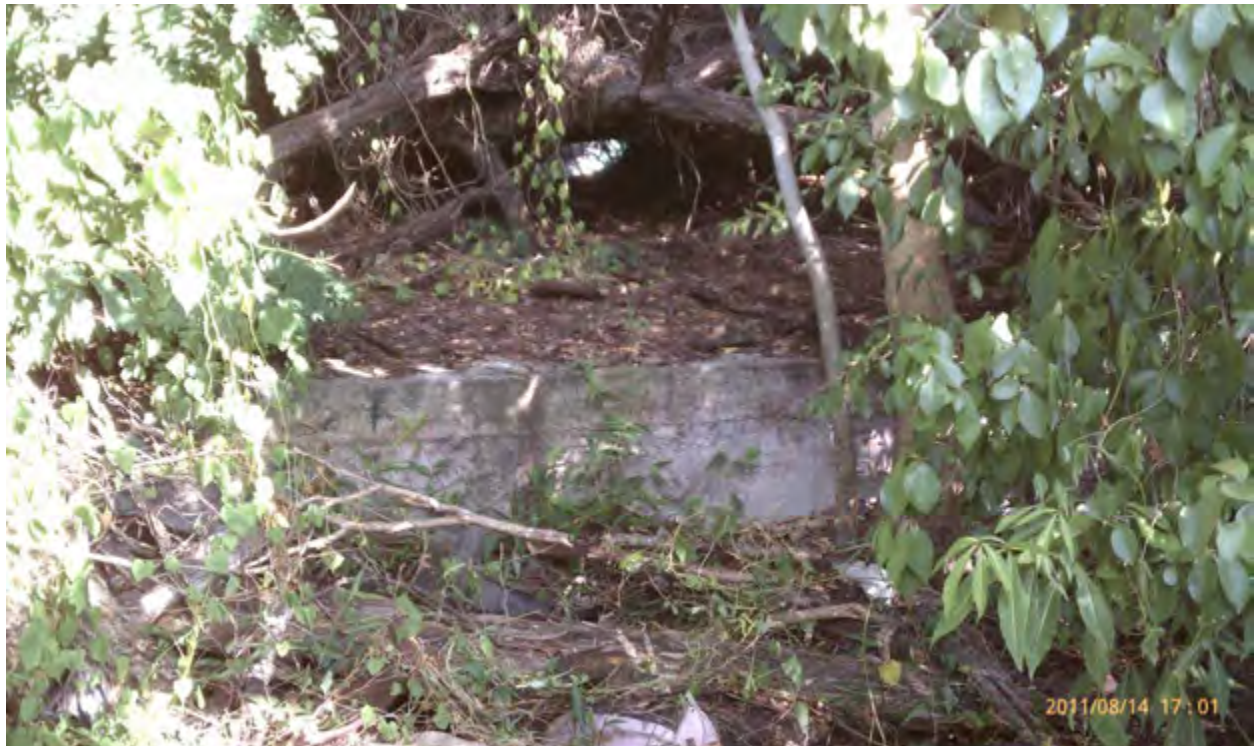
Photograph #1

The septic tank is concrete with a flat top 18.5 feet wide by 28 feet long and located approximately 75 feet west of the concrete pad used for the former Navy restroom facility. No outfall could be visually observed. A photograph of the septic tank is included in **Appendix C**.

## Septic Tank:

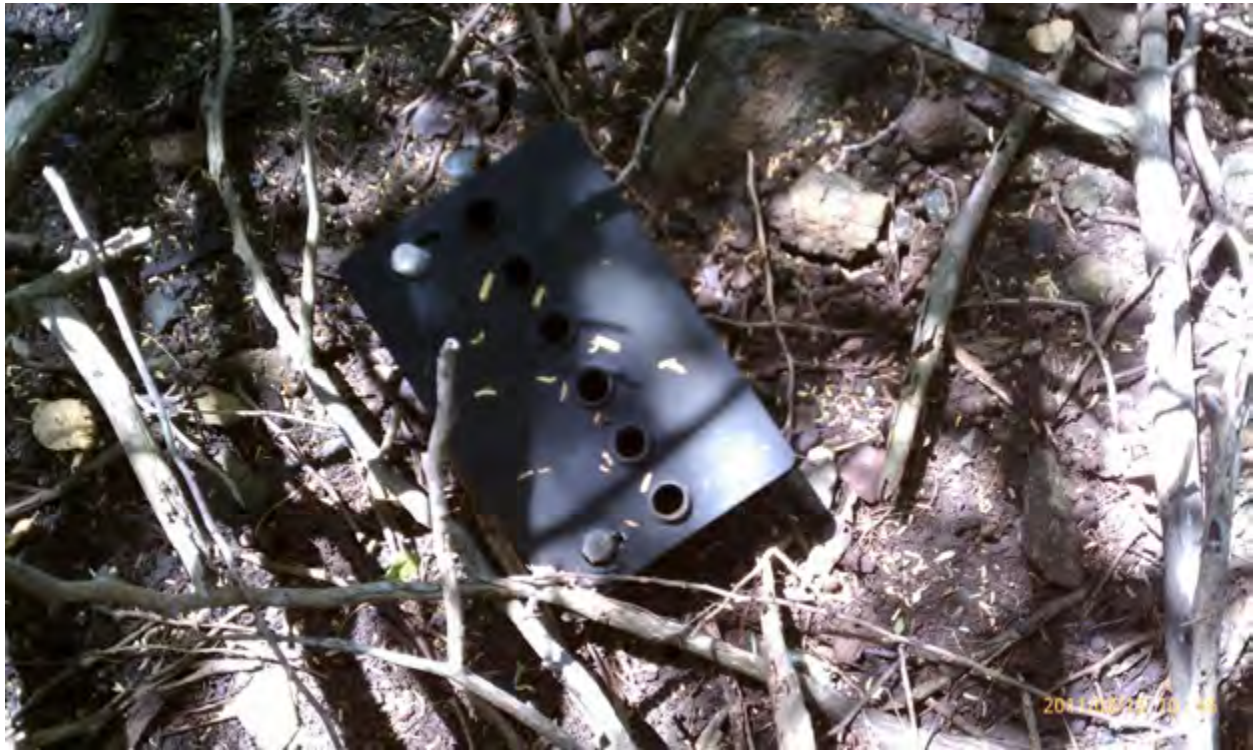
**Photograph #2**

**Battery:**

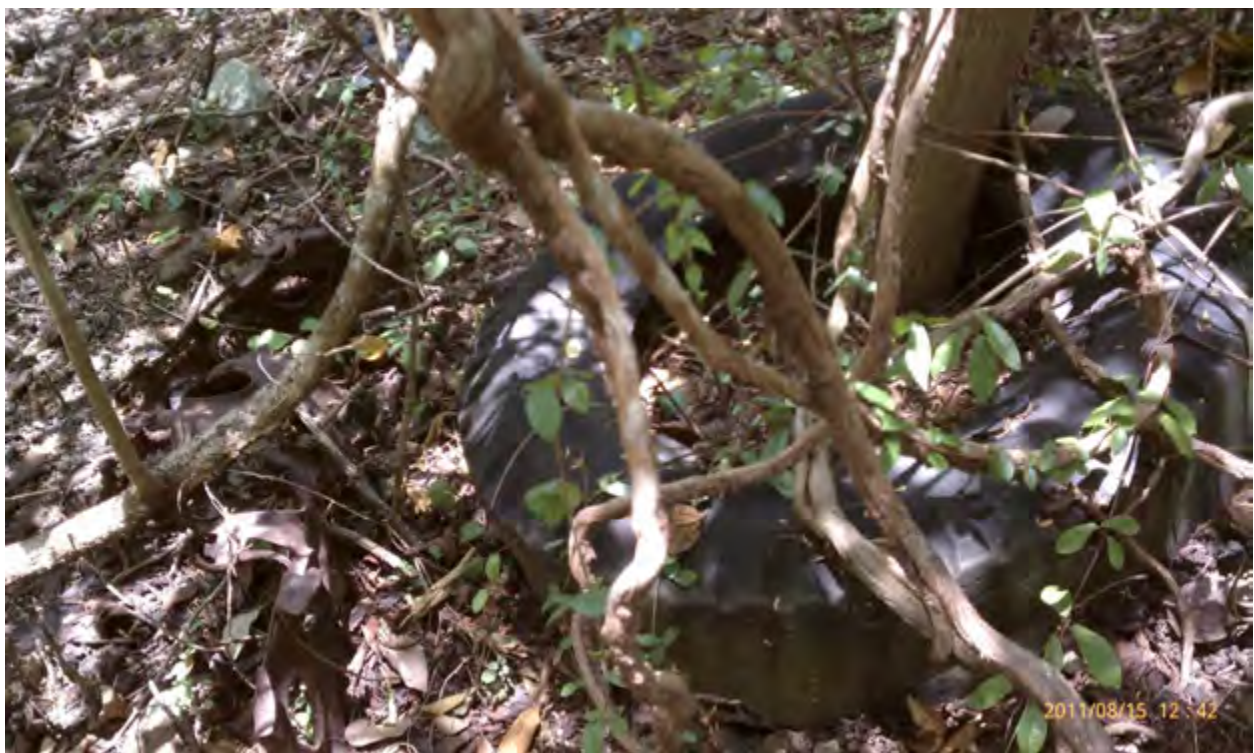
**Photograph #3**

**Old Tires:**

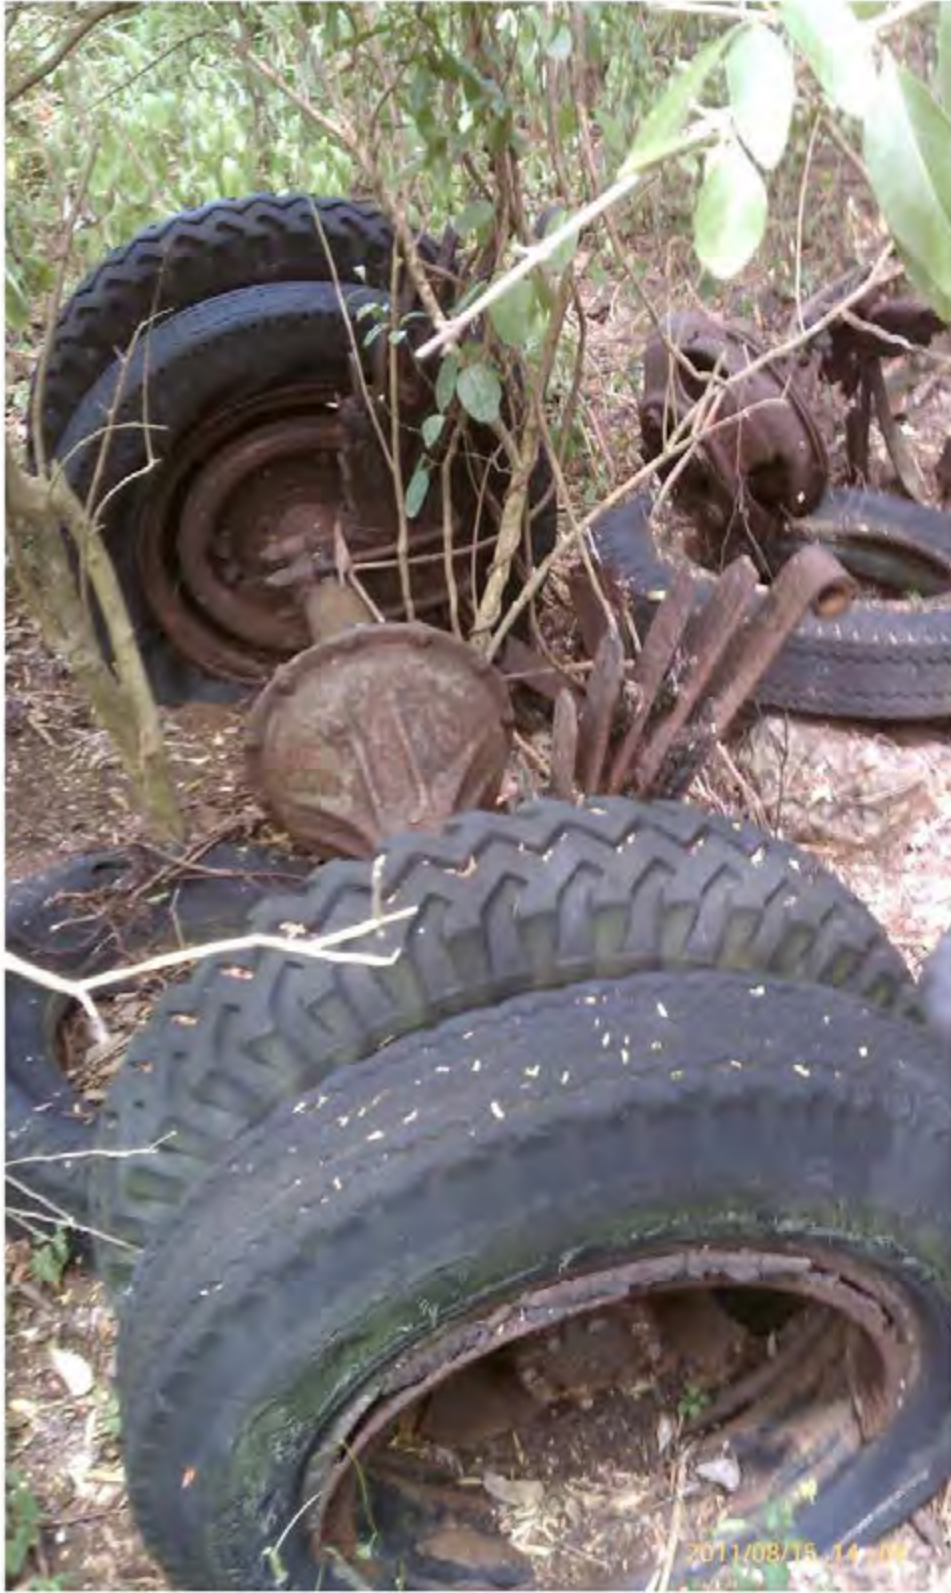
Photograph #4

## Vehicle Axle and Tires:

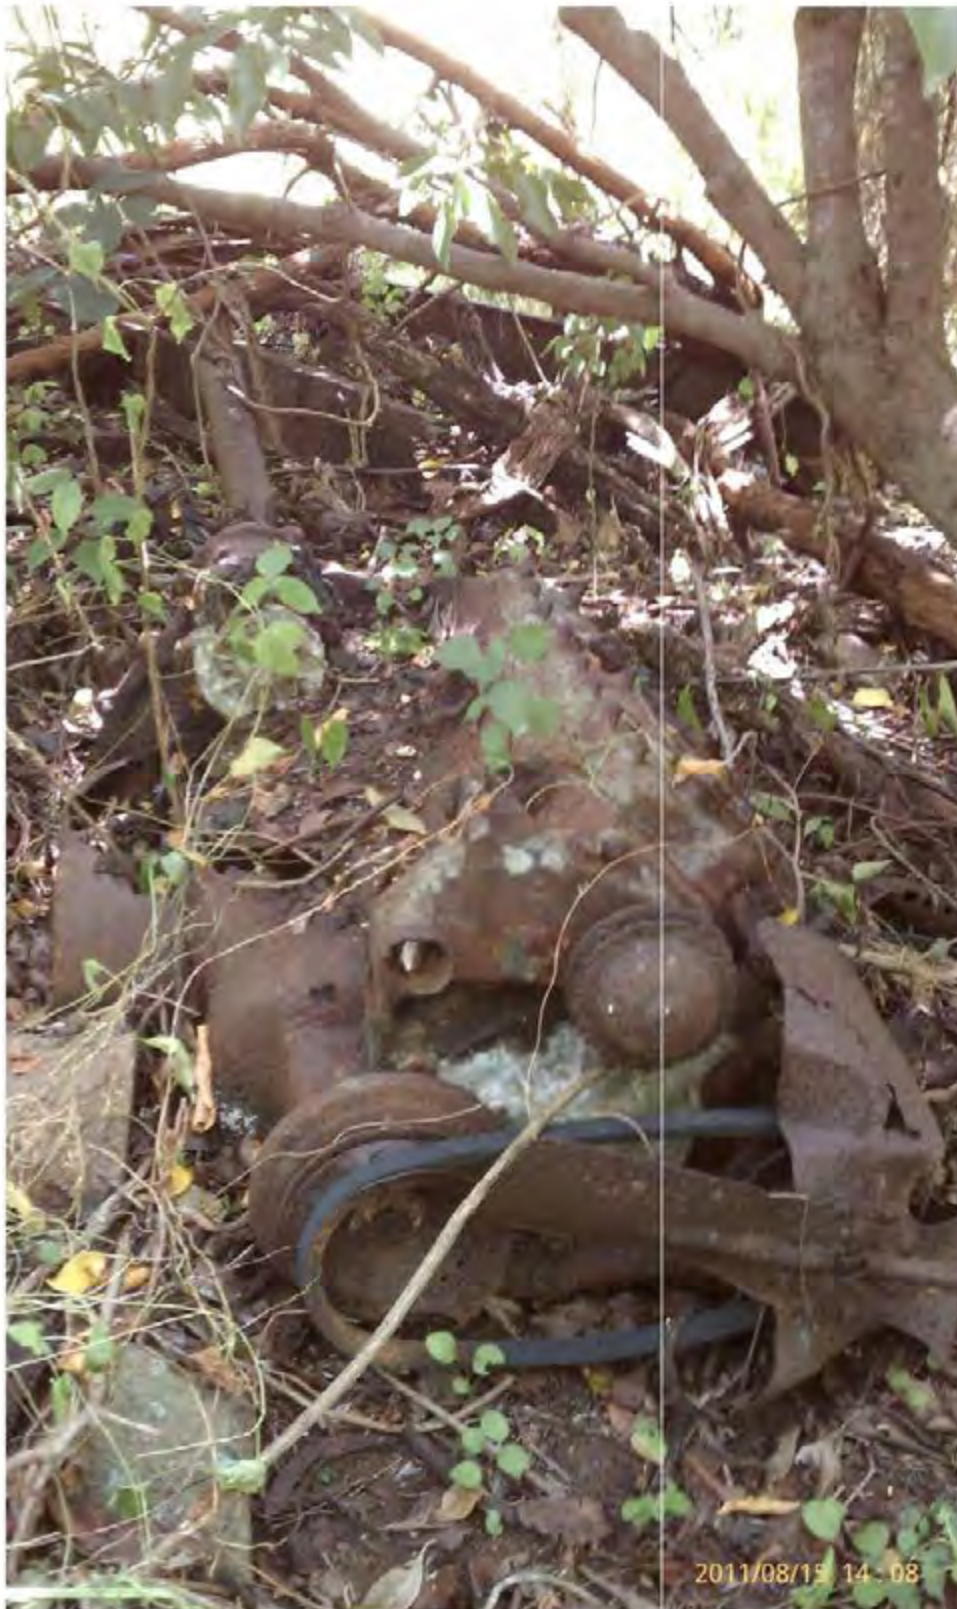
Photograph #5

## Vehicle Engine, Transmission, and Frame:

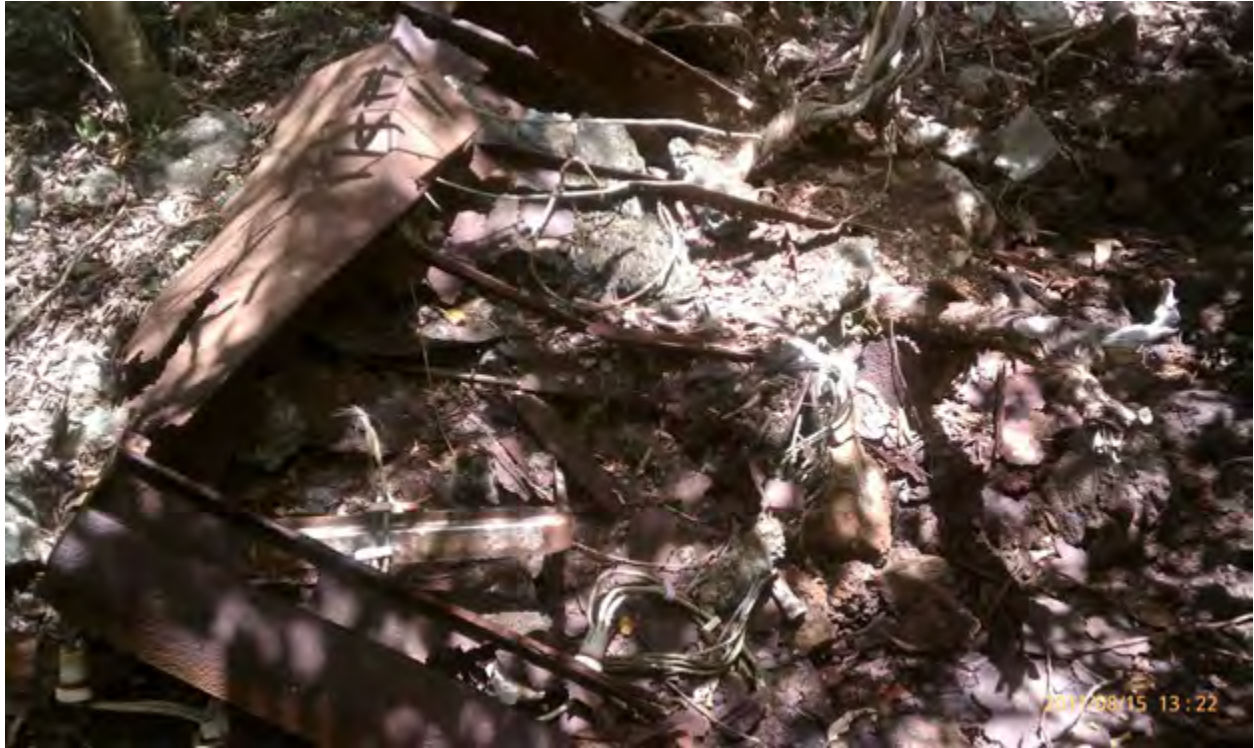
**Photograph #6**

**Refrigerator or Other Type Appliance:**

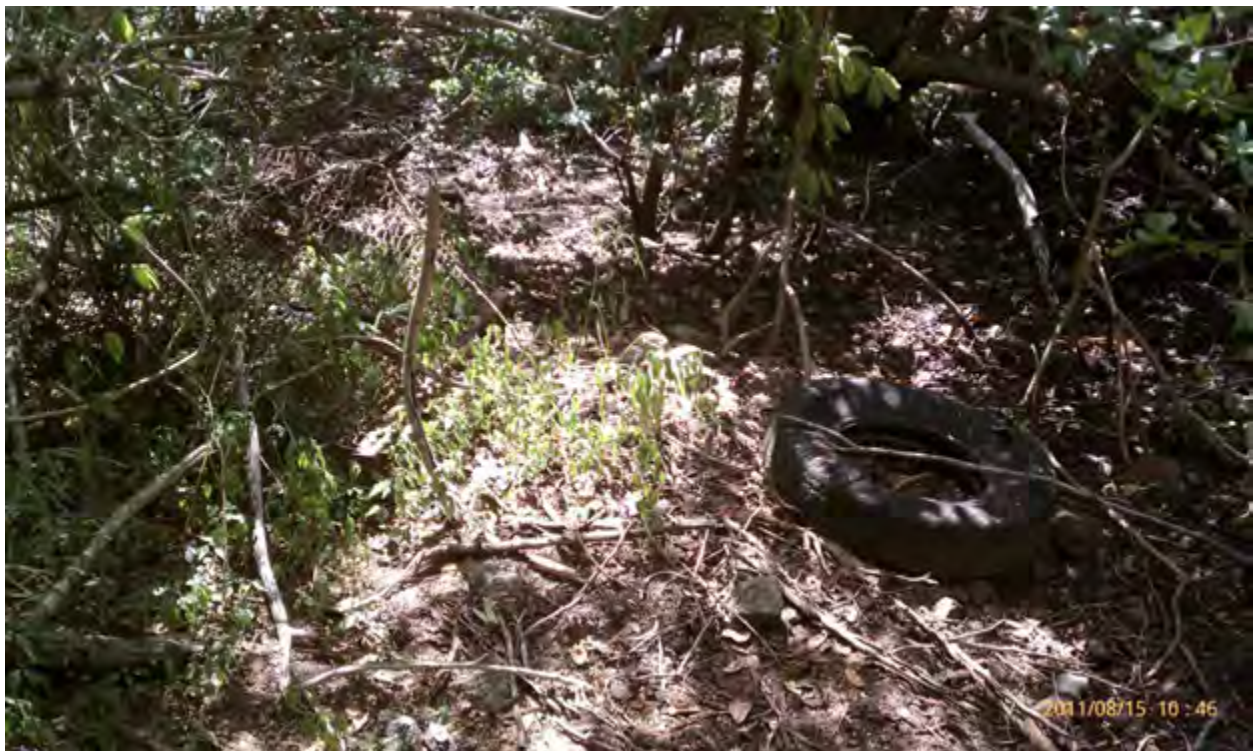
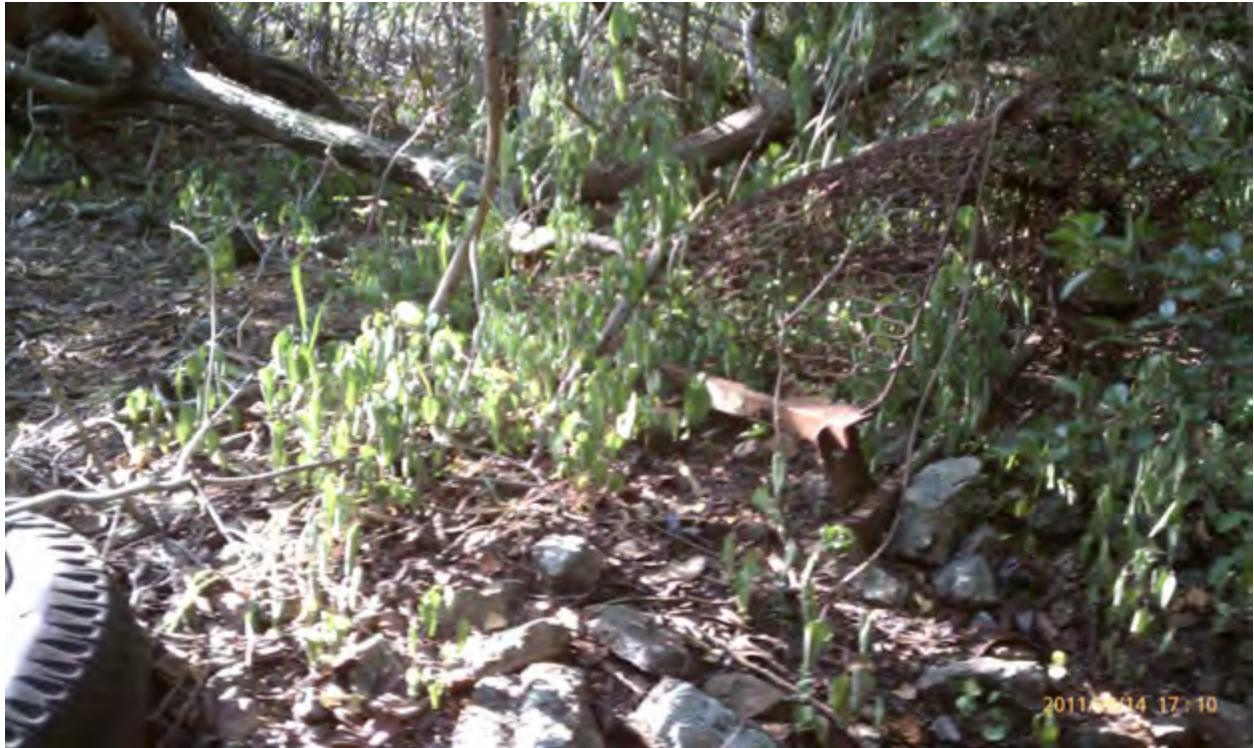
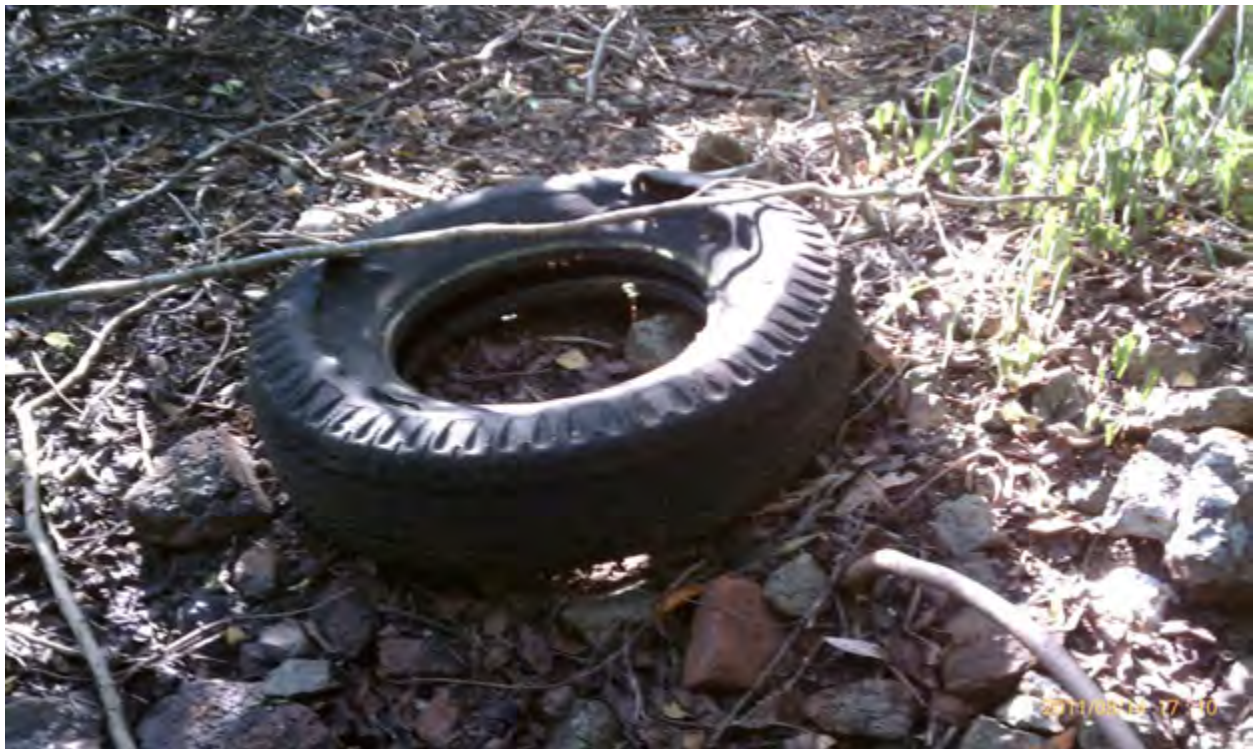
**Old Tire, Mattress Spring, Building Material:**
