**Hazardous, Toxic, and Radioactive Waste (HTRW)  
Site Inspection Report  
DERP-FUDS Site IO2PR006800**

**Former Lower Camp Debris Site  
Culebra Island, Puerto Rico**

December 2011

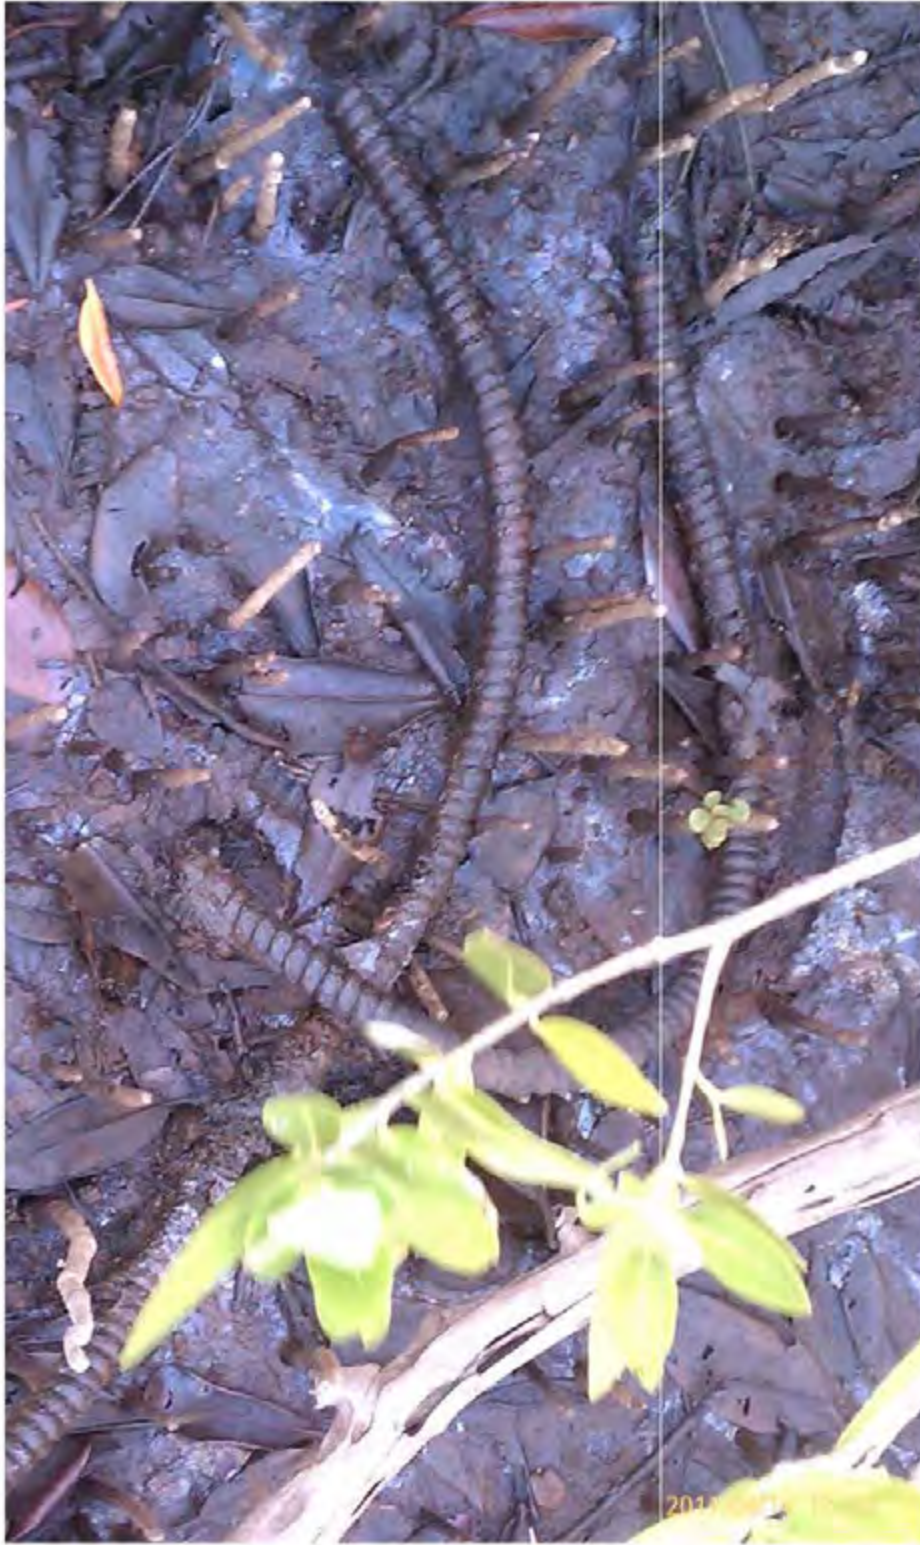
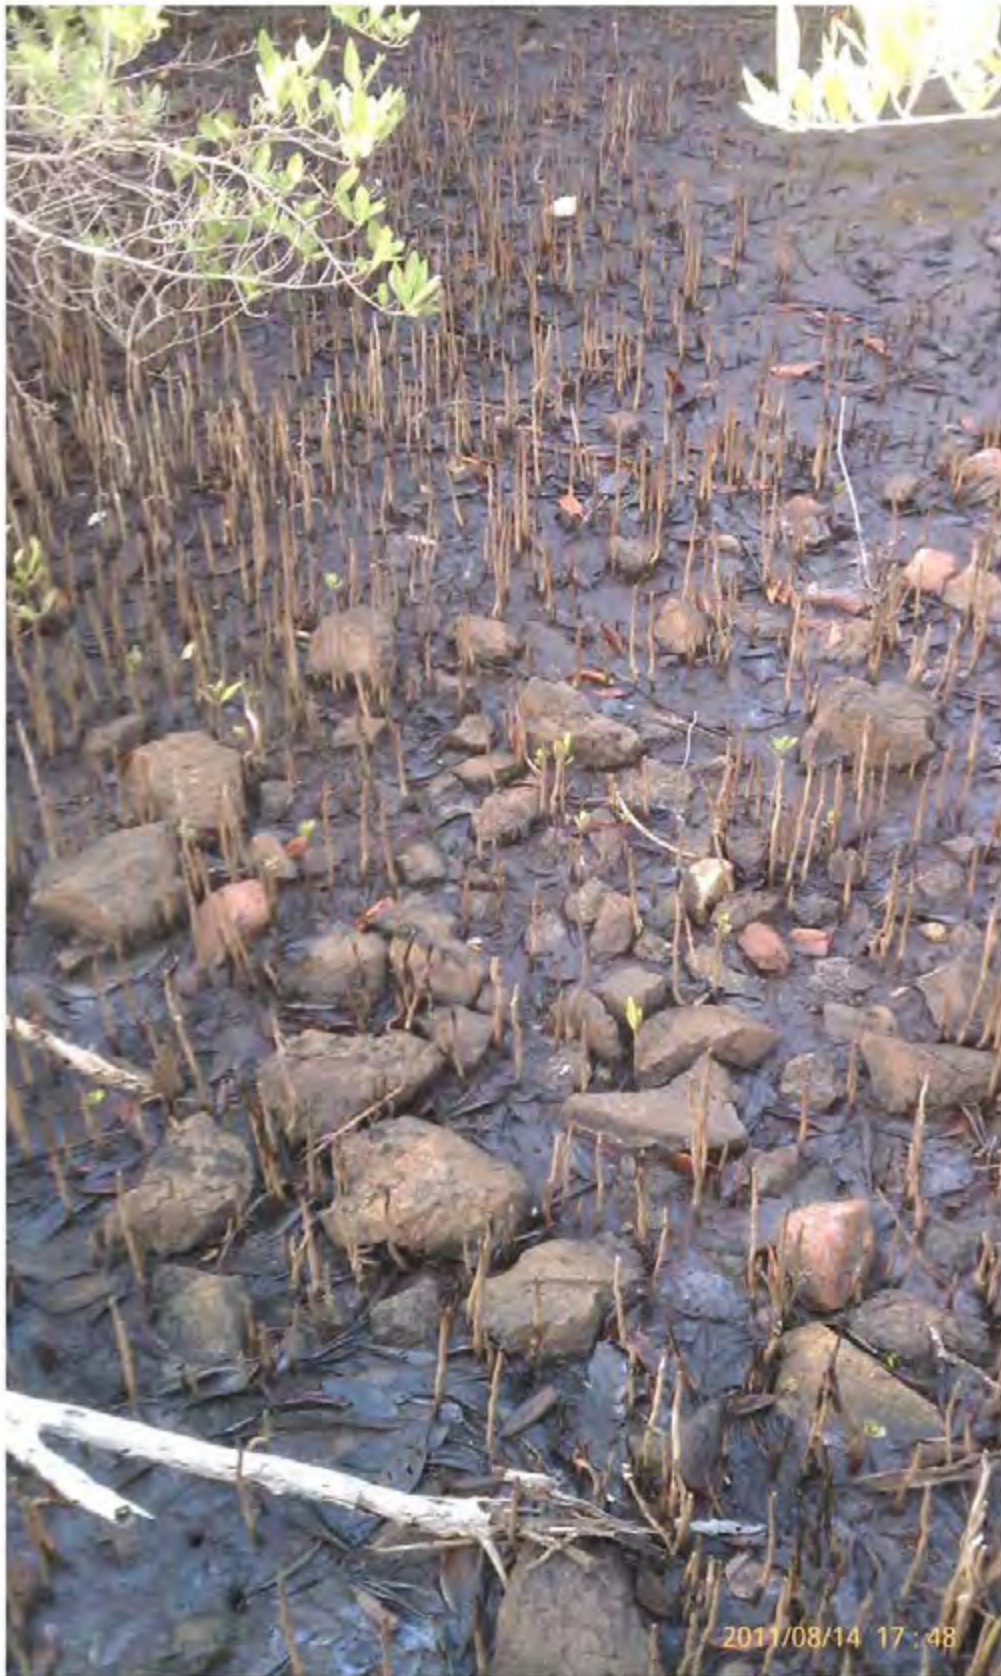
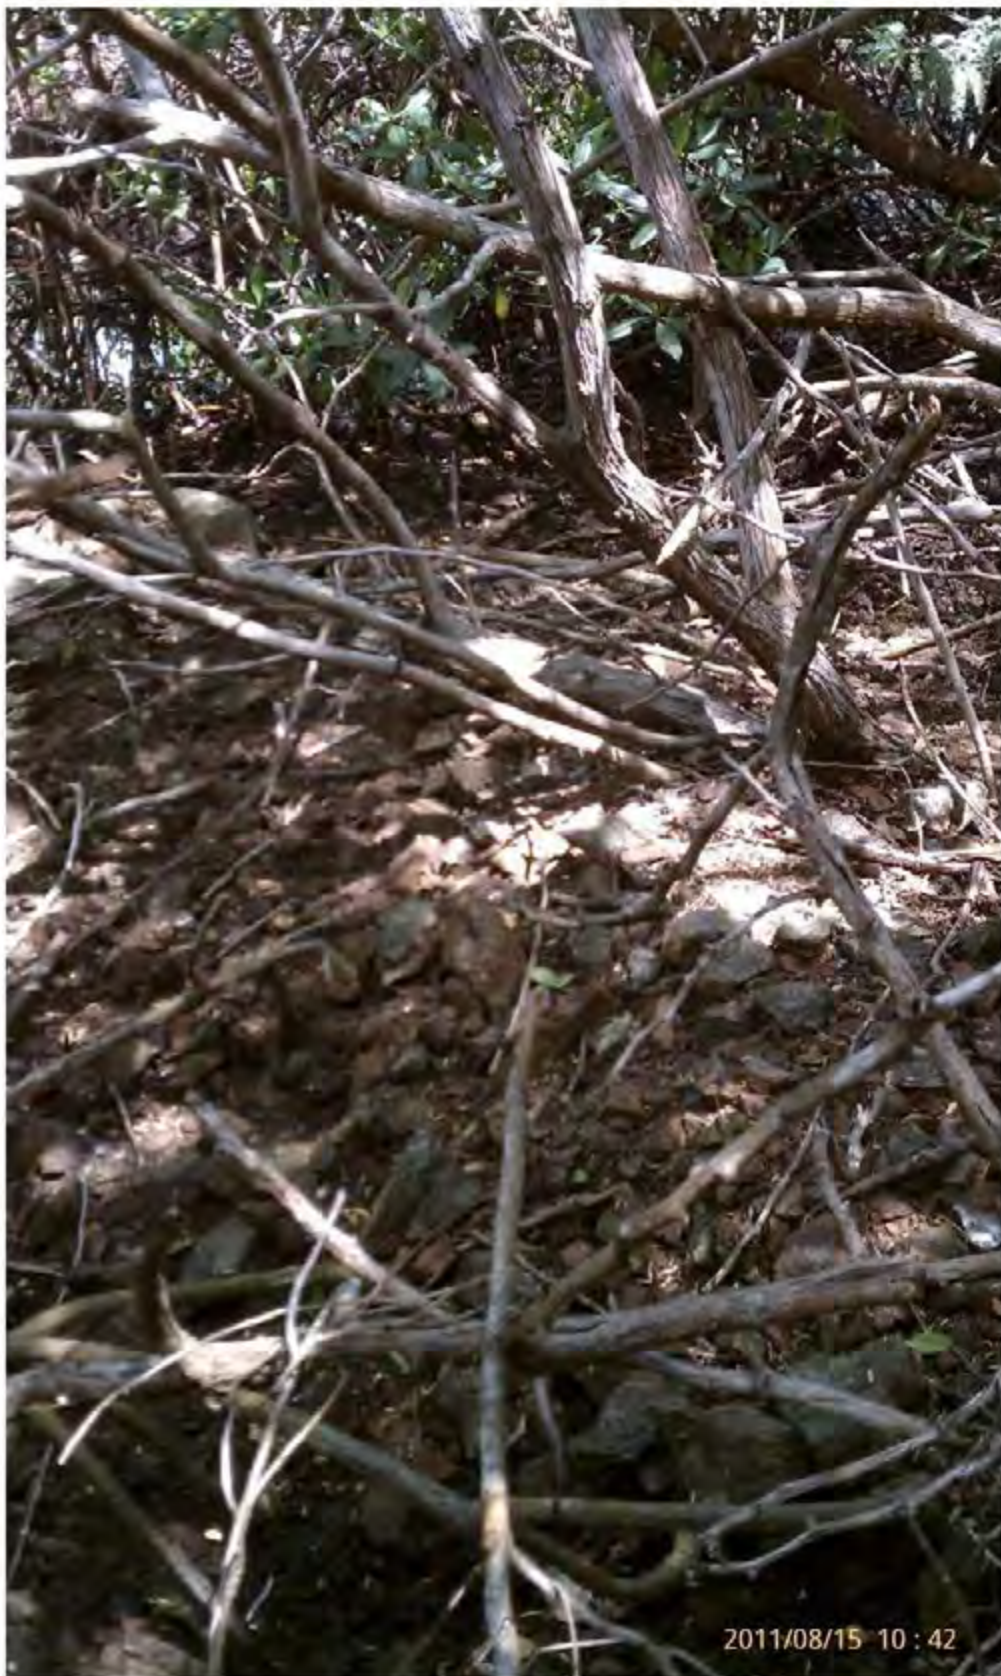
## Building Materials:

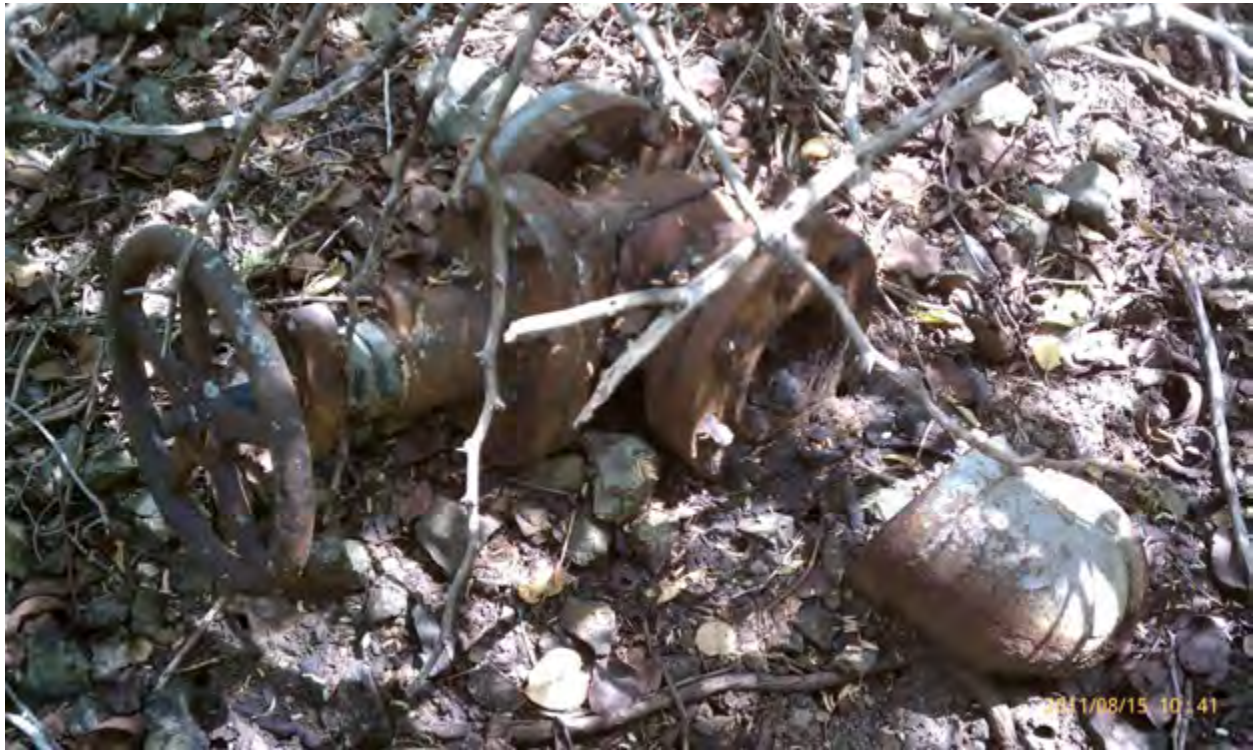
Photograph #13

## Water Valve:

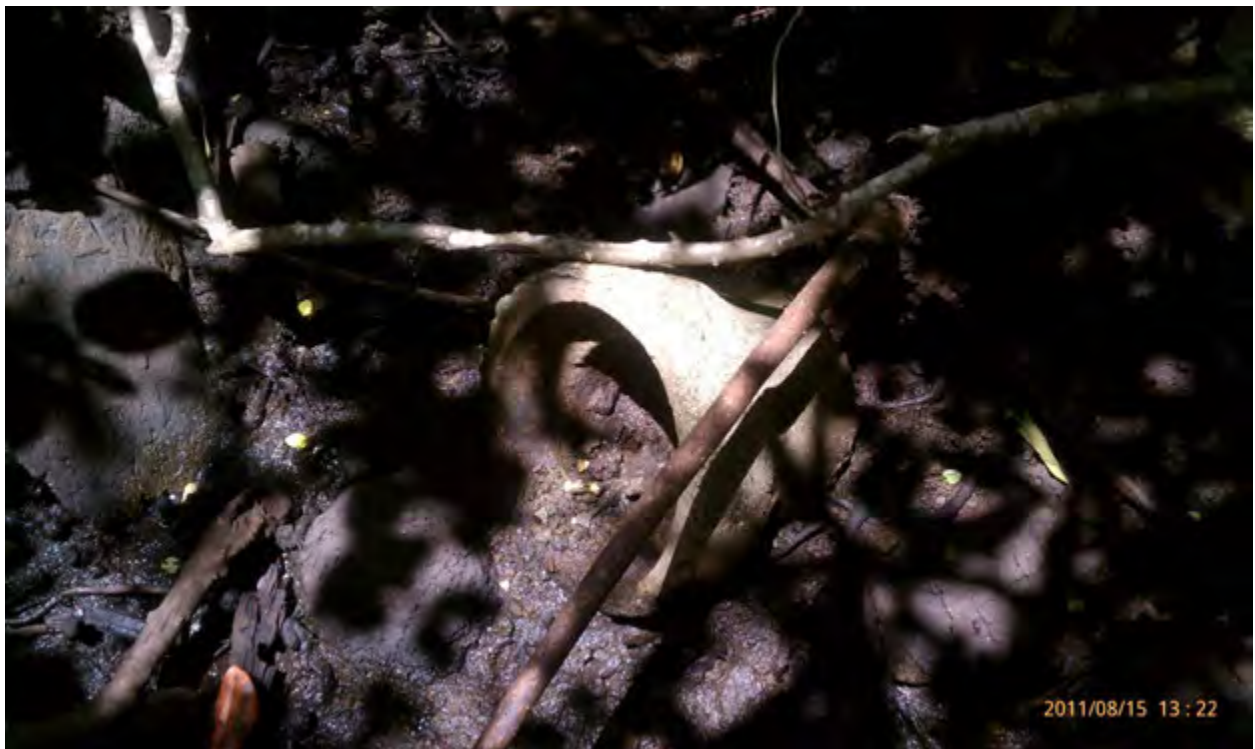
Photograph #14

## Concrete Pipe:

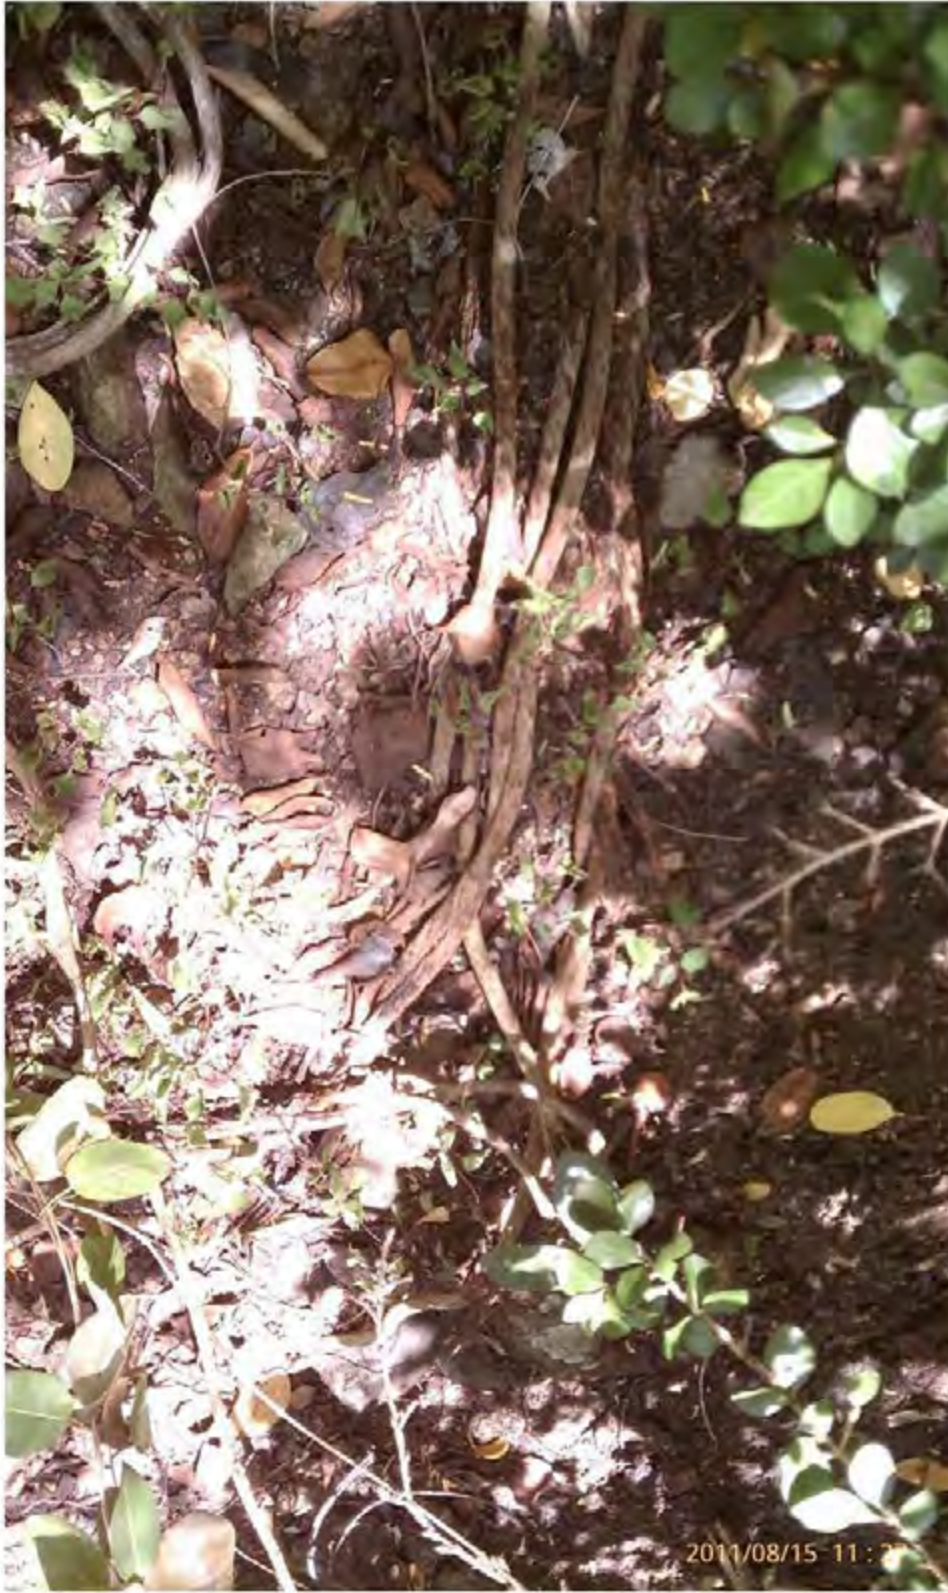
Photograph #15

## Metal Braided Cables:

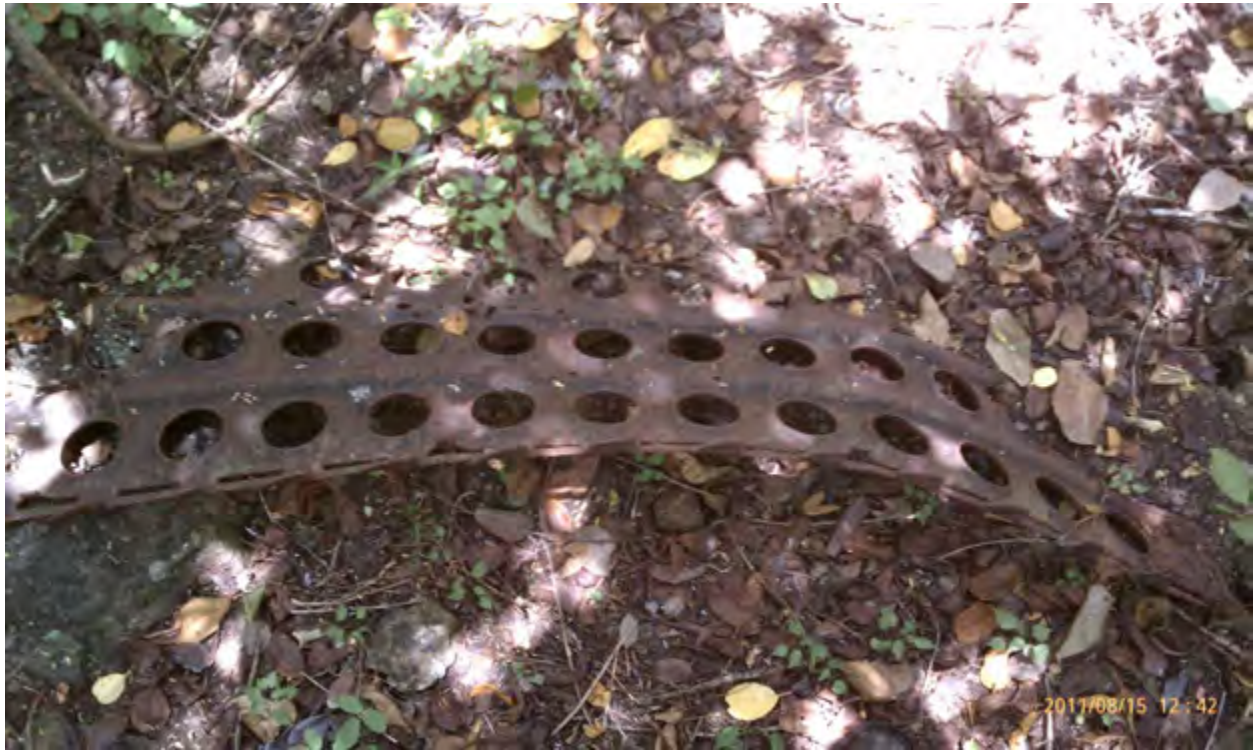
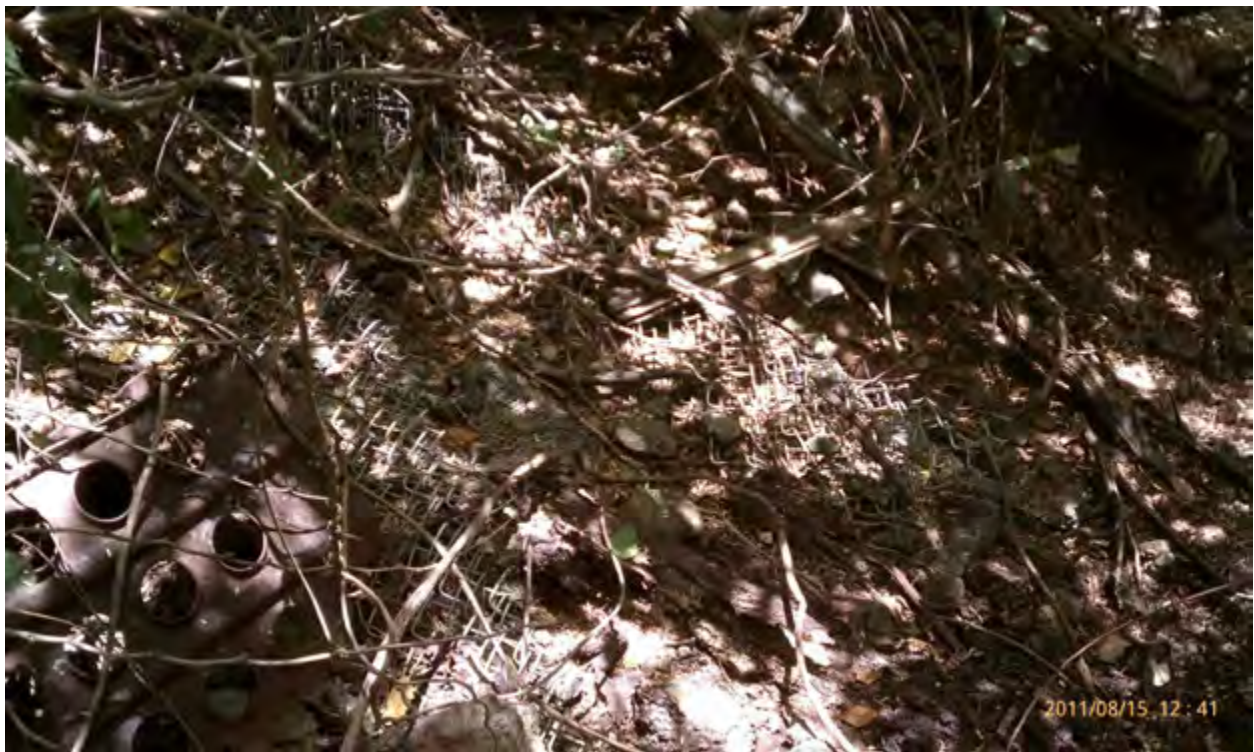
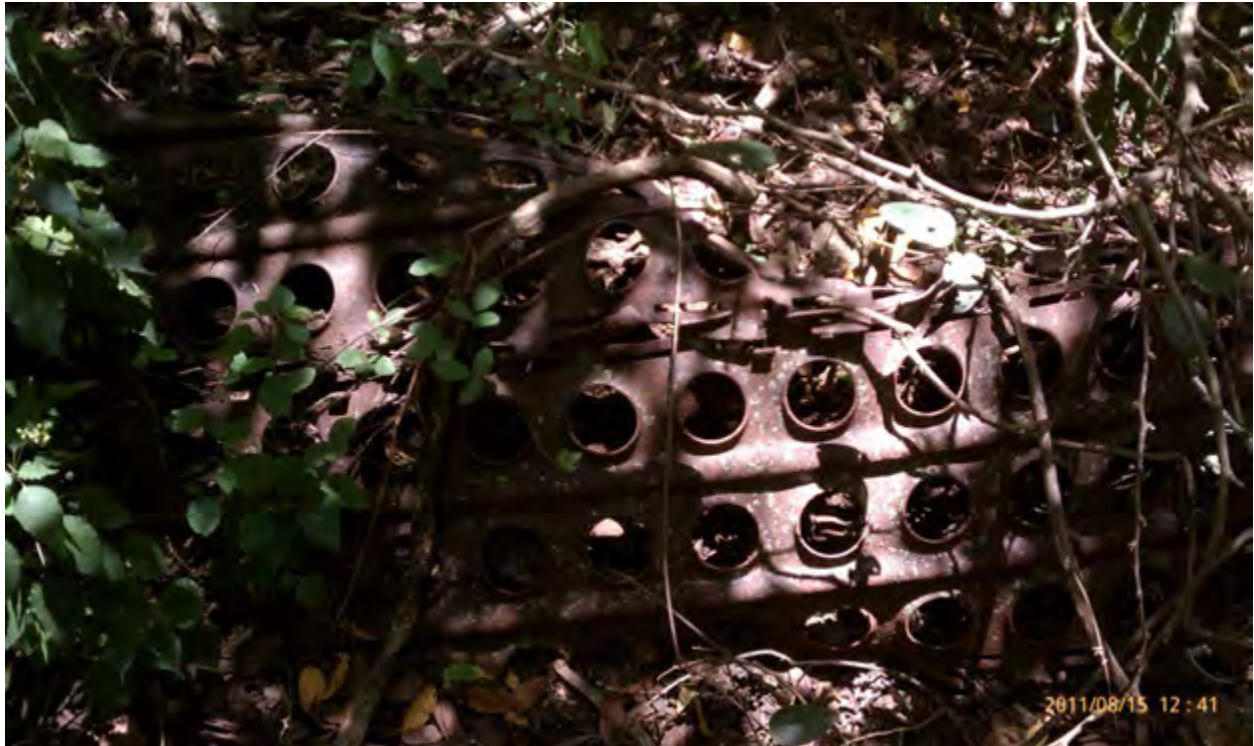
## Metal Walkway:

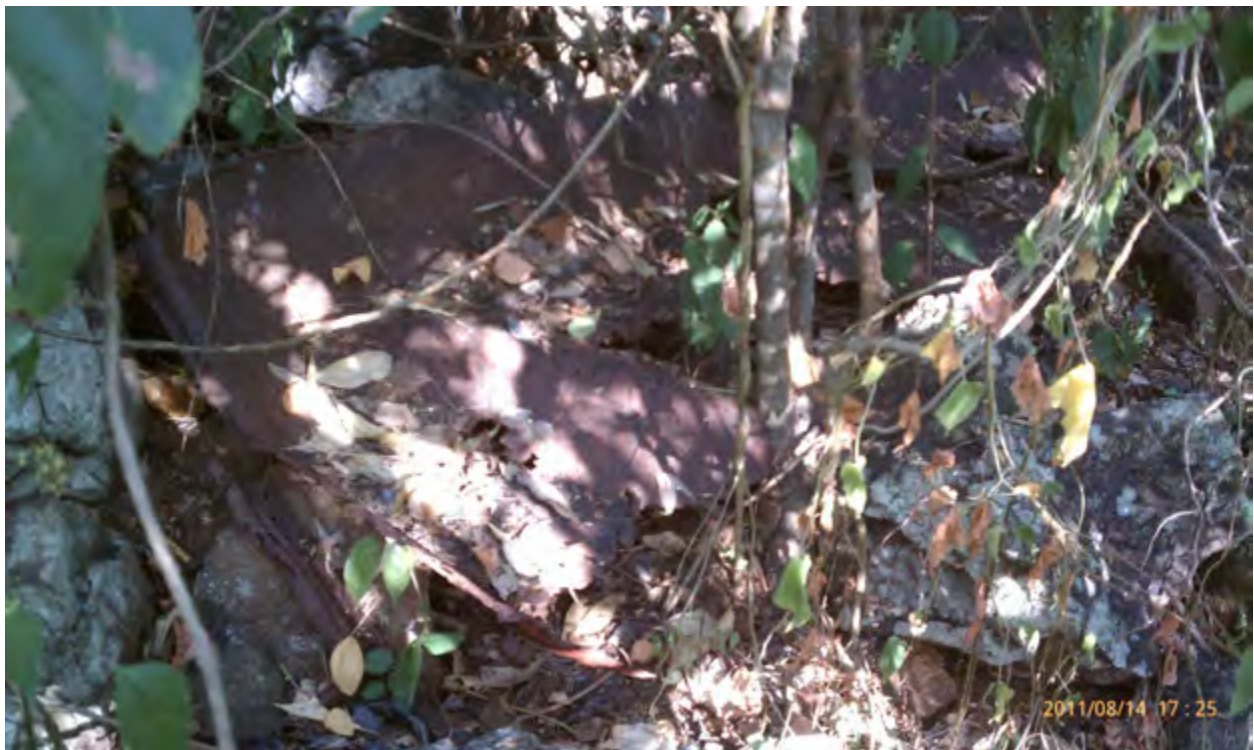
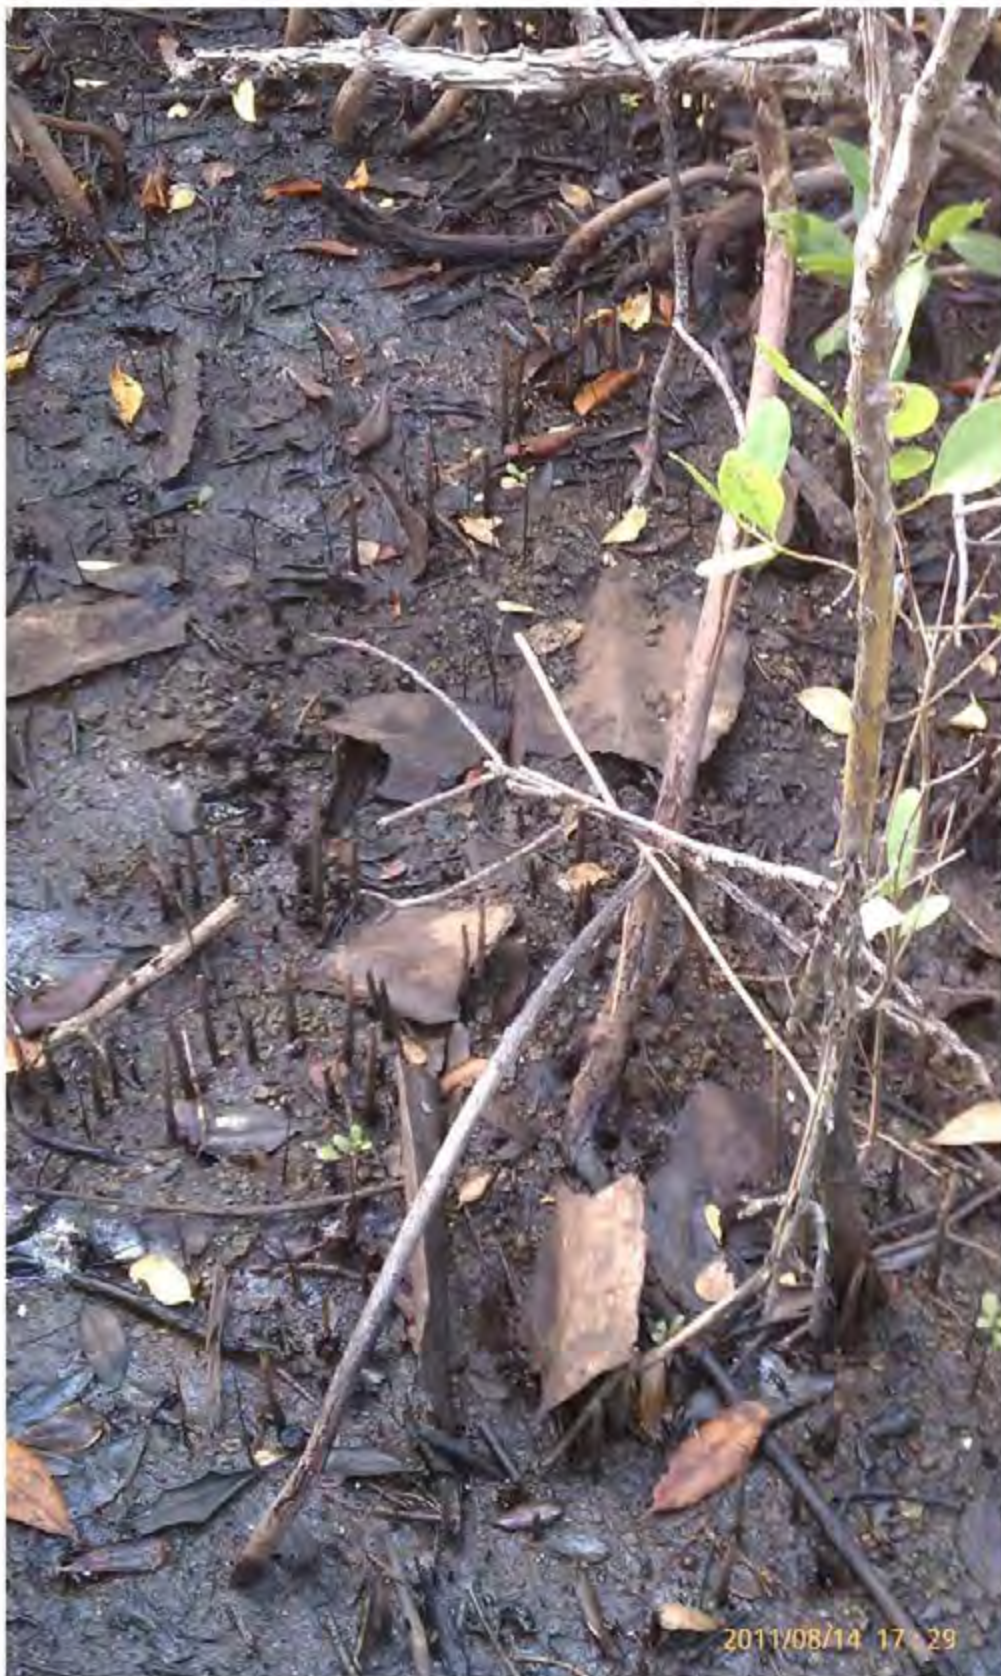
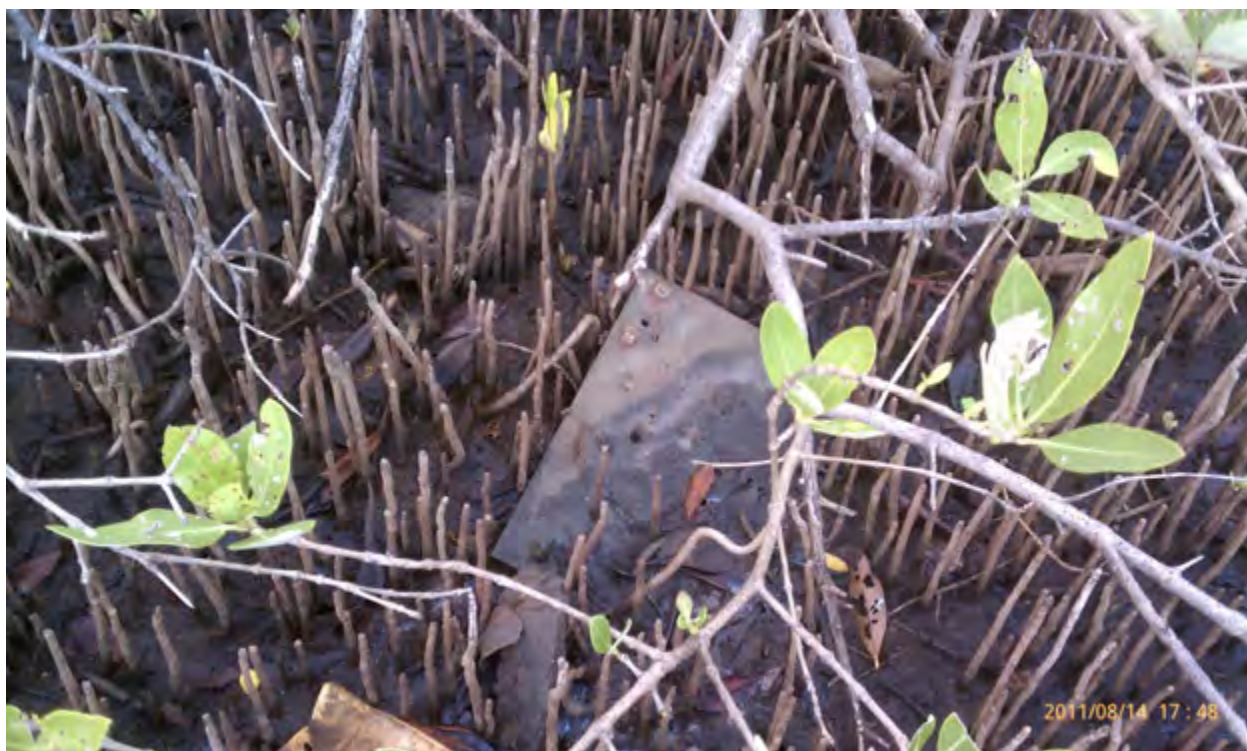
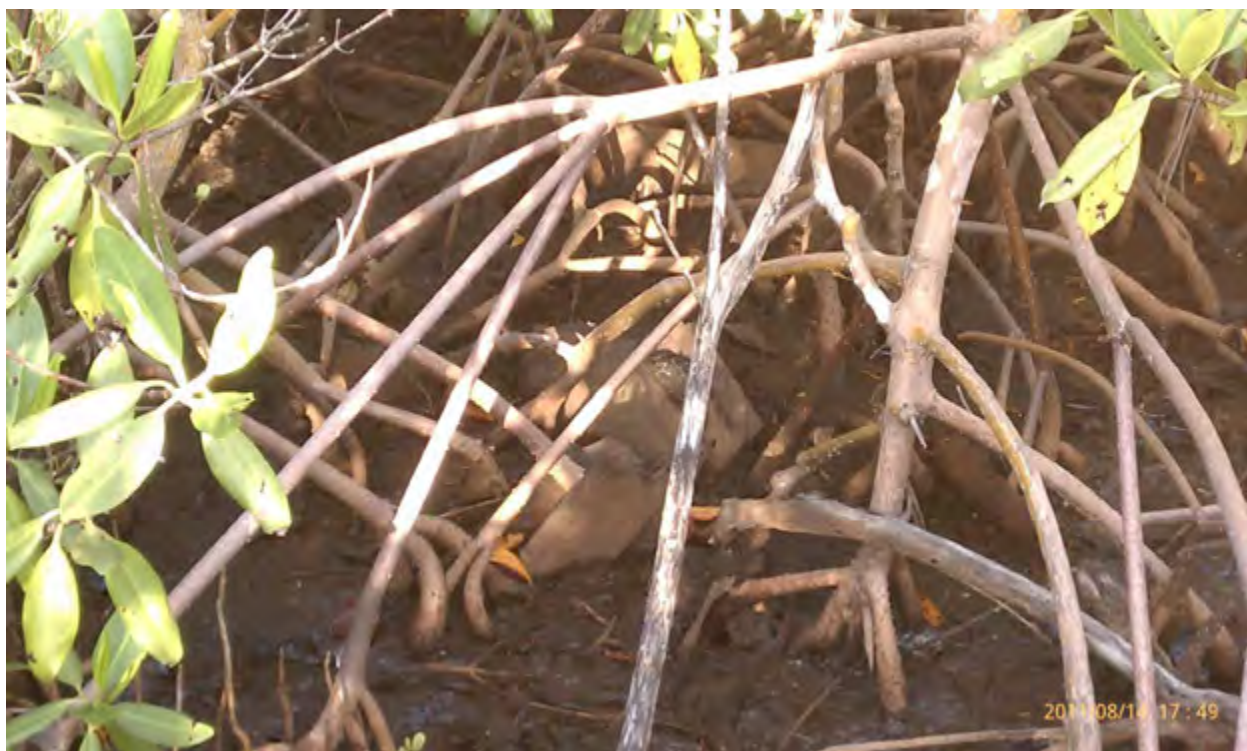
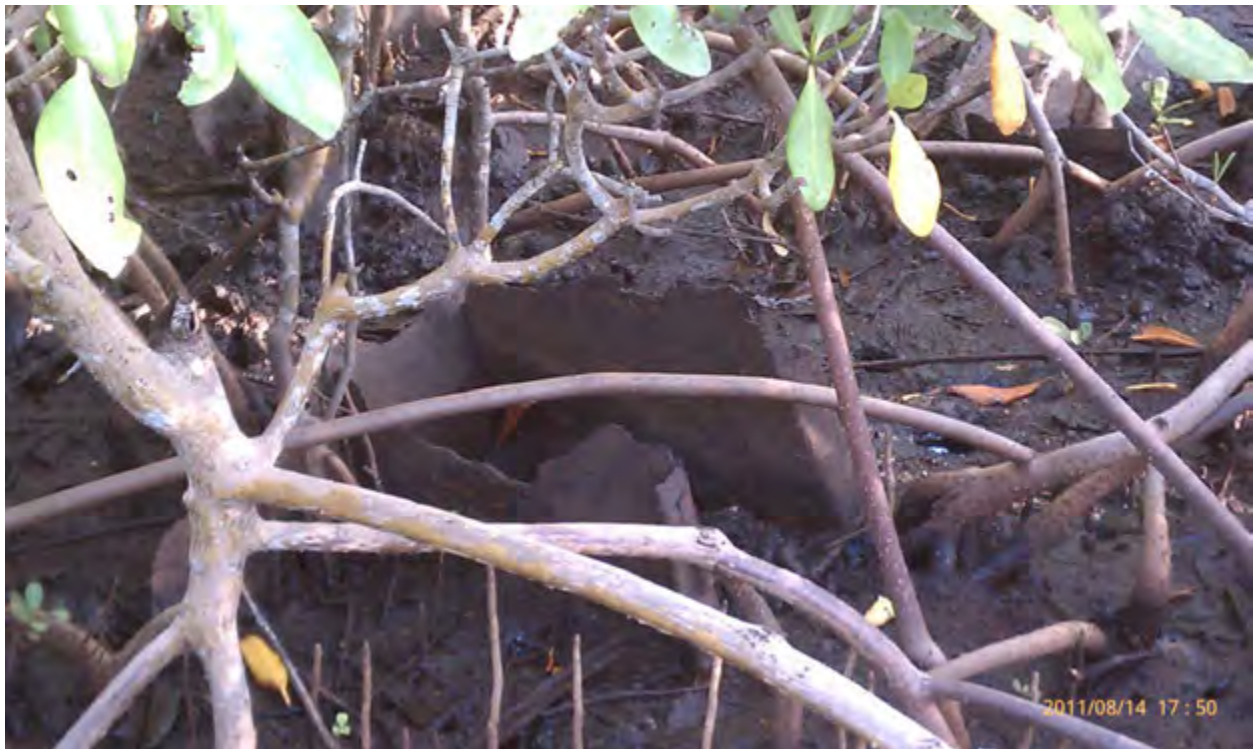
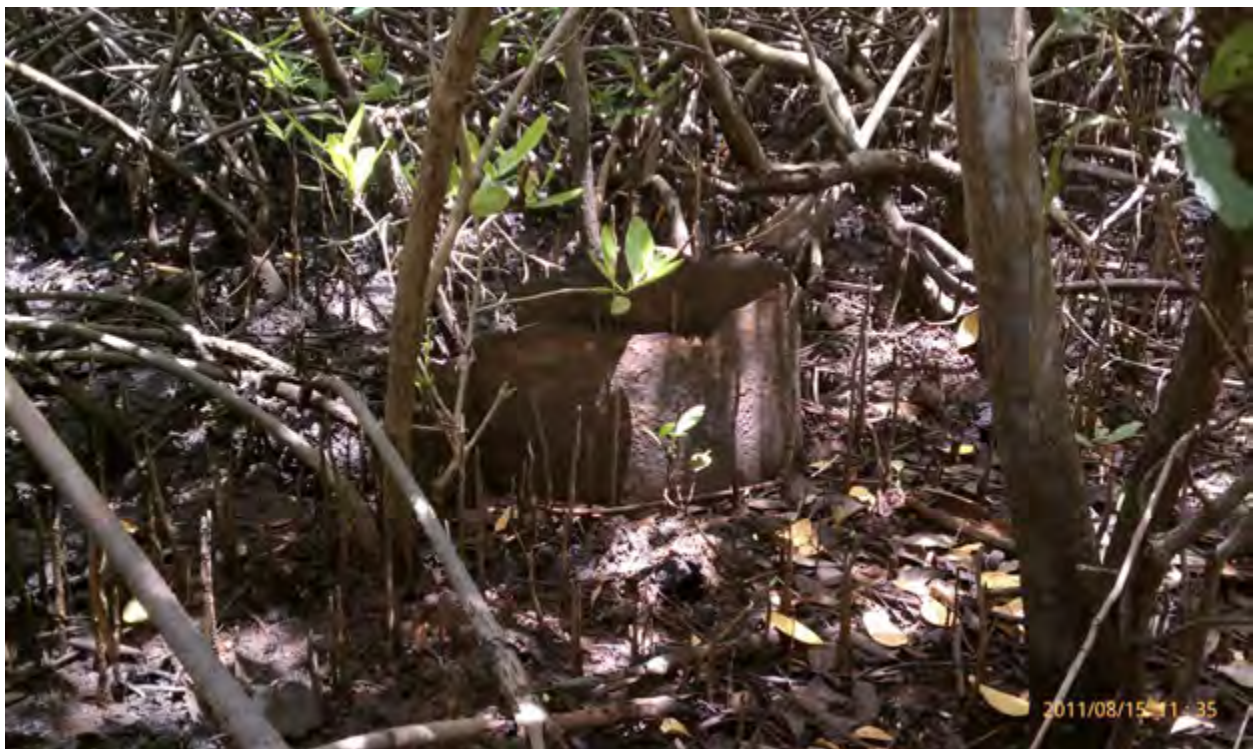
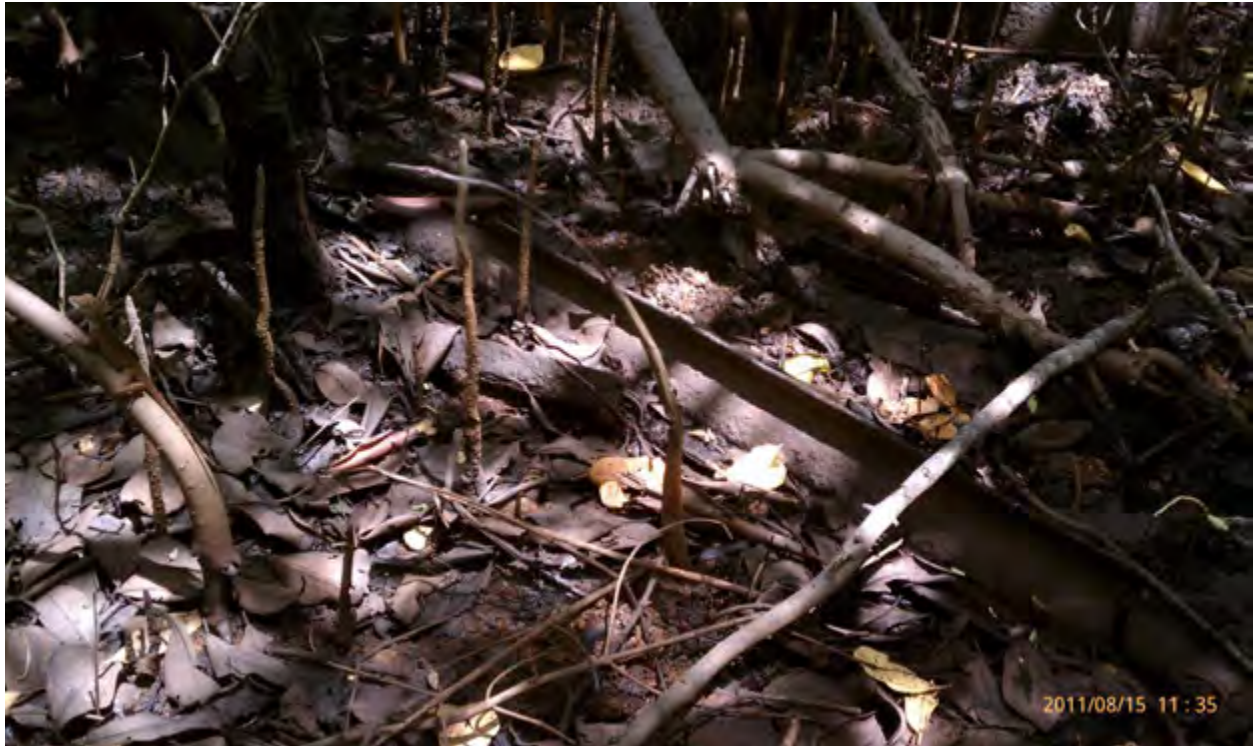
**Highly Deteriorated Oxidized Metal:**
