**Hazardous, Toxic, and Radioactive Waste (HTRW)  
Site Inspection Report  
DERP-FUDS Site IO2PR006800**

**Former Lower Camp Debris Site  
Culebra Island, Puerto Rico**

December 2011

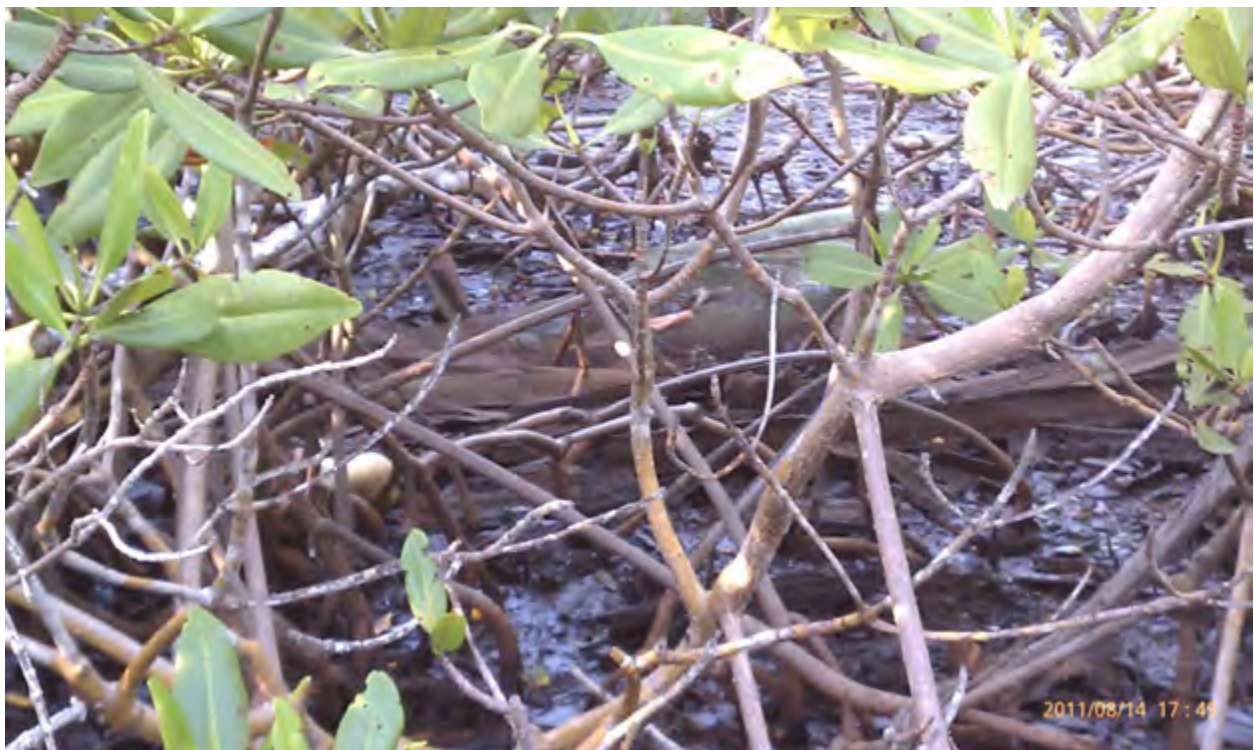
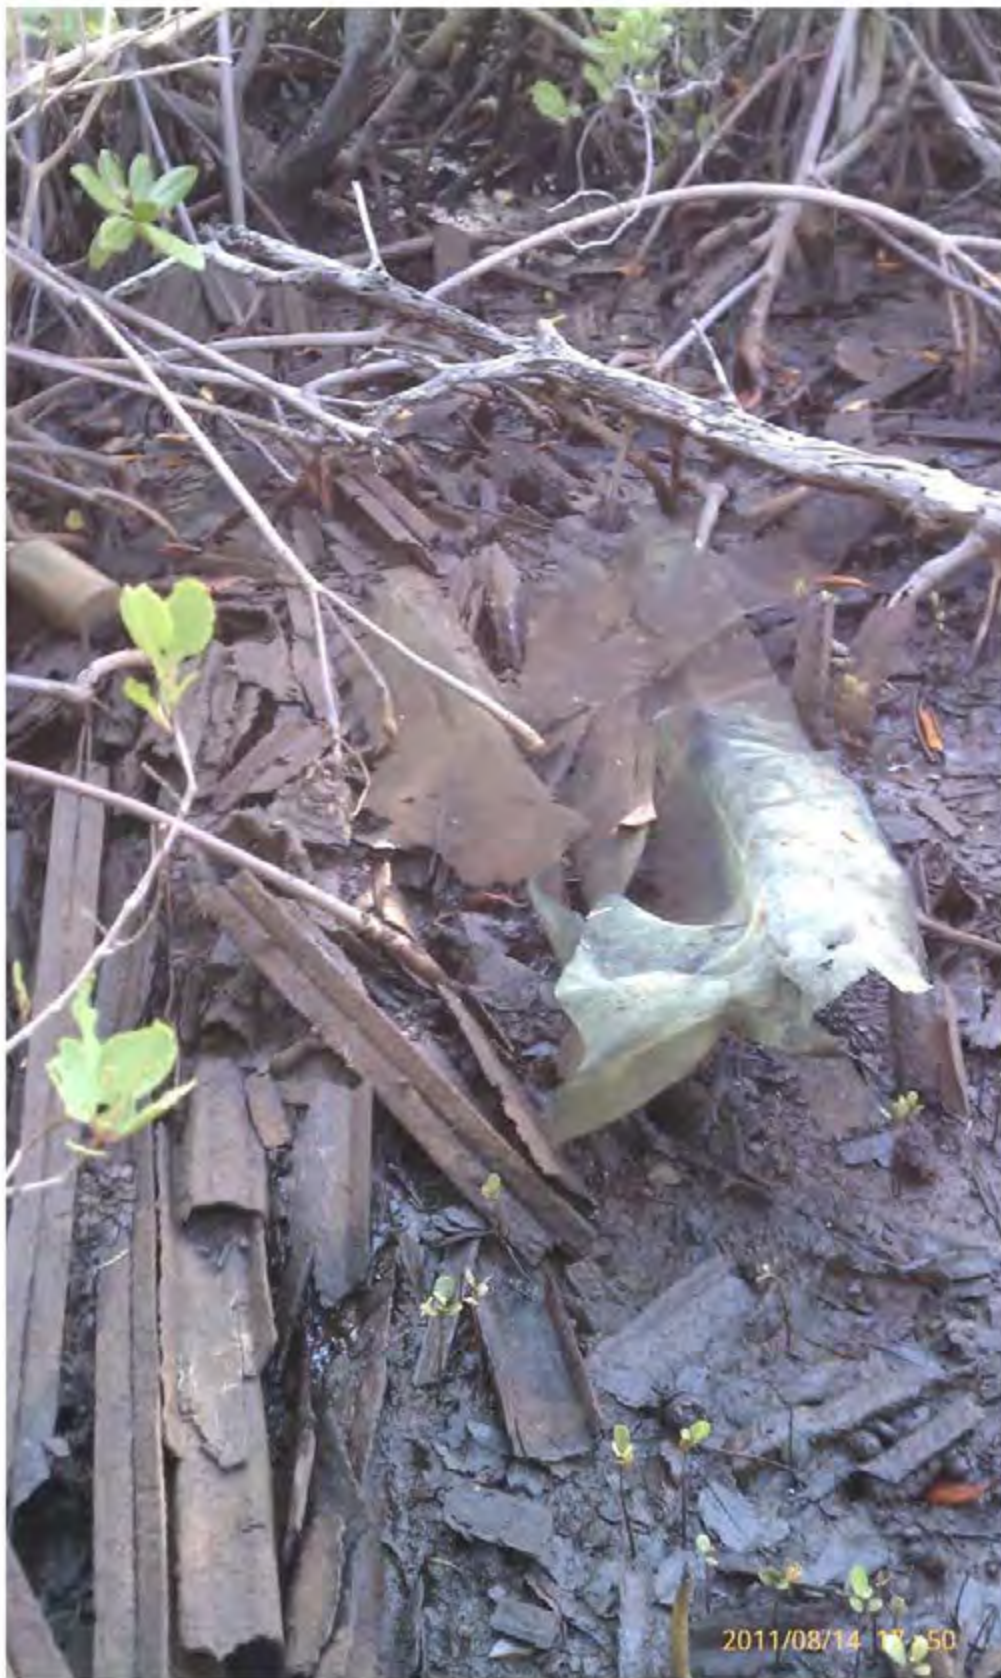
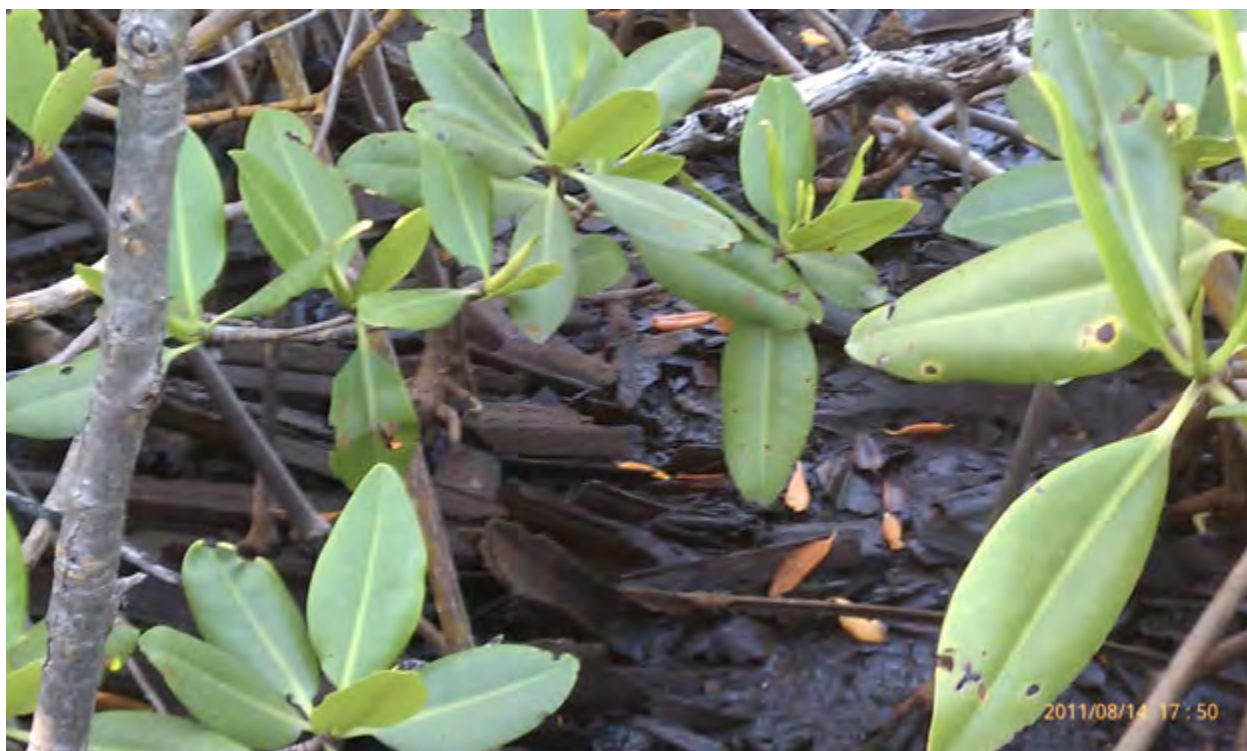
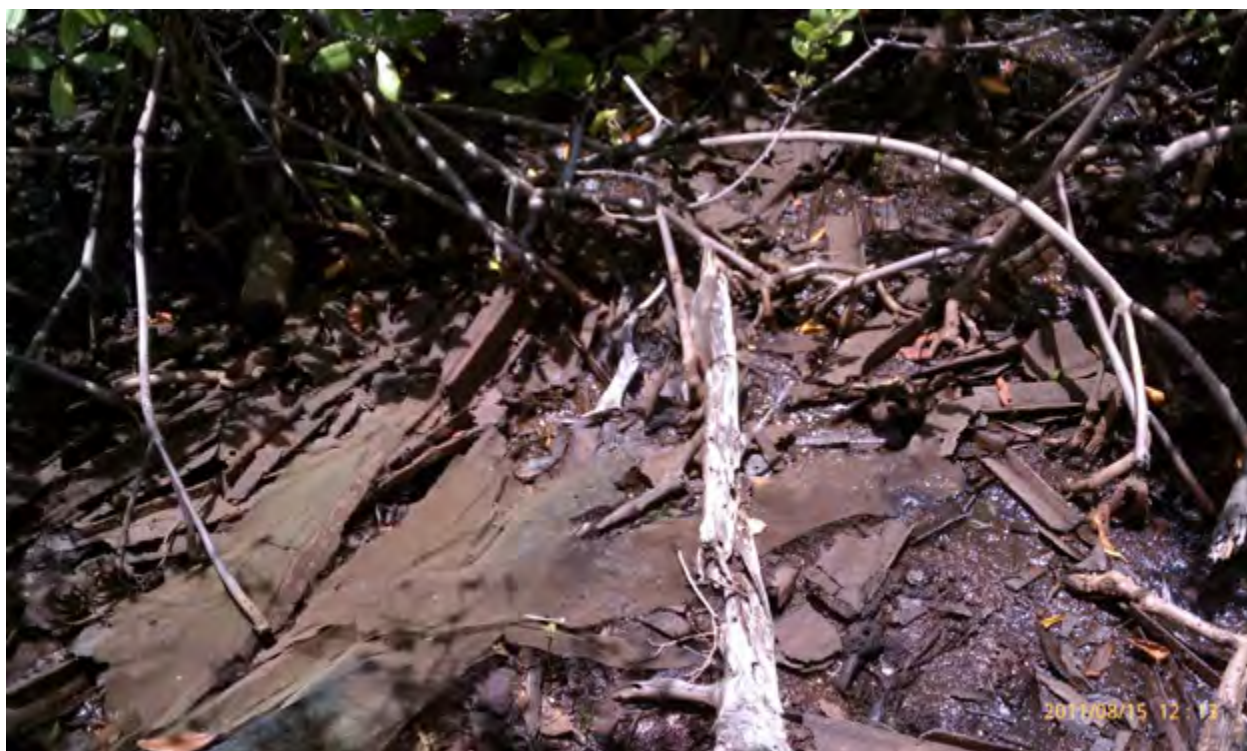
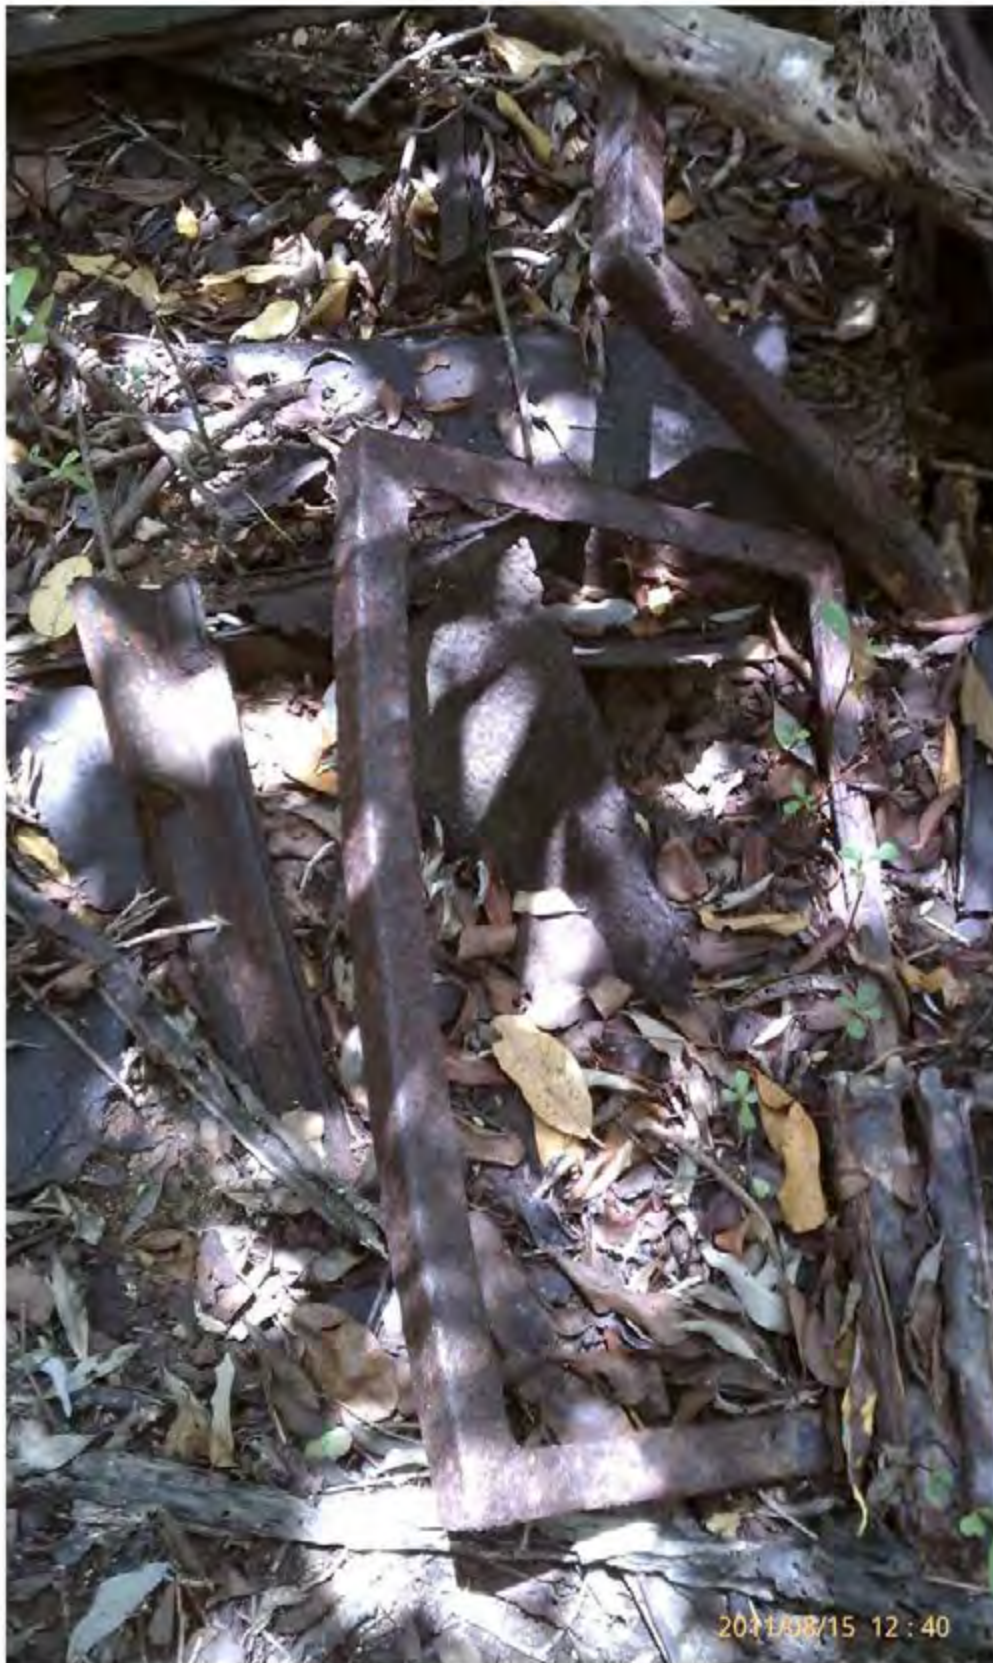
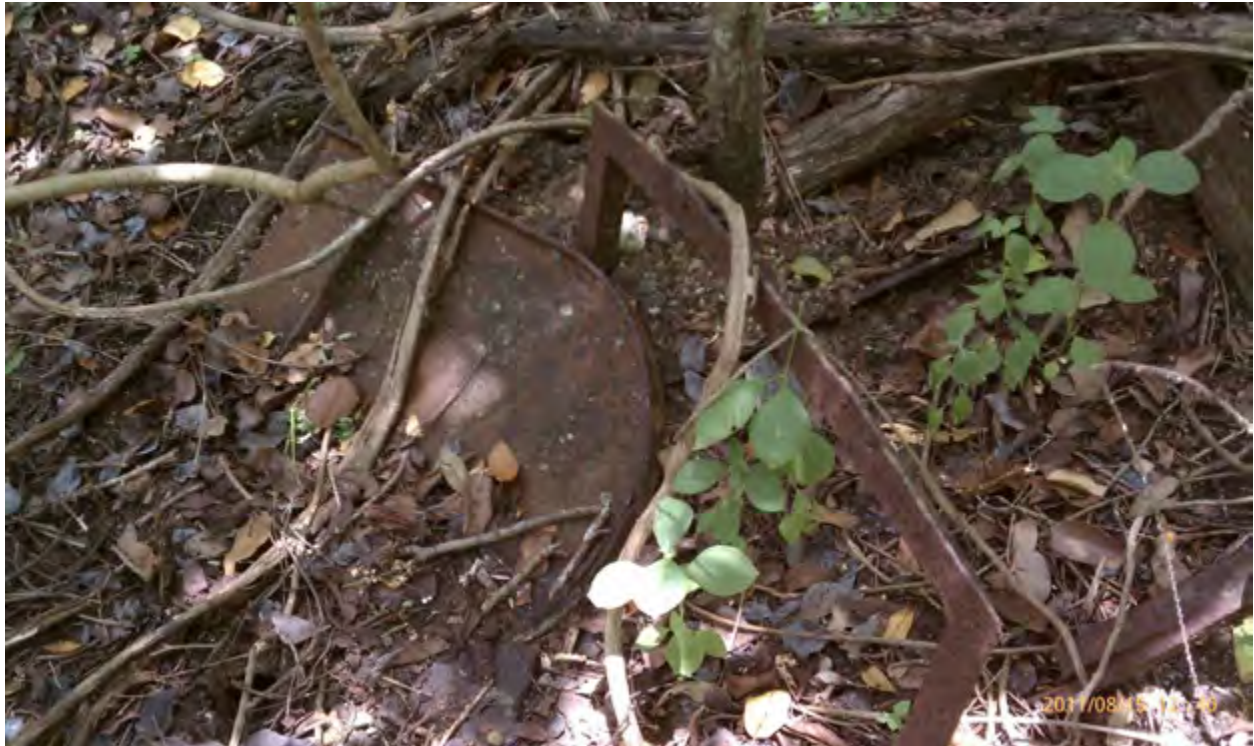
## Highly Deteriorated Oxidized Metal Pile:

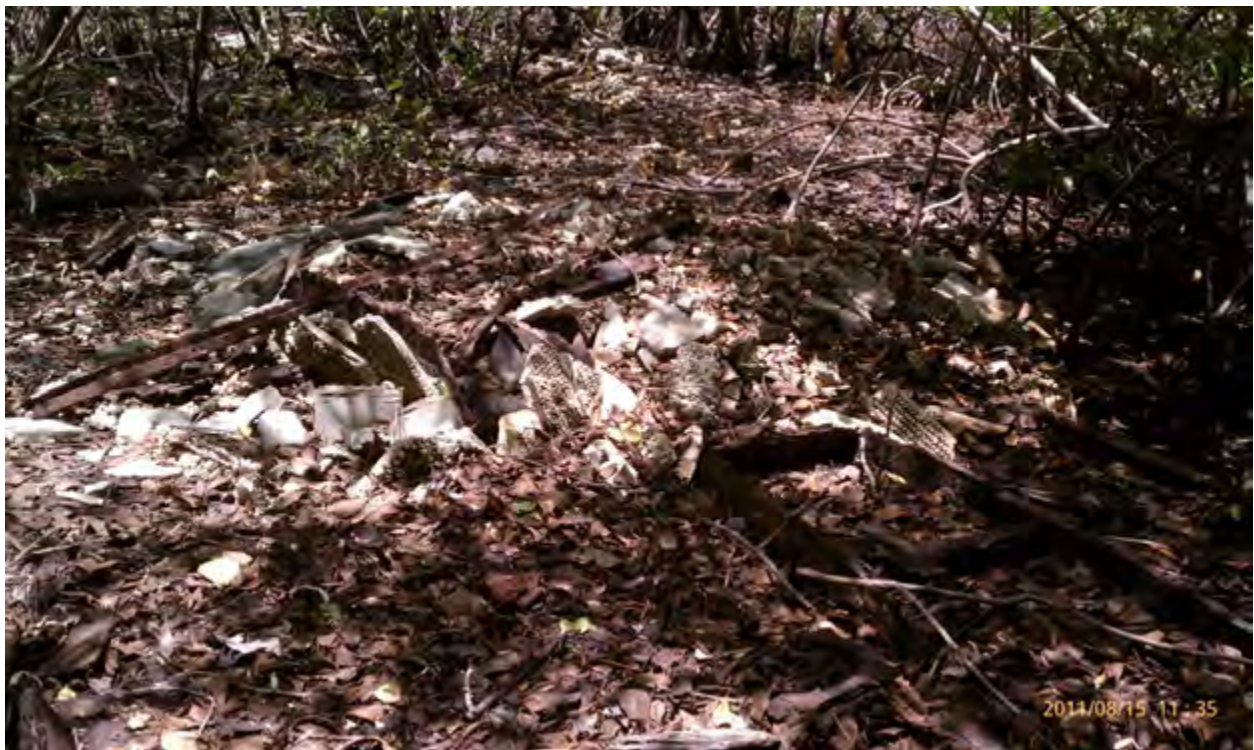
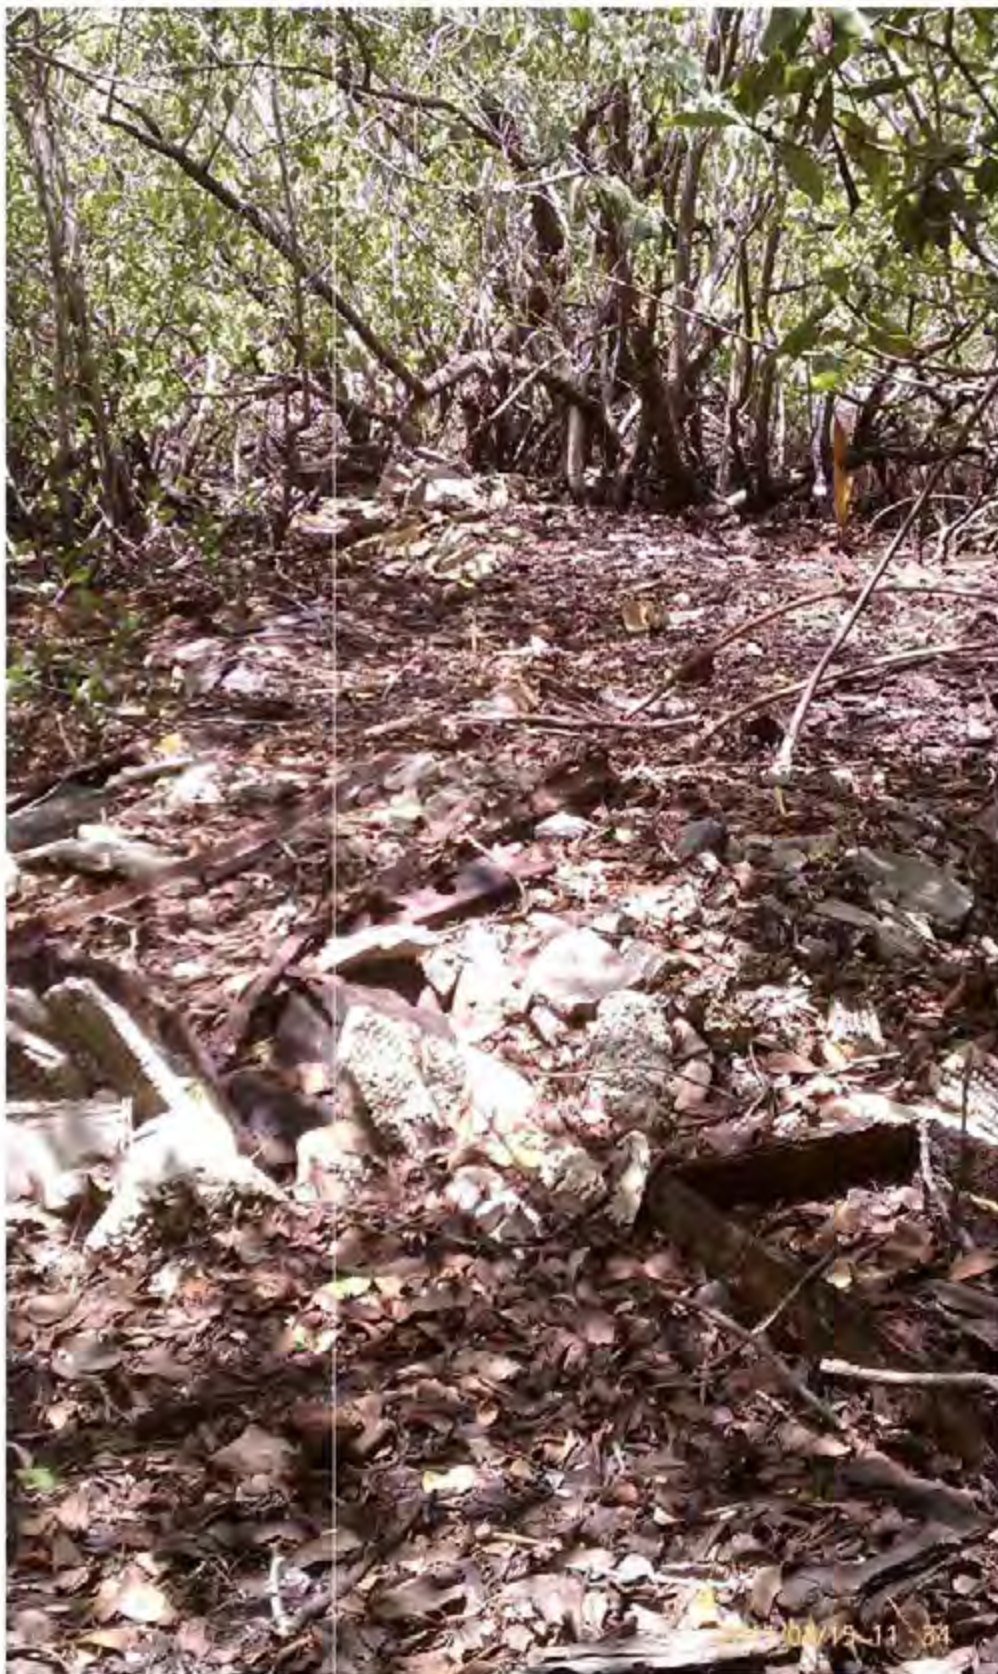
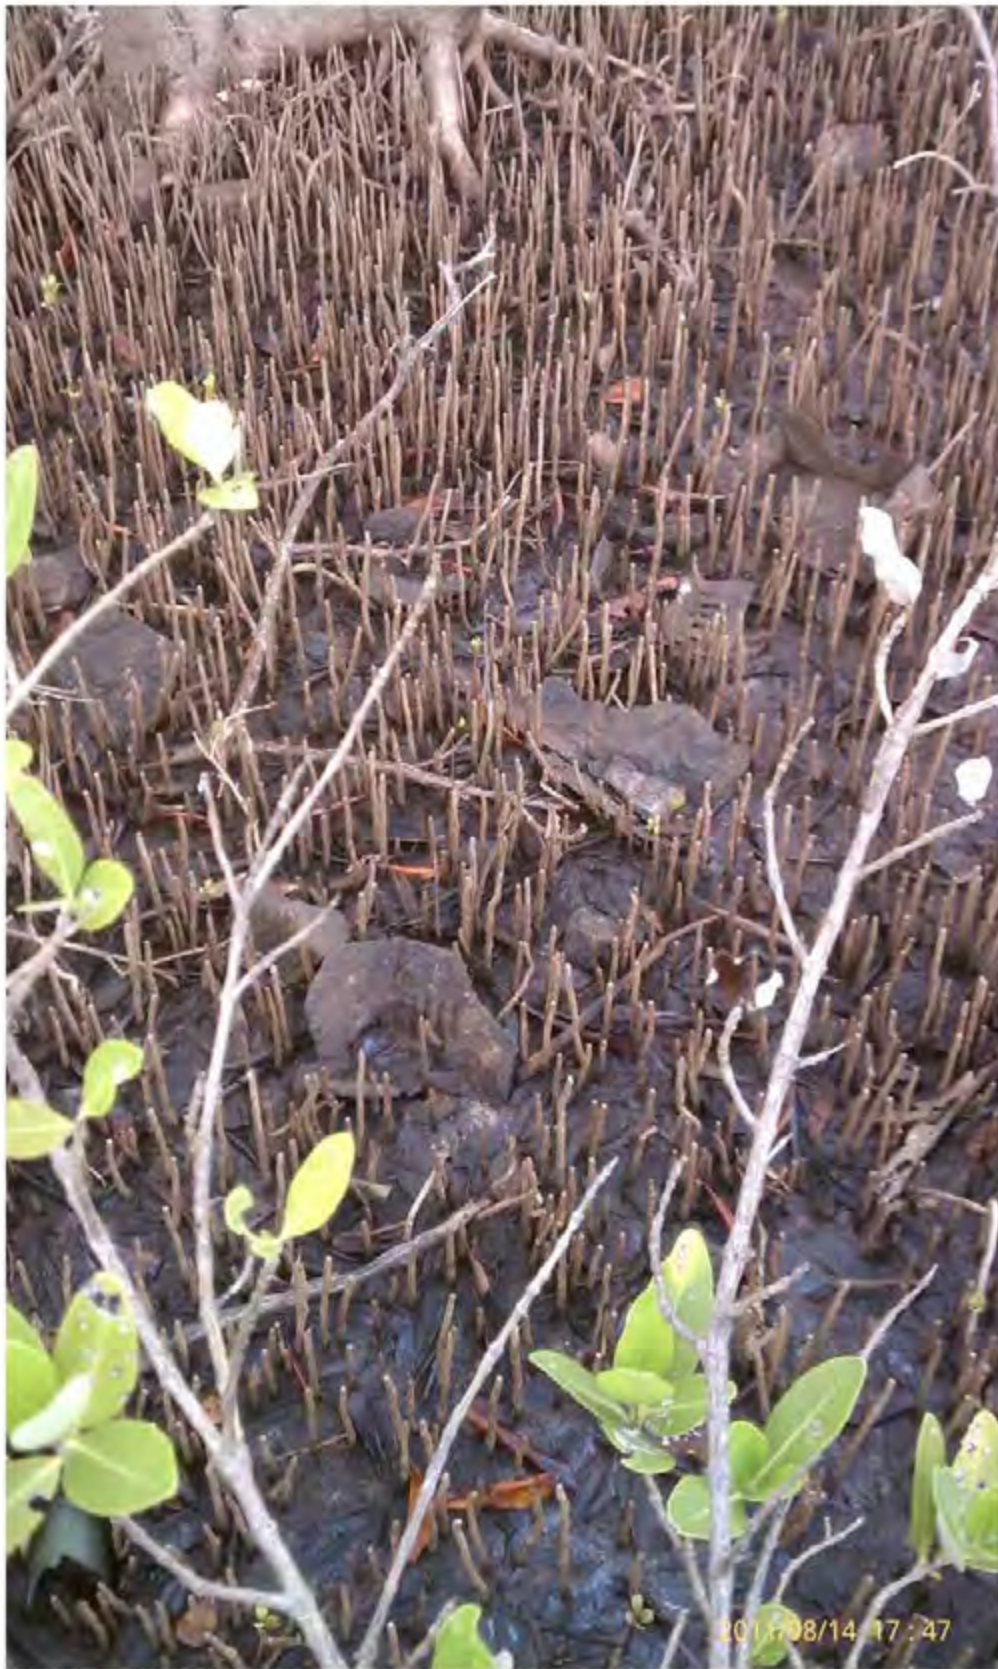
**Highly Deteriorated Oxidized Metal and Building Material:**

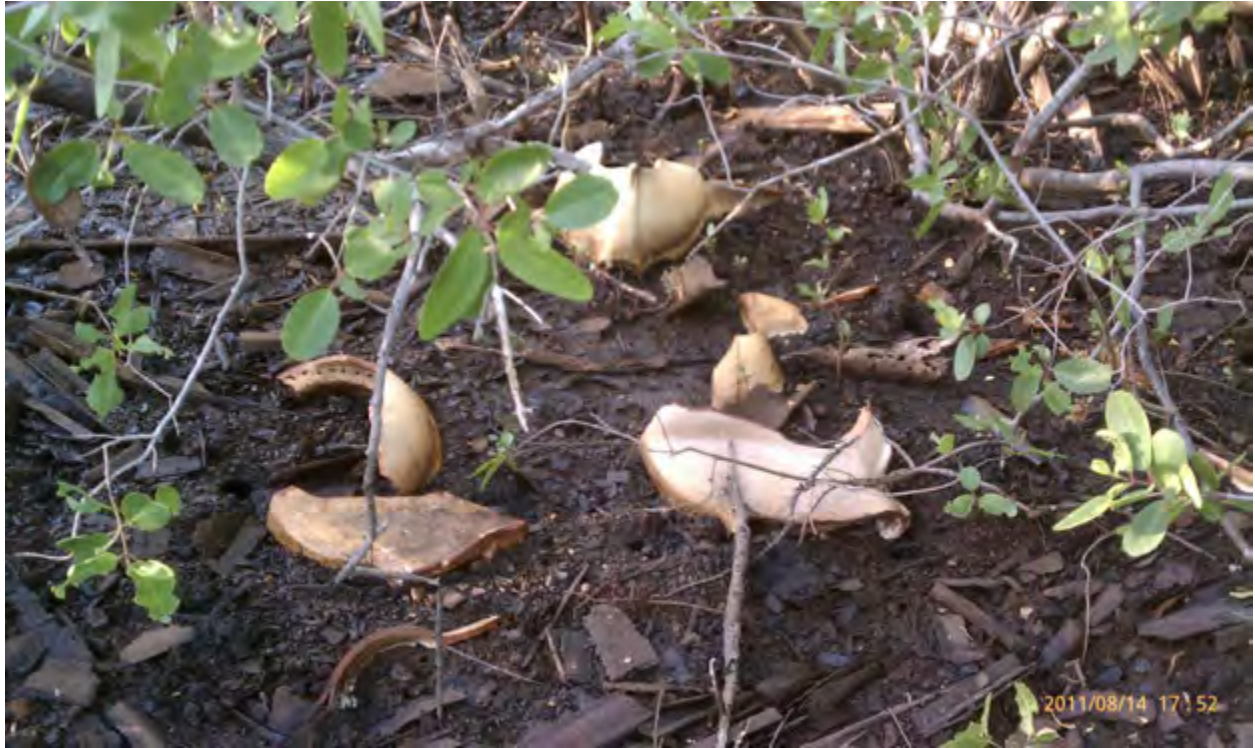
Photograph #35

## Broken Porcelain and Highly Deteriorated Oxidized Metal:

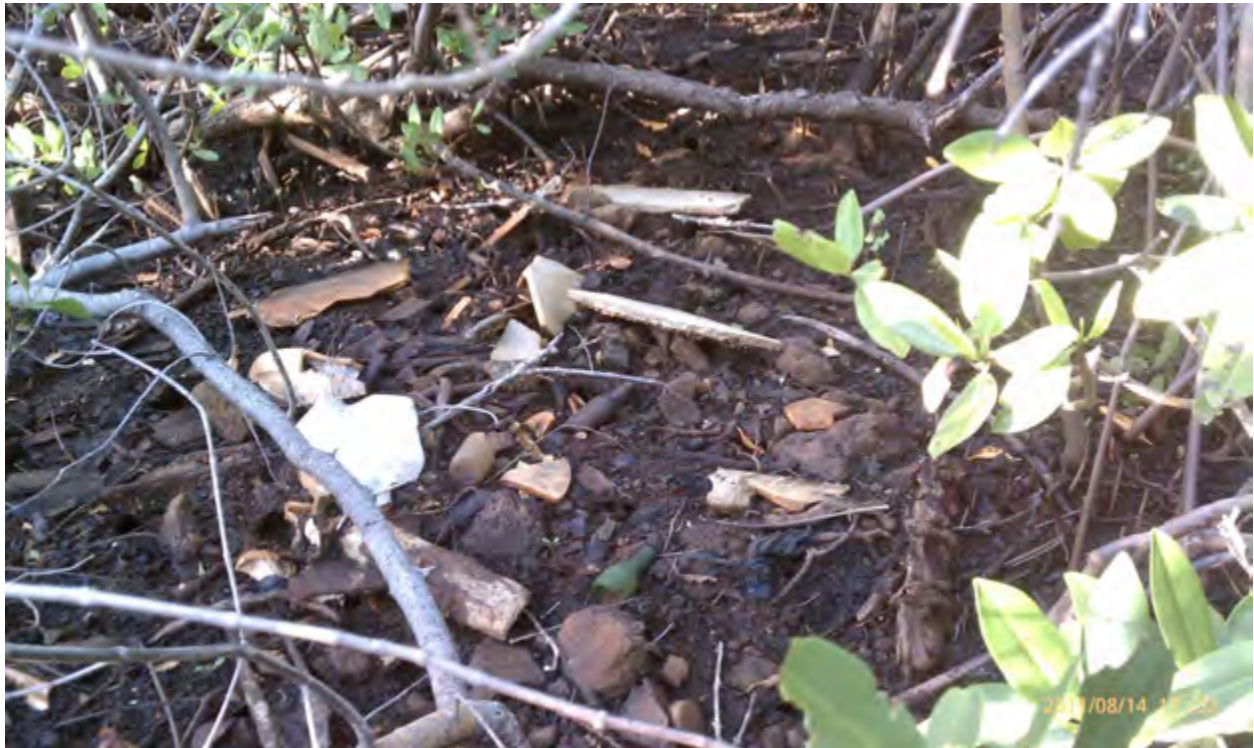
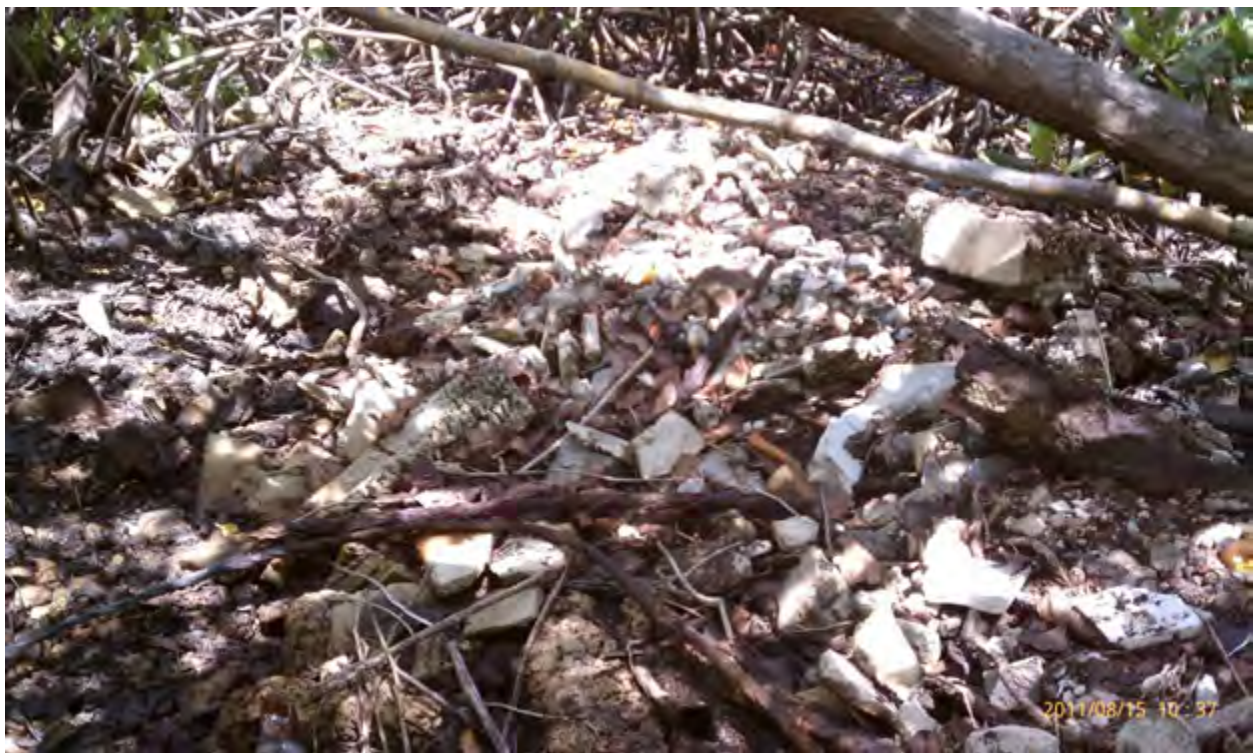
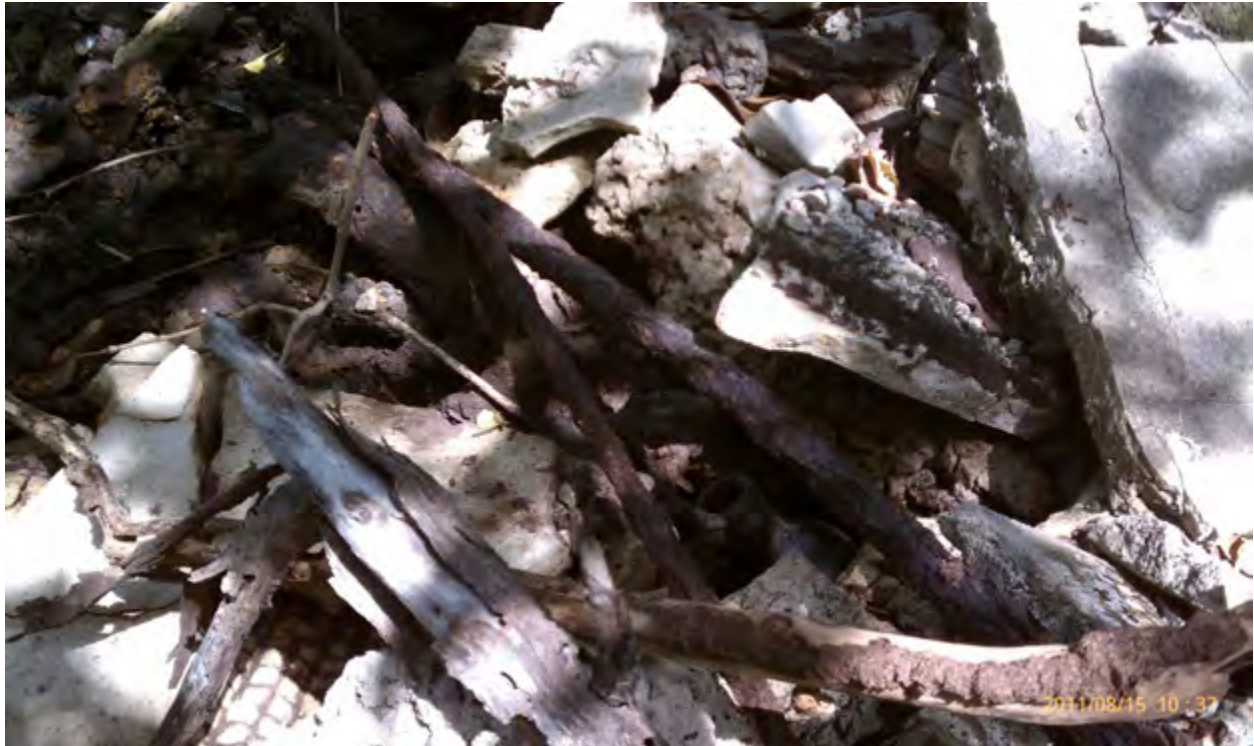
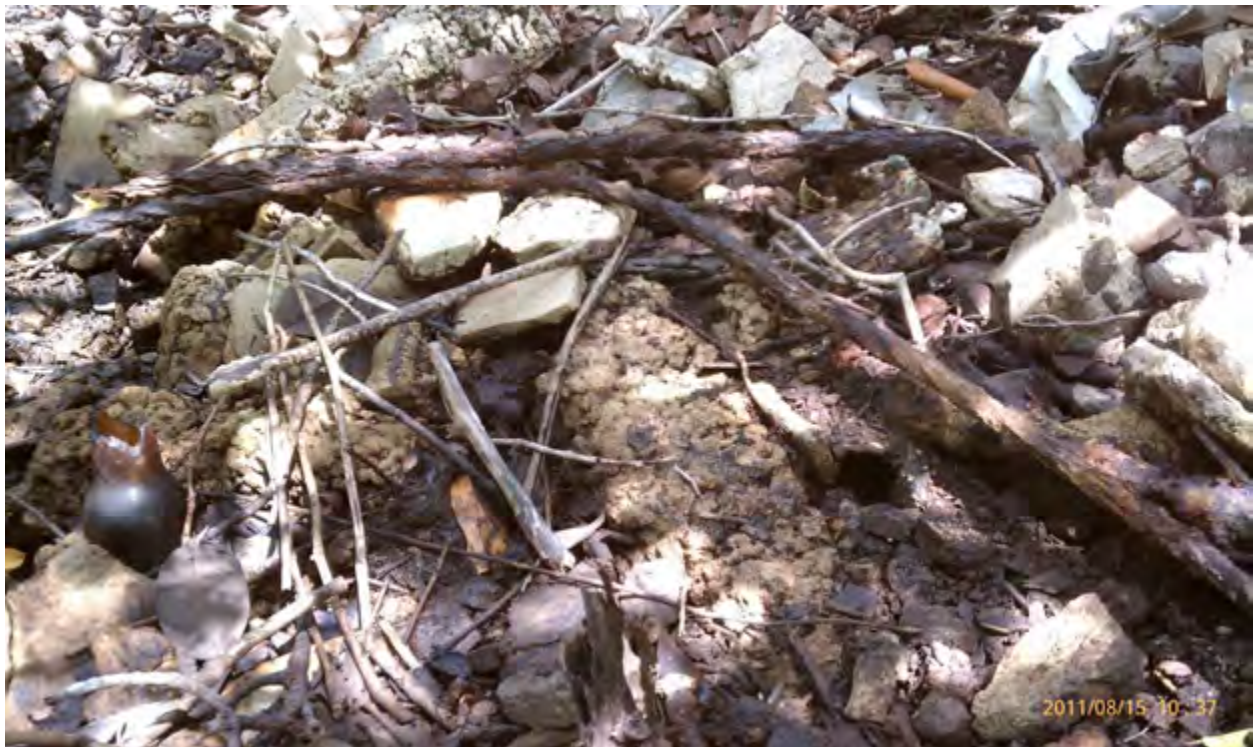
**Broken Porcelain, Highly Deteriorated Oxidized Metal,  
Building Materials, and Broken Bottles:**

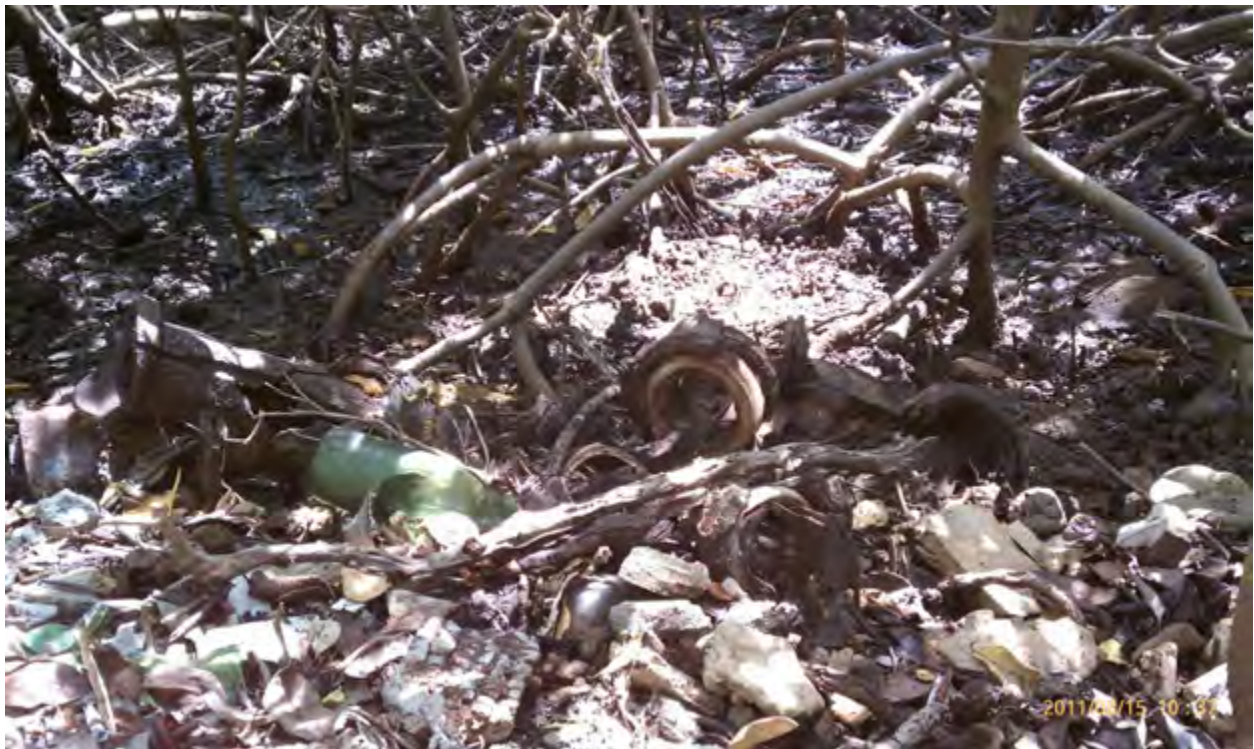
Photograph #41

## Metal Pipes:

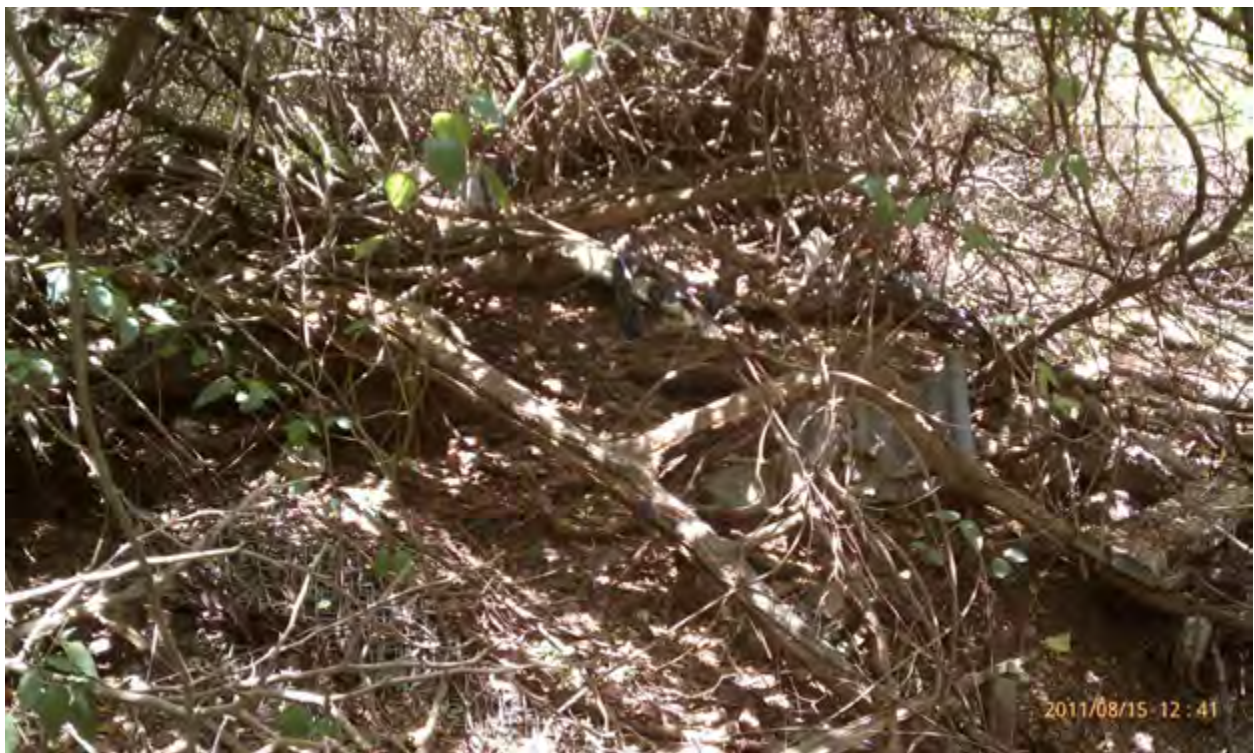
Photograph #43

**Metal Chain Linked Fencing, Corrugated Sheets, Building Materials:**

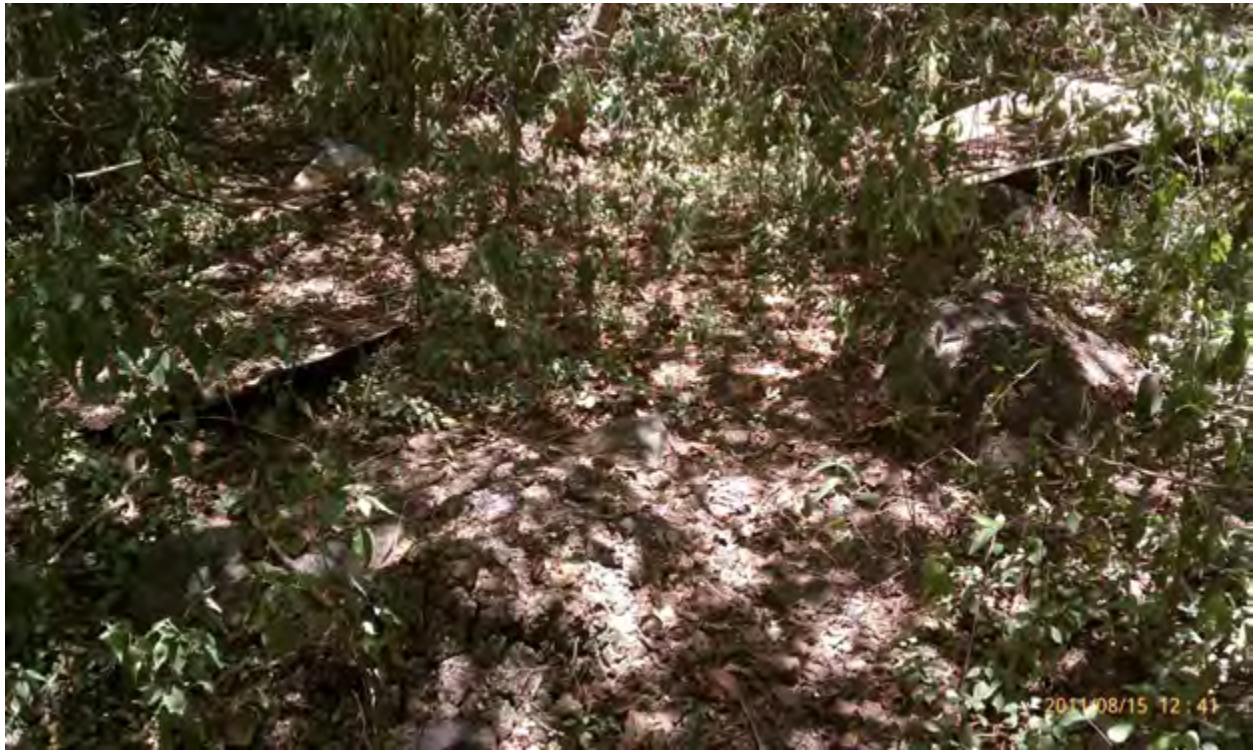
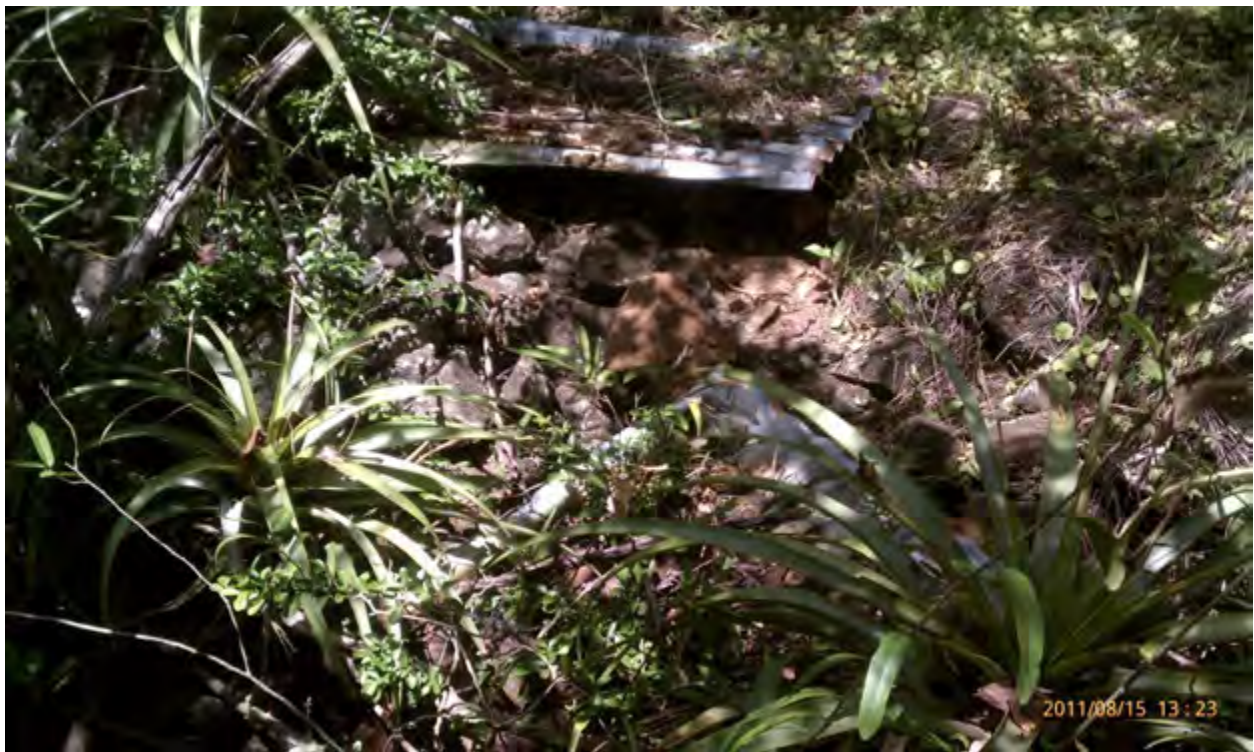
## Corrugated Sheet and Building Material:
