**Hazardous, Toxic, and Radioactive Waste (HTRW)  
Site Inspection Report  
DERP-FUDS Site IO2PR006800**

**Former Lower Camp Debris Site  
Culebra Island, Puerto Rico**

December 2011

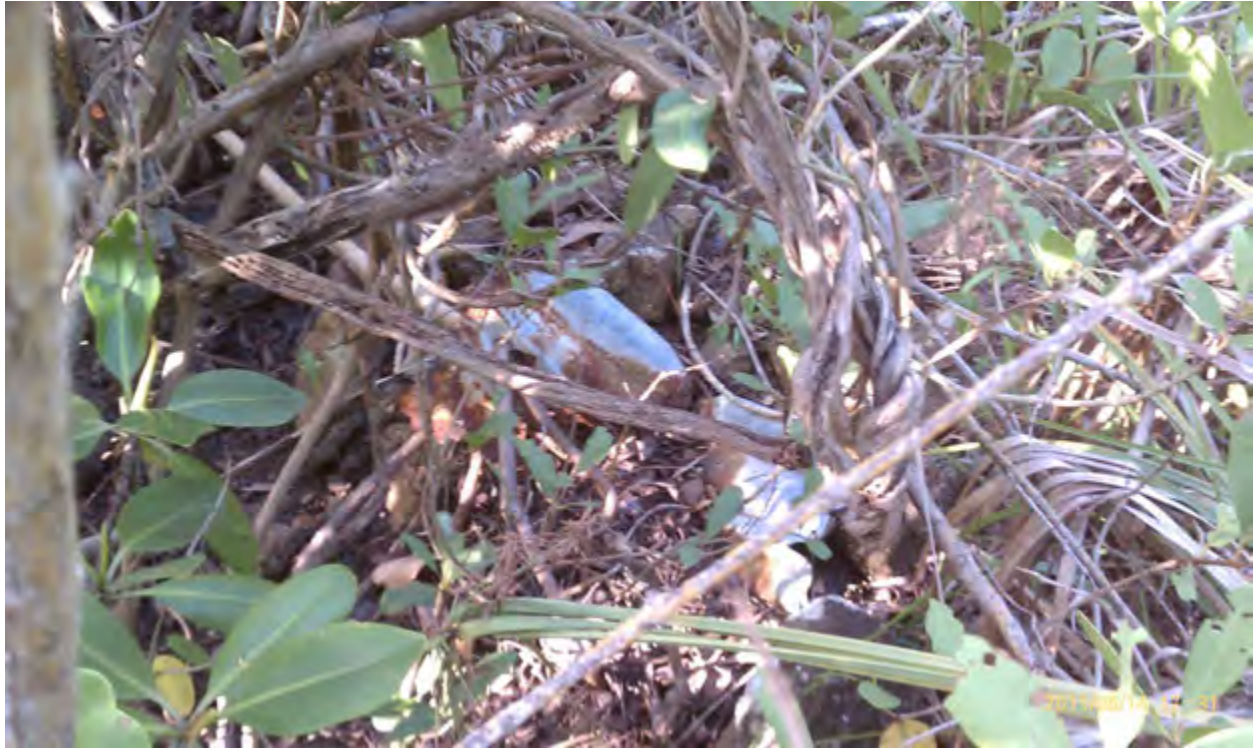
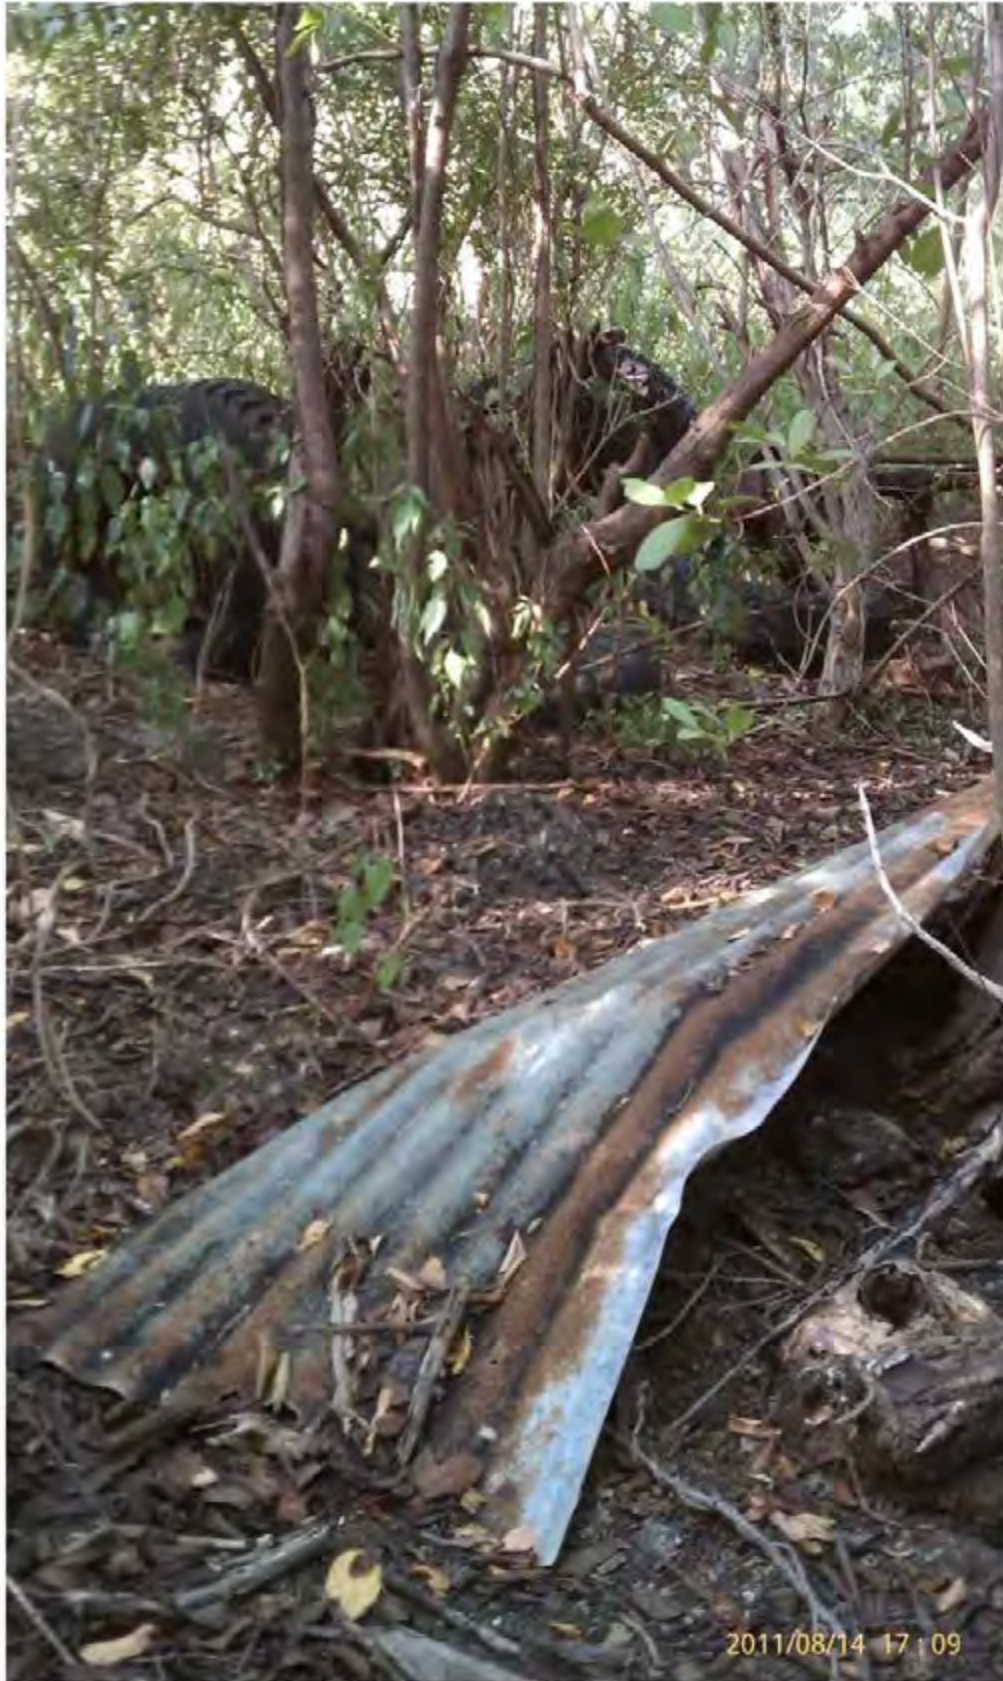
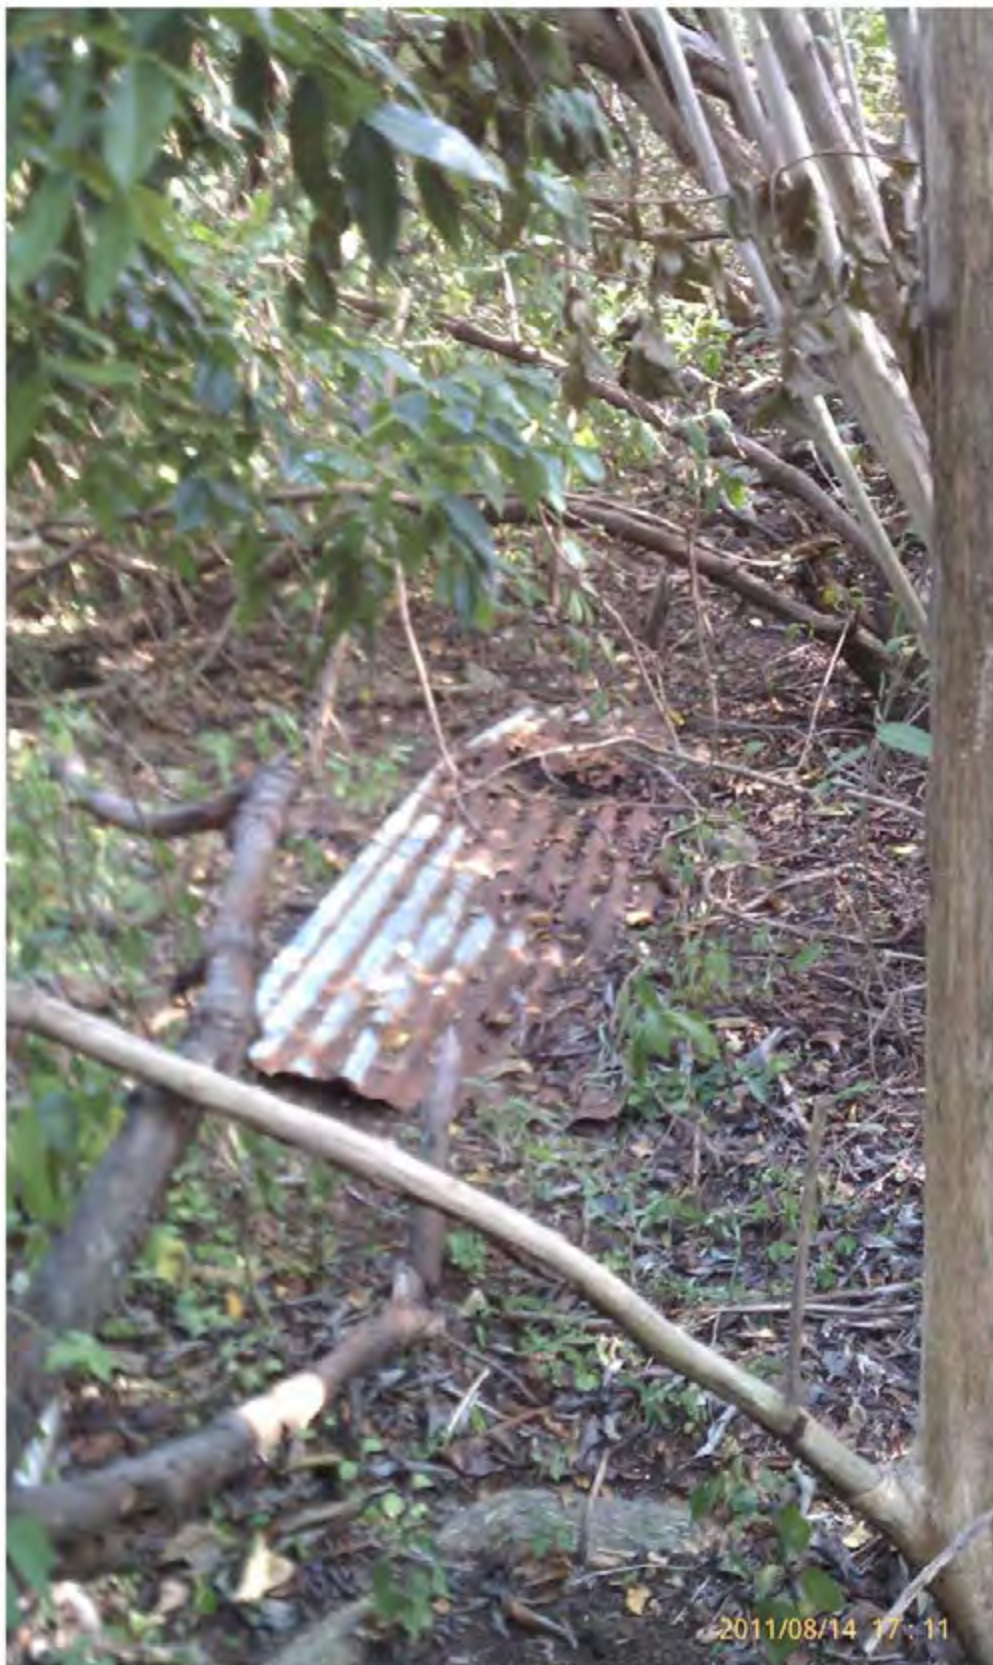
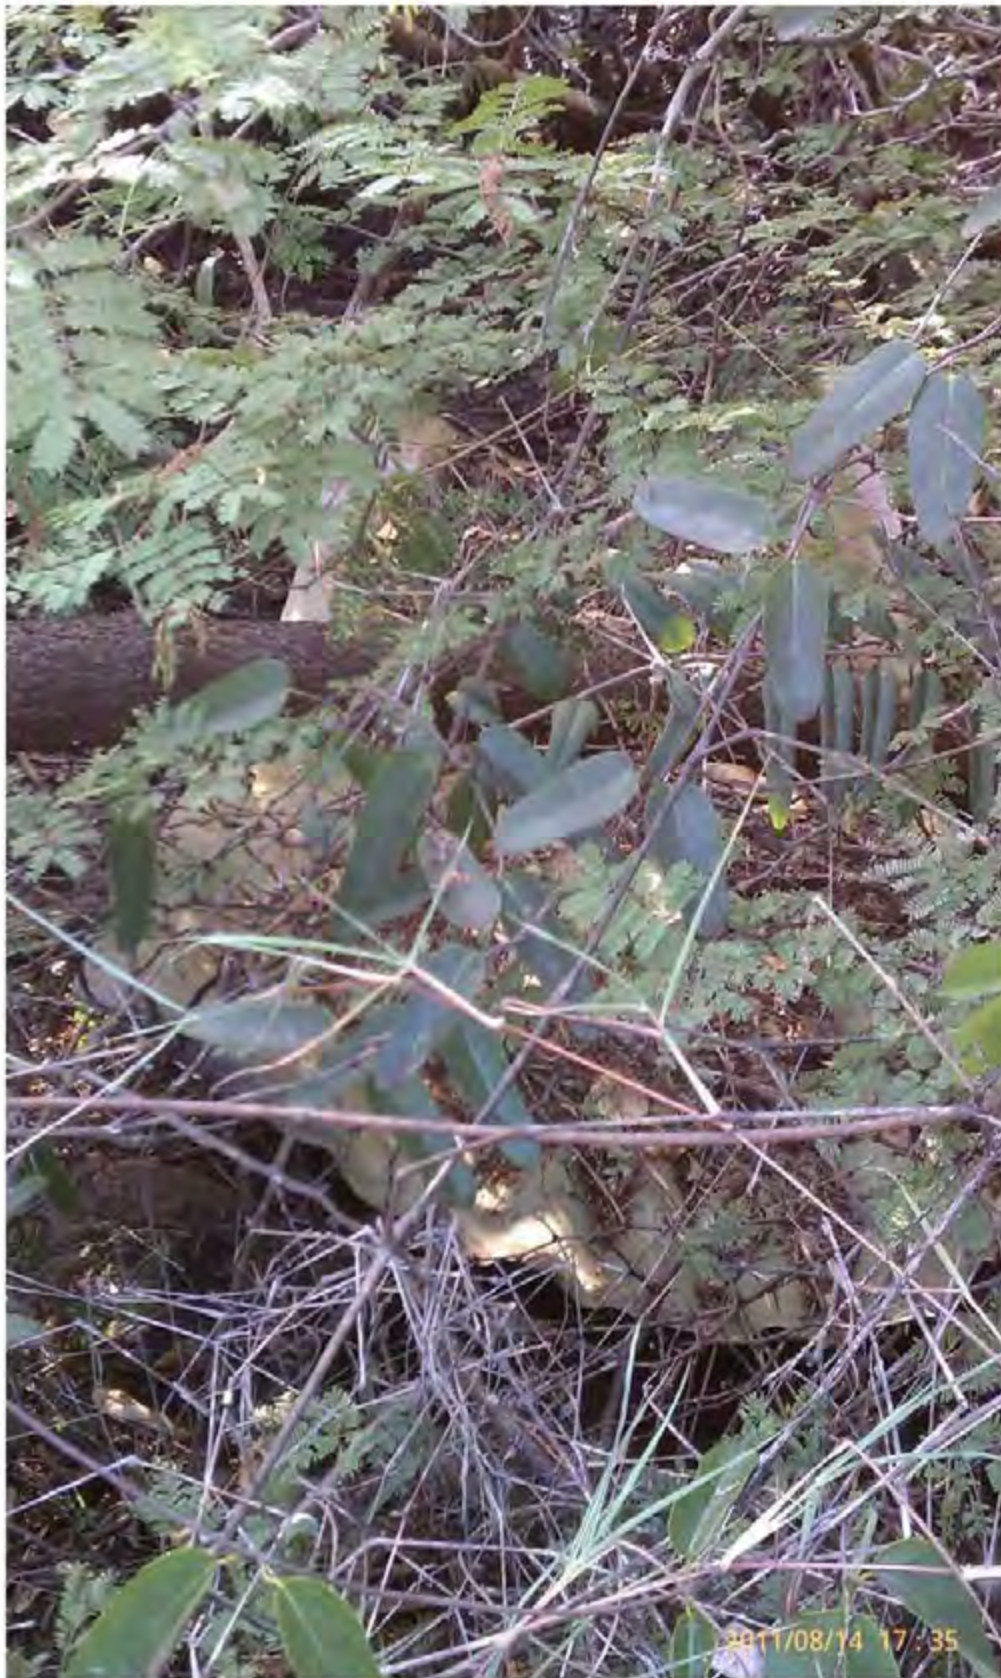
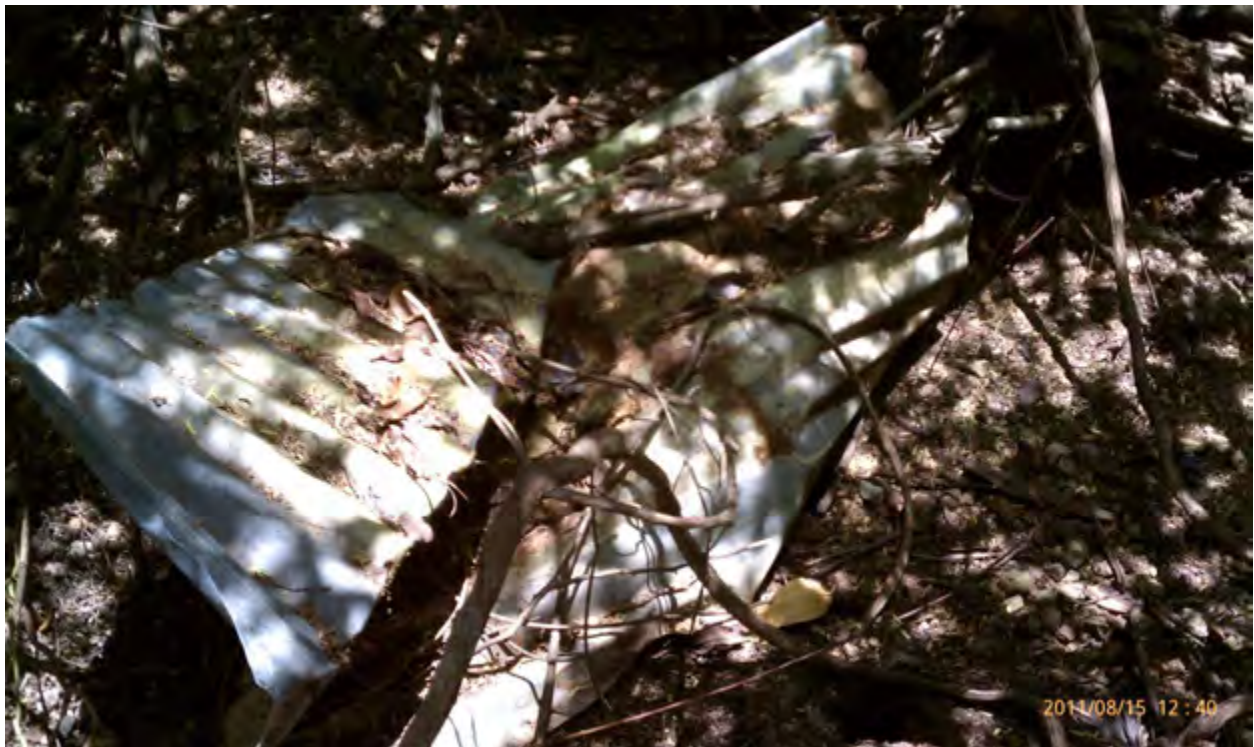
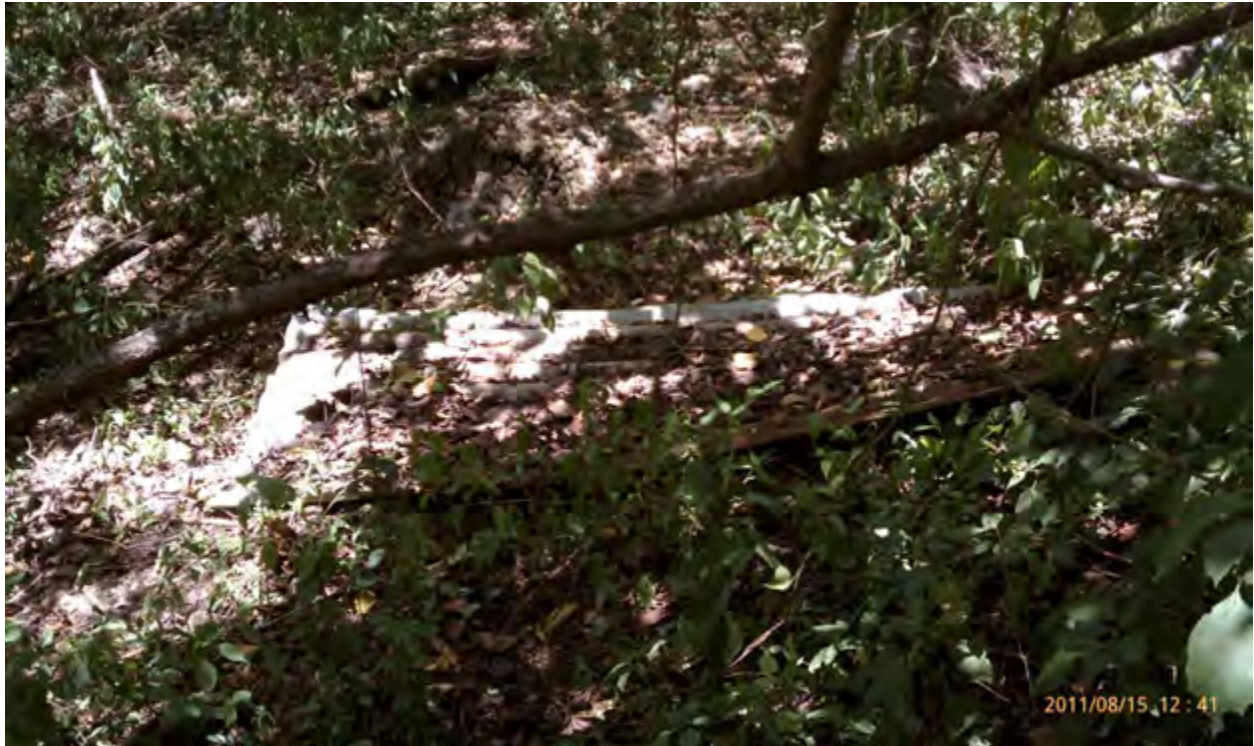
**Corrugated Sheet:**

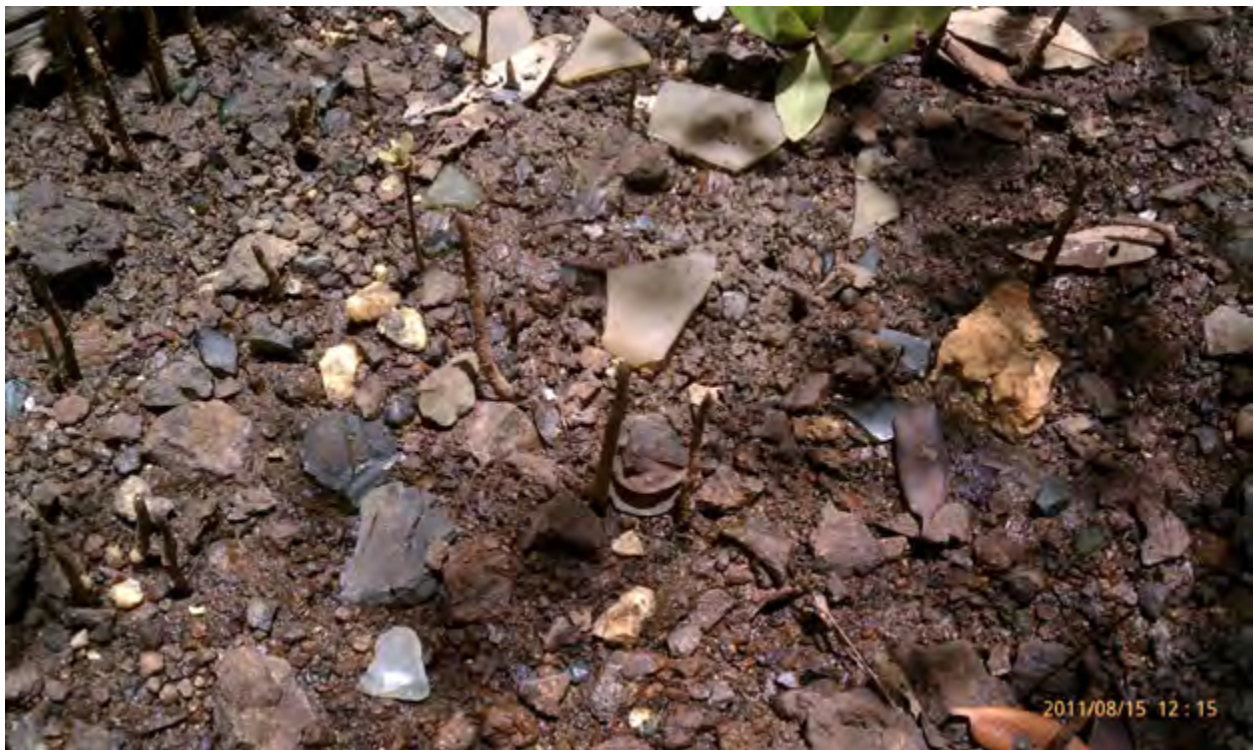
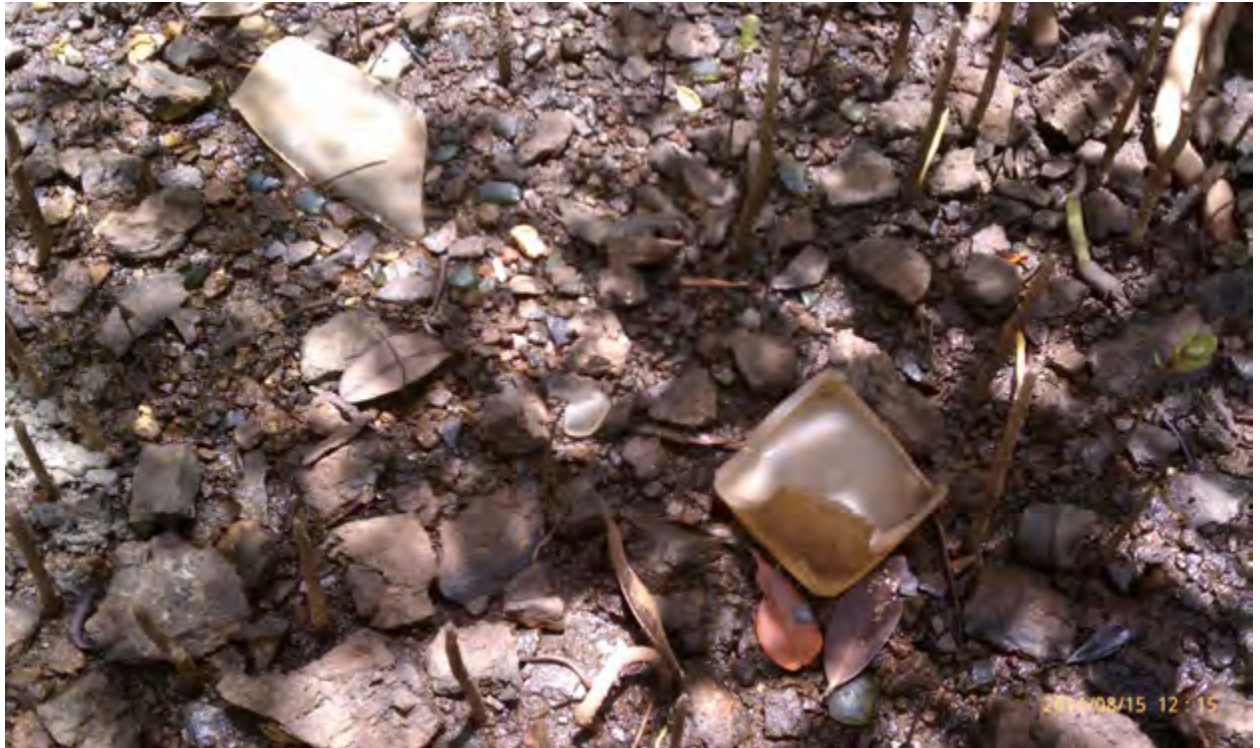
**Broken Glass:**
