MAINTENANCE DREDGING FOR SUNSET POINT FARM LLC  
56195 OVERSEAS HIGHWAY  
MARATHON, MONROE COUNTY, FL

**MAINTENANCE DREDGE BENTHIC ASSESSMENT**  
**SUNSET POINT FARM LLC**  
**LONG POINT KEY**  
**MONROE COUNTY, FLORIDA**

December 11, 2016

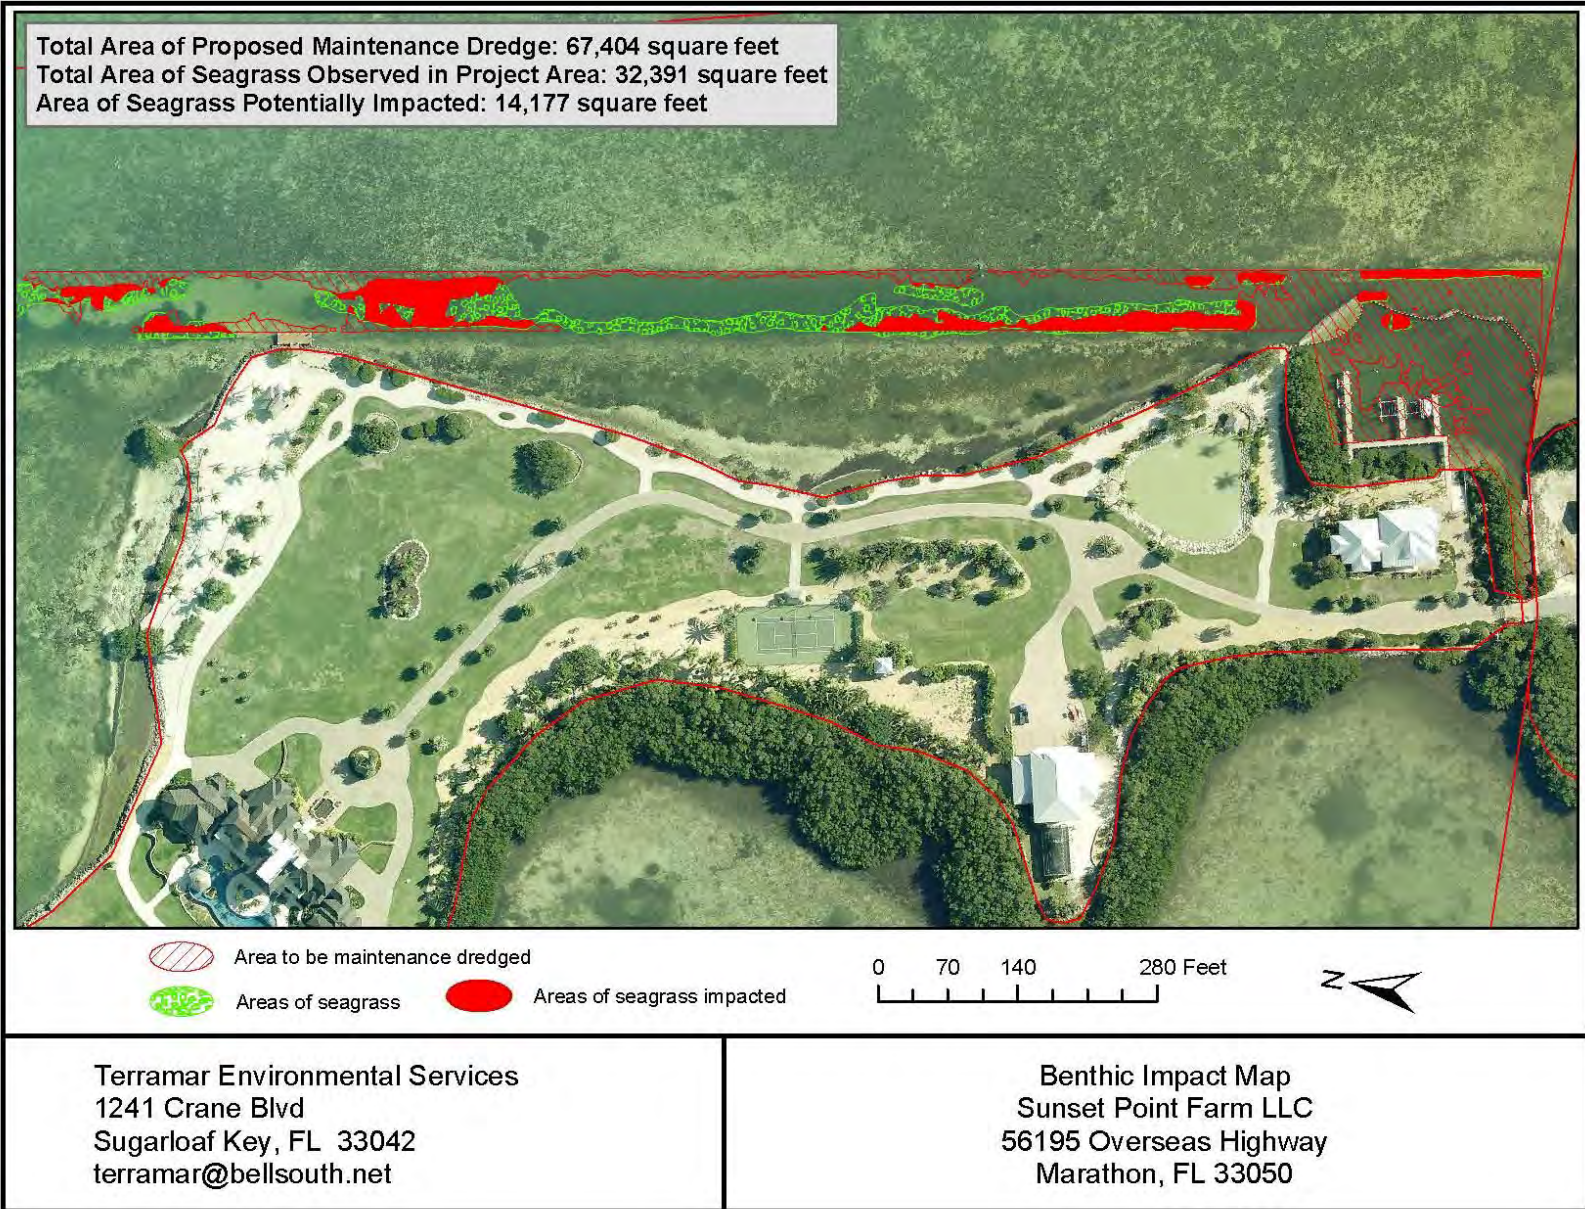
Figure 4. Seagrass distribution and estimated impacts.

Seagrass Beds: The most significant benthic resources identified within the area of proposed maintenance dredging were several large patches of consolidated seagrass (Figure 4). Within the southern section of the access channel extending into the boat basin, only occasional small seagrass isolates, primarily *Halodule wrightii*, were observed in a few locations near the center and along the eastern edge access channel that forms the eastern extent of the existing boat basin. Throughout the remainder of the access channel extending north appx. 1000 ft, several areas of the seafloor within the proposed project limits support well established mixed seagrass beds of manatee grass (*Syringodium filiforme*) and shoal grass (*Halodule wrightii*) ranging from moderate (25-50%) to dense (>75%) in cover. In addition, trace amounts of turtle grass (*Thalassia testudinum*) were present throughout the project area, but were limited to sparse isolated sprigs mixed in with denser beds of *Syringodium* and *Halodule*, or as isolated sprigs mixed in with areas of sand and macroalgae often noted along the edge of the channel seafloor near the rock edge of the channel.

To assess impacts to seagrass resources within the project limits, the seagrass map was overlaid onto the proposed maintenance dredging plan in ARCGIS and the overlap calculated. The total estimated impacts to seagrass habitat resulting from the proposed project is 14,177 sf, with the majority of those impacts in the access channel (Figure 4). The seagrass resources impacted are

moderate (25-50%) to dense (>75%) cover, mixed-species seagrass beds with manatee grass (*Syringodium filiforme*) and shoal grass (*Halodule wrightii*) present.

The proposed maintenance dredging will impact 14,177 sf of seagrass habitat within the existing access channel.

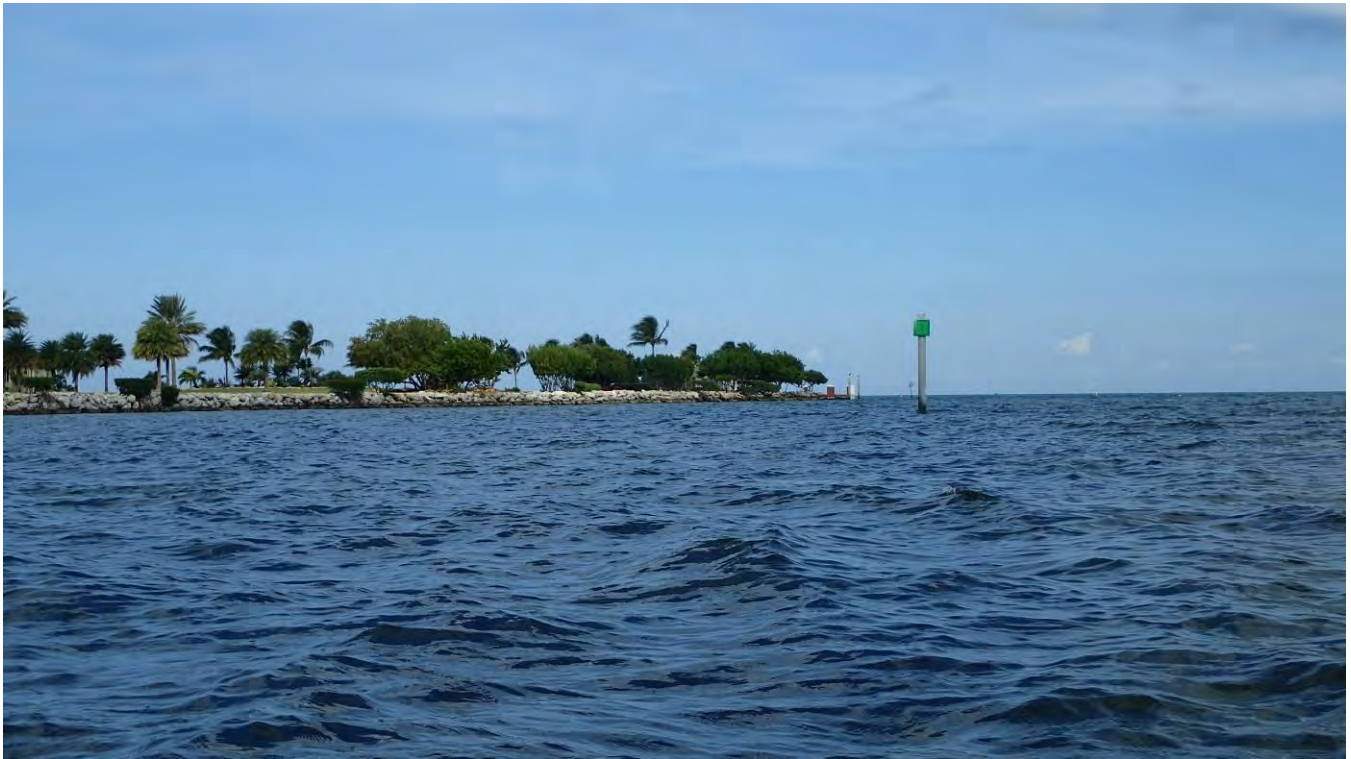
Photo from the south end of the project area near the boat basin looking down the access channel to the north.

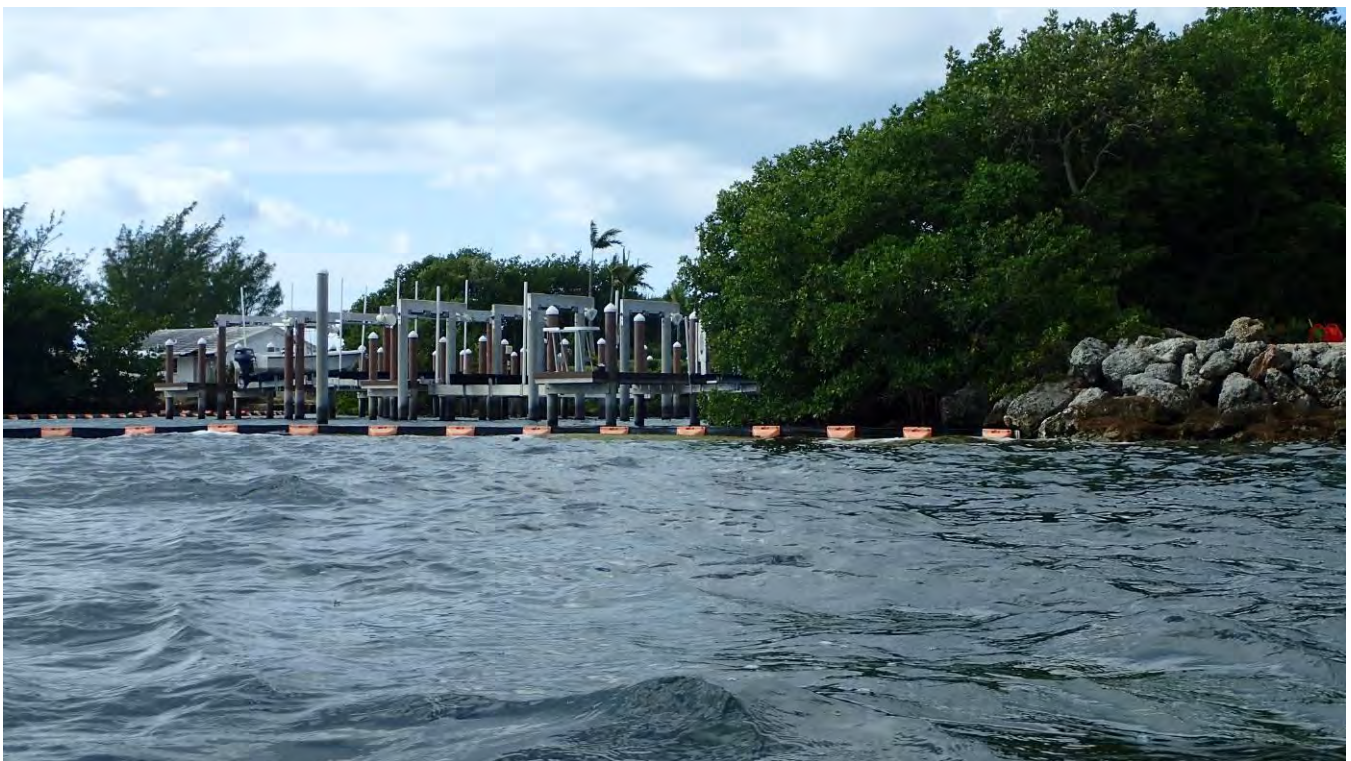
All other submerged materials associated with the concrete boat ramp and wooden support pilings for the existing docks were essentially barren, colonized by limited amounts of filamentous algae.

Photo of existing dock structures within the boat basin.

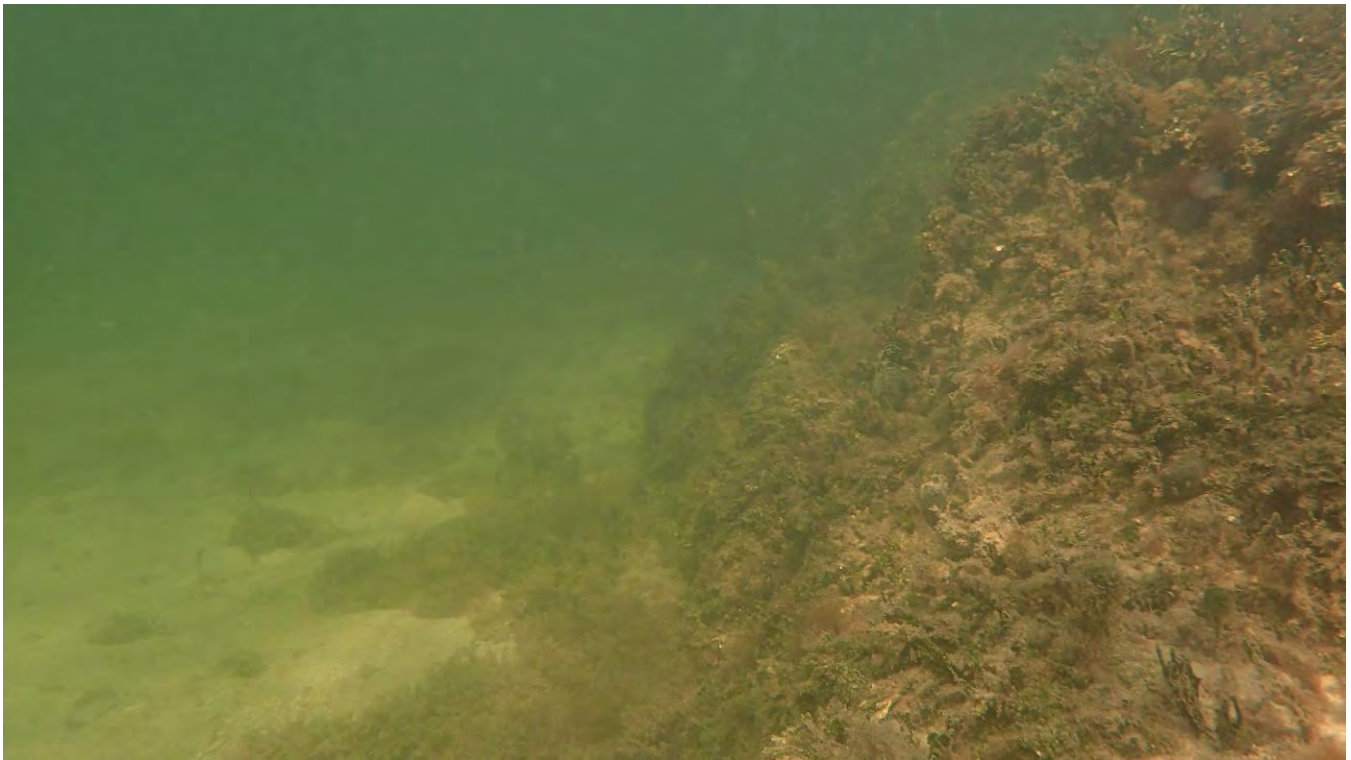
The limit of the access channel footprint was distinct, with a distinct rock ledge on both sides along the entire length, indicating the extent of the original removal of the seafloor during the original construction of the access channel.

Photo showing the clear delineation between the previously dredged access channel and the surrounding hardbottom area.

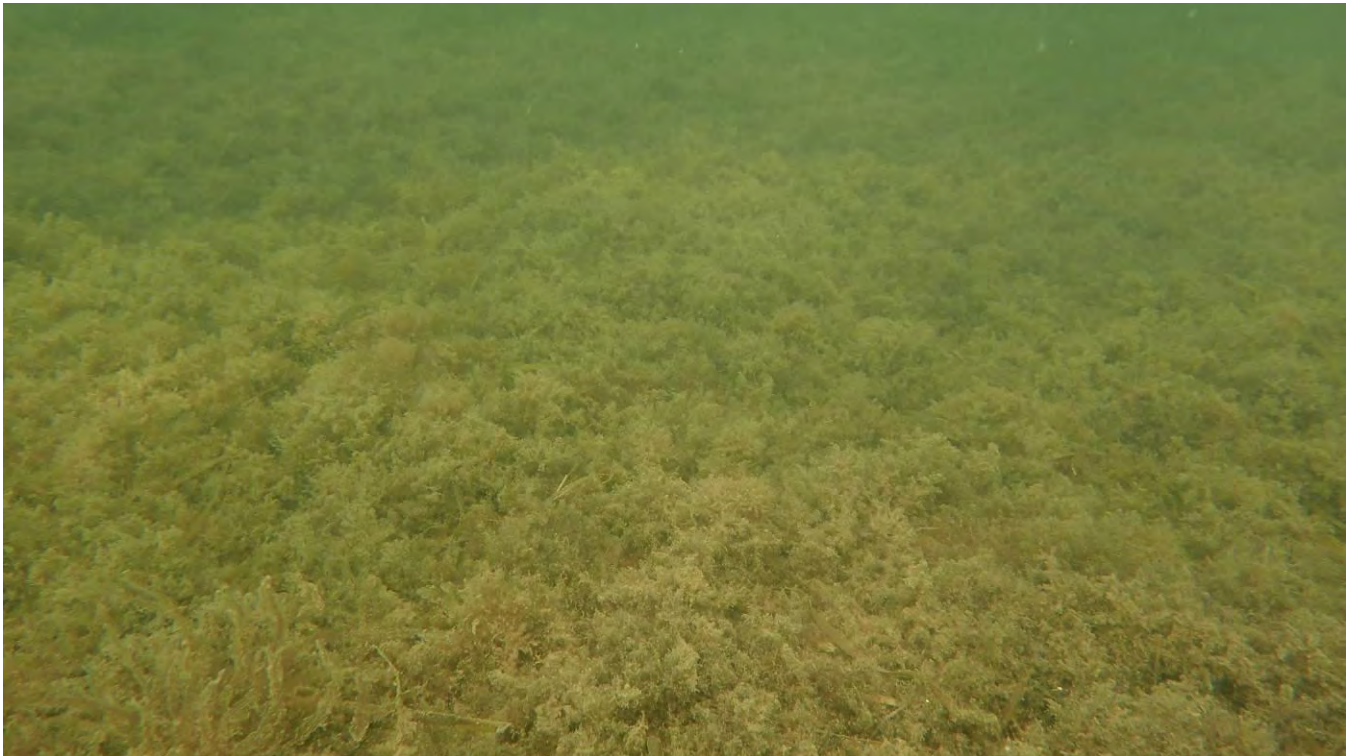
Sandy, largely barren habitats: Large areas of the seafloor located in the central portion of the access channel were characterized by extensive mats of accumulated detritus and drift algae mats covering a largely barren, sandy seafloor, with limited amounts of macroalgae, primarily *Halimeda* sp. present.

Photo of dense mats of accumulated drift algae over barren sand areas throughout majority of project area.

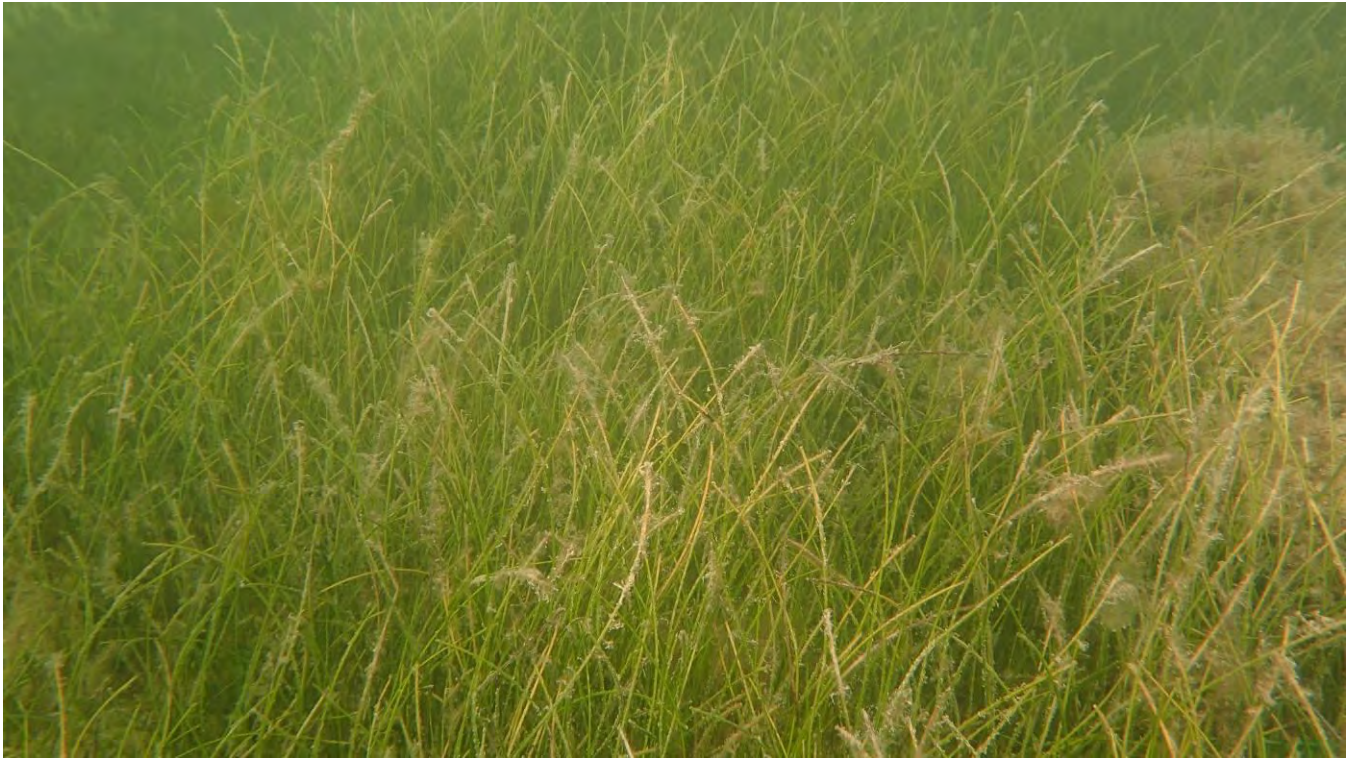
Photo of dense seagrass bed, typically either *Syringodium*, *Halodule*, or a mix of both seagrass species, located within the area proposed for maintenance dredging.

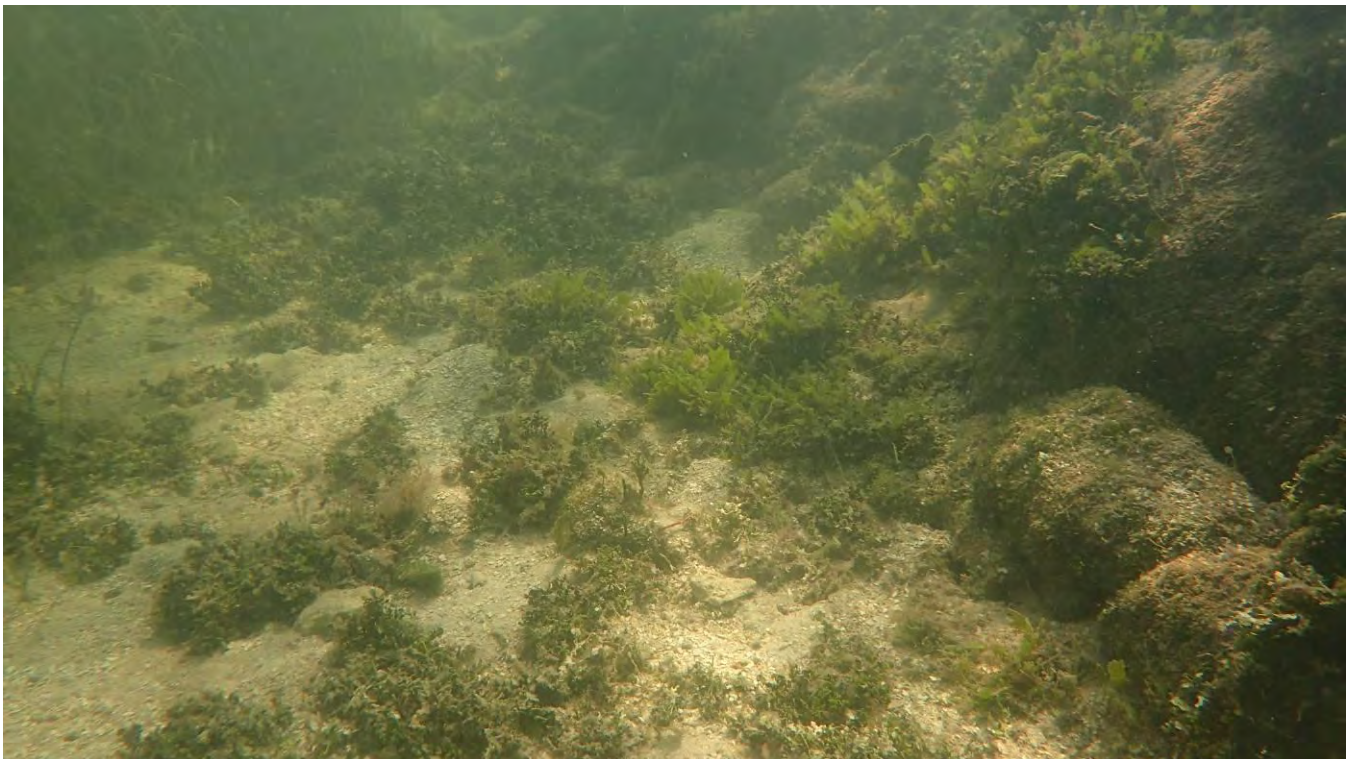
Sand and rubble habitats: The seafloor extending out 1-5 feet from the rock edge of the channel on either side was characterized by sand and rubble with limited amounts of macroalgae, predominantly *Halimeda* sp.

Photo of rubble, sand, and macroalgae typical in the narrow margin between the rock edge and the existing channel. These areas are located within the area proposed for maintenance dredging.

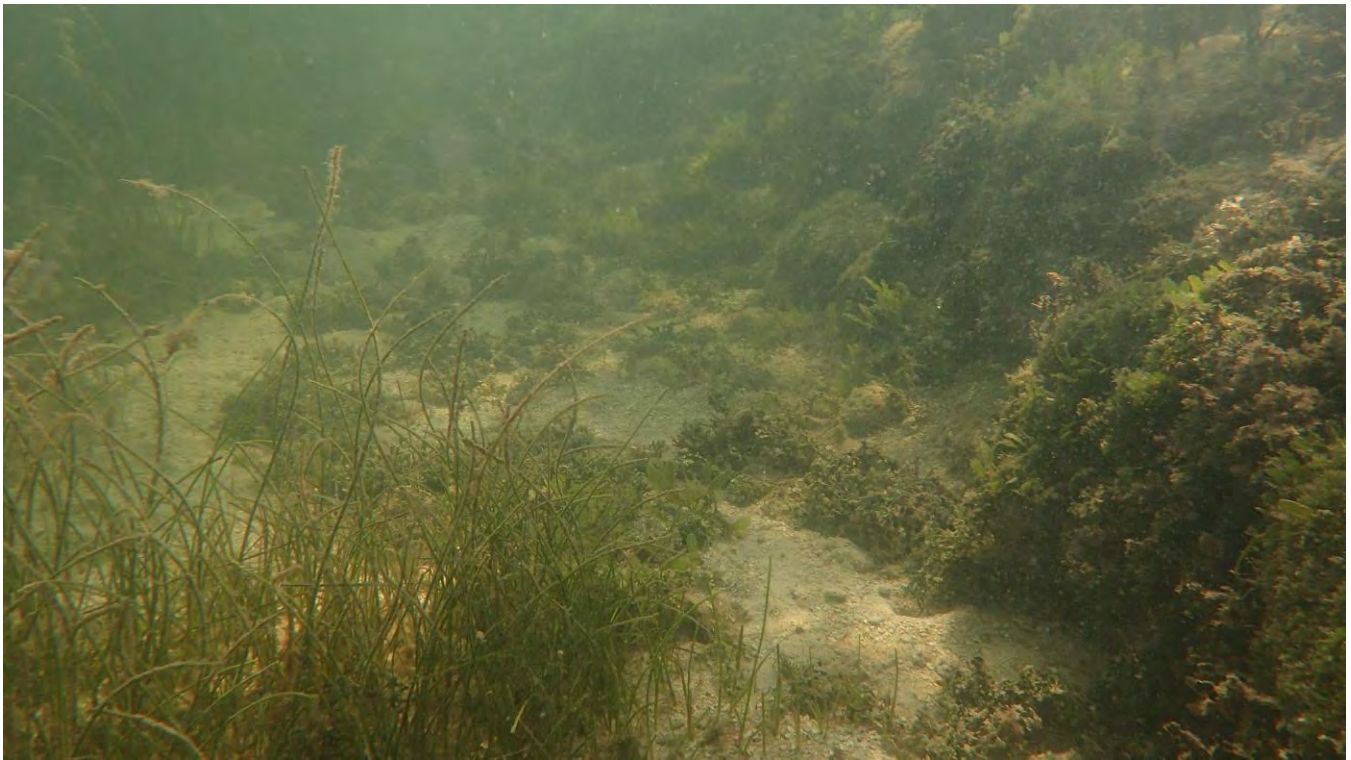
Photo of rubble, sand, and macroalgae typical in the narrow margin between the rock edge and the existing channel, with seagrass also visible. These areas are located within the area proposed for maintenance dredging.

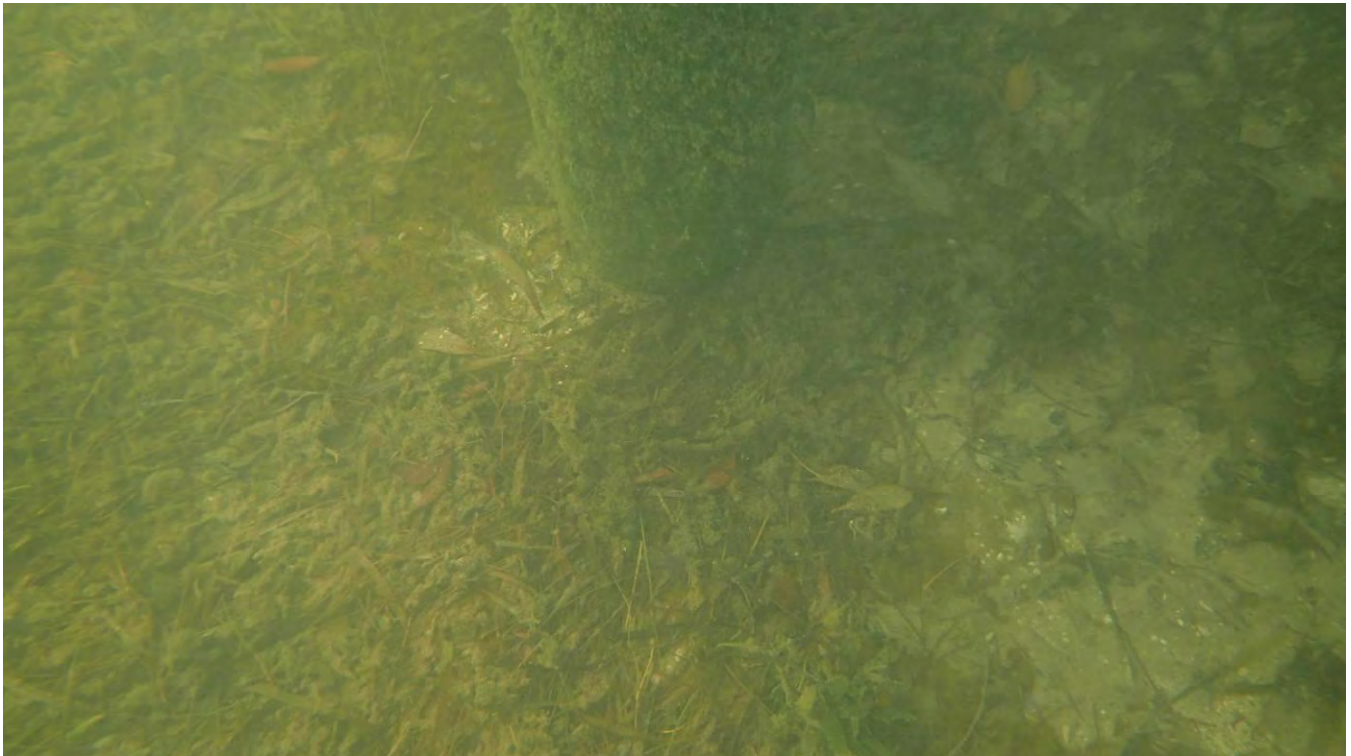
The benthic community of the existing boat basin is characterized by barren, deep silt and detritus throughout the entire area surveyed. The northern and western edges of the boat basin, as well as the northern edge of the small side channel located at the south-western extent of the boat basin were comprised of dense red mangroves (*Rhizophora mangle*) with drop roots that supported only limited algae and a few tunicates overhanging barren silt and decaying accumulated vegetation. The limit of the boat basin footprint was distinct, with a distinct rock ledge along the perimeter indicating the extent of the original removal of the seafloor to form the boat basin.

Photo of accumulated detritus and decaying vegetation accumulated over soft, mucky sediments within the existing boat basin.
