**HERBERT HOOVER DIKE  
REACHES 2 AND 3**

**DRAFT ENGINEERING ANALYSIS  
AND  
DRAFT SUPPLEMENT  
TO THE  
1999 DRAFT ENVIRONMENTAL IMPACT STATEMENT  
PALM BEACH, GLADES AND  
HENDRY COUNTIES, FLORIDA**

**U.S. Army Corps of Engineers  
Jacksonville District  
Jacksonville, Florida**

**December 2006**

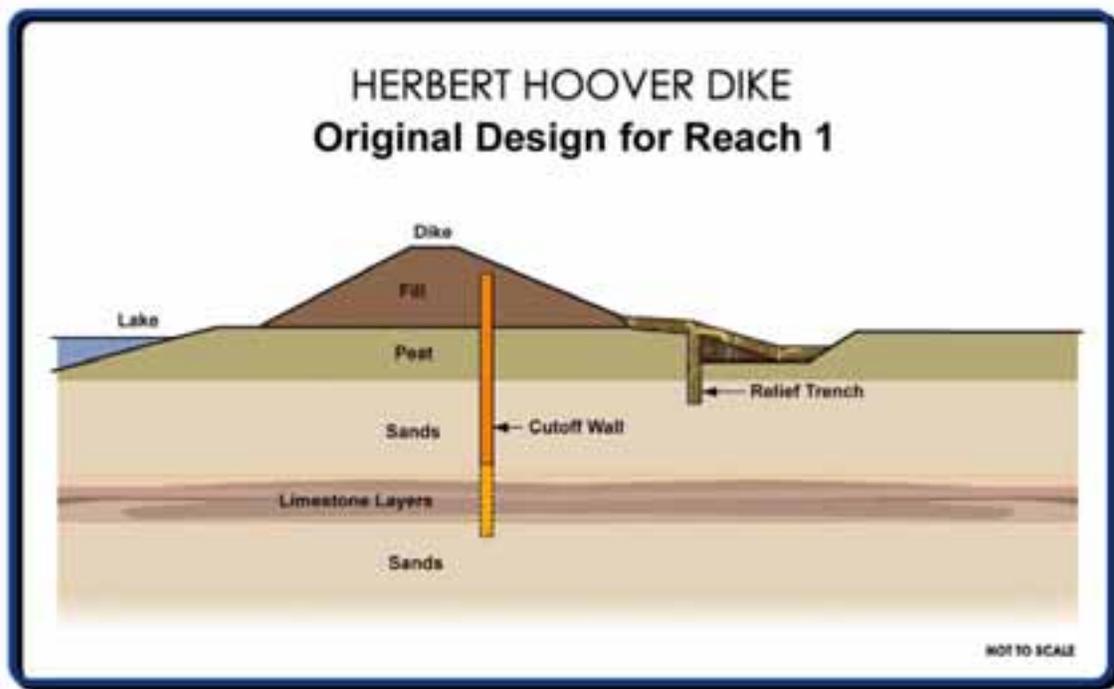
Figure 3. Herbert Hoover Dike, Original Design for Reach 1

**Alternative No. 4.** Alternative No. 4 was selected to be the Recommended Plan for Reach 1. The design included a hanging seepage cutoff wall (a vertically excavated trench filled with a mixture of bentonite and concrete to reduce water seepage through and under the dike) on the landward side of the dike slope and a relief trench with an inverted filter and relief berm at the toe of the landward slope of the dike, terminating at the toe ditch (Figure 3). The cutoff wall would be at an approximate elevation of 26 feet on the HHD slope, with excavation stopping prior to the impervious geologic layer. This would allow groundwater to flow beneath the HHD and underseepage to be collected by the relief trench. The relief trench and inverted filter would be constructed adjacent to the existing toe ditch and within the HHD footprint at the landward toe. An access road would be built on top of the relief trench. The plan is similar to the MRR solution Alternative No. 3, but would not contain a closed culvert system as outlined in the MRR. Further, it utilizes the hanging cut-off wall to prevent piping. The closed culvert system would be replaced with the existing open toe ditch for removal of seepage. Seepage water from the seepage toe berm and relief trench would flow freely into the existing toe ditch. Slight alterations in

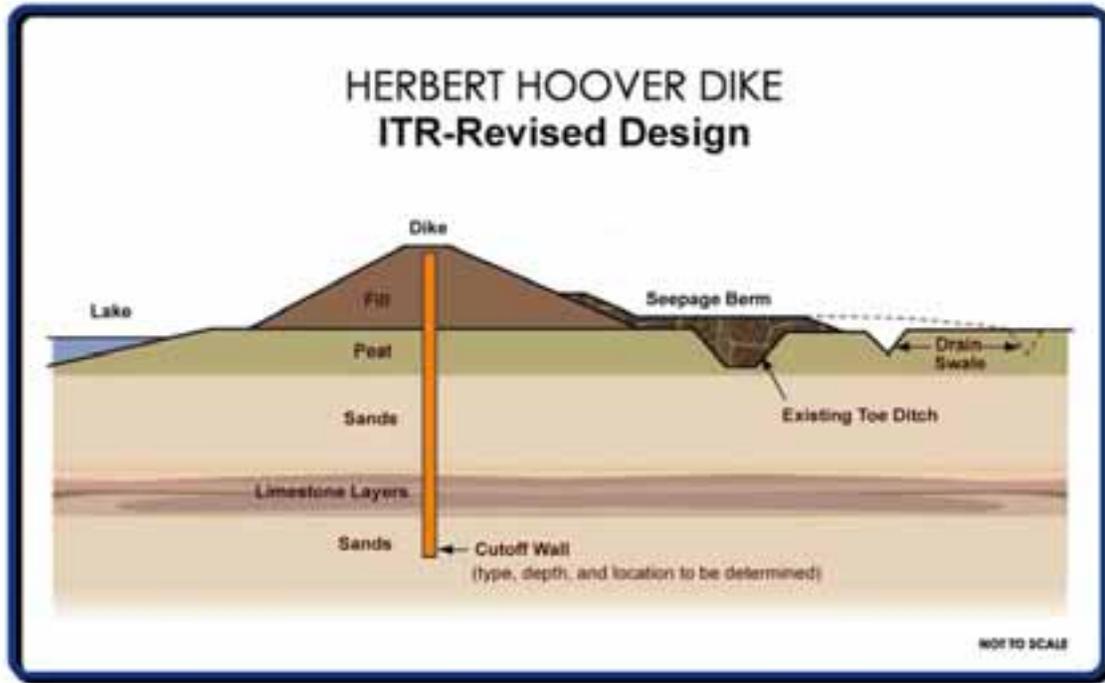
**Figure 4. Herbert Hoover Dike, ITR-Revised Design**

The plan recommended by the ITR team involved the incorporation of additional property into an expanded seepage berm of the dike system to provide additional stability and reduce piping. The local sponsor, SFWMD, would have the responsibility for acquisition of the additional real estate.

The plan developed for Reach 1 by the ITR team forms the basis for the Recommended Plan for Reaches 2 and 3.

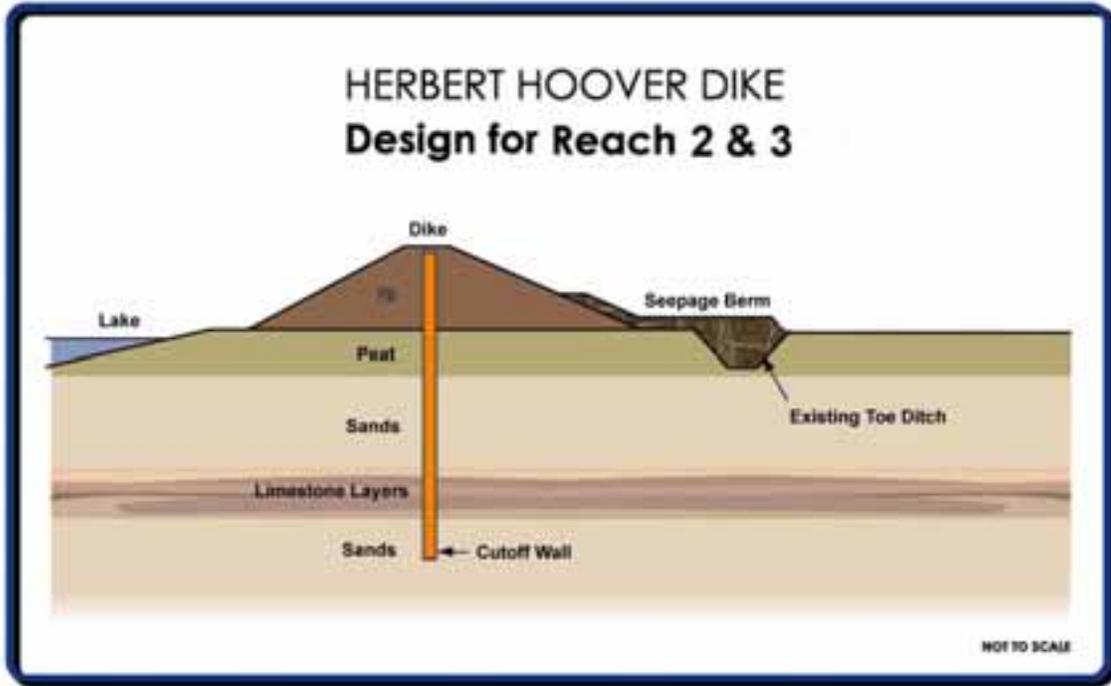
Figure 5. Herbert Hoover Dike, Design for Reaches 2 and 3

For Reach 3 and the eastern portion of Reach 2, the Recommended Plan includes the construction of a seepage berm that would extend to the far side of the existing toe ditch at the edge of the existing project right-of-way (Figure 5); the toe ditch would be filled. In addition, a seepage cutoff wall would be installed in the center of the dike. For additional details, please see Appendix G.

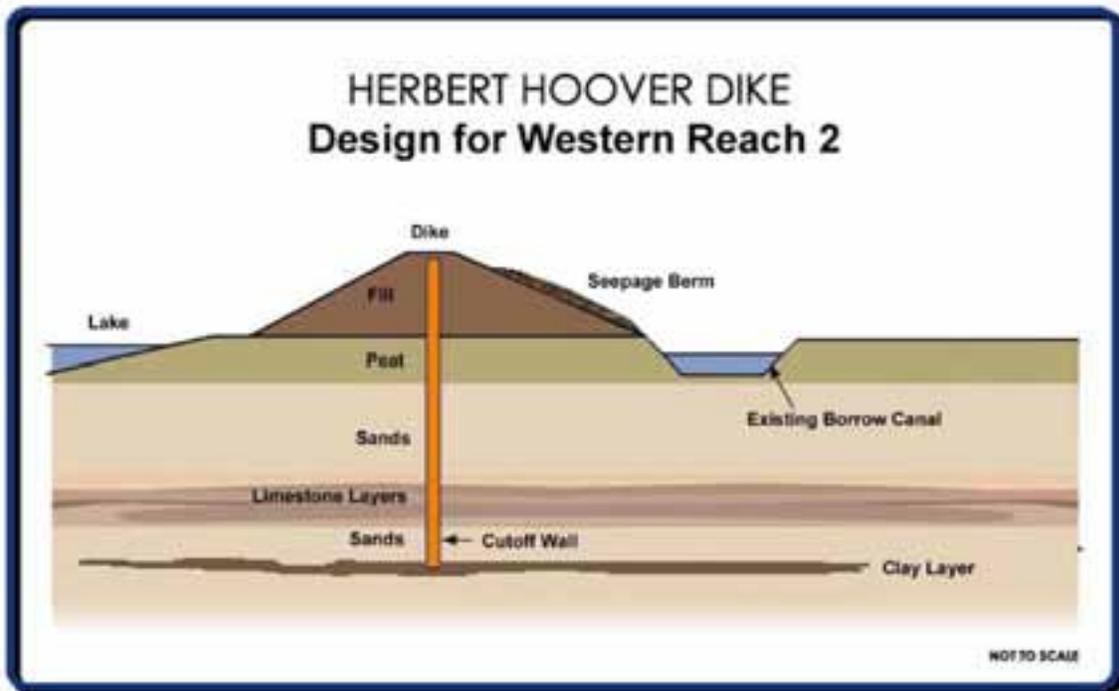
Figure 6. Herbert Hoover Dike, Design for Western Reach 2

This design would be modified slightly for the western portion of Reach 2 (Figure 6), where, instead of a toe ditch outside the levee, a borrow canal is present. The western portion of Reach 2 is characterized by a clay layer found approximately 20-40 feet below the surface; such a clay layer is not present at Reach 3 or eastern Reach 2. Tying the cutoff wall in western Reach 2 into the clay layer would result in less seepage than would be allowed by the cutoff wall alone. This would enable construction of a smaller seepage berm than is necessary in Reach 3 or eastern Reach 2. The berm would extend only to the canal edge adjacent to the dike; the borrow canal would not be filled. For additional details, please see Appendix G.

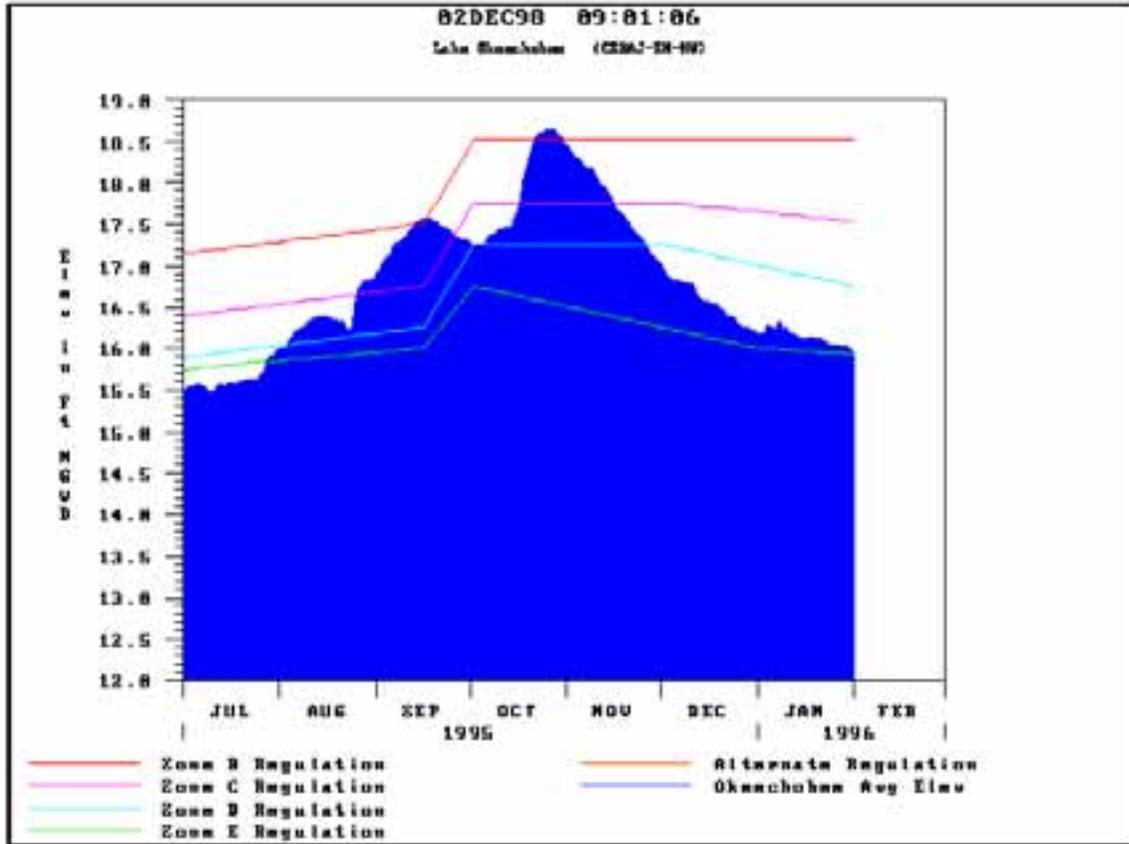
Figure G-2.1. Lake Okeechobee 10-Station Average water surface elevation.

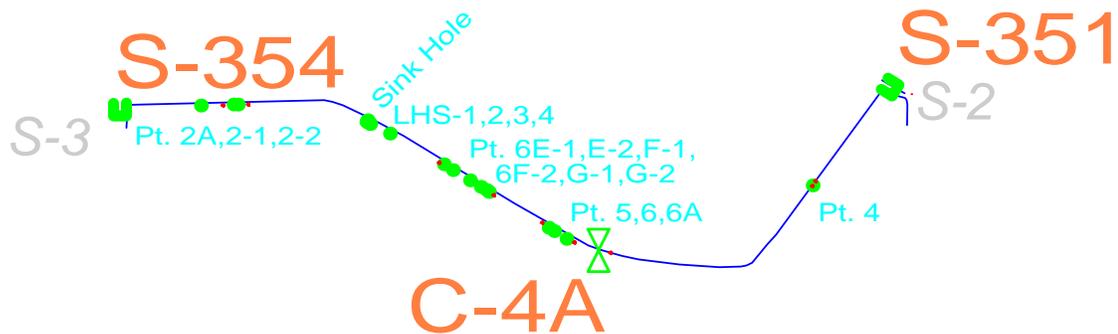
Figure G-2.3. Reach 3 Condition 3 and 4 sites.

There was one condition 4 site and five condition 3 sites reported and monitored in Reach 3. Refer to Figure G-2.3.

**Condition 4 Site.** The site labeled “Sinkhole” and LHS -1,2,3,4 were located midway between Spillway S-354 and Culvert 4A. The landside berm above the toe ditch was damaged for approximately  $\frac{1}{4}$  mile. The berm had collapsed in several areas and the ditch slopes that were next to the embankment had sloughed in several areas. A sinkhole was observed in the levee crest above the areas where piping occurred. Boils were also observed in the bottom of the toe ditch. No odor or white staining was present in the boils. The piping was considered caused from through seepage.

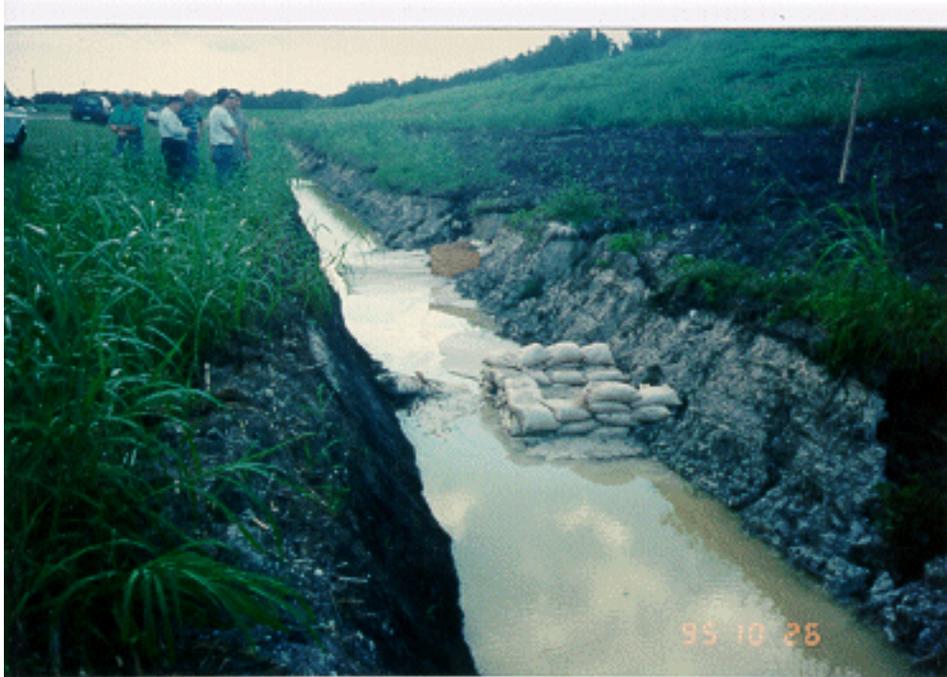
Photo G-2.1          Lake Harbor piping, ditch with sandbags

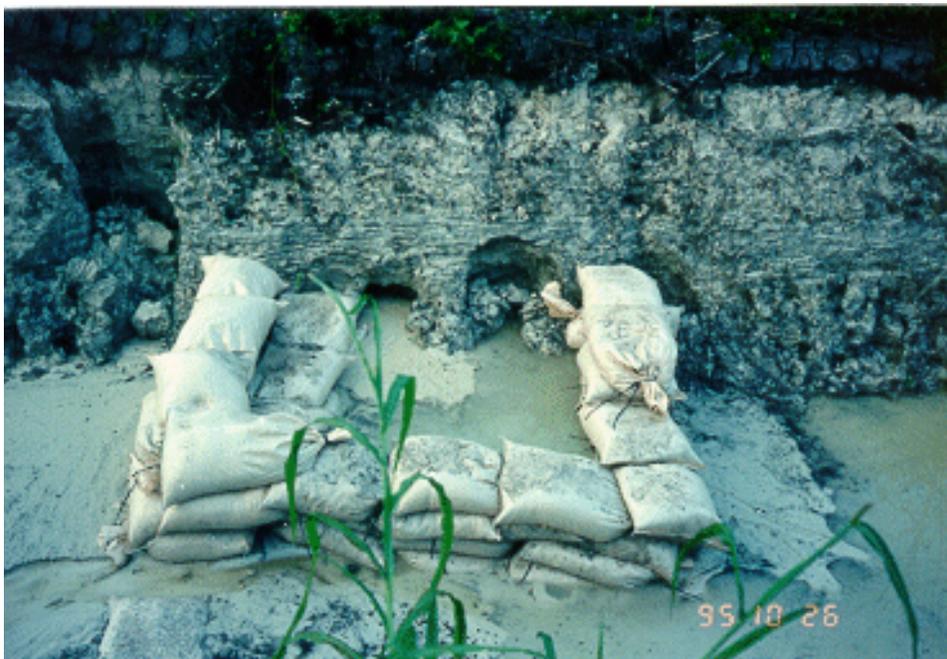
Photo G-2.2          Lake Harbor piping, ditch with sandbags, close-up

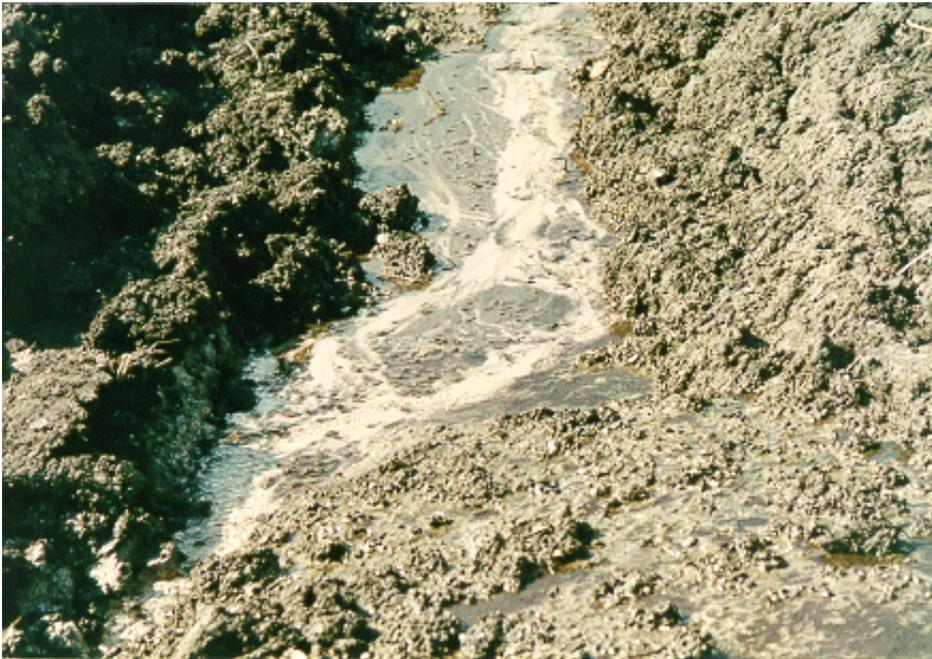
Photo G-2.12      Lake Harbor Point 2; closeup of seepage

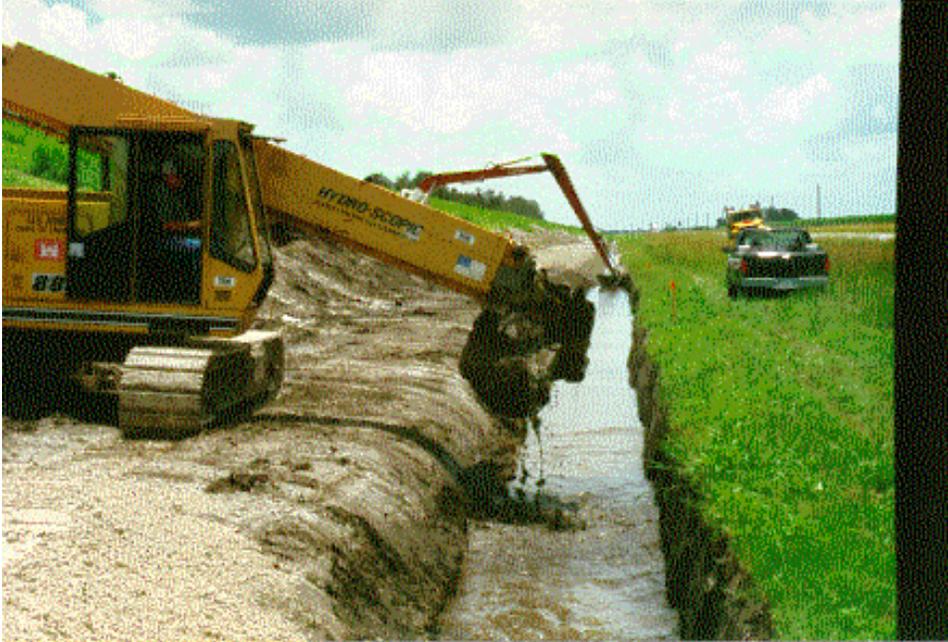
Photo G-2.19 Lake Harbor Pt 6 EFG Site; berm repair, excavating thru toe ditch

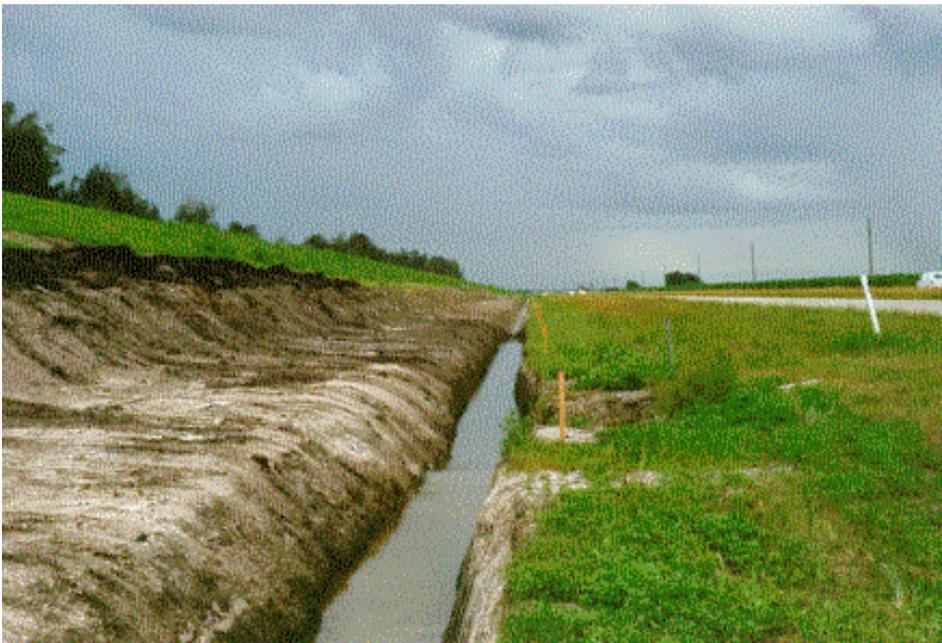
Photo G-2.20 Lake Harbor Pt 6 EFG Site; berm repair, berm peat stripped

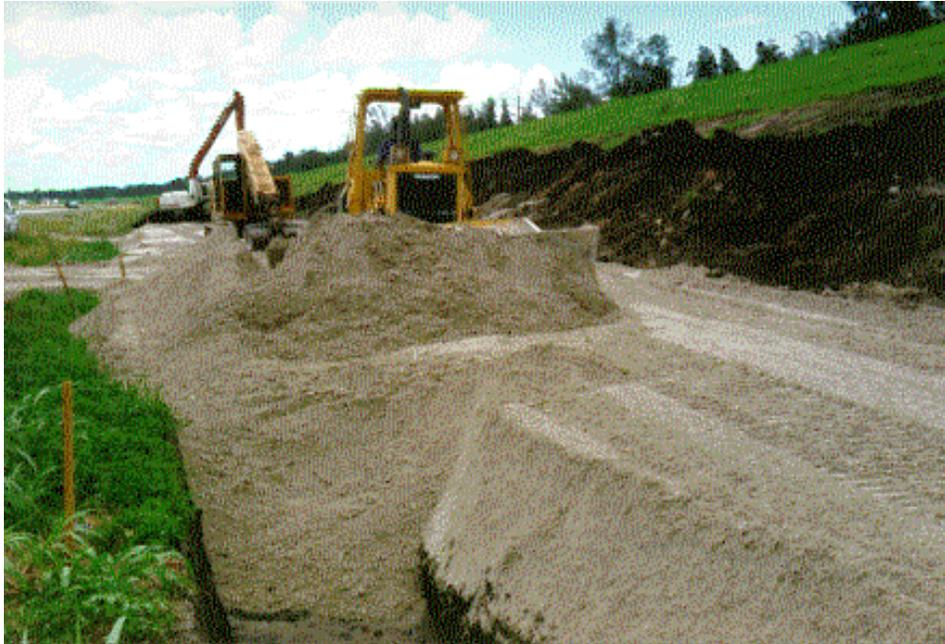
Photo G-2.21      Lake Harbor Pt 6 EFG Site; backfilling berm & ditch

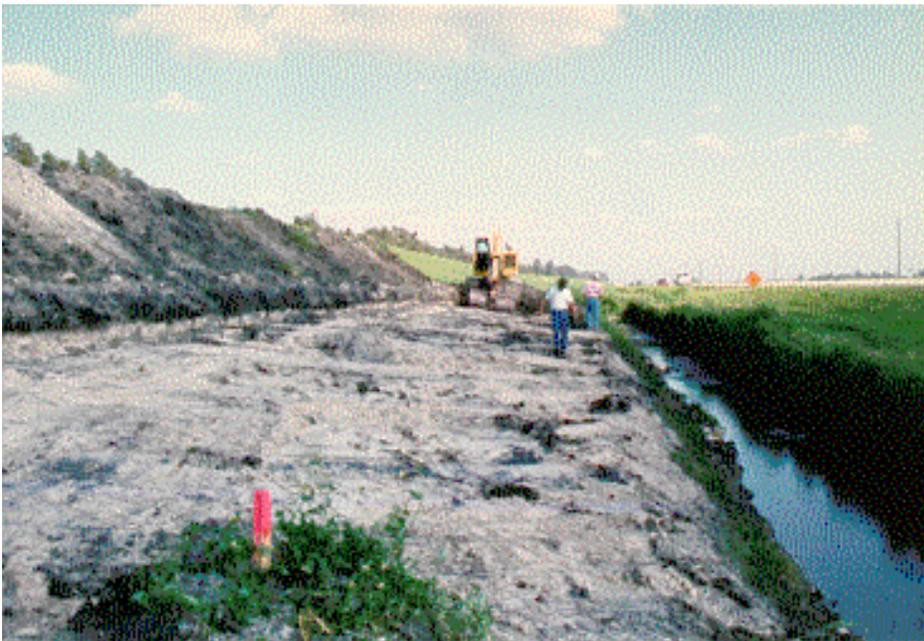
Photo G-2.24 Lake Harbor Sinkhole site; stripping peat on berm

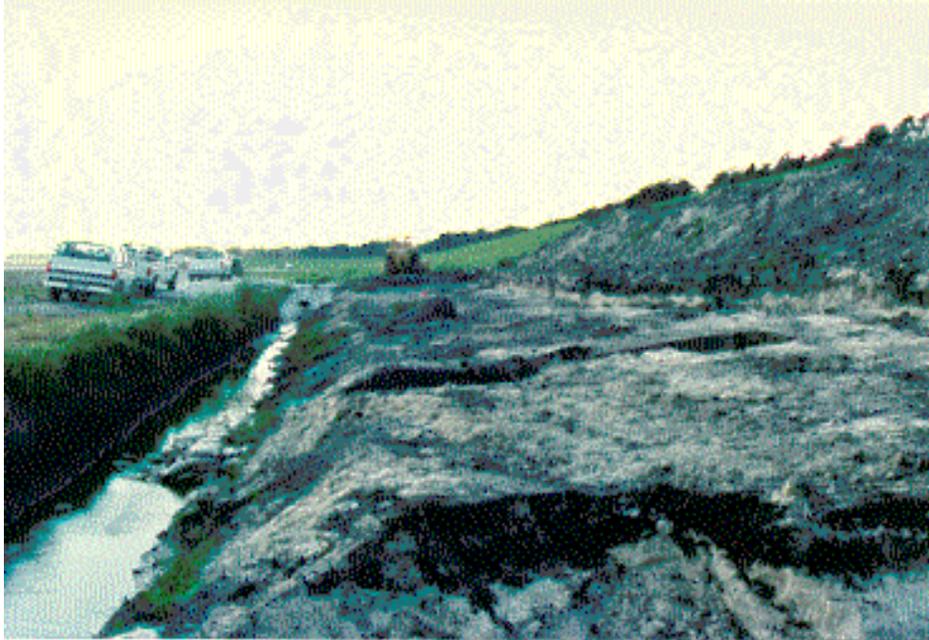
Photo G-2.25 Lake Harbor Sinkhole site; excavating pipes above sandbag sites

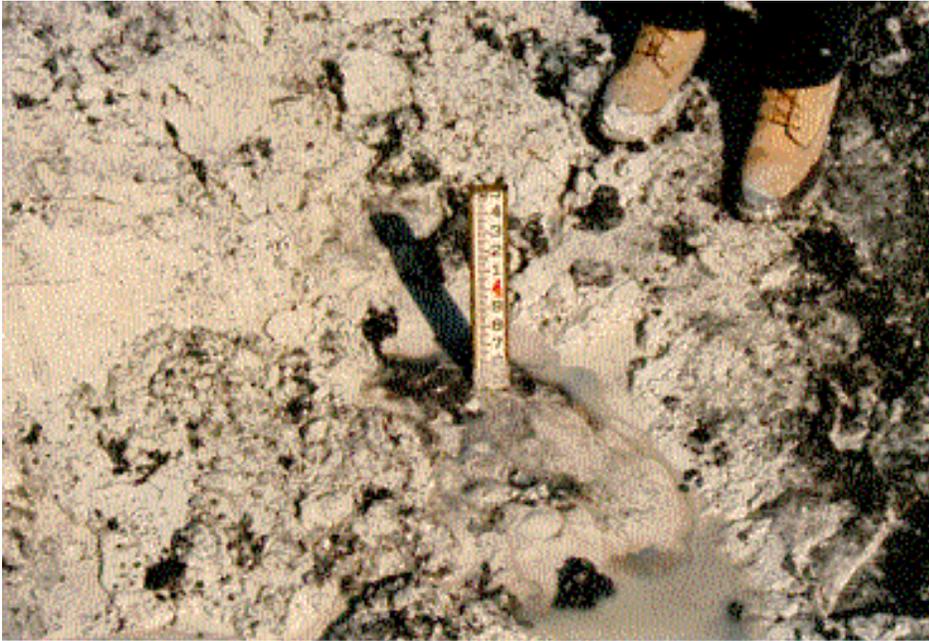
Photo G-2.27 Lake Harbor Sinkhole site; note liquified material (4' survey rod pushed into berm)

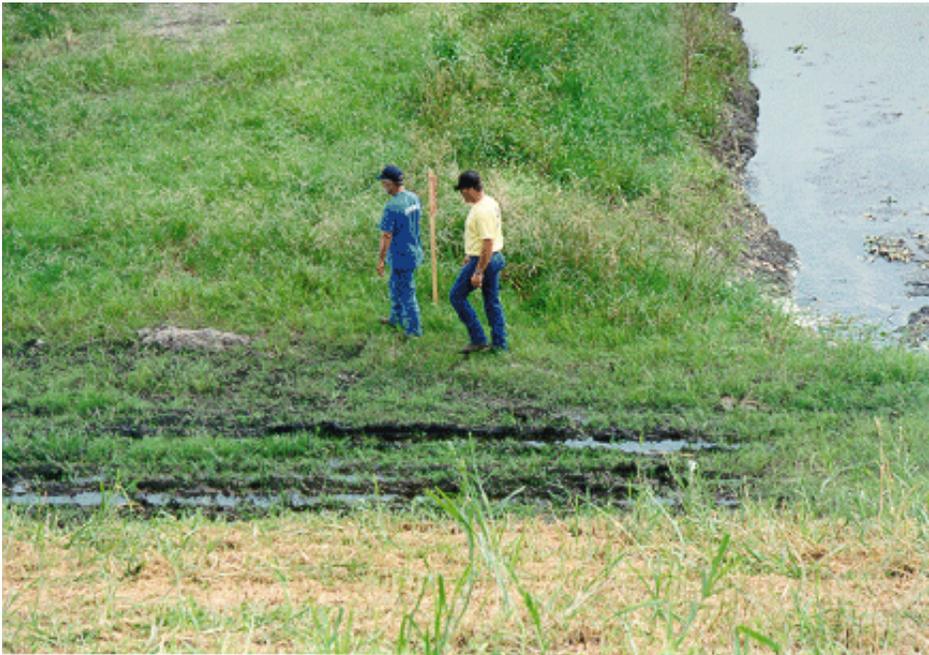
Photo G-2.28 Reach 3 point 4; Seepage on berm

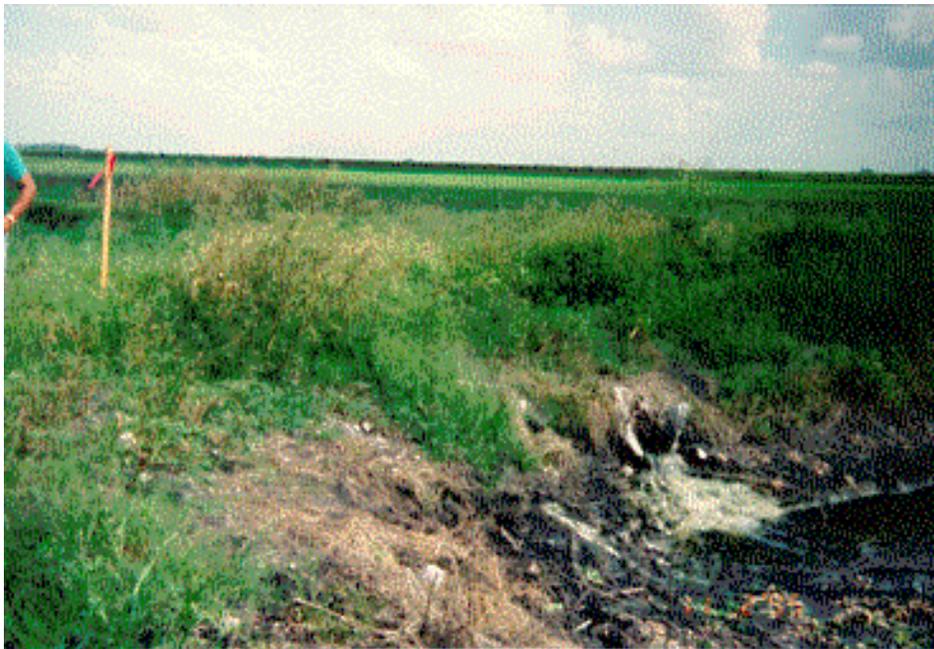
Photo G-2.30      Reach 3 point 4; close up of white staining from culvert discharge

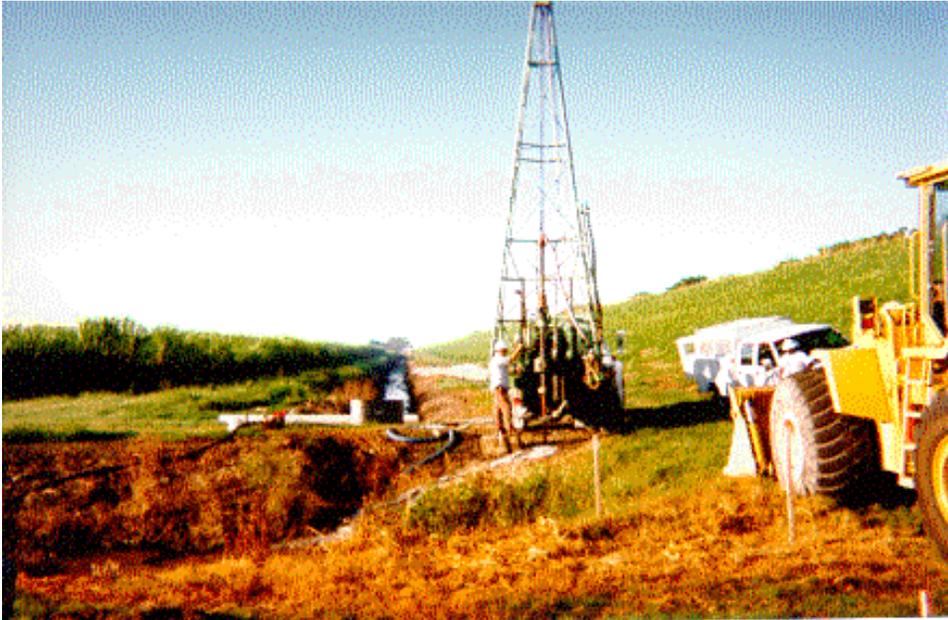
Photo G-2.31      Reach 3 point 4; drilling vertical drains

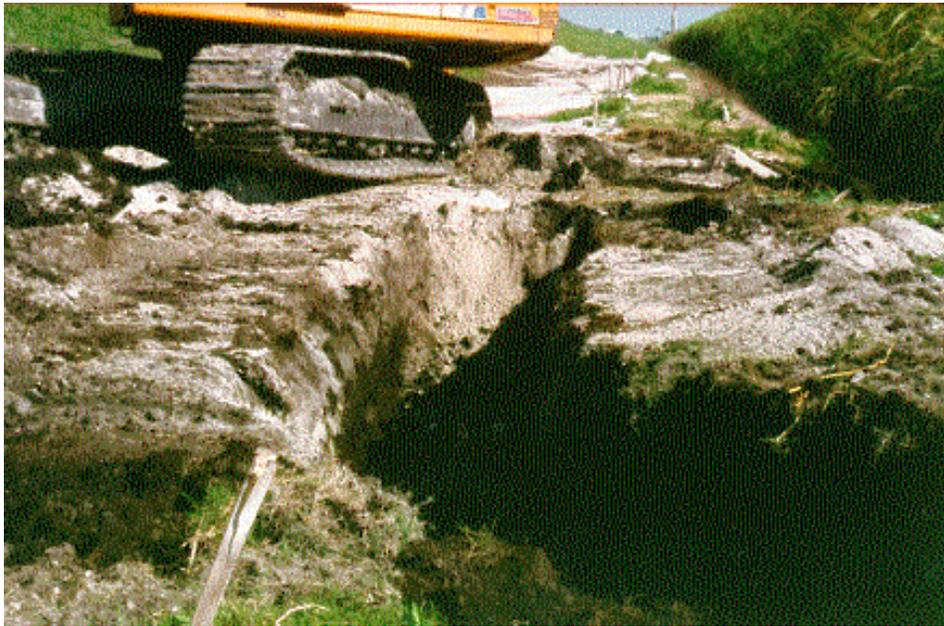
Photo G-2.33      Reach 3 point 4; excavating drain cap and laterals to ditch

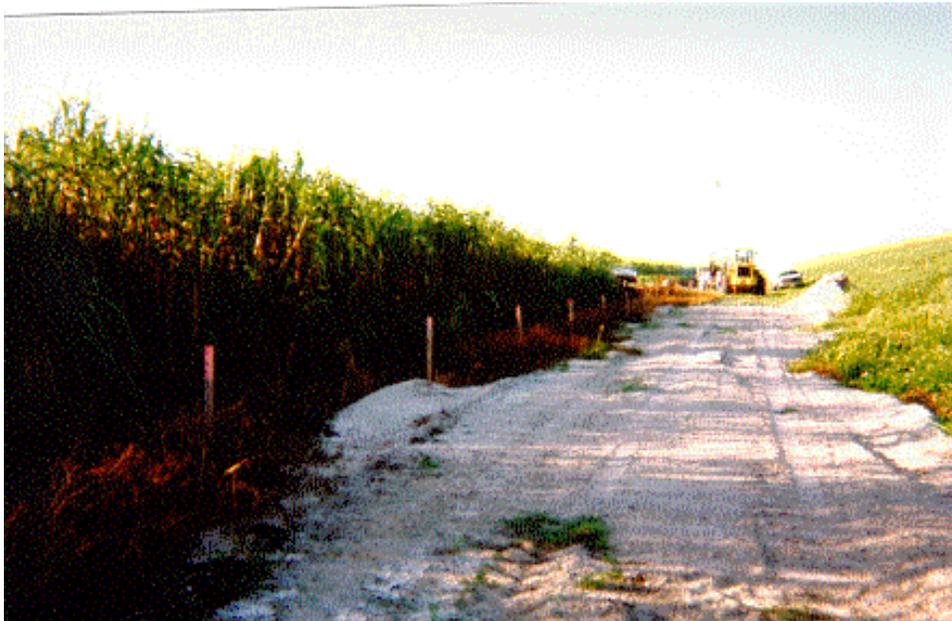
Photo G-2.34      Reach 3 point 4; vertical drains on 15' centers

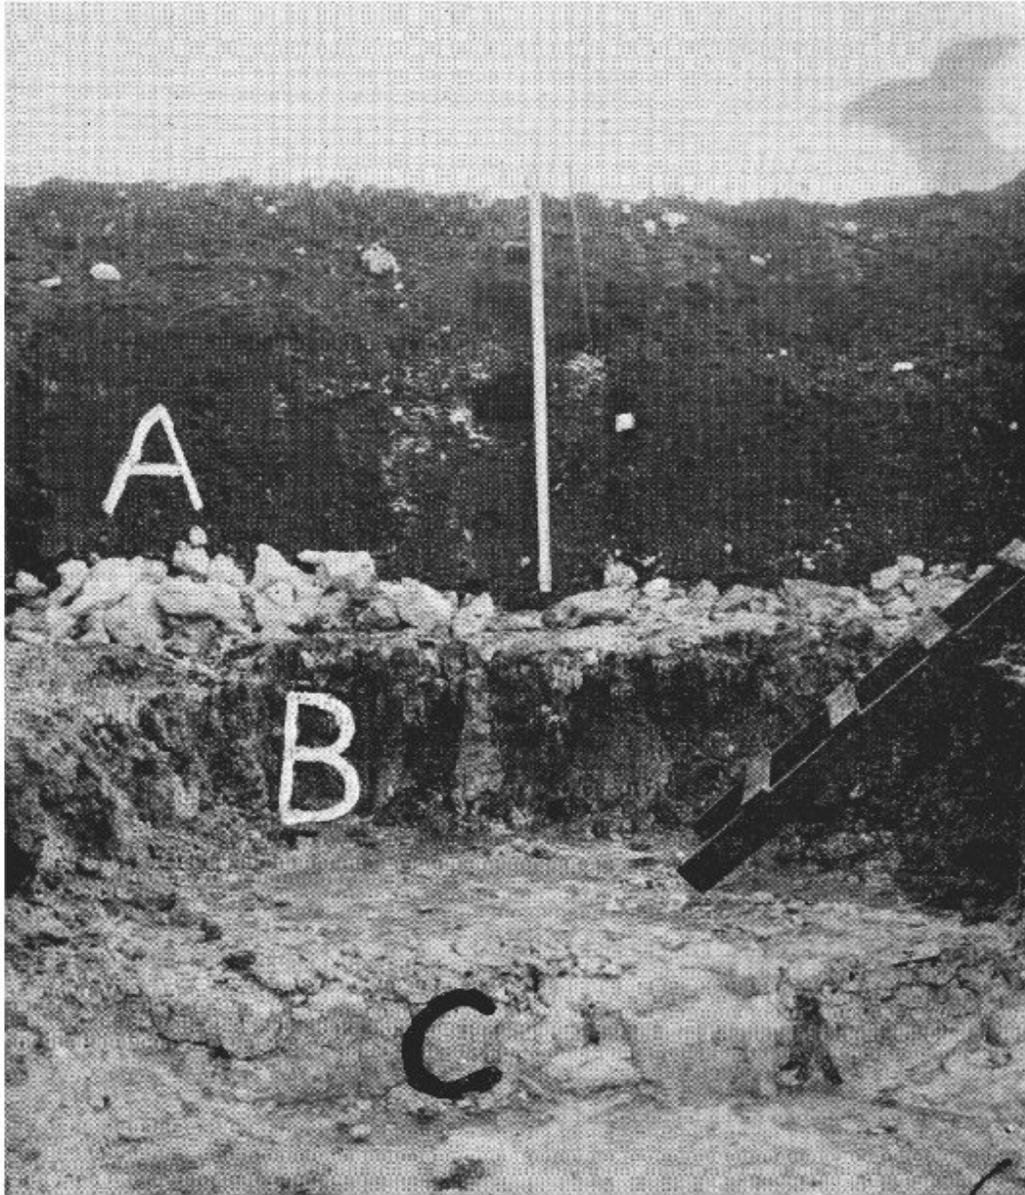
Figure H-4.1.-- Pit showing profile of sediments and peat in the Everglades near the northern part of the Hillsborough Canal. A. Saw-grass peat, 4 feet thick. B. Lake Flirt marl, 20 inches thick. C. Fort Thompson formation limestone.
