MEMORANDUM FOR RECORD

SUBJECT: Manatee Harbor Navigation Project, 10 March Site Visit

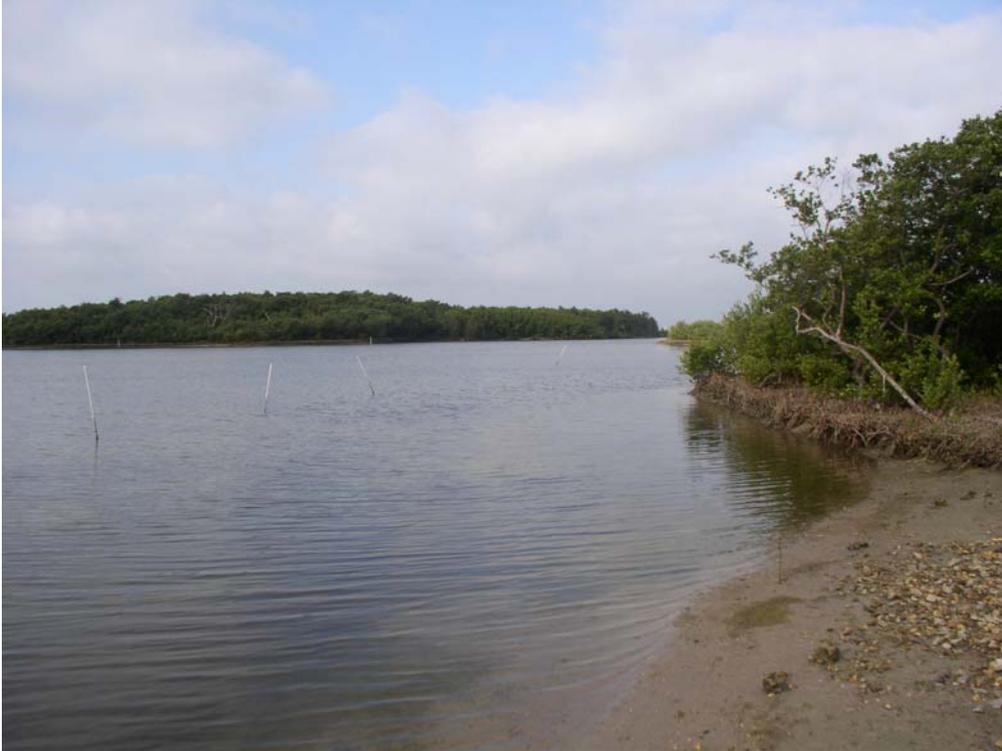
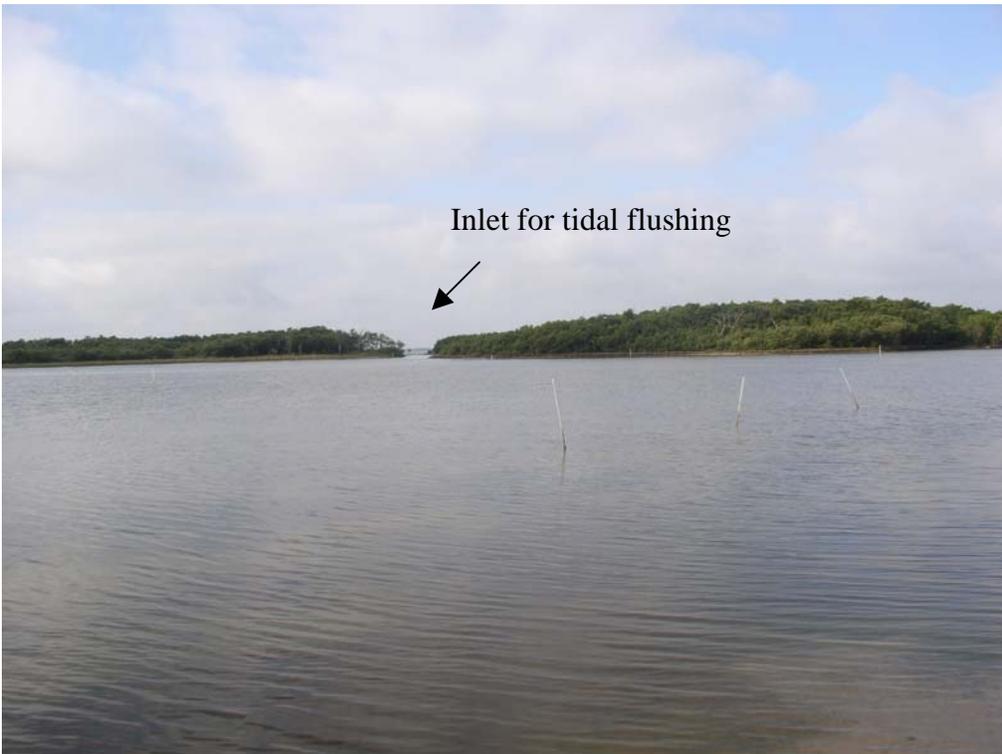
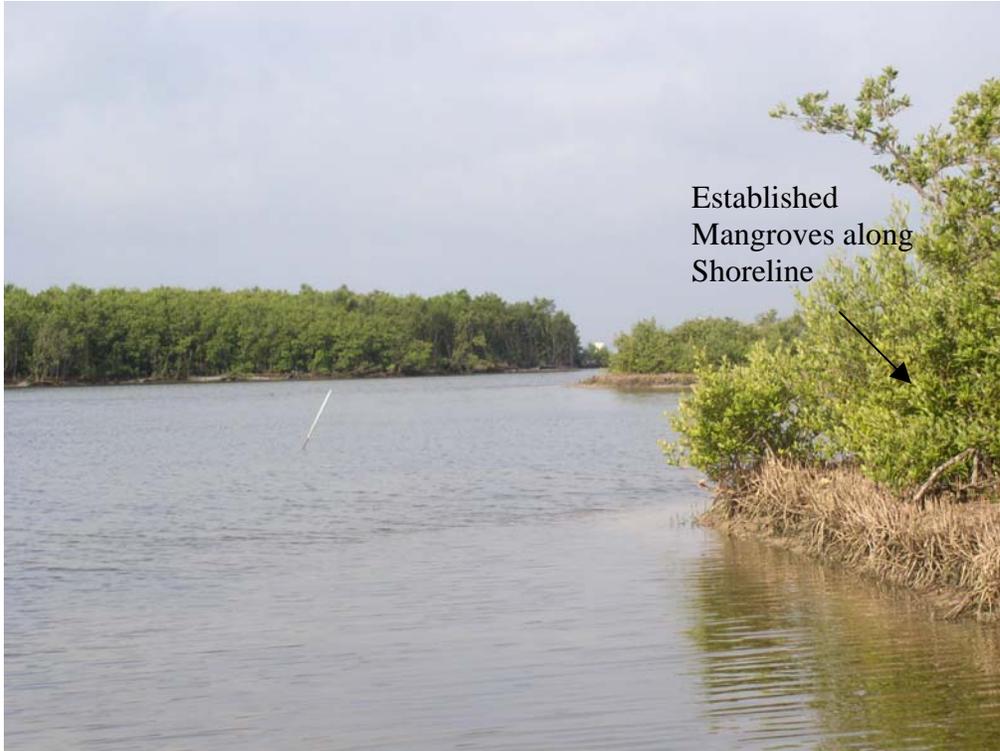
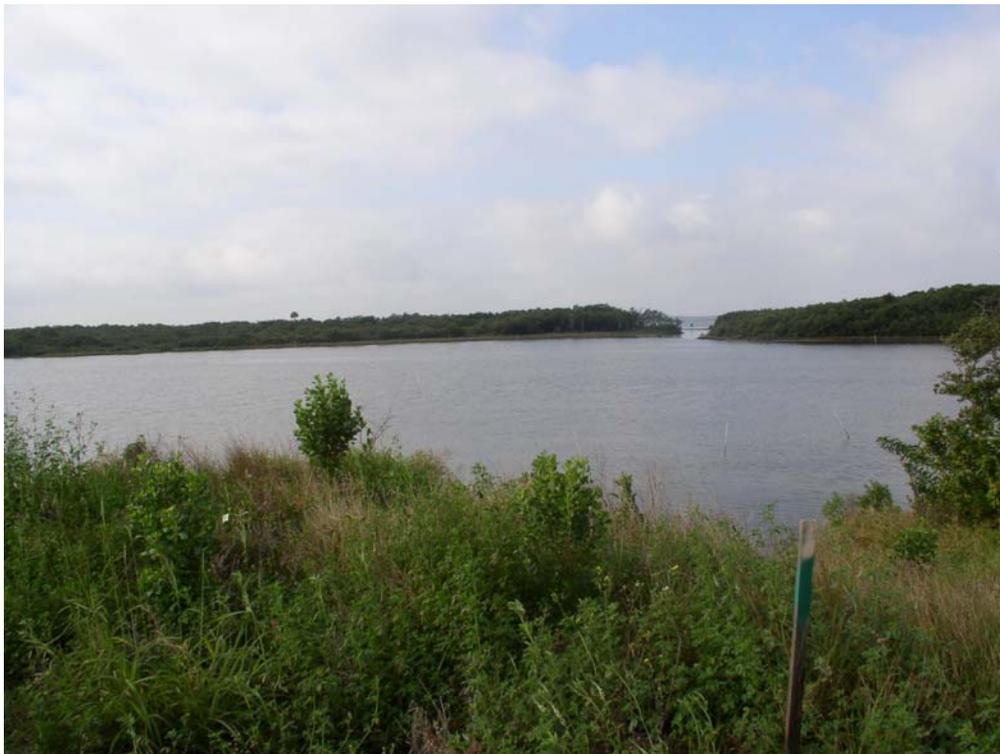
4. Seagrass transplant sites are numbered from 1-7. Many of these sites could be observed from the shoreline. The first site visited was Site 7 (Figures 1-4). This site is located to the south of the port basin. About 13-acres of suitable seagrass habitat was created at Site 7 by scraping down the upland area that was historically referred to as Little Redfish Creek. The creek was filled in with material many years ago. The original mitigation plan identified this area for tidal creek restoration. However, during the permitting process, the decision was made to use this area for creation of seagrass habitat.

Figure 1. Seagrass Mitigation Site No. 7

Figure 2. Seagrass Mitigation Site No. 7.

Figure 3. Seagrass Mitigation Site No. 7.

Figure 4. Seagrass Mitigation Site No. 7 (looking southwest).

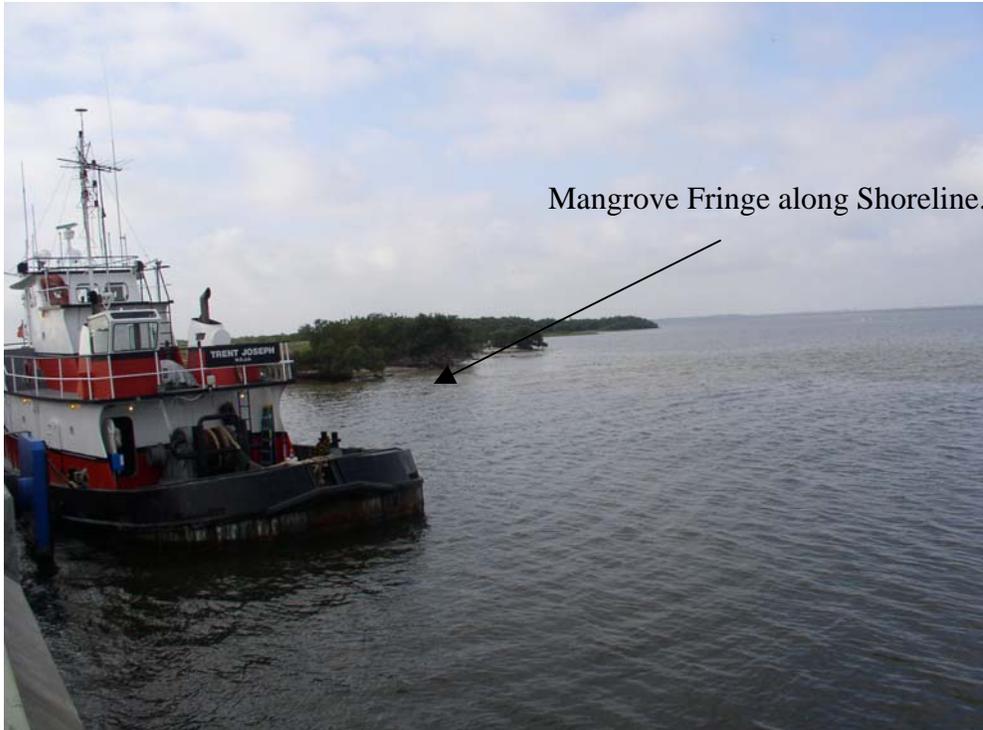
5. Figure 5 refers to the area to be impacted by extending the channel south of Berth 11. The photograph was taken from the berth looking south into the area to be impacted by the proposed south channel extension. A few mangrove trees are located along the shoreline (Figure 6). From the berth looking southwest, seagrass mitigation sites 1, 2 and 3 can be observed at a distance (Figure 7). The white PVC pipes are used for monitoring and location purposes.

Figure 5. Photograph taken from Berth 12, looking south. Area to be impacted by the side channel extension (Phase III).

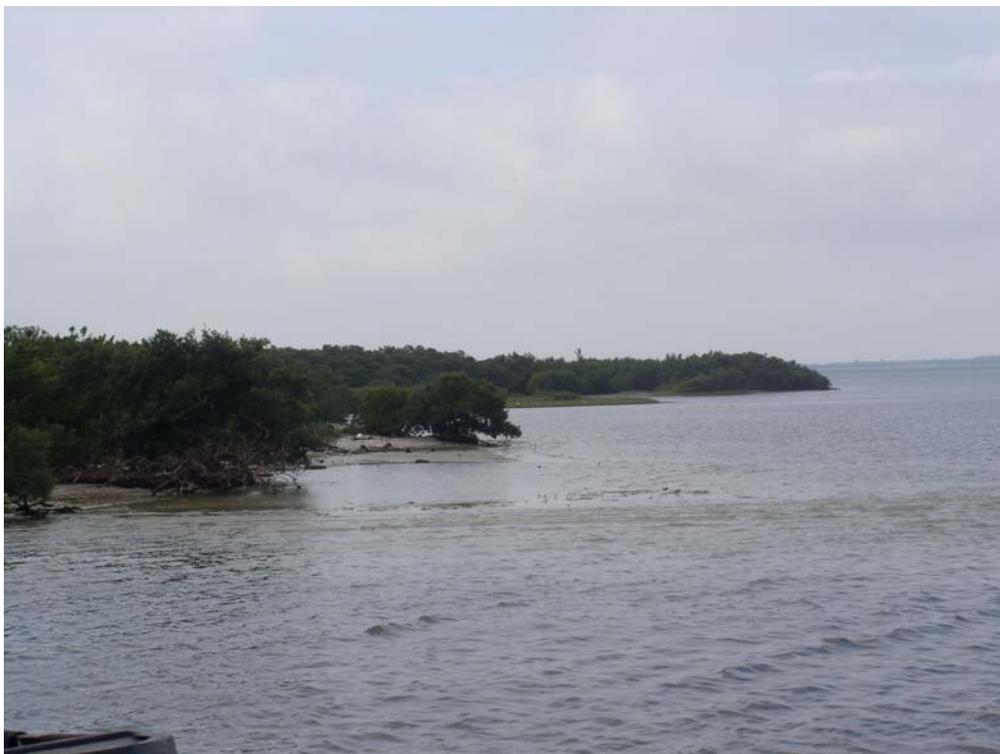
Figure 6. Closeup of mangrove fringe to be impacted by side channel extension (Phase III).

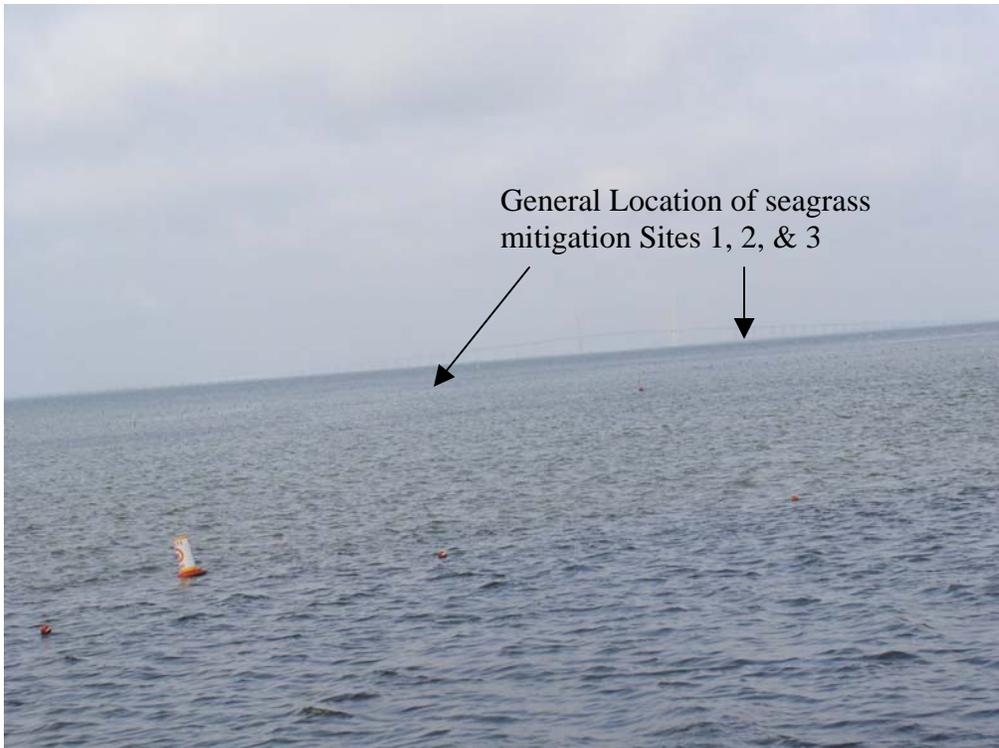
Figure 7. Seagrass mitigation sites 1, 2 & 3. Photograph taken from Berth 12 looking southwest.

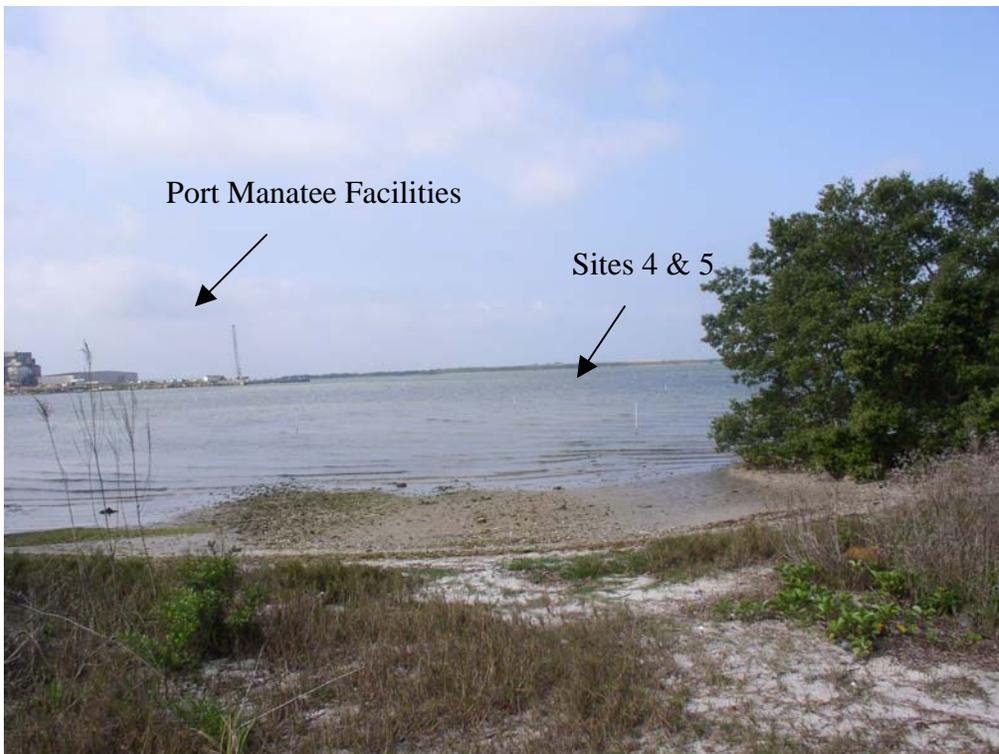
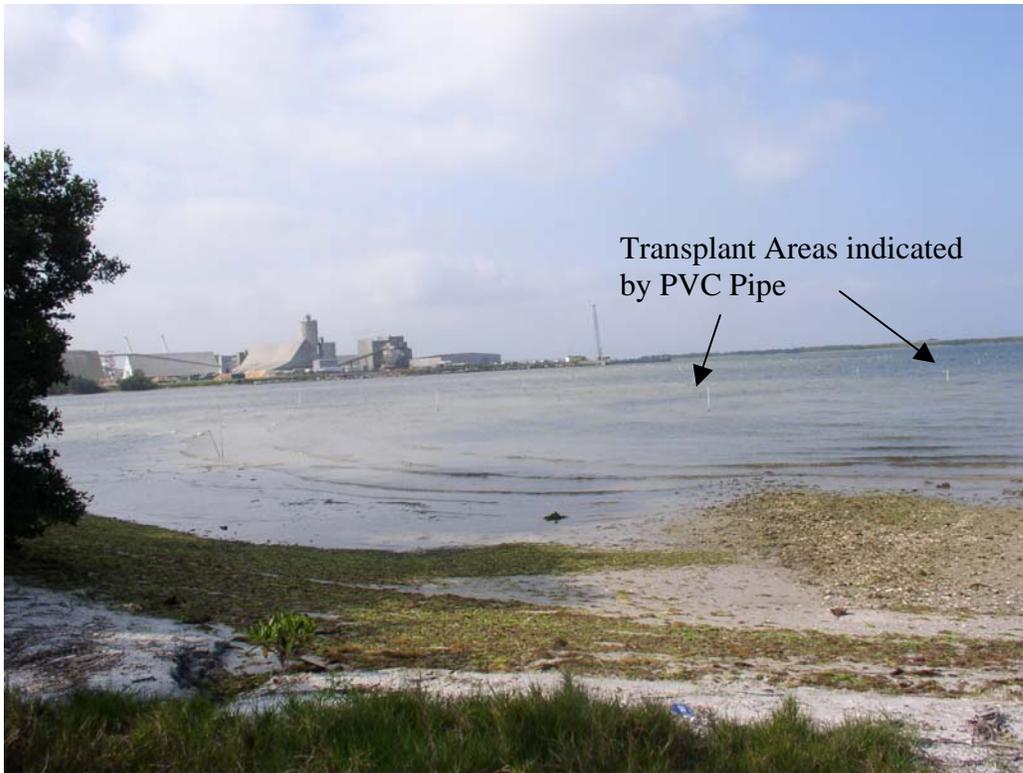
6. Seagrass mitigation sites 4, 5, and 6 are located at Piney Point. Sites 4 & 5 are to the south of the old boat ferry docking area (Figures 8-9). Site 6 is to the north. Breakwaters were designed and installed to protect these seagrass restoration areas from erosion. Piney Point Boat ramp, part of the overall mitigation plan, has not been constructed at this time.

Figure 8. Seagrass mitigation sites 4 & 5. Photograph taken standing at Piney Point looking south towards the port.

Figure 9. Seagrass mitigation sites 4 & 5. Photograph taken from Piney Point looking south.

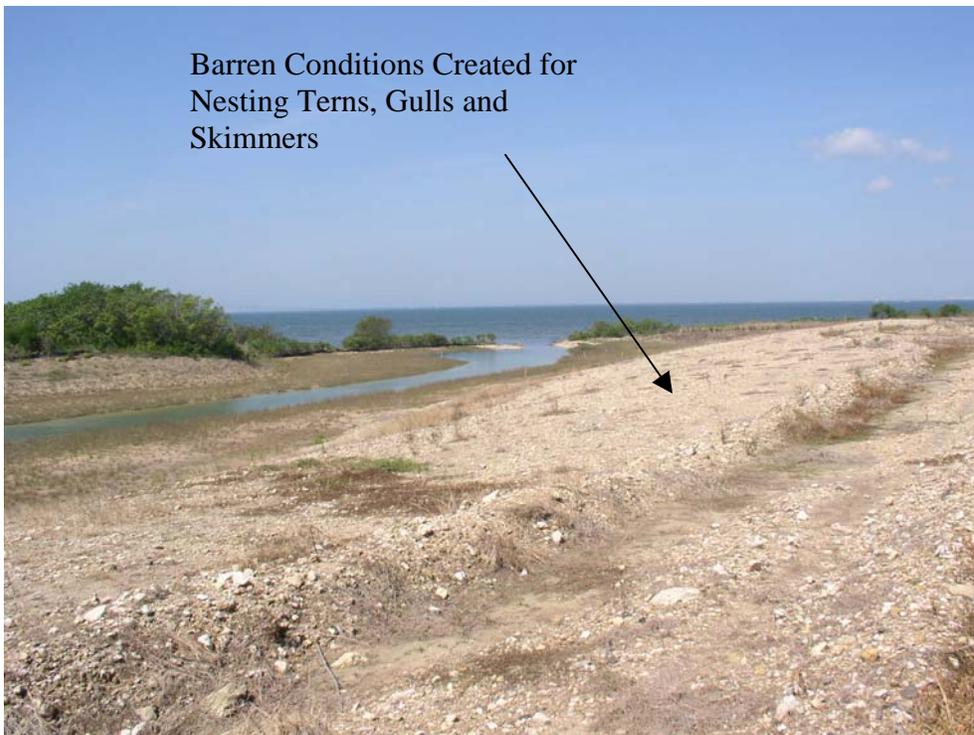
8. A boat was arranged for transportation to the restored dredged material island. The 59 acre disposal island at Port Manatee was created in 1969 by side casting disposal material from dredging the Port access channel. The island was used by ground nesting shorebirds until the early 1980's. After that time, the use of the island declined due to habitat displacement by invasive (exotic) vegetation such as Brazillian pepper. As part of mitigation for adverse impacts for Phases II and III of the harbor improvements project, the island was restored. Restoration work included removal of exotic vegetation, creation of suitable habitat for beach nesting birds (Figure 10), subtropical habitat for migratory birds, and enhancement and creation of a total of approximately 25 acres of mangrove, salt marsh, salt barren, and tidal creeks (Figures 11-13). The dredged material island restoration construction activities are complete. However, monitoring, maintenance and reporting is ongoing as per requirement in the Environmental Resource Permit (No.: 0129291-003-EI).

Figure 10. Dredged material island restoration work. Nesting habitat for beach-nesting, colonial birds.

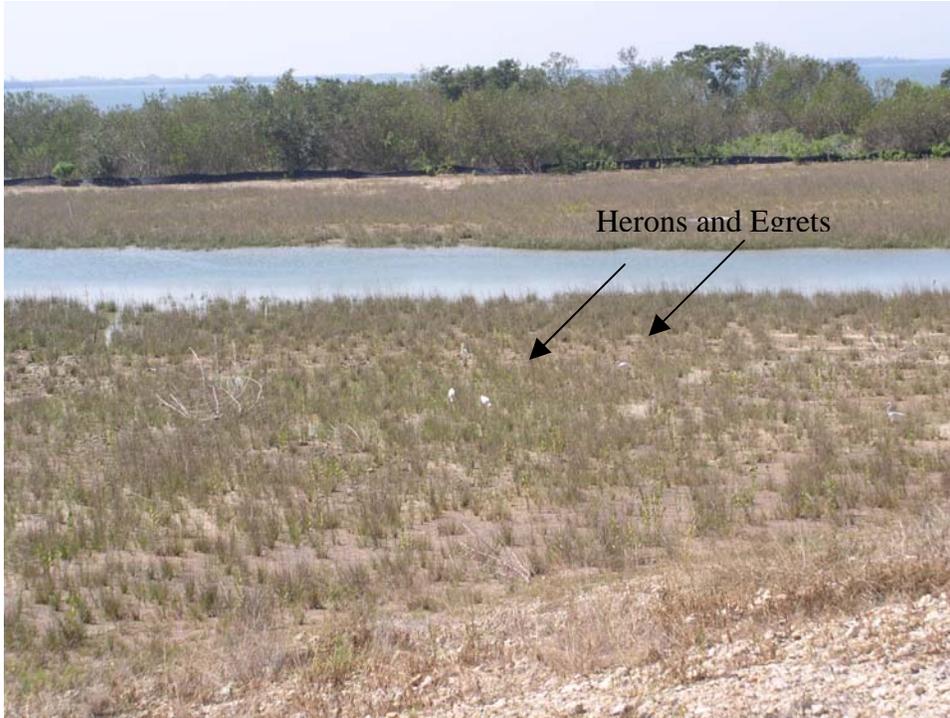
Figure 11. Dredge material island. Salt barren and tidal marsh.

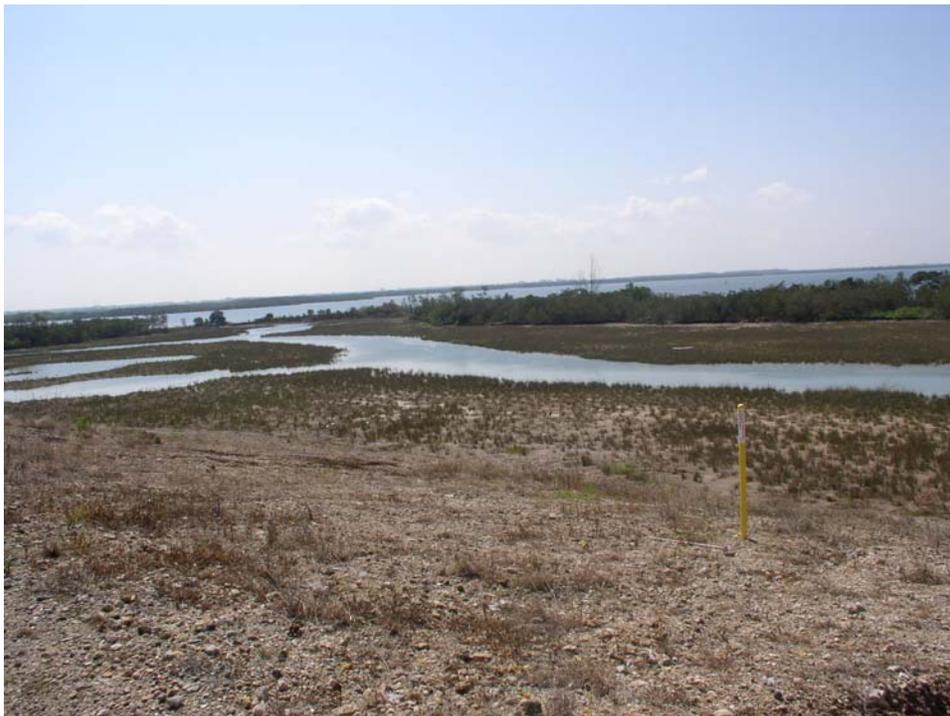
Figure 12. Dredge material Island. Enhanced creek and tidal lagoons.

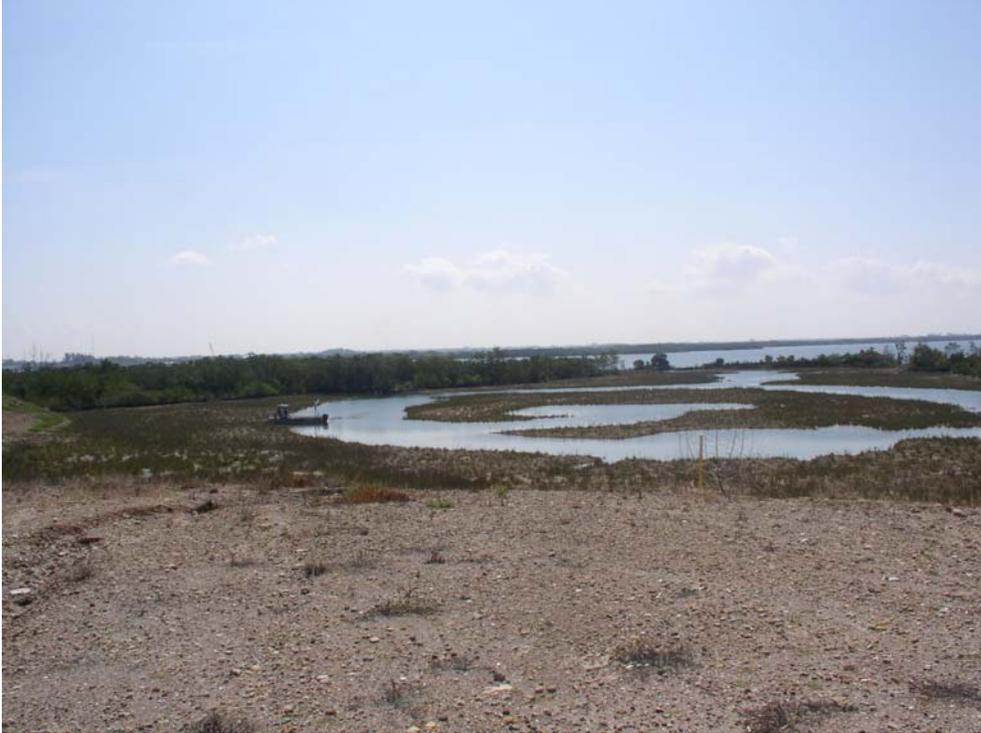
Figure 13. Dredged material island. Salt marsh and tidal creek/lagoons.

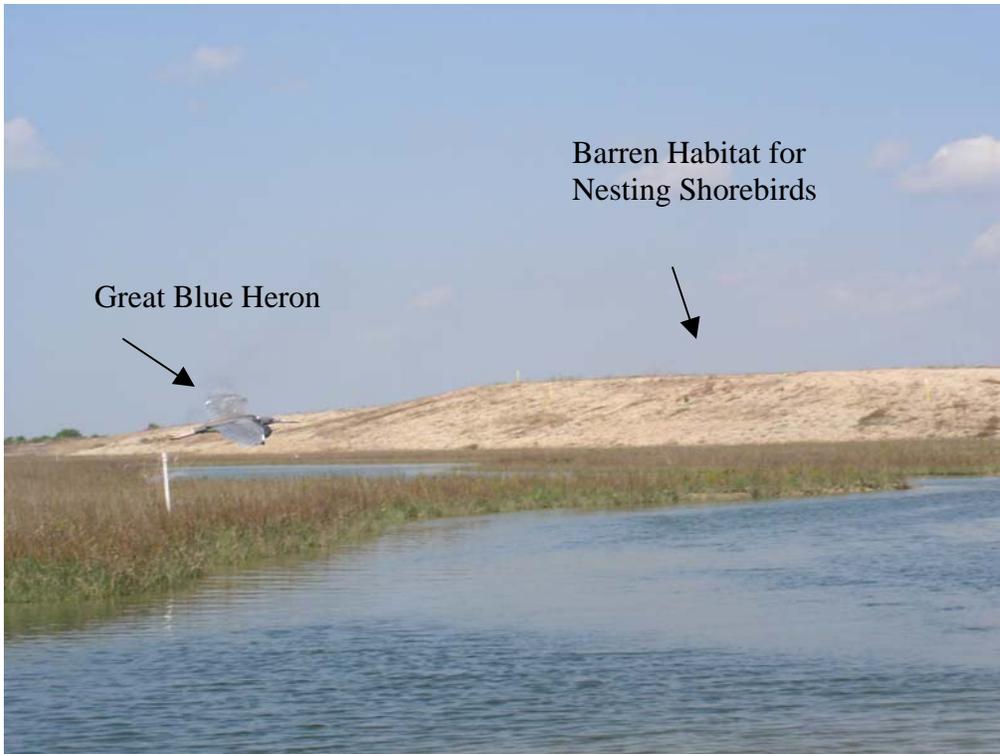
Figure 17. Dredge material island.

10. Vegetation management on the island is ongoing. Surveys have to be conducted twice each year to locate exotic plants. Depending on size, exotics are hand pulled or treated with herbicide. As observed in Figure 17, much of the beach nesting bird habitat is intended to be essentially devoid of vegetation to meet habitat objectives. Predator control is also essential on the island. Raccoons easily cross the shallow water barrier between the mainland and the island. Raccoons (*Procyon lotor*) are known predators on nesting shorebirds. As such, raccoons are removed if their presence on the island is detected. Live-traps are set around the island to catch the raccoons (Figure 18).

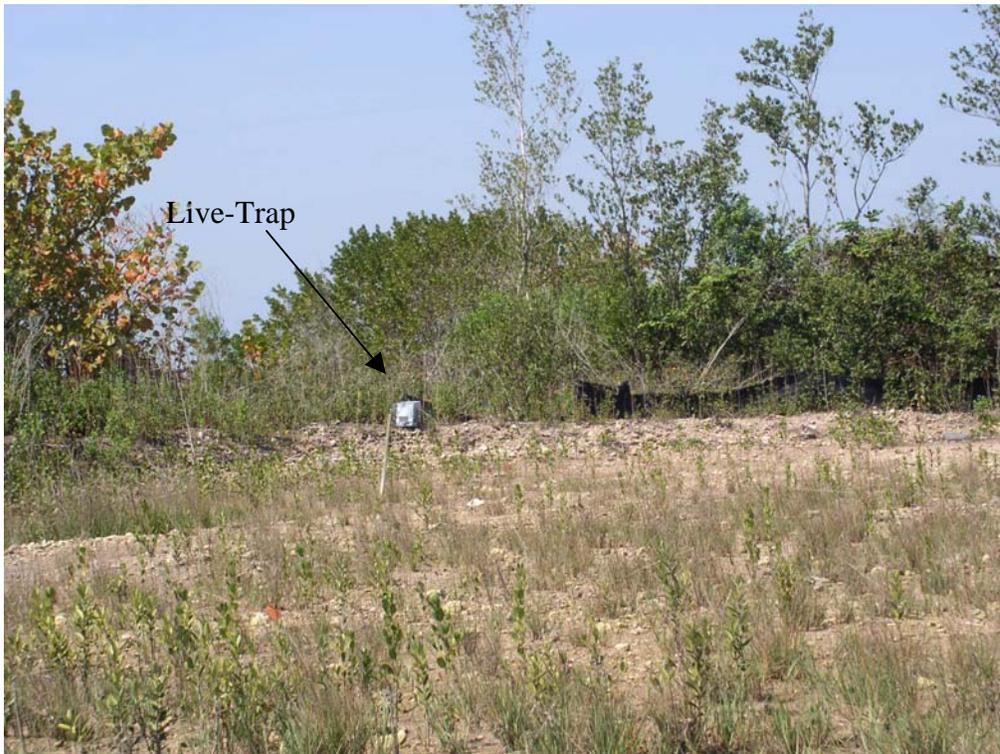
Figure 18. Dredge material island. Predator control effective for raccoons.

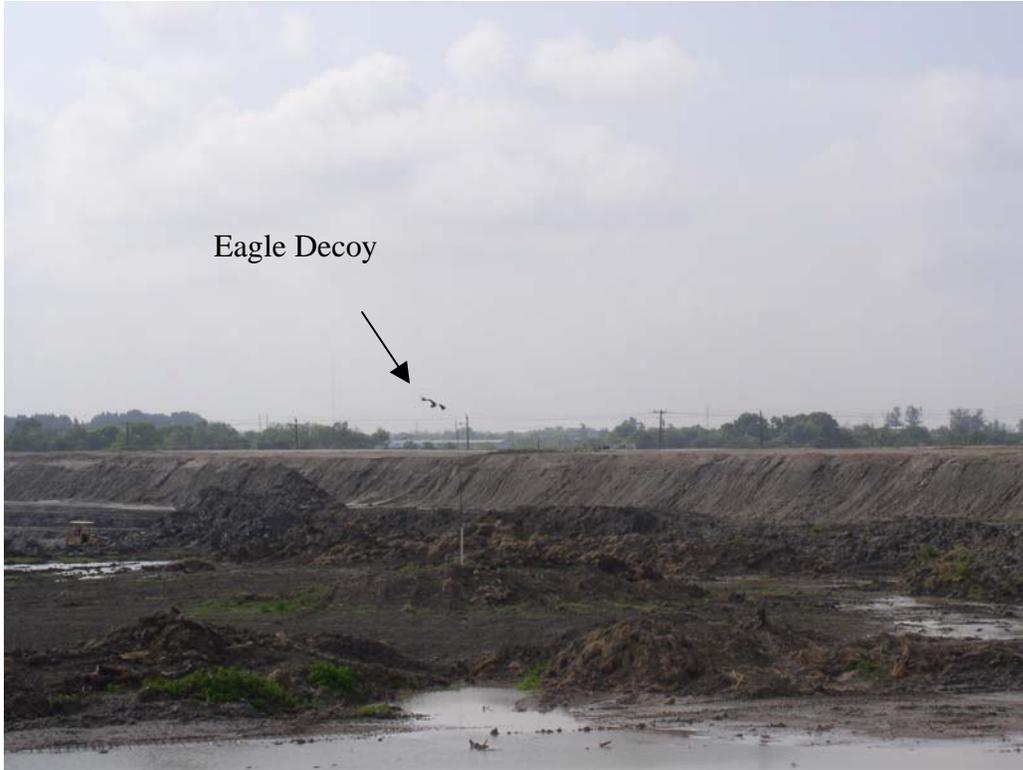
11. As part of the Phase II work, construction was taking place on the Port's upland material disposal site during the site visit (Figure 19). Work crews are currently elevating the perimeter dikes to meet the capacity needed for the new dredge material. Last year, construction was curtailed to avoid nesting birds on site. This year, work crews have installed several eagle decoys to deter nesting on the disposal site (Figure 19).

Figure 19. Dike elevation construction of the Port's upland disposal site. Eagle decoys installed to deter bird nesting activities.
