Non-Time-Critical Removal Action  
at the Municipality of Culebra, Puerto Rico

# *Environmental and Cultural Resources Surveys for Isla Culebrita*

**End of Fieldwork Report:  
Archaeological Walkover Survey Associated with Unexploded  
Ordnance Removal on Isla Culebrita and Cayo Lobo,  
Municipality of Culebra, Puerto Rico**

FLORA AND FAUNA SURVEY  
FOR  
CULEBRITA ISLAND  
DERP-FUDS CLEAN UP  
CULEBRA, Puerto Rico  
OCTOBER-2006

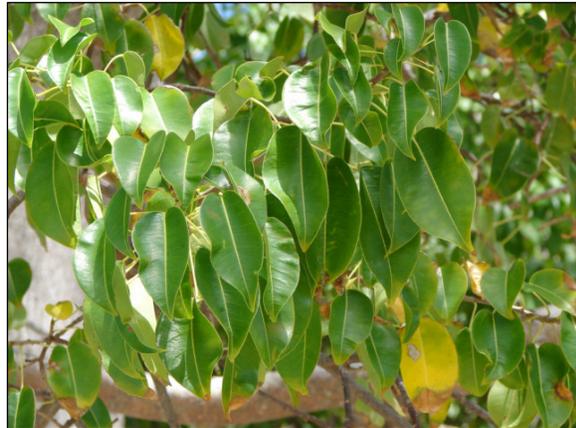
5. Clearing crews will be informed about the poisonous manchineel trees (photo at right). These trees exist in the coastal thickets. The manchineel tree is toxic and can burn the skin. The fruit of the manchineel tree resembles a small green apple and is poisonous. Contact with its leaves and fruit should be avoided and workers should not stand or sit under one when it is raining.

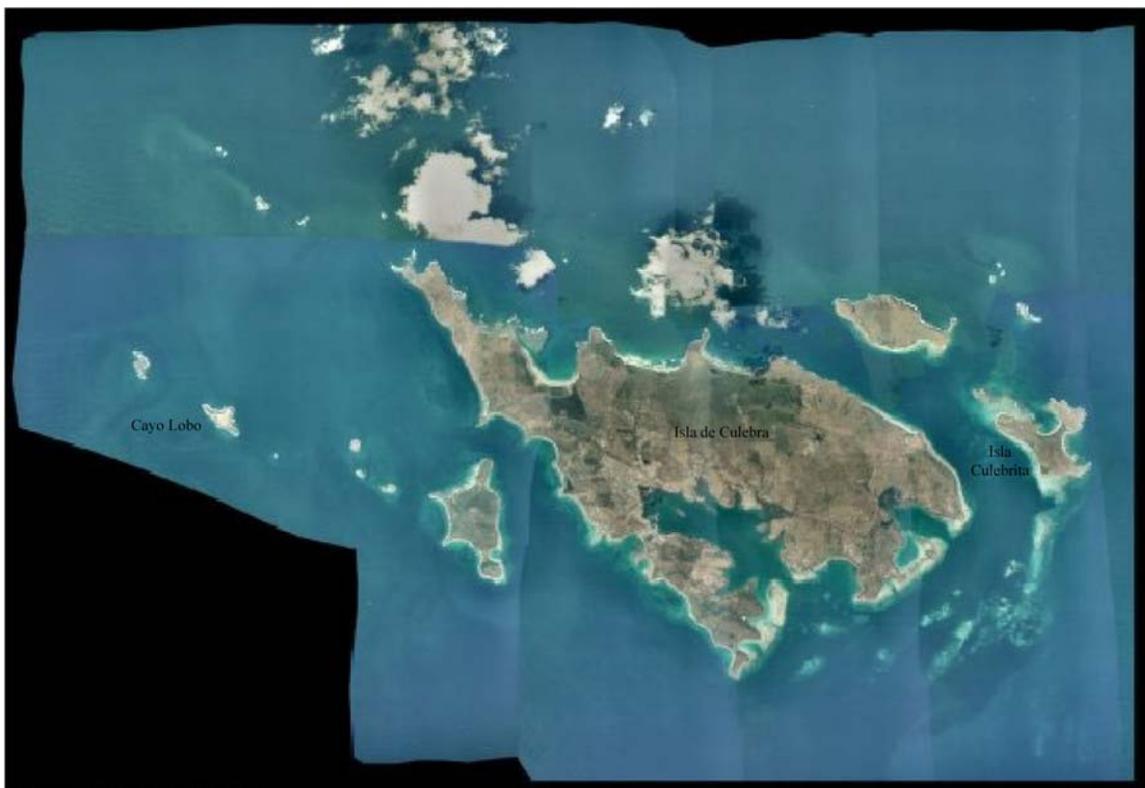
Figure 1. Location of Surveyed Cays—Cayo Lobo and Isla Culebrita

This End of Fieldwork report describes walkover surveys of Cayo Lobo and the northwestern peninsula of Isla Culebrita conducted in July 2006. Dr. William F. Keegan, Curator of Caribbean Archaeology, Florida Museum of Natural History, University of Florida, Gainesville, was sub-contracted as the Principal Investigator. Dr. Keegan conducted his investigation of Cayo Lobo on July 25 and Isla Culebrita on July 26, 2006. Unfortunately, due to severe weather conditions during the time of the survey, it was impossible to return safely to either island for follow-up investigations.

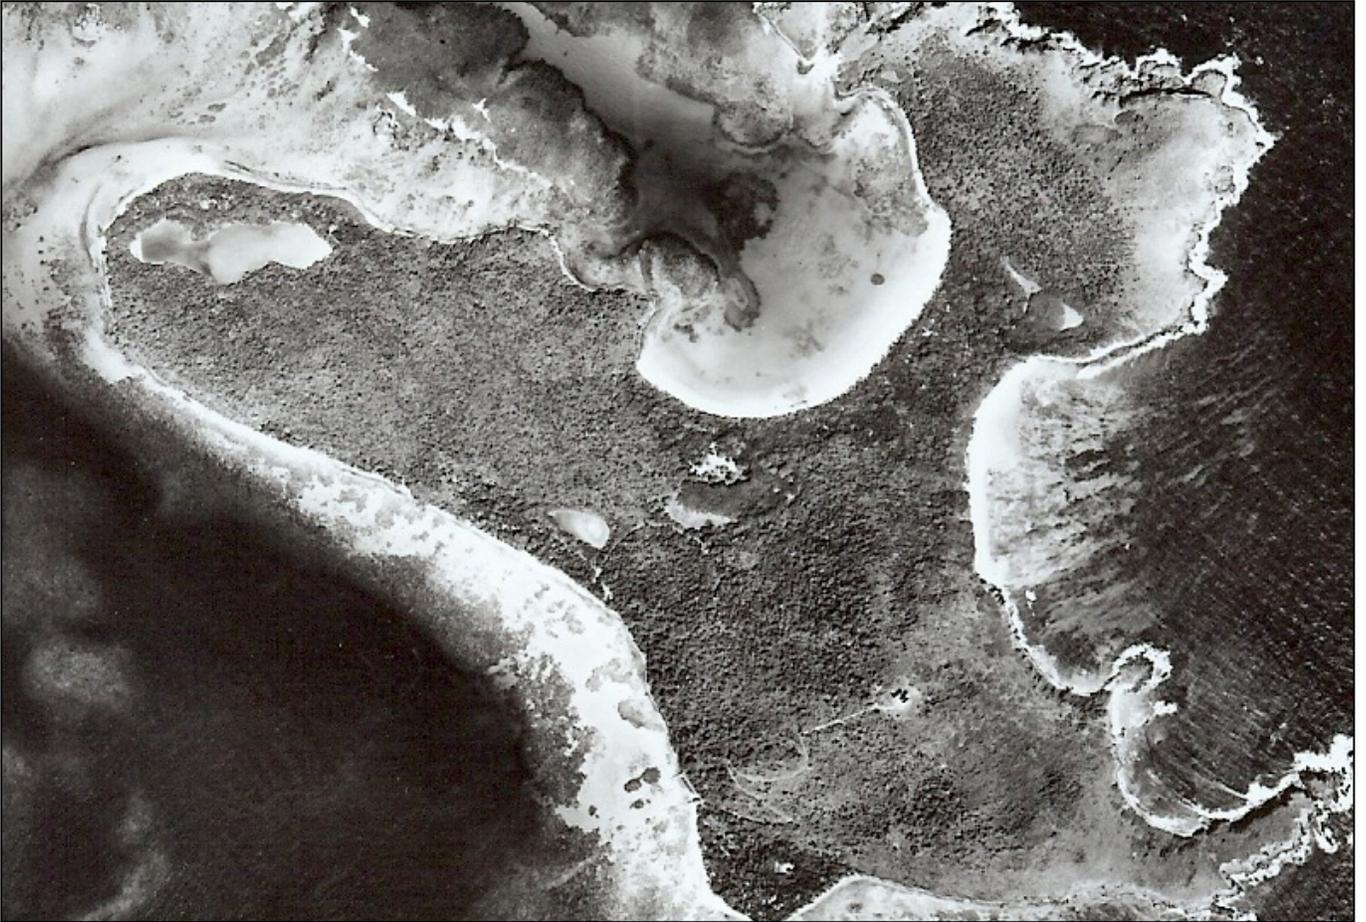
Figure 4. Vegetation cover in 1965.

To determine the degree of human disturbance in Culebrita before becoming a nature reserve, we obtained a 1965 aerial photo (earlier photos weren’t available in the PR Highway Authority). The main difference between vegetation cover in the sixties and today is the degree of fragmentation of the dry forests in the study area. Forty years ago scrub forest wasn’t as extensive as it is today. Earlier photography is needed to determine the degree of human impact in the island. It is very likely that the suitable trees found in the dry forest were exploited by the lighthouse caretakers and that fires must have been a common occurrence during military practices.

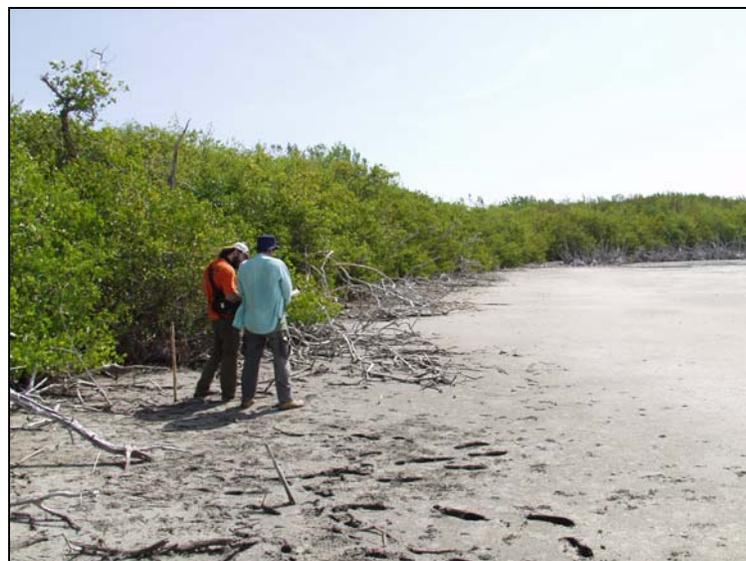
Figure 6. Tidal flat in northwestern tip of Culebrita.

4 – Tidal flats – Seasonally flooded shallow lagoons. May be partially or completely surrounded by mangrove forests dominated by White (*Laguncularia racemosa*) and Black (*Avicennia germinans*) mangroves.

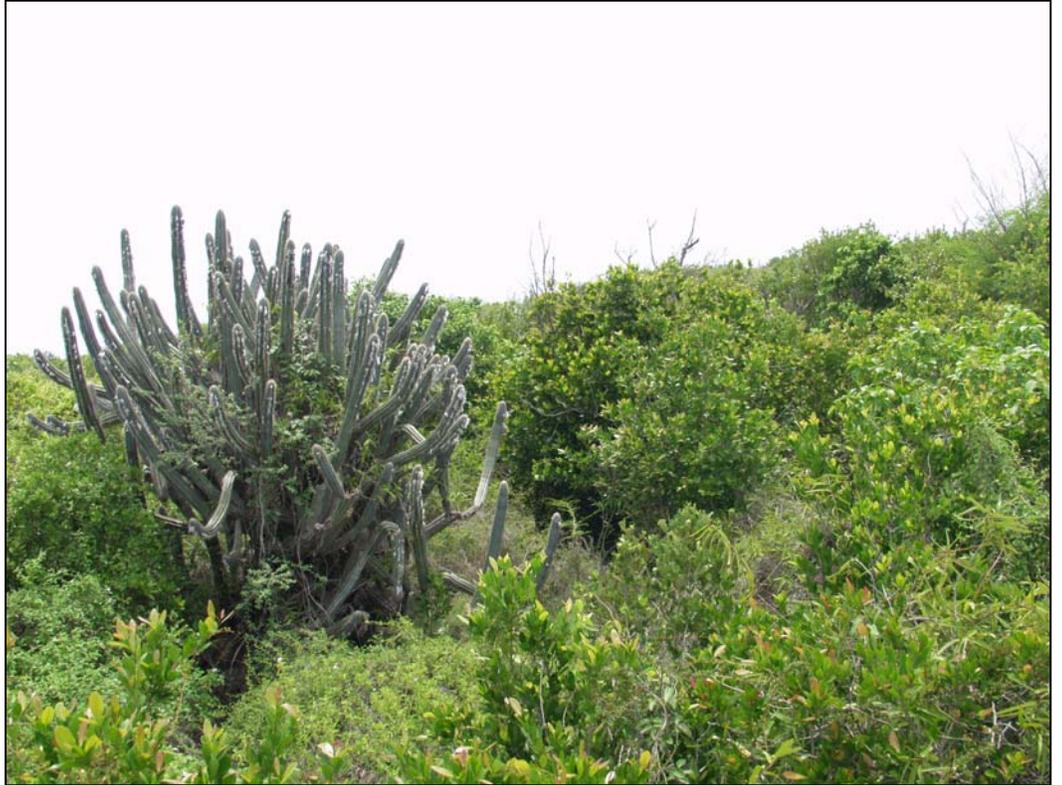
Figure 7. Pipe-organ cactus and surrounding scrub forest vegetation.

2 – Dry scrub forest – This is the most abundant habitat-type found in the study site. It occurs along the cliffs and hills of the island. The soil is rocky and very shallow. Canopy height averages 2.6 m. The dominant shrubs and trees growing in this community are: Cat’s claw (*Pithecellobium unguis-cati*), Pipe-organ cactus (*Pilosocereus royenii*), Crabwood (*Gymnanthes lucida*), and Black willow (*Capparis cynophallophora*). The thorny bushy-vine *Oplonia spinosa* is also abundant.

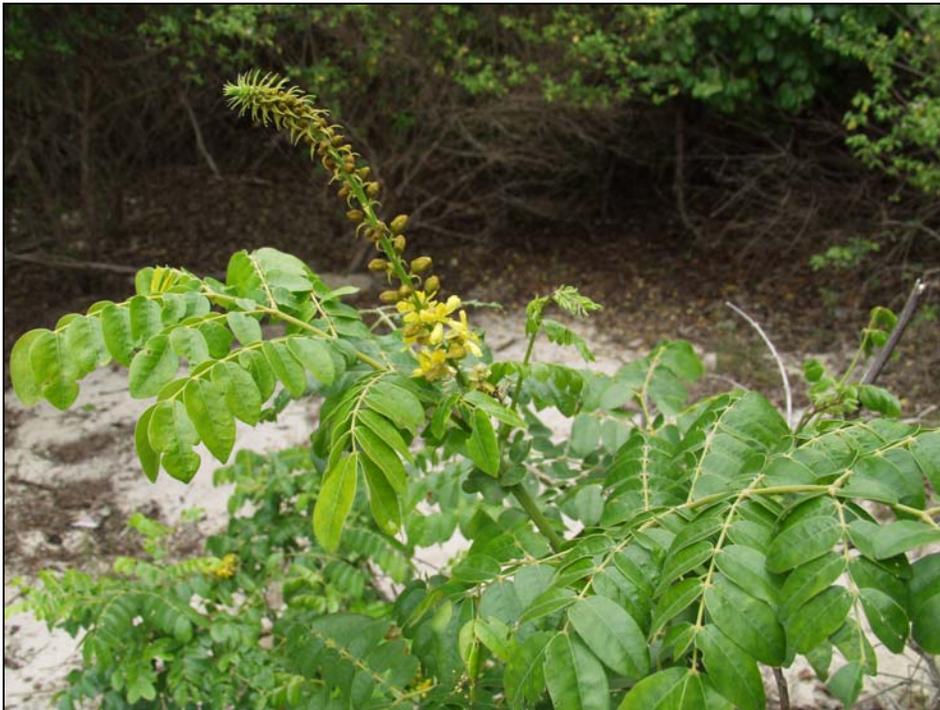
Figure 8. Flowering Gray nickers (*Caesalpinia bonduc*).

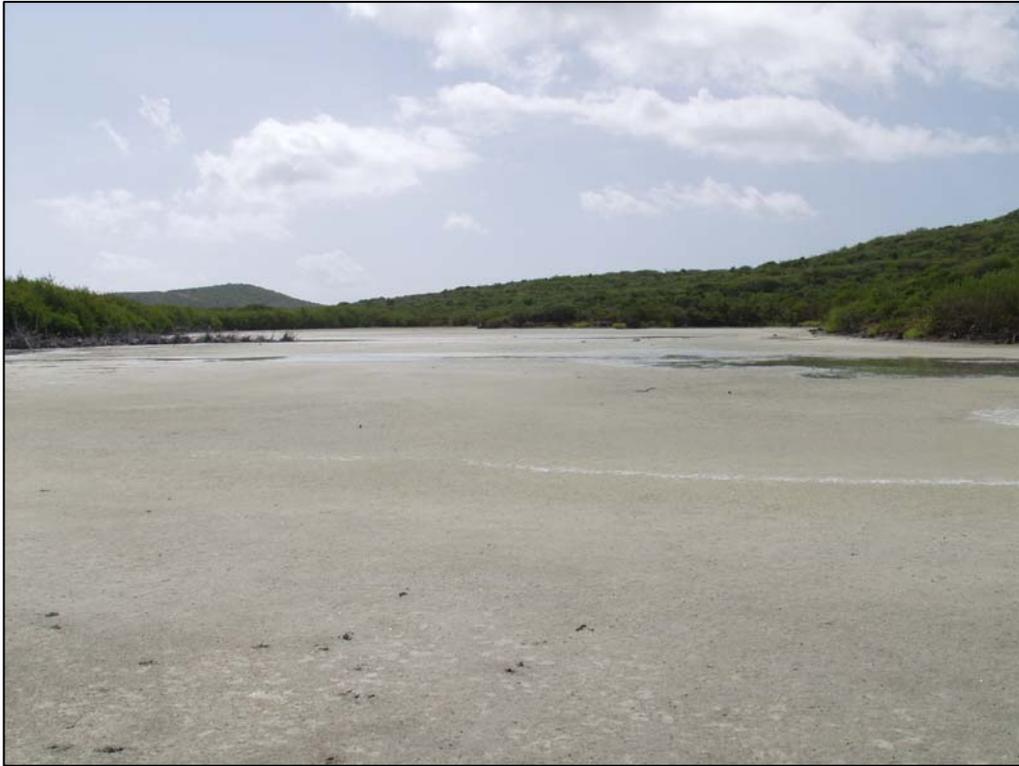
Figure 4. Laguna de Molino (western tidal flat) on July 26, 2006.

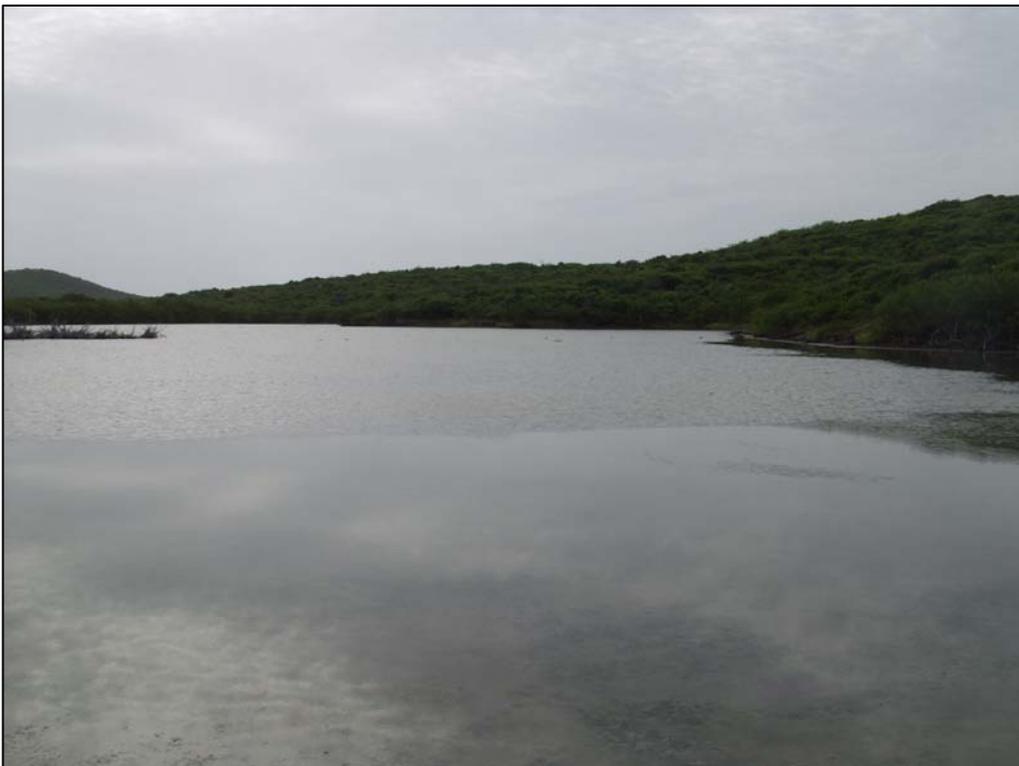
Figure 5. Laguna de Molino on August 11, 2006.

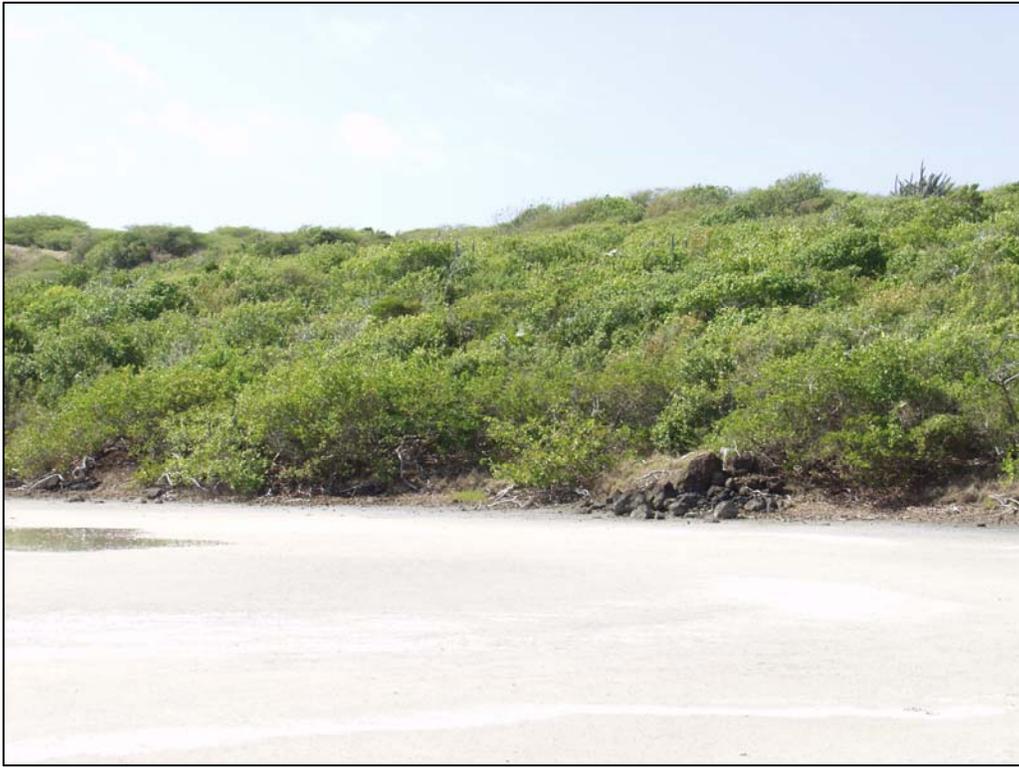
Figure 6. Northern limit of wetland at Laguna de Molino.

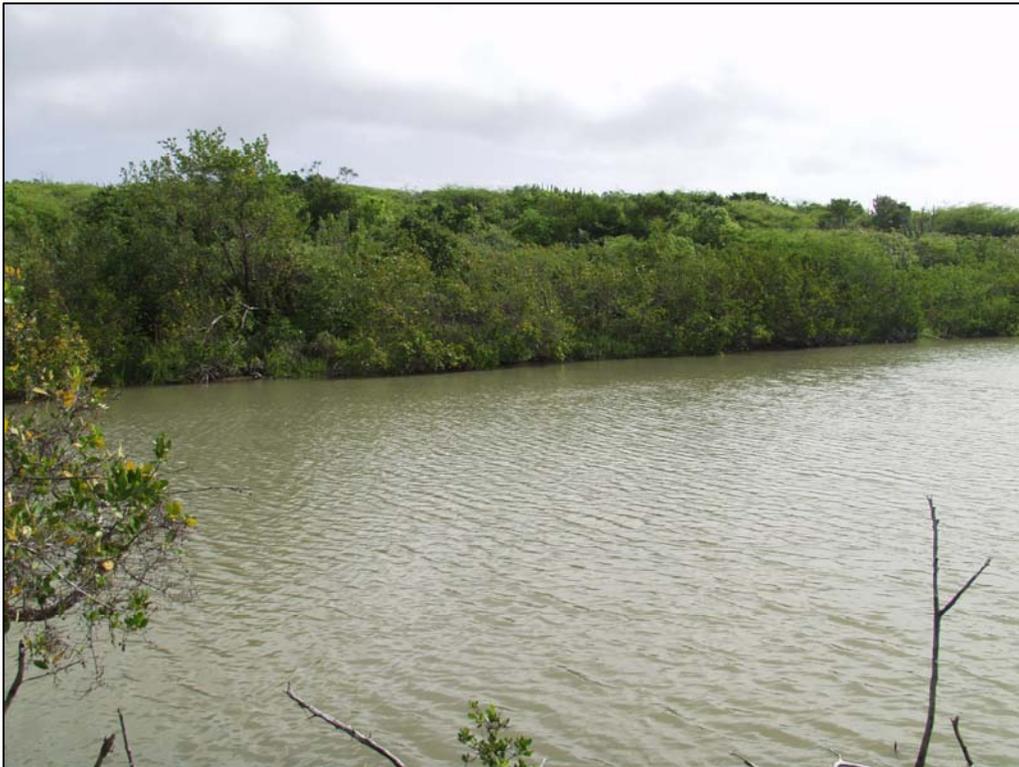
Figure 7. Eastern tidal flat on August 10, 2006.
