PERMIT PLANS

CONTRACT PLANS

FINANCIAL PROJECT ID 439206-1-52-01

STATE ROAD NO. 60
(COURTNEY CAMPBELL CAUSEWAY)
OLD TAMPA BAY WATER QUALITY IMPROVEMENTS

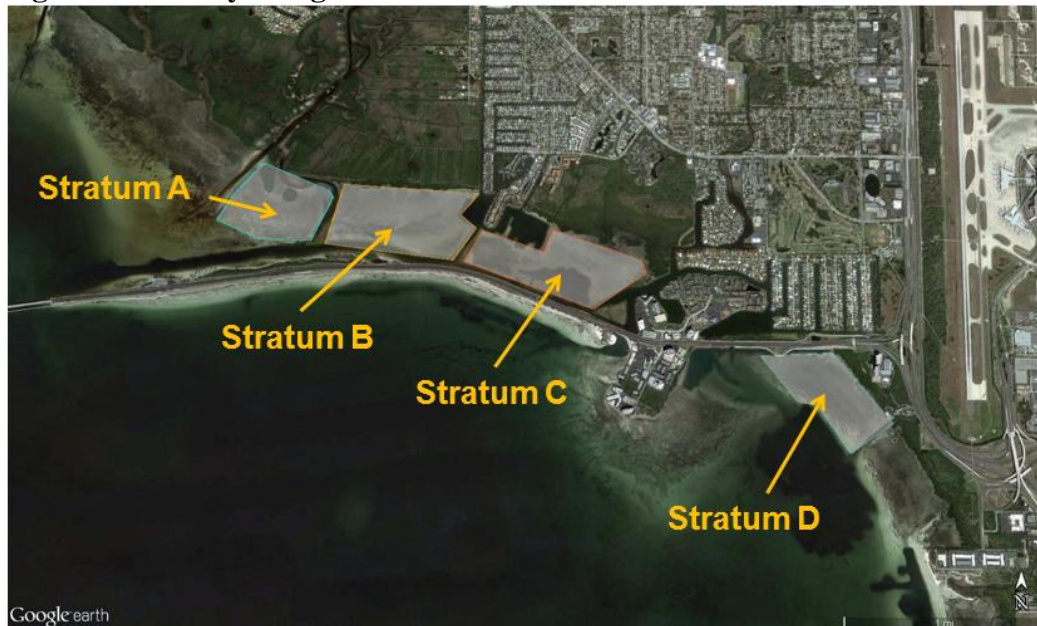
Figure 2-1: Study Design

Table 2-1: Field-Calibrated Model Results Demonstrating the Reduction in Residence Time*

Location	Acres	Residence Time (days)		Percent Reduction
		Existing conditions (no	With proposed 220 ft opening	
Stratum A	89	2.25	0.50	80
Stratum B	123	2.75	1.00	60
Stratum C	108	3.25	1.50	50

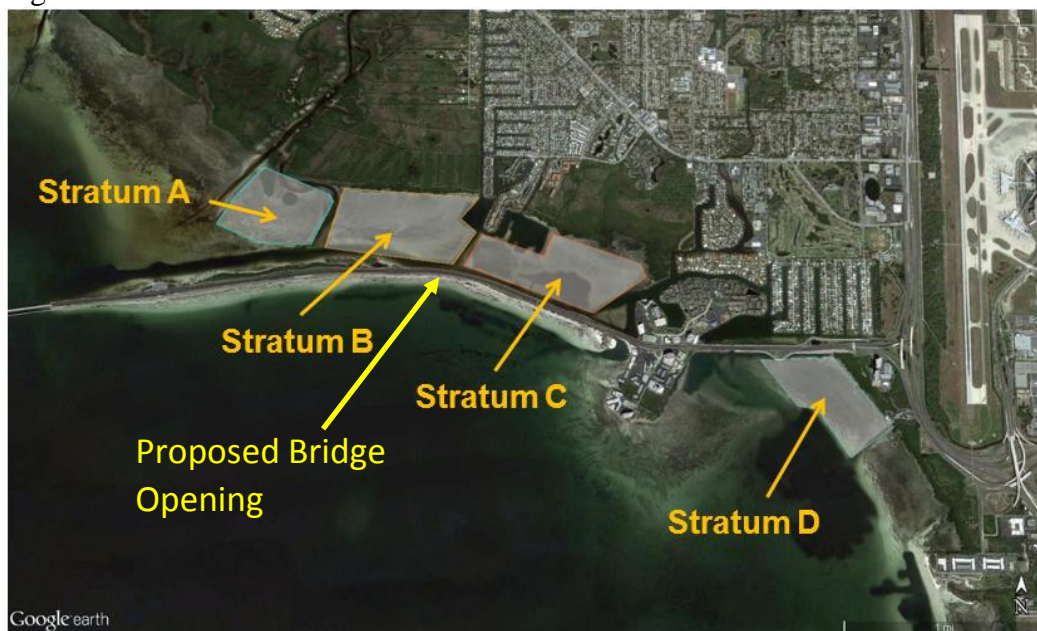
Figure 9-1. Stratum Locations

For this project, data would be collected prior to, during, and after the modification of the CCC, from the previously used Strata of A, B, C and D (see image below). Stratum C is the location where it is anticipated that the greatest benefit would occur, in terms of both water quality benefits and seagrass recovery. Benefits would also be expected to occur in Stratum B, particularly on the east side of Stratum B. Stratum A would act as a control for water quality and seagrass coverage in areas north of the CCC. While useful as a control for areas south of the CCC, it is not anticipated that Stratum D would be part of the proposed BACI design for monitoring.

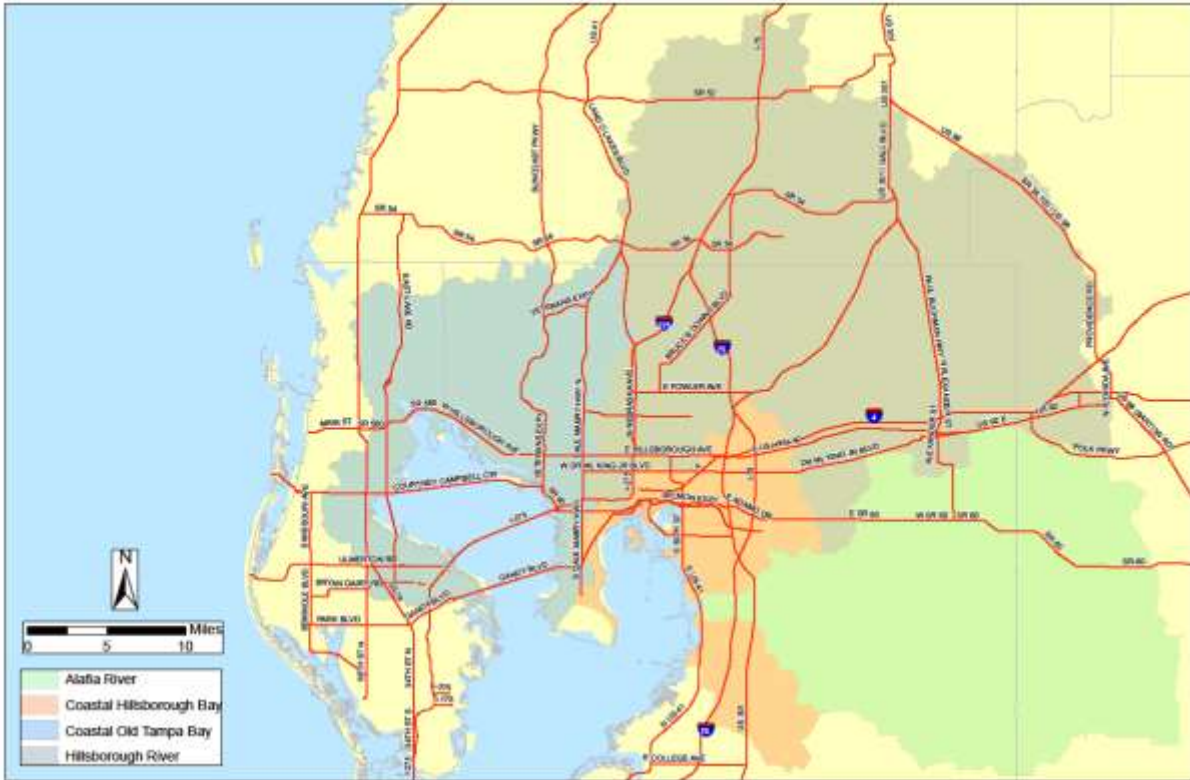
Figure 1 Map of Tampa Bay showing main transportation features and the watersheds of coastal drainage to Old Tampa Bay, the Hillsborough River, the Alafia River, and coastal drainage to Hillsborough Bay.

the Howard Frankland Bridge, and various projects associated with I-275 in Pinellas County. All of these projects are located within the portion of the Tampa Bay watershed that drains to Old Tampa Bay (**Figure 1**). Typically, FDOT’s road projects will result in an increase in impervious area, which will, unless offset in some manner, increase stormwater loads of various pollutants to nearby waterbodies.

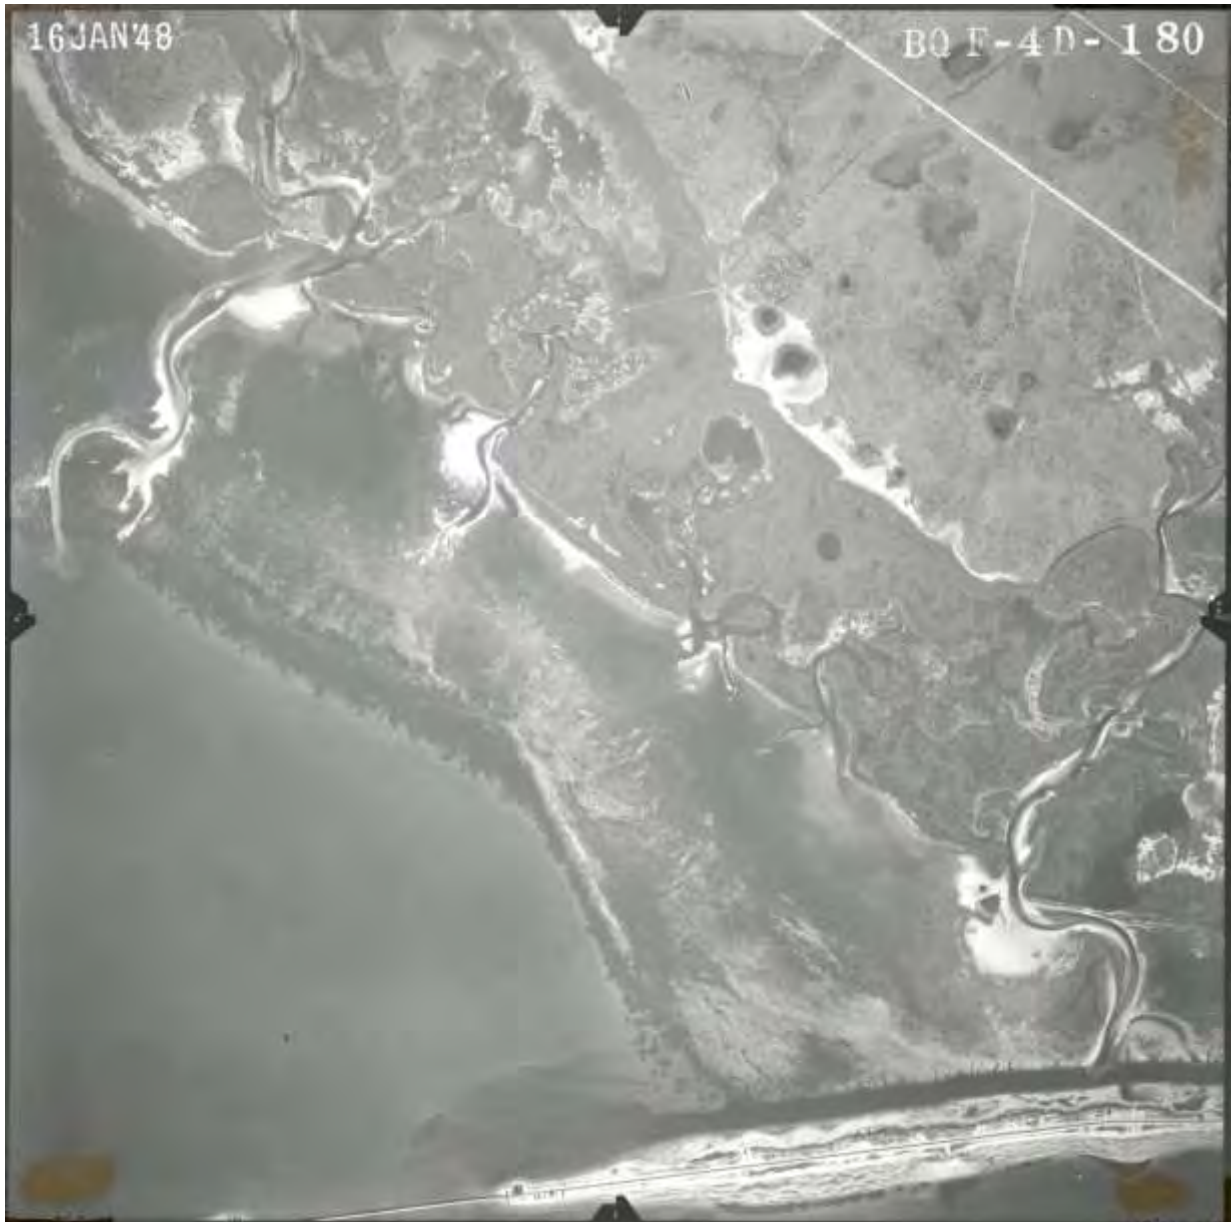
Figure 2 Aerial photograph from 1948 showing extensive seagrass meadows in Old Tampa Bay. Area shown is north of the CCC, west of the eastern terminus of the causeway.

In Old Tampa Bay, the Courtney Campbell Causeway (CCC) represents a potentially significant impact to seagrass resources. The CCC was constructed during the Great Depression and was completed in the early 1930s, during a time when Tampa Bay as a whole, and Old Tampa Bay as well, is considered to have had good water quality, based on photographic evidence of extensive seagrass resources. Aerial photography from 1948 shows evidence of extensive seagrass meadows in the nearshore waters of Old Tampa Bay west of the eastern terminus of the CCC (**Figure 2**) and also to the south of the CCC along Rocky Point (**Figure 3**).

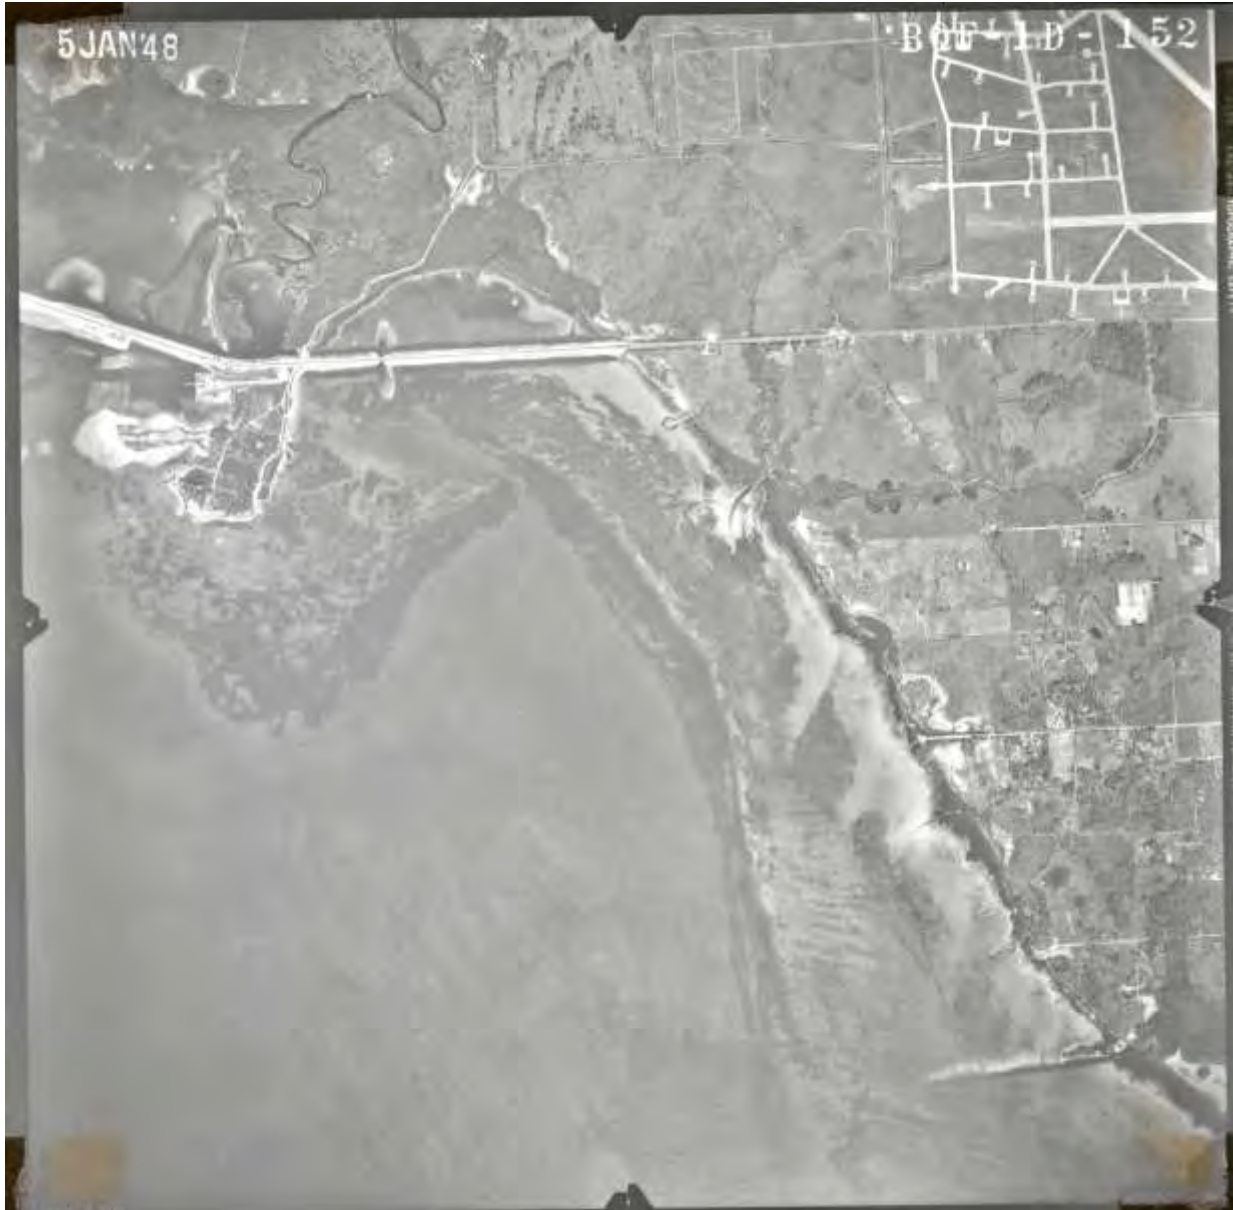
Figure 3 Aerial photograph from 1948 showing extensive seagrass meadows in Old Tampa Bay. Area shown is south of the CCC, below the eastern terminus of the causeway.

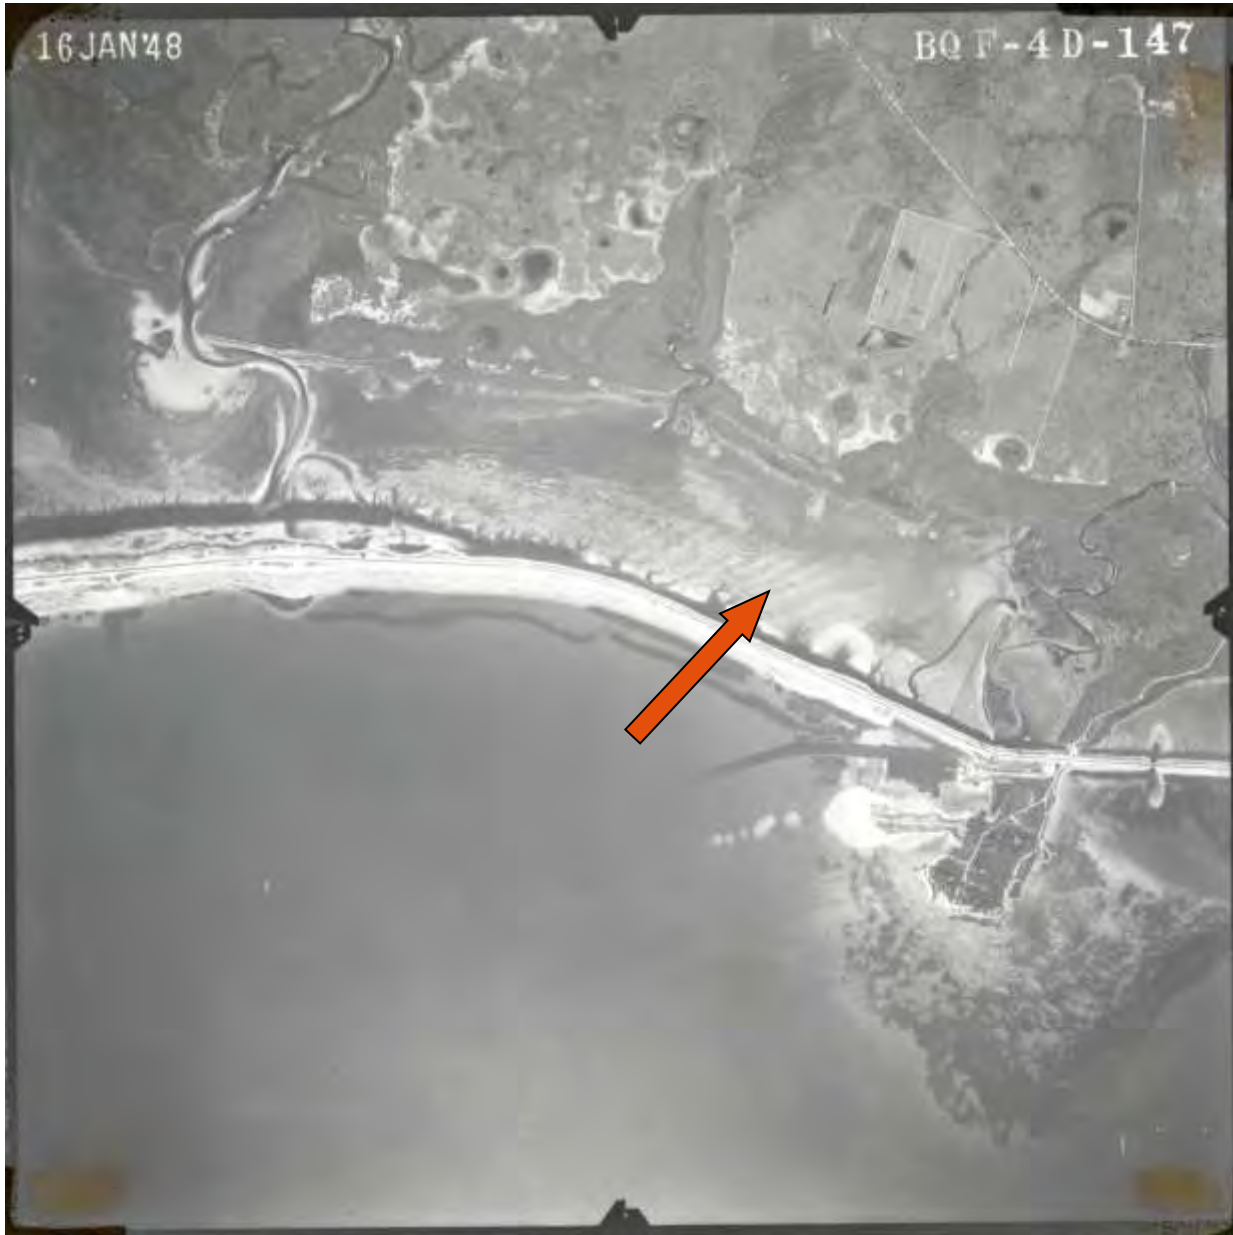
Figure 4 Aerial photograph from 1948 showing apparent impacts to seagrass meadows north of the CCC at the eastern terminus of the causeway. The red arrow indicates the photographic signature of shallow areas devoid of seagrass.

However, in the area north of the CCC shown in **Figure 4**, the photographic signature of seagrass meadows found in areas to the west and south is reduced or absent. While no ground-truthed data are available, it would appear that seagrass meadows were already impacted in the areas shown in Figure 3 at least as far back as 1948.

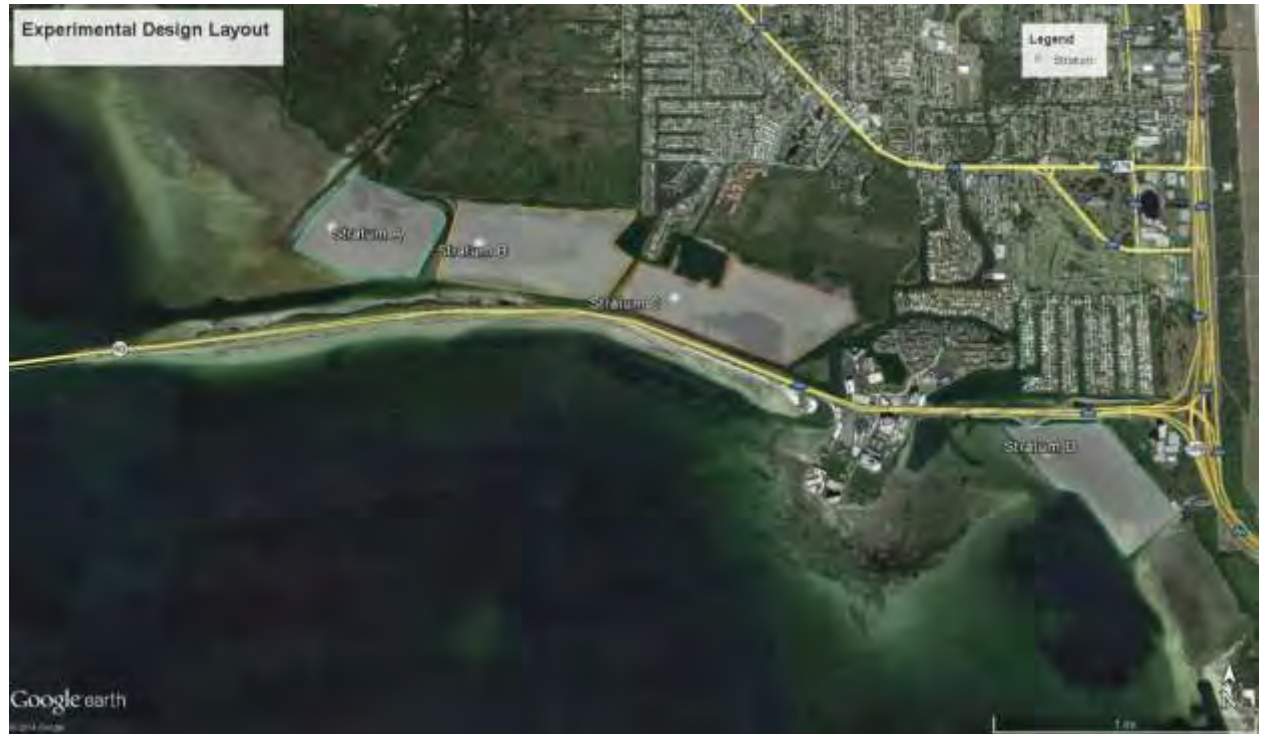
Figure 5 Experimental design layout with the four strata delineations.

Four representative areas (strata) were identified: three to the north of the causeway and one to the southeast (**Figure 5**). The strata were selected based on available biannual seagrass maps produced by SWFWMD. Seagrass layers were downloaded from the SWFWMD Shapefile Library (http://www.swfwmd.state.fl.us/data/gis/layer_library/). The seagrass layers for the area of study were available for the following years: 1988, 1990, 1992, 1994, 1996, 1999, 2001, 2004, 2006, 2008, 2010, and 2012. Two areas identified with extensive mapped seagrass (Strata A and D) and two areas identified without extensive mapped seagrass (Strata B and C) were delineated through interpretation of aerial photography.

Randomly selected sites were generated in GIS, using a random number generating algorithm applied to a grid-based overlay of each stratum. The Create Random Points tool in ArcGIS was used to create 40 sampling points (30 primary and 10 secondary) for each stratum. The tool was run for each stratum separately, constraining the points to be generated within the boundaries of the stratum polygon. Additionally, a distance of 10 meters was assigned as the minimum distance allowed between generated points. The first 30 points generated were designated as primary sampling points, with the remaining 10 points designated as secondary points. The secondary points could have been necessary if one or more primary sampling points were inaccessible.

Surface and near-bottom water quality samples were collected at the first 3 of the 30 randomly selected sites within each stratum (e.g., A1, A2 and A3; **Figures 5 to 8**). Water quality samples were collected and immediately iced in a cooler and analyzed using standard technique related to collection, transport and analysis. Surface and bottom water samples were assessed by Benchmark EnviroAnalytical, with the analysed parameters shown in **Table 2**. A YSI® 6250 water quality probe was used to measure *in situ* water temperature, dissolved oxygen, salinity and conductivity.

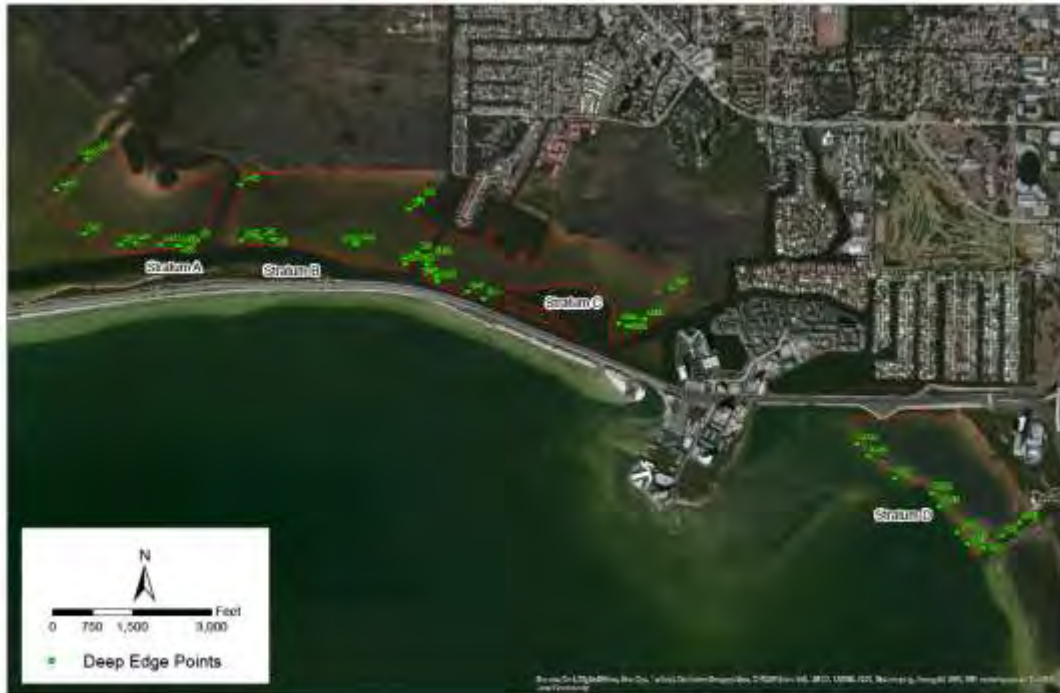
Figure 12 Sampling sites for determining the depth of the deep edge of seagrass.

The depth to which seagrass grows was documented at ten locations for each stratum (**Figure 12**). The depth to which seagrass beds grow were quantified as in Tomasko and Keenan (2010). The deep edge of the seagrass meadows was operationally defined as that point at which less than 10 percent of the bottom is occupied by seagrass. Prior work in Sarasota Bay (Tomasko and Keenan 2010) has shown that this coverage level is a more precise (and deeper) estimate of seagrass depth penetration than the offshore edge of seagrass meadows as determined via aerial photography and subsequent photointerpretation. In an area with reduced water clarity inhibiting aerial photography interpretation, such as this portion of Old Tampa Bay, this approach is warranted. Water depth at the deep edge was determined at 10 locations for each of the strata being assessed. Depth measurements were made using a customized staff gauge designed to reduce errors associated with the anticipated soft substrate. Weather conditions were recorded to quantify any introduced errors associated with fetch and chop, which were minimized by collecting data during calm conditions (e.g., wind less than 10 knots, wave height less than 10 cm). The GPS coordinates were recorded for each station using a WAAS (Wide Area Augmentation System) enabled Garmin GPSmap 60CSx or similar. The water depth data were corrected for tide and referenced to Mean Sea Level (MSL). The 6-minute verified water level data from the Old Port Tampa, FL (8726607) tide station was used to model the tide for Old Tampa Bay locations, as in Tomasko and Keenan (2010).

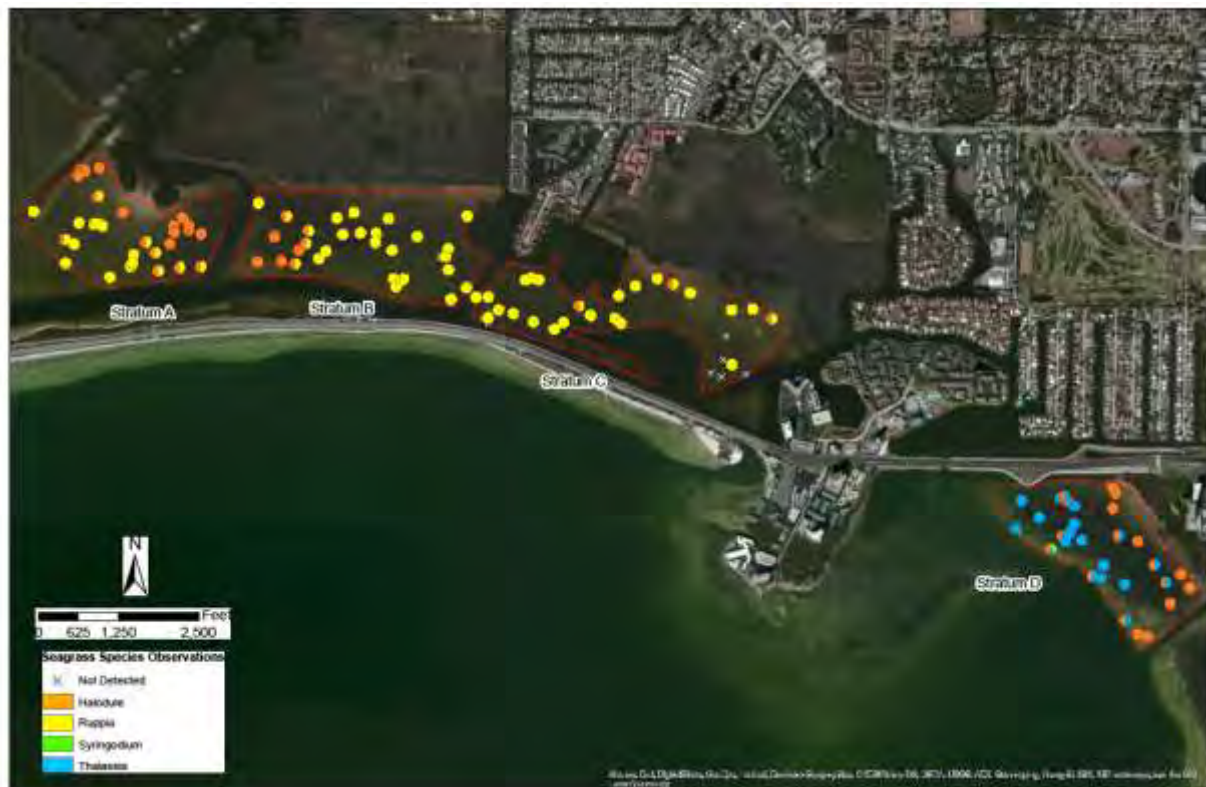
Figure 13 Seagrass species observed within each stratum.

Four species of seagrass were identified within the overall study area: *Halodule wrightii*, *Ruppia maritima*, *Syringodium filiforme*, and *Thalassia testudinum* (Figure 13). The dominant seagrass species identified in Strata A, B and C was *R. maritima*, with reduced coverage of *H. wrightii* in Strata A and B. While *H. wrightii* was identified in Stratum C, it was very sparse there. In contrast, *T. testudinum* was the dominant seagrass species identified in Stratum D following by *H. wrightii*. *Syringodium filiforme* was identified at one location in Stratum D, but *R. maritima* was not present. A copy of the datasheets completed during the field effort is available in Appendix A. Appendix B provides representative photographs of the seagrass abundance found within each stratum.

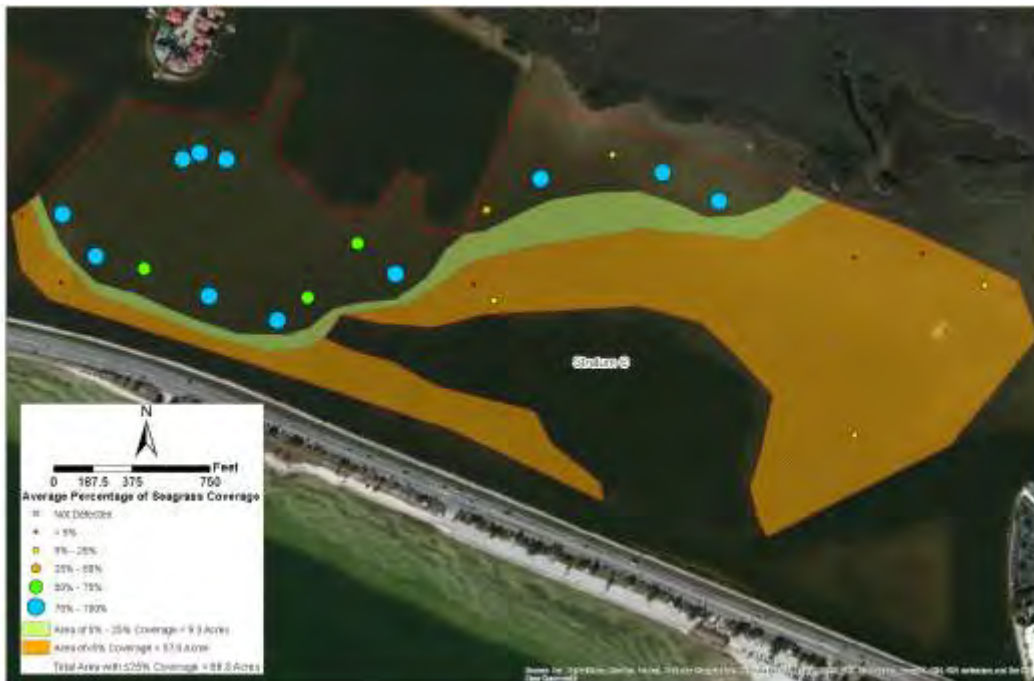
Figure 16 Average percentage of seagrass coverage in Stratum C and estimated portion of the stratum with less than 25 percent seagrass abundance.

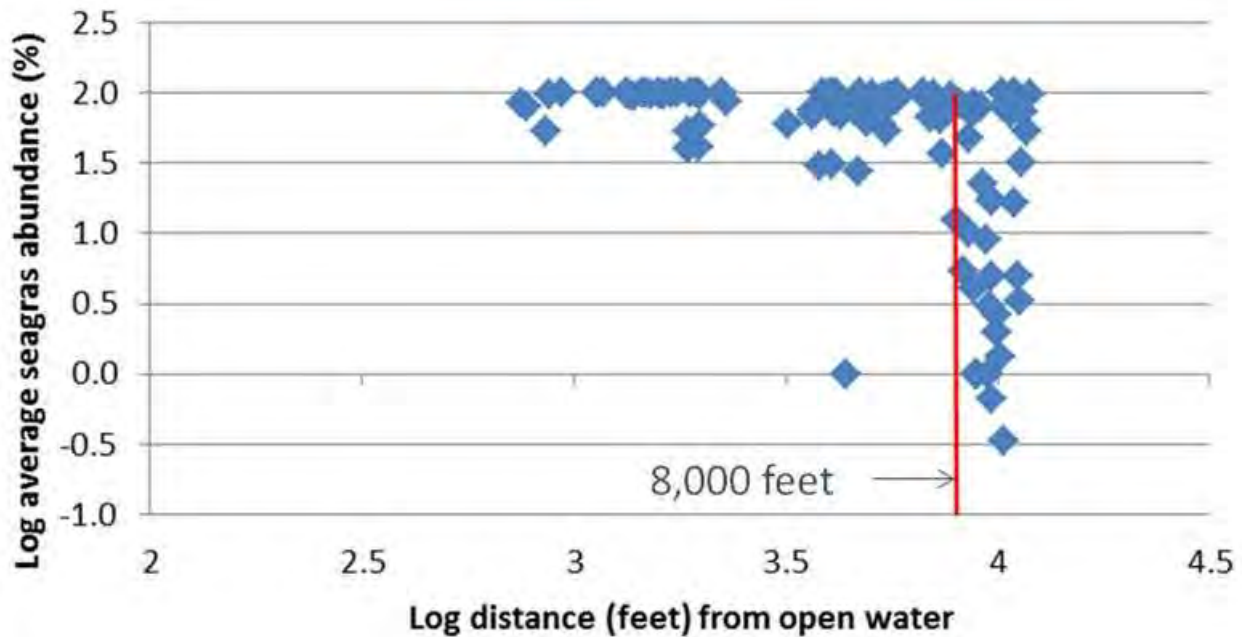
Figure 17 Seagrass abundance compared to the calculated distance from open water.

The results shown in Figures 17 and 18 strongly suggest that artificially reduced tidal influences and/or increased residence times are important stressors to seagrass health in this region of Old Tampa Bay, as areas farthest removed from tidal influences (i.e., those farthest from open water) are the areas with the lowest probability of occurrence and abundance.

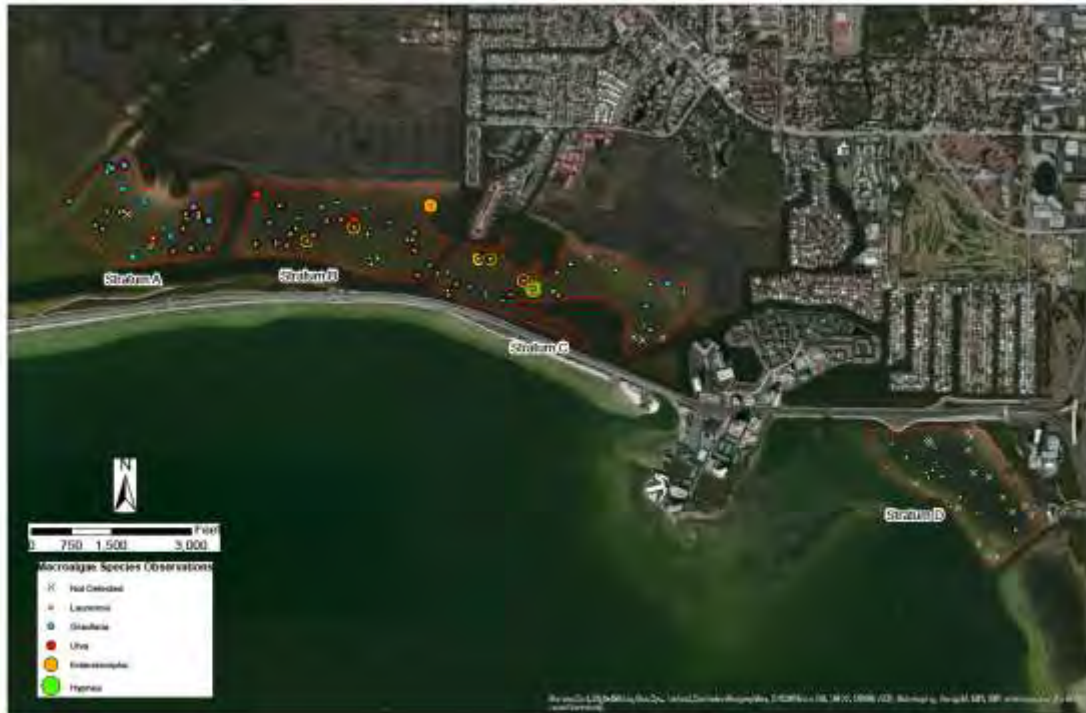
Figure 19 Macroalgal genera observed within each stratum.

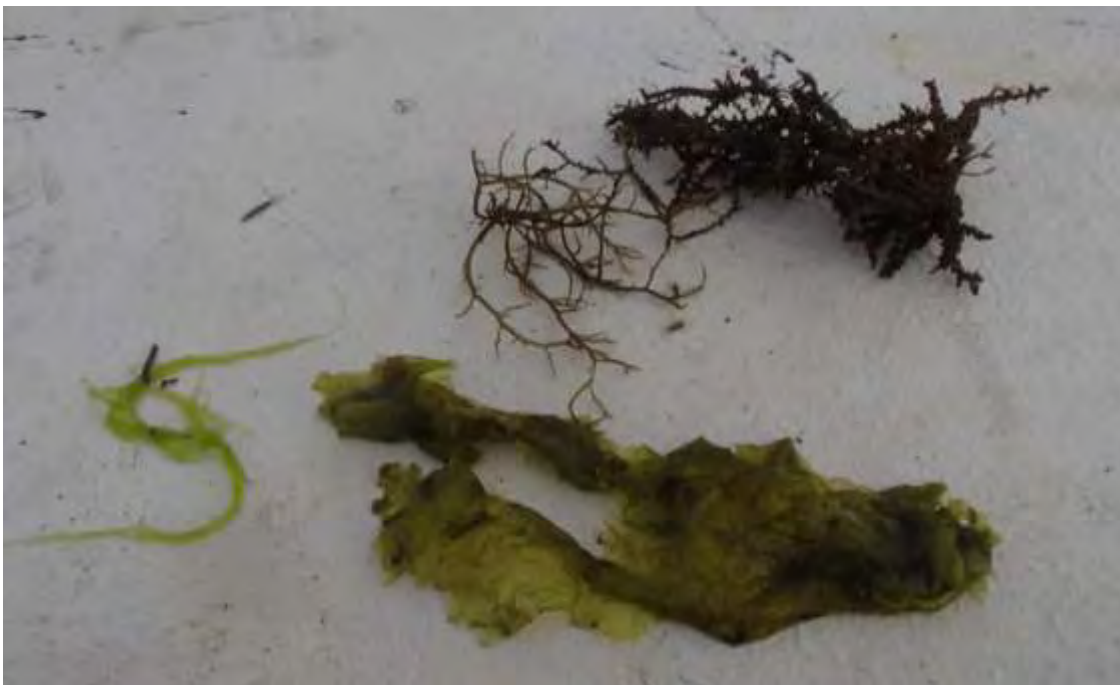
Figure 20 Photograph of four of the five genera of macroalgae identified within the study area (*Laurencia*, *Ulva*, *Enteromorpha* and *Gracilaria*, respectively, clockwise from top right corner).

Five genera of macroalgae were identified within the overall study area: *Enteromorpha*, *Gracilaria*, *Hypnea*, *Laurencia* and *Uva* (**Figures 19 and 20**). The dominant macroalgal genera identified in Strata A, B and C were *Gracilaria* and *Laurencia*. *Laurencia* was found almost exclusively in Stratum D, with only one site having *Gracilaria* as well. A copy of the datasheets completed during the field effort is available in Appendix A.

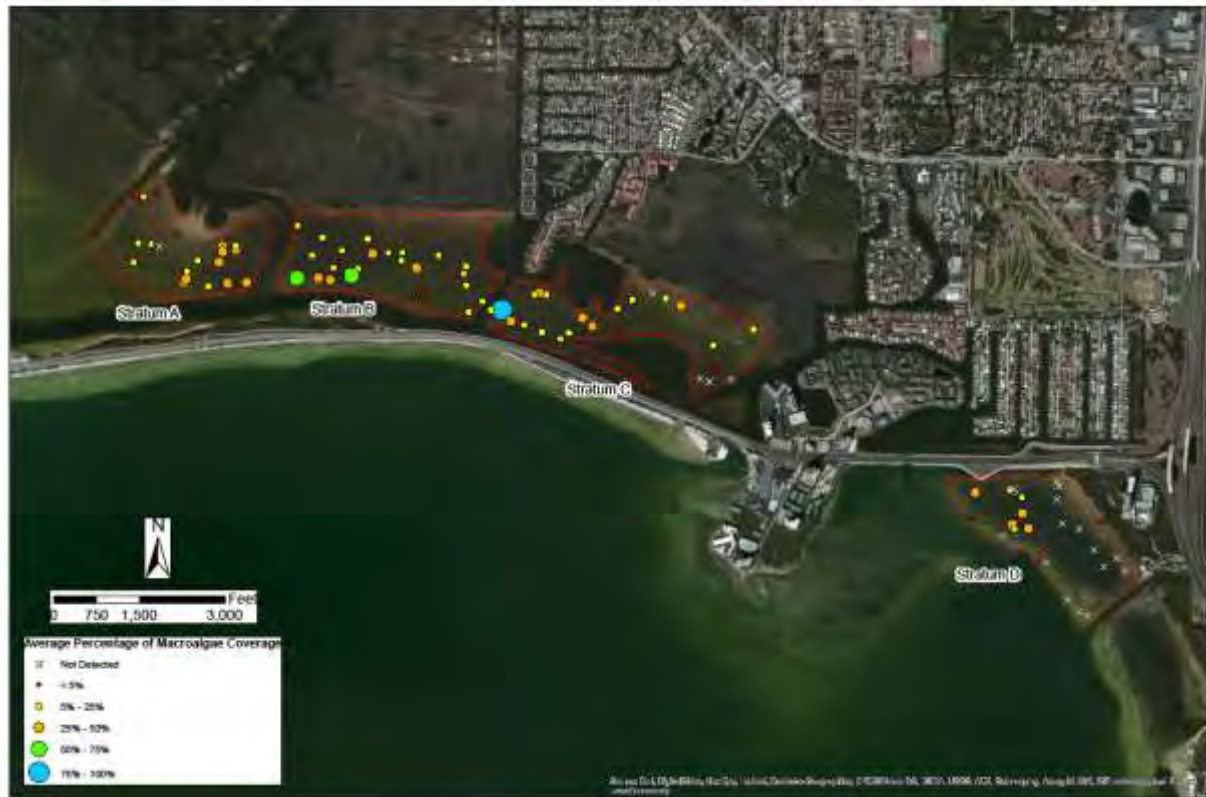
Figure 21 Average percentage of macroalgal coverage at each sampling site.

The average percentage of macroalgae coverage throughout the study area was less than 50 percent (**Figure 21**). There were a few sites where 50 to 100 percent of the area was covered by macroalgae. However, there were more sites in which no macroalgae were reported at all, particularly in Stratum D.

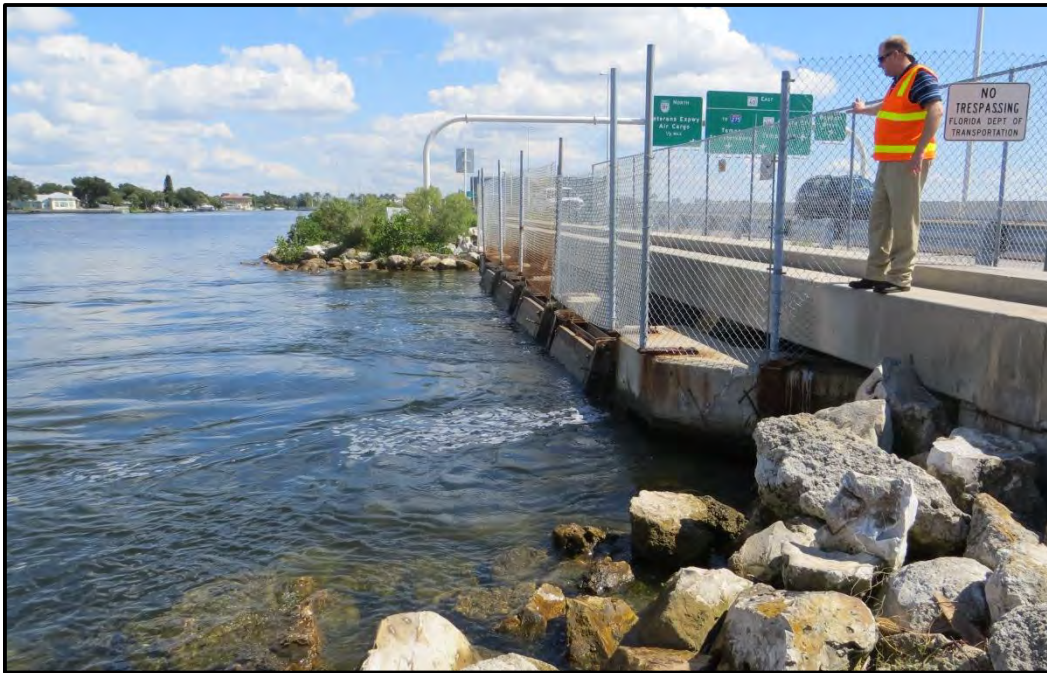
Figure 1-2 Tide flap gates at incoming (high) tide.

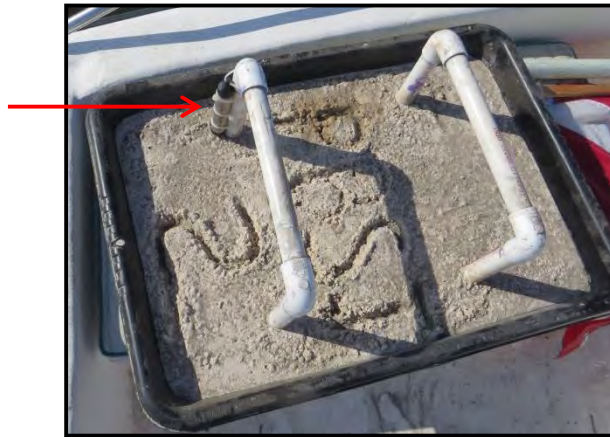
Figure 2-2 Solinst Levellogger (indicated by red arrow) attached to concrete base.

current data every 10 minutes. The Levelloggers and Aquadopps were successfully retrieved, and data were downloaded and corrected using the RTK GPS elevations provided by Cumbey and Fair surveyors (Appendix A). Data were recovered for the entire 17-day period. The tidal lag between the north and south side of the causeway was recorded to be one hour at most.

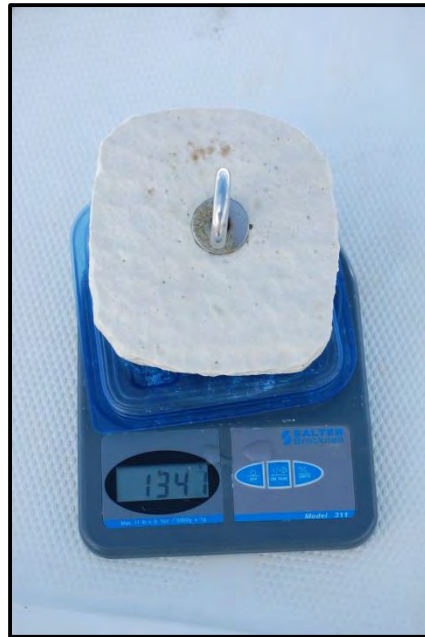
Figure 2-4 Block of plaster of Paris on scale showing hardware used for deployment.

In their work, Jokiel and Morrissey (1993) compared dissolution rates of blocks of plaster of Paris at various locations along a portion of the Great Barrier Reef (Australia) and found that coverage of different coral types correlated with weight loss of deployed materials. Using a variation of the same technique, ESA scientists deployed blocks of plaster of Paris at five locations in Strata A, B, and C, to determine if patterns of seagrass abundance would correlate with a physical measurement indicative of water movement. Blocks of plaster of Paris were constructed as per directions on boxes of this material, and these blocks were then modified to include a rod, washer and hook assembly so that they could be deployed in the water column (Figure 2-4).

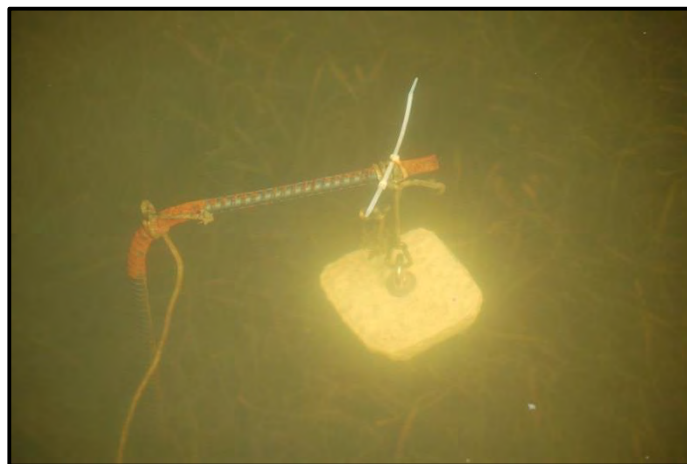
Figure 2-5 Block of plaster of Paris deployed in the water column.

These blocks were then deployed at five randomly-selected locations in Strata A, B, and C at a depth approximating the top of the canopy of any nearby seagrass beds (Figure 2-5).

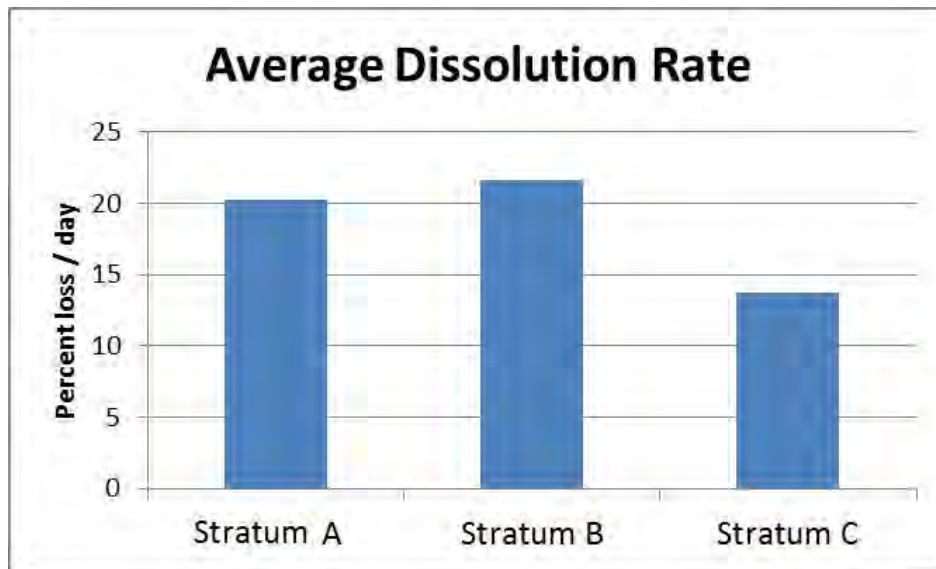
Figure 2-6 Average dissolution rates for block of plaster of Paris deployed in the water column.

Results shown in Figure 2-6 illustrate that the rate of dissolution of suspended blocks of plaster of Paris were greatest in Stratum A and B, with lower rates in Stratum C. These results indicate that net water movement is greatest in those areas north of the CCC that are farthest west, and that net water movement decreases in areas farther to the east.

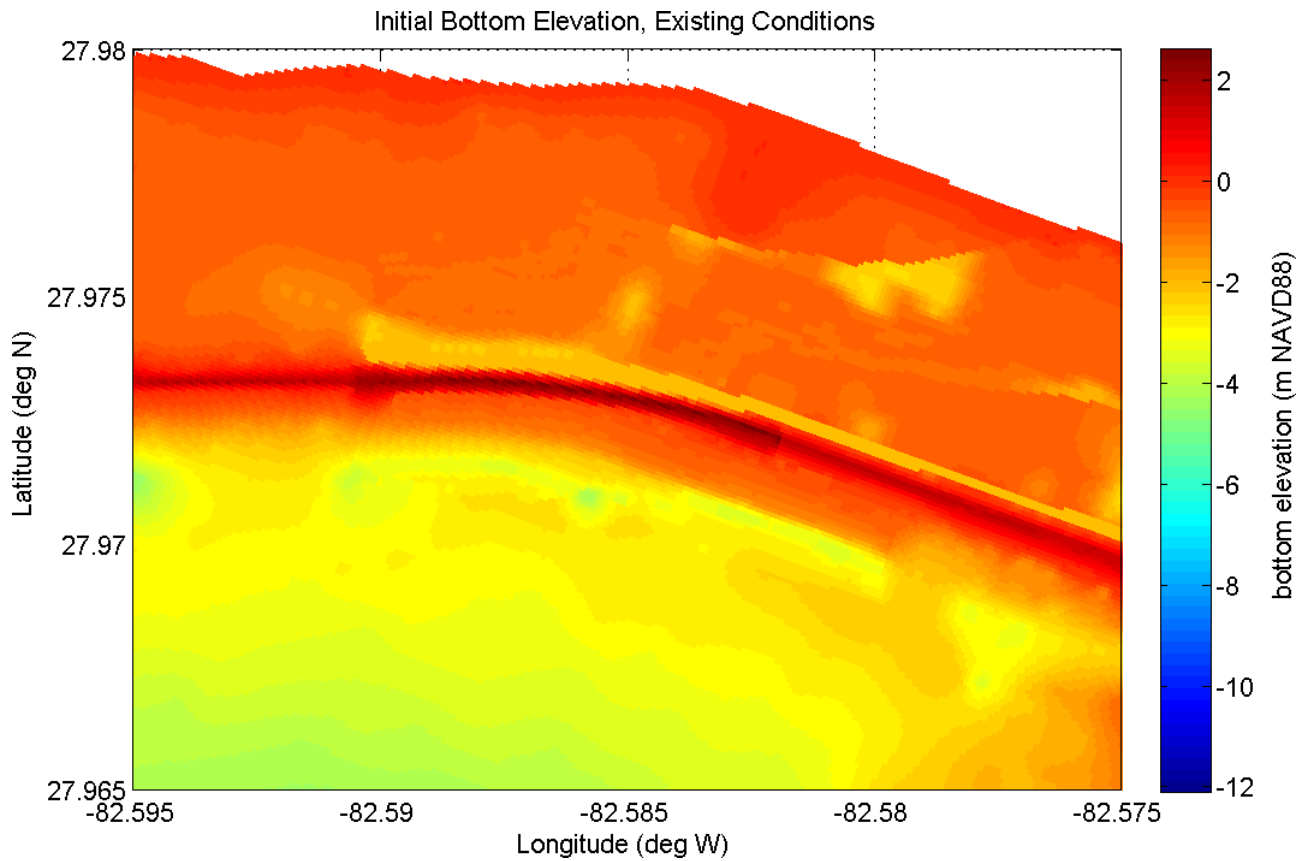
Figure 3-13 Model bathymetry around eastern CCC; existing conditions.

Name	Proposed opening	Flap gate condition
Existing conditions	None (no change)	1-way (no change)
Existing conditions w/ flap gate removal	None (no change)	2-way
Alternative 1, 200 ft opening	200 ft width, 10 ft depth	1-way (no change)
Alternative 1, 200 ft opening w/ flap gate removal	200 ft width, 10 ft depth	2-way

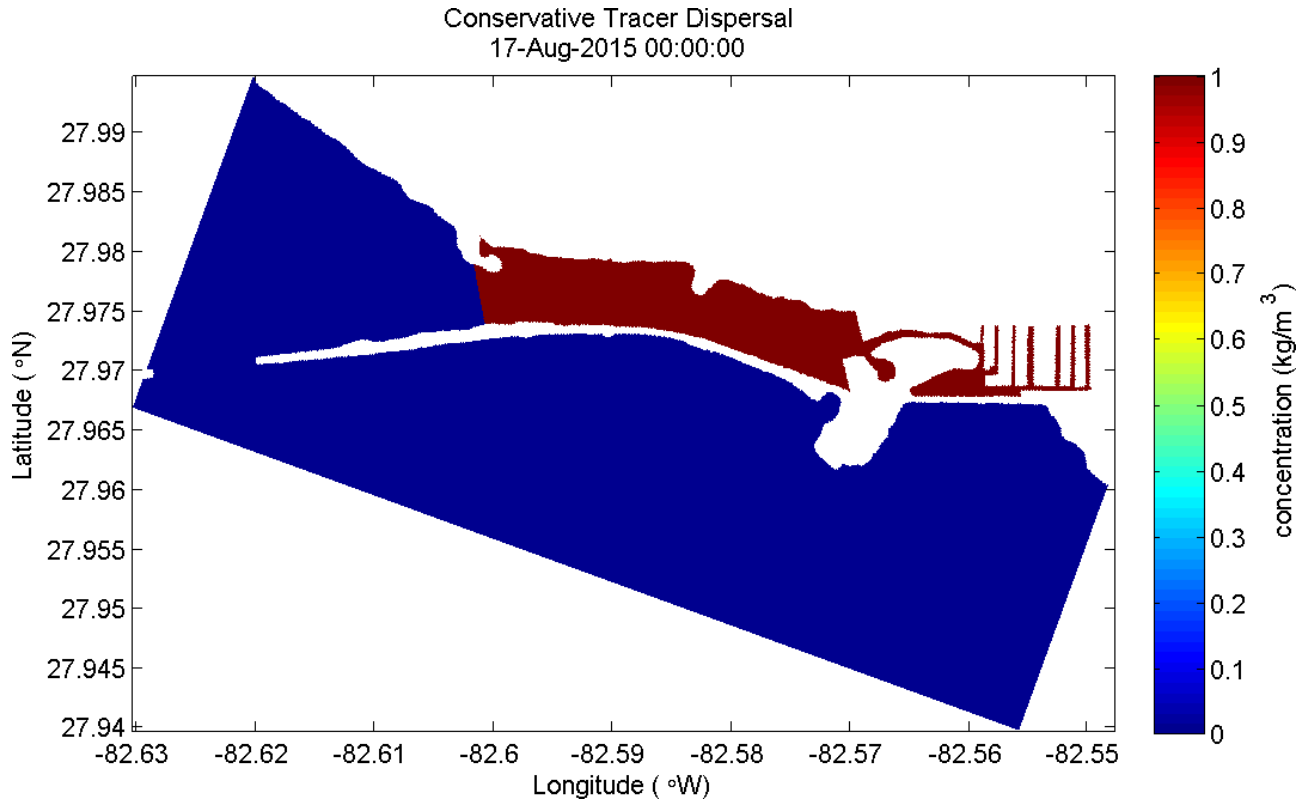
Figure 4-13 Initial tracer concentration; all scenarios.

concentration time series at these locations. Table 4-1 presents the dispersal time to reach 50% of initial or peak concentration for select locations. Within the area of concern, adding the 200 ft opening reduces residence time (defined as time to reach 50% of initial concentration) from about 3 days to about 1 day, location dependent.

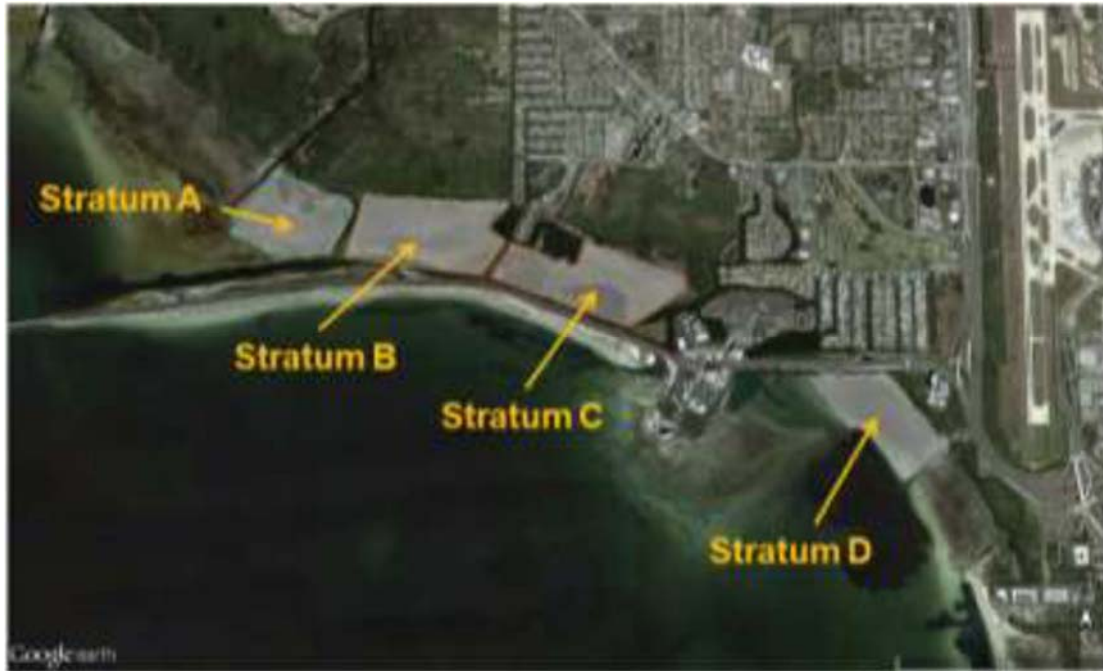
Figure 1. Project study design (FDOT 2016)

The Old Tampa Bay Water Quality Improvements, Project Overview (Florida Department of Transportation, District 7 2016 = FDOT 2016) explains the current distribution of seagrasses north and south of the Courtney Campbell Causeway (CCC) and how the proposed 220 foot opening will bring positive change in water quality to the area. The current pattern of seagrasses is such that shoal grass (*Halodule wrightii*) and widgeon grass (*Ruppia maritima*) are the dominant species north of the CCC, while mixtures of turtle grass (*Thalassia testudinum*), shoal grass, and manatee grass (*Syringodium filiforme*) dominate the seagrass areas south. This was the pattern found in the study design (Figure 1)

with strata A, B, and C north of the CCC and stratum D south. Furthermore, the strata north of the CCC also varied in the distribution and abundance of shoal grass and widgeon grass. Stratum A had a mix of shoal grass and widgeon grass with the abundance consistently greater than 75 percent. The seagrass abundance in strata B and C was found to be inconsistent with the eastern portion of each stratum devoid of seagrass and with the western portion having some areas with 50 percent seagrass coverage, predominately widgeon grass. Approximately 58 and 66 acres in strata B and C, respectively, were found to be comprised of 25 percent or less seagrass abundance, again, predominately widgeon grass (an ephemeral species). The increasing pattern of increasing dominance of widgeon grass in the eastern stratum north of the CCC is consistent with literature description that suggest that salinities are lower and more variable in the areas furthest away from the tidal influences of the open waters of Old Tampa Bay (OTB). The analysis of long term water quality data showed that the salinity north of the CCC was both lower and more variable than the salinity at station immediately south of the CCC.

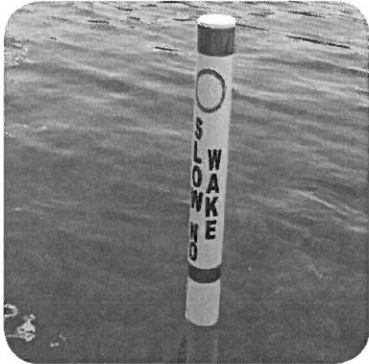
SL-B576 Model 5" Spar Buoy

SPECIFICATIONS* *	SL-B1060	SL-B576
General Characteristics		
Available Colours	Red, Green, White, Yellow as per IALA Recommendations	Black, Red, Green, White, Yellow as per IALA Recommendations
Focal Plane Height (mm/inches)	863 / 34	914 / 36
Nominal Freeboard (mm/inches)	863 / 34	914 / 36
Nominal Draft (mm/inches)	686 / 27	1016 / 40
Reserve Buoyancy (kgs/lbs)	33 / 15	9 / 4
Maximum Mooring Load (kgs/lbs)	12 / 5	5 / 2
Submergence (kg/cm, lb/inches)	0.507 / 2.8	0.127 / 0.7
Visual Area (m ² /ft ²)	0.2 / 2.2	0.11 / 1.2
Physical Characteristics		
Material	Rotationally-moulded UV-stabilised virgin polyethylene, 316-grade mooring eye	Rotationally-moulded UV-stabilised virgin polyethylene
Wall Thickness (mm/inches)	9 / 3/8	7 / 1/4
Ballast (kg/lbs)	22.6 / 50 internal counter-weight	6.8 / 15 internal counter-weight
Filling	Closed-cell polyurethane foam	Closed-cell polyurethane foam
Height (mm/inches)	1549 / 61	1930 / 76

Diameter (mm/inches)	254 / 10	127 / 5
Mass (kg/lbs)	29 / 65	10.4 / 23
Product Life Expectancy	Up to 12 years	Up to 12 years
Certifications		
IALA	Surface colours compliant to IALA E-108	Surface colours compliant to IALA E-108
Intellectual Property		
Trademarks	SEALITE® is a registered trademark of Sealite Pty Ltd	SEALITE® is a registered trademark of Sealite Pty Ltd
Warranty *	1 year	1 year
Lantern Options	Sealite SL-15 or SL-60 lantern	
Options Available	<ul style="list-style-type: none"> • Custom signage • Vinyl 'buoy wrap' • Reflective band 	<ul style="list-style-type: none"> • Custom signage • Reflective band
