PERMIT PLANS

CONTRACT PLANS

FINANCIAL PROJECT ID 439206-1-52-01

STATE ROAD NO. 60
(COURTNEY CAMPBELL CAUSEWAY)
OLD TAMPA BAY WATER QUALITY IMPROVEMENTS

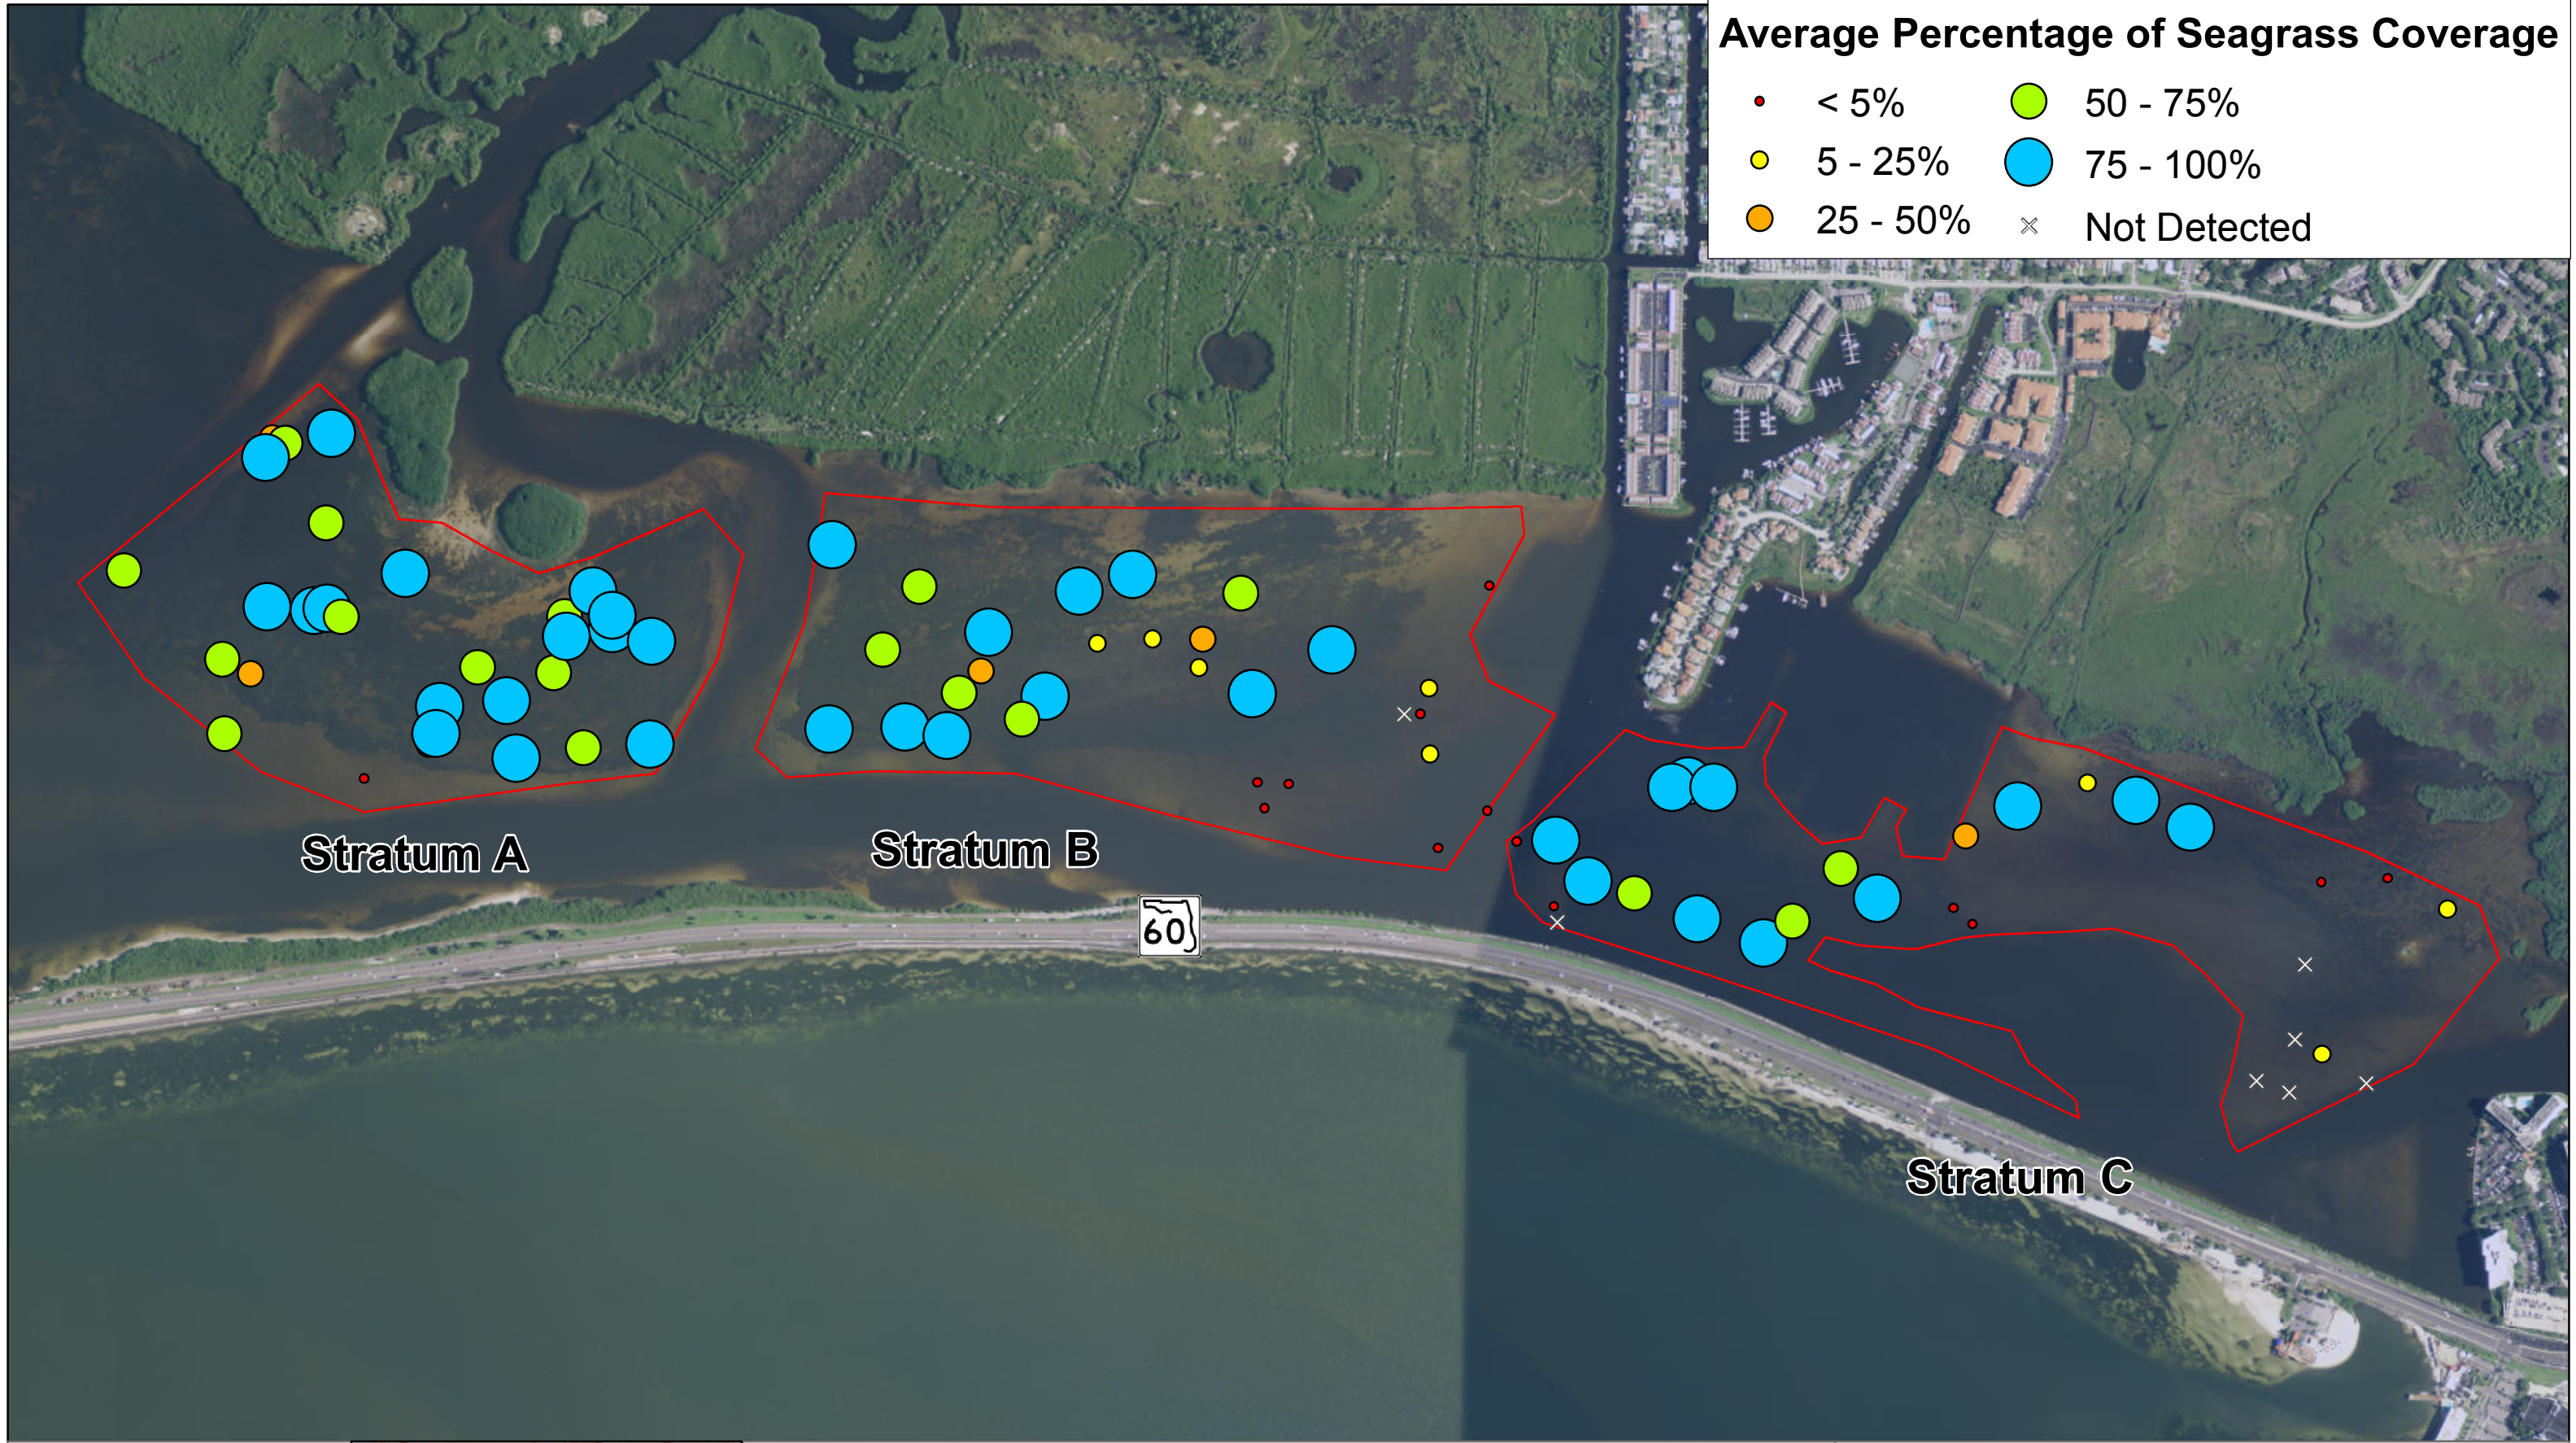
Average Percentage of Seagrass Coverage

- < 5%
- 5 - 25%
- 25 - 50%
- 50 - 75%
- 75 - 100%
- × Not Detected

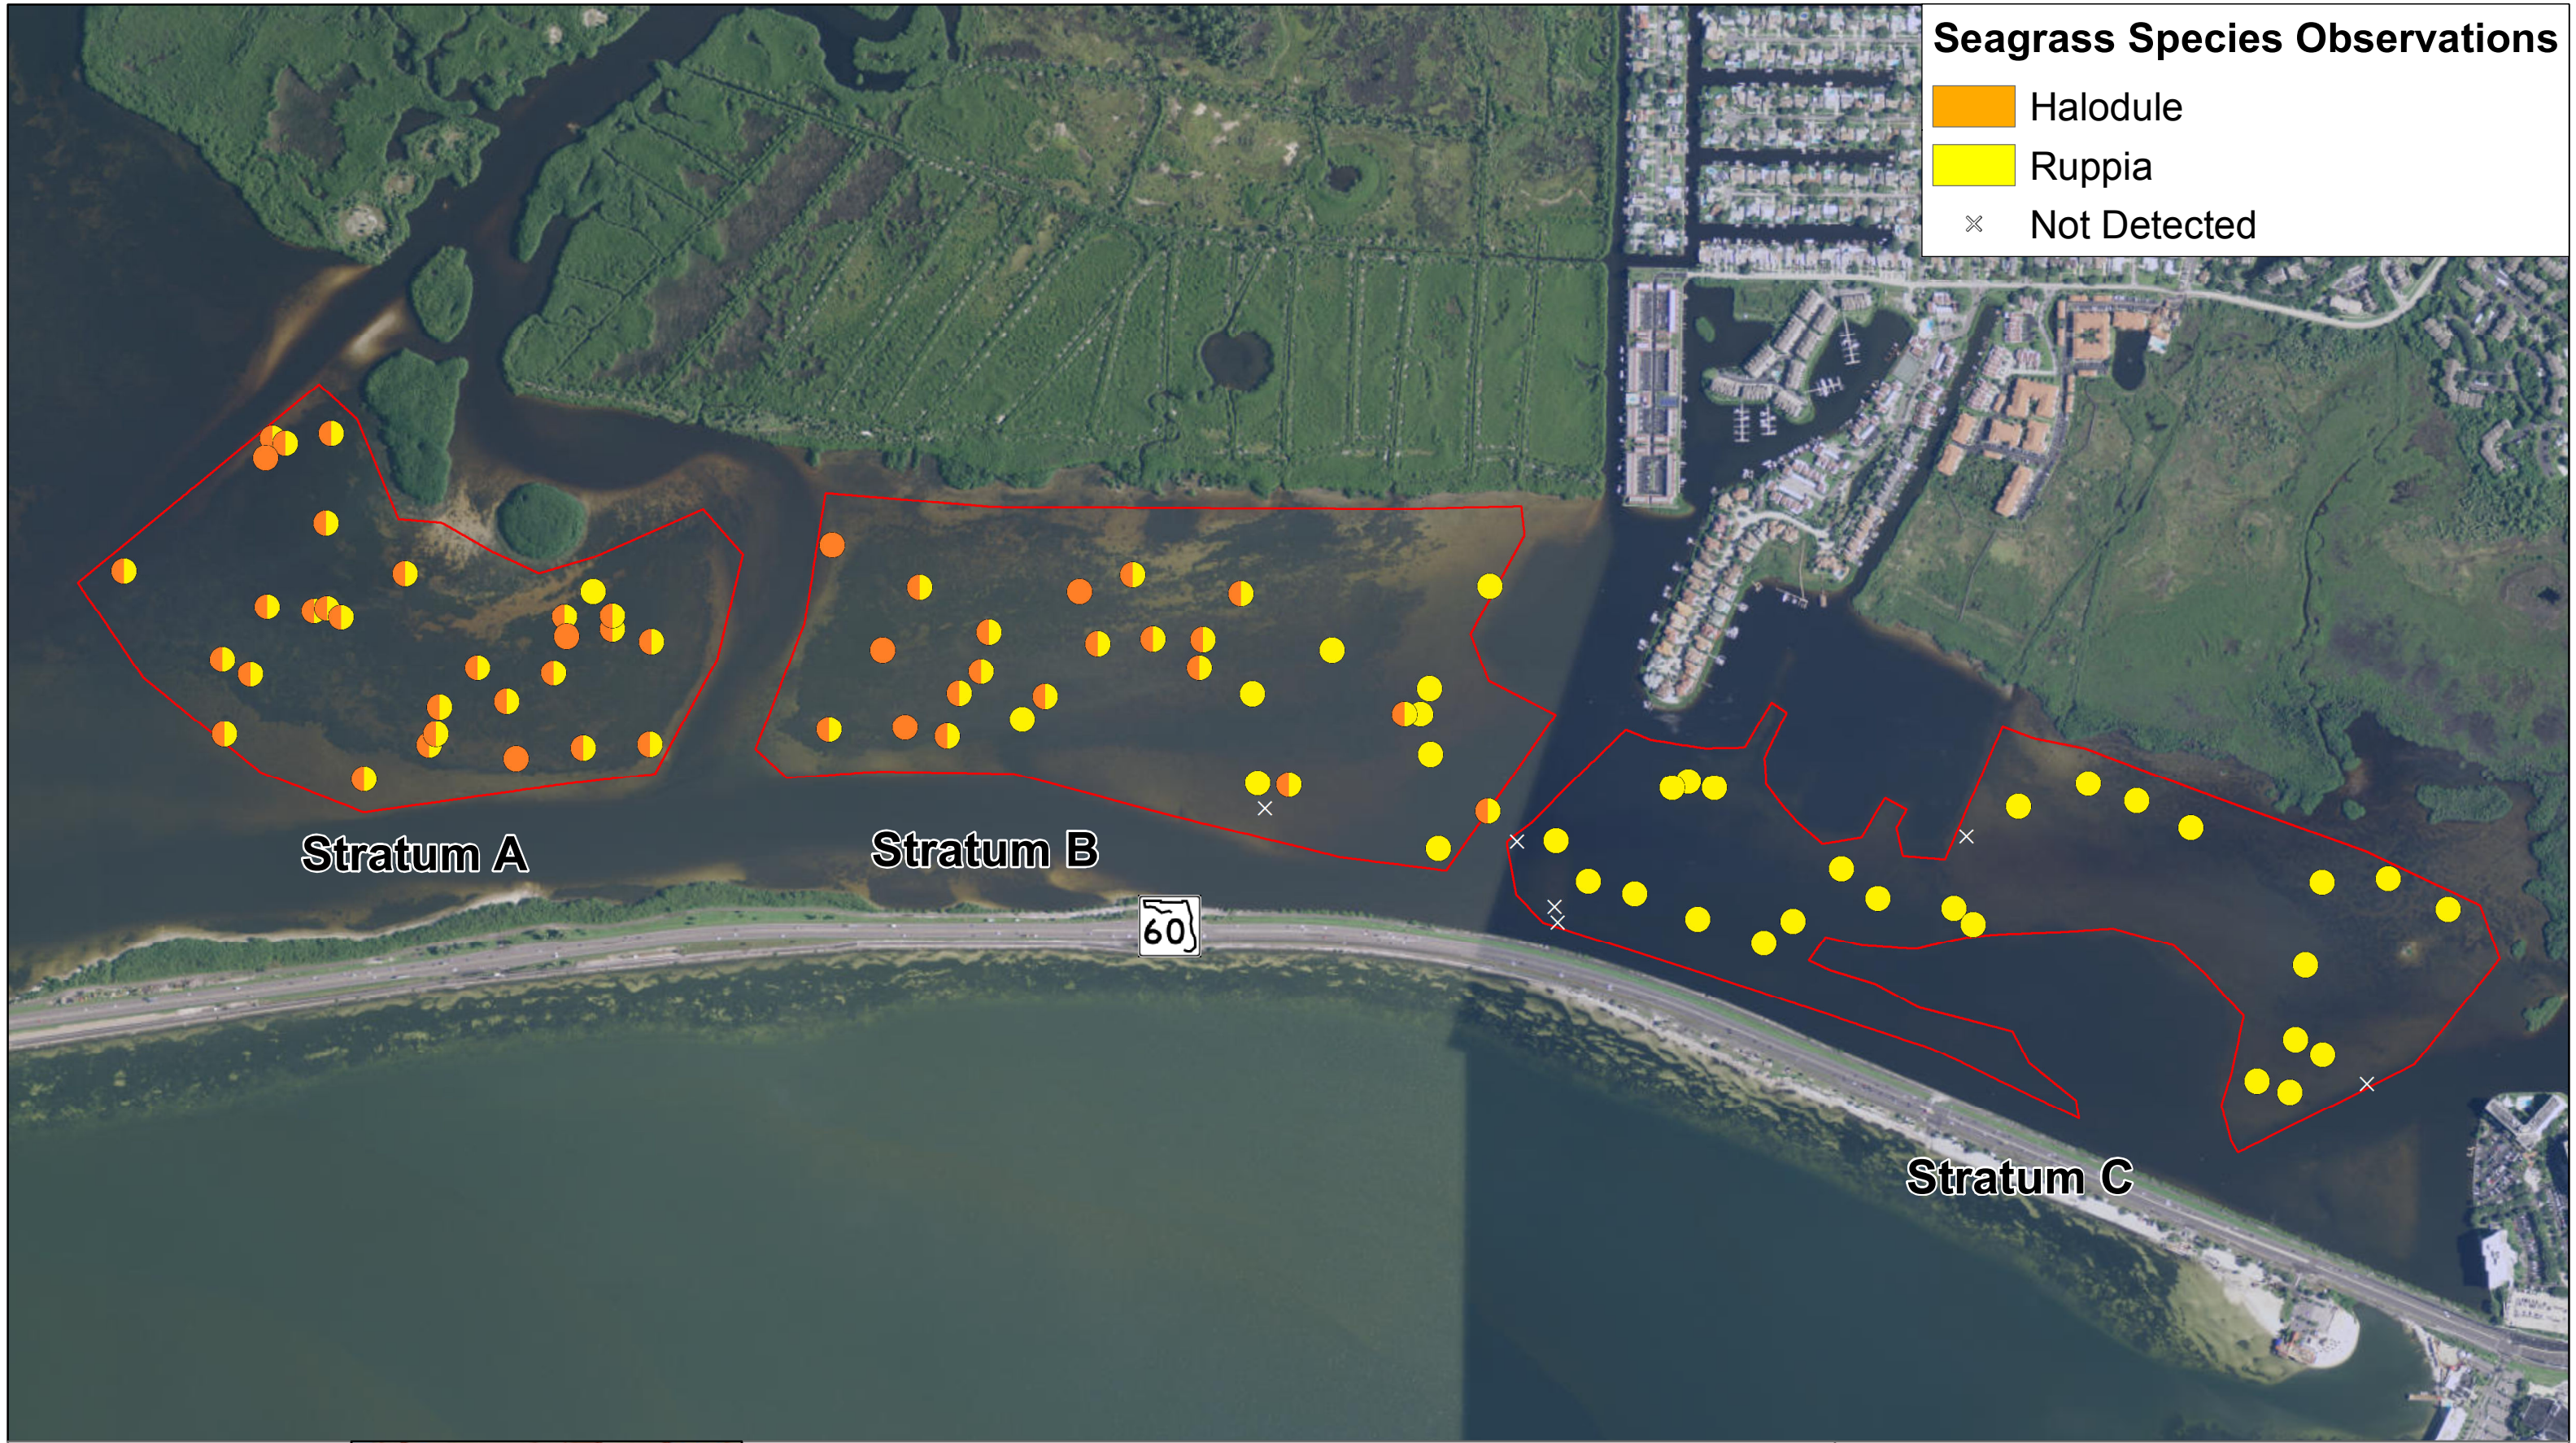
Seagrass Species Observations

- Halodule
- Ruppia
- Not Detected
