Non-Time-Critical Removal Action  
at the Municipality of Culebra, Puerto Rico

# *Environmental and Cultural Resources Surveys for Isla Culebrita*

**End of Fieldwork Report:  
Archaeological Walkover Survey Associated with Unexploded  
Ordnance Removal on Isla Culebrita and Cayo Lobo,  
Municipality of Culebra, Puerto Rico**

FLORA AND FAUNA SURVEY  
FOR  
CULEBRITA ISLAND  
DERP-FUDS CLEAN UP  
CULEBRA, Puerto Rico  
OCTOBER-2006

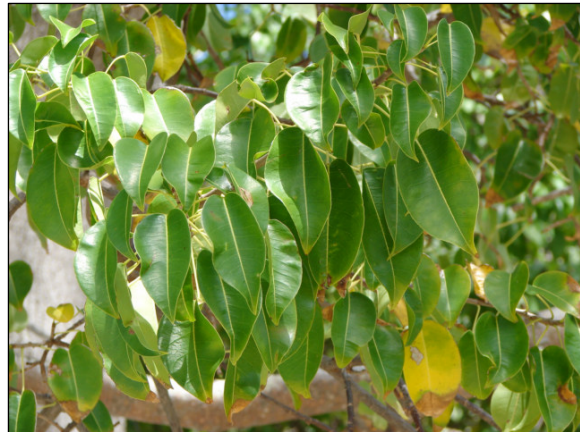
5. Clearing crews will be informed about the poisonous manchineel trees (photo at right). These trees exist in the coastal thickets. The manchineel tree is toxic and can burn the skin. The fruit of the manchineel tree resembles a small green apple and is poisonous. Contact with its leaves and fruit should be avoided and workers should not stand or sit under one when it is raining.

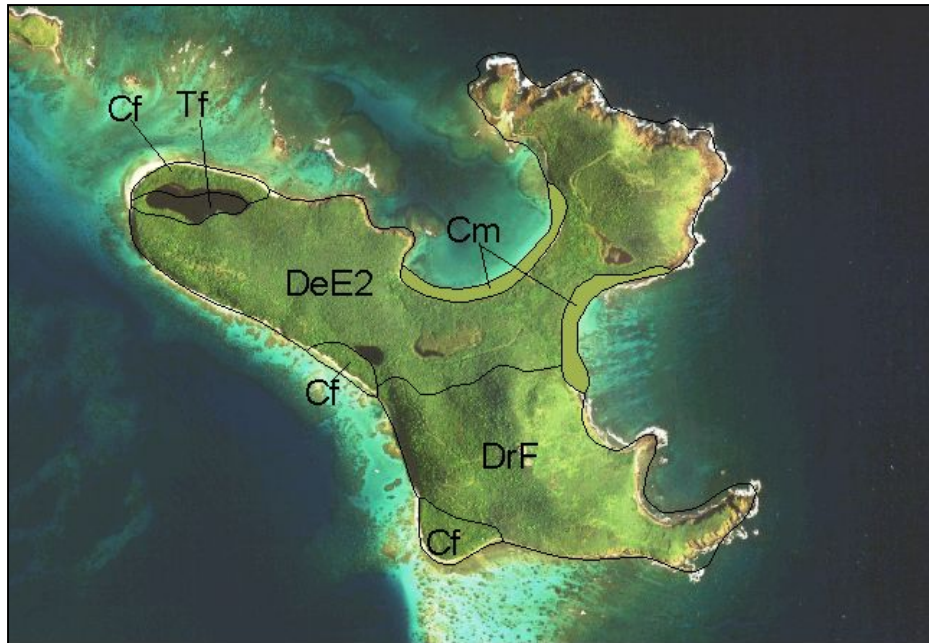
Figure 2. Soil map.

**Cf - Cataño Loamy sand** (Deep soils that are excessively drained and rapidly permeable. Parent material: Beach sand deposits).

**Td - Tidal flats** (Low areas that are affected by seawater during high tide).

**DeE2 - Descalabrado clay loam** (Well-drained moderately permeable soils found on mountain side slopes and ridge tops in the semiarid volcanic uplands).

According to the National Resource Conservation Service there are three soil types in the study area (see Appendix 1 for map):

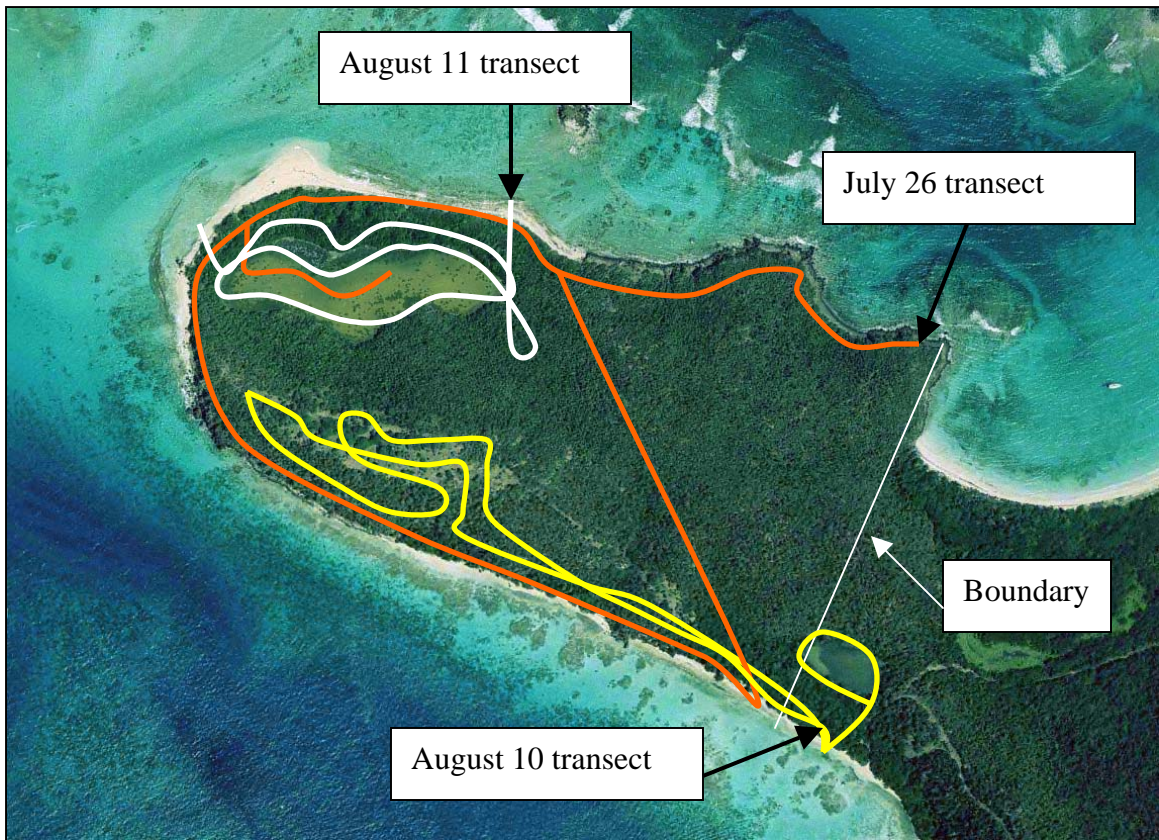
Figure 3. Colored transects depicting sampled areas.

Penetrating the thick spiny scrub forest was the biggest challenge in conducting the field work. To maximize our effort, we selected representative areas by analyzing a 2005 aerial photo to establish linear study transects (see Appendix 2 for transect location), since total coverage was not possible. Emphasis was given to closed canopy forests and wetland areas. Steep cliffs were out of the scope of work of this survey. Coordinates were recorded with a handheld GPS in DEG.DDDDD, NAD 27 datum.

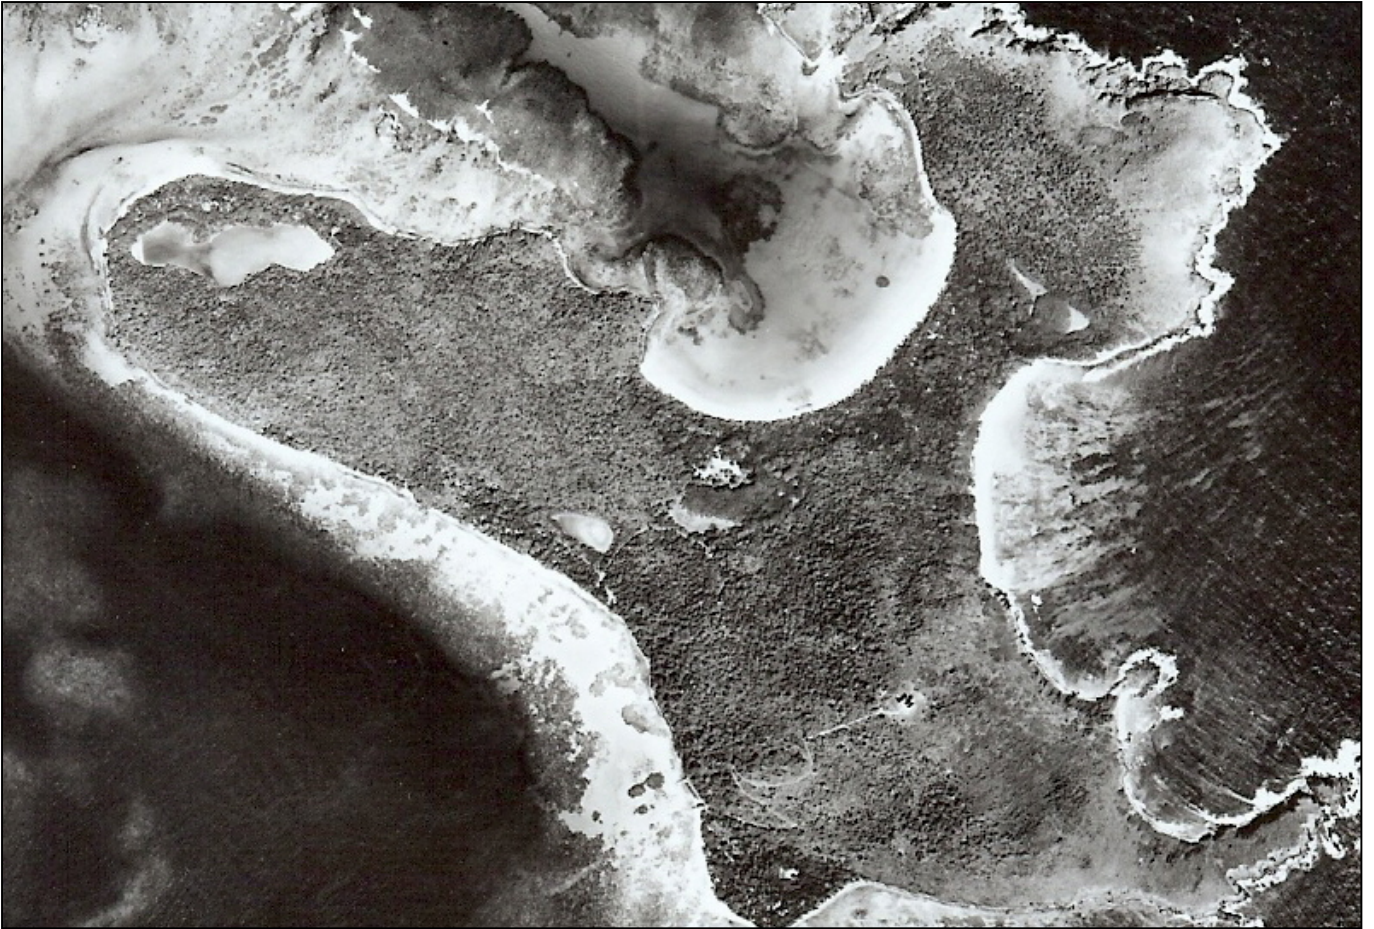
Figure 4. Vegetation cover in 1965.

To determine the degree of human disturbance in Culebrita before becoming a nature reserve, we obtained a 1965 aerial photo (earlier photos weren’t available in the PR Highway Authority). The main difference between vegetation cover in the sixties and today is the degree of fragmentation of the dry forests in the study area. Forty years ago scrub forest wasn’t as extensive as it is today. Earlier photography is needed to determine the degree of human impact in the island. It is very likely that the suitable trees found in the dry forest were exploited by the lighthouse caretakers and that fires must have been a common occurrence during military practices.

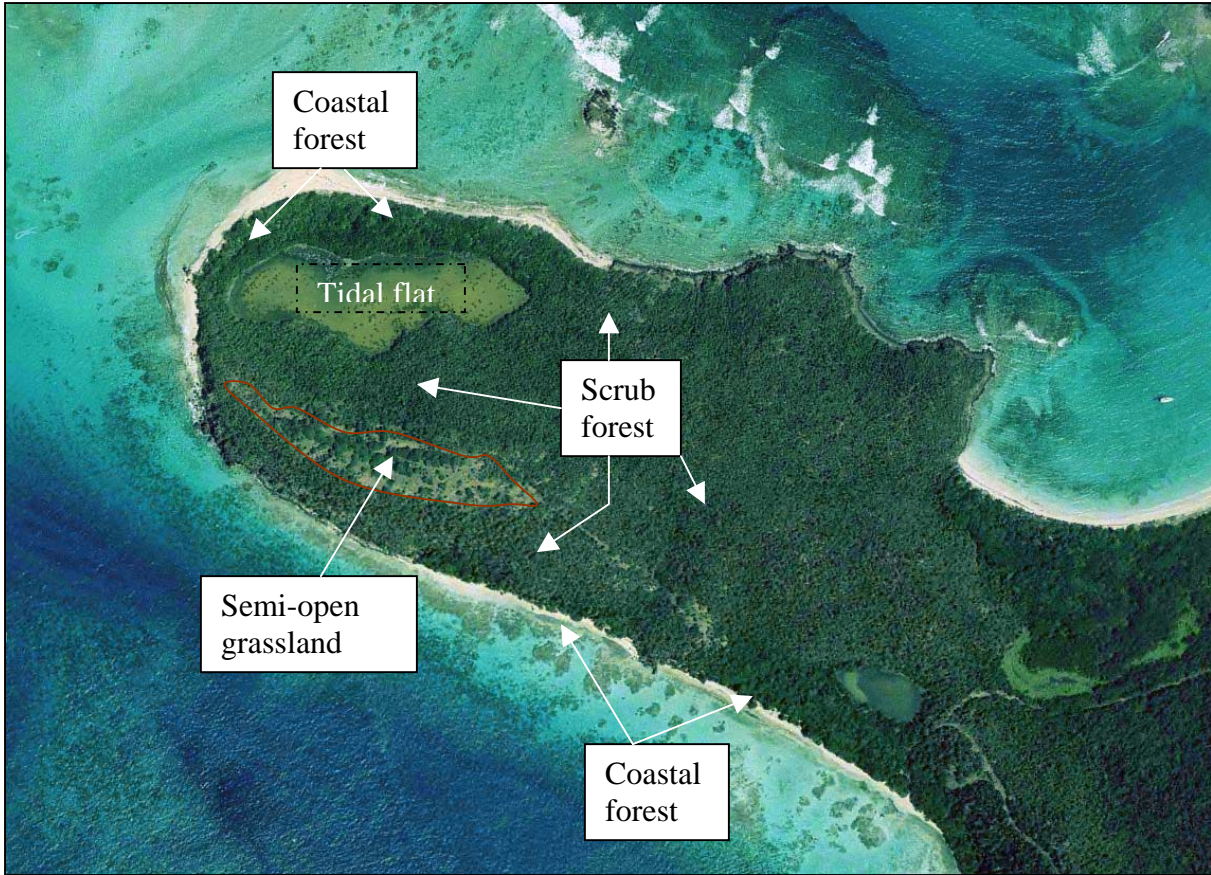
Figure 5. Approximate location of plant communities in study site.

1 - Coastal forest – Flat coastal areas with closed tree canopy from 3.5 to 5 meters in height. The dominant tree species occurring in this community are: Button mangrove (*Conocarpus erectus*), Sea grape (*Coccoloba uvifera*), Water mampoo (*Pisonia subcordata*), and the Spoon tree (*Elaeodendron xylocarpum*). The poisonous Manchineel tree (*Hippomane mancinella*) occurs in these coastal thickets.

2 – Dry scrub forest – This is the most abundant habitat-type found in the study site. It occurs along the cliffs and hills of the island. The soil is rocky and very shallow. Canopy height averages 2.6 m. The dominant shrubs and trees growing in this community are: Cat’s claw (*Pithecellobium unguis-cati*), Pipe-organ cactus (*Pilosocereus royenii*), Crabwood (*Gymnanthes lucida*), and Black willow (*Capparis cynophallophora*). The thorny bushy-vine *Oplonia spinosa* is also abundant.

3 – Semi-open grasslands – Grassy patches dominated by Hurricane grass (*Bothriochloa pertusa*), and Guinea grass (*Urochloa maxima*). Scattered Cashia (*Acacia farnesiana*) trees and (*Capparis flexuosa*) bushes are common.

4 – Tidal flats – Seasonally flooded shallow lagoons. May be partially or completely surrounded by mangrove forests dominated by White (*Laguncularia racemosa*) and Black (*Avicennia germinans*) mangroves.

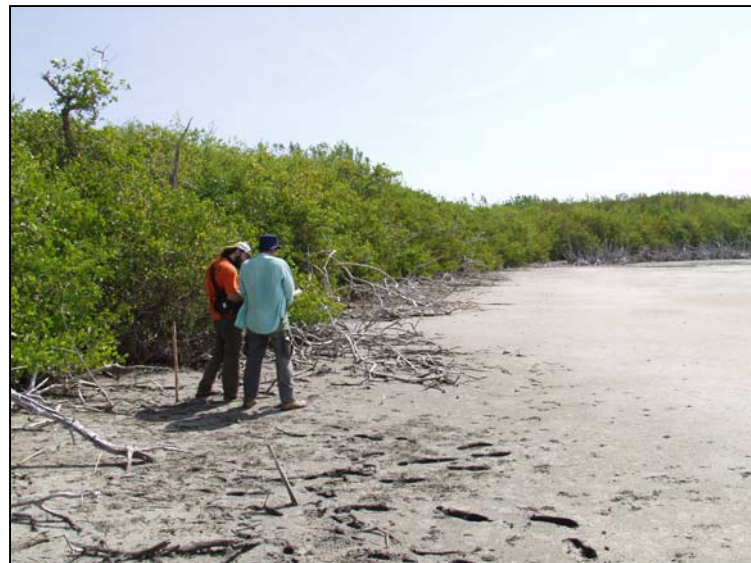
Figure 6. Tidal flat in northwestern tip of Culebrita.

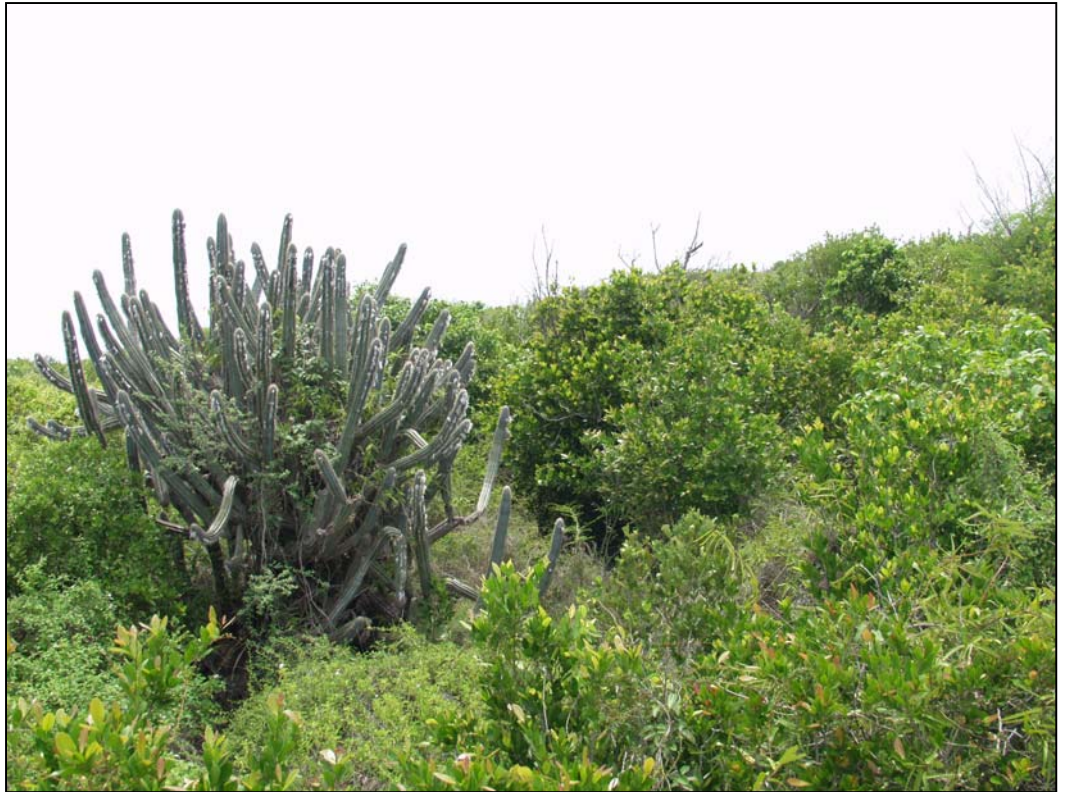
Figure 7. Pipe-organ cactus and surrounding scrub forest vegetation.

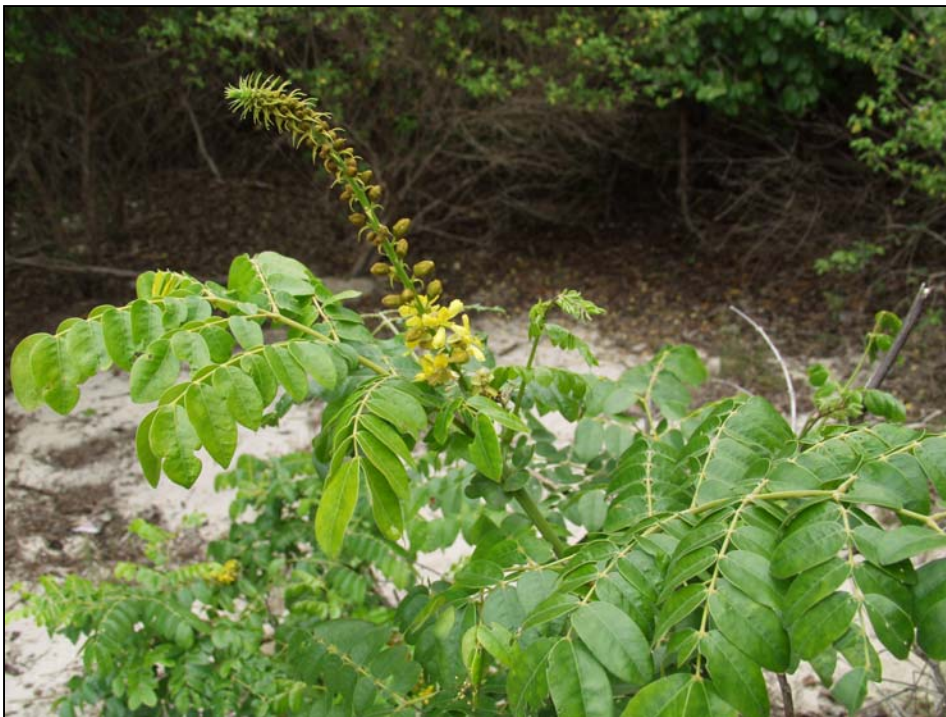
Figure 8. Flowering Gray nickers (*Caesalpinia bonduc*).

*Flora* – We recorded 97 plant species of plants (see Table 1). No state or federally threatened and endangered species of plants were recorded. Grey nickers (*Caesalpinia bonduc*) is listed as an “elemento crítico” by the Puerto Rico Department of Natural and Environmental Resources (PR-DNER) and is found throughout the coastal thickets in the study area. This plant is not uncommon throughout Puerto Rico and

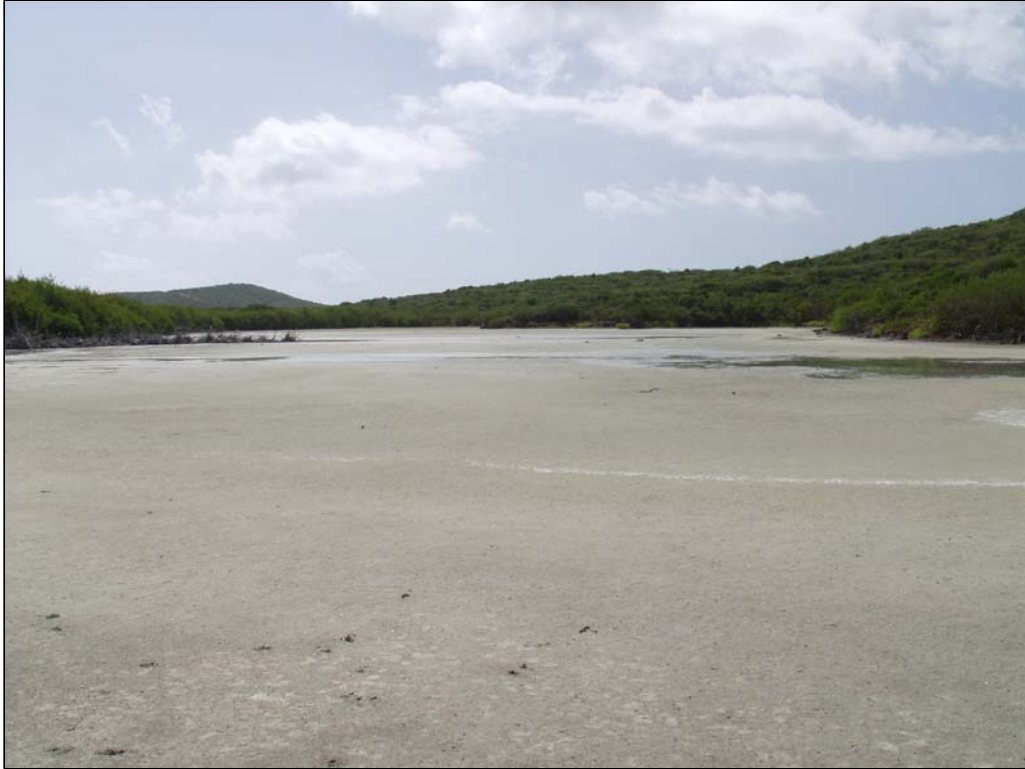
Figure 4. Laguna de Molino (western tidal flat) on July 26, 2006.

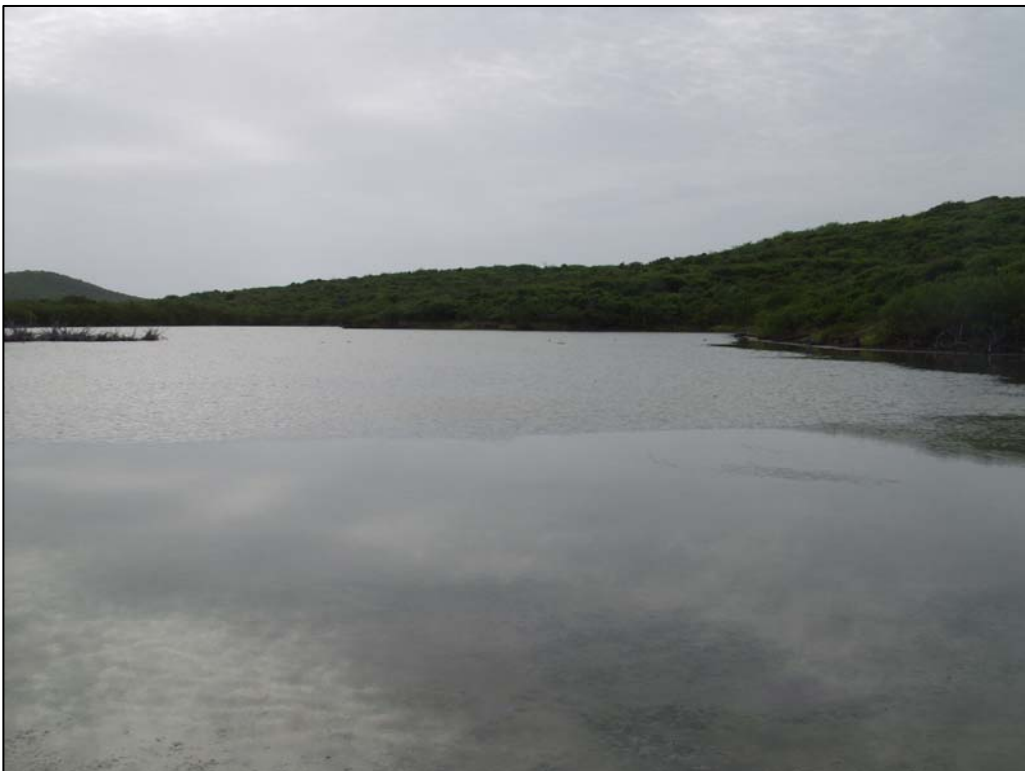
Figure 5. Laguna de Molino on August 11, 2006.

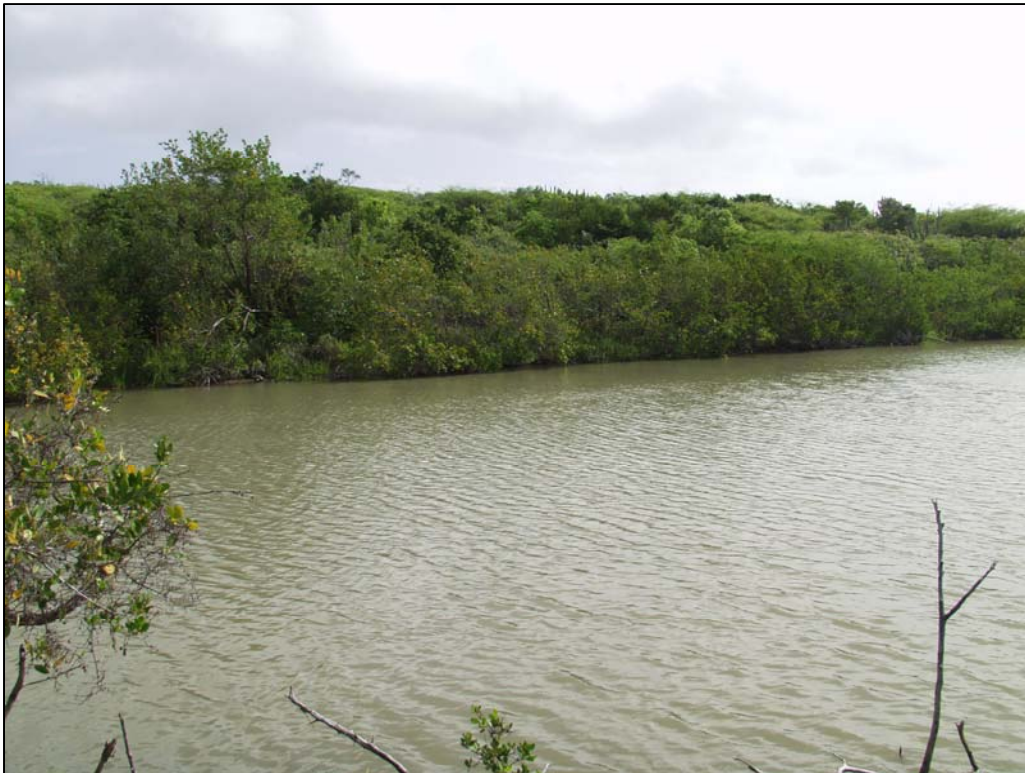
Figure 7. Eastern tidal flat on August 10, 2006.

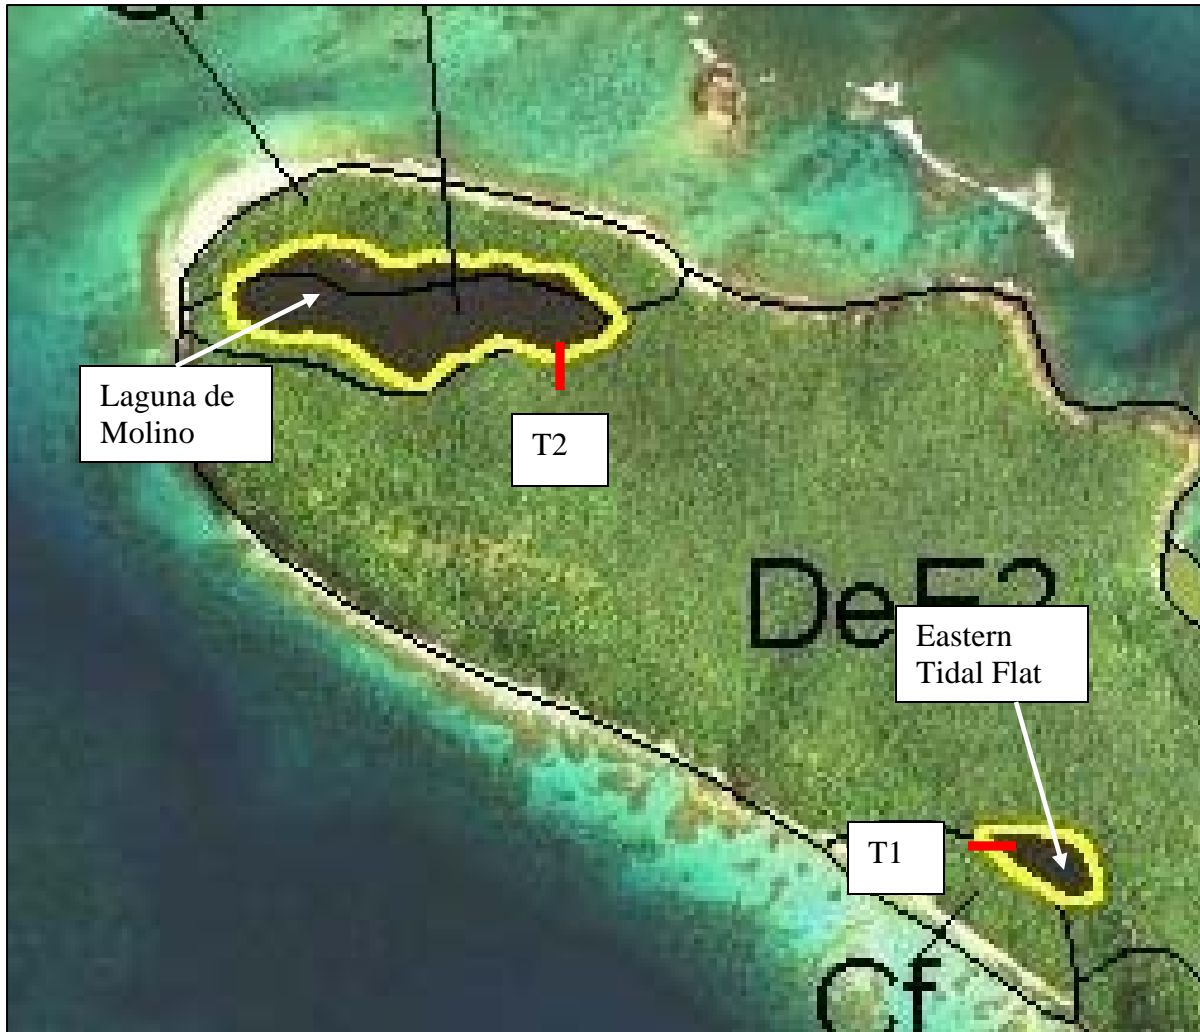
Figure 11. Location of both tidal wetlands and sampling transects. Yellow lines represent wetland boundaries.

Wetlands were also delineated as part of the survey completed by ReForesta, Inc. Two areas were identified during the survey. The larger of the two areas is located in the northwestern portion of the survey area. The other area is located to the southeast, beginning along the eastern survey boundary and extending to the east. The wetlands are described in the jurisdictional survey included as **Appendix C**.
