ENVIRONMENTAL BASELINE SURVEY

**CULEBRA WATER RANGES –
FLAMENCO BAY WATER AREA (MRS 03) AND
LUIS PEÑA CHANNEL WATER AREA (MRS 12)**

CULEBRA, PUERTO RICO

**Final
2012-2013 Field Data Collection Report**

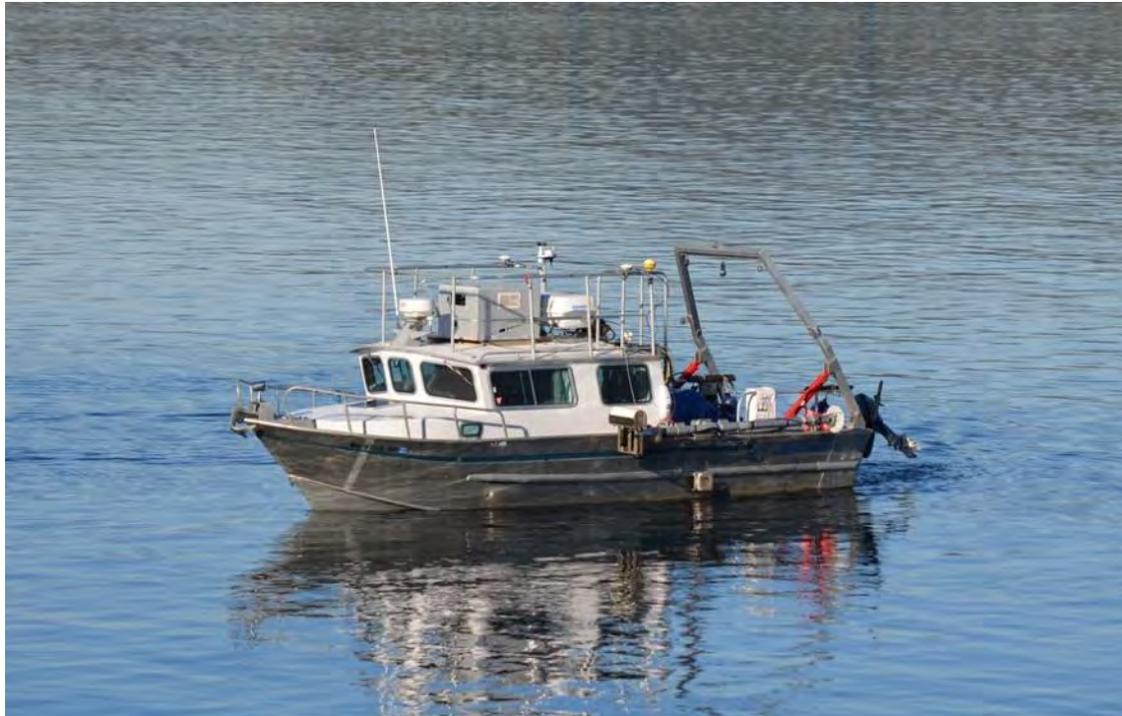
Figure 5. RESON SeaBat 7125 Multibeam Survey Vessel – R/V *Streak*

2.1.1.01 Tetra Tech configured their 9-meter (29.5-foot) boat (the research vessel [R/V] *Streak*) with MBE on a retractable side mount (Figure 5). When the pole was lowered into the water, it was bolted into place, allowing the pole to be raised or lowered while maintaining proper orientation. Data collection and navigation software for the bathymetry survey was HYPACK[®]/HYSWEEP[®] v.2012. SSS data were collected in EdgeTech Discover software. Equipment used for this survey is listed in Table 4.

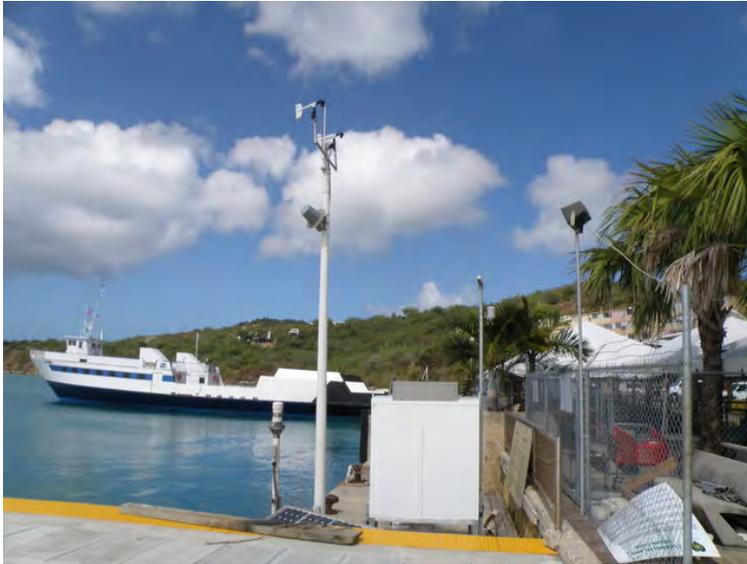
Figure 6. NOAA Tide Station ID: 9752235, Culebra, Puerto Rico

2.1.4.02 Tidal data for the survey were generated using post-processed POS MV data (via POSpac software). The observed tide gauge data that were used to validate the GPS derived tidal data and to fill any data gaps were from NOAA Tide Station ID 9752235, which is near the ferry terminal on Culebra, Puerto Rico (Figure 6).

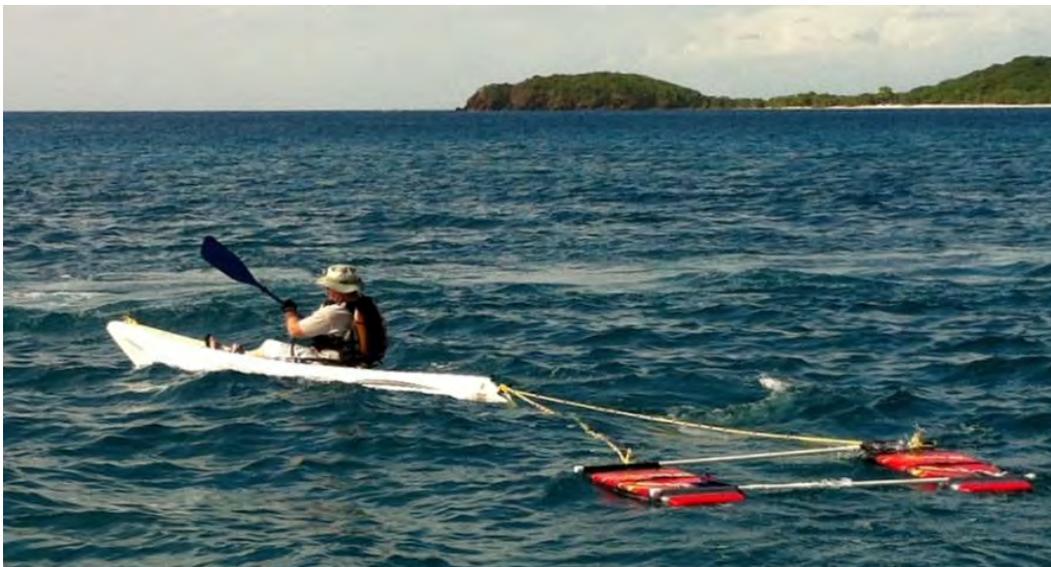
Figure 7. Kayak Towing Float-Mounted Underwater Cameras

2.4.01 A combination of several cameras, mounted on the multibeam survey vessel or towed behind the vessel, was used to provide a visual record of the bottom as well as any species that were encountered. In very shallow areas, these cameras were supplemented with cameras mounted on floats and towed behind a kayak (Figure 7).

- The vessel pole-mounted camera was a SplashCam Deep Blue standard definition video camera.
- The T³ROV (towed camera system) had both a DeepSea Power and Light Wide-I standard definition video camera and a GoPro HERO3 Black Edition that took high-definition (HD) still images.
- The kayak-towed surface floated camera array contained a pair of Panasonic Lumix TS4 cameras recording HD video.

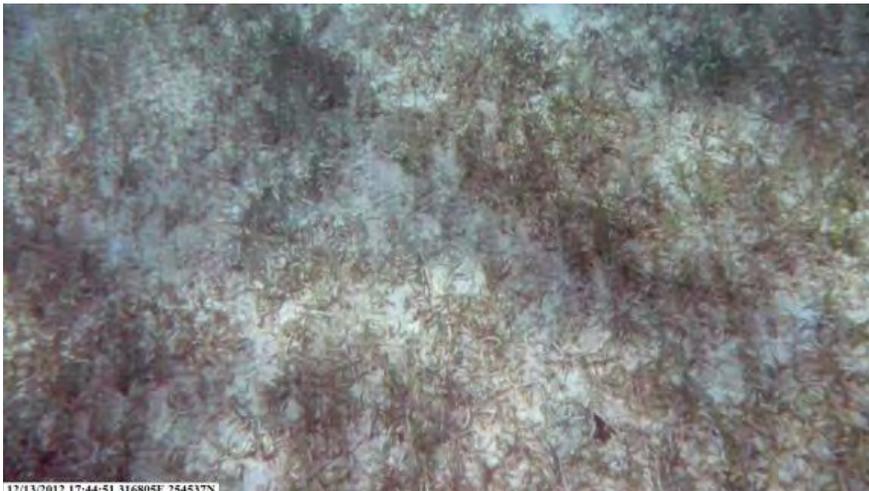
Figure 14. Underwater Image of Continuous Seagrass

- 3.4.1.05 Areas within Flamenco Bay and the Luis Peña Channel that were considered to be in the continuous seagrass category based on a combination of the following: the bathymetry data displayed a relatively smooth and flat seafloor, the sidescan data did not show any areas of relatively high reflectivity, the underwater photo displayed an image of seagrass (Figure 14), and in most cases, the aerial imagery showed a green tint throughout the water column.

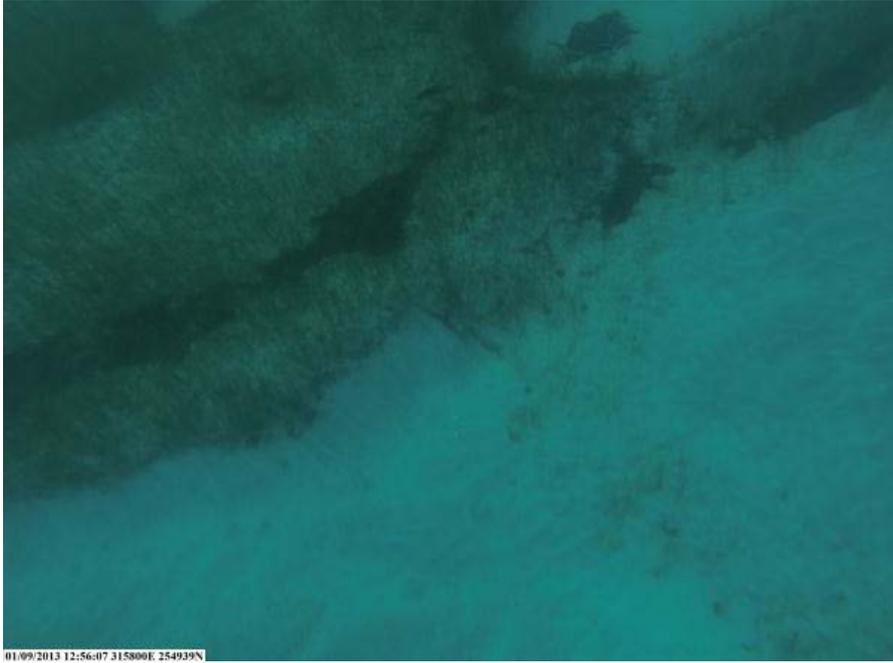
Figure 15. Underwater Image of Patchy Seagrass

3.4.1.06 The patchy seagrass category includes areas where underwater photos showed presence of seagrass interspersed with other hardbottom material such as shells (Figure 15). This region was categorized by the textured bottom clearly seen in the sidescan and bathymetry data.

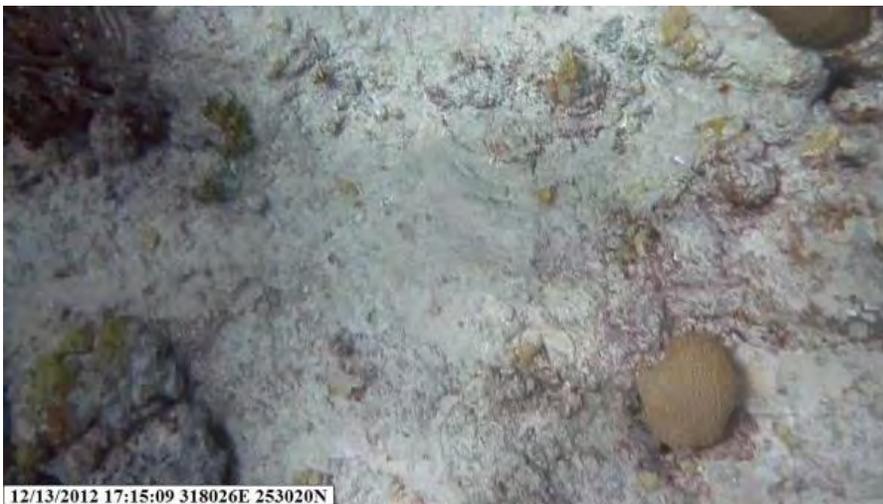
Figure 16. Underwater Image of Colonized Bedrock

3.4.1.07 Areas within Flamenco Bay and the Luis Peña Channel that were considered part of the colonized bedrock category included areas where the aerial imagery showed coral through the shallow water, where bedrock was observed through the water and where coral was present in the still photo (Figure 16).

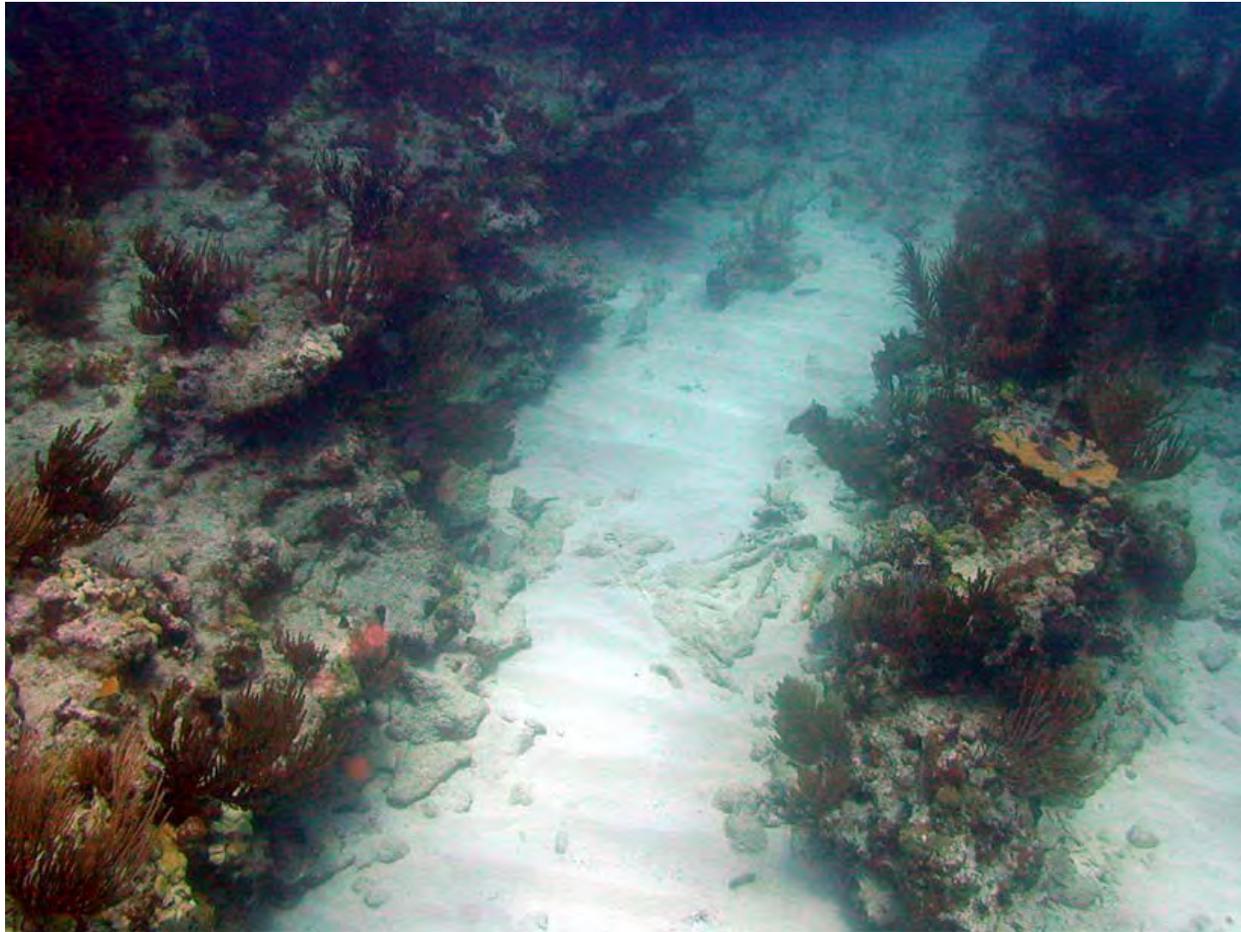
Figure 17. Underwater Image of Colonized Pavement (or Coral) with Sand Channels (Source: Kendall et al. 2001).

2. *Colonized Pavement (or Coral) with Sand Channels* – Habitat having alternating sand and colonized pavement formations that are oriented perpendicular to the shore or bank/shelf escarpment. The sand channels of this feature have low vertical relief compared to spur and groove formations. This habitat type occurs in areas exposed to moderate wave surge such as that found in the bank/shelf zone.

3.4.1.08 Sections of the MRS areas were classified as colonized pavement (or coral) with sand channels based on aerial imagery. This category was observed only in areas where the water was shallow and where sand channels could clearly be seen through the water in the aerial imagery. Figure 17 provides an example of this habitat type, though the photo is not from MRS 03 or 12.

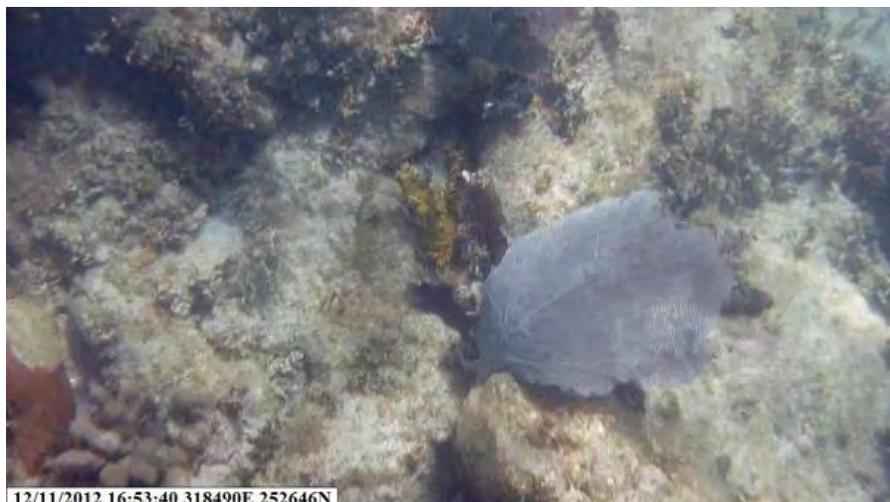
Figure 18. Underwater Image of Colonized Pavement

3.4.1.09 Sections of the MRS areas were classified as colonized pavement if the aerial imagery showed coral through the shallow water and the coral beds were flat and low-lying (Figure 18).

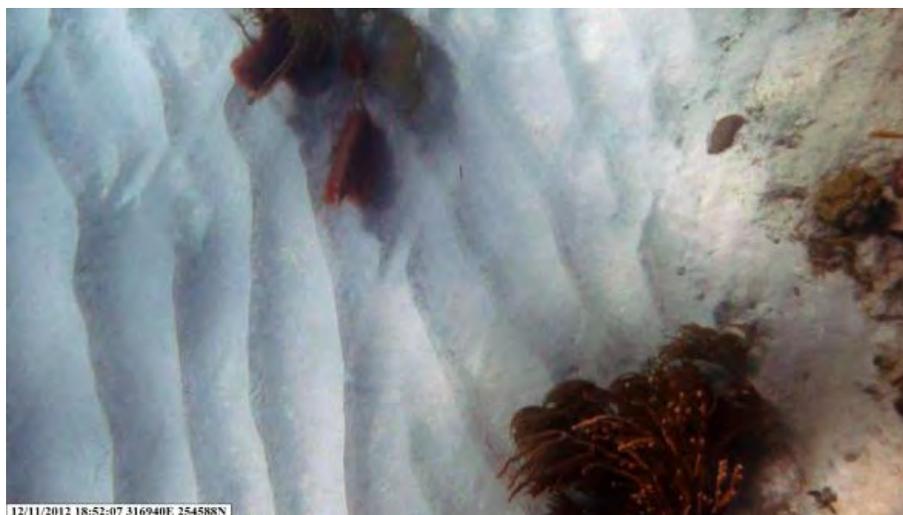
Figure 19. Underwater Image of Scattered Coral/Rock

3.4.1.010 The scattered coral/rock in unconsolidated sediment– category included scattered rock and coral and possibly sand (Figure 19). These areas tended to be shallow with a gentle slope.

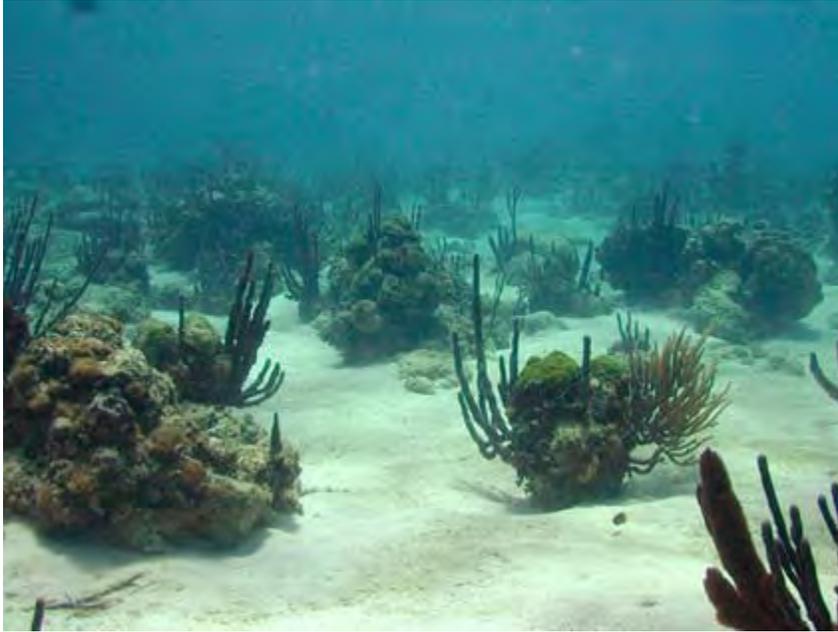
Figure 20. Underwater Image of Aggregate Patch Reefs (Source: Kendall et al. 2001)

3.4.1.011 Areas within the MRS boundaries that appeared to exhibit individual or aggregate patch reefs are present. Figure 20 provides an example of this habitat type, though the photo is not from MRS 03 or 12.

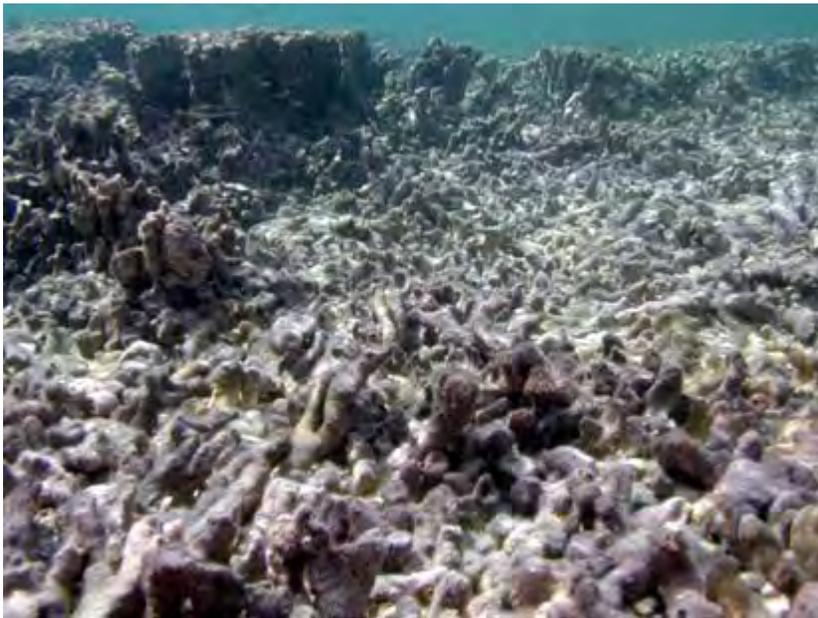
Figure 21. Underwater Image of Hardbottom/Reef Rubble (Source: Kendall et al. 2001)

3.4.1.012 Areas within the MRS boundaries that appeared textured in the bathymetry data and acoustically reflective in the sidescan data were classified as hardbottom/reef rubble. The underwater images taken in these locations were often too murky in the deeper water to distinguish coral; however, the bathymetry and sidescan data show the bottom is hard in these areas. Figure 21 provides an example of this habitat type, though the photo is not from MRS 03 or 12.

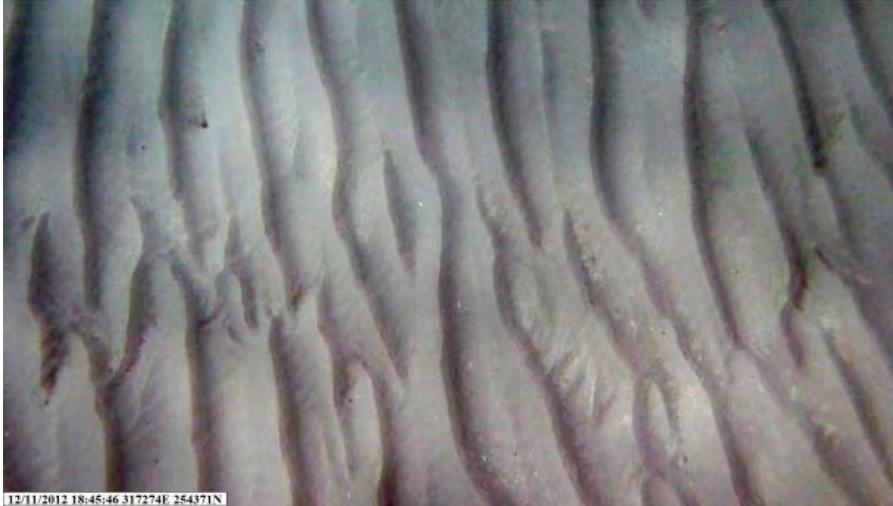
Figure 22. Underwater Image of Sand

3.4.1.013 Flat, acoustically non-reflective areas were categorized as sand (Figure 22).

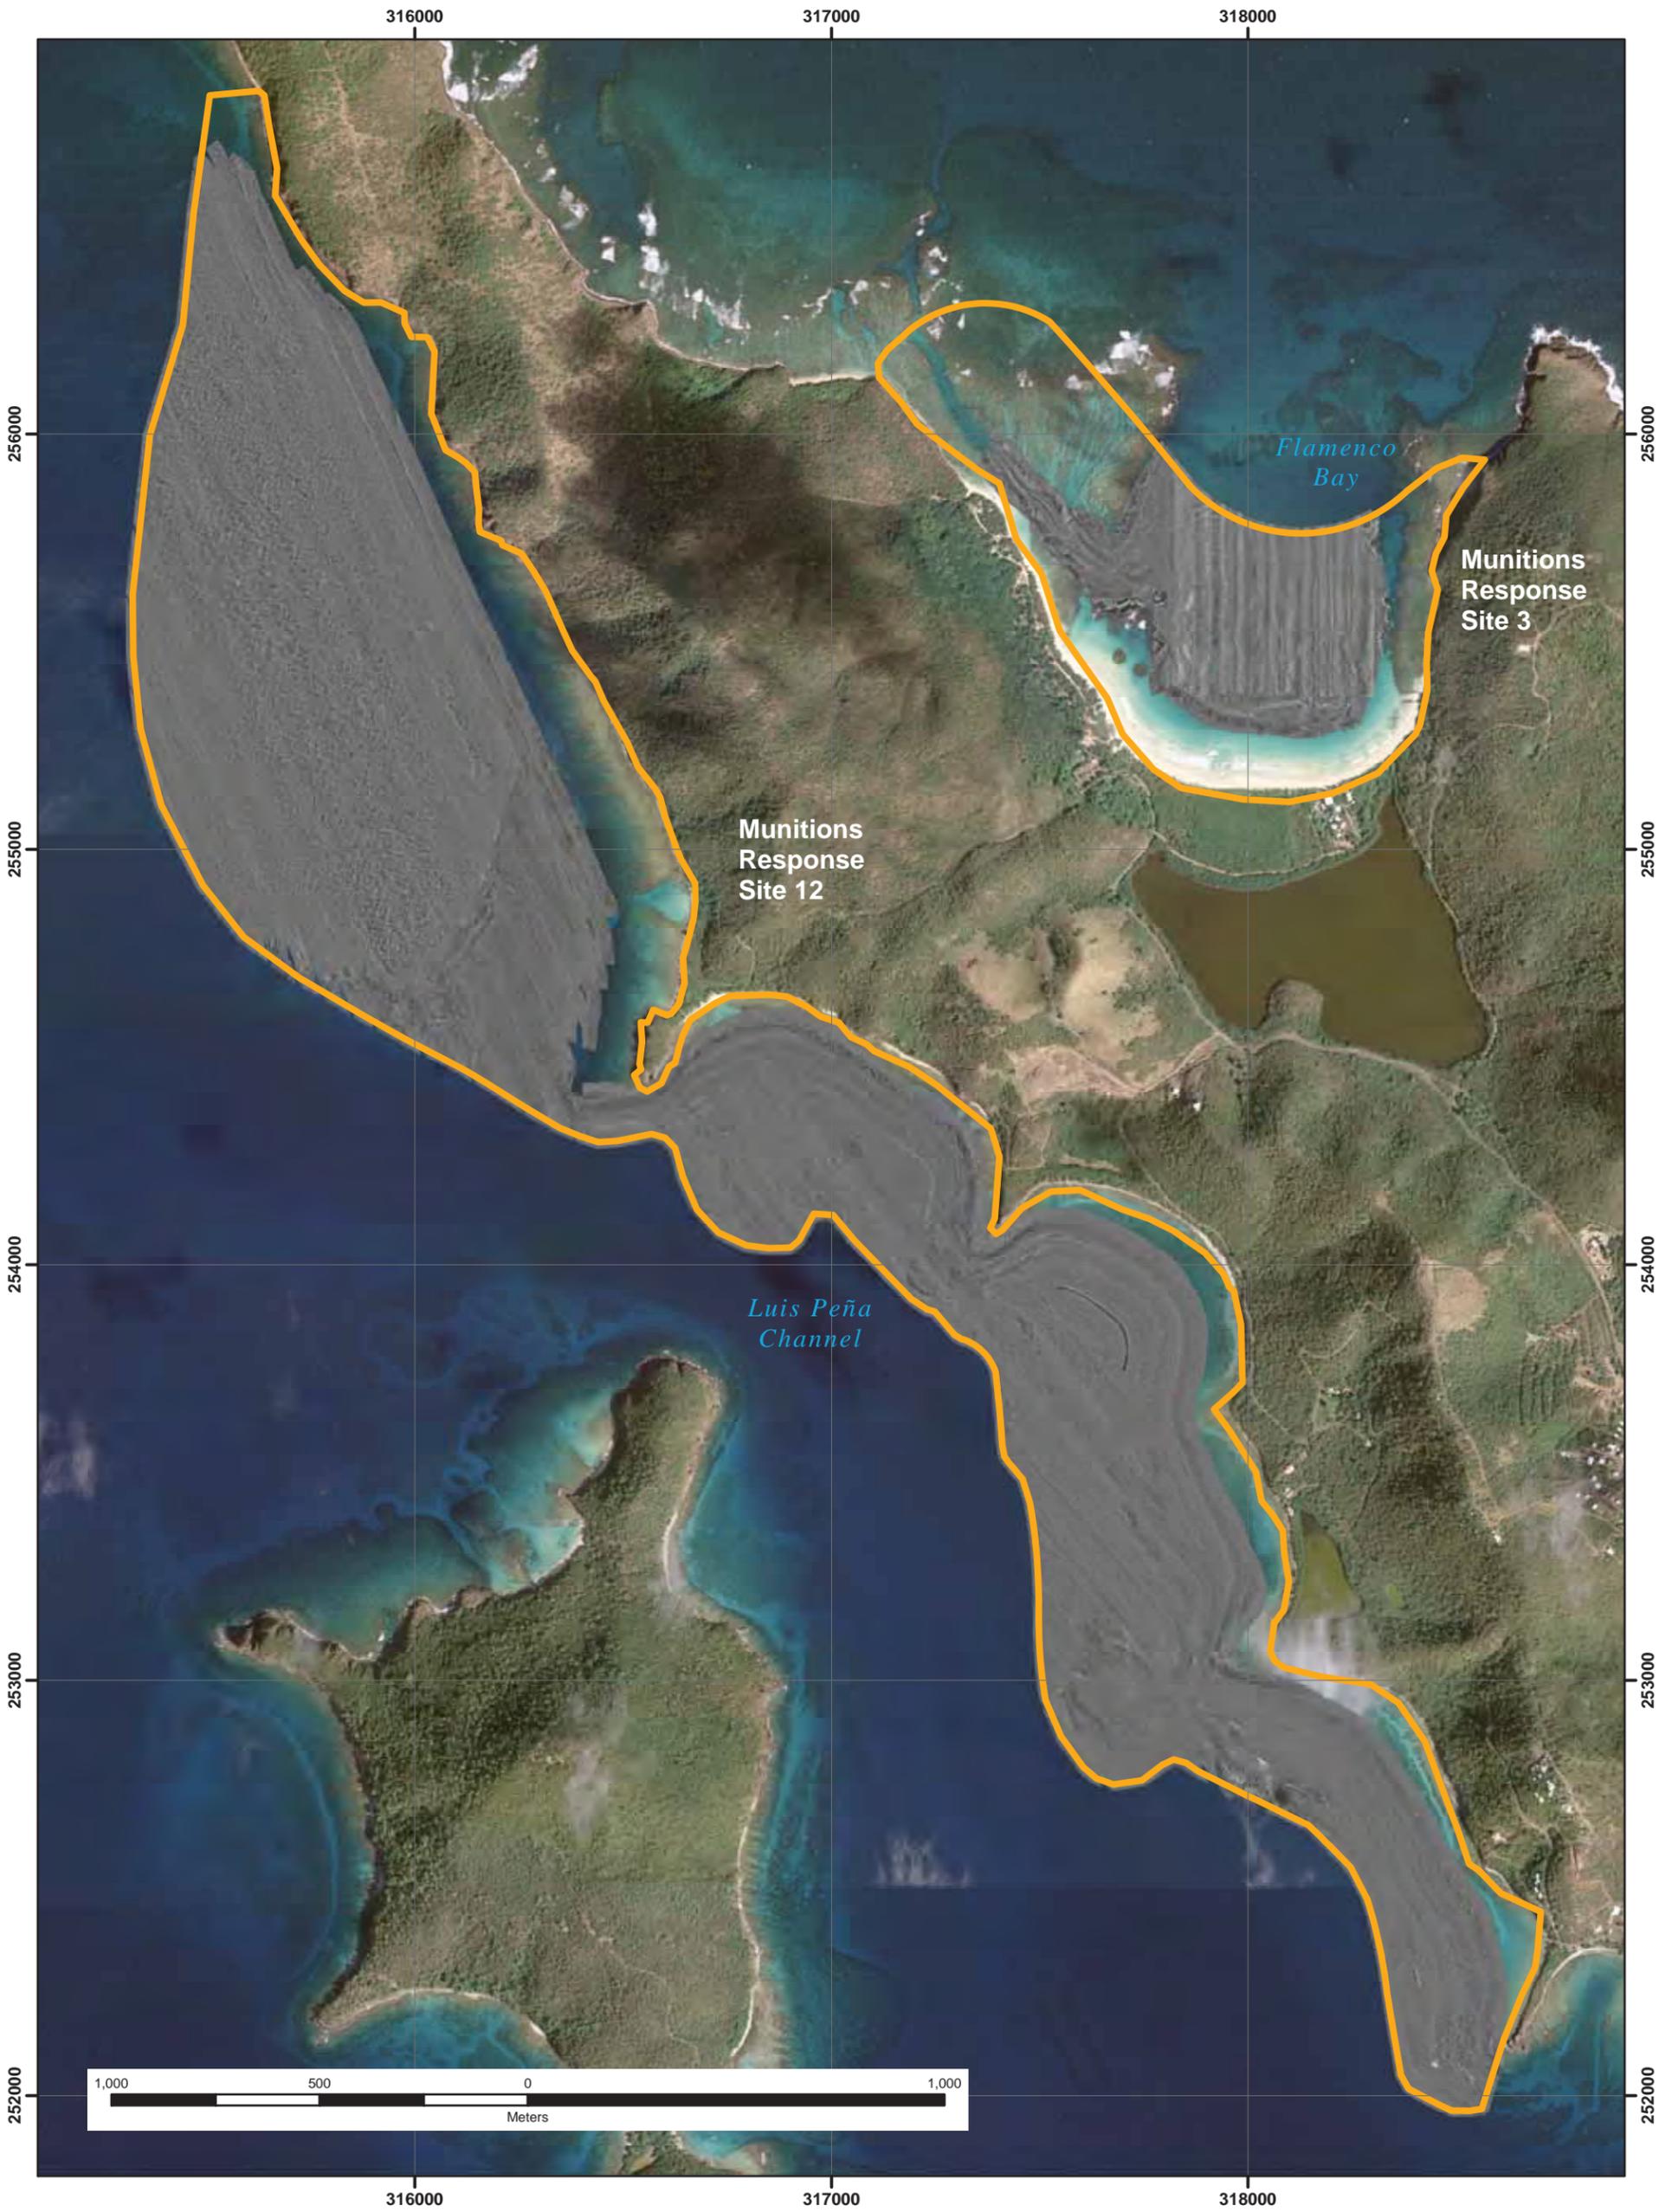
**APPENDIX B
SIDESCAN SONAR**

REMEDIAL INVESTIGATION/FEASIBILITY STUDY (RI/FS)
 CULEBRA WATER RANGES, CULEBRA, PUERTO RICO
 EXPLOSIVES SAFETY SUBMISSION

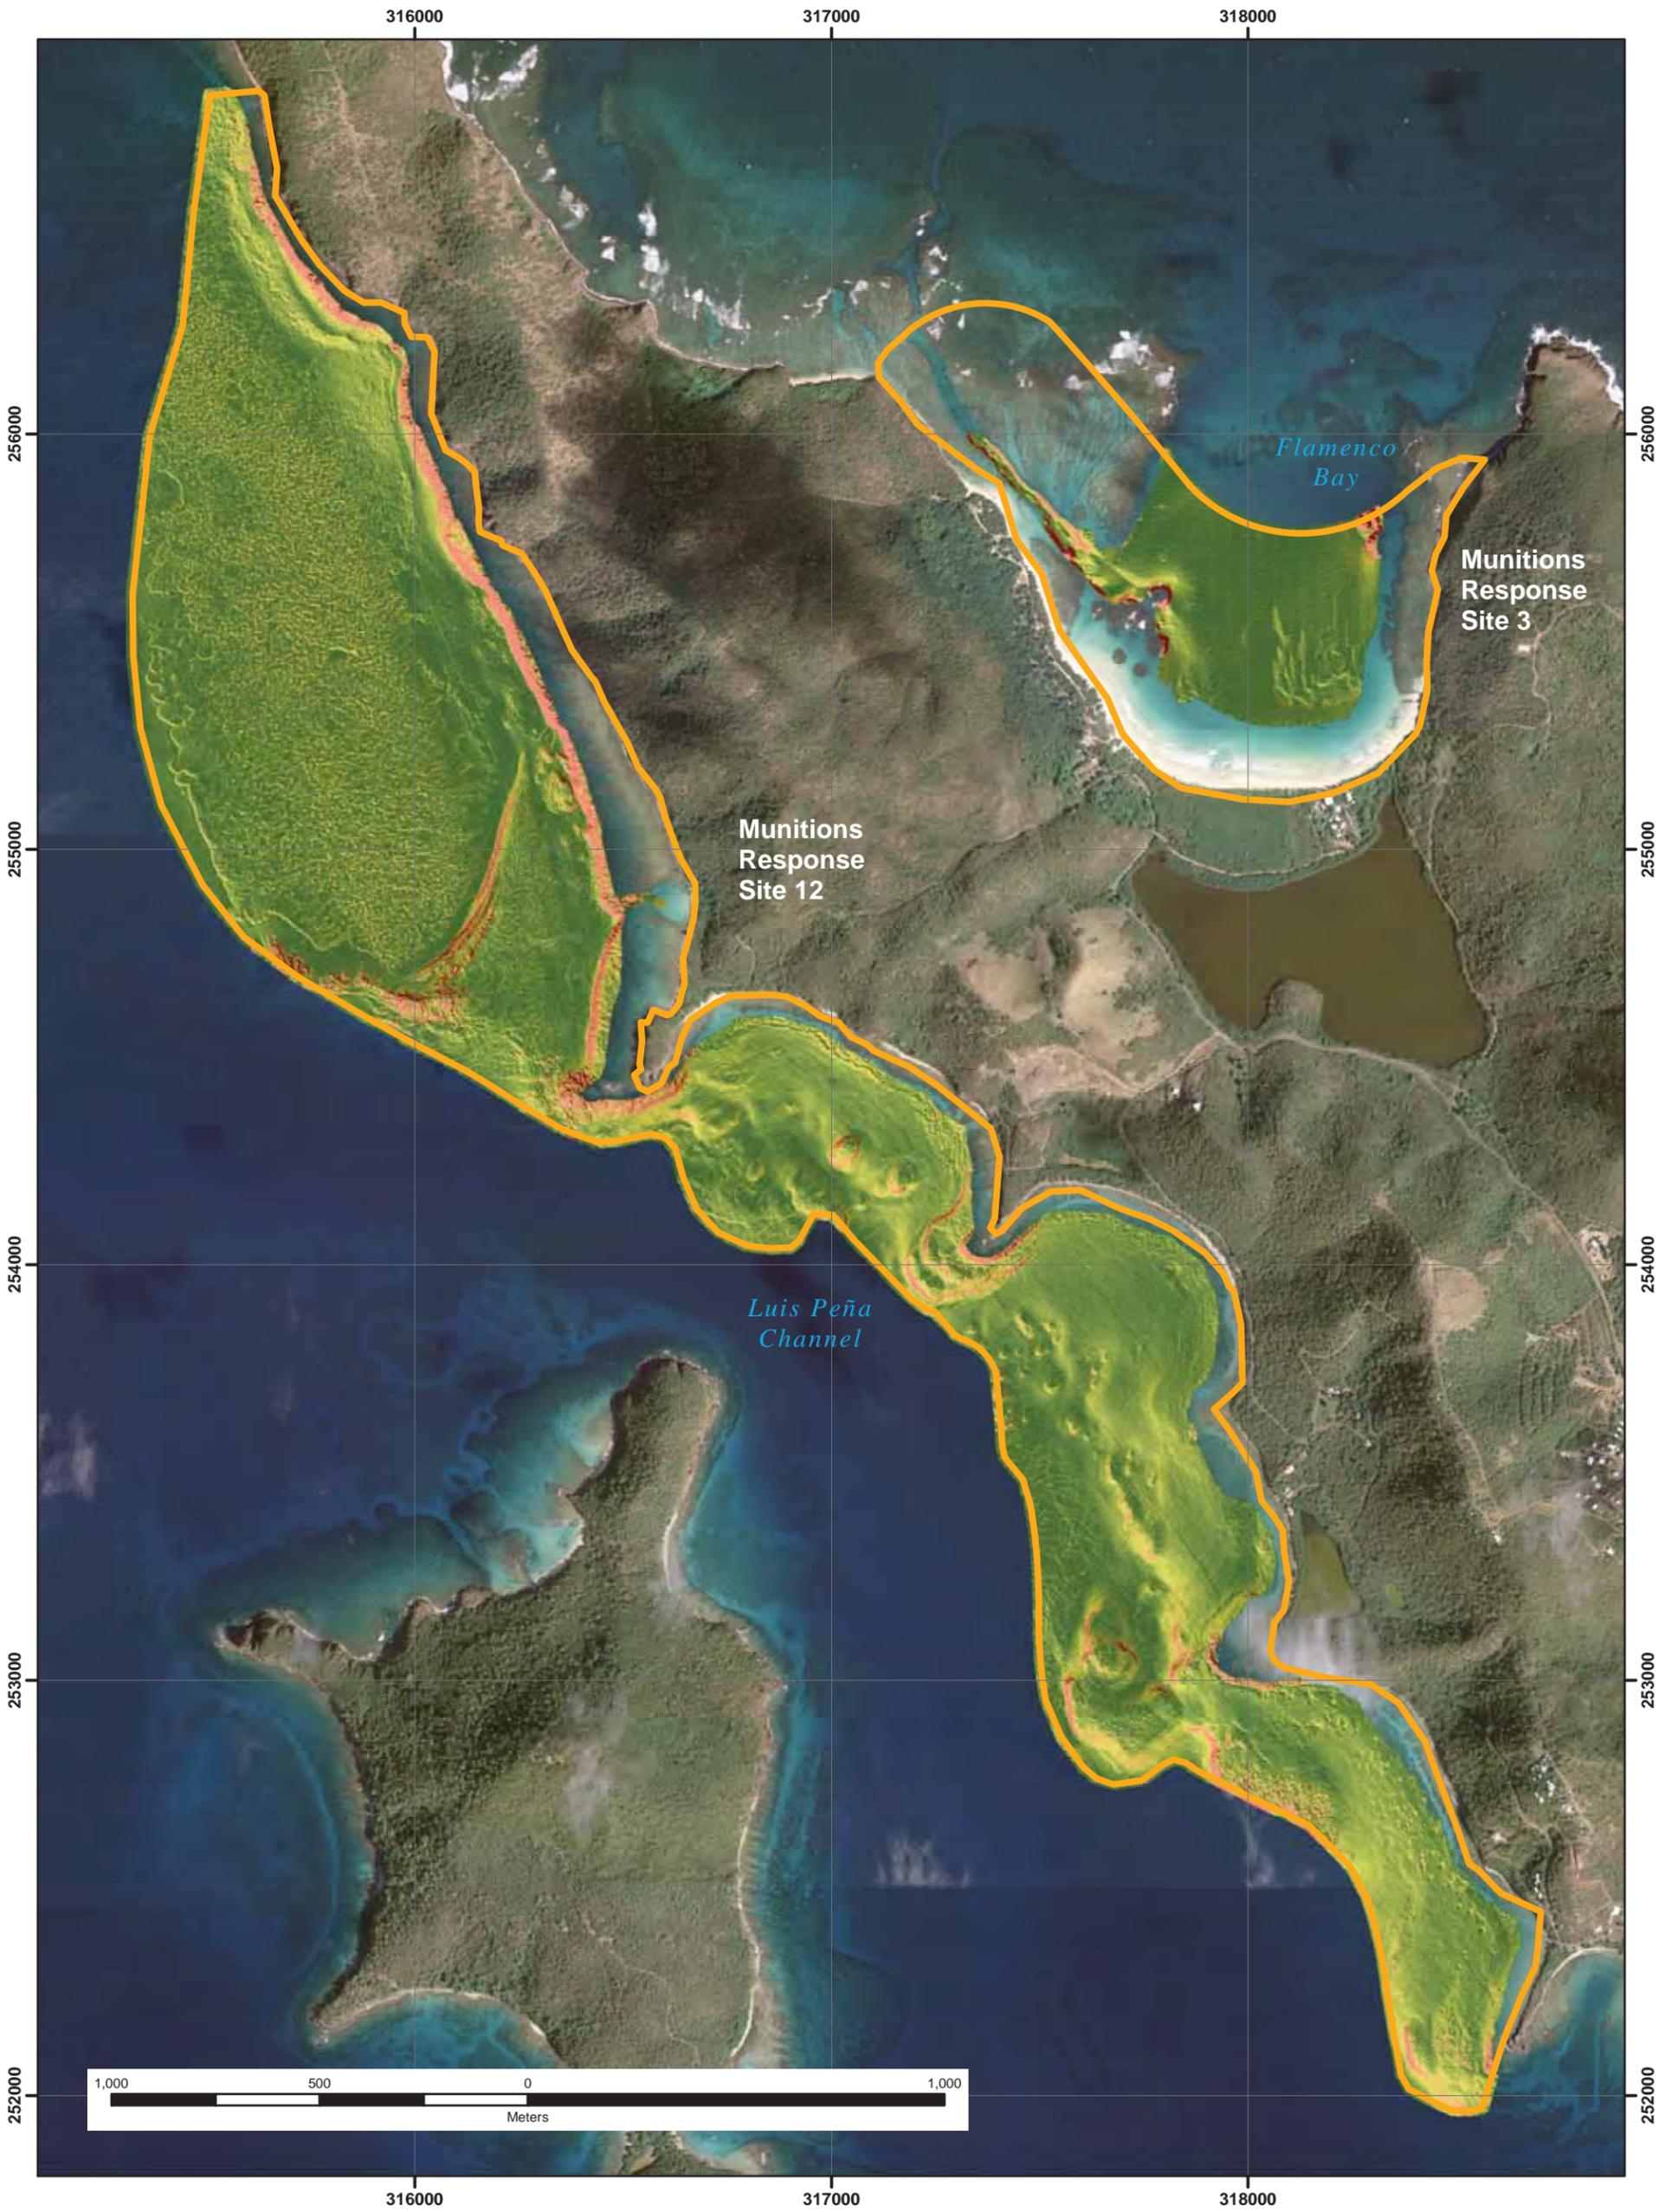
APPENDIX C
SLOPE

Slope (degrees)

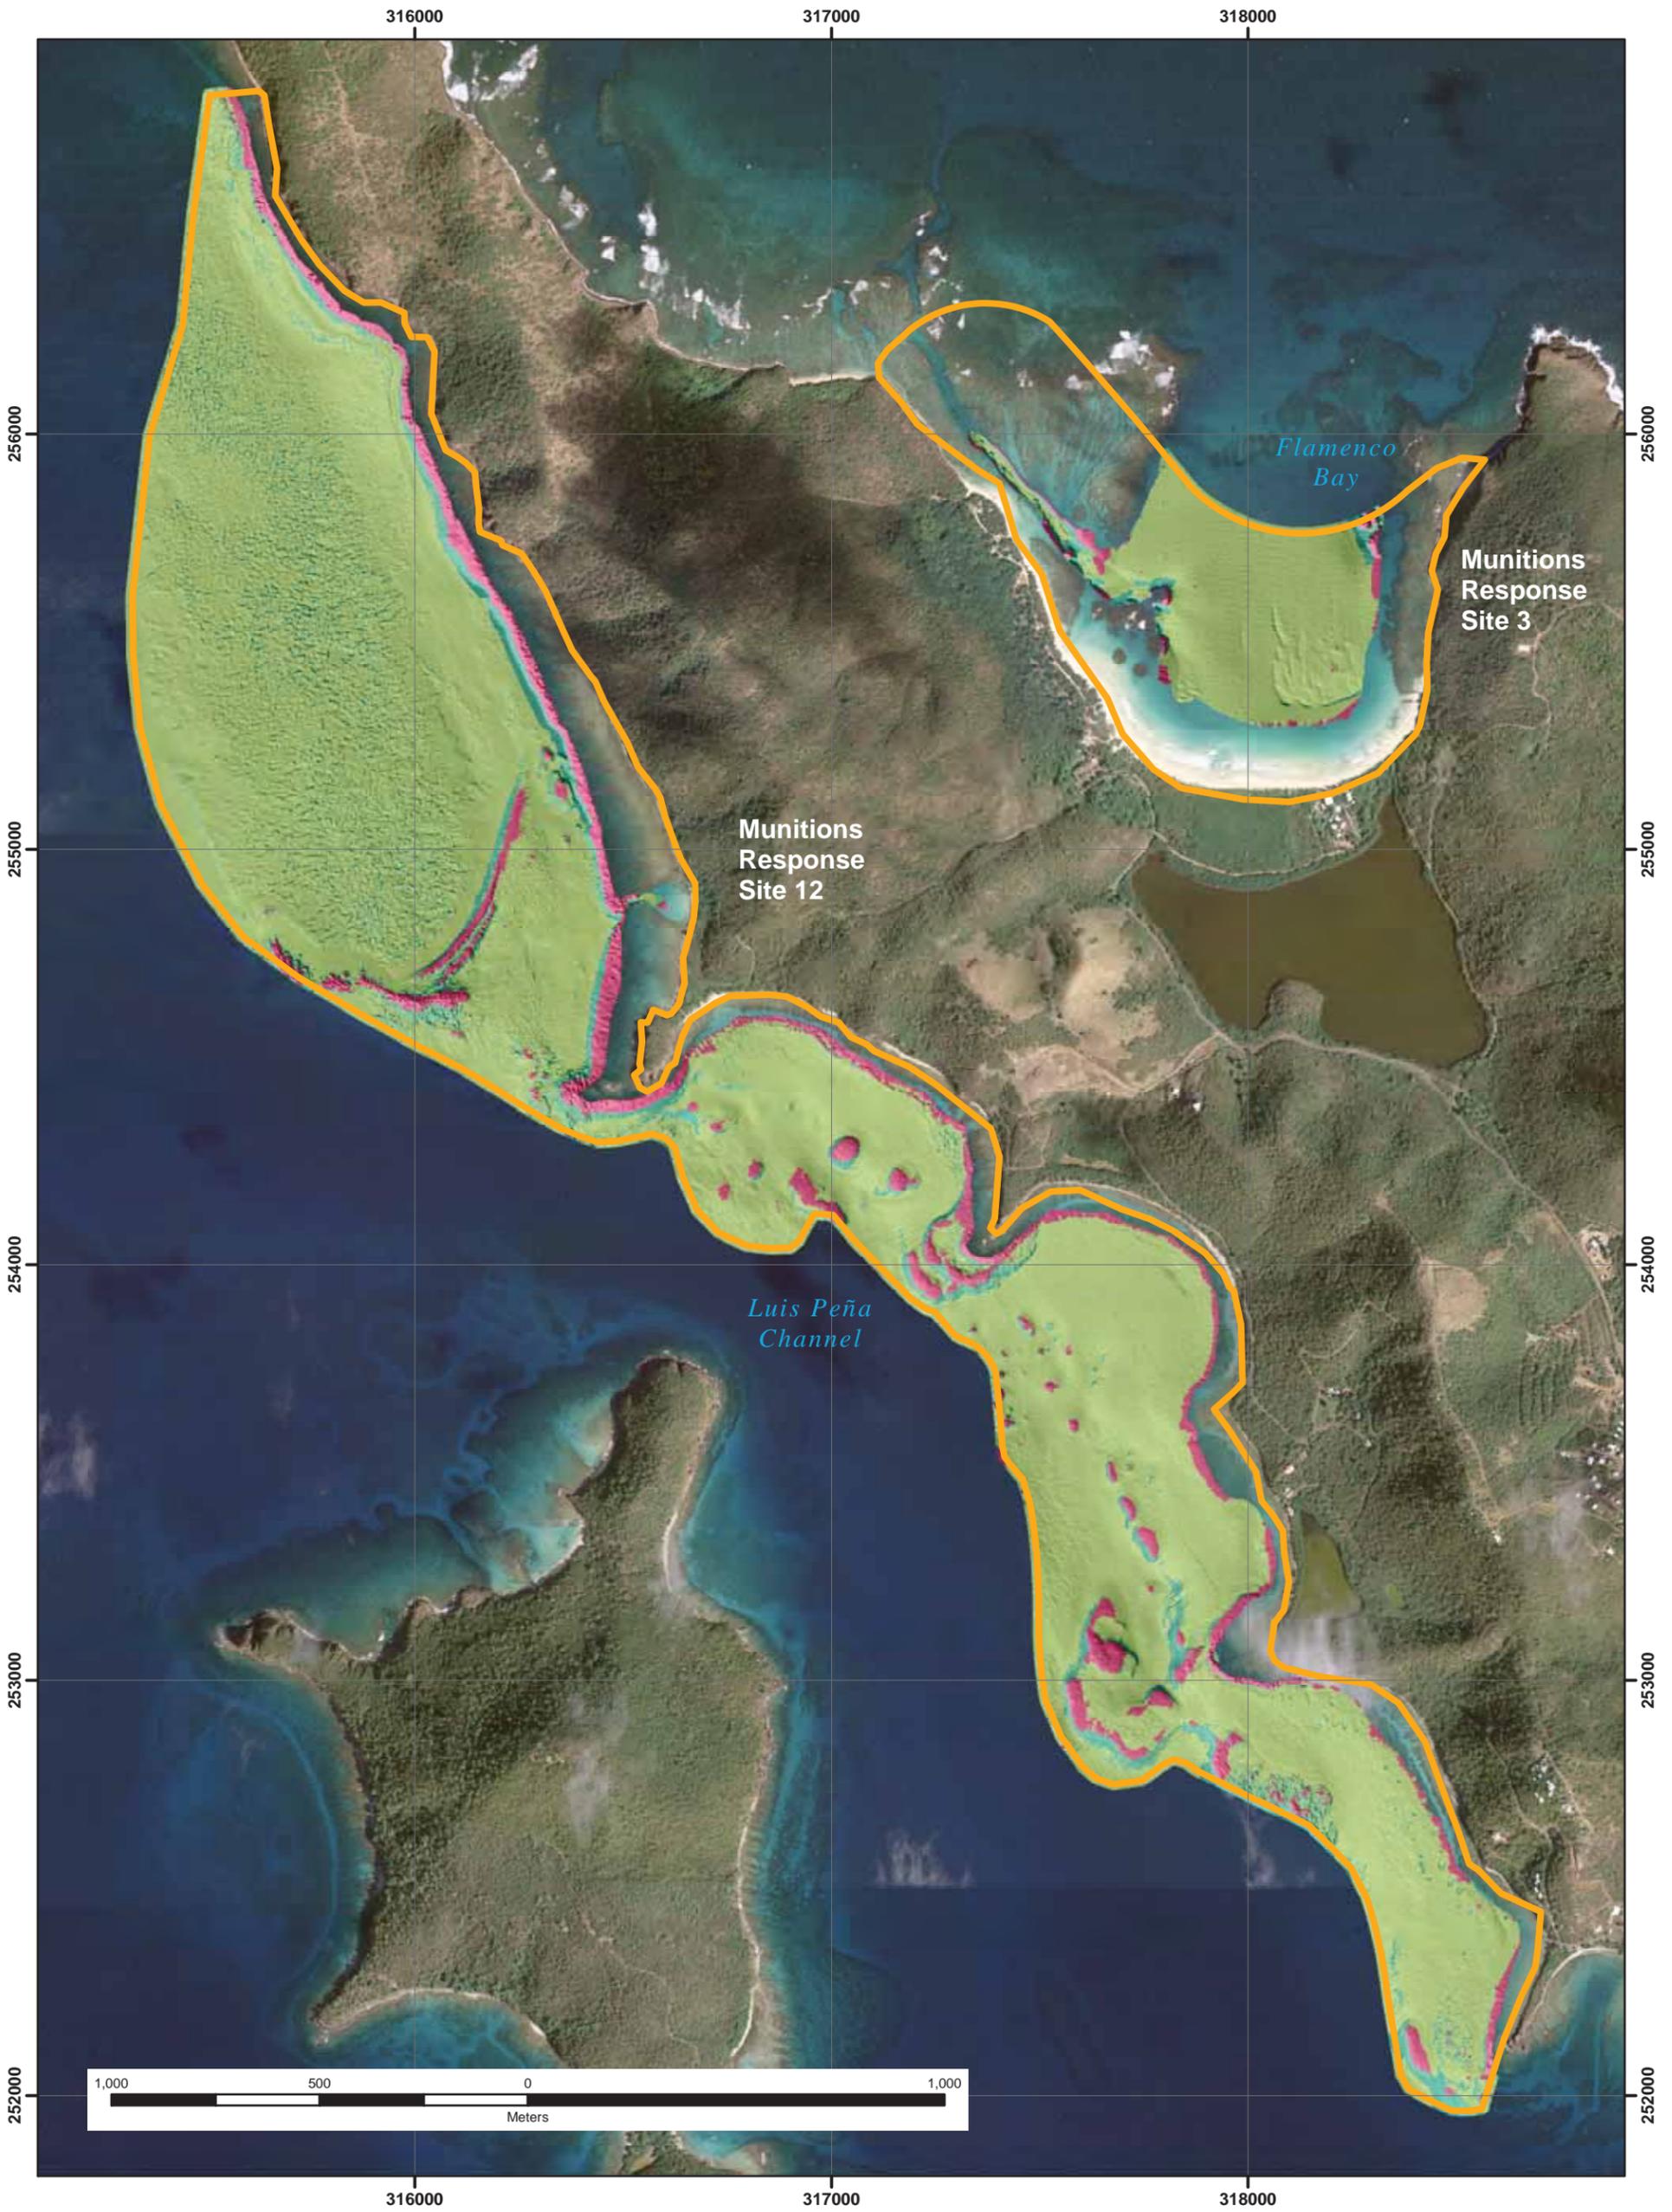
APPENDIX D
BENTHIC TERRAIN MODELER ZONE CLASSIFICATION

**Benthic
Terrain
Modeler
Zones**

- Crests
- Flats
- Slopes
