ENVIRONMENTAL BASELINE SURVEY

**CULEBRA WATER RANGES –
FLAMENCO BAY WATER AREA (MRS 03) AND
LUIS PEÑA CHANNEL WATER AREA (MRS 12)**

CULEBRA, PUERTO RICO

**Final
2012-2013 Field Data Collection Report**

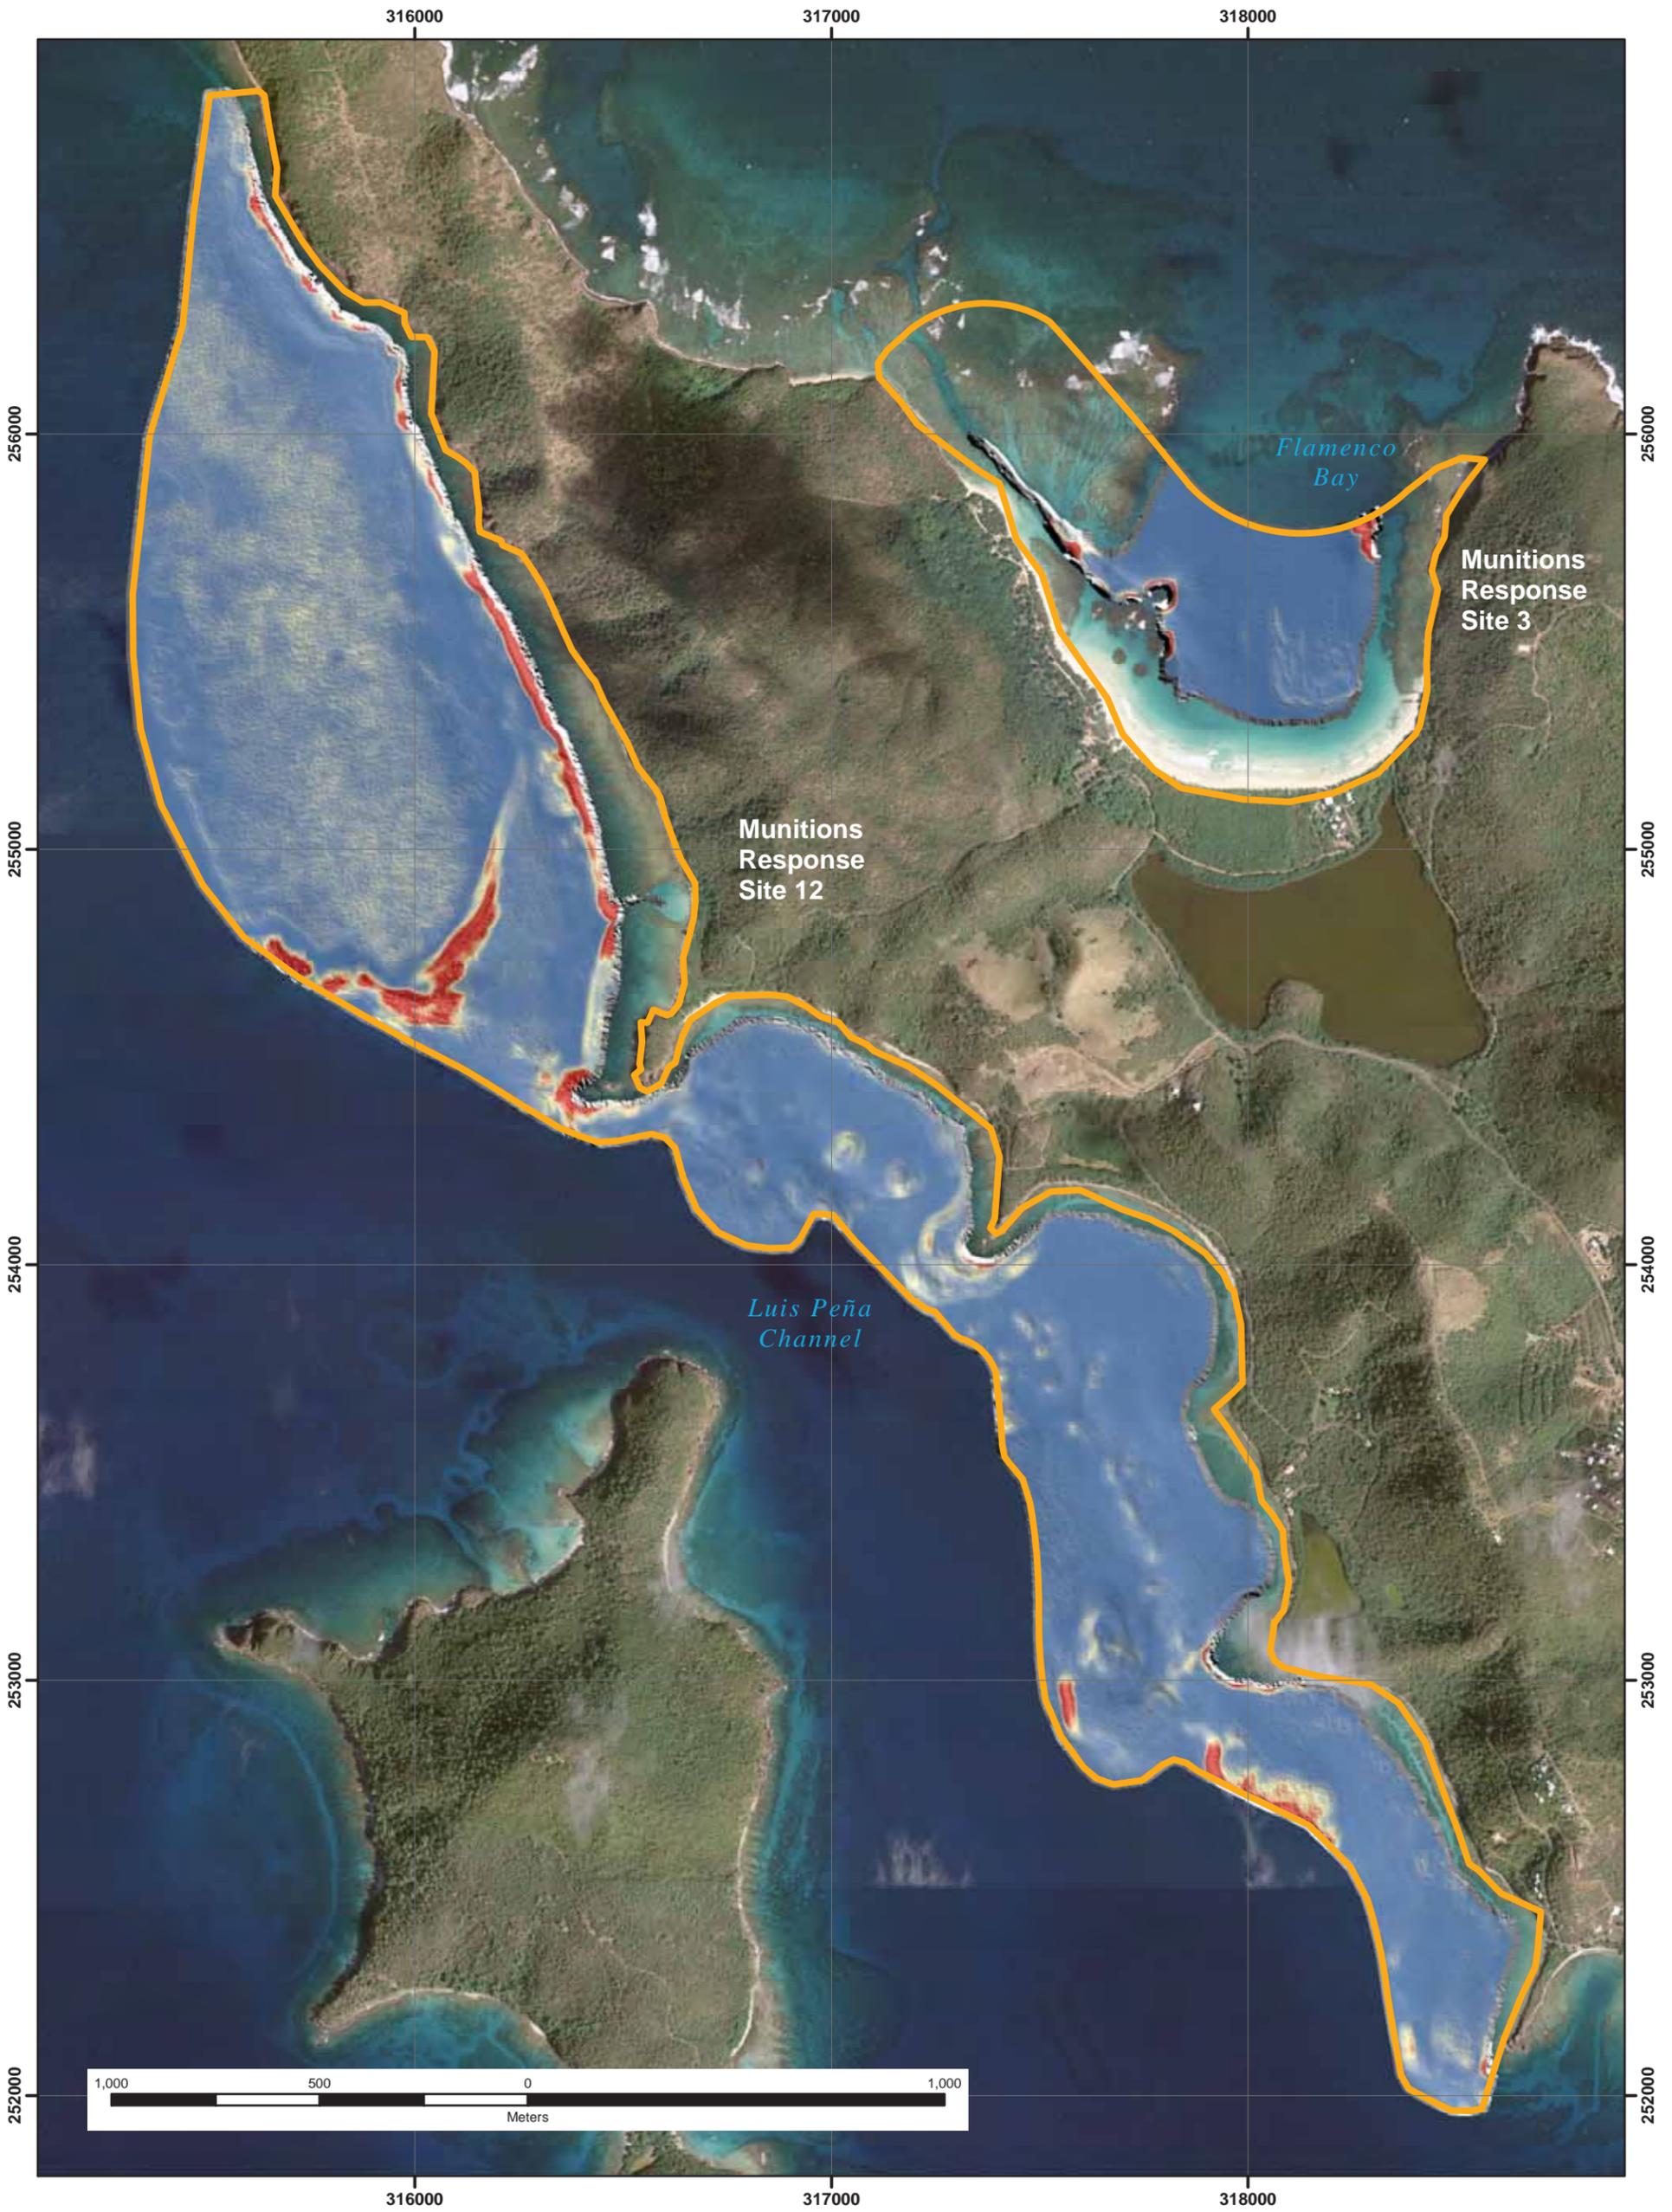
APPENDIX E
VECTOR RUGGEDNESS MEASURE

REMEDIAL INVESTIGATION/FEASIBILITY STUDY (RI/FS) CULEBRA WATER RANGES, CULEBRA, PUERTO RICO EXPLOSIVES SAFETY SUBMISSION	
VECTOR RUGGEDNESS MEASURE MUNITIONS RESPONSE SITES 3 AND 12	
Tetra Tech 19803 North Creek Parkway Bothell, WA 98011	
PROJECT NUMBER 44070003	FILE NAME \\mmg_archive_02\2012_Culebra\ArcGIS\Charts\ Sites_1mBathy.mxd

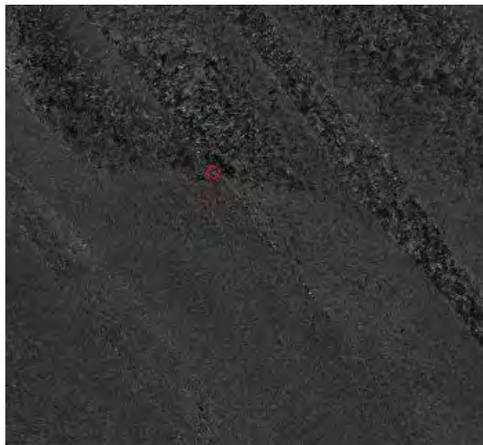
- 12/16/12 Change in bottom type. Lines cu_121612.006-ch12 and cu_121612.004-ch12 agreement within 2 meters in the Luis Pena region of MRS-12.

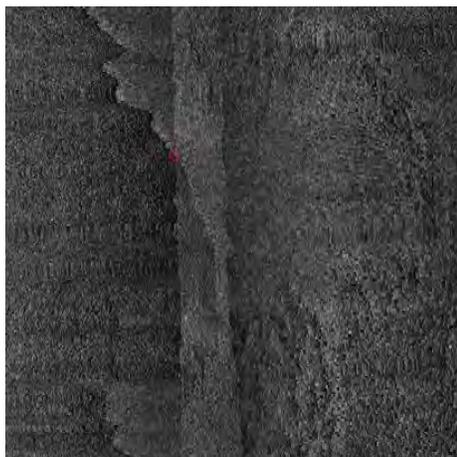
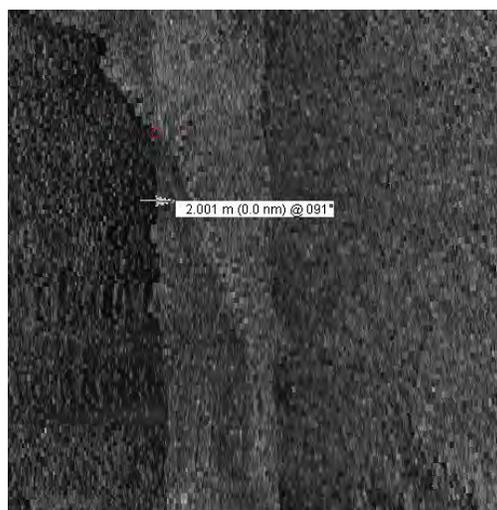
- 01/12/13
Bottom feature. Lines 20130112141716 and 20130102043157 agreement within 2 meters in the Flamenco Bay region of MRS-03.
