SITE SPECIFIC FINAL REPORT
Non-Time Critical Removal Action (NTCRA)
Culebrita and Culebra Beaches
Municipality of Culebra, Puerto Rico

U.S. Army Engineering and Support Center, Huntsville
and
U.S. Army Corps of Engineers, Jacksonville District

Contract No. W912DY-04-D-0006
Task Order No. 0012
Project No. I02PR00682

USA Environmental, Inc.
720 Brooker Creek Boulevard, Suite 204
Oldsmar, Florida 34677

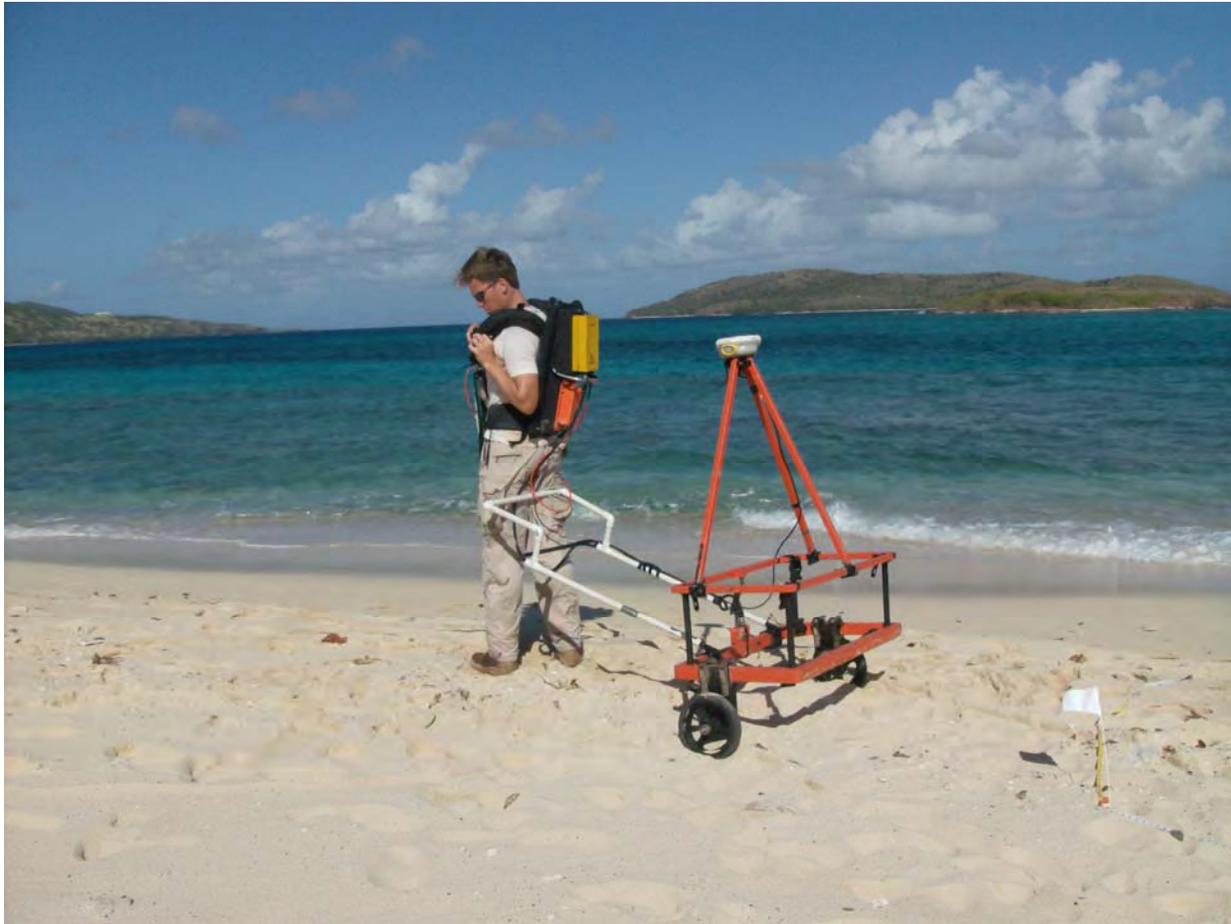
Data was collected with the EM61 in "wheel" mode due to the smooth, slightly undulating ground surface and lack of surface debris (stumps, roots, etc). The wheel mode required two people to maneuver the EM61 (one to pull and one to push), with the rover GPS attached above the center of the coil. Using the wheels allowed the coil to be maintained at the operational height of 10 inches in order to adequately detect all targets of interest. The EM61 amplitude data readings were recorded at 10 Hz and were interleaved with the 1-Hz GPS position data by EM61MK2A on an Allegro data logger. The operators in the field monitored the EM and GPS values displayed within the data logger at regular intervals in order to "field-check" for any dramatic changes in data quality, e.g. loss of GPS or excessive EM response values.. Figure 2-2 shows EM61 data collection in conjunction with GPS positioning to adequately sample the work areas.

Figure 2-2 : EM61 Wheel Mode at Culebrita Beach E (Handle modification needed for small wheels)

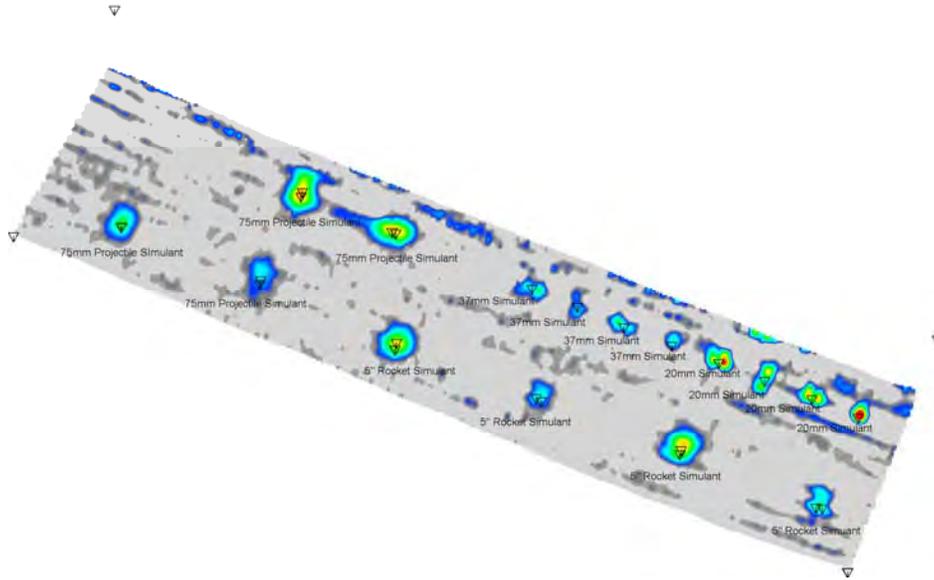
During the first mobilization, anomaly reacquisition, using the RTK DGPS and EM61-MK2 with small wheels, was demonstrated to the Site Geophysicist at the remaining portion of the GPO on Flamenco Beach. The GPO was also remapped documenting that only 5 of the 16 GPO seed items remained. The

8 small GPO seed items (20mm and 37mm simulants) and three large GPO seed items (75mm simulants) are gone. The reasons for this may include the dynamic nature of the beach site exposed to all natural and storm events, as well as public access that is both random access (sun bathers using the GPO and digging holes in the sand) and intentional treasure hunting with all metals detectors. Even though the GPO seed items were tagged, none were reported or returned to USA.

Figure 2-3: Flamenco Beach GPO Feb 2009

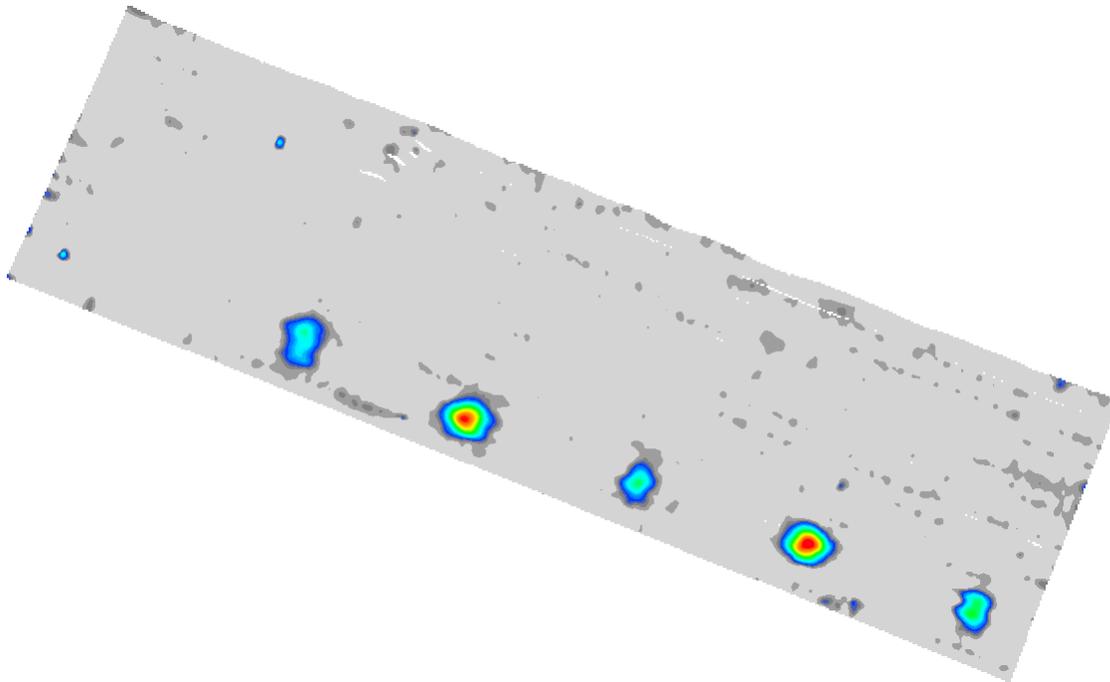
Figure 2-4: Original Flamenco Beach GPO Nov 2008

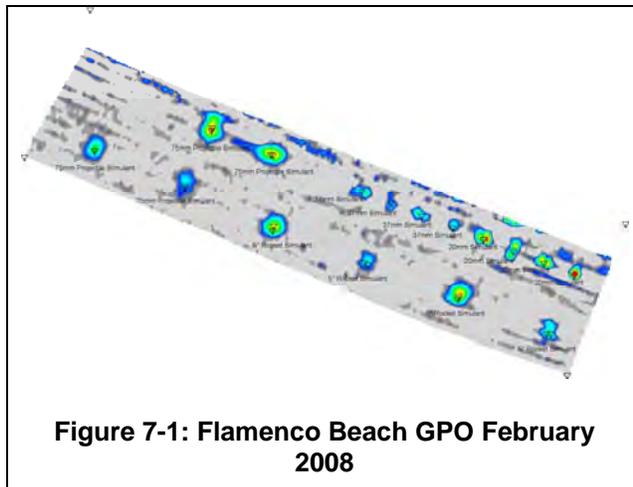
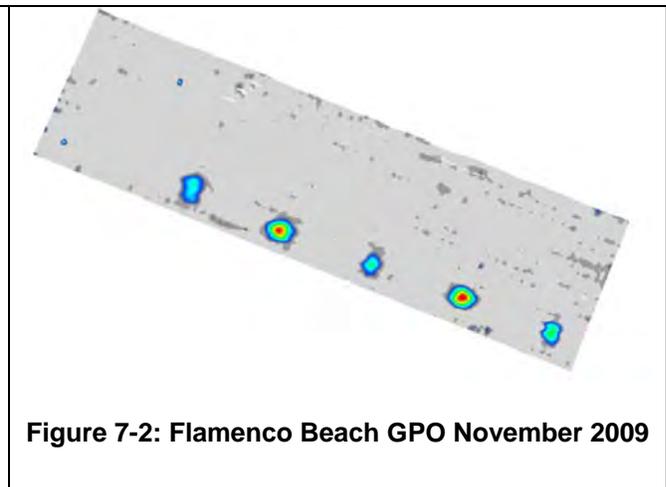
Discussion: USA contacted the City of Dewey, the Fish and Wildlife Service (FWS), and the Department of Environmental and Natural Resources to locate an area for the GPO. USA explored the possibility of leasing land, until approval to locate the GPO on Flamenco Beach was received from DNER (see Figure 7-1: Flamenco Beach GPO February 2008 and Figure 7-2: Flamenco Beach GPO November 2009). In the period between February 2008 and November 2008 the majority of the GPO disappeared. This was probably due to beach erosion and tourists using metal detectors or just digging in the sand.

Lesson Learned: If a GPO must be placed in a dynamic site, it should be recovered shortly after the GPO is complete. Otherwise, it should be located in a less dynamic environment.

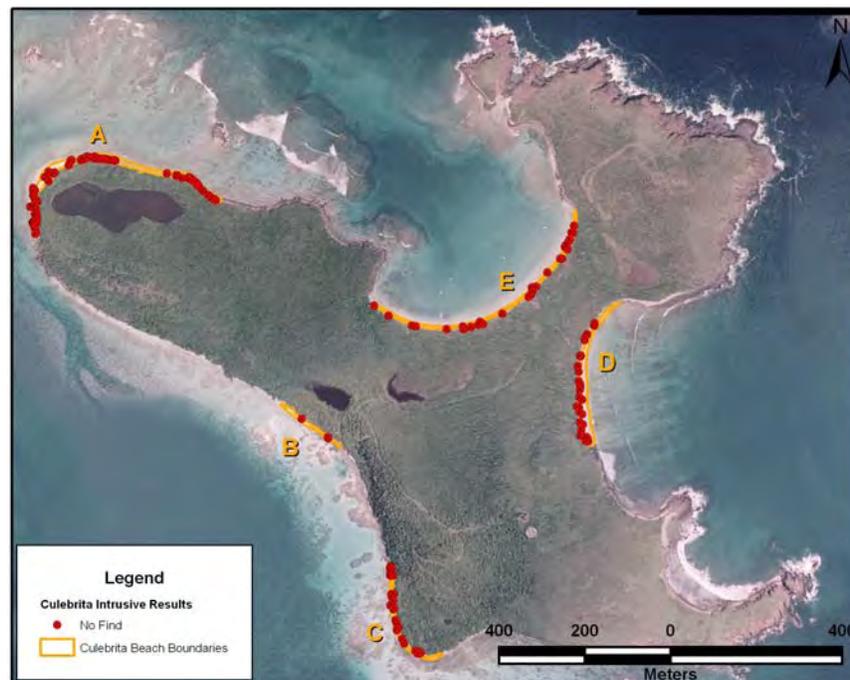
Discussion: The DGM survey was performed in February 2008 and the Intrusive Operations did not commence until November 2008. The long lag between DGM and Intrusive Operations proved problematic. This needs to be shortened to “next day approval” to minimize adverse natural and cultural effects. (See Figure 7-3: Number of No Finds on Culebrita Beaches)

Figure 7-3: Number of No Finds on Culebrita Beaches

Lesson Learned: Given what we know now, USA would recommend that beaches needing removal actions be cleared using analog and dig techniques. If DGM is required, it should follow the analog and dig immediately to document clearance effectiveness. Intrusive investigation of any remaining DGM anomalies should be investigated immediately.

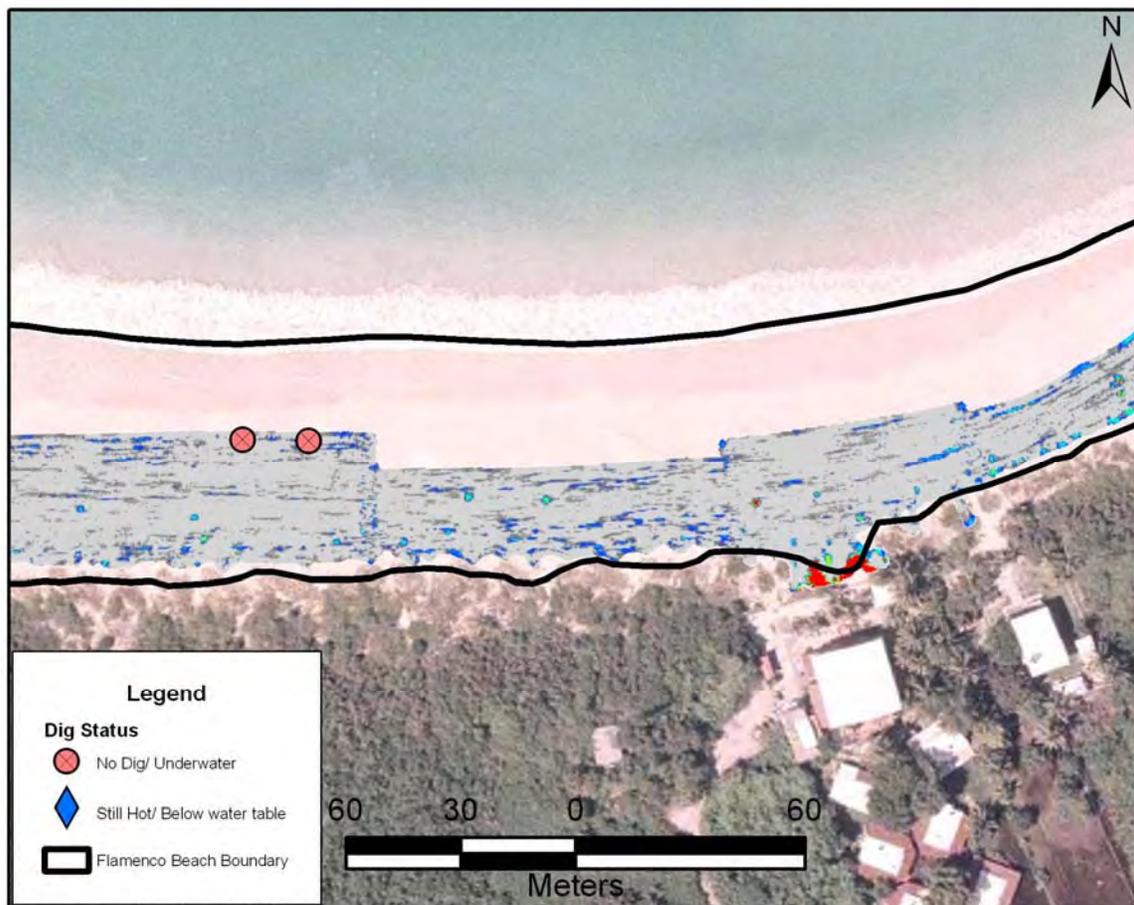
Discussion: USA experienced numerous incidences of collecting data on a beach and returning the next day to see the areas worked under water or the beach may have increased in size. (See Figure 7-4: Example of Flamenco Beach with Impact of Water on DGM Survey and Figure 7-5: Attempting to Perform Reacquire on Anomalies in the Surf) The performance of field operations at “low tide” can be used in some incidences to reacquire anomalies or perform intrusive operations but it is mainly due to the time of the month for the height of the tides and whether access to previously surveyed areas can be gained.

Figure 7-4: Example of Flamenco Beach with Impact of Water on DGM Survey

Lesson Learned: If DGM is required, it needs to be rapid DGM (e.g. use of a towed array) to maximize production at low tides and minimize the environmental and cultural impacts during each beach survey.

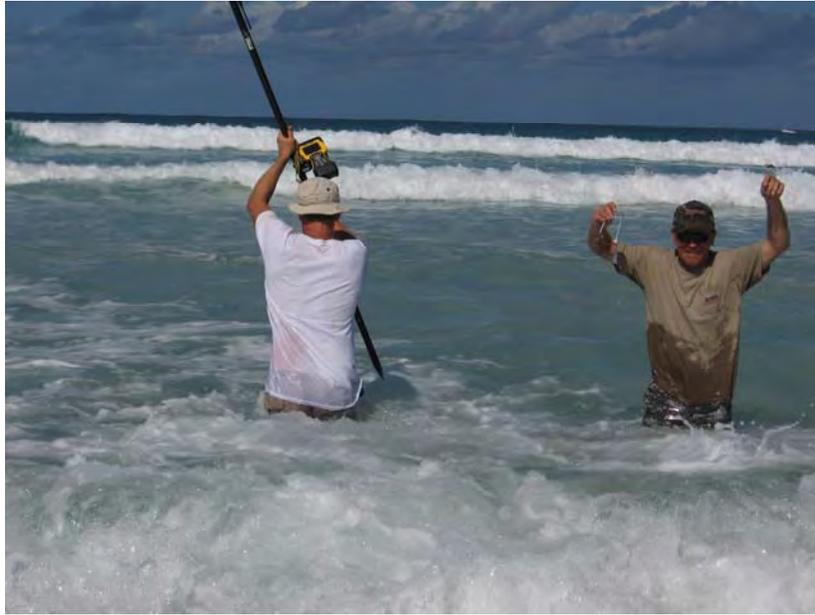
Figure 7-5: Attempting to Perform Reacquire on Anomalies in the Surf

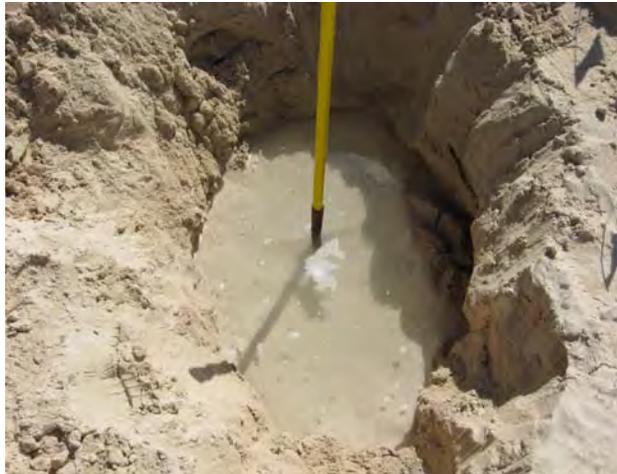
Discussion: No acceptable solution was found during this project, resulting in many anomalies left uninvestigated because they could not be safely accessed and identified. This issue includes the invasion of water at the bottom of the excavation but also includes the sides of the excavation collapsing into the hole because of the water.

Figure 7-6: Water Intrusion

Lesson Learned: No effective solution was found for this problem. USA would suggest experimenting with an additional excavation to the side of the anomaly and to attempt pumping to temporarily reduce the level of the water during excavation of the anomaly and/or use of coffer dams of PVC pipe (2' by 3') if teams are allowed to dig over the anomaly.

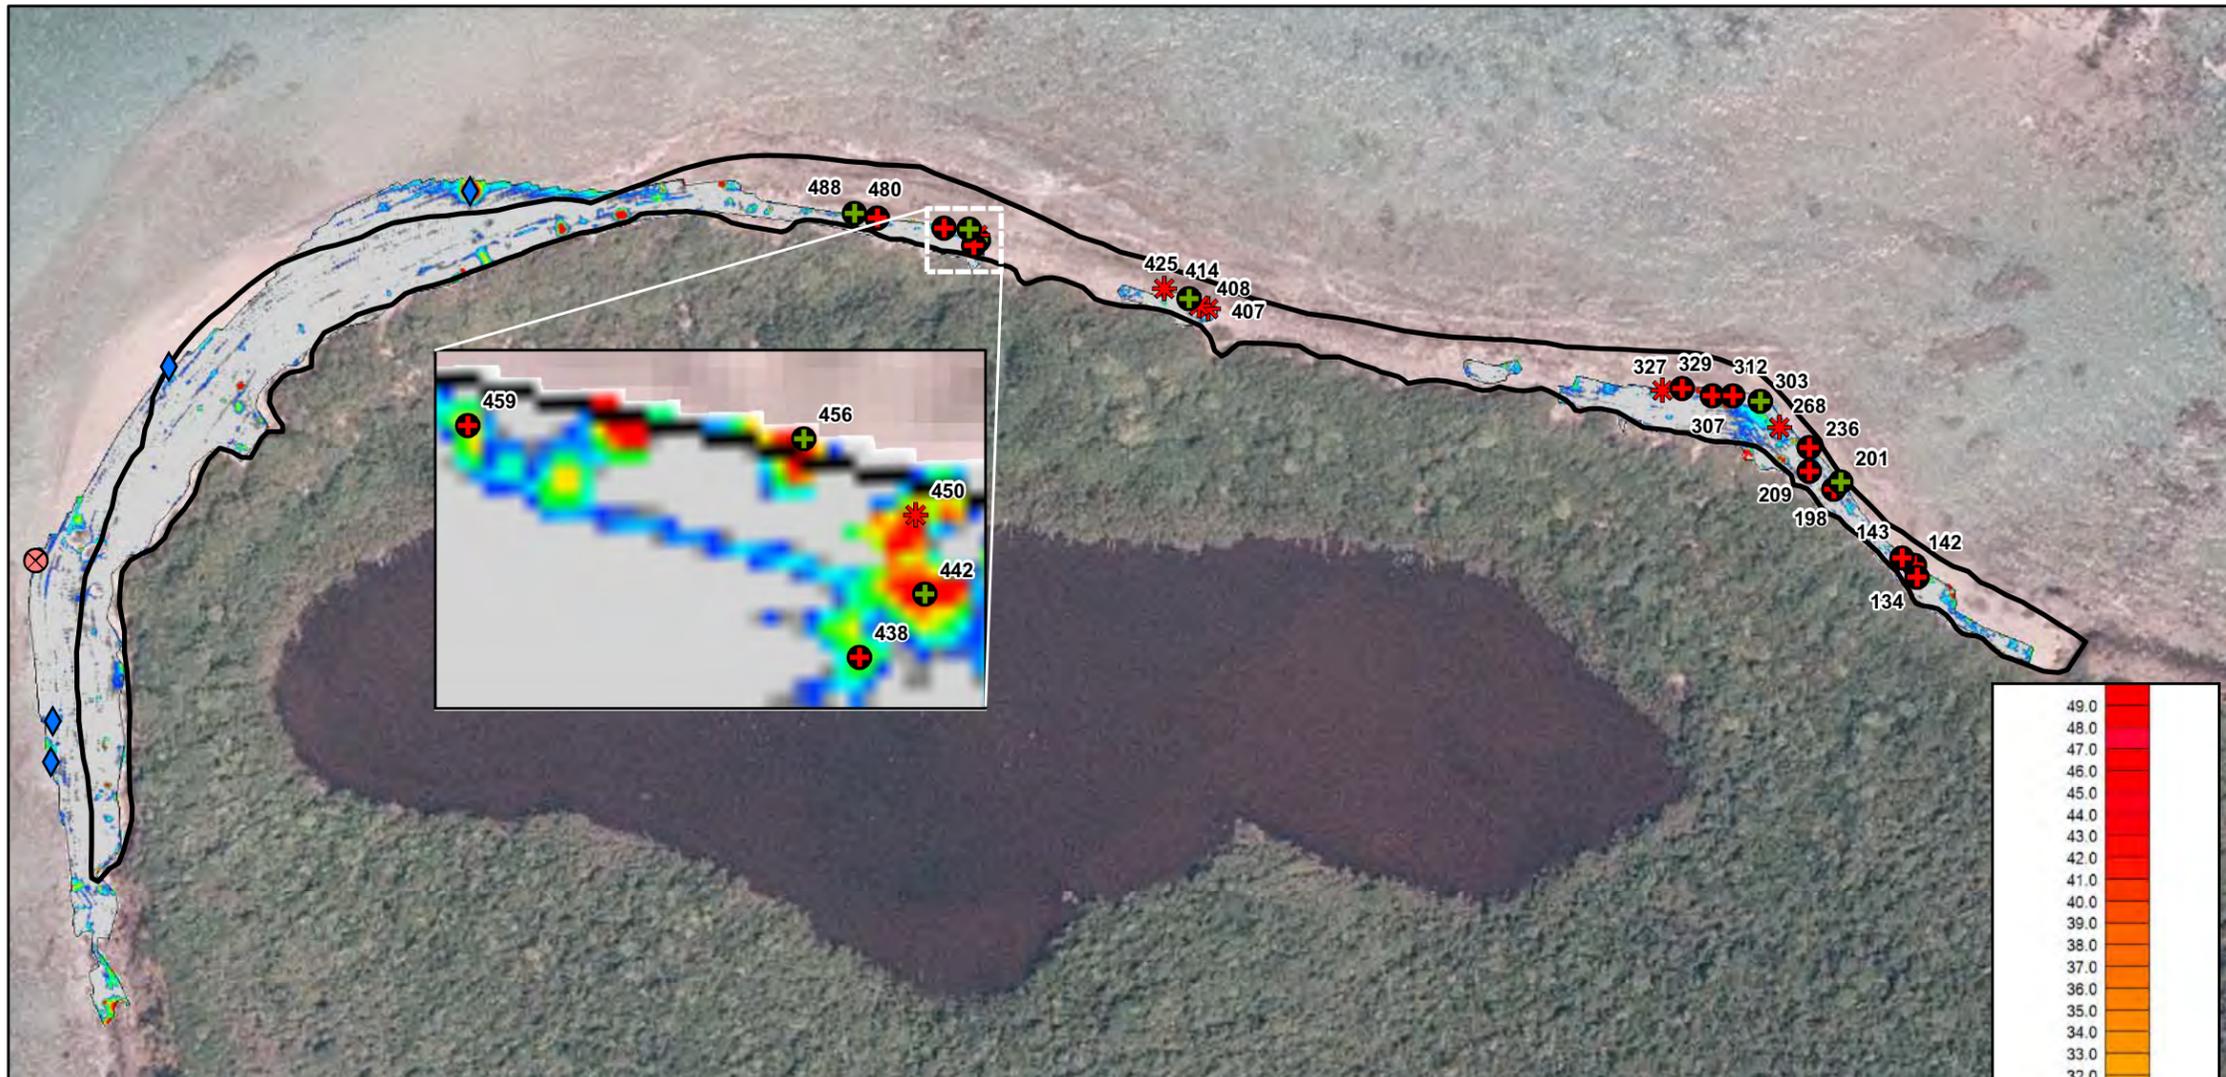
Anomaly ID	Anomaly Type	Anomaly Class	Description
134	75mm Base	MD	base of 75mm projo
142	75mm Base	MD	75mm base. Also: section of rebar and thin metal rod.
143	Fuze	MD	Piece of PTF fuze.
198	75mm	MD	lead balls from 75mm projo
201	20mm Projo	MPPEH	20mm projo, unfuzed, unknown filler
209	75mm Base	MD	75mm projo base
236	75mm Projo	MD	75mm projo, unfuzed, expended
268	20mm Projo	UXO	20mm HE projo, fuzed
303	20mm Projo	MPPEH	20mm projo, unfuzed, unknown filler.
307	75mm Base	MD	Base of 75mm. POLY 4
312	Fuze	MD	PTTF fuze, expended.
327	20mm Projo	UXO	20mm HE projo, fuzed.
329	Fuze	MD	PTTF fuze, expended
407	20mm Projo	UXO	20mm HE projo, fuzed.
408	20mm Projo	UXO	20mm HE projo, fuzed. Also large piece of fence.
414	20mm Projo	MPPEH	20mm projo, unfuzed, unknown filler.
425	20mm Projo	UXO	20mm HE projo, fuzed. Also 5 lbs of rebar taken from same target.
438	20mm cartridge	MD	20mm cartridge case, expended.
442	20mm Projo	MPPEH	2ea 20mm projos. One unfuzed, unknown filler. One TP.

450	20mm Projo	UXO	20mm HE projo, fuzed.
456	20mm Projo	MPPEH	20mm projo, unknown filler.
459	20mm Cartridge	MD	20mm cart, expended.
480	20mm Projo	MD	20mm projectile, empty, unfuzed
488	20mm Projo	MPPEH	20mm projo, unknown filler, unknown fuzing
