Final Remedial Investigation Report

Culebra Island Site Puerto Rico

**Soldado Point Mortar and Bombing Area (MRS 09) –
Project Number I02PR006809**

**Cayo Luis Peña Impact Area (MRS 13) –
Project Number I02PR006813**

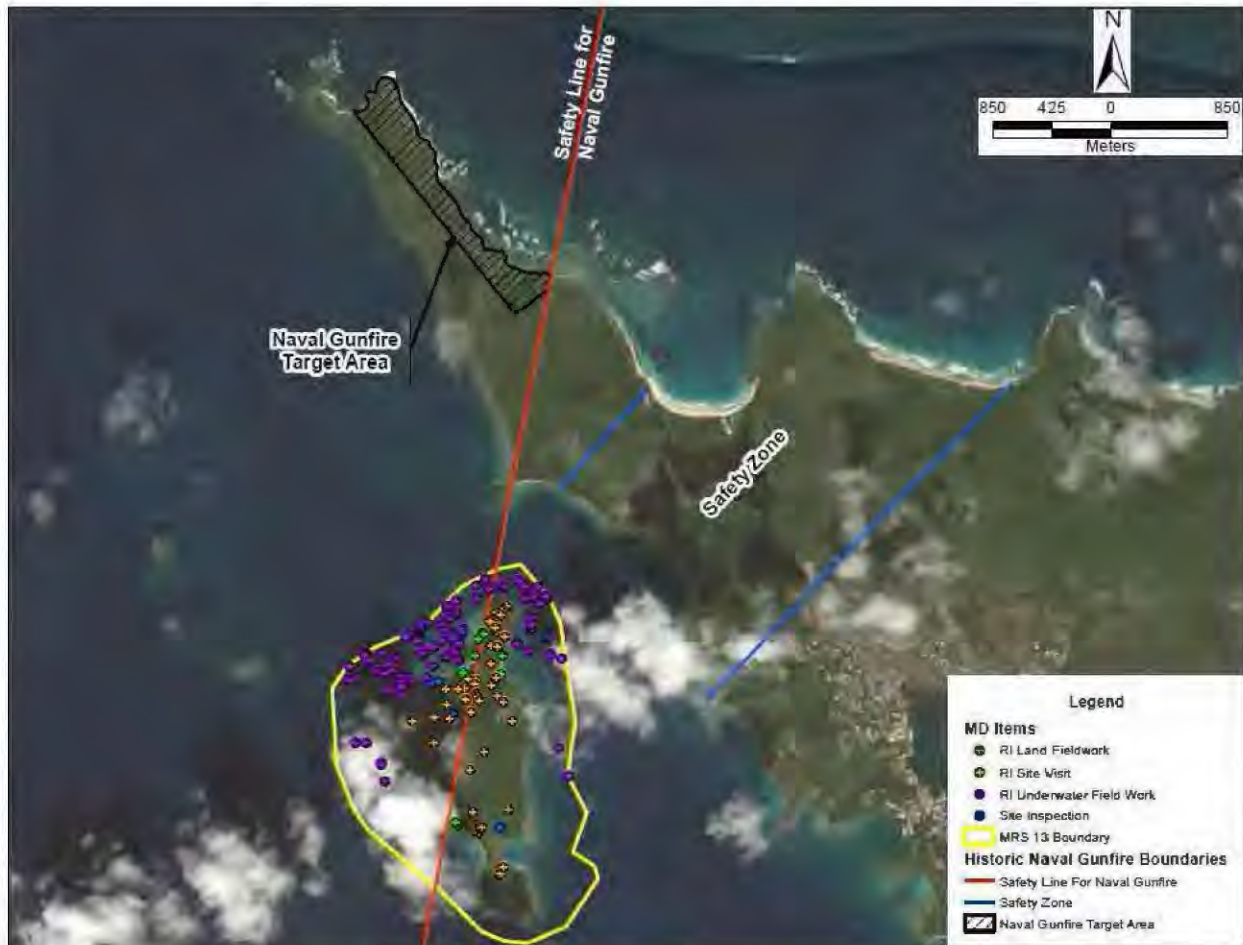
and disposed of as MEC. The Archive Search Report Findings for Culebra Island National Wildlife Refuge, Culebra, Puerto Rico (USACE 1995) describes the Naval Gunfire Target area on the NWP and identifies the safety line for Naval Gunfire which aligns with the MD items located in MRS 13 (see Figure ES-1).

Figure ES-1: Naval Gunfire Target Area

ES.5.4.1 In evaluating these findings, the most likely scenario that justifies the presence of the expended 5 inch illumination projectiles within the MRS 13 underwater acres is the result of Navy 5 inch illumination projectiles fired over the Naval Gunfire Target Area (located on NWP), functioning as designed and then deploying the illumination payloads to illuminate the NWP. The momentum and trajectory of the now empty illumination projectiles carried the munitions to the waters adjacent to Cayo Luis Peña. The presence of the expended illumination projectiles within the waters of MRS 13 was confirmed by the underwater RI investigation teams.

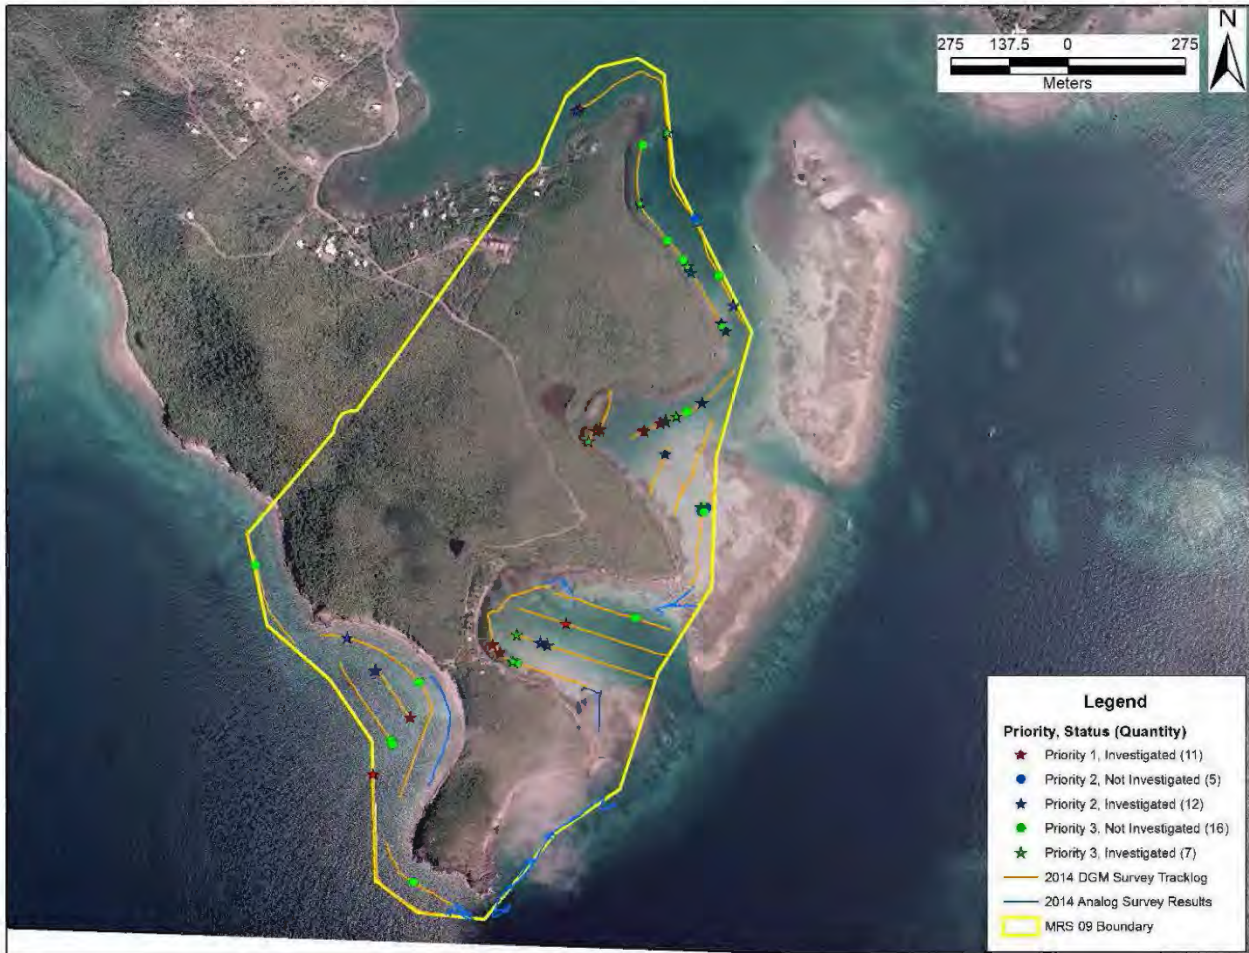
3.1.4.7 As a means to control the number of DGM transect anomalies investigated, the USA team investigated 100% of the Priority 1 anomalies, 50% of Priority 2 anomalies, and 20% of Priority 3 anomalies. In the selection of Priority 2 and 3 anomalies, the Project Geophysicist made recommendations for anomaly selection. Some revisions of those recommendations were made on site by the Project Manager, taking into account (1) areas of each Munitions Response Site where Munitions use had been documented, (2) areas that receive heavy use by tourists and the community, (3) restrictive sea state conditions, or (4) other cultural or natural resource interferences (i.e., considerations for anomalies within critical habitat and anomalies that may cause the closing and evacuation of recreational areas). Figure 3-5 and Figure 3-6 identify the locations of the DGM Priorities and if the DGM Priority was selected for intrusive investigation.

Figure 3-5: MRS 09 DGM Anomaly Priorities Selected for Investigation

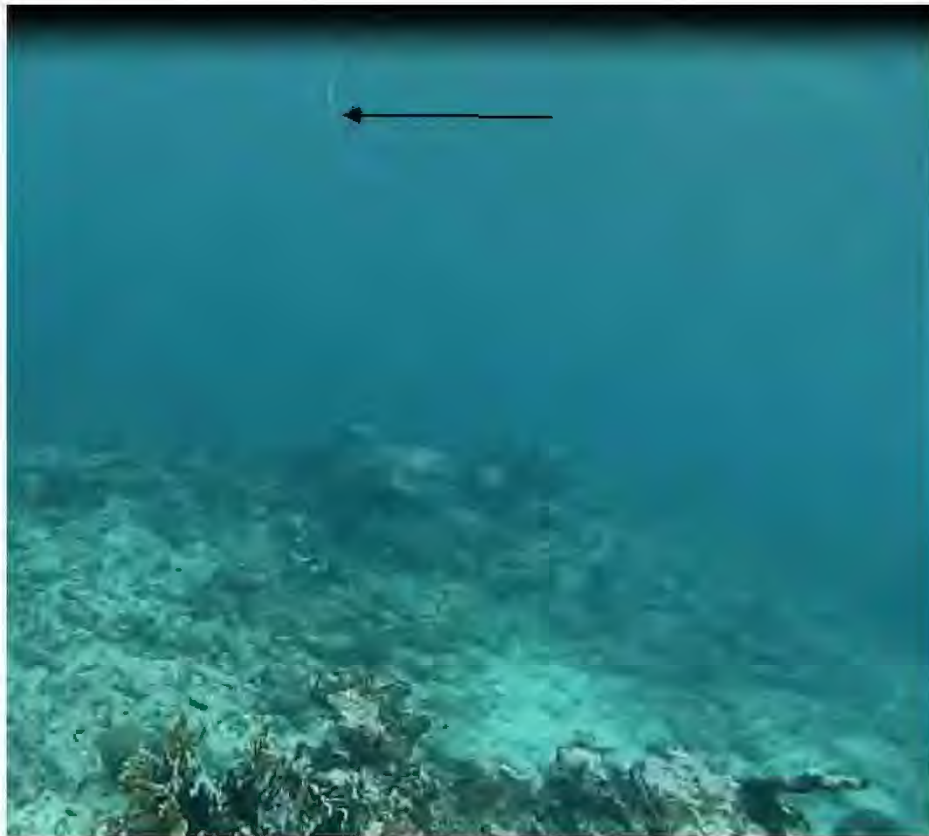
3.1.6.4 In order to track the distance and routes swum by the UXO Technicians, a Trimble GEOXT GPS was attached to the SCUBA divers with a polypropylene line and floated above them while they swam their underwater transect. When UXO Technicians were snorkeling a transect the Trimble GEOXT was placed on a swim board and the UXO Technicians pushed the board along the transect. To guide the UXO Technicians when they were in SCUBA along the proper route, a 100-ft polypropylene (floating) line was suspended in the middle or top of the water column between two clumps with buoys (see Figure 3-7). The UXO Technicians SCUBA Divers followed the line to ensure they stayed on the transect. The line and buoys were pulled upon completion of the transect segment and deployed at the next transect segment. This process continued until the survey of the transect was complete. Snorkeled transects required the use of a second GPS with waypoints programmed into the unit; the UXO Technicians followed the route as the Trimble GEOXT tracked the actual progress. At the end of each day, the Trimble GEOXT track log was uploaded to the USA GIS Manager and provided for QC review by the Project Geophysicist. On several occasions, the UXO Technicians swam outside of the 10-meter transect error allowed by the WP, requiring that segment in error to be reworked.

Figure 3-7: Polypropylene Floating Line Suspended over the UXO Technicians Marking the Transect Route

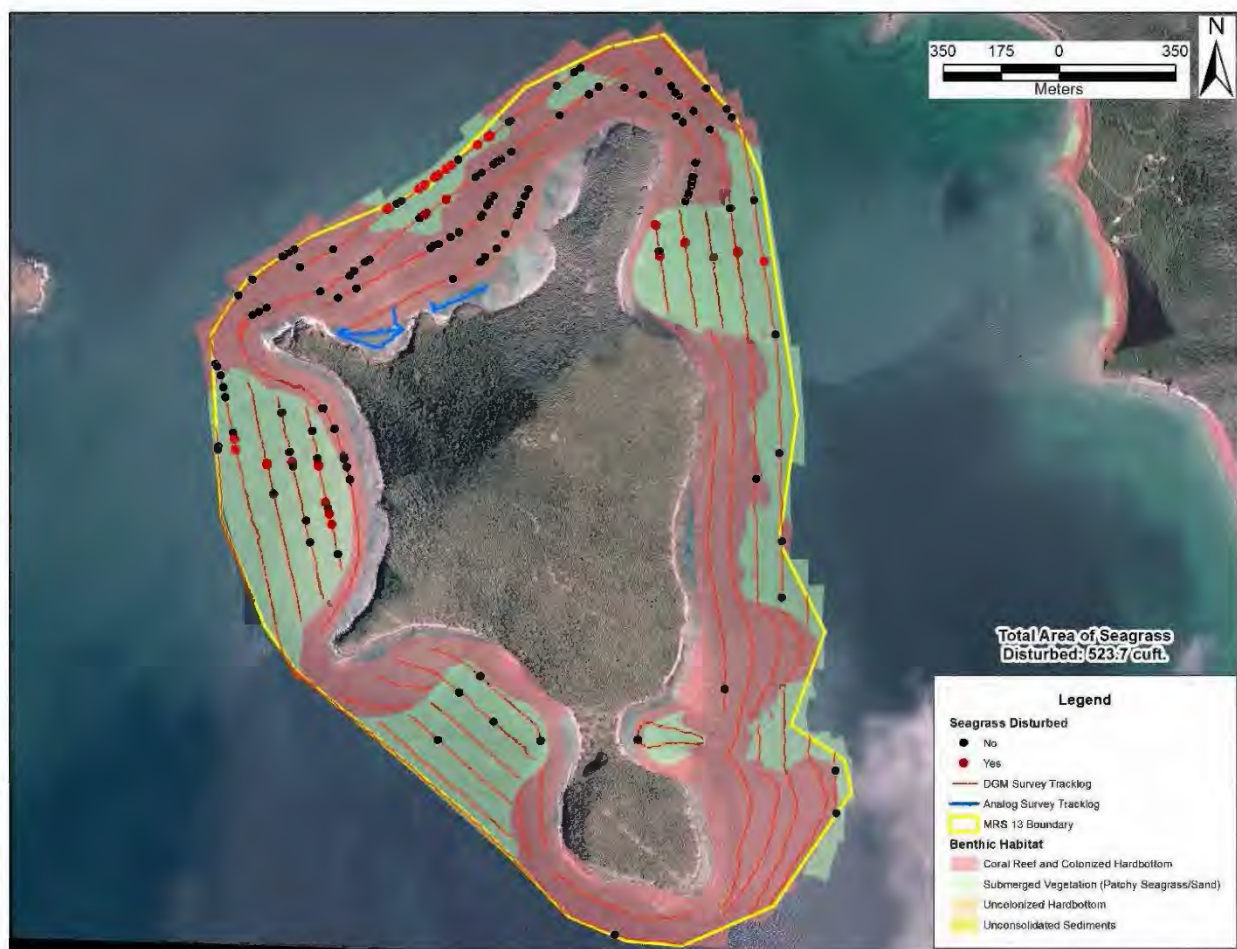
Figure 3-10: MRS 13 Disturbed Seagrass Areas

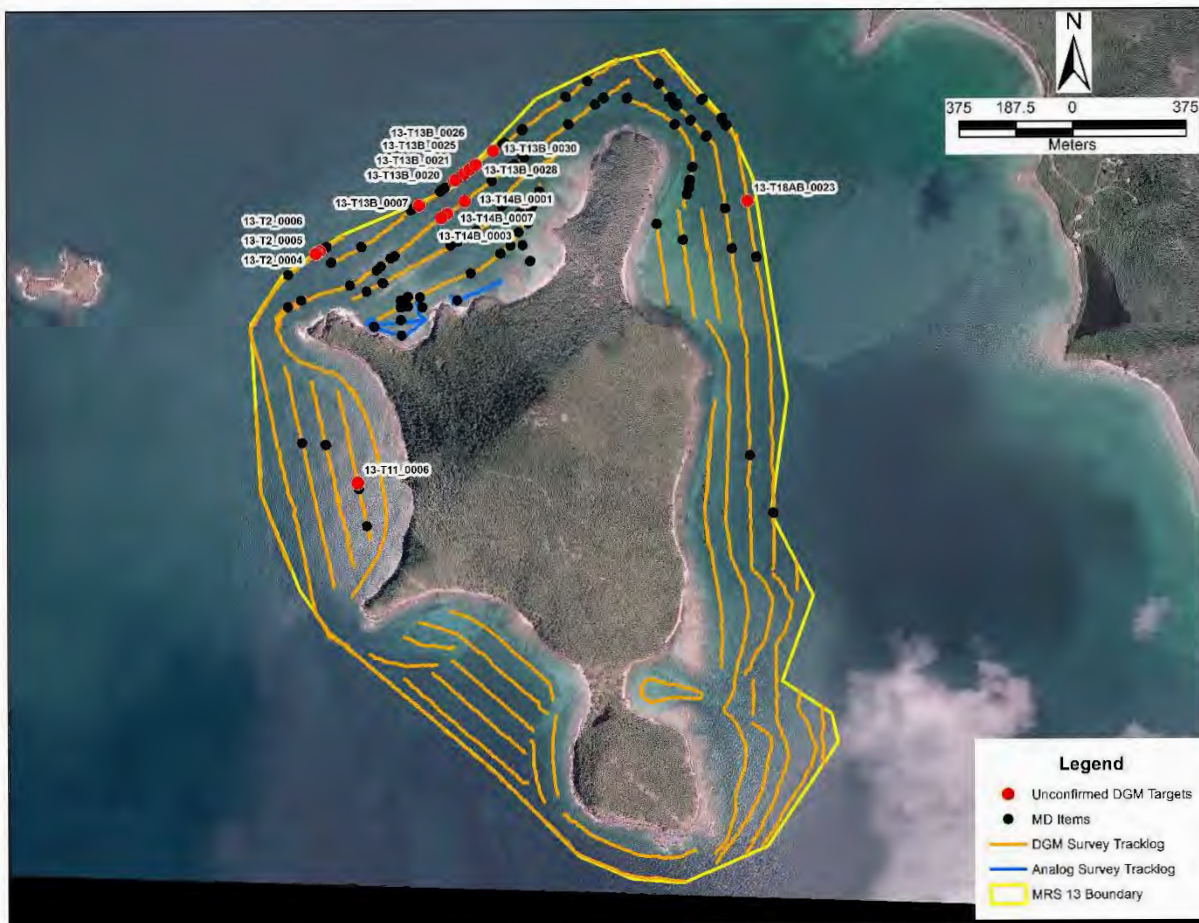
4.1.3.3 Within the estimated MEC/MD contamination area boundary, the depth of MD contamination was dependent on the bottom type (rock, coral, sand, etc.). MD discovered in rock and coral bottom types were found on the surface of the sea floor. In some cases, the MD item was partially or fully encrusted with coral or algae and on two occasions the MD item had become part of the rock bottom, almost fully engulfed. The deepest MD contamination was confirmed at 36 inches and MD was suspected to be present at deeper depths in the sand and unconsolidated sediment areas of MRS 13. The average depth of MD discovered within the unconsolidated sediment area was 4.57 inches. Forty MD items were excavated in the unconsolidated sediment areas of MRS 13. Figure 4-2 demonstrates the locations of the fifteen MD in unconsolidated sediment and DGM Targets that were too deep to excavate that could not be ruled out as MEC or MD.

Figure 4-2: Unconfirmed DGM Targets Selected for Intrusive Investigation

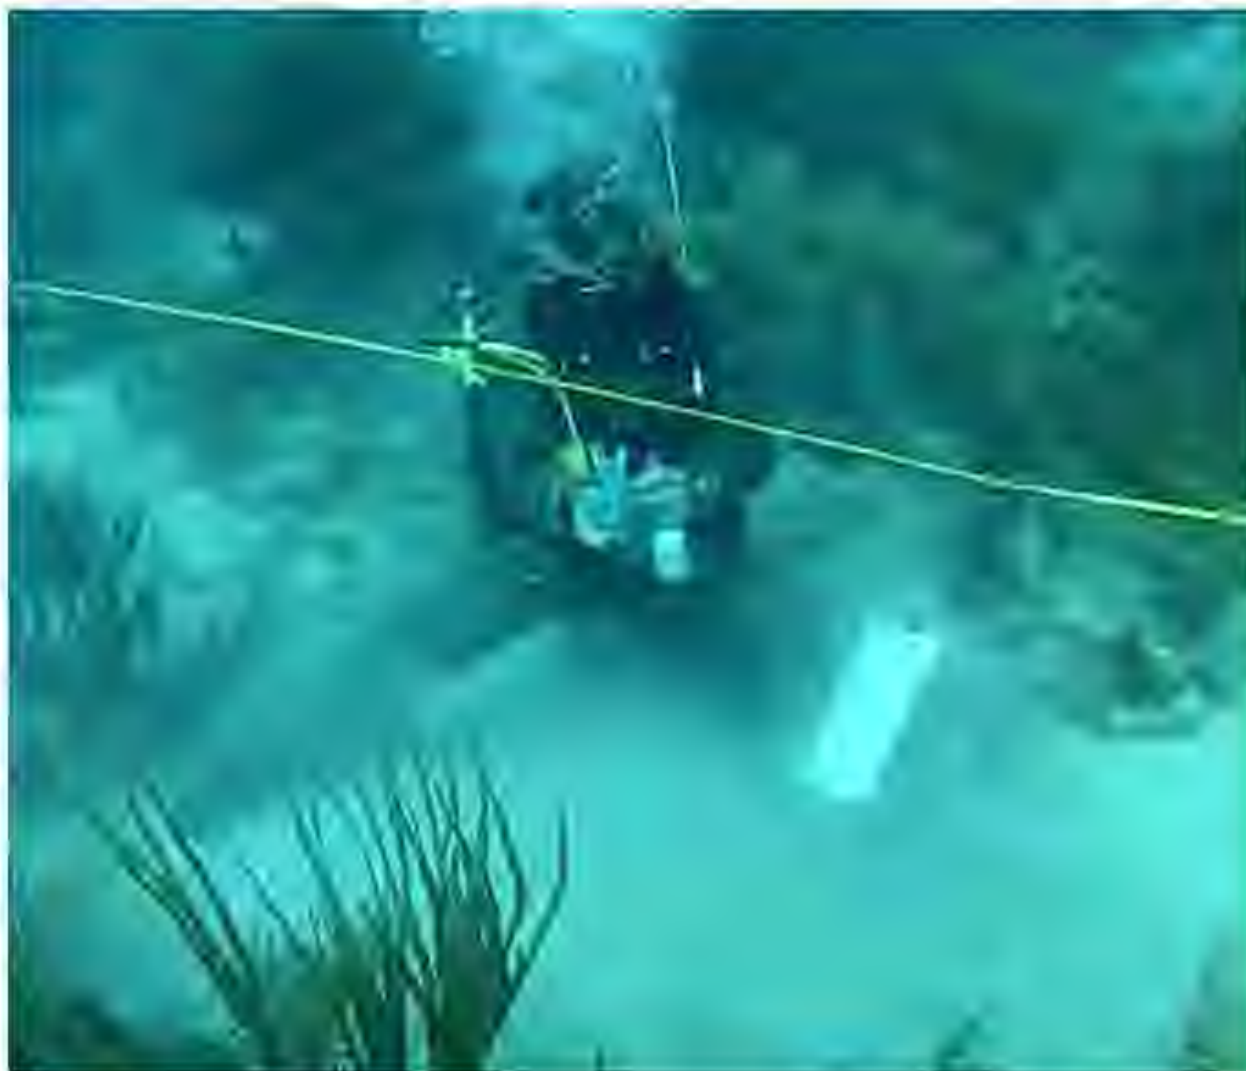
Appendix B: RI Maps Figure B-9, provides the location for the background samples collected. Figure 4-4 and Figure 4-5 show UXO Technician SCUBA Divers collecting background samples. Samples were collected with a sterile plastic scoop and placed in a 2-gallon zip-loc bag. The samples were then homogenized, quartered, and transferred from the plastic bag to a sterile glass jars on the surface. All samples were collected from a depth range of 0 to 6 inches below ground surface (bgs). If a munition was buried, the sample was collected from directly beneath the item immediately after removal. Analysis for background samples was for the same analytes as the investigative samples: explosives, MC metals (aluminum, antimony, barium, chromium, copper, lead, mercury, and zinc), and ammonium picrate (a breakdown product of Explosives D).

Figure 4-4: UXO Technician SCUBA Diver Prepares to Take a Background Sample

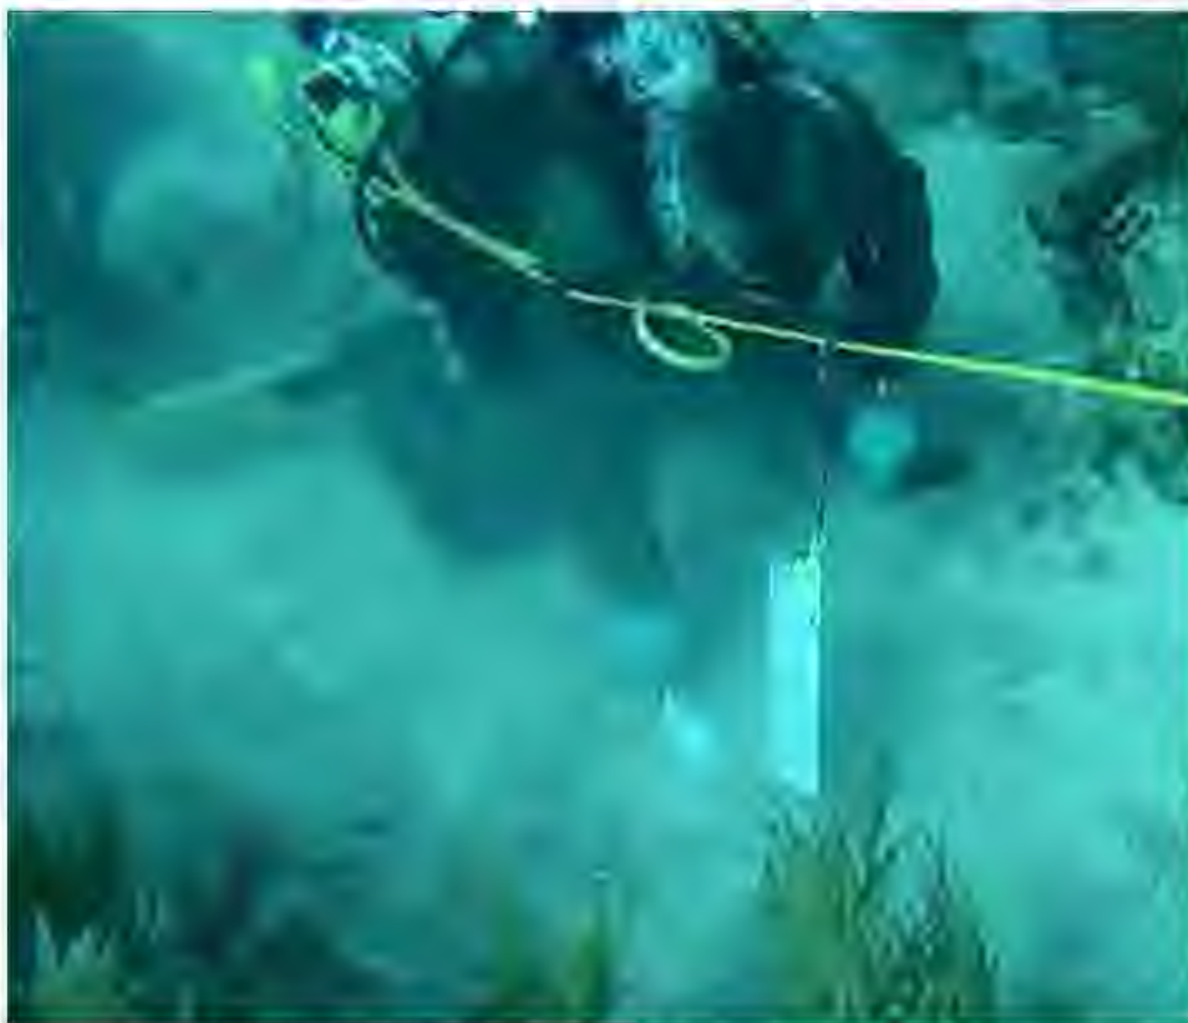
Figure 4-5: UXO Technician SCUBA Diver Collects a Marine Sediment Background Sample

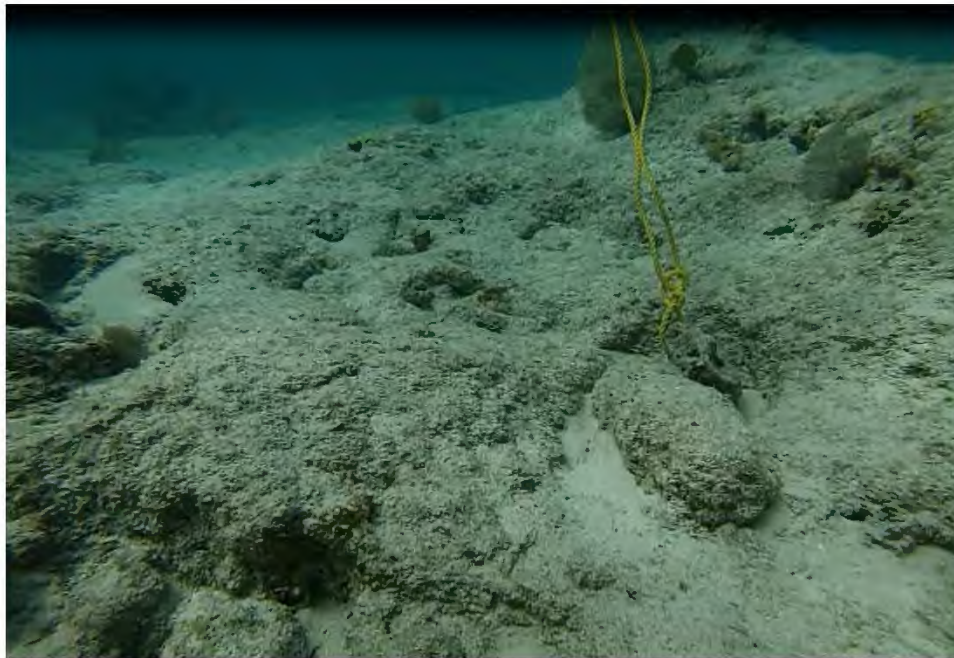
4.1.4.2.3 Figure 4-6 and Figure 4-7 show UXO Technician SCUBA Divers collecting marine sediment samples. Samples were collected with a sterile plastic scoop and placed in a plastic bag. The samples were then transferred from the plastic bag to a sterile glass jar on the surface. All samples were collected from a depth range of 0 to 6 inches bgs. If a munition was buried, it was collected from directly beneath the item. Analysis was for explosives, MC metals (aluminum, antimony, barium, chromium, copper, lead, mercury, and zinc), and ammonium picrate (a breakdown product of Explosives D).

**Figure 4-6: MD Item (ITEM 12/Sample number PR-1404-SDM-13-14A)
Selected for a Discrete Marine Sediment Sample**

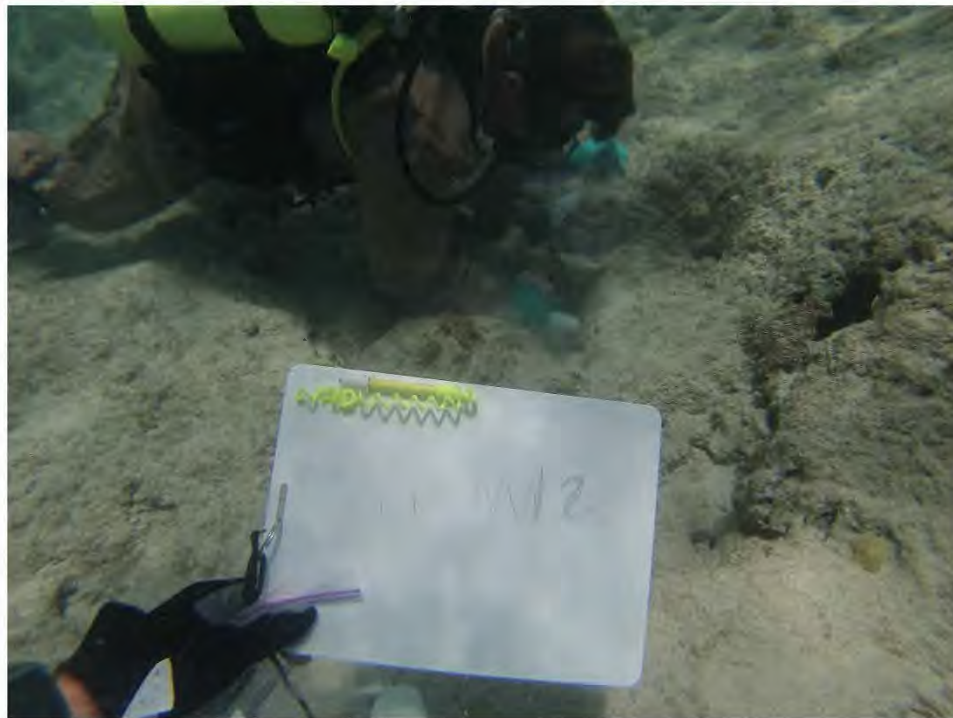
**Figure 4-7: UXO Technician SCUBA Diver Collects a Discrete Marine Sediment Sample
(ITEM 12/Sample number PR-1404-SDM-13-14A was moved to collect the sample)**

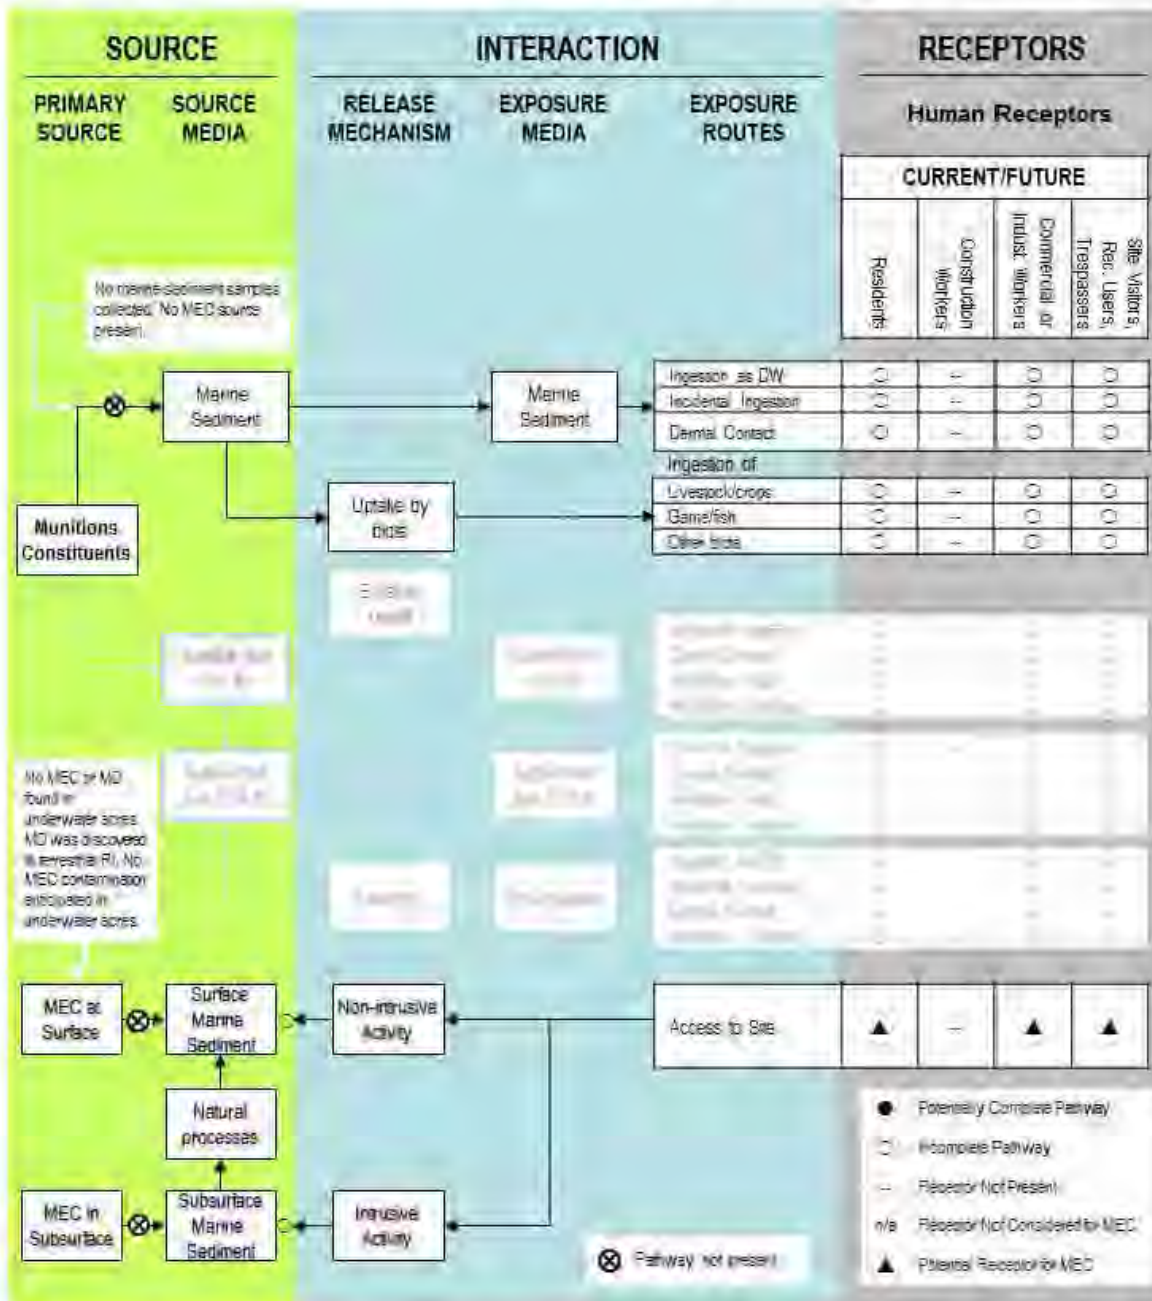
Figure 4-8: Revised MRS 09 Human Conceptual Site Exposure Model

Conceptual Site Exposure Model Diagram

4.2.3.1 Potential exposure pathways to both human and ecological receptors are presented below and summarized on the CSEMs presented in Figures 4-8 through 4-11.

4.2.3.2 MRS 09: No MEC or MD were found during the underwater MEC investigation of MRS 09 and only minimal amounts of MD were found in the terrestrial investigation. Since there is no source present there can be no exposure pathways for MEC/MC contamination in the MRS.
