**FLORIDA INLAND NAVIGATION DISTRICT
DREDGE MATERIAL MANAGEMENT AREA
IR-2 MITIGATION AREA**

First Annual Mitigation Monitoring Report

**FDEP Permit #s 56-0255662-001, 31-0273920-001-EI, 31-
0273920-003-EM**

April 2014

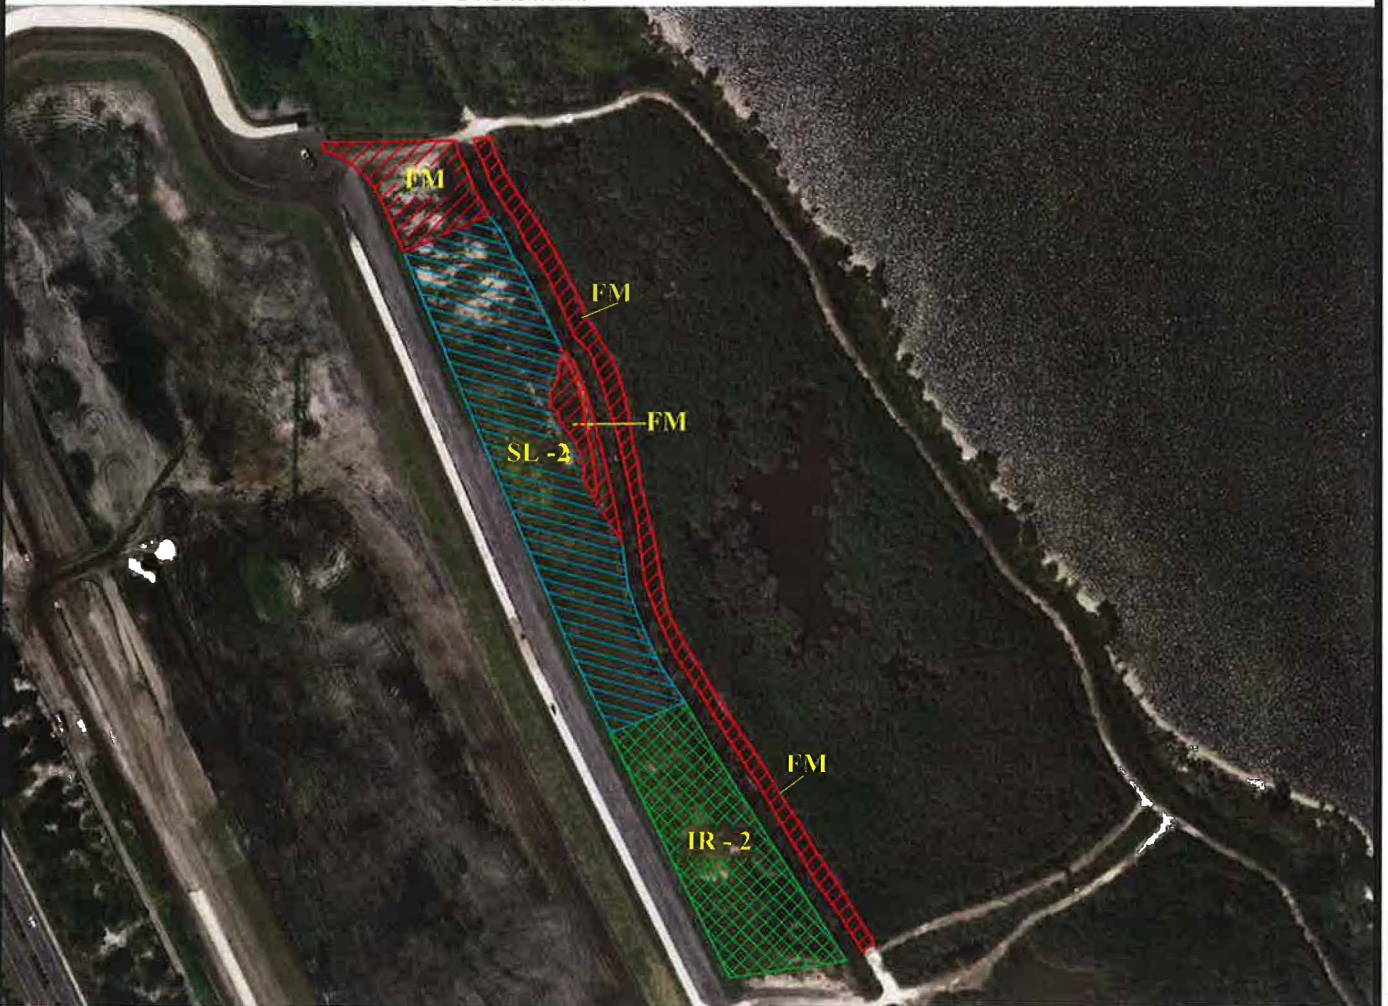
**FLORIDA INLAND NAVIGATION DISTRICT
DMMA IR - 2 MITIGATION AREA
FIRST ANNUAL MITIGATION MONITORING REPORT
MITIGATION AREAS, IR - 2, SL - 2 AND FUTURE MITIGATION**

The Florida Inland Navigation District (FIND) Dredge Material Management Area (DMMA) IR-2 mitigation area consists of approximately +/- 7.18 acres of land located north of CR 510, east of Federal Highway, and west of the Indian River Lagoon in Section 20, Township 31S, Range 39E, Sebastian, Indian River County, Florida (Figures 1, 2 and 3 of 9). The mitigation area is divided into three (3) areas: a mitigation area of 1.55 acres for DMMA IR-2 construction impacts, a mitigation area of 2.80 acres for DMMA SL-2 construction impacts and a 1.60 acre area for advanced mitigation of future impacts (Figure 4 -6 of 9).
