**Compensatory Wetland Mitigation Plan**  
Improvements for Shore Protection  
Highway 187 at Piñones,  
Loíza, Puerto Rico

**September 2013**

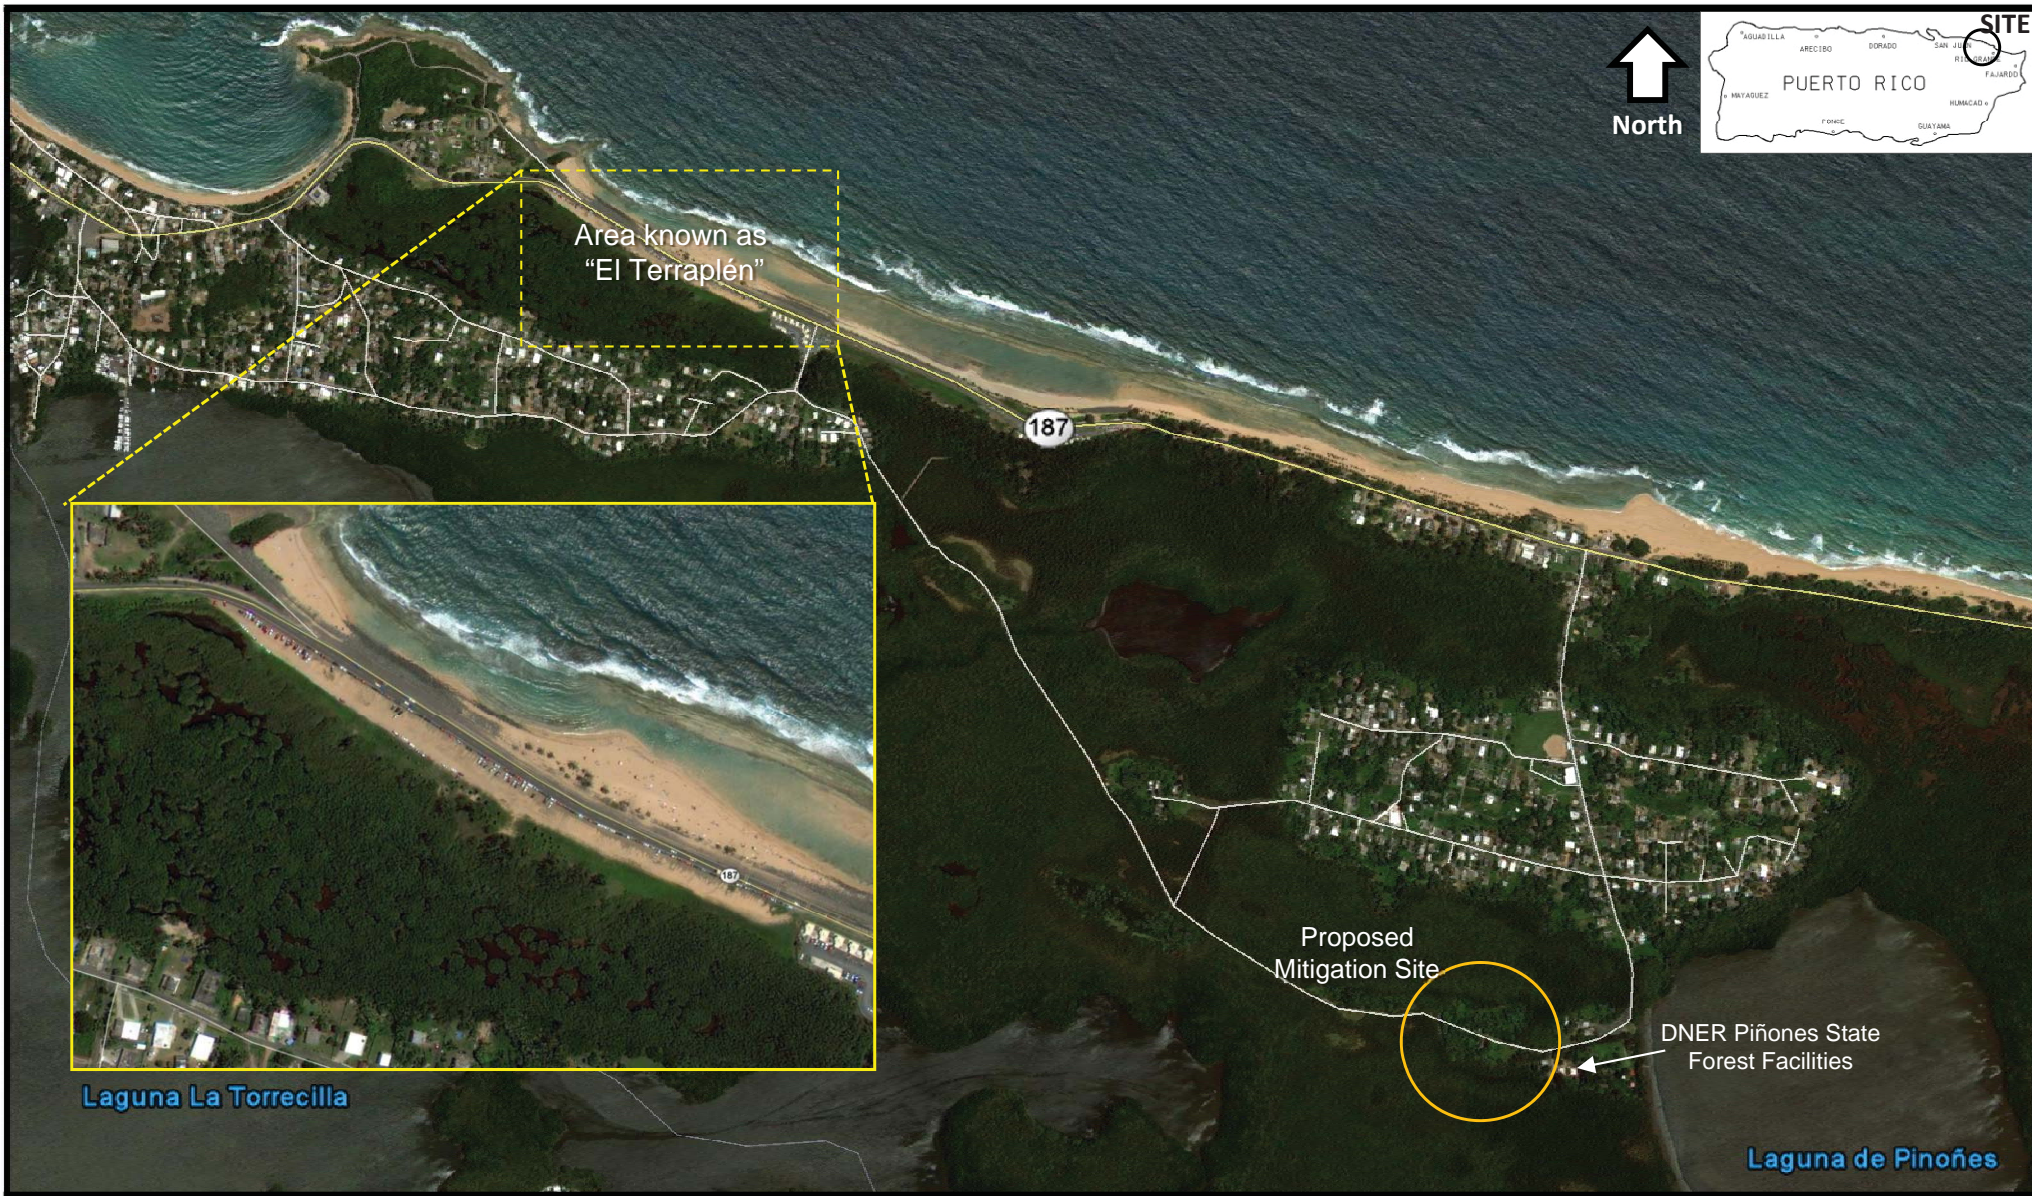
**Figure 1: Site Location "El Terraplén"**

- a) Location: The proposed mitigation site is an upland parcel located next (west) to the Piñones State Forest facilities (**Figures 1 and 2**).
- b) Soils: There are two different soils found within the mitigation site. They are Corcega sandy loam (Cs) and Tidal swamp (Ts). The site is dominated by Cs (**Figure 3**). Both are described as frequently flooded.

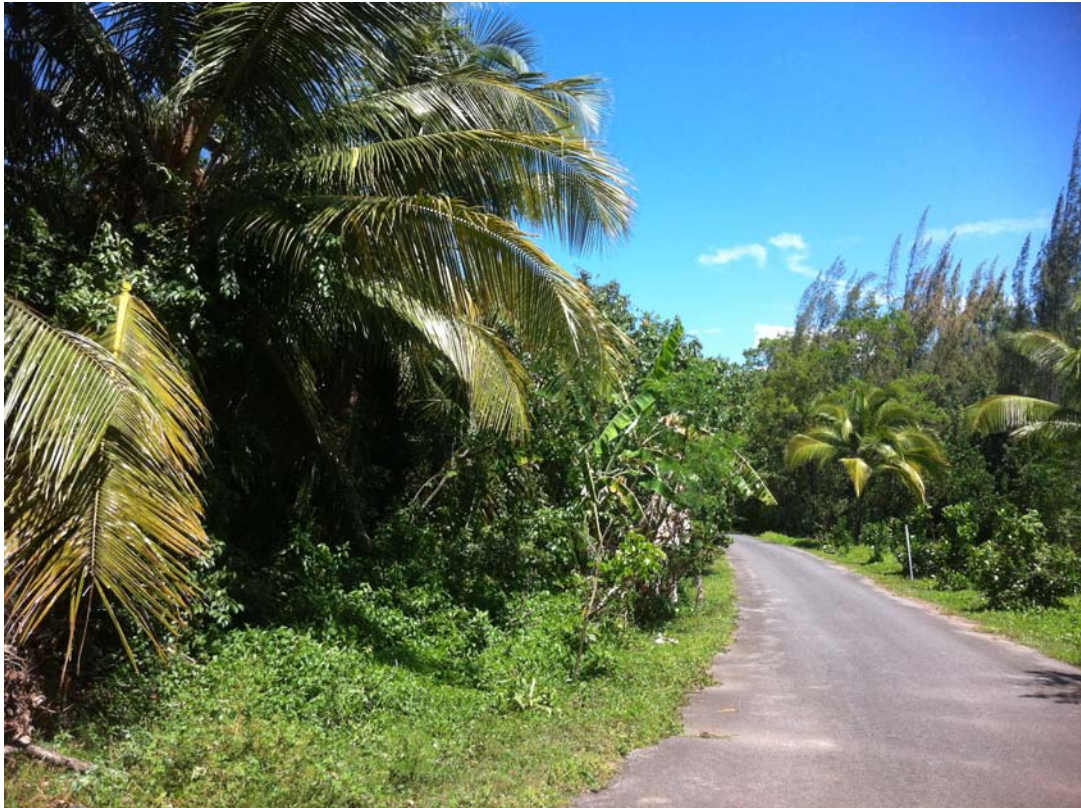
**Figure 4. Mitigation site landscape.**

- c) Vegetation: The site is bordered by mangroves and the landscape is dominated by a mix of coastal trees such as coconut palm (*Cocos nucifera*), tropical almond (*Terminalia catappa*), Australian pine (*Casuarina equisetifolia*), and mango (*Mangifera indica*) trees (**Figure 4**). Several Ceiba (*Ceiba pentandra*) trees were observed within the site and they will be marked and protected as part of the mitigation project.

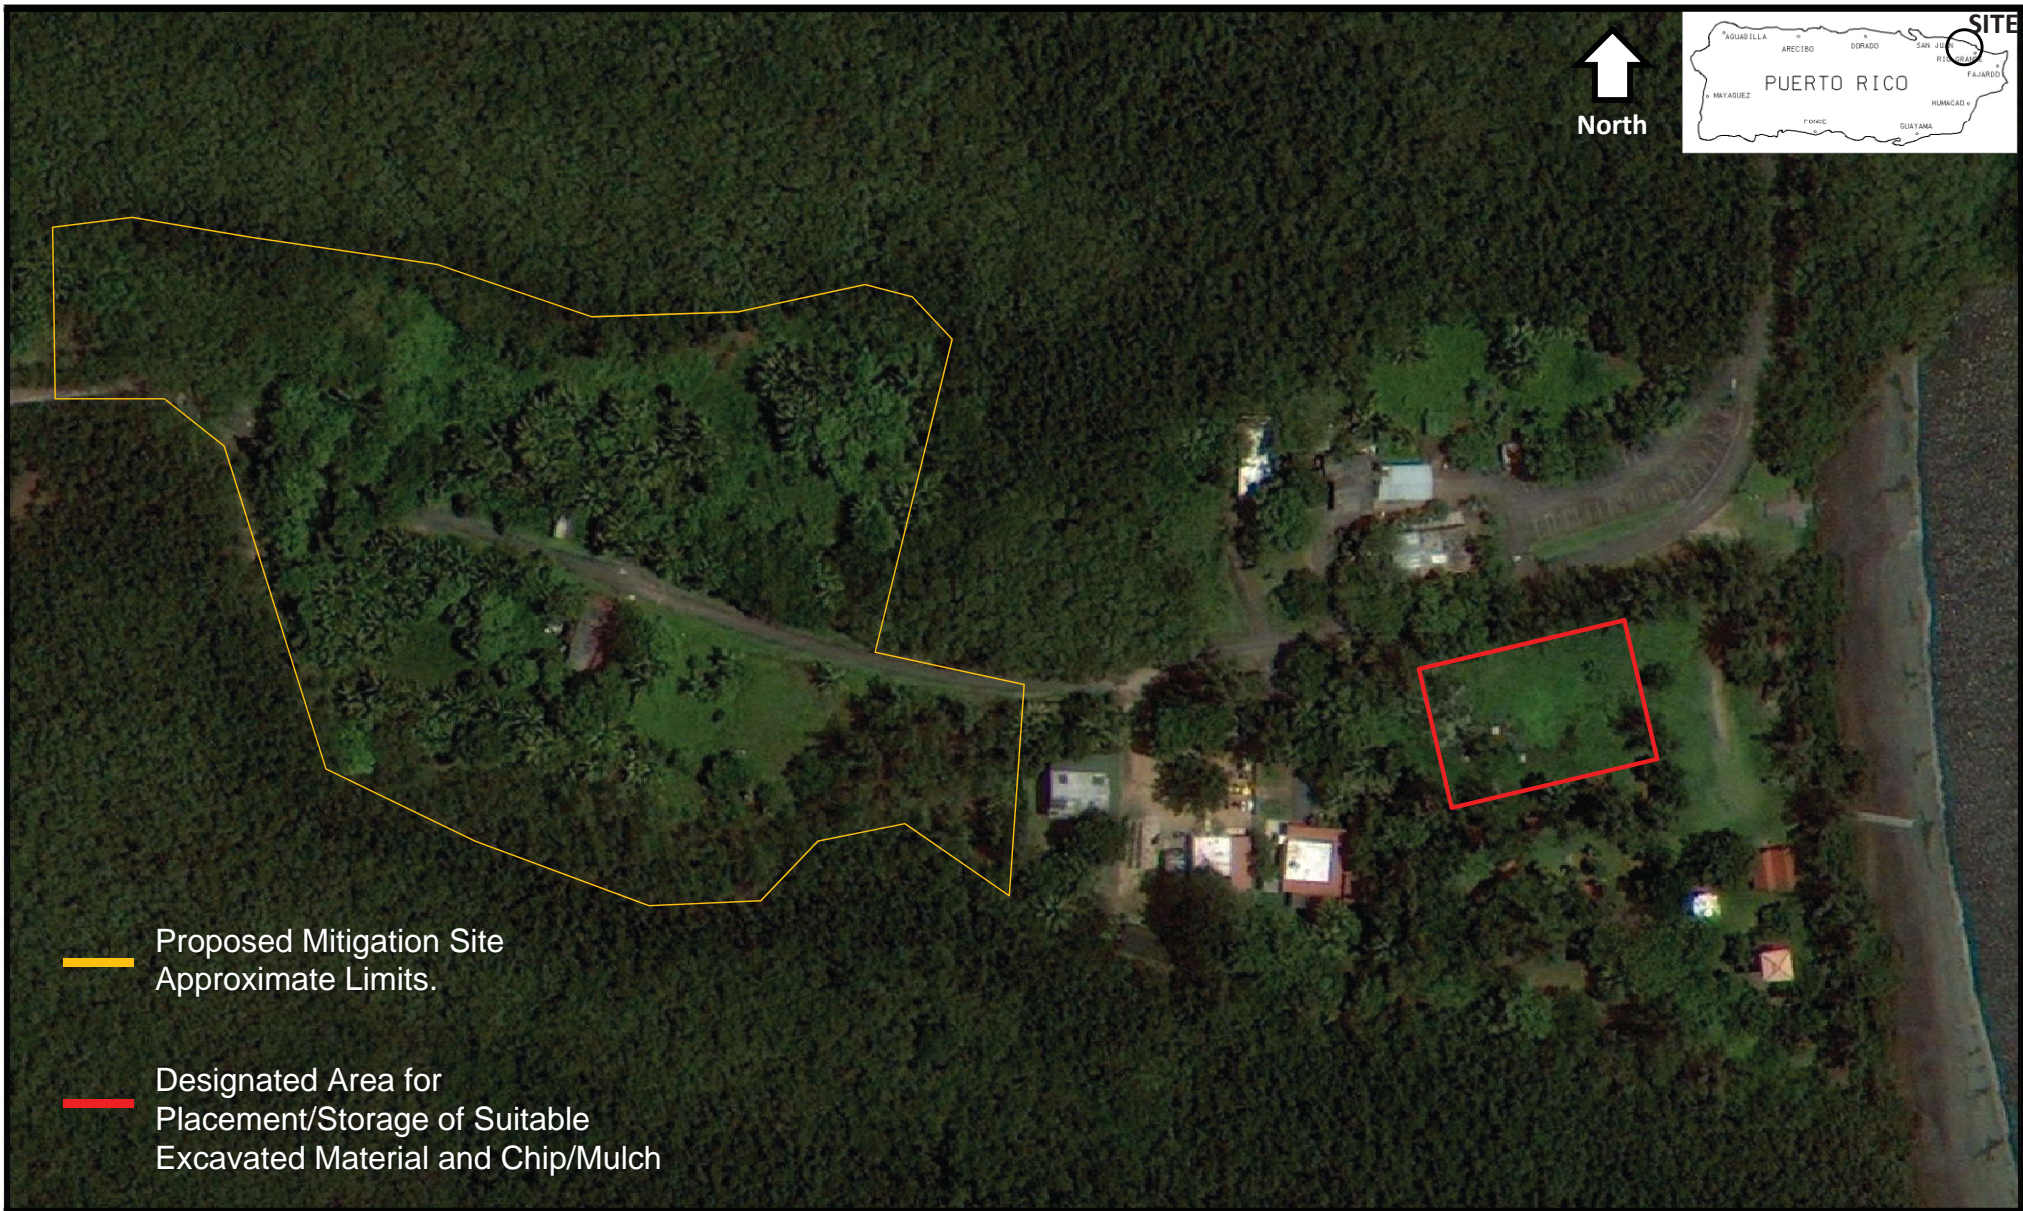
**Figure 6: Designated Area for Placement/Storage of  
 Excavated Suitable Material and Chip/Mulch**

- 4) Suitable excavated material (soil/sand) without debris (or solid waste) will be placed at the designated area for its beneficial use by DNER to restore erosion areas within the forest (**Figure 6**). All unsuitable material (e.g. slag, cinders, garbage and debris) will be disposed of off-site in an approved solid waste disposal facility.

- 5) Chipping/mulching of vegetative material: A portable grinder will be used to chip all vegetative material into 1 to 2 inch diameter sized chip/mulch. The resultant mulch will be left at the designated area for the use of DNER. There is a small stand of Australian pines within the proposed mitigation site. They will be cut, chipped and disposed of off-site in an approved facility.
