**FINAL
MITIGATION PLAN**

**MARINE BENTHIC RESOURCE SURVEY
FORT SAN GERONIMO
SAN JUAN, PUERTO RICO**

**CONTRACT NUMBER: W912EP-08-D-0004
TASK ORDER NUMBER: 0013**

AEROSTAR Project Number 0110-510-19
February 2011

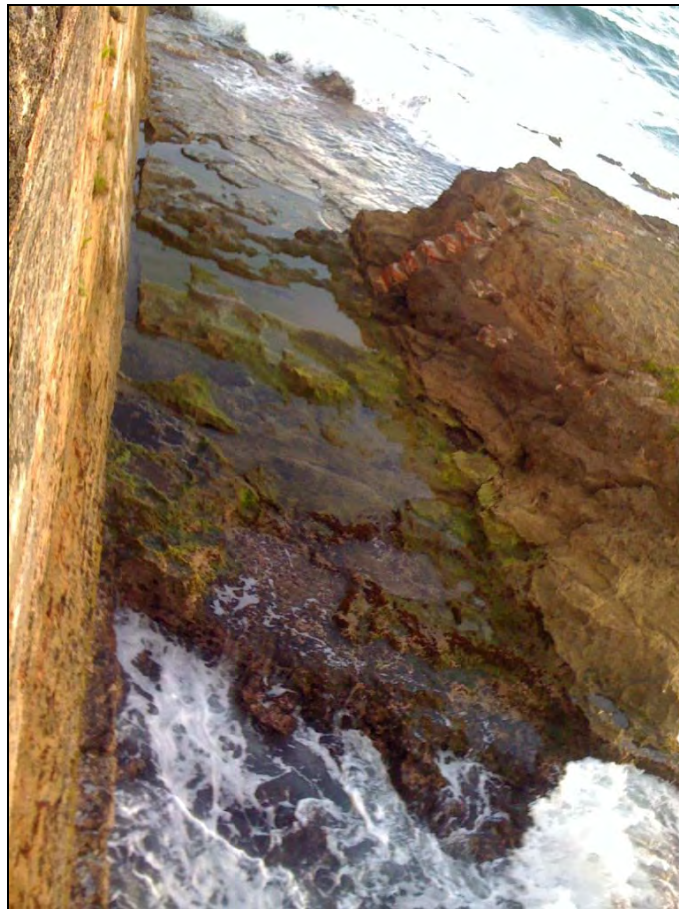
Image 1. View along the eastern wall of the Fort, facing north. Note the turf algae coating the exposed, rocky platform between the Fort's eastern wall (left) and the exposed island (right).

The eastern wall of the Fort experienced heavy wave action during the entire survey period. In order to maintain diver safety and equipment integrity, benthic survey data were not collected along the eastern wall of the Fort structure. Visual observation of the area revealed a rocky, partially exposed platform between the Fort structure and the emergent island. This revetment was subject to heavy wave action and covered with turf algae. No corals were observed in this area.

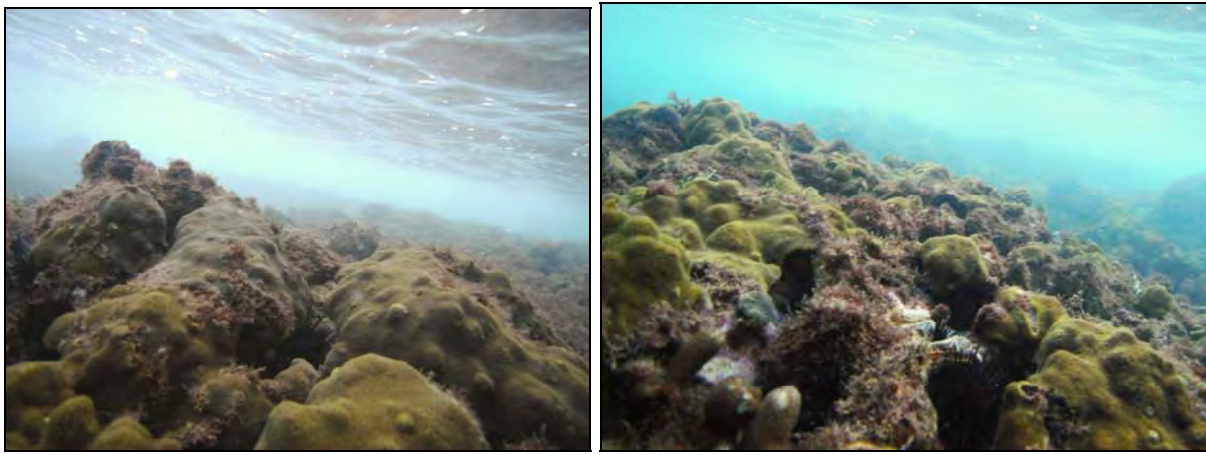
Images 2 and 3. Coral community assemblage at the northeastern corner of the Fort.

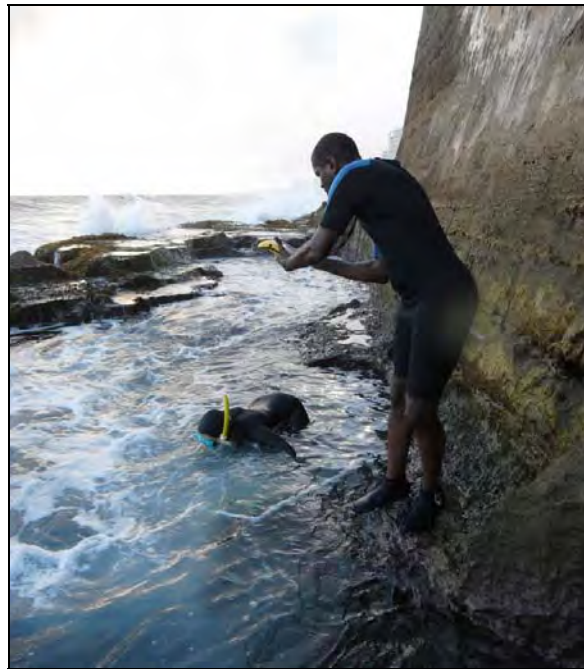
Image 4. Biologist conducts quadrat survey at the northeastern corner of the Fort. Quadrat location is documented using a Trimble DGPS unit.

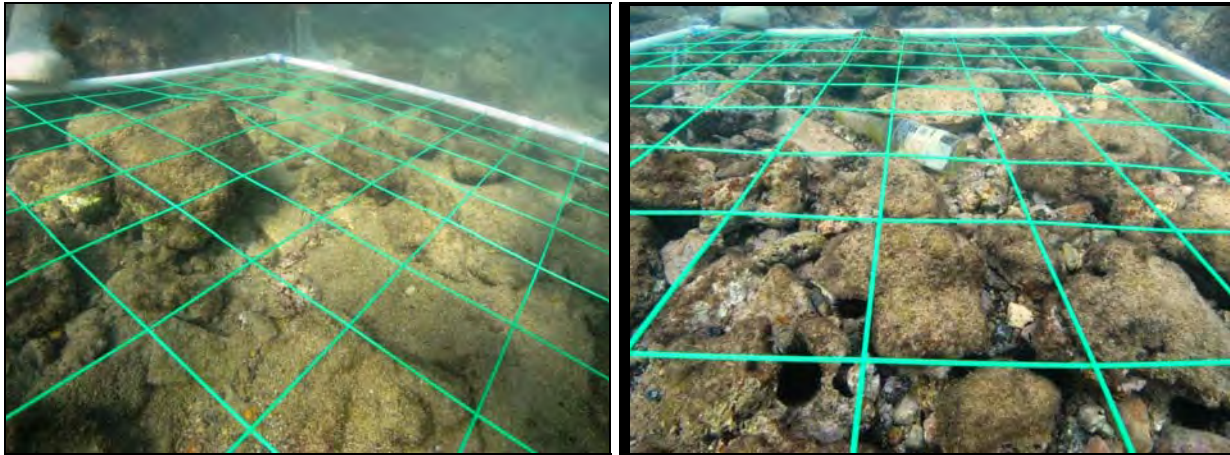
Images 5 and 6. Quadrats conducted in the area of rubble and sand located south of the Fort bridge and west of the relic caisson structure of the Fort. Figure 2 details the quadrat locations.

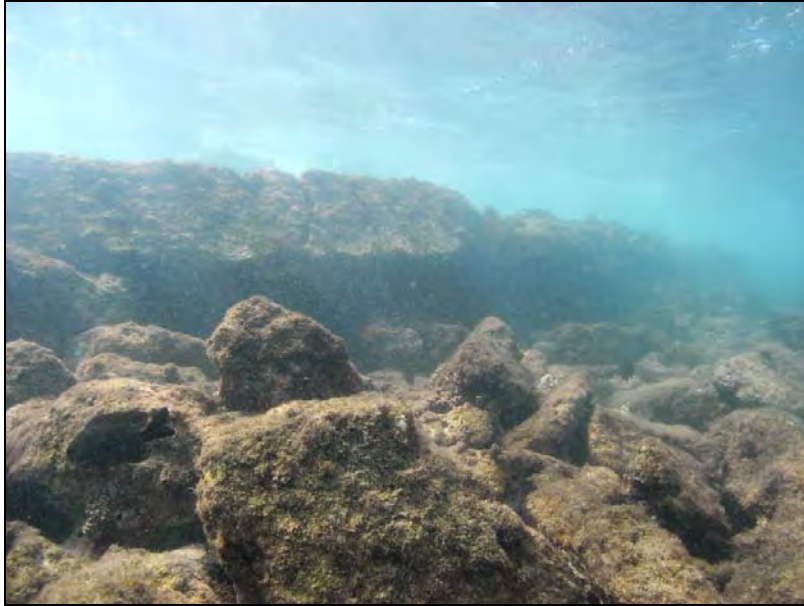
Image 7. Photograph (facing west) of the relic caisson structure and rubble/boulders located adjacent to it.

East of the relic caisson structure (Image 7), a solid rocky platform with unconsolidated rubble and boulders projected horizontally out from the southern wall of the Fort (Images 8 and 9). This community was dominated by macroalgae and turf algae, sponges, and occasional small corals.

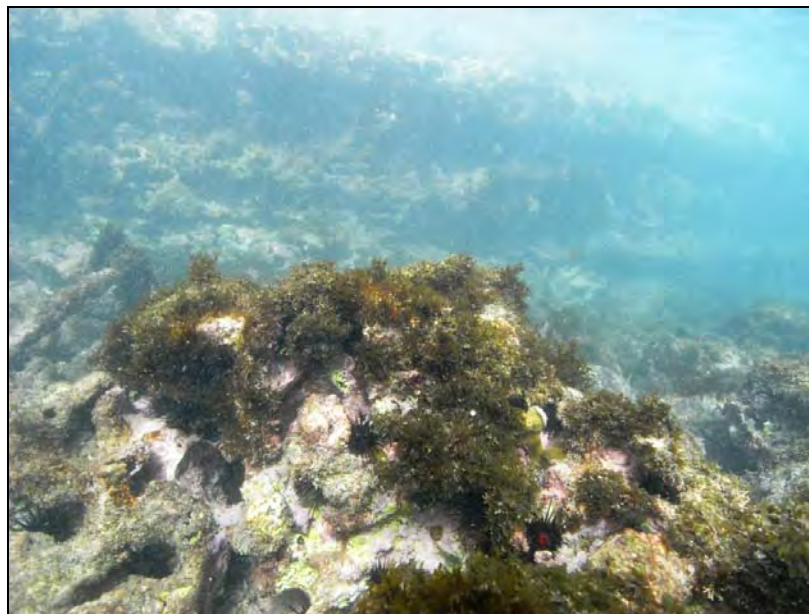
Image 8. Photograph of the Fort's southern wall, facing north-northeast. The wall is visible in the background.

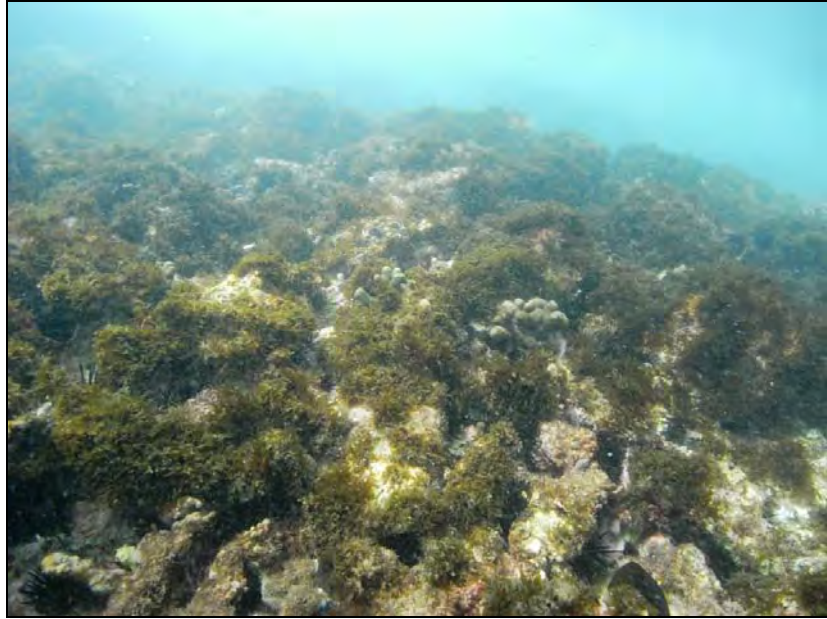
Image 9. Photograph (facing west) of the rocky solid slab revetment adjacent to the Fort's southern wall. The benthic community in this area is dominated by the macroalgae, *Dictyota* sp., with occasional coral colonies.

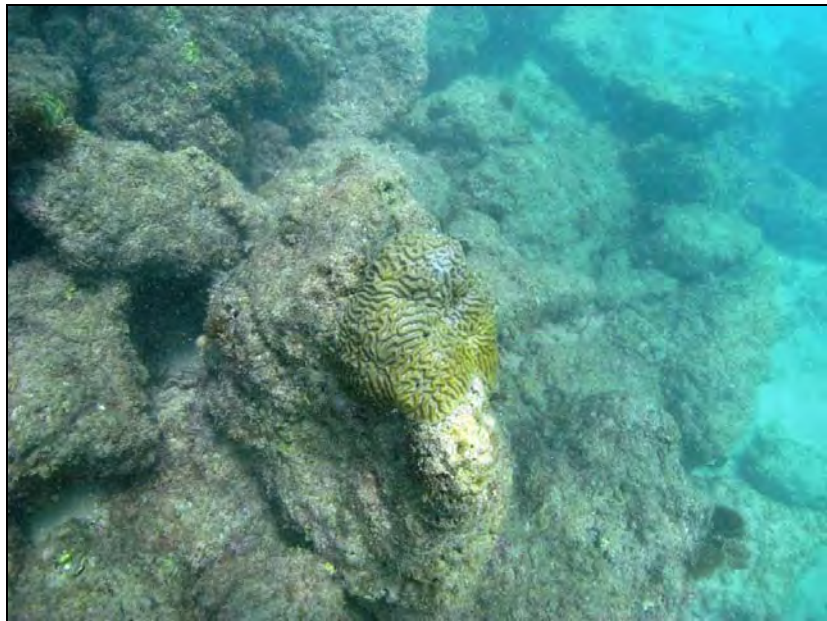
Image 10. Photograph of the area of unconsolidated rubble and large boulders that sloped down into sand.

Moving away from the Fort, the solid slab transitioned to unconsolidated rubble and large boulders and sloped down into sand (Image 10). Individual coral colonies were mapped and a video transect was conducted in this area.

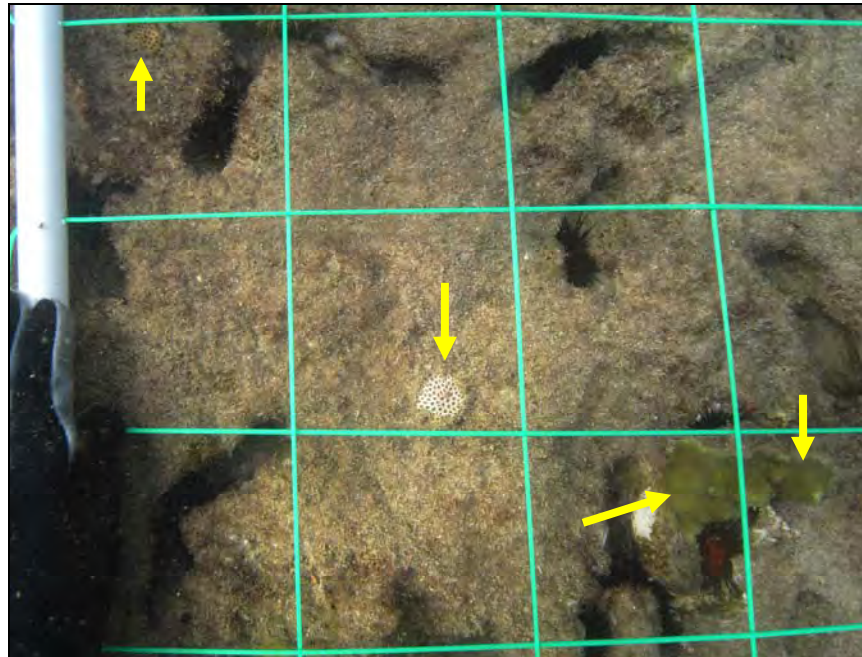
Image 11. Photograph of a portion of a quadrat conducted on the north side of the Fort. Arrows indicate the corals identified and documented by the biologist to estimate percent cover of coral.

During quadrat data collection, the biologist recorded the total number of cells containing coral (each cell representing 1% of the quadrat) to determine the total percent cover of coral within the quadrat (Image 11). In addition, the biologist recorded the total number of cells occupied by each individual coral species to estimate the percent cover by species. It should be noted that this method may provide an overestimation of the actual percent cover because it does not distinguish between those 10 cm^2 cells that are only partially occupied by coral and those cells that are entirely occupied by coral. The quadrat data were entered into Microsoft Excel spreadsheets and analyzed to determine the mean percent cover of coral and percent cover by individual coral species.

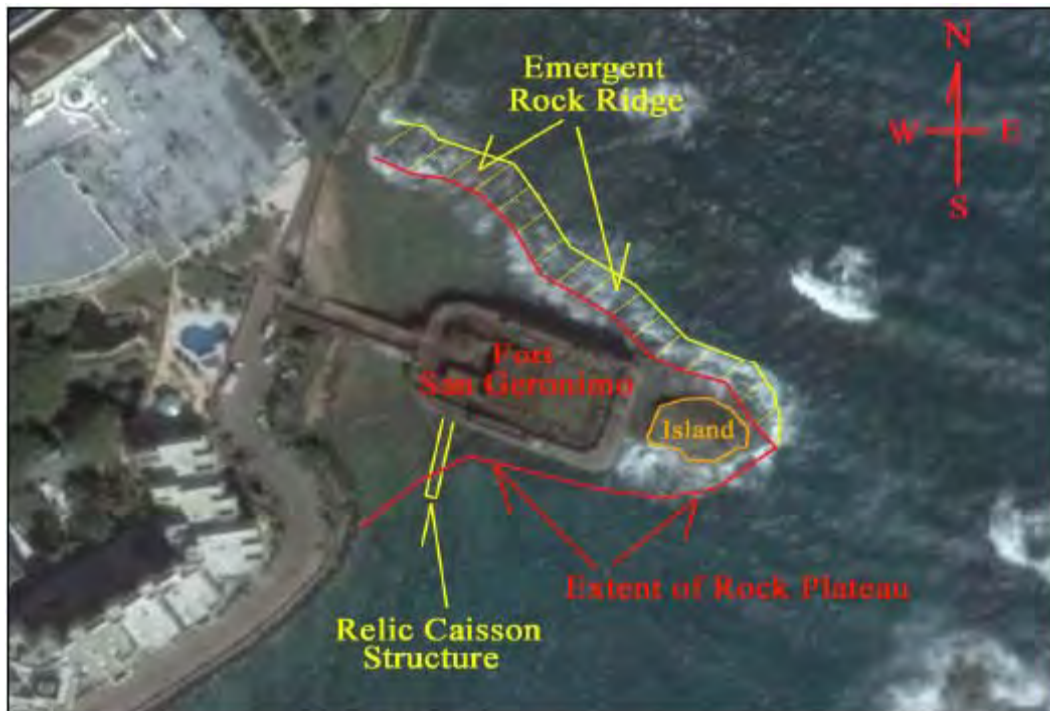
Image 12. Fort San Geronimo Area Features

The basic features of Fort San Geronimo and its immediate environment are shown in Image 12. The main structure of the Fort is approximately 170 feet long by 100 feet wide, and is connected to the mainland by a 180-foot stone bridge. The Fort is built on a rocky plateau which extends outward from the Fort's outer walls in all directions. This plateau is generally 1 to 3 feet deep, relative to msl. An emergent rocky ridge (+1 to +2 feet, msl) extends along the northern edge of the plateau and serves as a breakwater, substantially reducing the energy of large storm waves from the Atlantic before they reach the Fort. An emergent island on the east side of the Fort likewise protects this side of the structure from direct wave attack. The rock plateau is at its narrowest along the south side of the Fort, where the bottom begins to slope away from the outer Fort wall only a few feet from the Fort's foundation. The west side of the Fort is protected by the shoreline and the shallow waters (-1 to -2 feet, msl) of the rocky plateau between the Fort and the shoreline.

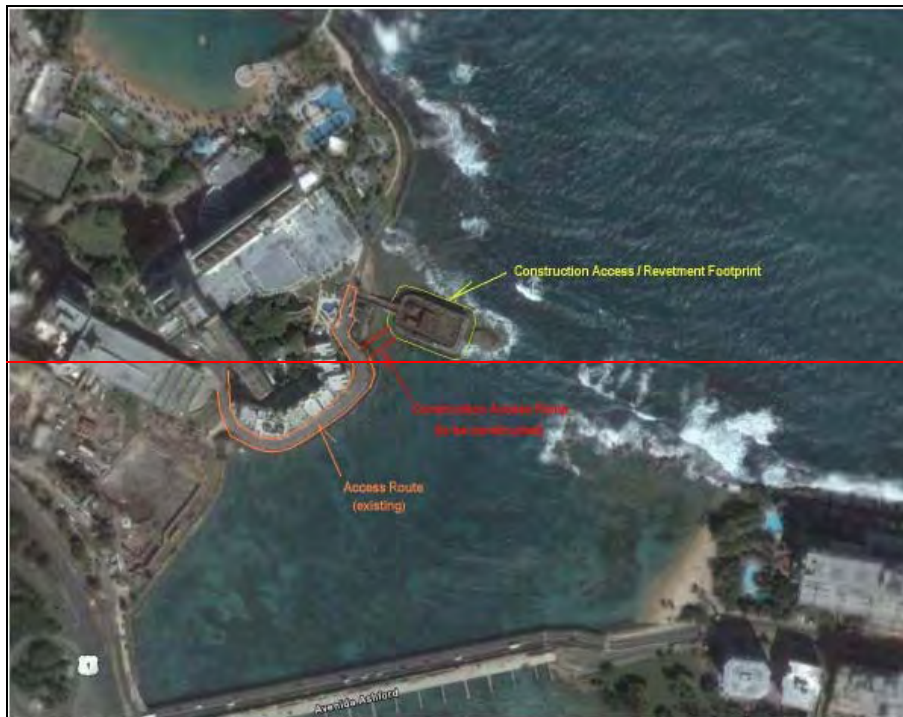
Image 13. Plan View of Revetment and Access Route Footprint

To construct the concrete apron and the rubble revetment, a temporary construction access would be built from the shore to access the southwestern corner of the Fort's foundation. The access ramp would be approximately 25 feet wide and 85 feet long (2,125 square feet).

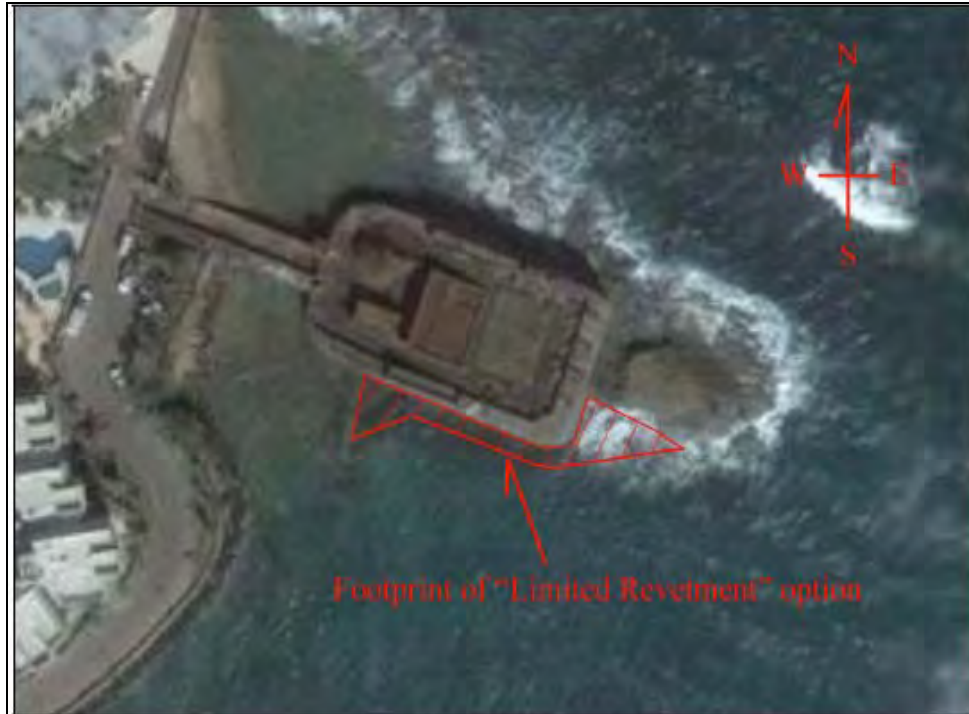
Image 14. Approximate Footprint of Limited Revetment Alternative

Subsequent to the review and evaluation of the various factors of each of the four alternatives, Alternative 3 was selected as the Preferred Alternative and is being evaluated in this mitigation plan. Whereas the full revetment option would completely encircle the Fort, the limited revetment option would protect only the areas of the Fort which have experienced the most damage and are the most vulnerable to future damages. These areas extend along the southern 30 feet of the east wall, around the southeast corner of the Fort, and along approximately 120 feet of the south wall as shown in Image 14. The endpoints of this revetment encompass the two areas of wave energy focusing. Each of the triangular areas of wave energy focusing would be filled in with 2-ton armor stone to reduce wave impacts on the Fort. The revetment cross-section shown in Illustration 2 would be constructed along the south wall, connecting the two areas of wave energy focusing. The concrete scour apron, as depicted in Illustration 1, will encircle the entire perimeter of the Fort's foundation. Approximately 500 cubic yards of 2-ton, 165 pcf armor stone would be required to construct this limited revetment option. This alternative represents the USACE Preferred Alternative and recommended plan.

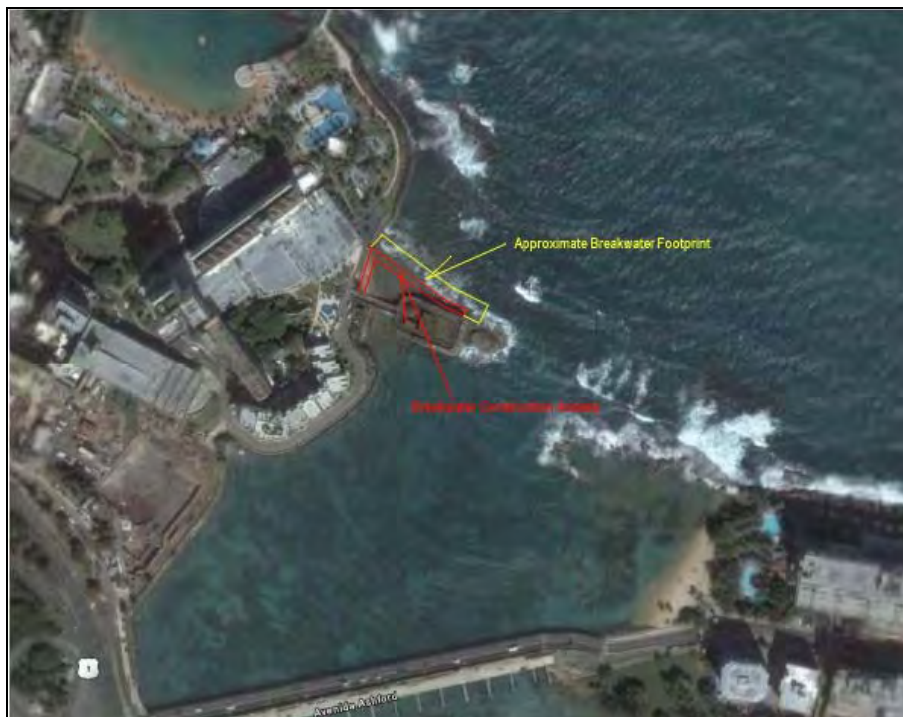
Image 15. Proposed Breakwater Location and Access Ramp View

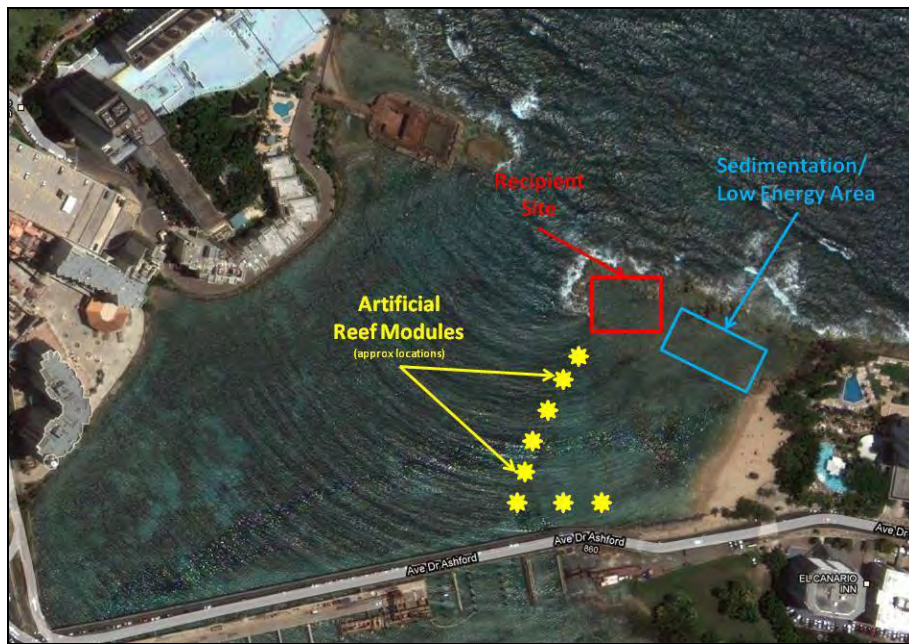
Image 16. Approximate location of the proposed coral recipient site MAKE SURE MAP PRINTS RECIPIENT SITE

- Southeast Corner: N18° 27.708'/ W66° 4.976'
- Northeast Corner: N18° 27.718'/ W66° 4.976'
- Southwest Corner: N18° 27.708'/ W66° 4.992'
- Northwest Corner: N18° 27.718'/ W66° 4.992'

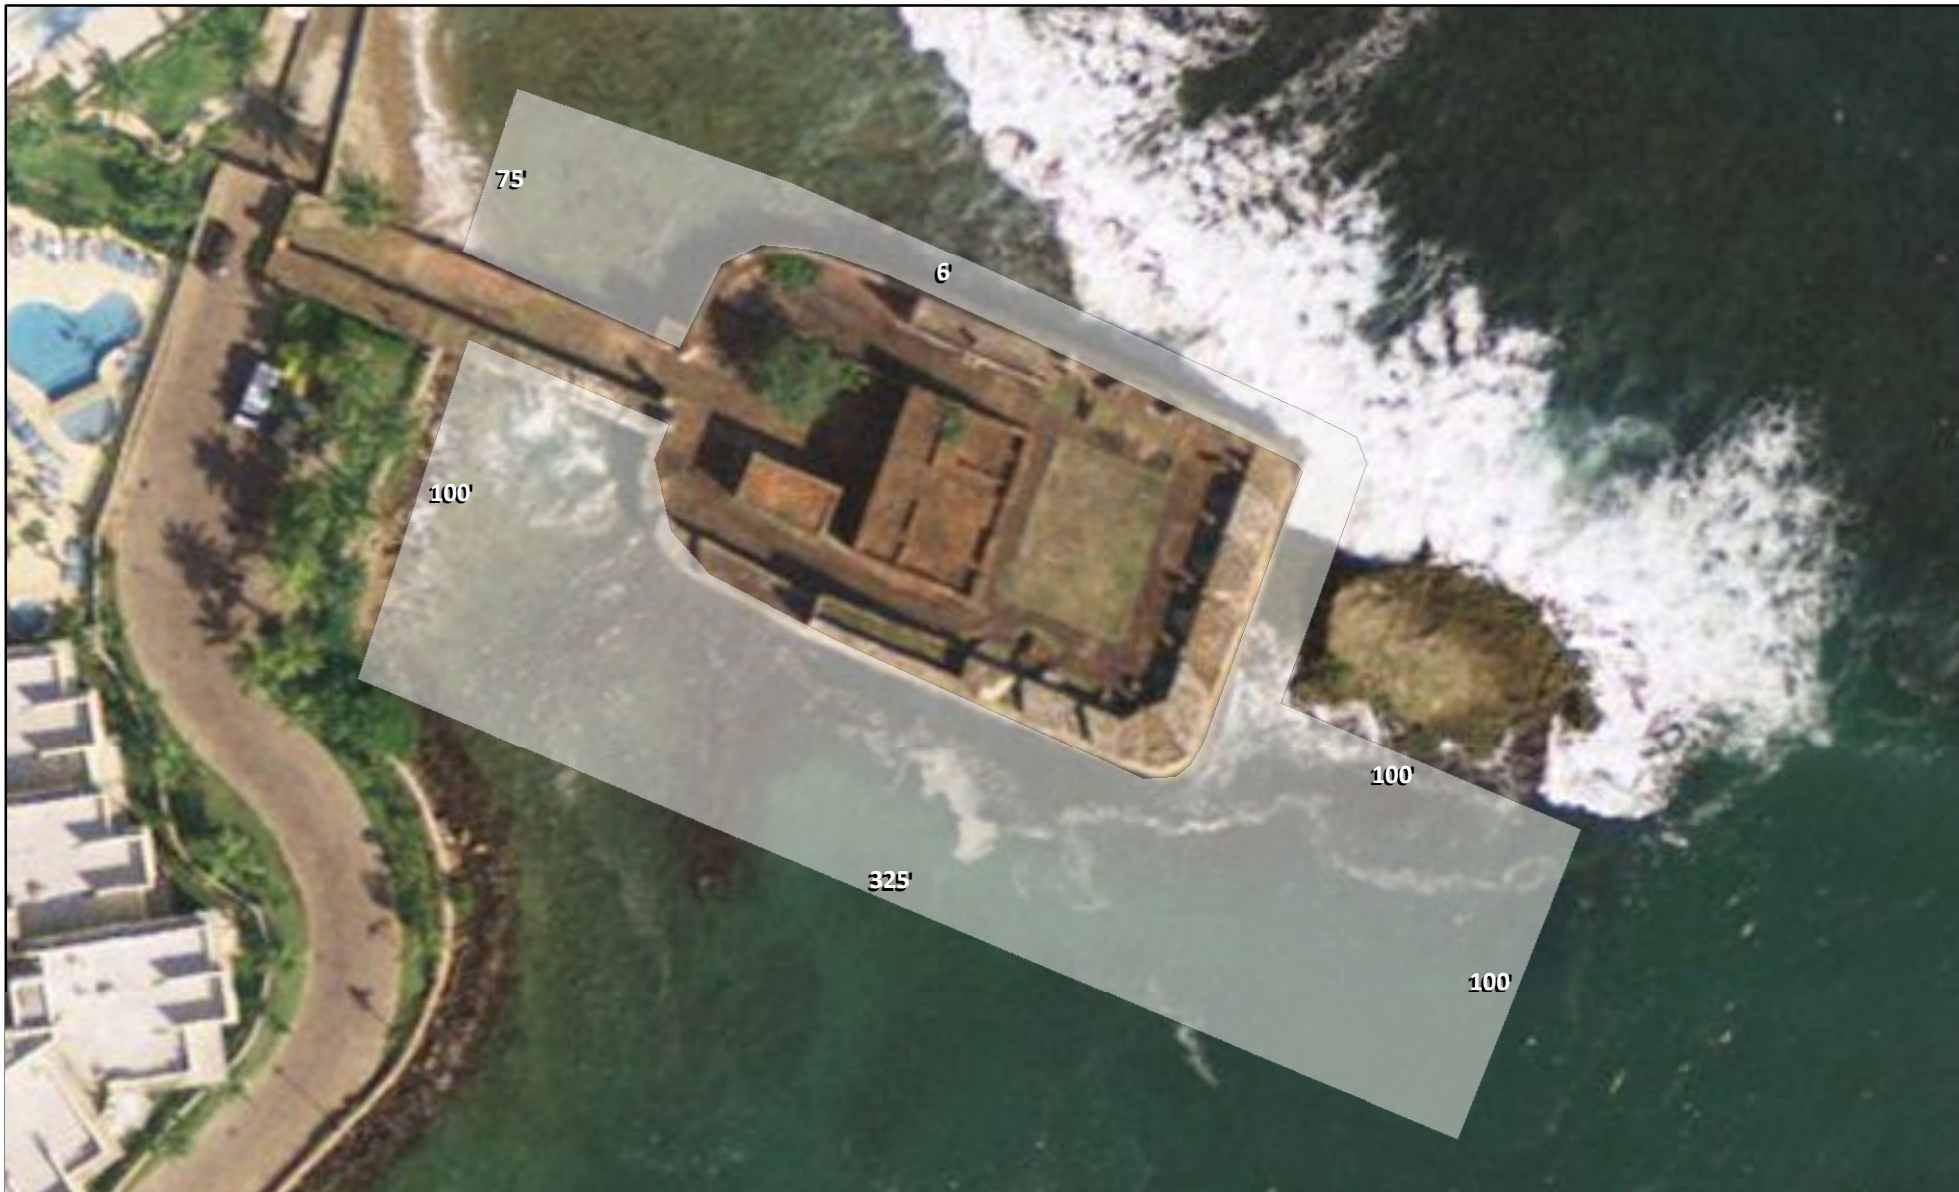
To characterize the coral community within the survey area, a combination of video transects and quadrat data were collected. Four video transects were conducted throughout the survey area. Quadrats to assess the coral community were collected north of the Fort and in the shallow area south of the bridge. Figure 3 details the locations of the video transects and quadrats conducted within the survey area.

Along the northern wall of the Fort, the survey was conducted only during the lowest tide level. This area is occupied by a very shallow rocky shelf and at higher tides, water turbulence associated with waves breaking over the emergent rock ridge/breakwater located north of the Fort made assessments impossible in this area. The northern wall of the Fort exhibited the highest coral cover within the project area, where the coral community consisted of multiple, smaller encrusting and platy corals, rather than distinct colonies (Images 2 and 3). Mapping of individual coral colonies in this area was not effective and depths were not adequate to conduct video transects; thus, quadrats were determined to be the best method for documenting the coral community and assemblage (Image 4). Figure 3 details the locations of these quadrats.

Further west, in the vicinity of the bridge, the substrate consisted of a cemented sand platform with rubble and sand. The water was deeper with lower wave energy, making it possible to conduct a video transect in this area. Individual coral colonies with a diameter greater >4 in (10.2 cm) were mapped as described in Section 2.3.2.1. Figure 3 details the video transect location.

The area south of the Fort bridge was occupied by rubble and sand and was strongly influenced by tidal flow through the bridge spillways. At low tide, the depths and lower water flow in this area made a video transect possible. Individual coral colonies located along the Fort structure were mapped. Moving further south from the bridge, the area of rubble and sand becomes very shallow and did not allow for video transects; thus, eight quadrats were conducted to assess the benthic community (Images 5 and 6). Further south from here, depths increased over rubble and sand substrate, allowing for a video transect and individual coral mapping efforts. Figure 3 details the location of the video transects and quadrats.

All individual coral colonies with diameters >4.0 in (>10.2 cm) within the survey area were identified and documented. As can be seen in Figure 3, corals were also mapped outside of the defined survey area. Mapping outside of the benthic survey boundaries was conducted to 1) demonstrate the continuity of the coral community outside of, and adjacent to, the survey area and 2) demonstrate that the location of the proposed construction activity minimizes impacts to the coral community. A map of the individual coral colony locations was produced by biologists using mask, snorkel and Geographical Information System (GIS). A Trimble Geo-XT handheld Digital Global Positioning System (DGPS) unit, running ArcPad 7.0, was utilized to document the coral colony locations. The following data were recorded for each mapped coral colony: coral species, colony dimensions, benthos type, and potential for relocation (i.e., colony relocation possible, colony relocation not possible, or partial colony removal).

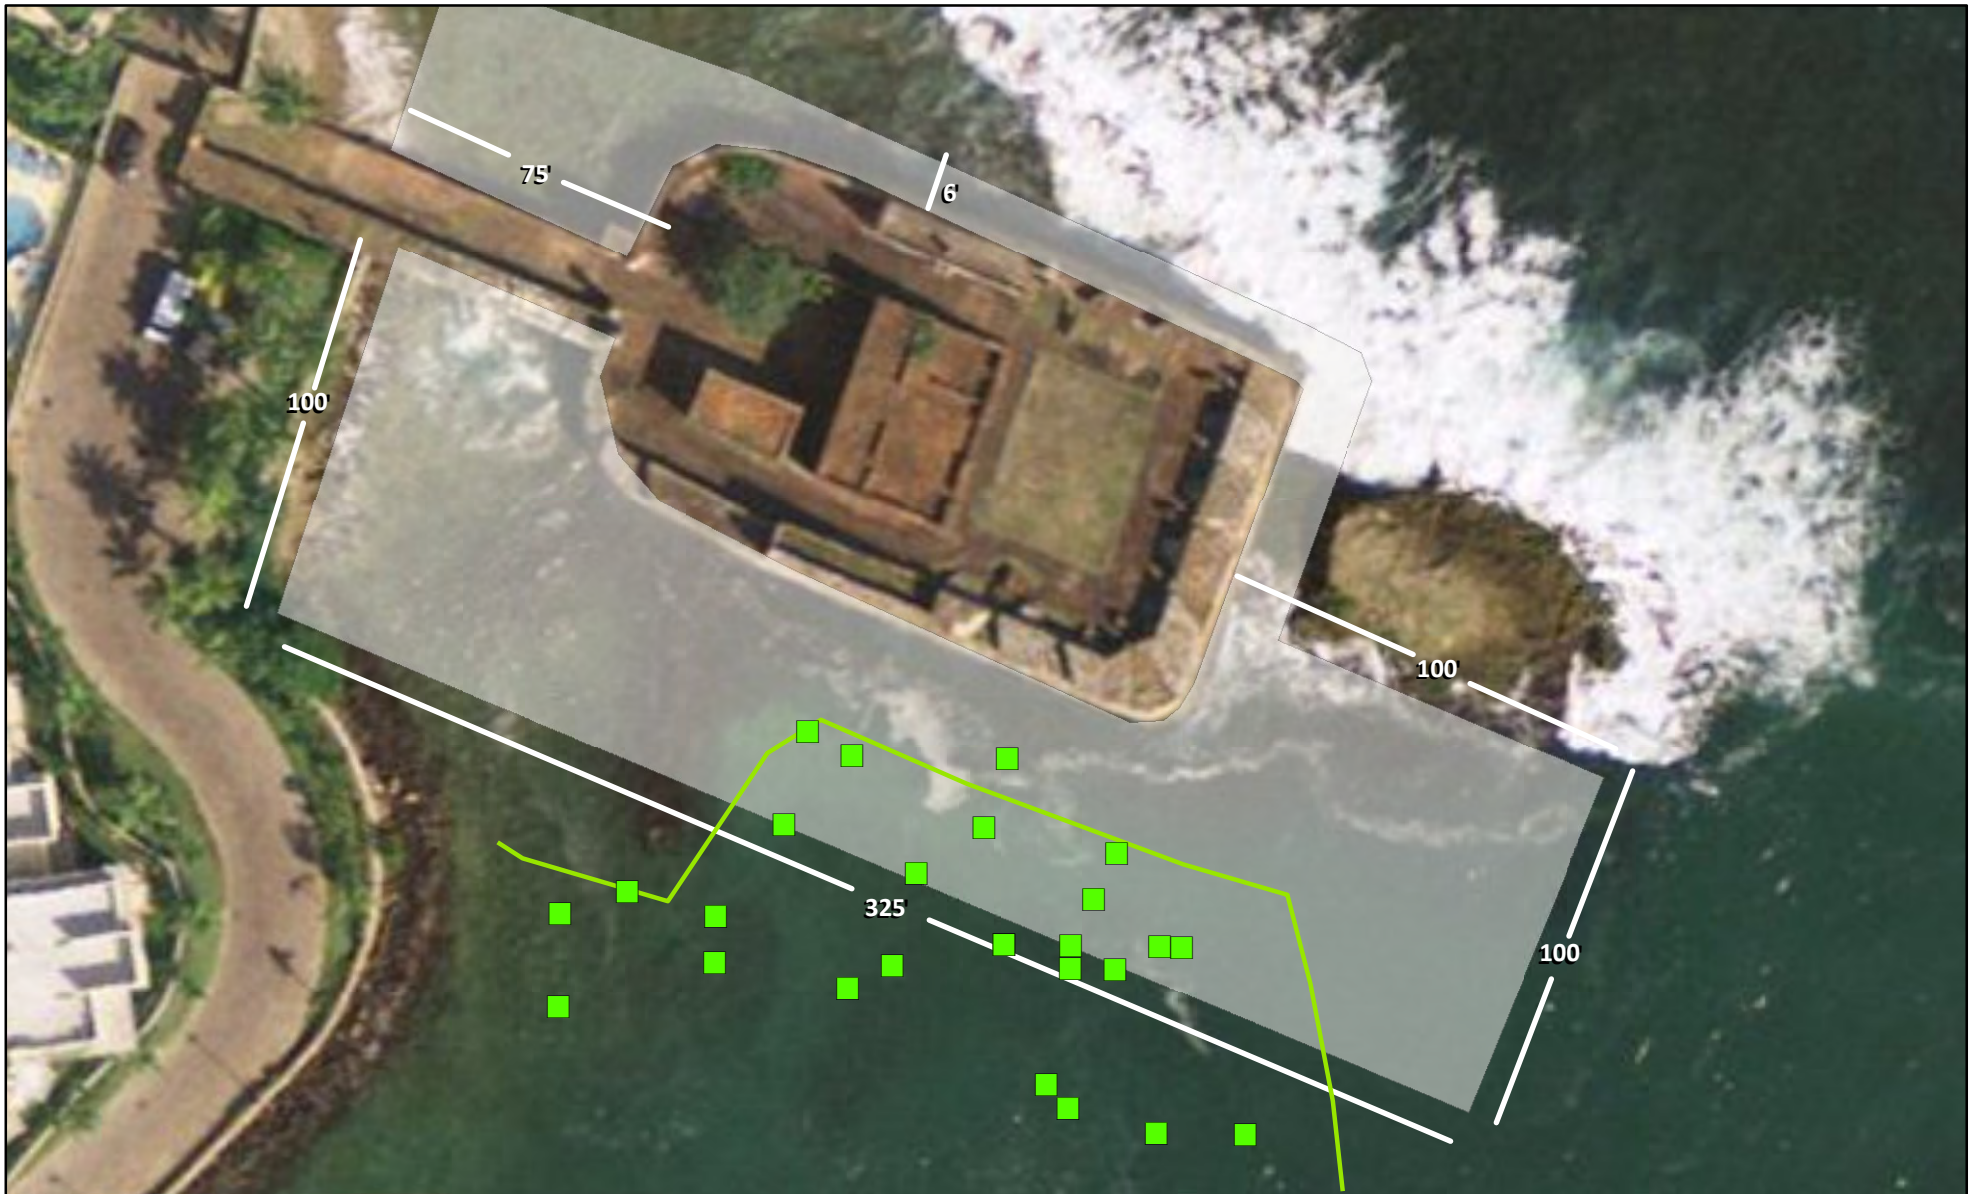
The October 2010 benthic survey revealed a very low mean total coral cover (1.13% +/- 0.79%) consisting of only two species, *Siderastrea radians* and *Favia fragum* in the area south of the Fort bridge and west of the relic caisson structure. All the colonies in this area are <4.0 inches in diameter. Thus, this area was selected for installation of the temporary access road. Figure 5 shows the proposed location for the temporary access road.
