APPENDIX C - PERTINENT CORRESPONDENCE

The U.S. Army Corps of Engineers (Corps) is conducting a beach renourishment project in Sarasota County, Florida. The project name is the Venice Beach Hurricane and Storm Damage Reduction Project. The Corps proposes to use the Statewide Programmatic Biological Opinion (SPBO) to complete the consultation requirements under the Endangered Species Act (ESA) for this project.

Hardbottom Analysis of Four Proposed Borrow Areas Near Venice Beach, Sarasota County, Florida

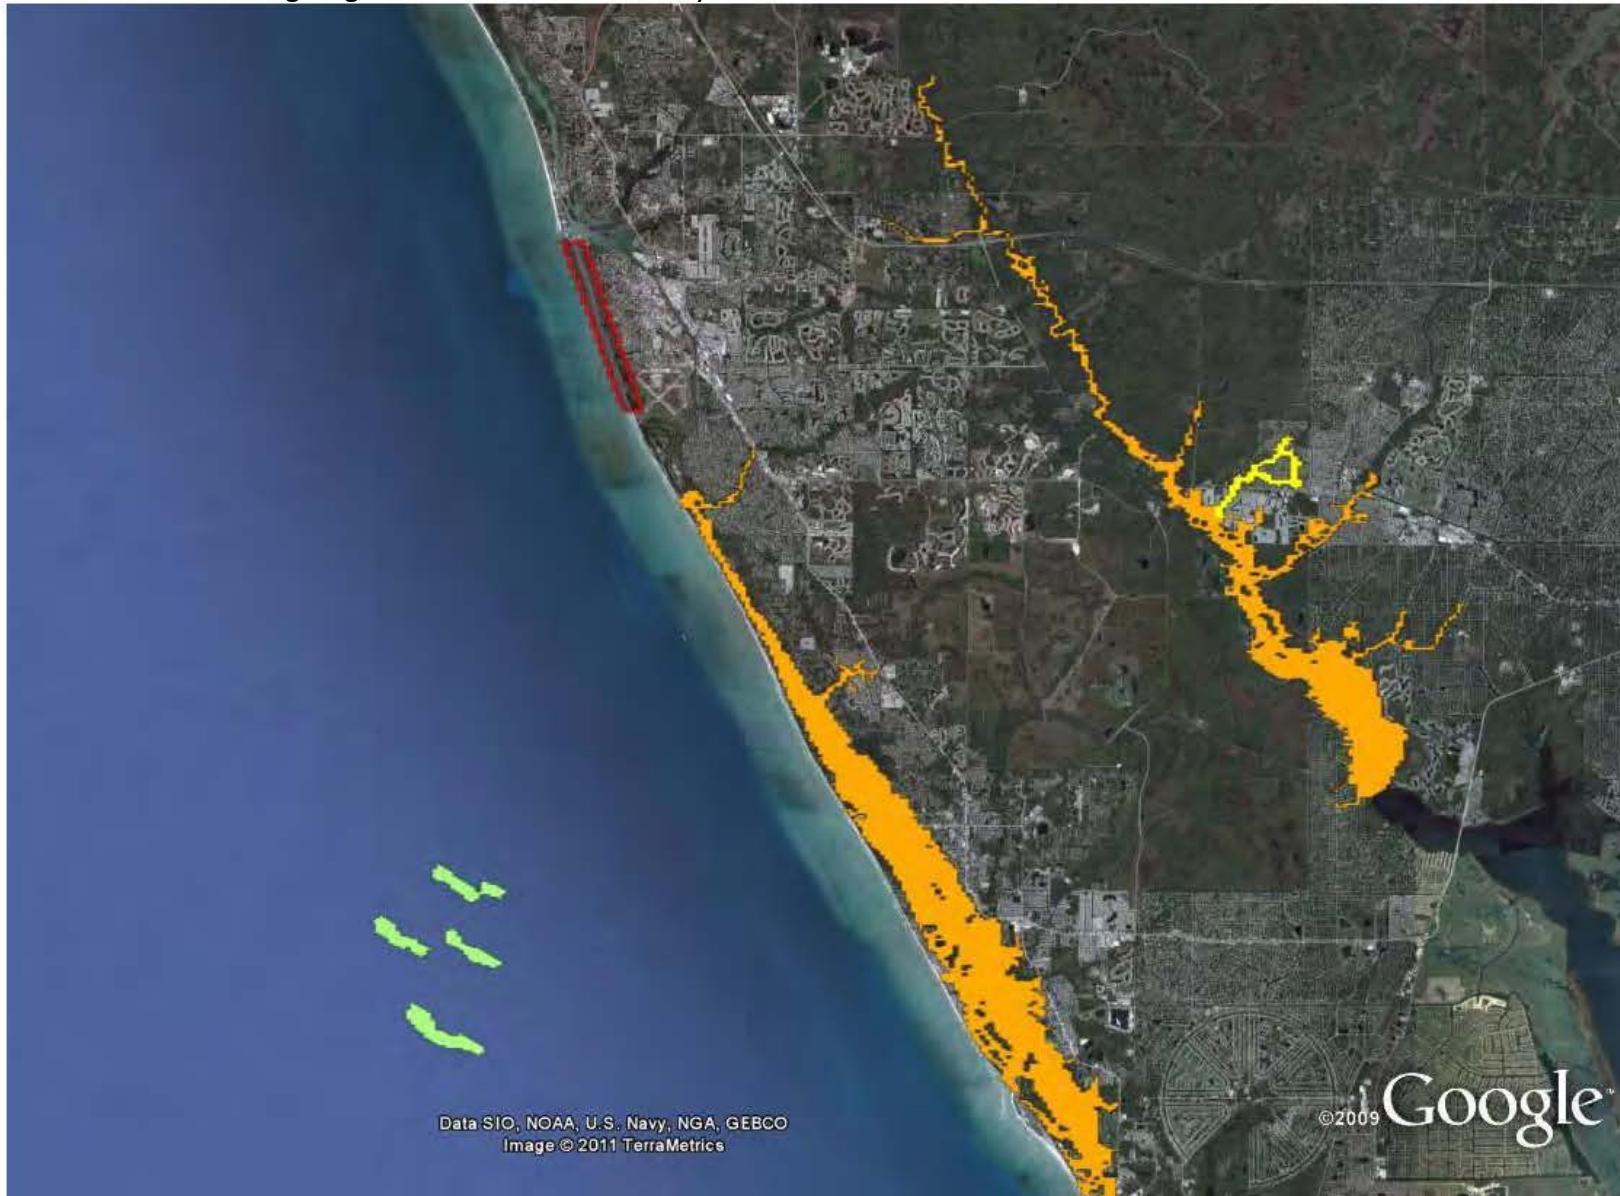
Figure 3: Important Manatee Areas (IMAs) in the project vicinity. The placement site is shown in red, the borrow areas in light green, and the IMAs in yellow.

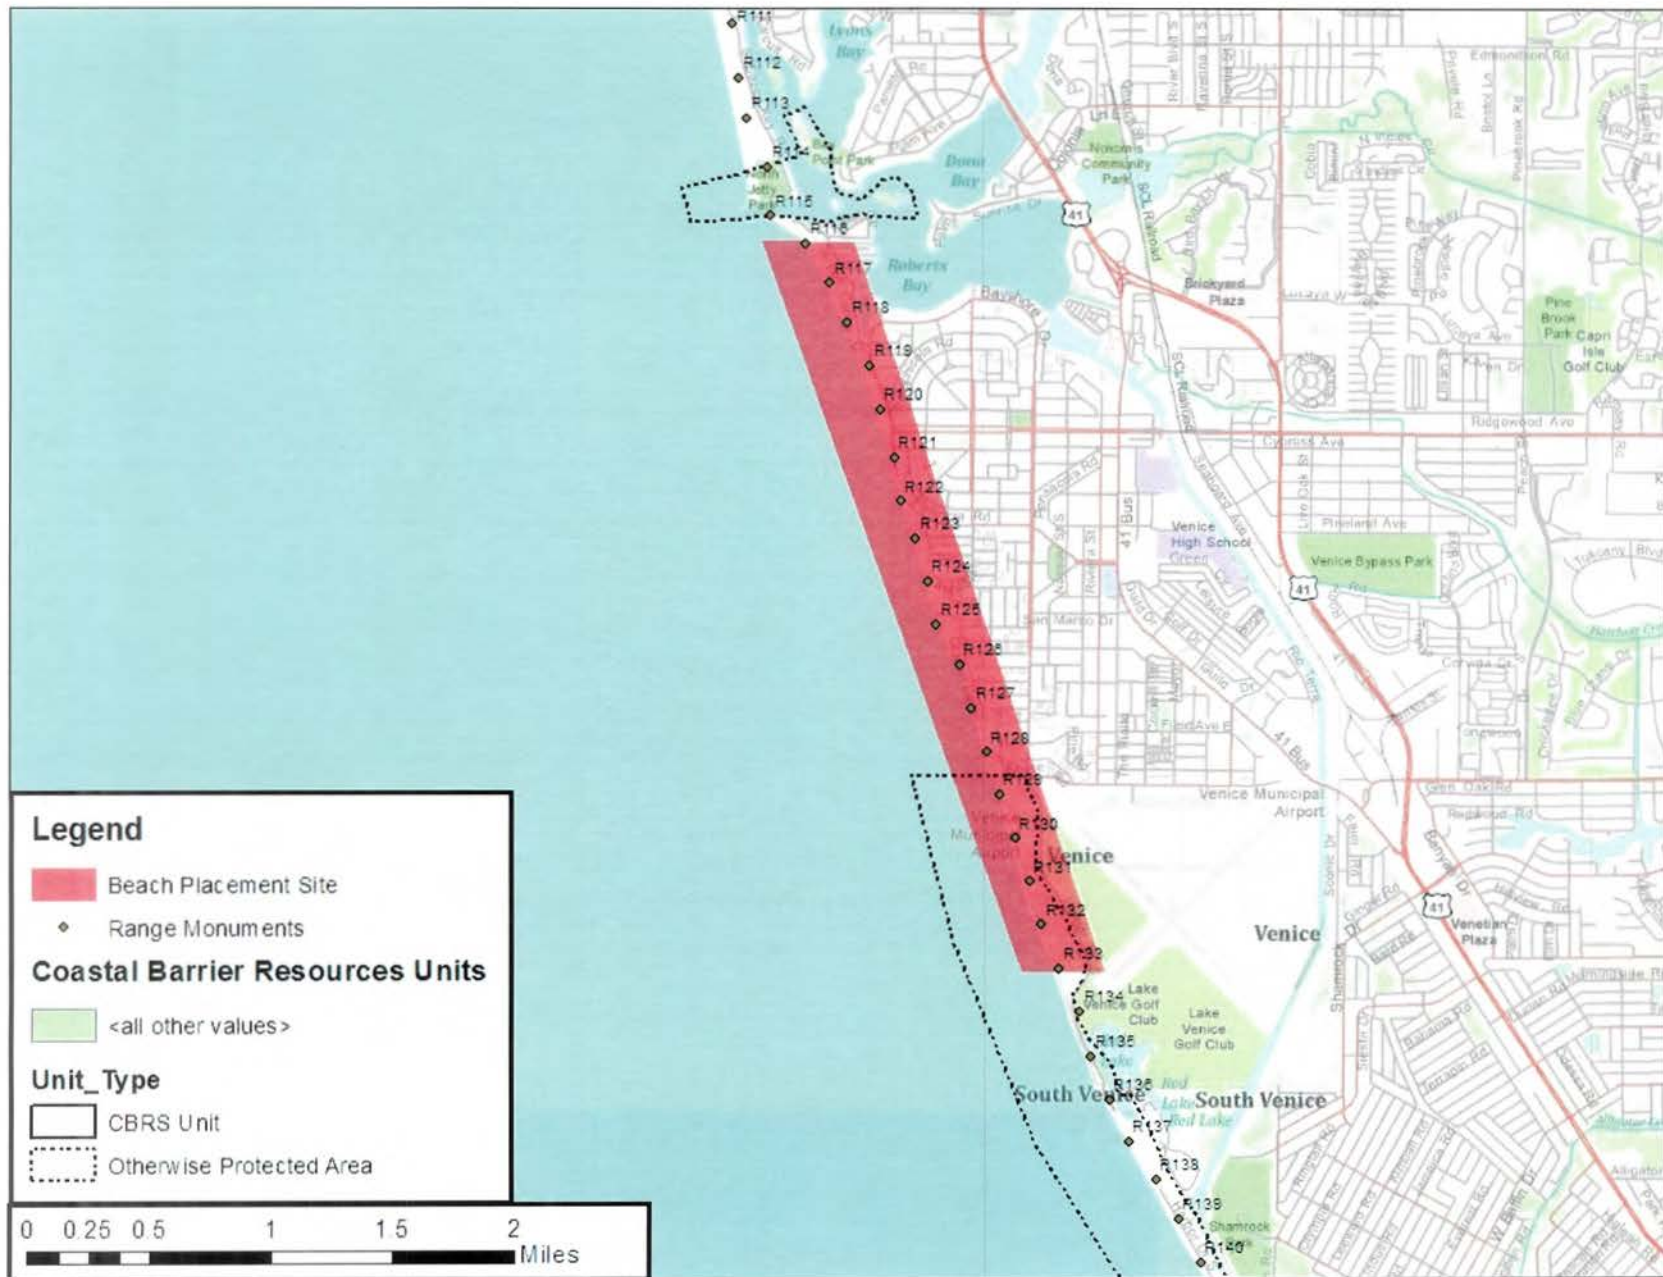
Figure 2: Map showing the location of the CBRA Units in the project area.

The following describes the history and the applicability of the Coastal Barrier Resources Act (CBRA) of 1982 and the Coastal Barrier Resources Improvement Act (CBRIA) of 1990 to the Venice Beach Hurricane and Storm Damage Reduction Project (HSDR). The project is located along the shoreline of Sarasota County, Florida (see Figure 1). The proposed borrow areas are located approximately 10.5 miles southwest of the placement site. The placement site is located adjacent to and within two "otherwise protected areas" (OPA) of the John H. Chafee Coastal Barrier Resources System (CBRS). The northern project limit is near CBRA Unit FL-71P, Venice Inlet, and the southern portion of the project is located in a portion of CBRA Unit P21AP, Manasota Key (see Figure 2).

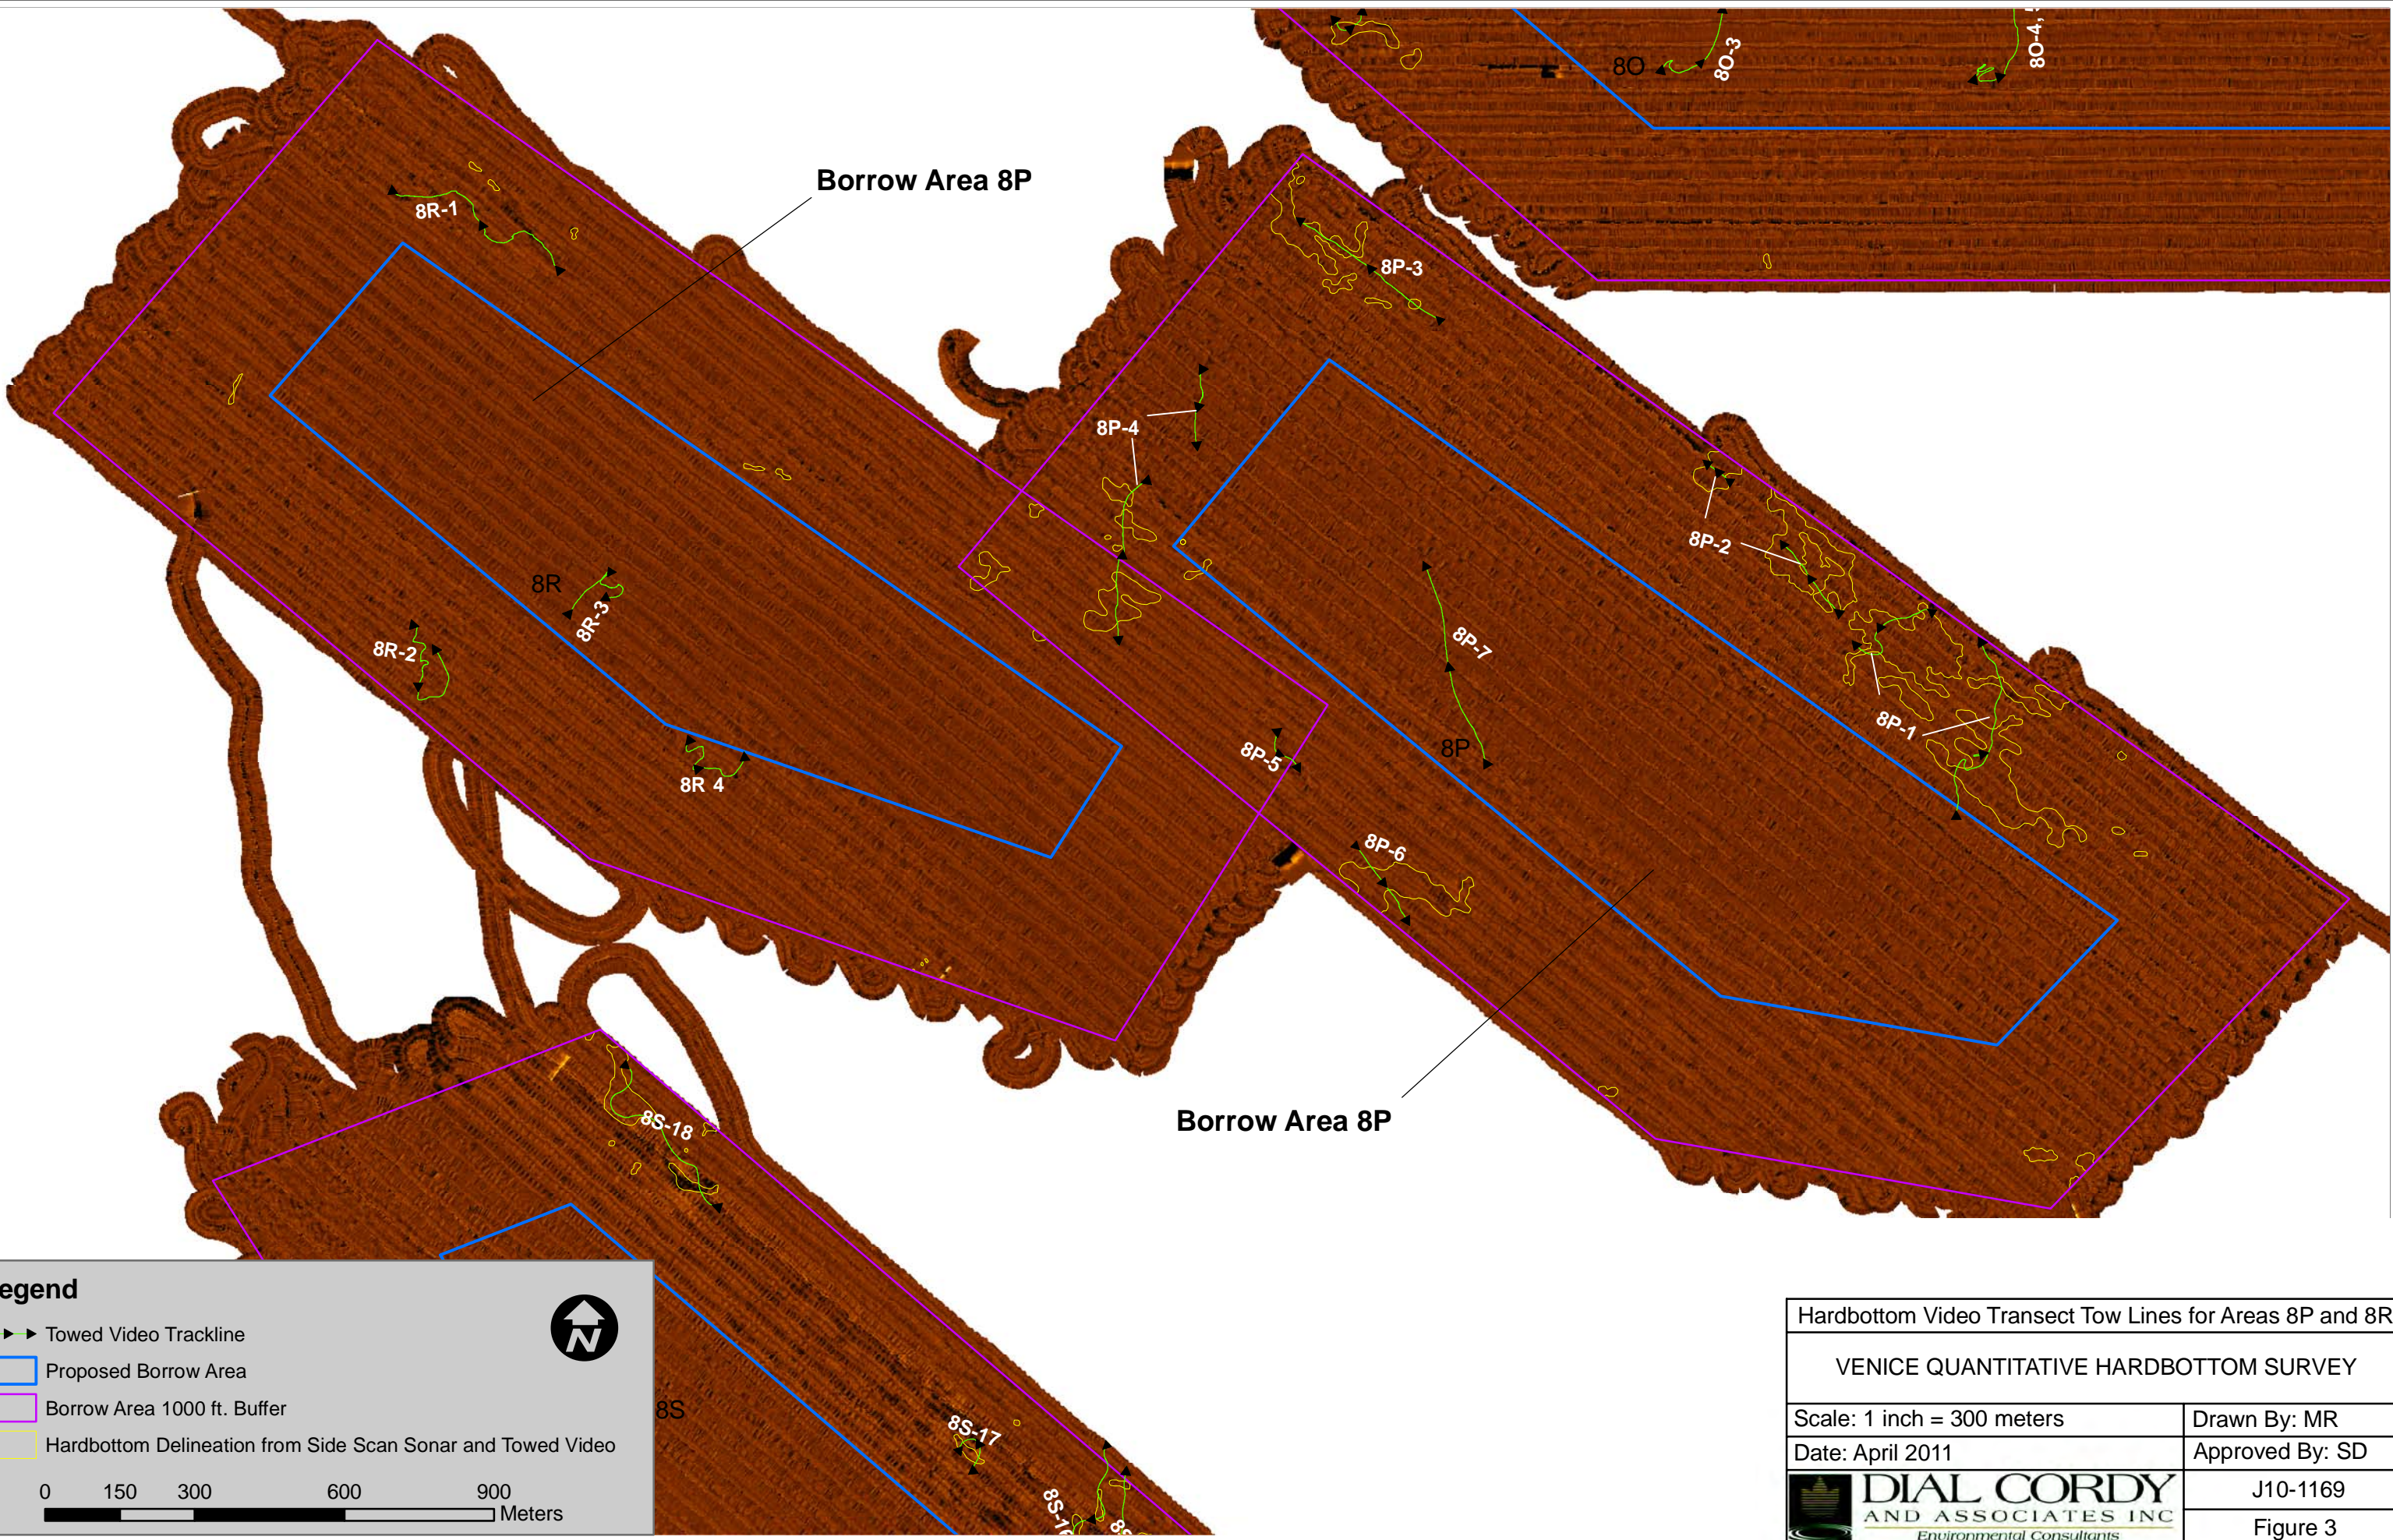
Hardbottom Video Transect Tow Lines for Areas 8P and 8R	
VENICE QUANTITATIVE HARDBOTTOM SURVEY	
Scale: 1 inch = 300 meters	Drawn By: MR
Date: April 2011	Approved By: SD
 Environmental Consultants	J10-1169
	Figure 3

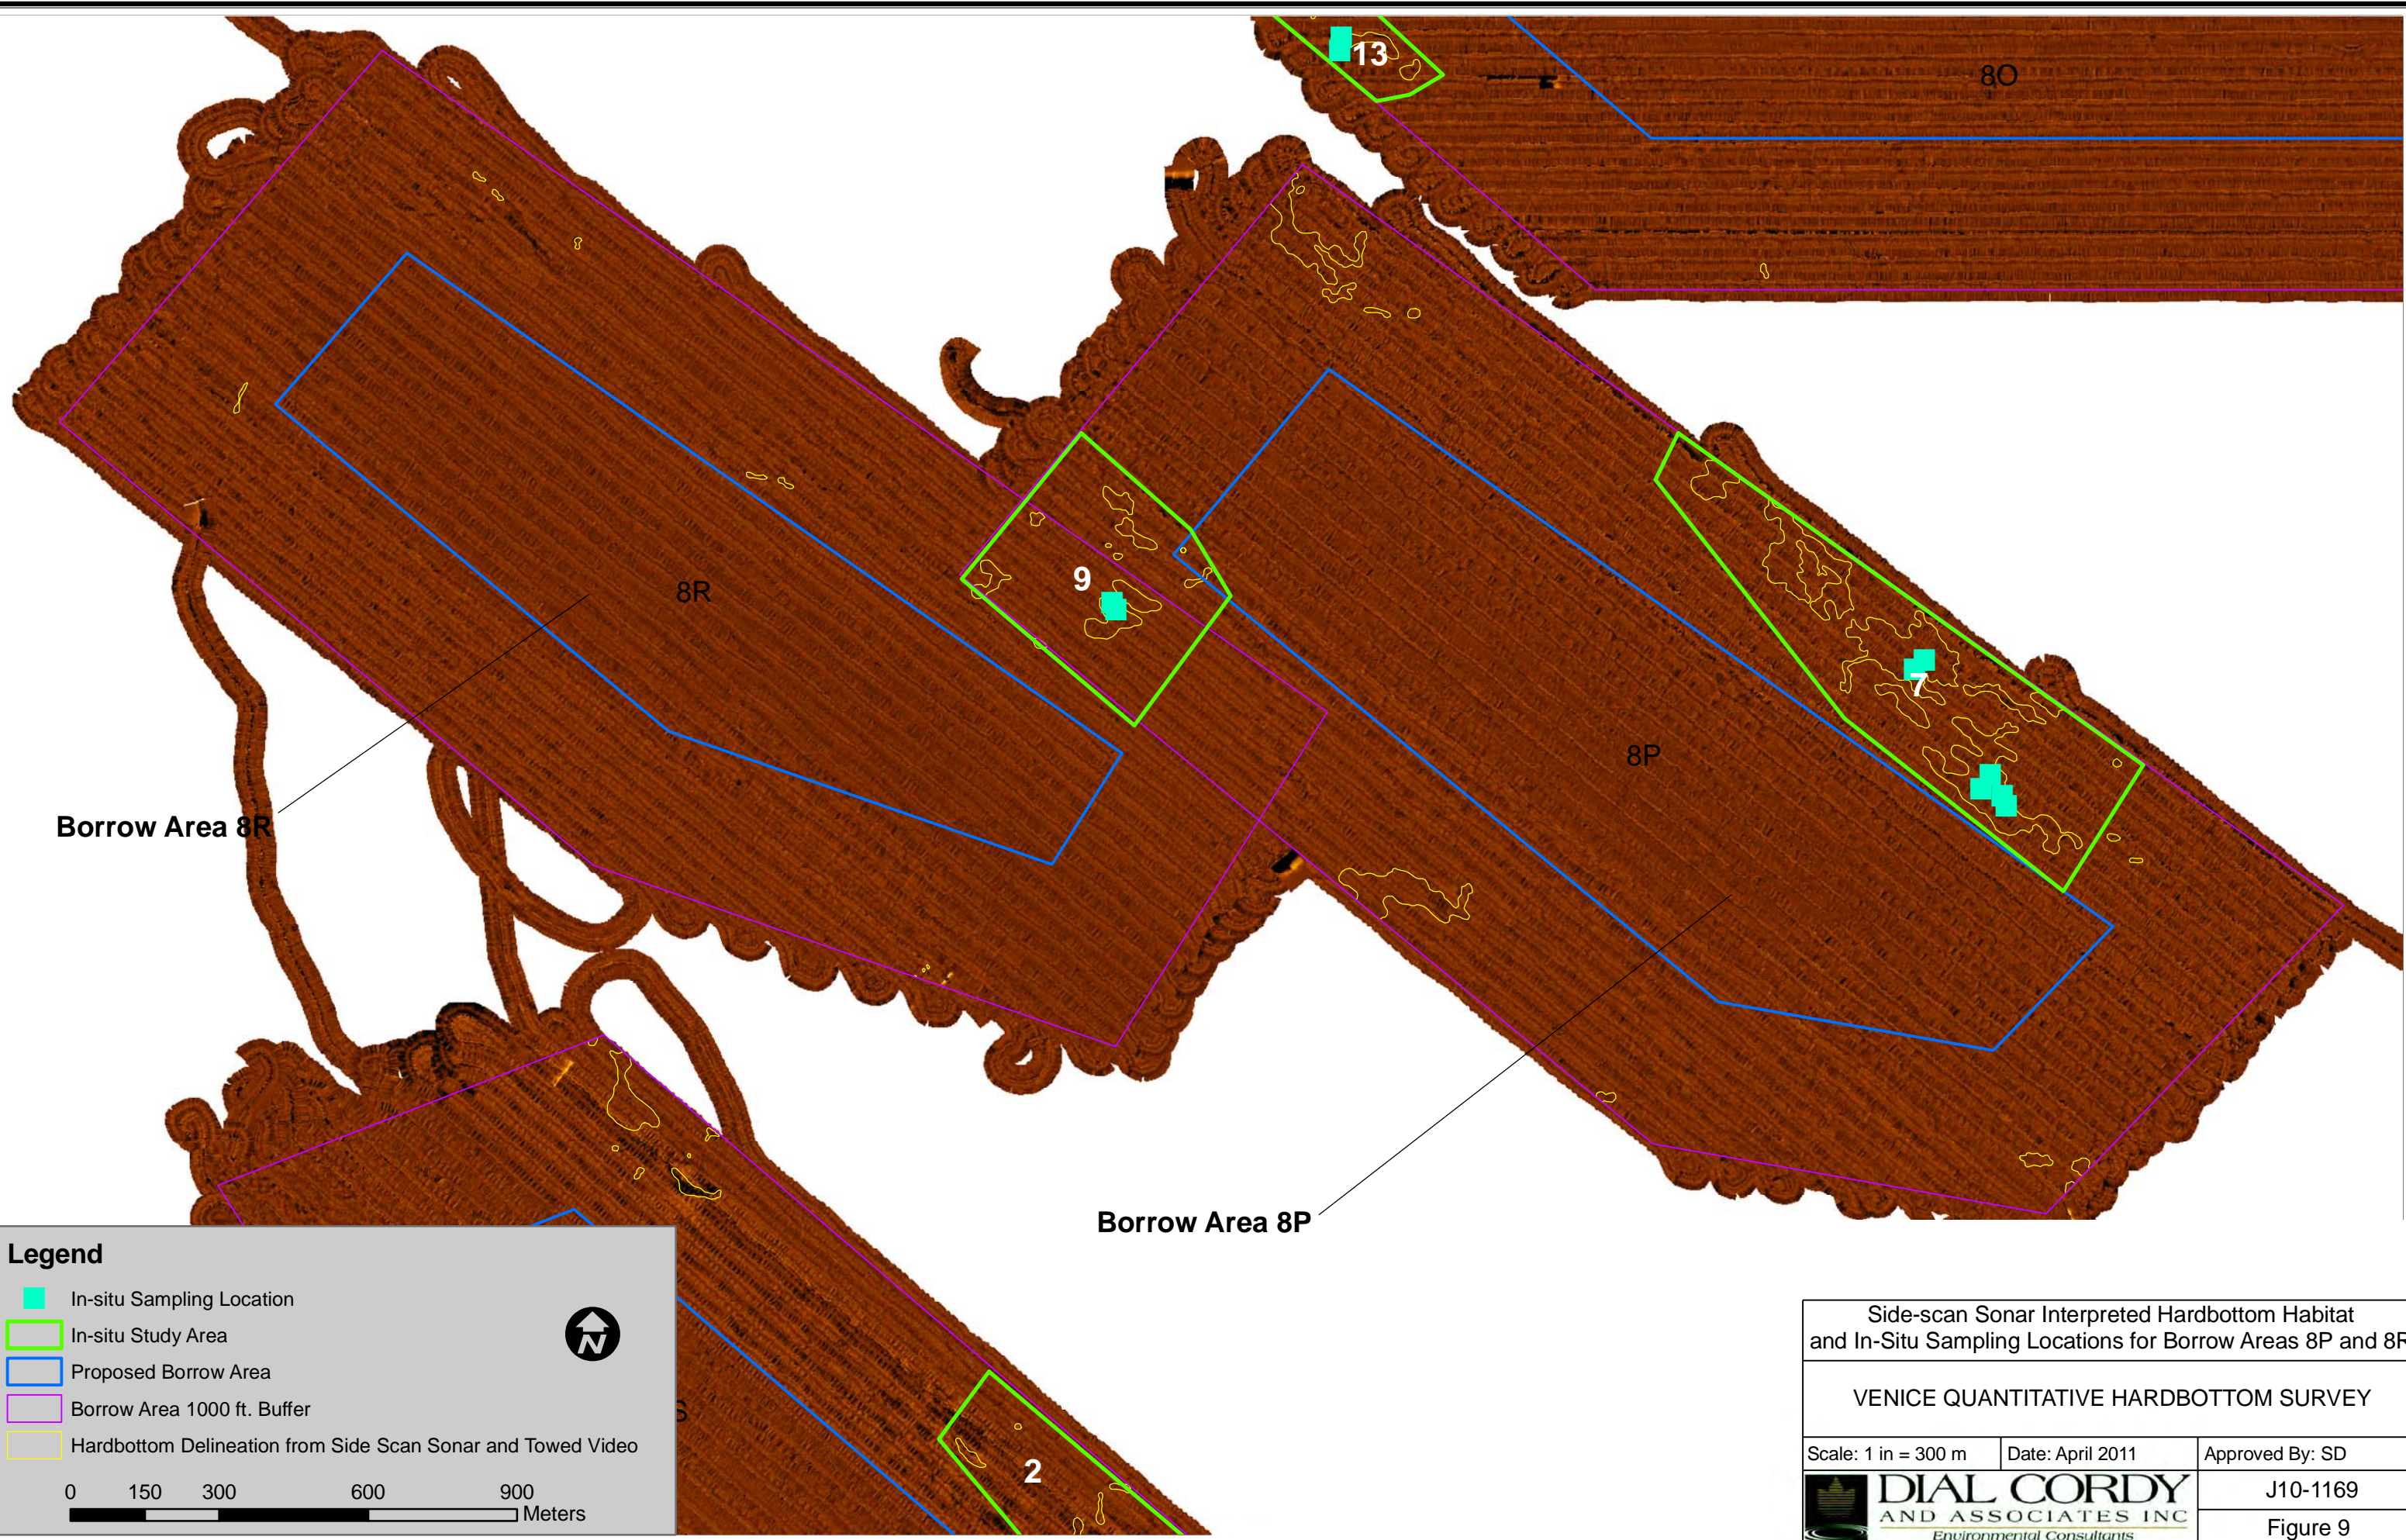
J10-1169
		Figure 9

The 8P borrow area included 0.08-acre of hardbottom habitat within the proposed borrow area. The closest hardbottom habitat adjacent to Borrow Area 8P is 23 meters from the borrow area on the northwestern side: this area was surveyed using *in-situ* methods (Area 7, Section 3.3). An estimated 26.7 acres of hardbottom habitat is located within the 1,000-foot buffer, adjacent to the 8P borrow area (Figure 9).

No hardbottom habitat was located within the 8R borrow area. The closest hardbottom habitat adjacent to Borrow Area 8R is 23 meters from the borrow area on the northwestern side, this area was surveyed using *in-situ* methods (Area 9, Section 3.3). An estimated 3.9 acres of hardbottom habitat is located within the 1,000-foot buffer, adjacent to the 8R borrow area. A portion of this hardbottom habitat is also within the 1,000-foot buffer of Borrow Area 8P, however, the acreage is only included in the 8R hardbottom habitat estimate value (Figure 9).

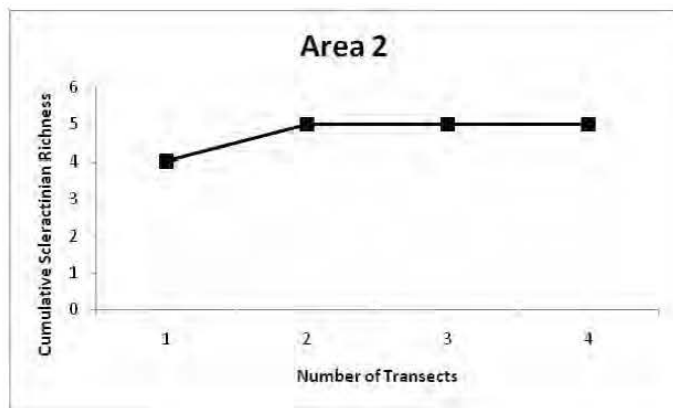
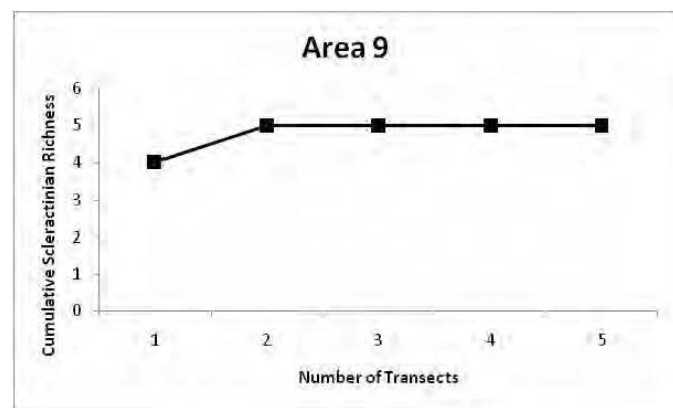
Figure 11 Scleractinian species rarefaction curves for all hardbottom sites.

Asymptotic species richness curves show that an adequate sample size (number of transects) was surveyed to document scleractinian species richness at all hardbottom sites (Figure 11).

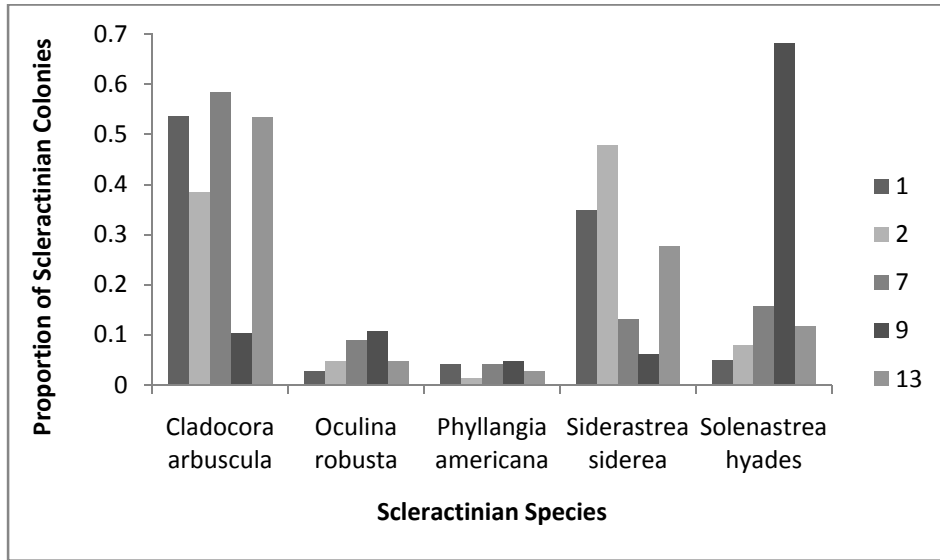
Figure 12. Proportional Abundance of the Scleractinian Corals at Each Hardbottom Site

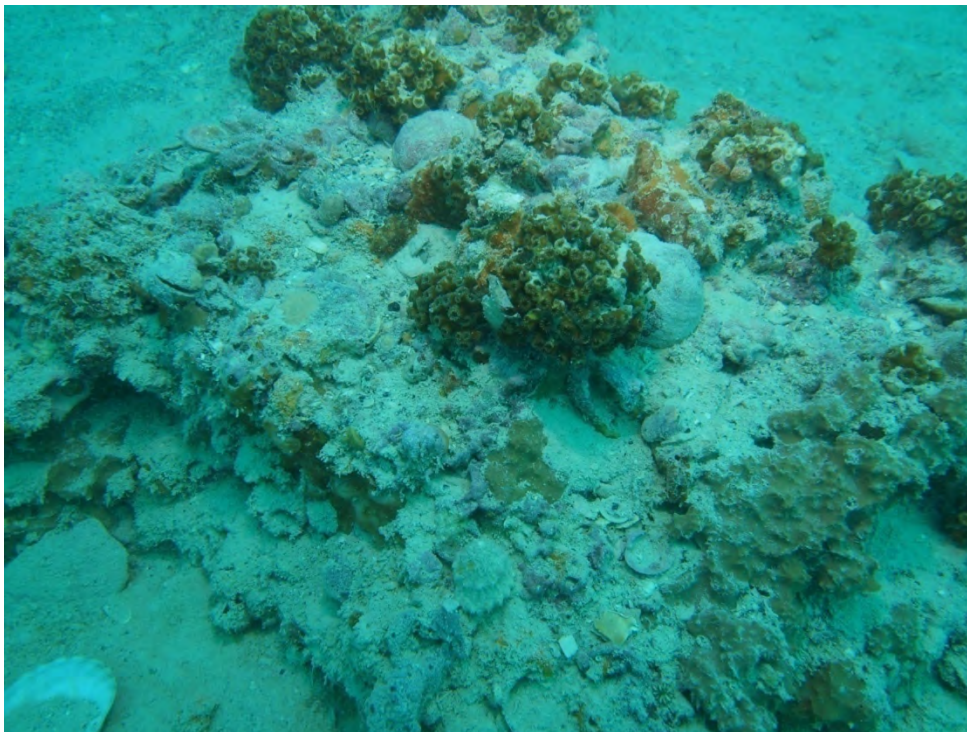
Figure 13. Shell and Sponge Assemblage with *Cladocora arbuscula* Colonies

Five scleractinian coral species were documented at all hardbottom sites (Table 2). Each site included all five species. Colony density varied by site and ranged from 4.3 to 13.5 individuals/m² (Table 3). *Oculina robusta* and *Phyllangia americana* were the least abundant species across sites, while *Cladocora arbuscula* was the most abundant (Figure 12). Photographs of typical hardbottom communities found across sites are shown in Figures 13 and 14.
