**SOUTHERN PALM BEACH ISLAND COMPREHENSIVE SHORELINE
STABILIZATION PROJECT ENVIRONMENTAL IMPACT STATEMENT (EIS)
SBEACH ANALYSIS REPORT**

**U.S. Army Corps of Engineers (USACE)
Engineering Division**

**Coastal Planning & Engineering, Inc.
a CB&I Company (CB&I)**

January 2014

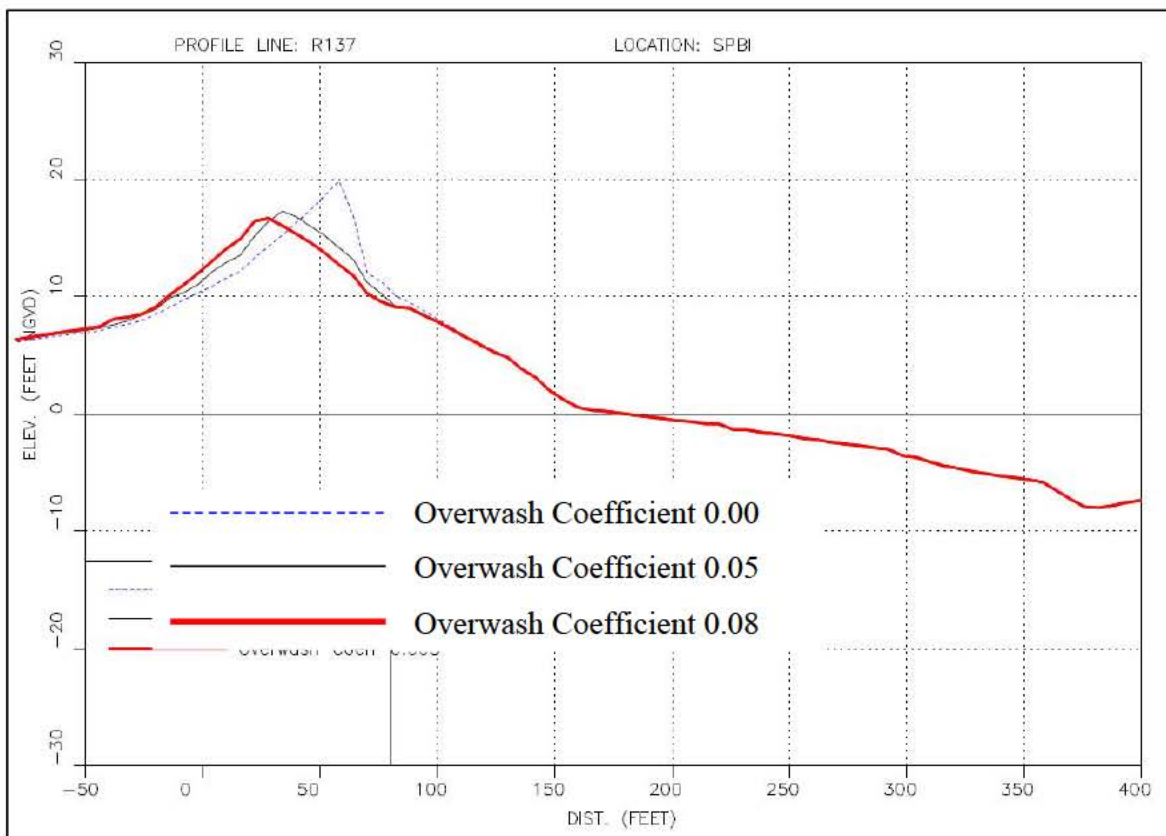
Figure 4-1 Sensitivity of overwash coefficient for R-137 profile, 100 year storm.

- The beach profiles were represented in the model with grid cell spacing of 6 feet.
- The time step used in simulations was 1 minute.
- An overwash coefficient of 0.008. The overwash coefficient is a relatively recent addition to the SBEACH model (see Larson, et al, 2004). The default value of this parameter is 0.005 for an unreinforced dune. No significant difference is noticed between simulations with varying overwash parameters for the 5, 15, 25, and 50 year storms. During the 100 year storm, the profiles are sensitive to the overwash coefficient and the magnitude of overwash increases as the coefficient increases (Figure 4-1).

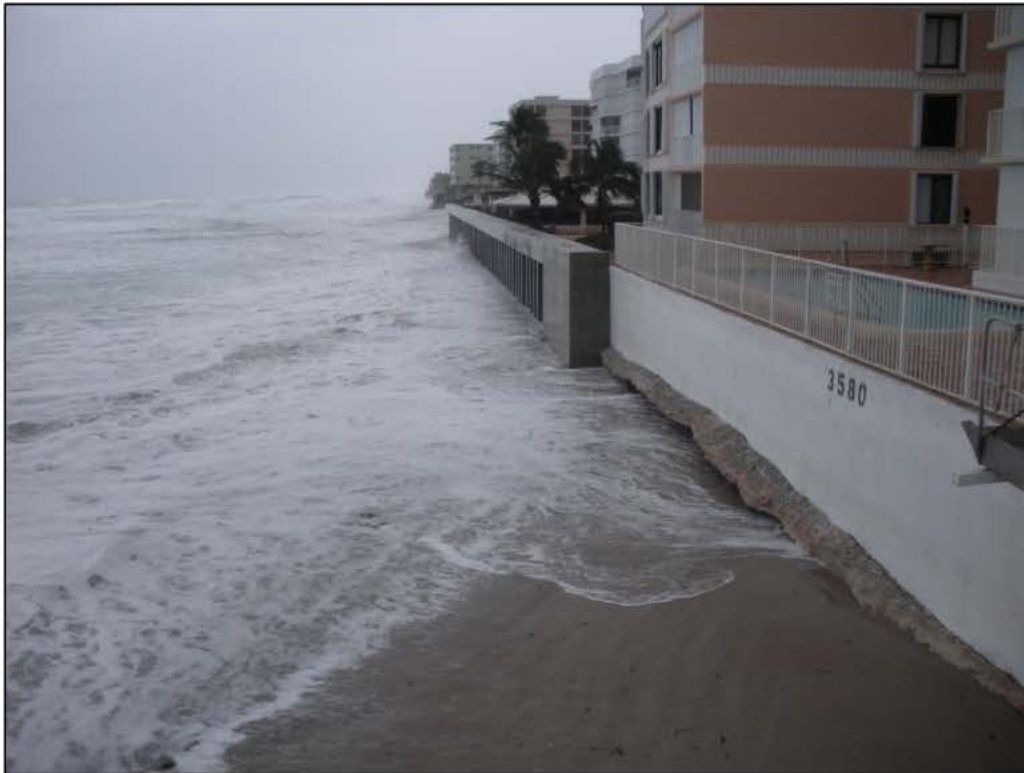
Figure 4-2. Impacts of Hurricane Sandy near R-136, Town of South Palm Beach (October 26, 2012).

Recent storms have provided evidence of the likelihood of seawall failure along the project area. Along the southern portion of the project area, many of the seawalls are exposed directly to wave action during storms (Figure 4-2 and Figure 4-3). The seawalls along the project area vary in age, stability and degree of exposure, leaving them more or less vulnerable to the modes of failure discussed previously. As an example, wave impacts and scouring that occurred during Hurricane Sandy led to failure and undermining of walls less than one mile south of the project site resulting in significant property damage and loss (Figure 4-4). Examining the likelihood and magnitude of toe scour using SBEACH will assist in understanding the risk of seawall failure along the project area and determining the overall need for the project.

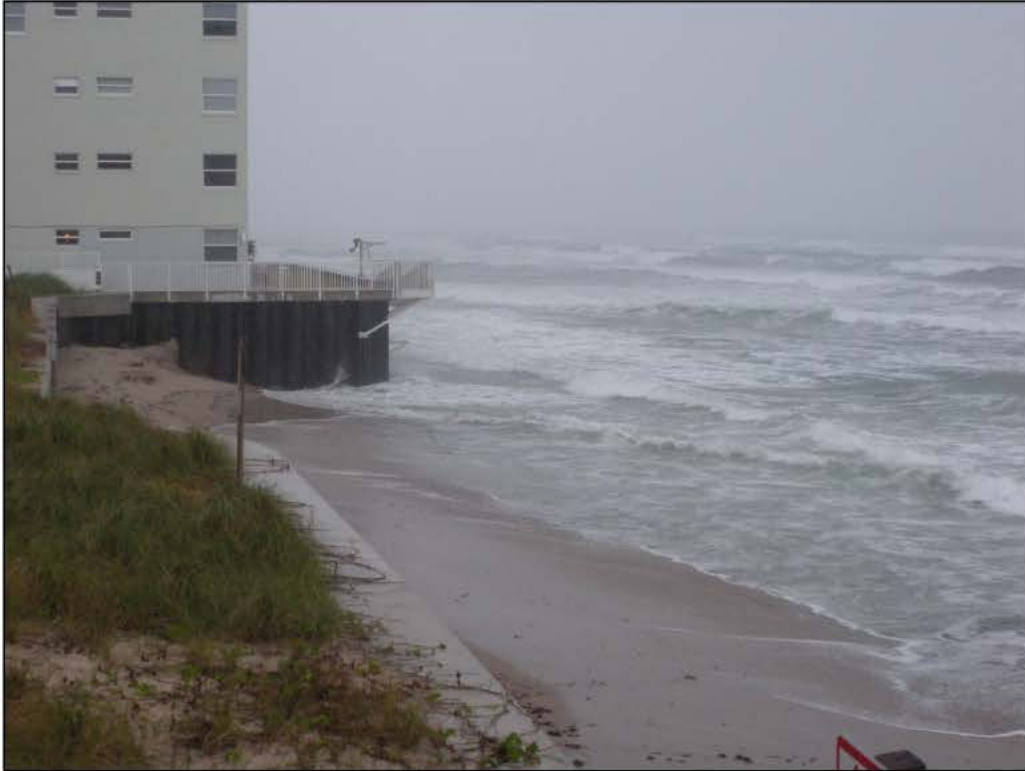
Figure 4-3. Impacts of Hurricane Sandy near R-137, Town of South Palm Beach (October 26, 2012).

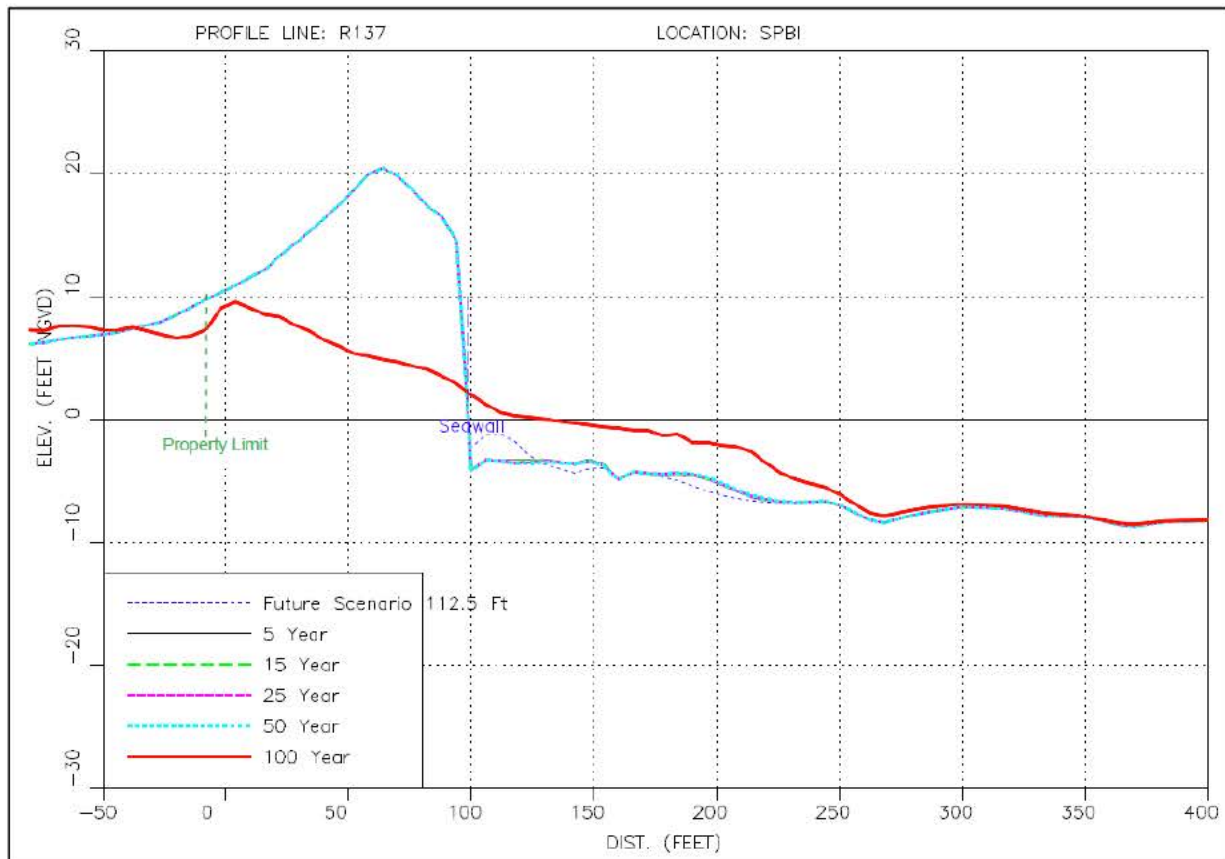
Figure 5-1 Seawall failure profile R-137 Future Scenario (50 years into the future)

The landward limits of erosion for the future scenarios are presented in Table 5-5. Based on the future scenario simulations, all storm protection provided by the dune between R-130 and R-134 is lost. Seawalls that were buried within the dune have become exposed and are subject to wave action. The seawalls along the shoreline between R-136 and R-138 fail due to toe scour, allowing erosion of upland property and damage to infrastructure (Figure 5-1).

- Based on the simulation of two forecasted No Action scenarios 10 and 50 years from the present (not Status Quo, no dune nourishments included in simulation setup), all remaining storm protection provided by the dune between R-130 and R-134 would be lost after one major storm event. Seawalls that were buried within the dune would become exposed and subjected to wave action. The seawalls between R-136 and R-138 would possibly fail due to toe scour depending on the depth of the wall, allowing erosion of upland property and damage to infrastructure.

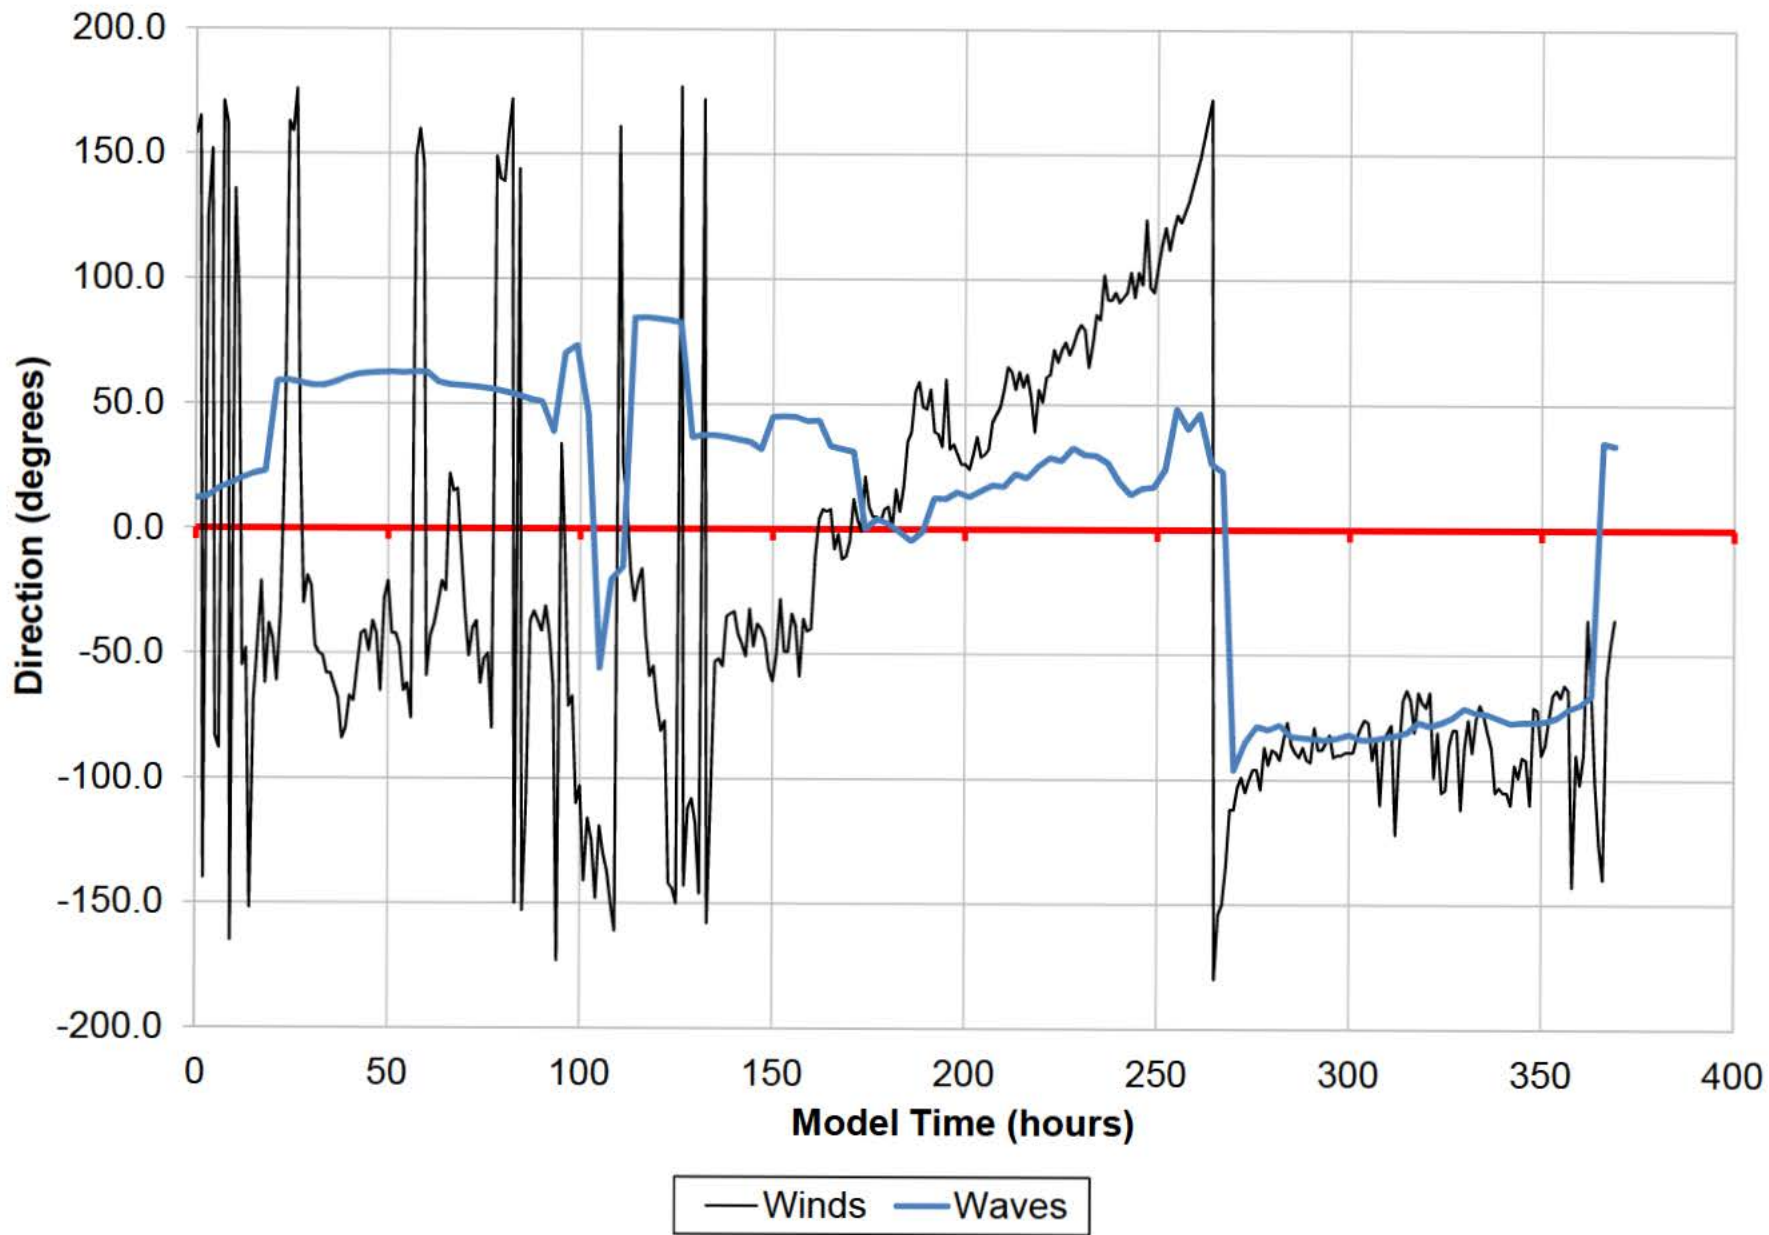
Wind Directions & Offshore Wave Directions

APPENDIX B
INPUT STORMS FOR SBEACH MODEL

Five specific return interval storm events were used in the SBEACH cross-shore analyses, 5 year, 15 year, 25 year, 50 year and 100 year. Wind, water level and wave data from Hurricane Frances observed during the time period from August 25, 2004 to September 9, 2004 was used as the basis for the design of the return interval storms. The Hurricane Frances data was scaled accordingly to match the maximum values listed in Table 4-5 for each storm. Maximum wave heights, wave periods, and water levels during each storm appear in Table 4-5. Plots of the wave height, wave period, and water level versus time appear in Appendix B.

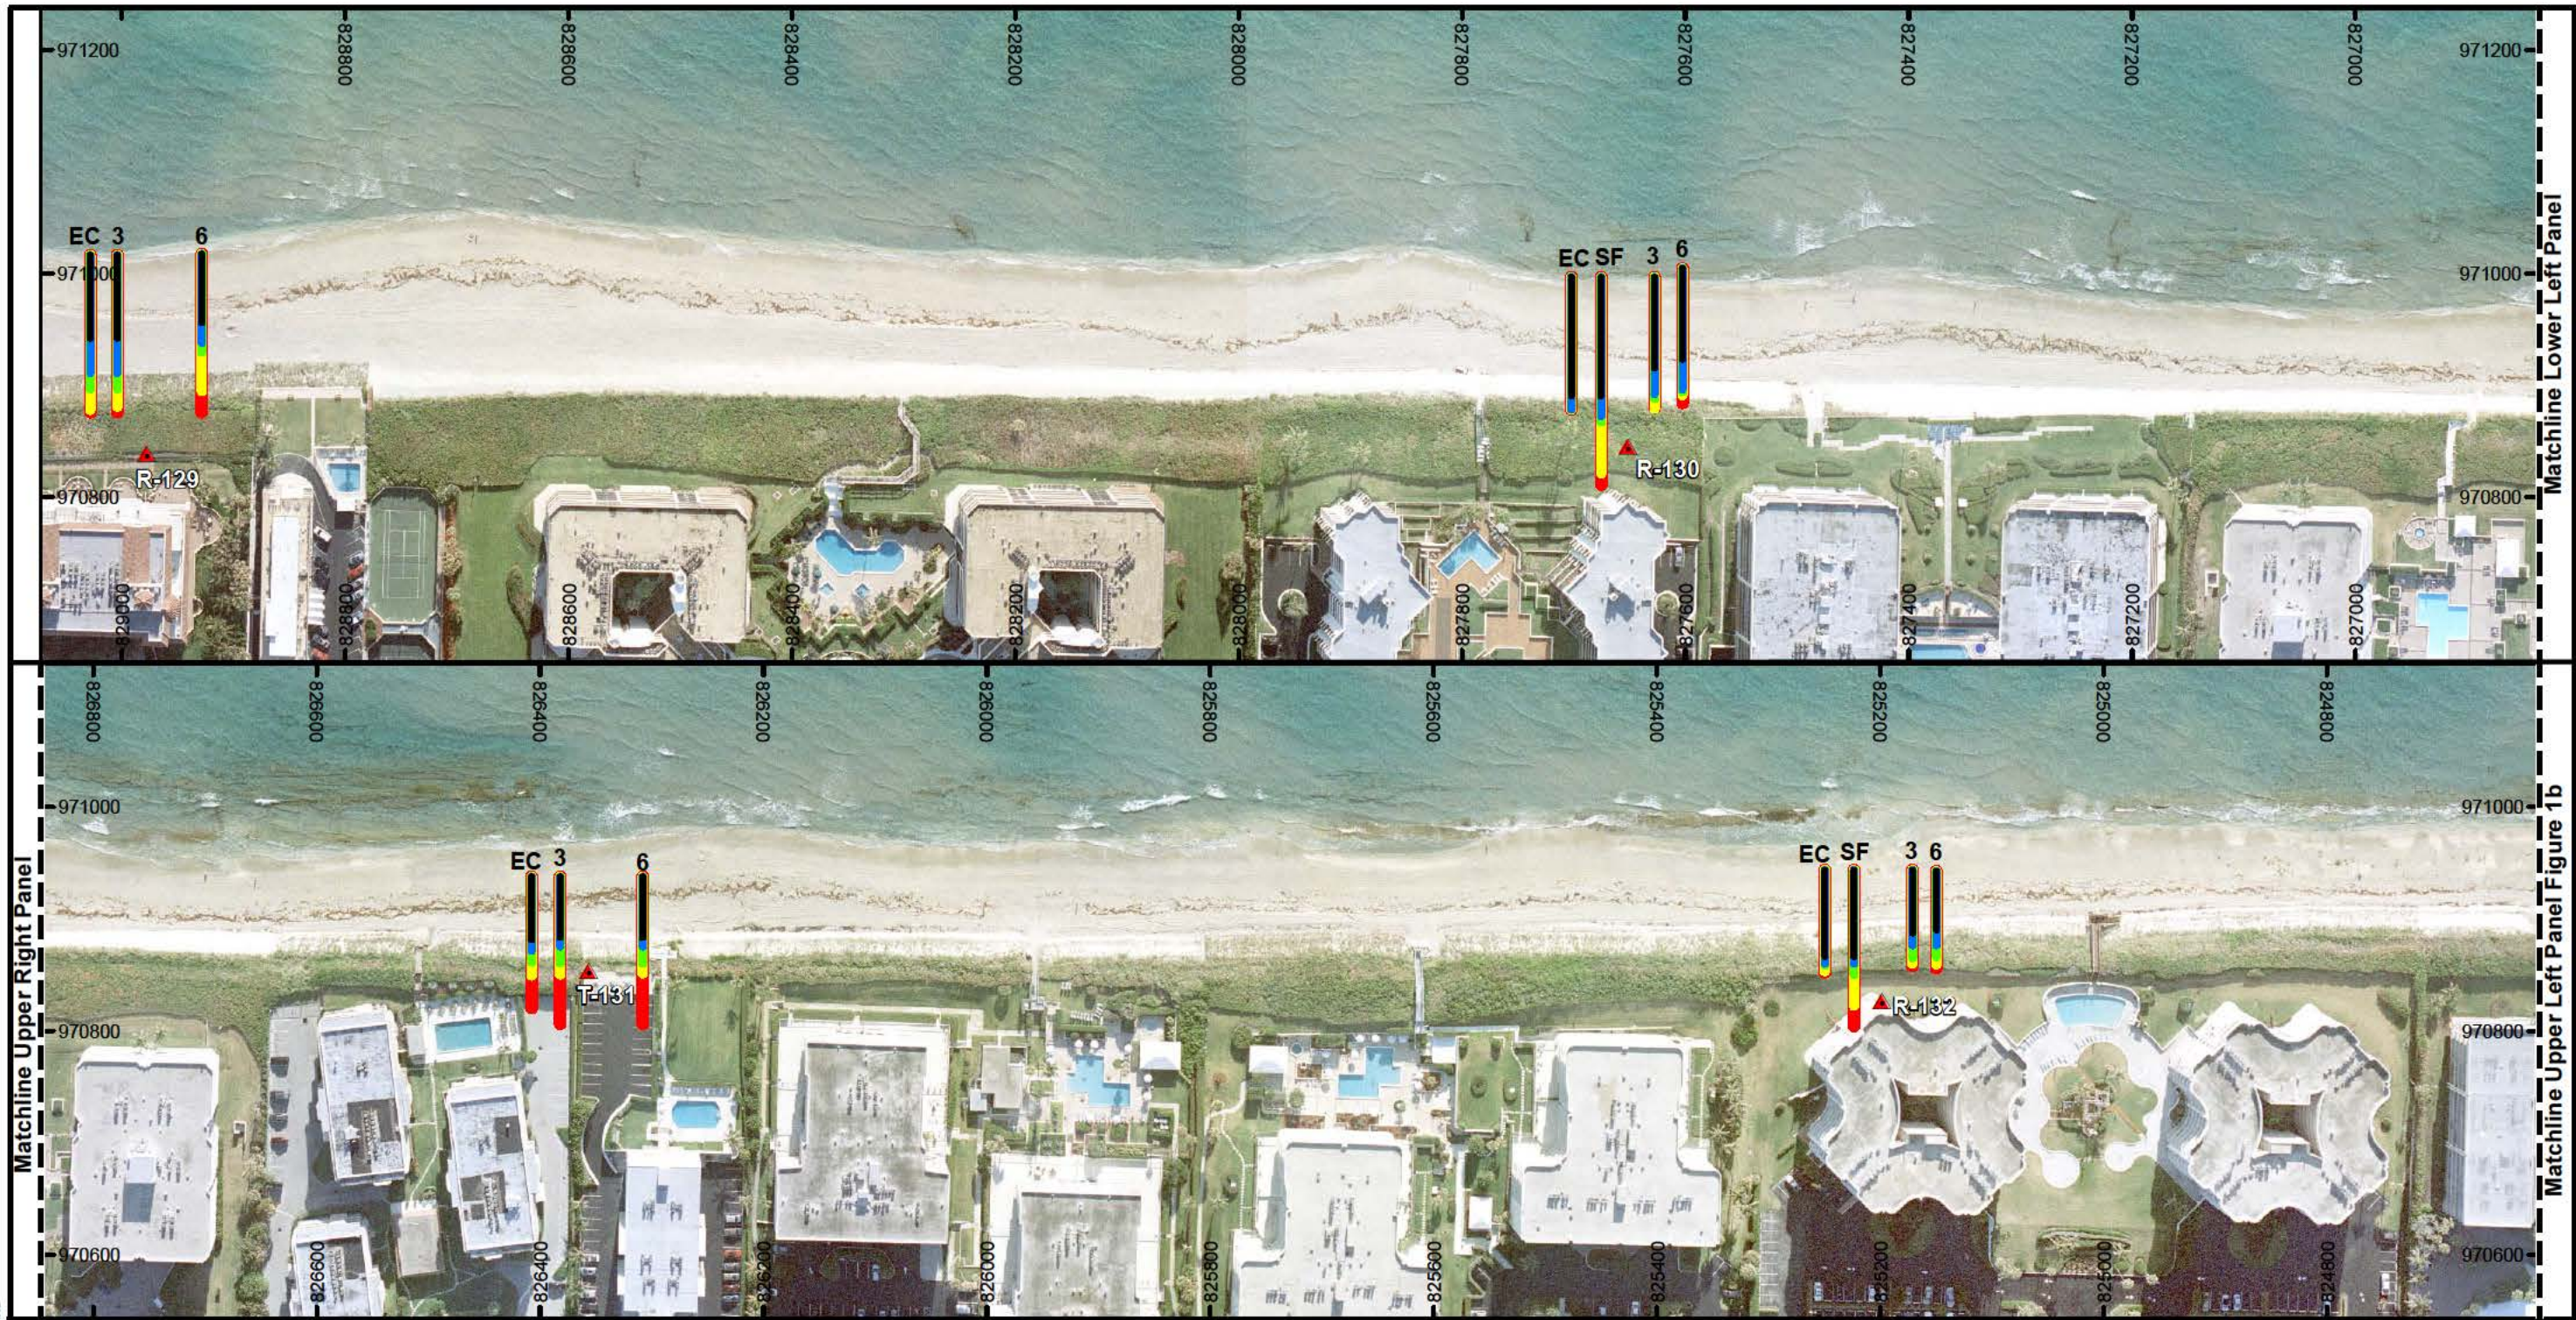
Date: 01/22/14 By: HMV Comm No.: 150814 Figure No.: 1a

**LANDWARD LIMIT OF RECESSION BY RETURN PERIOD STORM BASED ON
SBEACH RESULTS**

The landward limit of erosion was quantified to determine the potential impacts to infrastructure and property landward of the project area (**Error! Reference source not found.**). The landward limit of erosion was defined as the landward position where at least 0.5 feet of elevation was lost as a result of the storm. The values in Table 5-3 are referenced to the FDEP R-monuments since the monuments are at a fixed location. As the profiles erodes landward towards the R-monuments, the values in the table decrease until they retreat landward of the monument and then the values are negative. The table values in red signify that recession landward of the improved or maintained property has occurred. Maintained property refers to landscaped areas or paved/ gravel areas. While a seawall is operational, the landward limit of recession is the same for different return interval storms because the seawalls prevent further landward recession as shown in the table at R-130 for the 15, 25, 50, 100-year storms. In general, profiles without seawalls, R-131 and R-135 are certainly at risk of damage during the occurrence of a 25-year return interval storm or stronger storm. Damage is possible adjacent to profile R-133 as a result of a 50-year return interval or stronger storm. The critical storm return interval for damage to property to occur is between a 15-year and 25-year storm.
