Lake Worth Lagoon Waterways Town of Palm Beach, Florida North Waterway

North Waterway - Plan View

Central Waterway - Plan View

South Waterway - Plan View

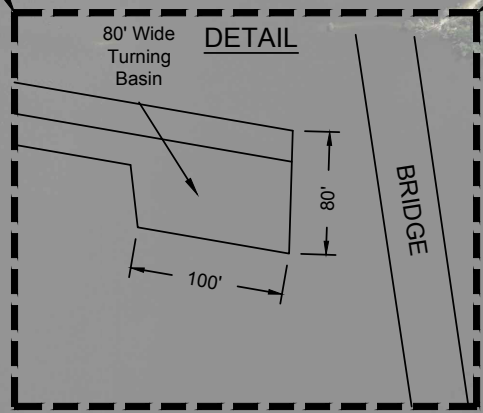
North Waterway - Plan View
 Channel Extension
 Lake Worth Lagoon Waterways
 Town of Palm Beach, Florida
 North Waterway

N-7
**NO SEAGRASS OBSERVED
 DURING JUNE 2014
 SURVEY.**

**PERMIT MODIFICATION
 CHANNEL ADDITION AREA**

| NORTH MAIN WATERWAY | | |
| Segment | Length (ft) | Volume (cy) |
| Extension | 1802 | 3500 |

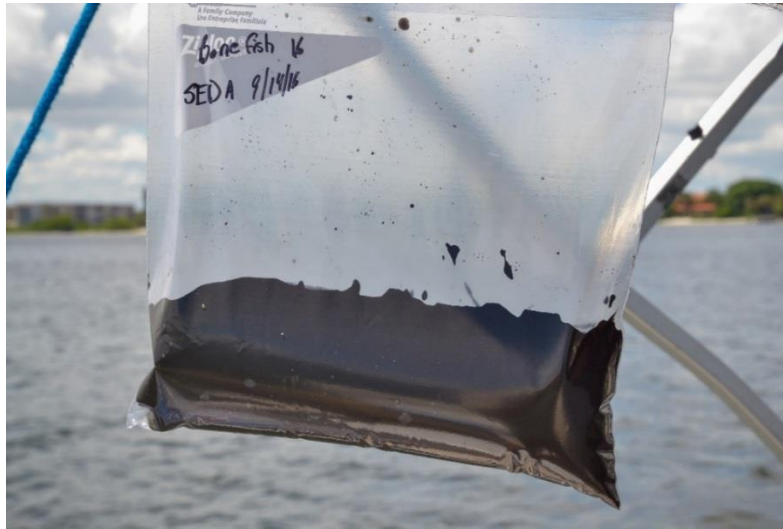
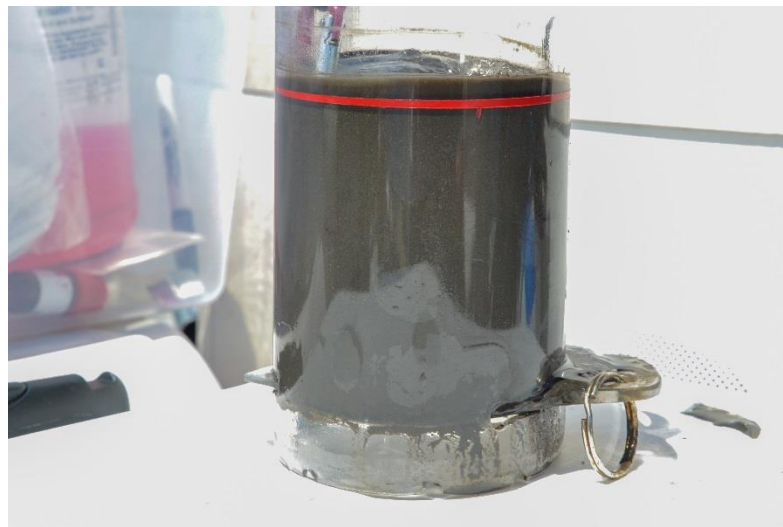
Bonefish Cove sediment cores, sampled on September 14, 2016, showing dark muck sediment.

Bonefish Cove was sampled on September 14, 2016 as part of Palm Beach County's CAP 1135 benthic macroinvertebrate study to compare five restoration sites within the Lake Worth Lagoon with five areas proposed for restoration projects. The benthic community was sampled at two sites within Bonefish Cove to characterize the biological community and sediment environment. A total of 10 cores samples and 10 grab samples were collected for quantification of the benthic community, and two sediment cores were analyzed. The sediment at Bonefish Cove was black muck (100% silt/clay), and muck depth exceeded 1.7 m. Bonefish Cove also had the highest organic content of the 10 study locations at 38.9%. One of the Bonefish Cove sample sites had the lowest overall macrofaunal abundance and diversity of all study sites.
