ENVIRONMENTAL ASSESSMENT

Anclothe River, Florida Project and Gulf Intracoastal Waterway (GIWW) Cut P-41 Pinellas & Pasco Counties

MAINTENANCE DREDGING AND DREDGED MATERIAL PLACEMENT

APPENDIX E

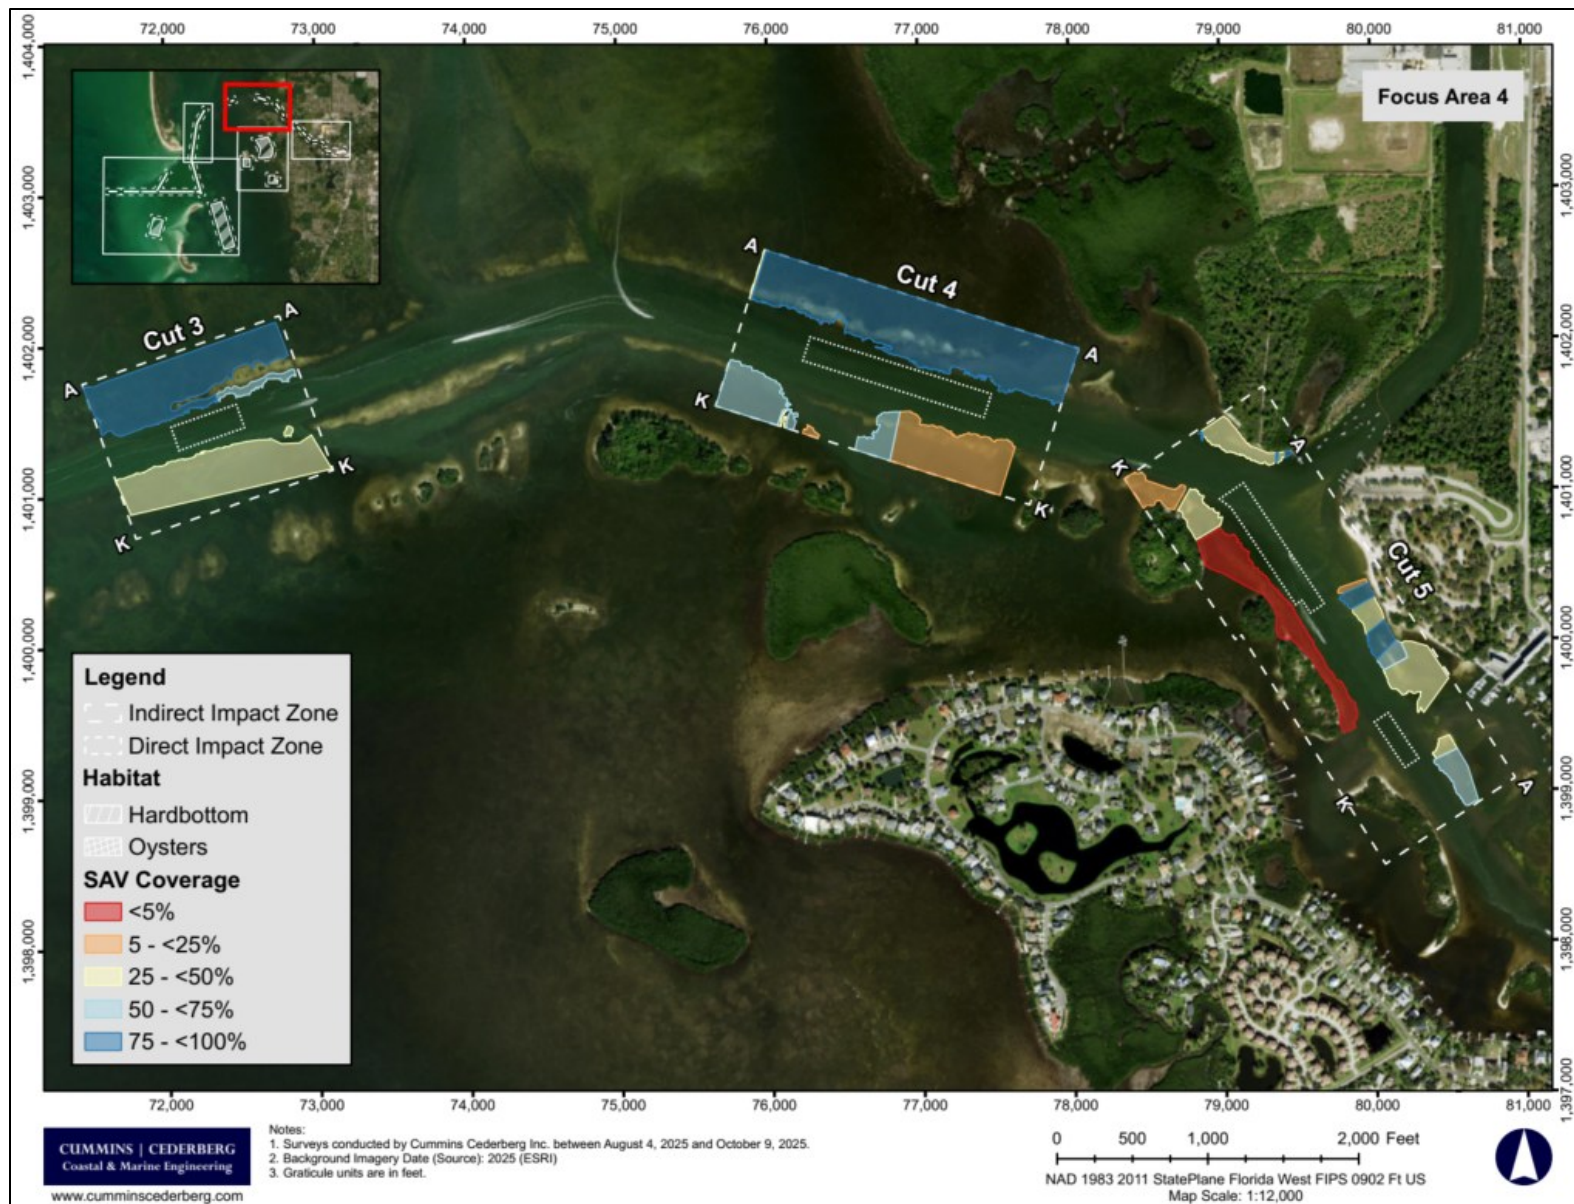
The observed SAV habitat within the IIA at Cut 5 is 14.97 acres (**Table 5**) and the estimated actual surface area of SAV is 4.66 acres (**Table 6**), or 31% of the observed footprint. No SAV was documented within the DIA.

The observed SAV habitat footprint in the IIA of Cut 4 is 28.75 acres (**Table 5**) and the estimated actual surface area of SAV is 19.72 acres (**Table 6**), or 68% of the observed habitat footprint. No resources of importance were documented within the DIA at Cut 4.

The observed SAV habitat footprint in Cut 3 is 18.44 acres (**Table 5**) and the estimated actual surface area of SAV is 11.71 acres (**Table 6**), or 64% of the observed footprint. No SAV was documented within the DIA at Cut 3.

Figure 7. Benthic resource map for Cuts 3, 4, 5.

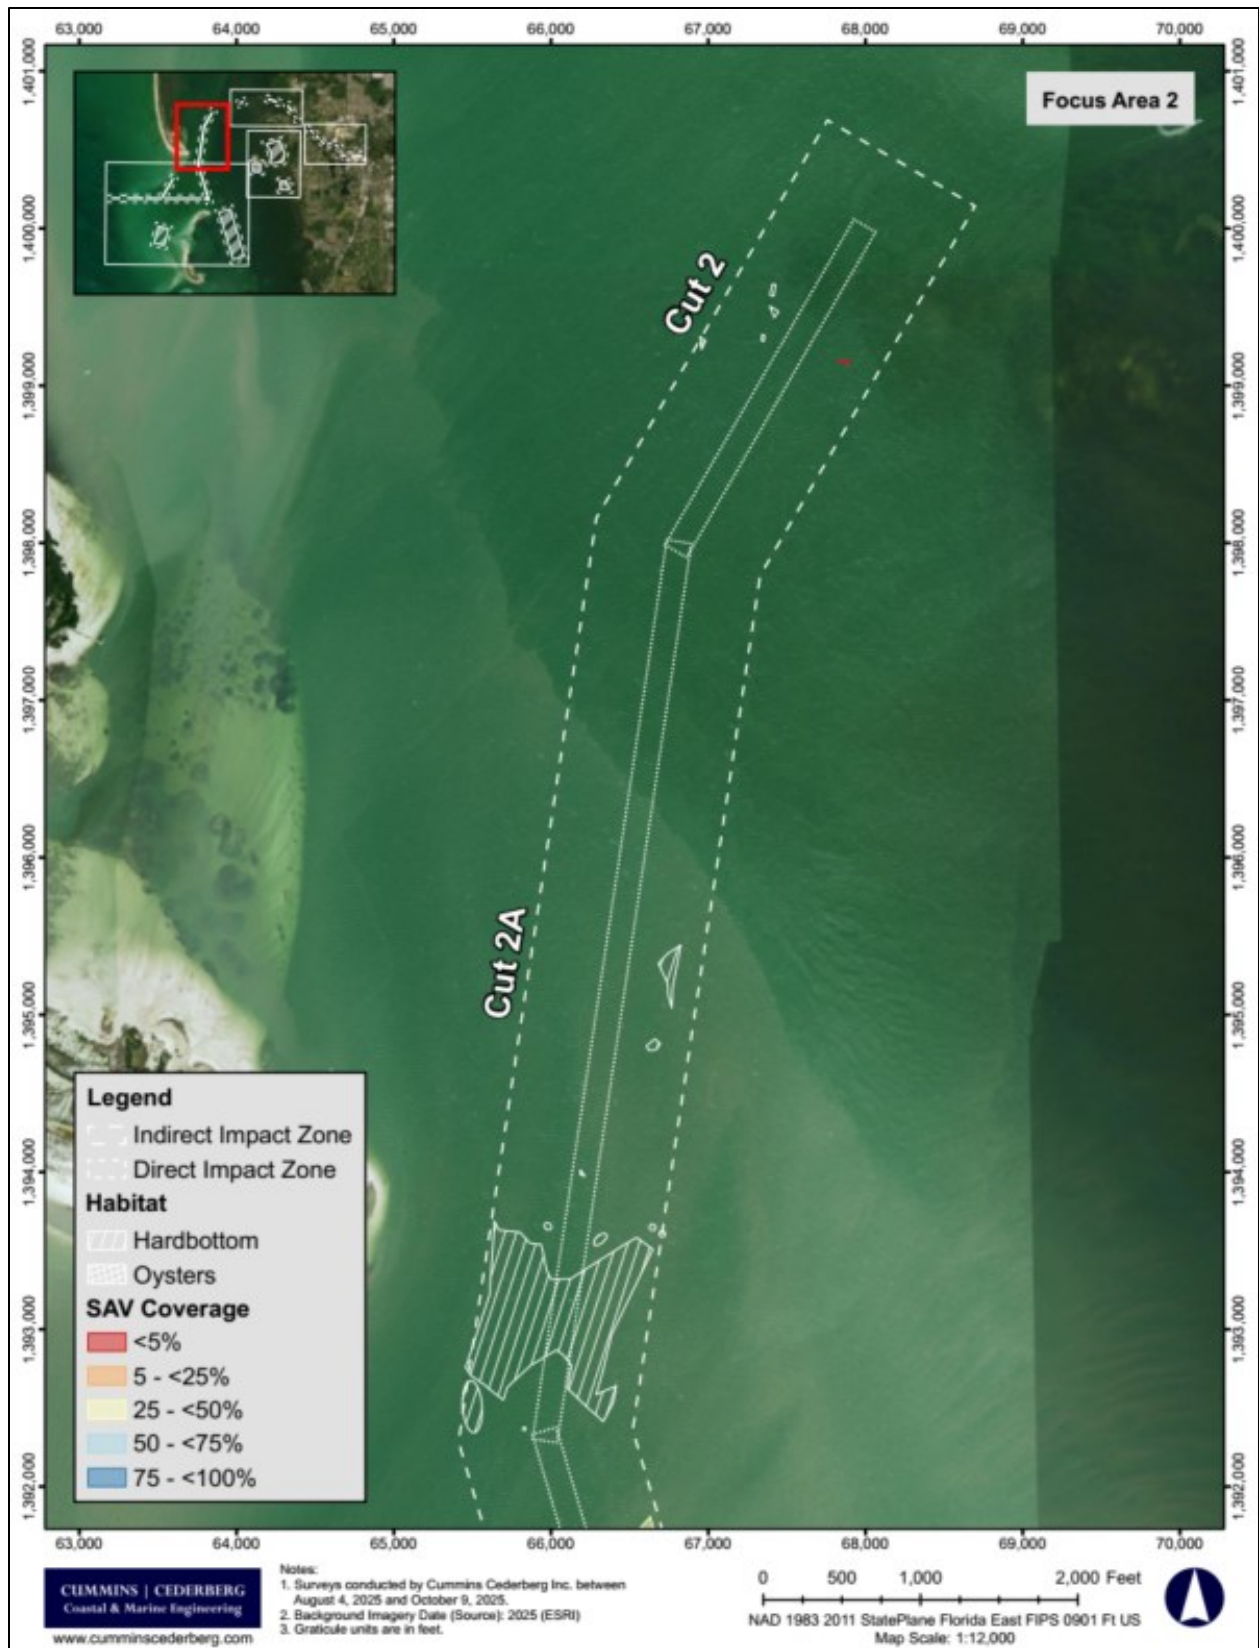
Figure 8. Benthic resource map for Cuts 2 and 2A.

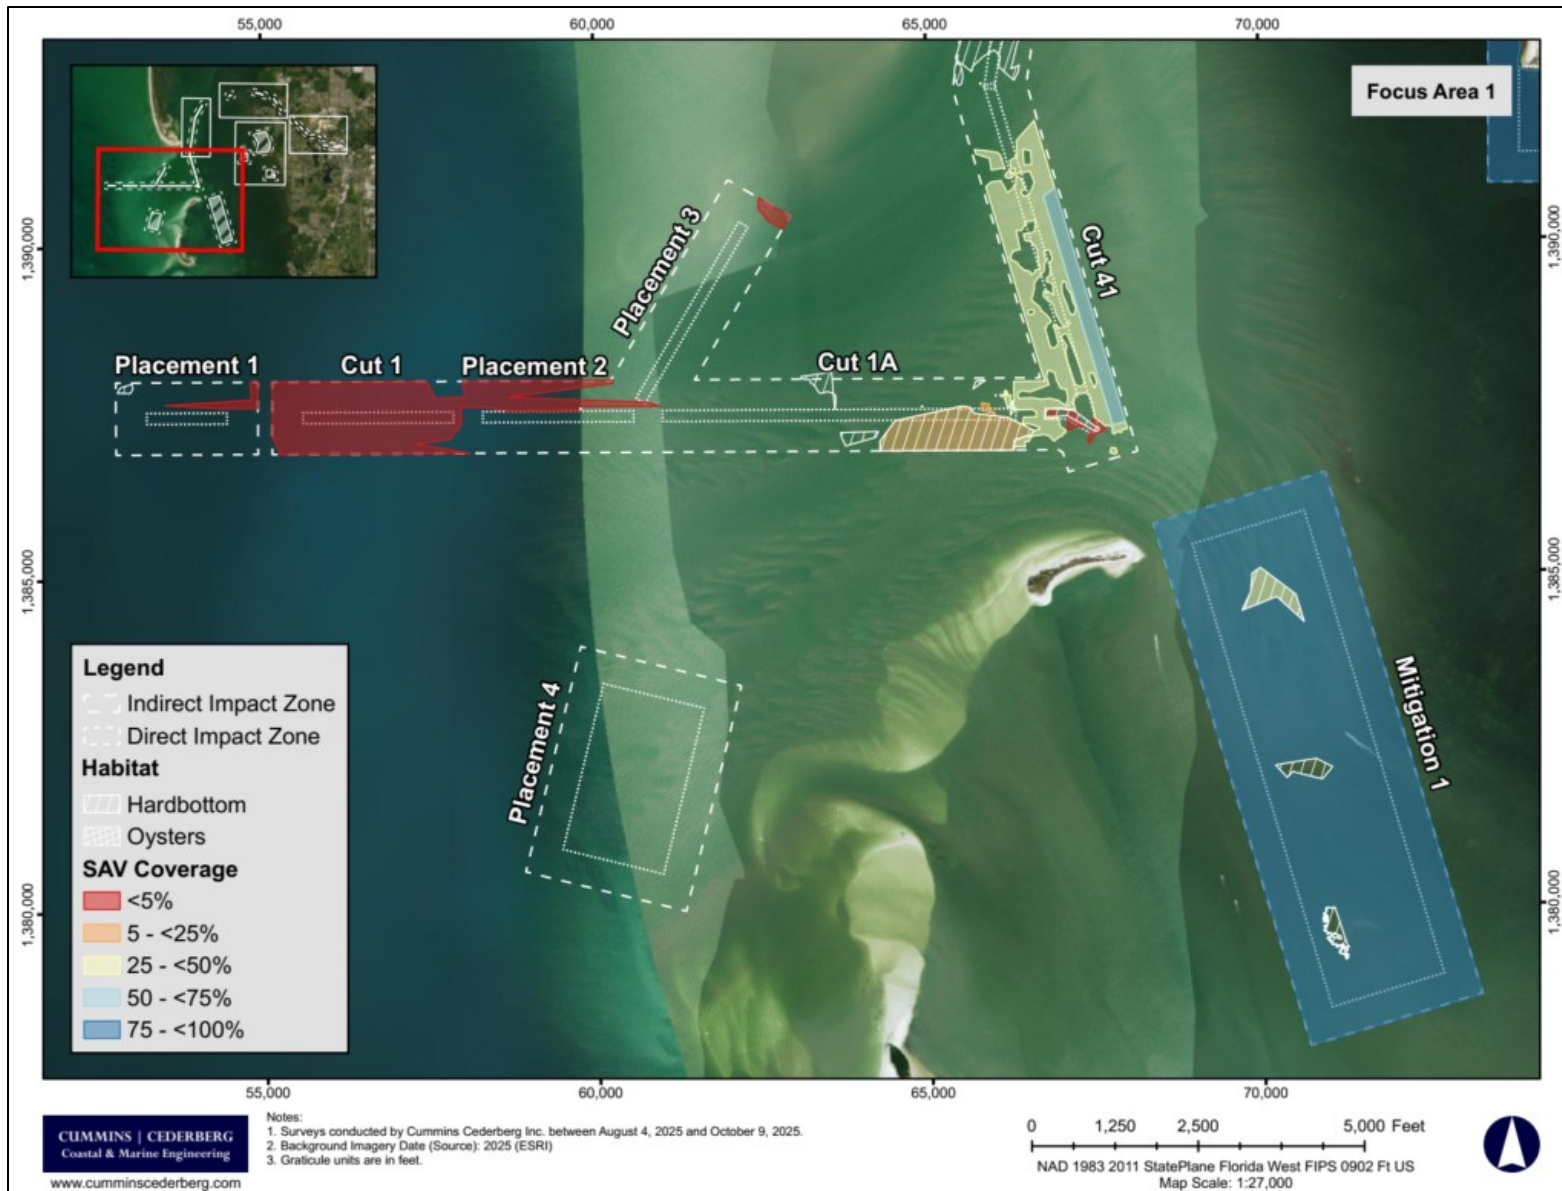
Cut 1A is located to the east of Cut 1 and west of Cut 41. It is generally devoid of resources on the western half of the site but seagrass and hardbottom are found in the eastern extent of the survey area (**Figure 9**). Along the southeast portion of the site, there is an area characterized by patchy hardbottom and seagrass habitat (5 - <25% cover; *H. wrightii*). Seagrass and hardbottom patches in this area are not substantial – seagrass patches are typically 100 ft² or less and the hardbottom areas are often small rocky outcroppings less than 50 ft² – however they are consistently present throughout. There are two larger hardbottom habitat areas in the north central and south central sections of the survey area. These larger areas exhibit consolidated hardbottom with emergent rock and extensive corals including *S. bournoni*, *P. americana*, *C. arbuscula*, *Octocorallia* spp., and sponges (**Photo A-18**). Between larger outcroppings, smaller unconsolidated rocky areas that are sponge dominated are present. The other two noteworthy areas are larger standalone 25- <50% cover *H. wrightii* patches (**Photo A-19**). Substrate within Cut1A consists of a fine sand composition.

The observed SAV habitat footprint in the IIA of Cut 1A is 32.94 acres (**Table 5**) and the estimated actual surface area of SAV is 4.94 acres (**Table 6**), or 15% of the observed habitat footprint. Within the DIA, there is 3.82 acres of SAV habitat, or 0.57 acres of estimated actual surface area.

Figure 9. Benthic resource map for Cuts 1 and 1A; Placement 1, 2, 3, 4; Mitigation 1.

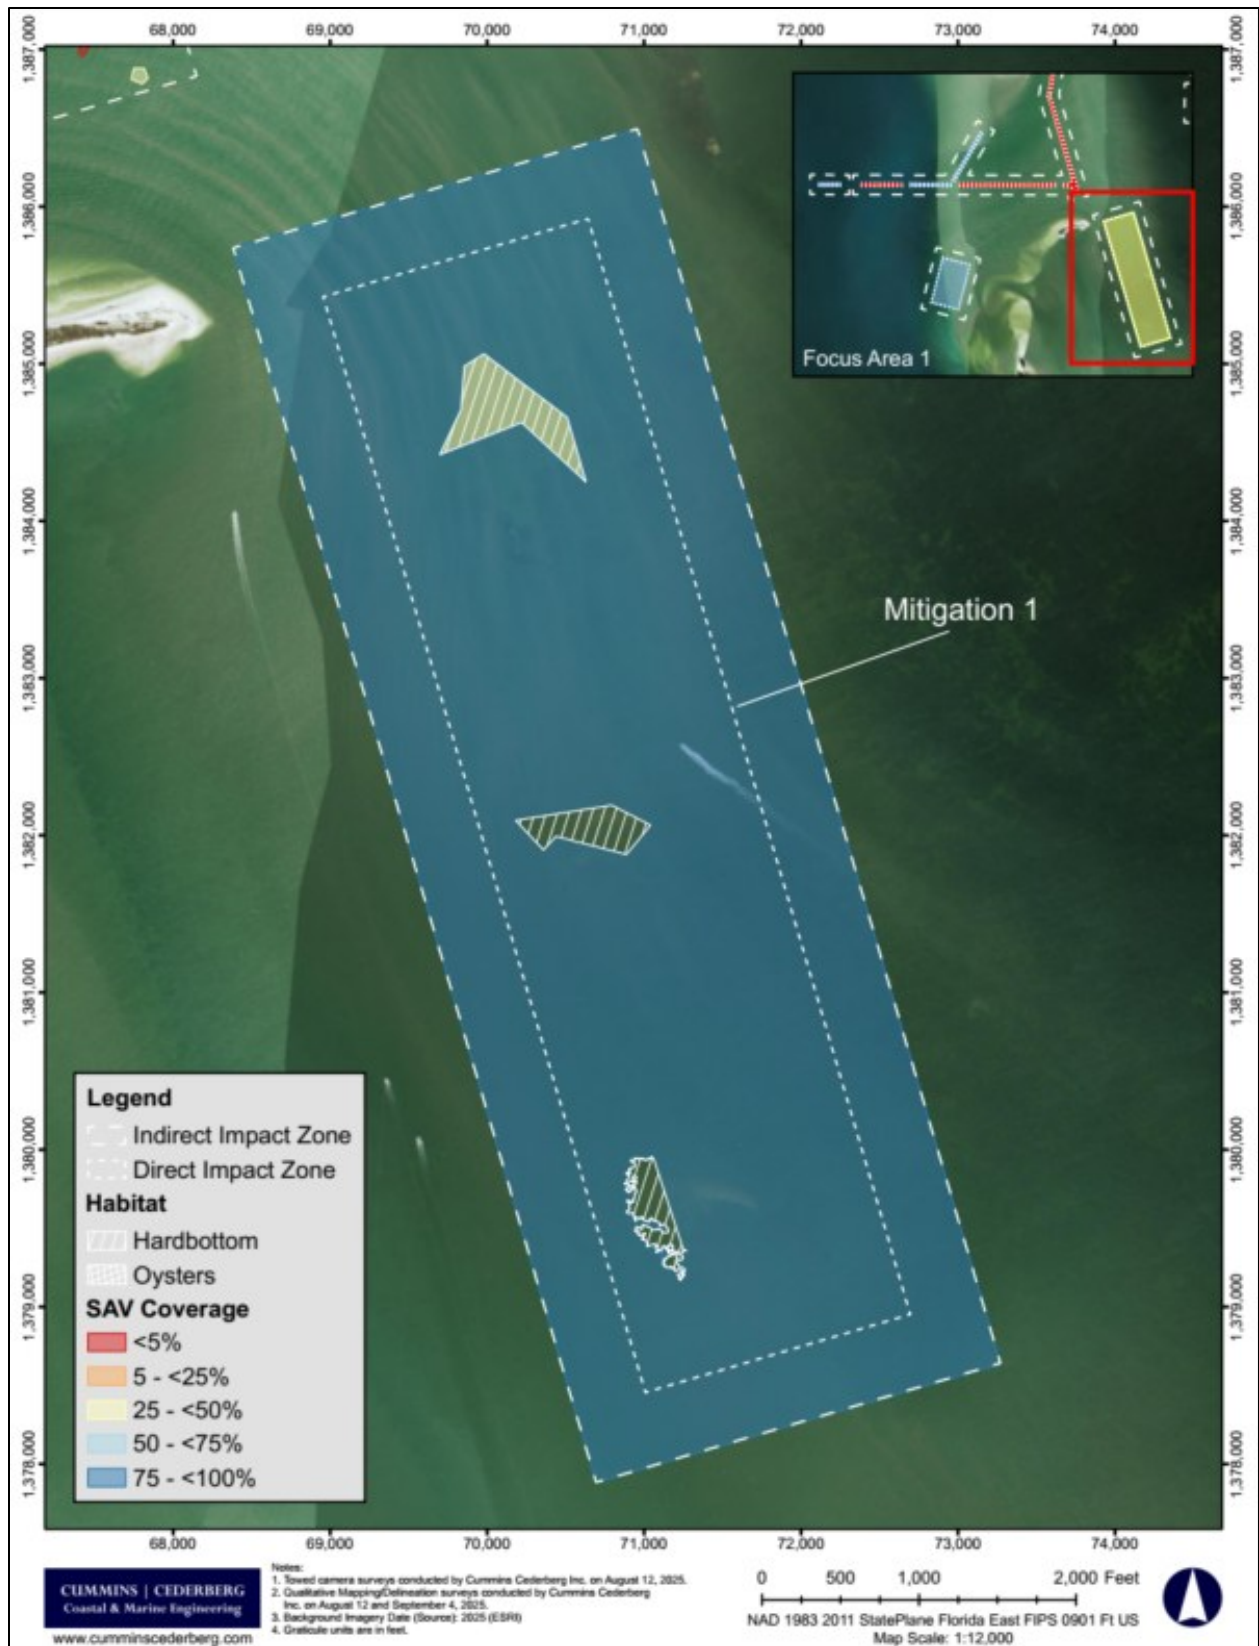
The area also supports three discrete areas with hardbottom habitat (12.79 acres collectively, **Table 5**) – one in the south extent (2.8 acres), one near the midpoint of the site (3.57 acres), and one near the north extent (6.43 acres). The southern hardbottom area is characterized by shelly sand and occasional unconsolidated rocks with standalone sponges and corals. The corals present in this hardbottom area are *Siderastrea radians*, *S. bournoni*, *P. americana*, *Oculina* spp., and *S. intersepta* (**Photo A-24**). All the corals observed were less than 30 cm in diameter and most are less than 10 cm in diameter. The transitional edge between the hardbottom and seagrass habitat supports multiple macroalgae genera, including *Penicillus* sp., *Caulerpa* spp., *Halimeda* sp., and *Udotea* sp. The two other patches that support hardbottom habitat (middle and north) are characterized by shelly sand and occasional rocks with standalone sponges and corals. Coral diversity within these two areas is reduced and only small, paling or bleached *S. radians* were observed.

Figure 10. Benthic resource map for Mitigation 1.

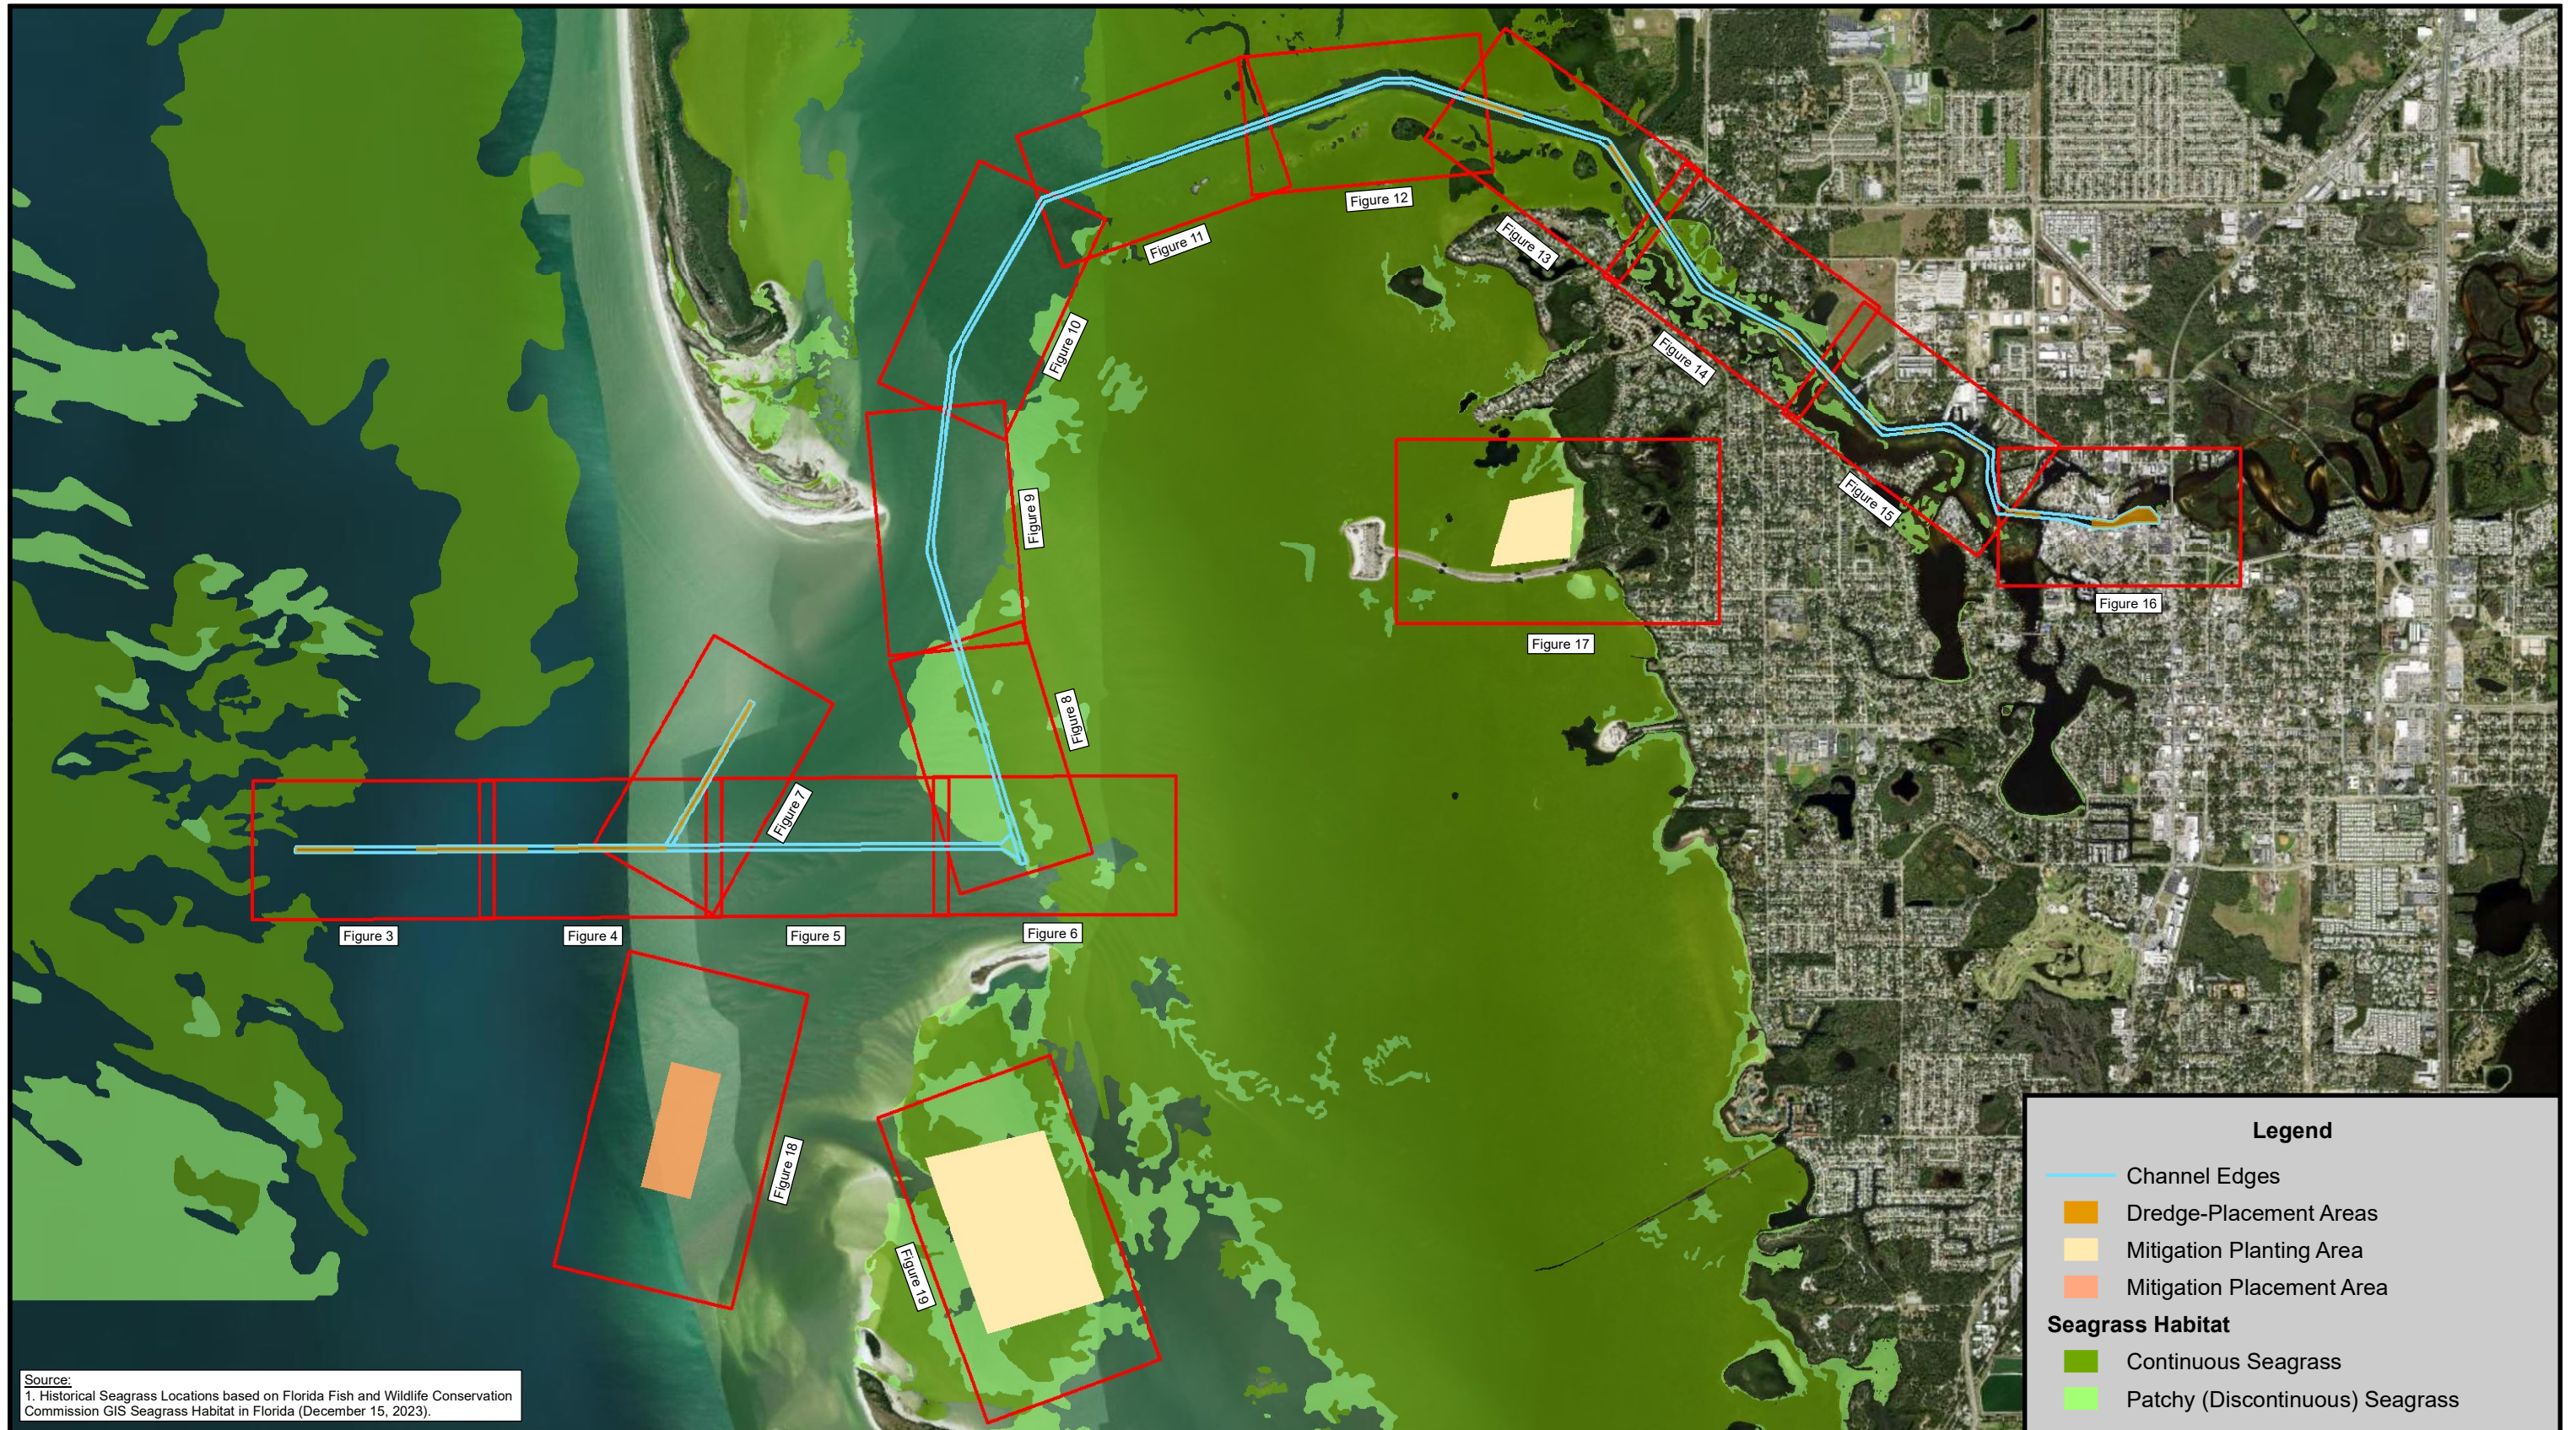
Figure 1.
 Site Location Map
 Anclote / GIWW
 Submerged Aquatic Vegetation Resource Surveys
 Pasco / Pinellas County, Florida
 Source: Water & Air Research, Inc., 2024.

Source:
 1. Historical Seagrass Locations based on Florida Fish and Wildlife Conservation Commission GIS Seagrass Habitat in Florida (December 15, 2023).

Beds of seagrasses and other types of SAV are located in close proximity to the authorized dredging footprint of Anclote and Gulf Intracoastal Waterway (GIWW) O&M Federal channels and proposed placement areas, Pinellas, Florida (Figures 1 and 2). The U.S. Army Corps of Engineers (USACE) is preparing an Environmental Assessment (EA) and Joint Coastal Permit (JCP) application for these areas. Benthic surveys will be used for the EA, JCP application, and pre-construction. The areas shown have not been previously dredged or used for dredge material placement.

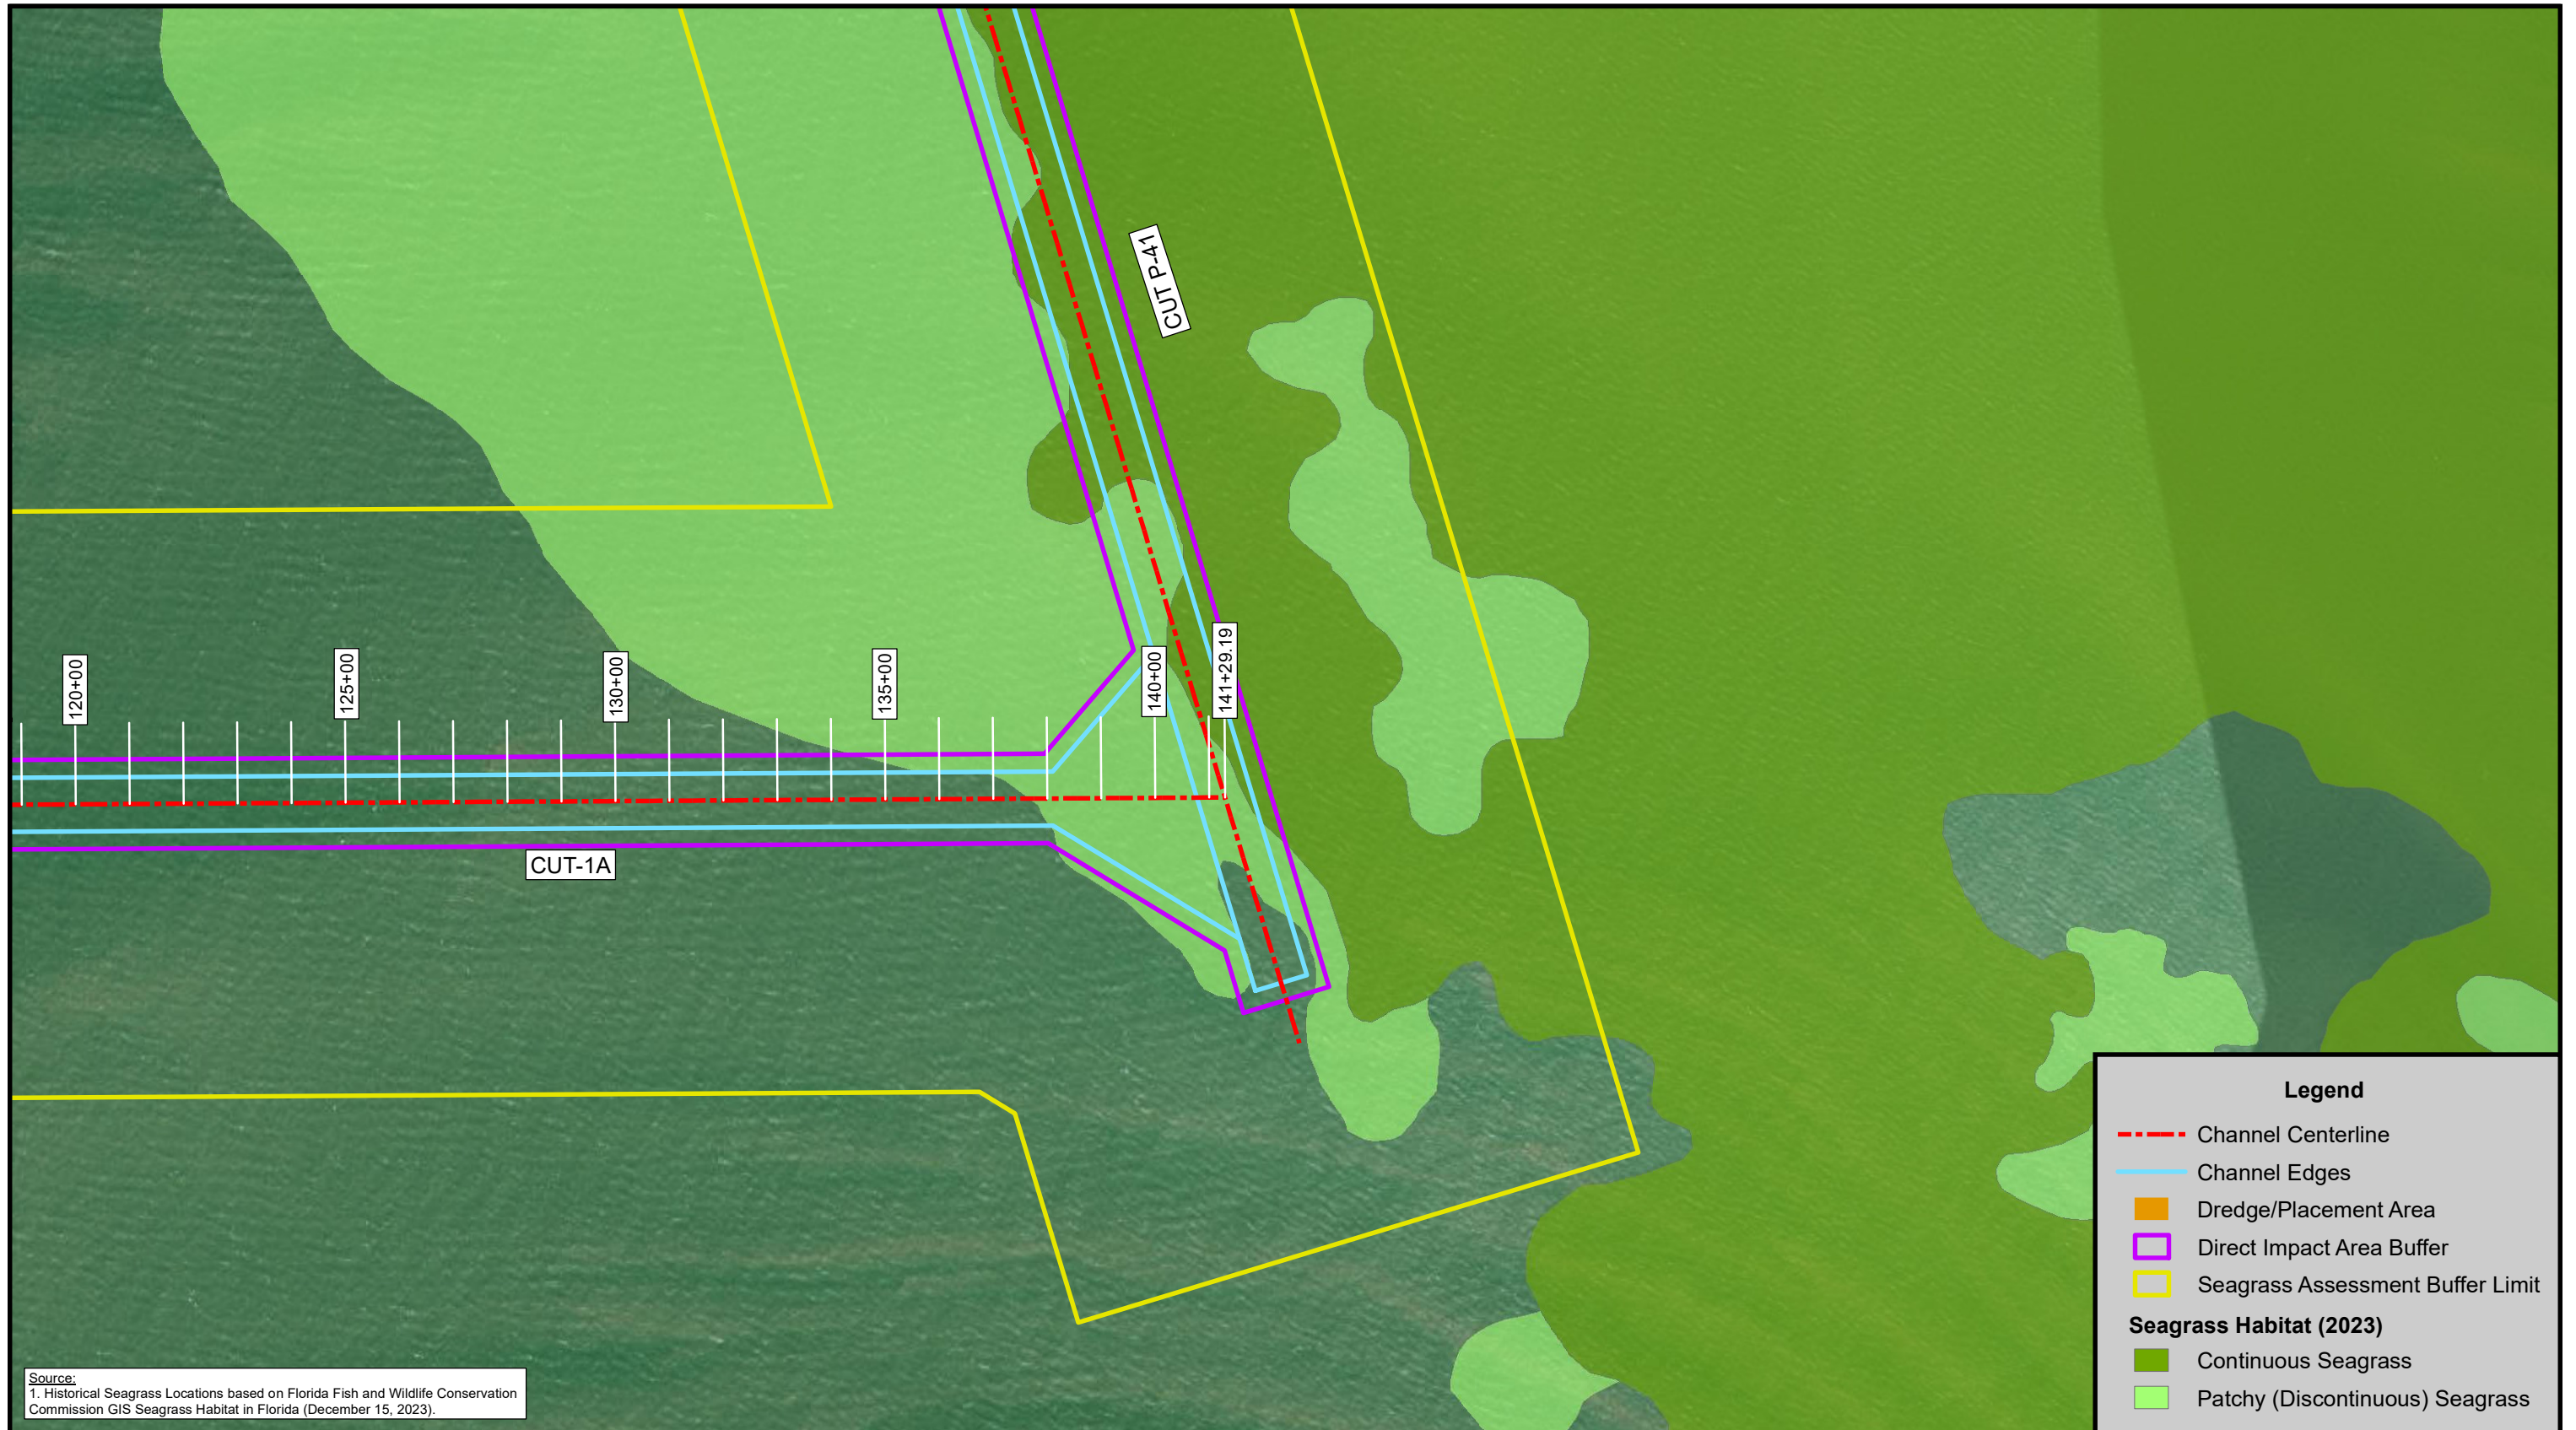
Figure 5.
 Dredge Area Layout
 Anclote / GIWW
 Submerged Aquatic Vegetation Resource Surveys
 Pasco / Pinellas County, Florida
 Source: Water & Air Research, Inc., 2024.

Source:
 1. Historical Seagrass Locations based on Florida Fish and Wildlife Conservation Commission GIS Seagrass Habitat in Florida (December 15, 2023).

2023 identified existing SAV within the 150 meter Seagrass Assessment Buffer at Cuts 1, 1A, Old Cut 2, P-41, 3, 4, 5, 6, 7, 8, 9, 10, 11, 12, 14, Fred Howard Park Mitigation Area (FHPMA), Three Rooker Island Placement Area (TRIPA), and Three Rooker Island Mitigation Area (TRIMA) (Figures 3-19). SAV was identified existing within the Direct Impact Area for Cuts 1, 1A, Old Cut 2, P-41, 3, 6, 14, FHPMA, and TRIPA (Figures 3, 6, 7, 8, 9, 11, 14, and 16). SAV was identified existing within the Mitigation Planting Area for TRIMA (Figure 19).

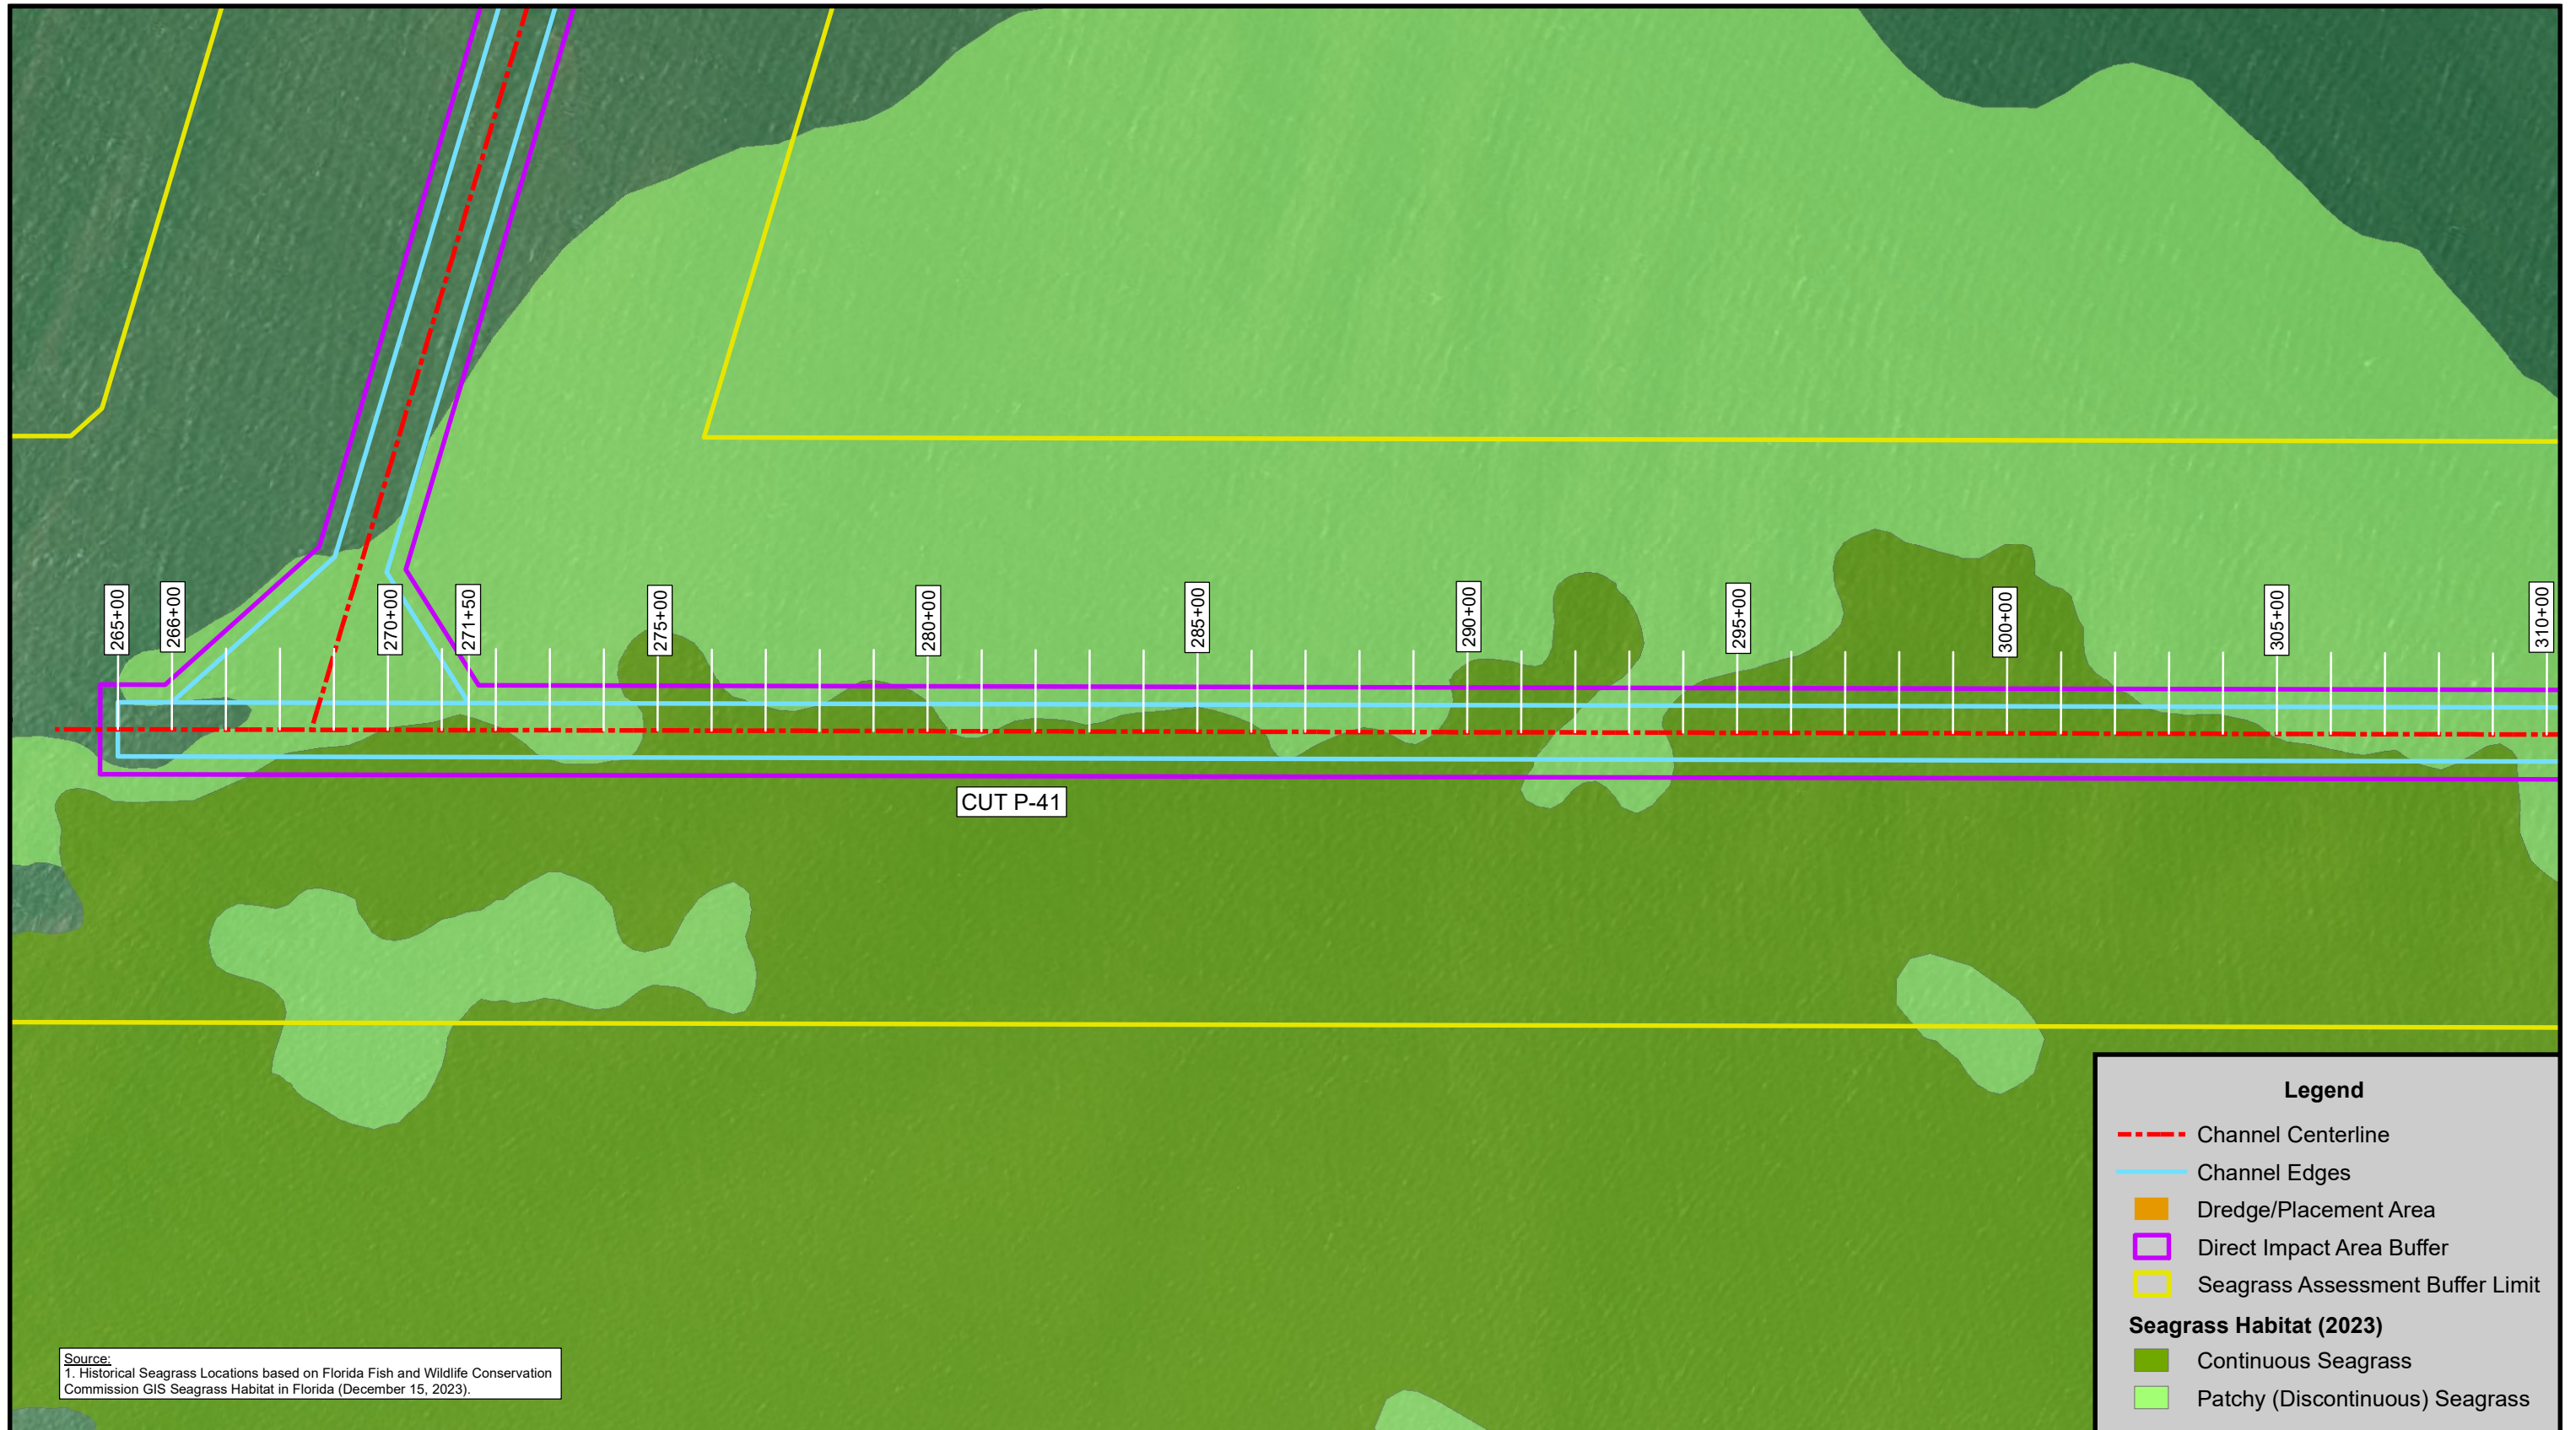
Figure 7.
 Dredge Area Layout
 Anclote / GIWW
 Submerged Aquatic Vegetation Resource Surveys
 Pasco / Pinellas County, Florida
 Source: Water & Air Research, Inc., 2024.

Source:
 1. Historical Seagrass Locations based on Florida Fish and Wildlife Conservation Commission GIS Seagrass Habitat in Florida (December 15, 2023).
