ENVIRONMENTAL ASSESSMENT

Anclothe River, Florida Project and Gulf Intracoastal Waterway (GIWW) Cut P-41 Pinellas & Pasco Counties

MAINTENANCE DREDGING AND DREDGED MATERIAL PLACEMENT

APPENDIX E

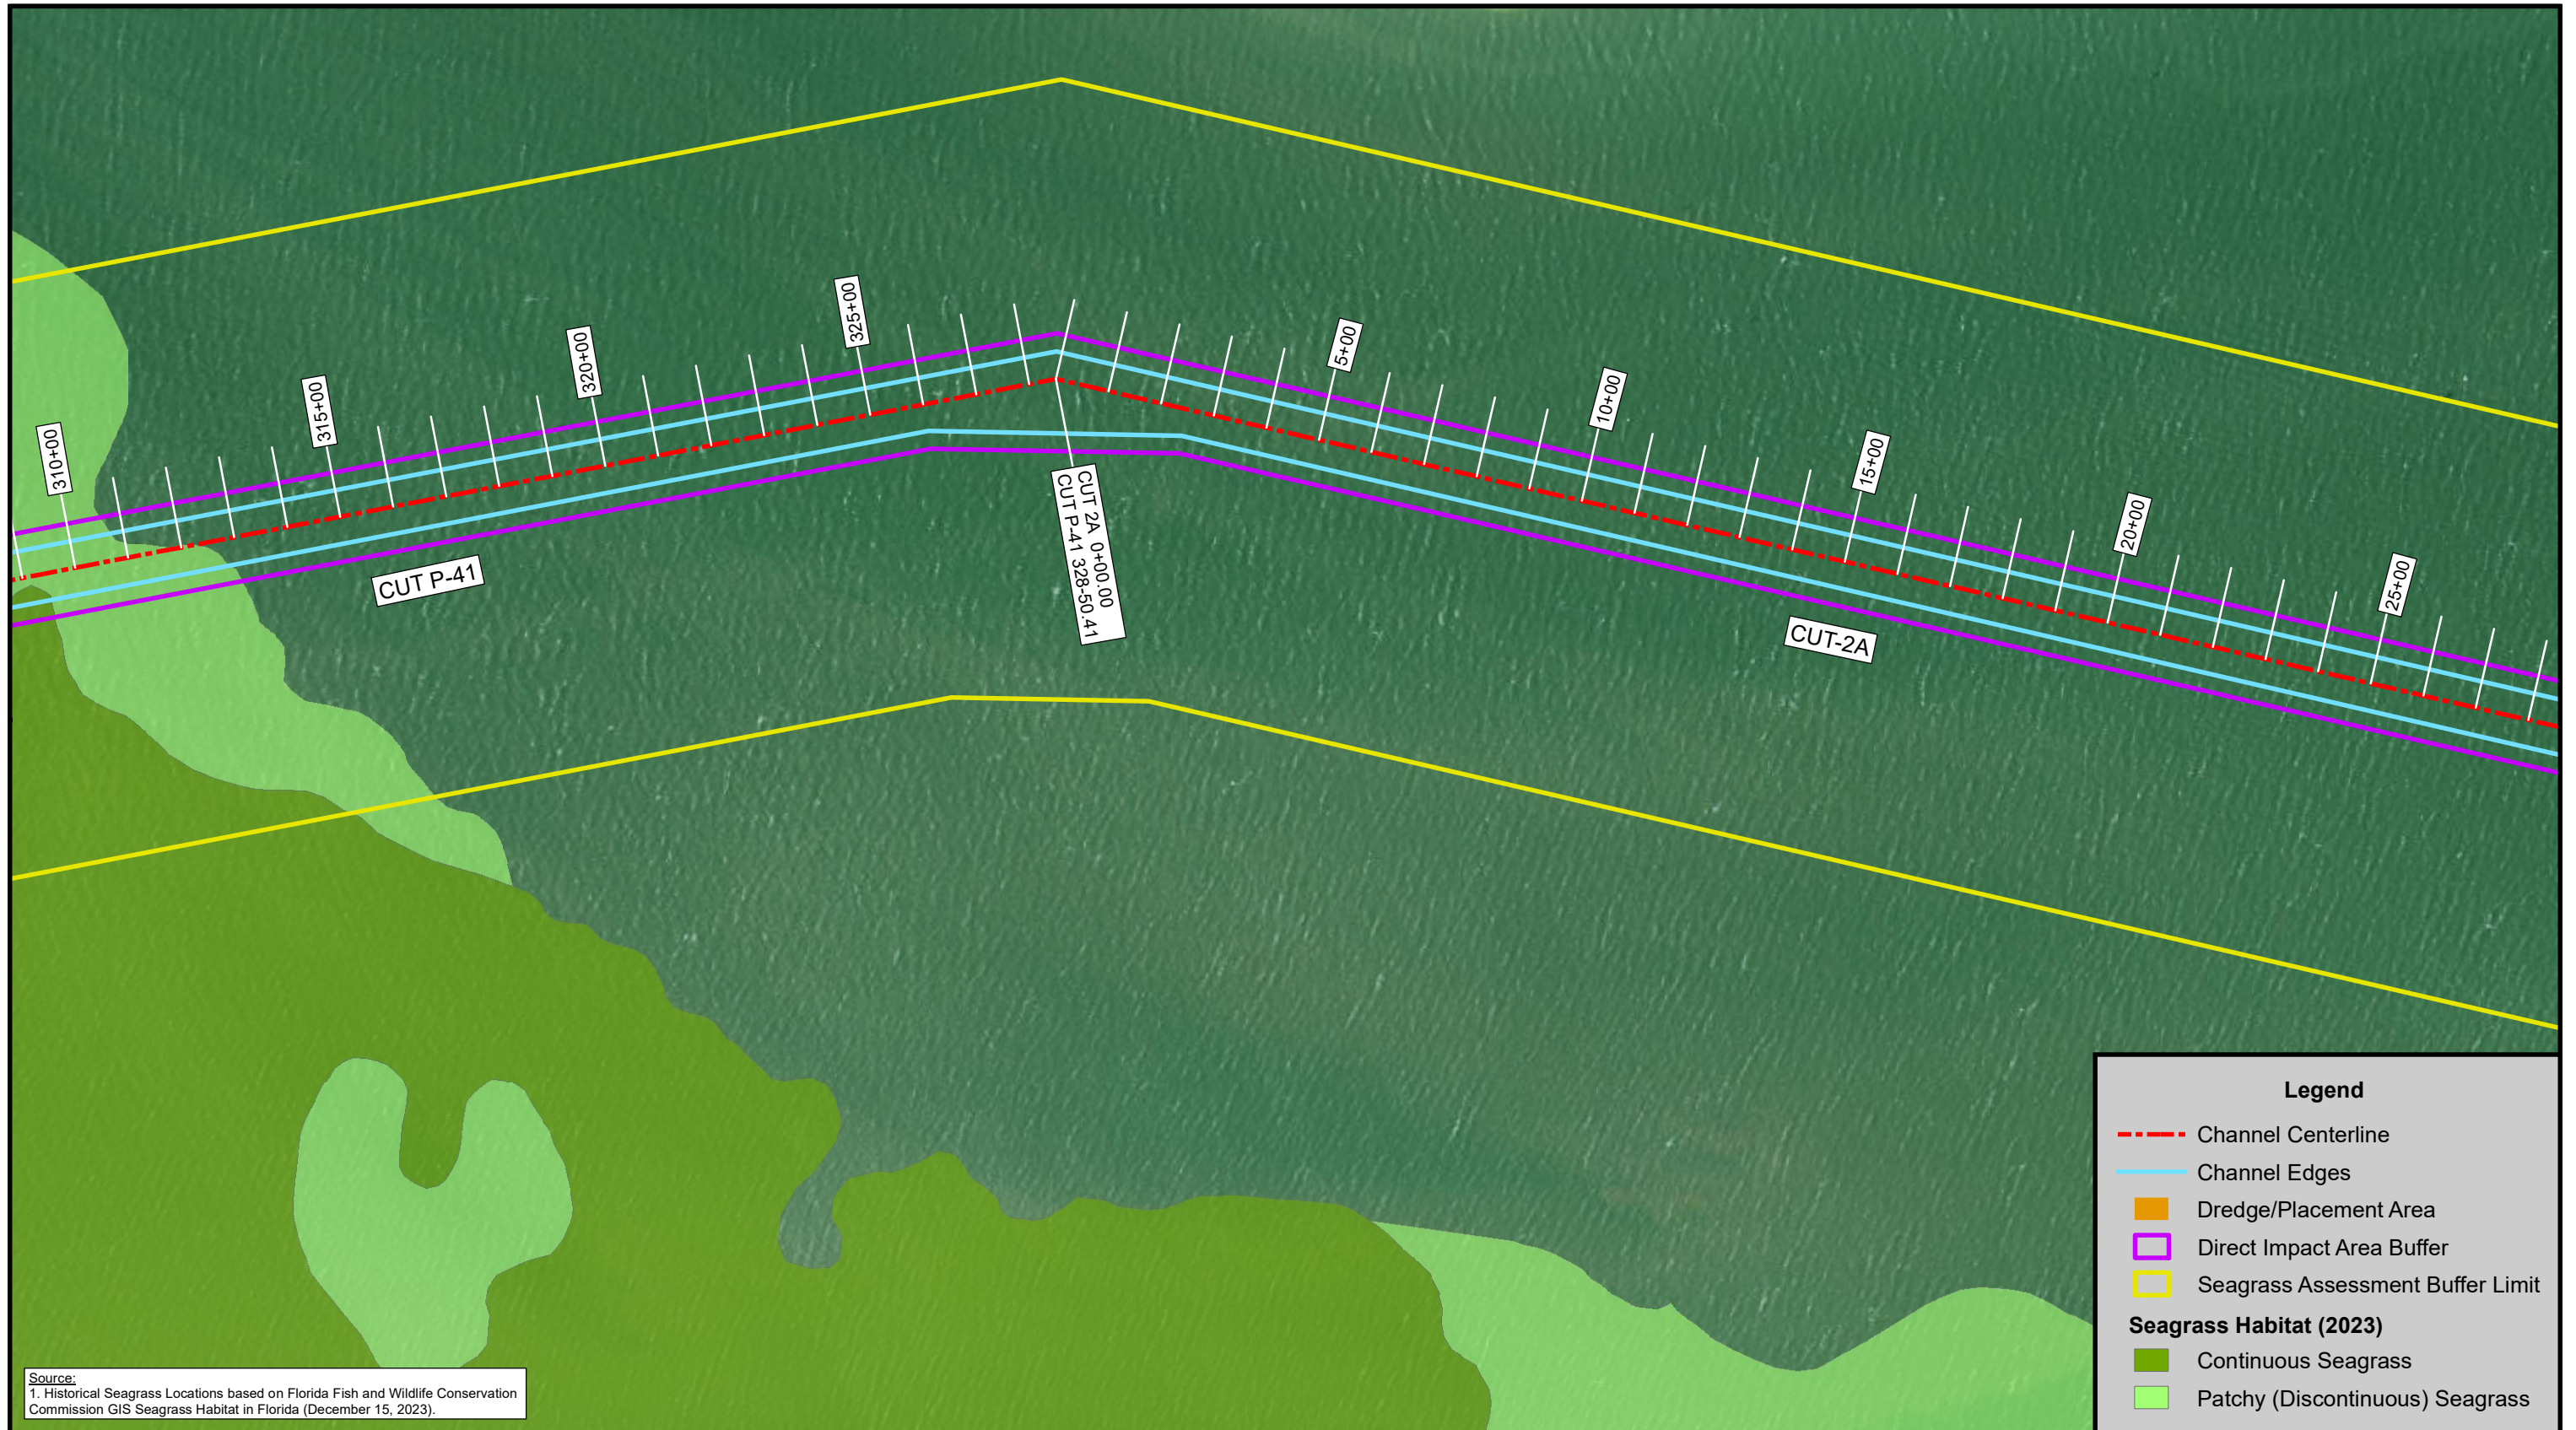
Figure 8.
 Dredge Area Layout
 Anclote / GIWW
 Submerged Aquatic Vegetation Resource Surveys
 Pasco / Pinellas County, Florida
 Source: Water & Air Research, Inc., 2024.

Source:
 1. Historical Seagrass Locations based on Florida Fish and Wildlife Conservation Commission GIS Seagrass Habitat in Florida (December 15, 2023).

2023 identified existing SAV within the 150 meter Seagrass Assessment Buffer at Cuts 1, 1A, Old Cut 2, P-41, 3, 4, 5, 6, 7, 8, 9, 10, 11, 12, 14, Fred Howard Park Mitigation Area (FHPMA), Three Rooker Island Placement Area (TRIPA), and Three Rooker Island Mitigation Area (TRIMA) (Figures 3-19). SAV was identified existing within the Direct Impact Area for Cuts 1, 1A, Old Cut 2, P-41, 3, 6, 14, FHPMA, and TRIPA (Figures 3, 6, 7, 8, 9, 11, 14, and 16). SAV was identified existing within the Mitigation Planting Area for TRIMA (Figure 19).

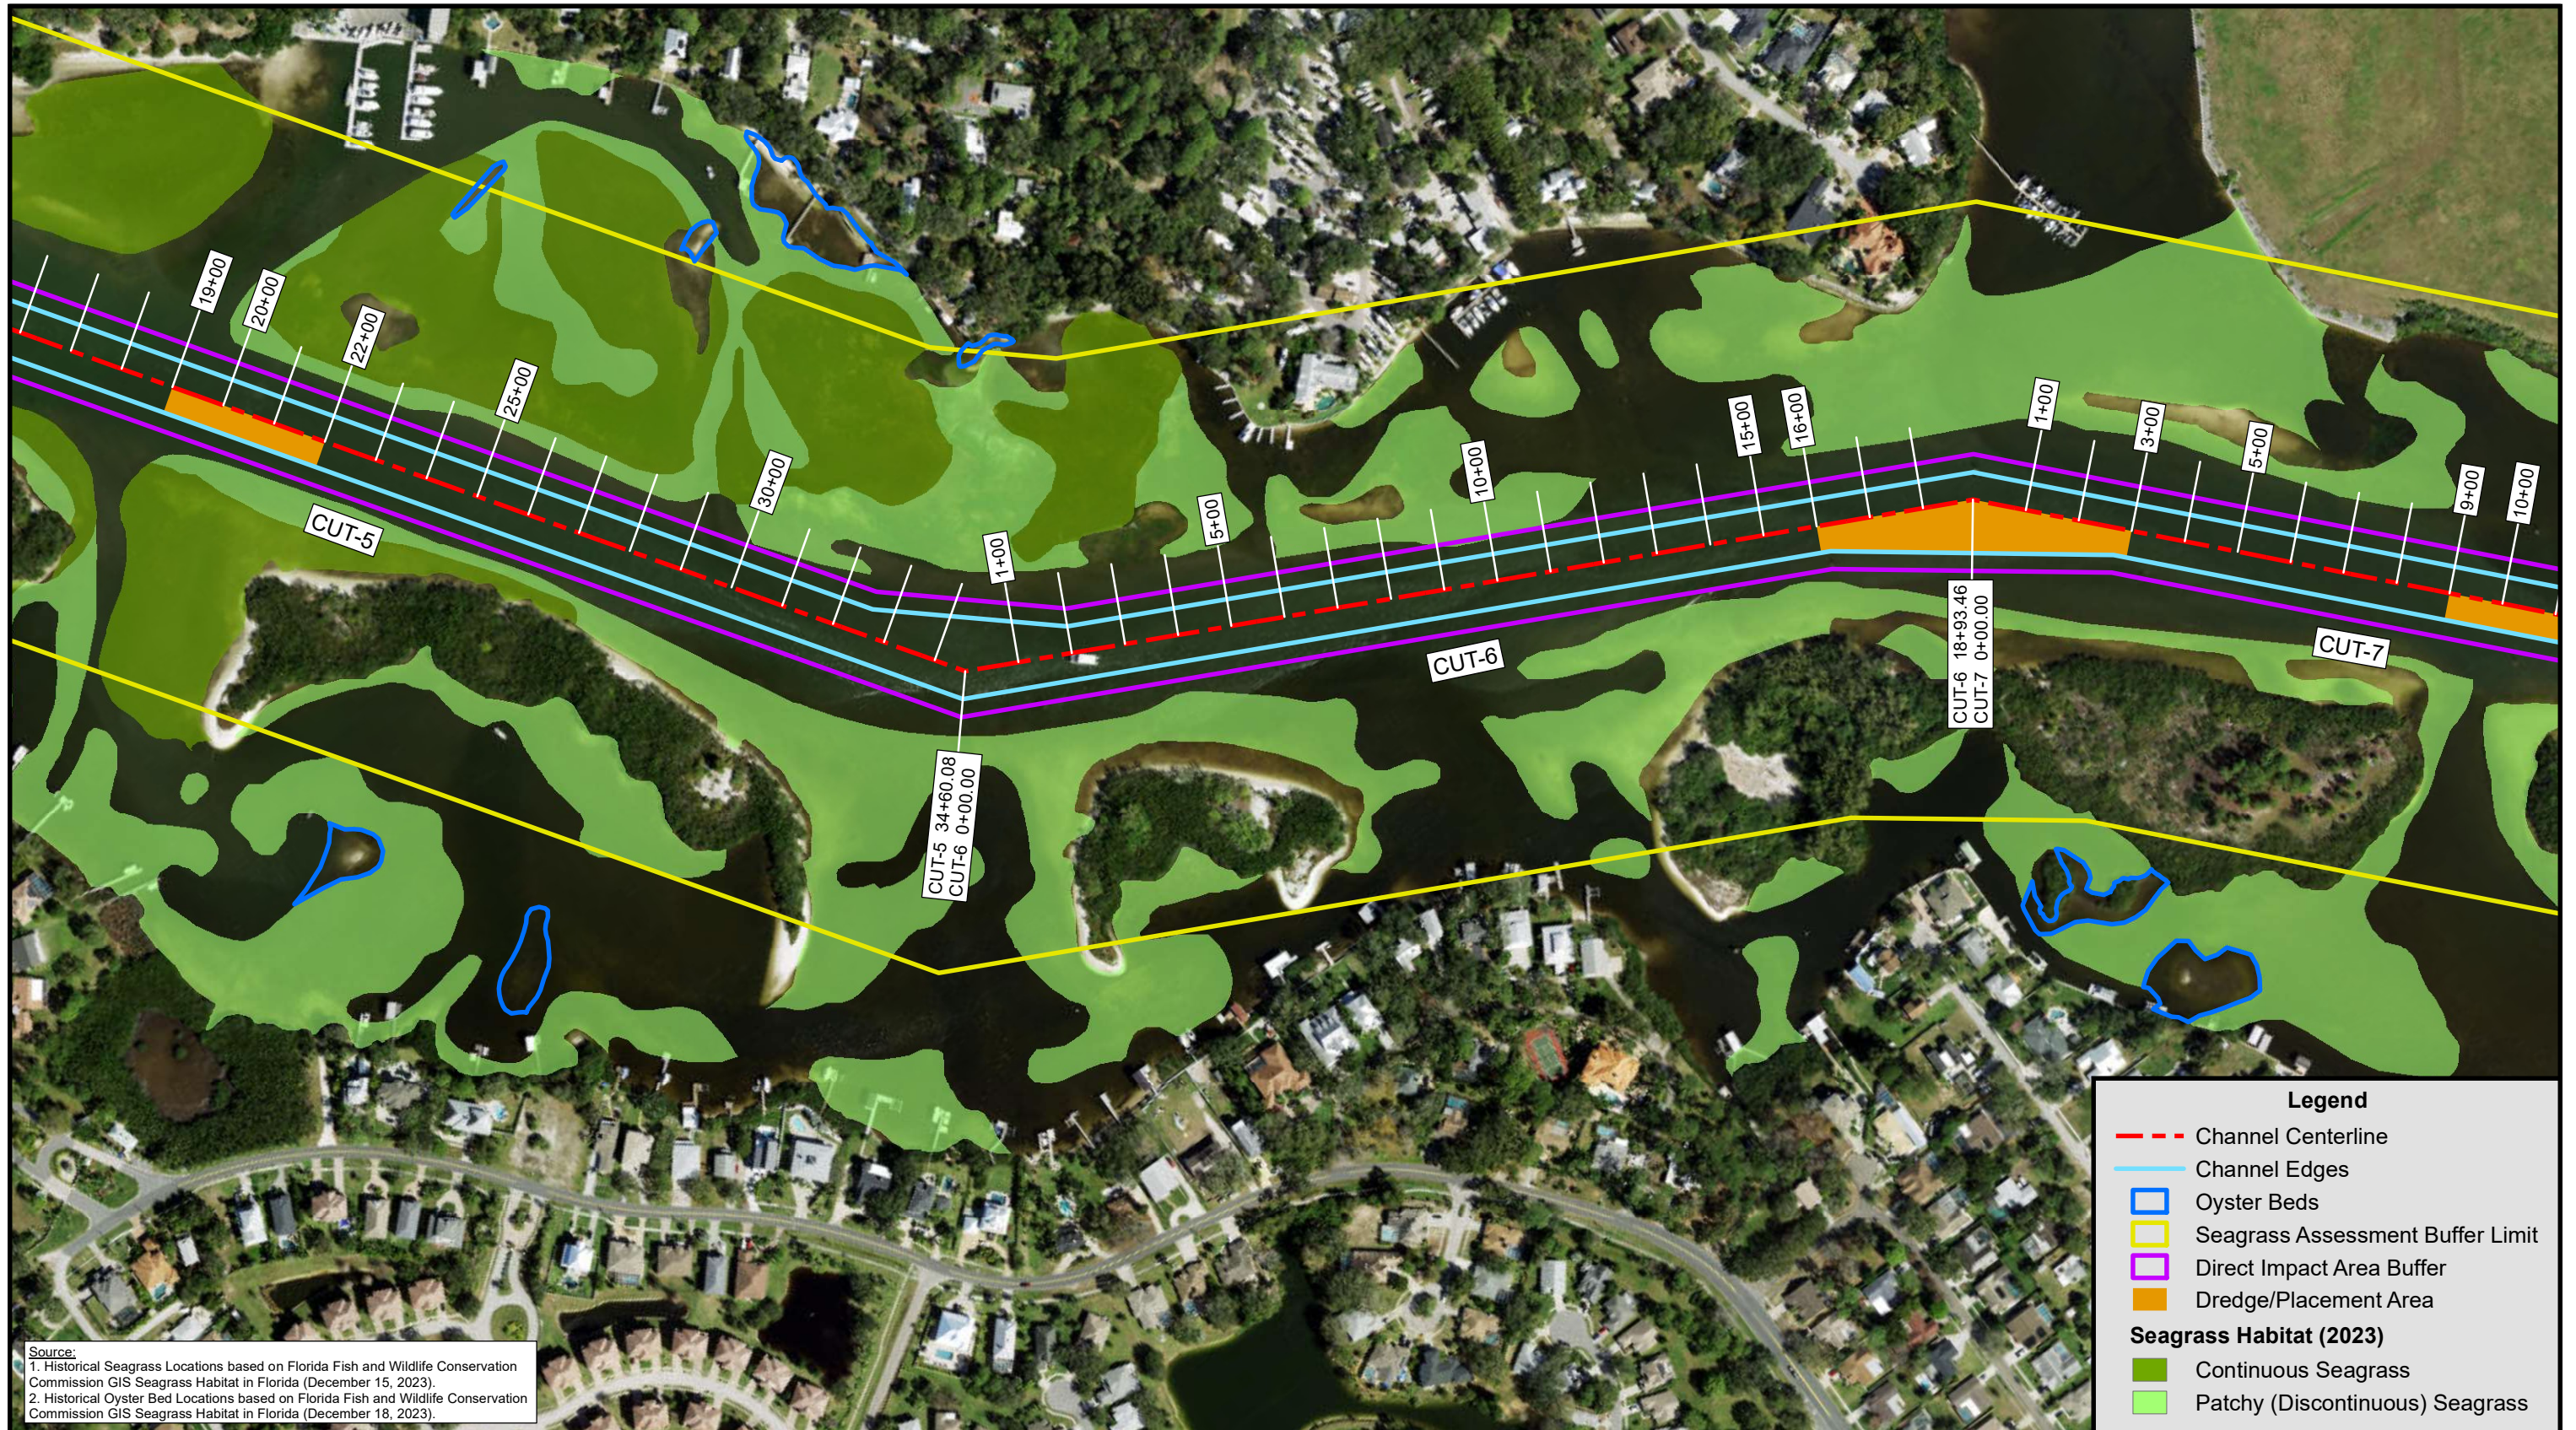
Figure 13.
 Dredge Area Layout
 Anclote / GIWW
 Submerged Aquatic Vegetation Resource Surveys
 Pasco / Pinellas County, Florida
 Source: Water & Air Research, Inc., 2024.

Source:
 1. Historical Seagrass Locations based on Florida Fish and Wildlife Conservation Commission GIS Seagrass Habitat in Florida (December 15, 2023).
 2. Historical Oyster Bed Locations based on Florida Fish and Wildlife Conservation Commission GIS Seagrass Habitat in Florida (December 18, 2023).

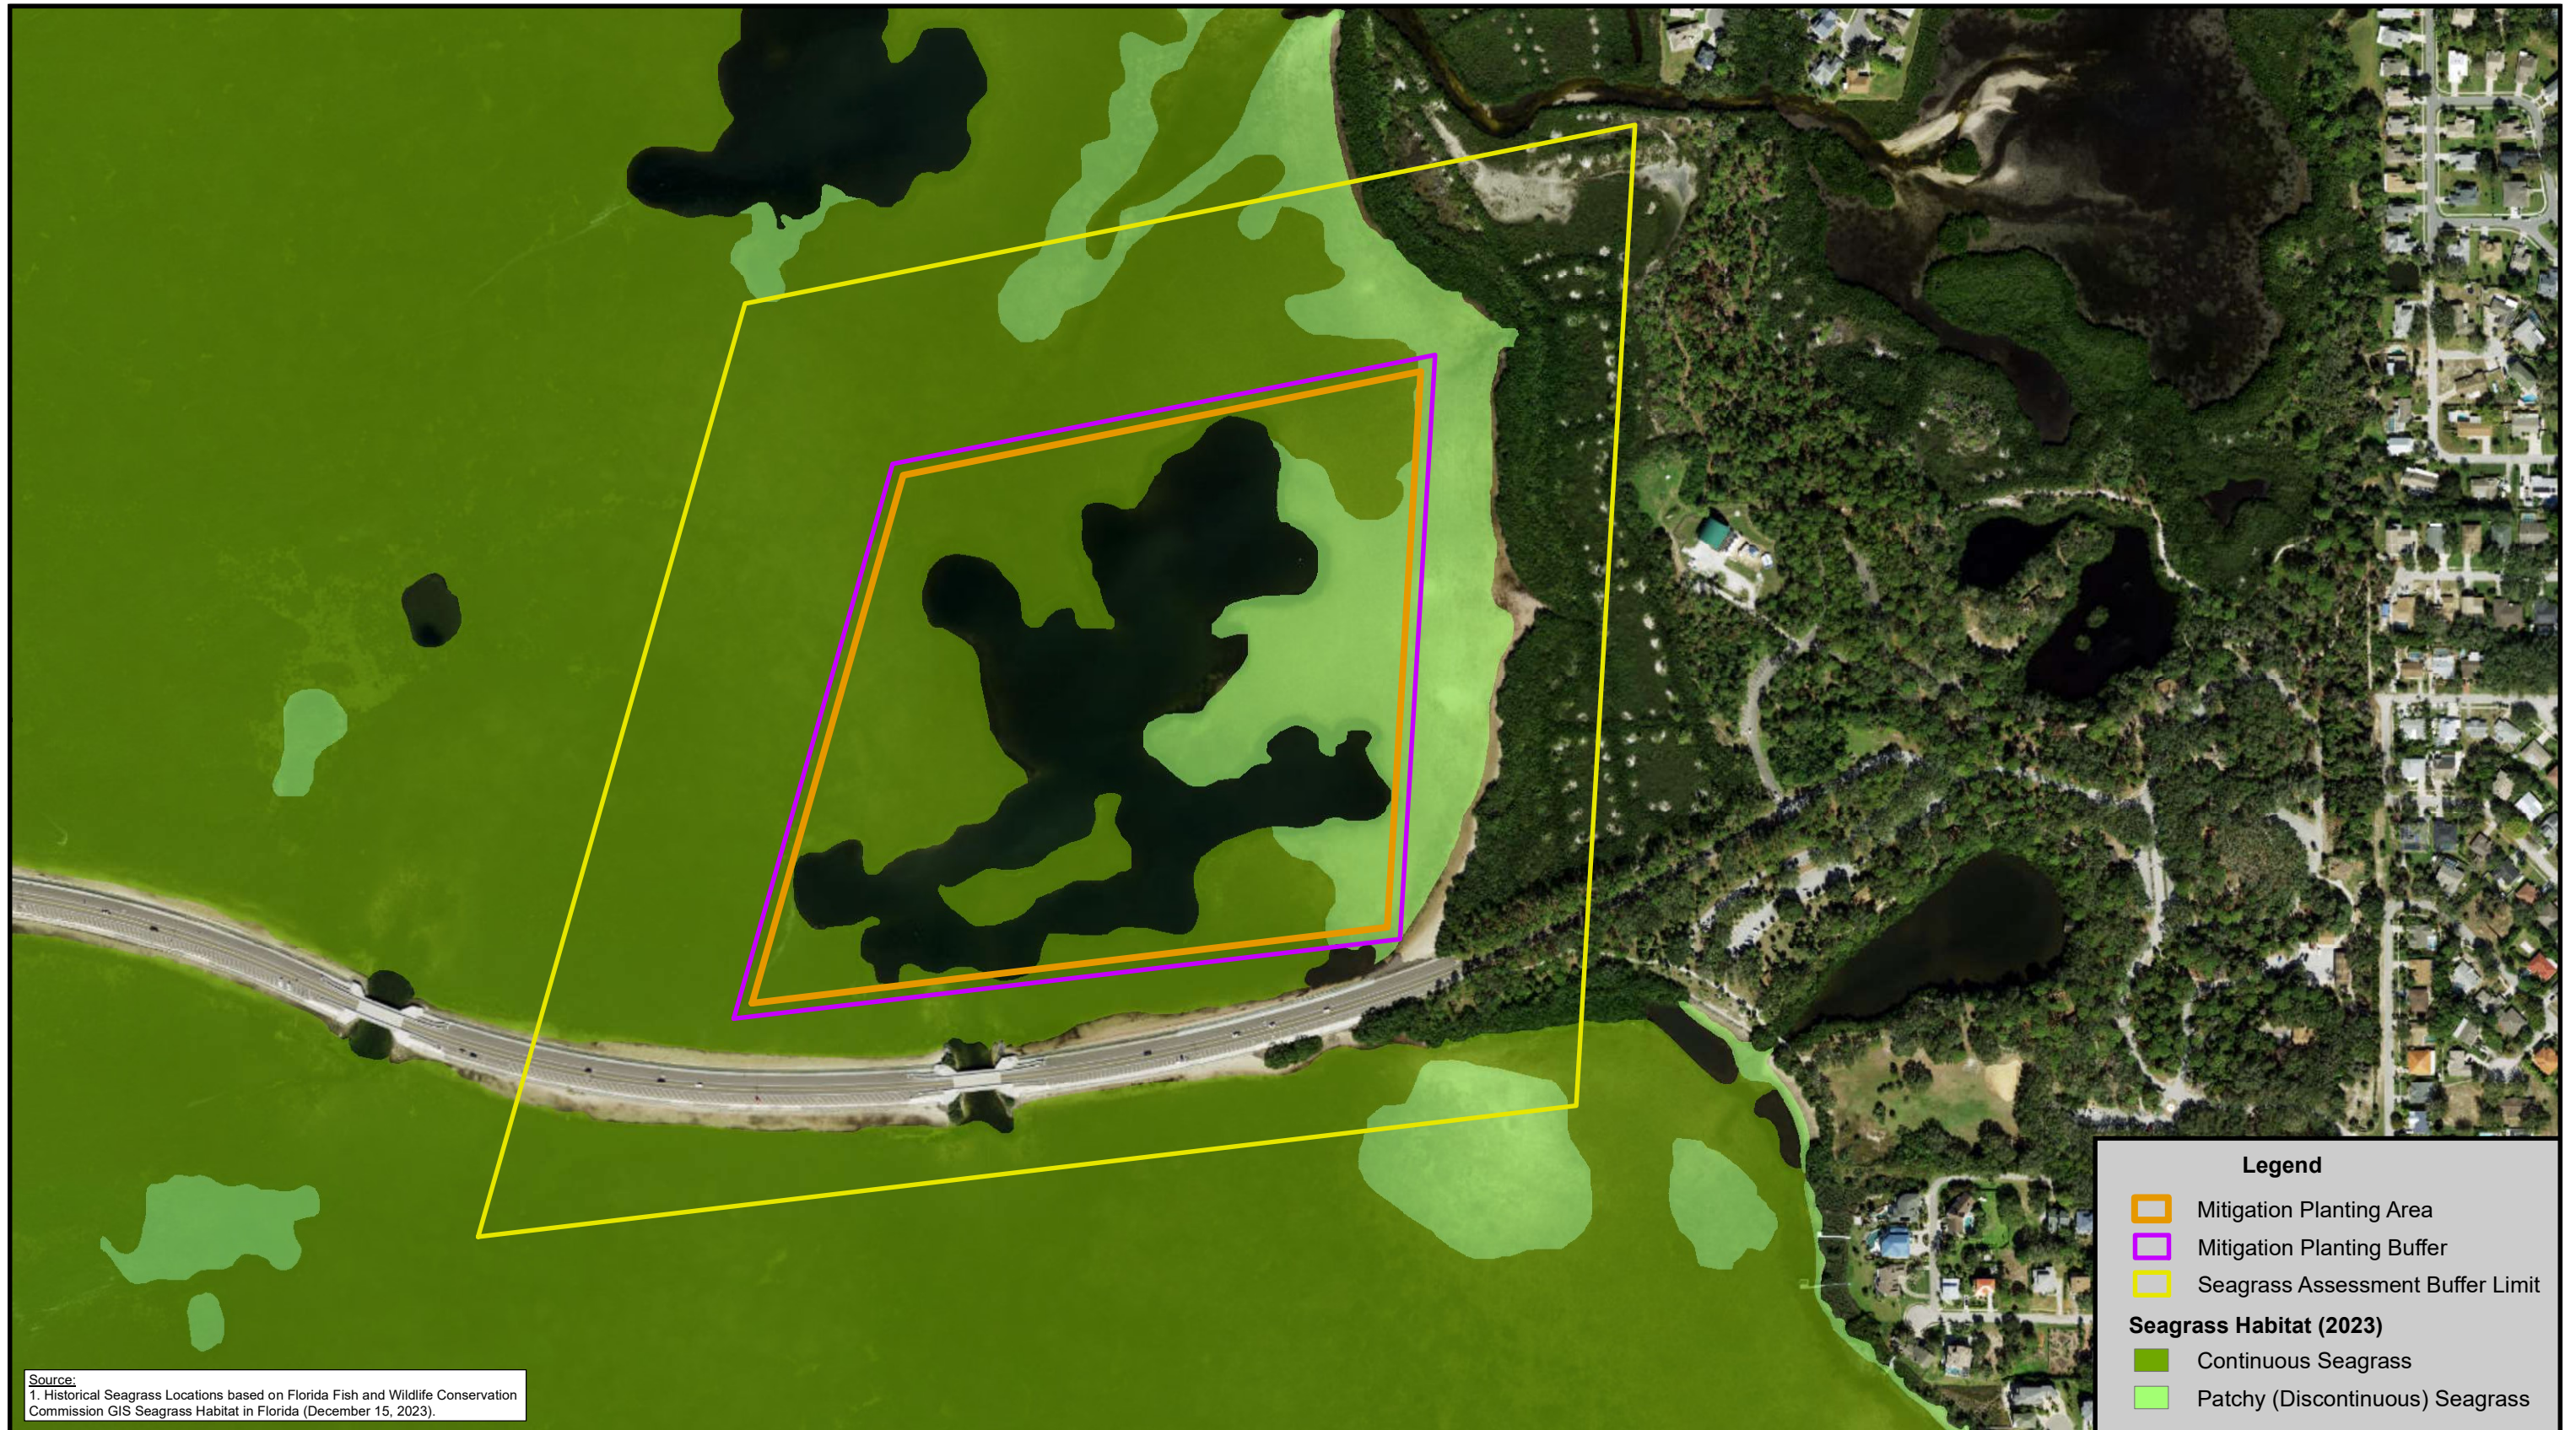
Figure 16.
 Dredge Area Layout
 Anclote / GIWW
 Submerged Aquatic Vegetation Resource Surveys
 Pasco / Pinellas County, Florida
 Source: Water & Air Research, Inc., 2024.

Source:
 1. Historical Seagrass Locations based on Florida Fish and Wildlife Conservation Commission GIS Seagrass Habitat in Florida (December 15, 2023).

A review of the FWC Oyster Beds in Florida last updated December 2023 identified existing SAV within the 150 meter Seagrass Assessment Buffer at Cut 5, 7, 11, 12, and 14 (Figures 14, 15, and 16). No oyster beds were within the Direct Impact Area.

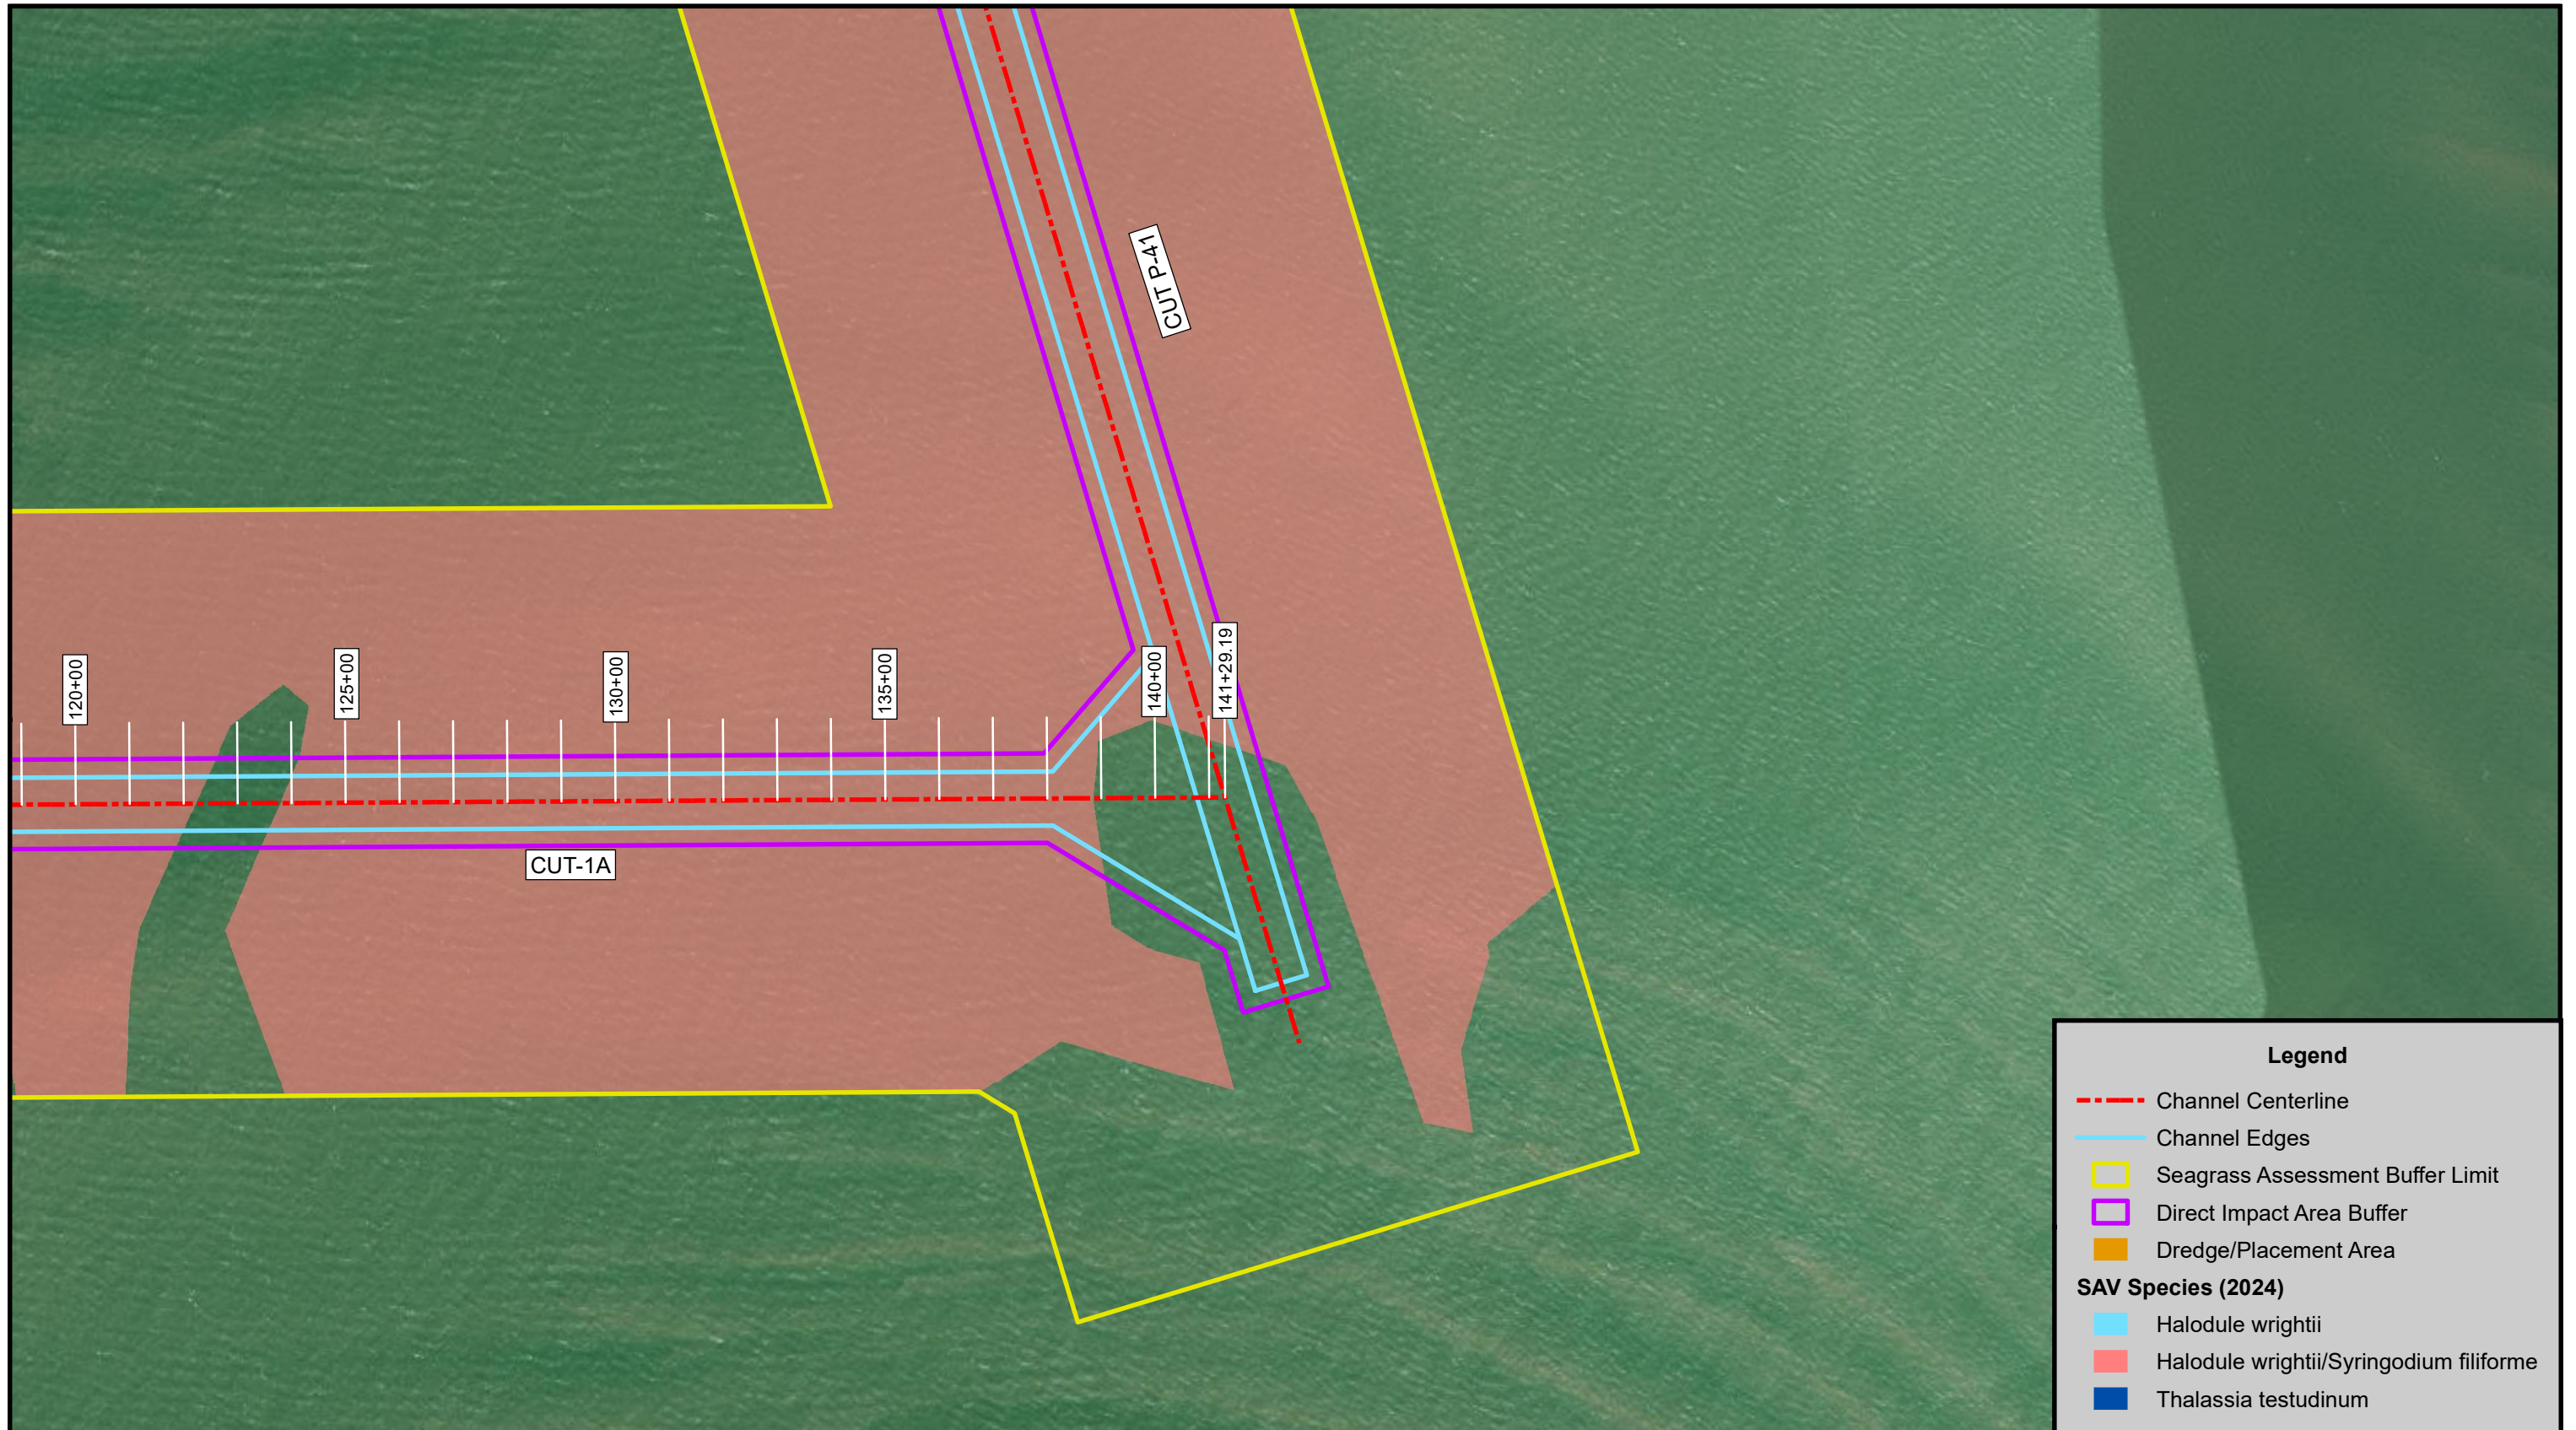
Figure 24.
 New SAV Locations (Species)
 Anclote / GIWW
 Submerged Aquatic Vegetation Resource Surveys
 Pasco / Pinellas County, Florida
 Source: Water & Air Research, Inc., 2024.

- Halodule wrightii
- Halodule wrightii/Syringodium filiforme
- Thalassia testudinum

The 2024 benthic SAV survey work was performed within channel cuts 1, 1A and P-41, as well as the FHPMA and approximately half of the TRIMA (Figure 20). Within the Direct Impact Area of the three channel cuts, *Halodule wrightii* was present in approximately 16.71 acres and *Halodule wrightii/Syringodium filiforme* was present in approximately 25.02 acres (Table 2, Figures 21-26). Within the 150-meter Seagrass Assessment Buffer of the three channel cuts, *Halodule wrightii* was present in approximately 113.37 acres and *Halodule wrightii/Syringodium filiforme* was present in approximately 158.65 acres (Figures 21-26).

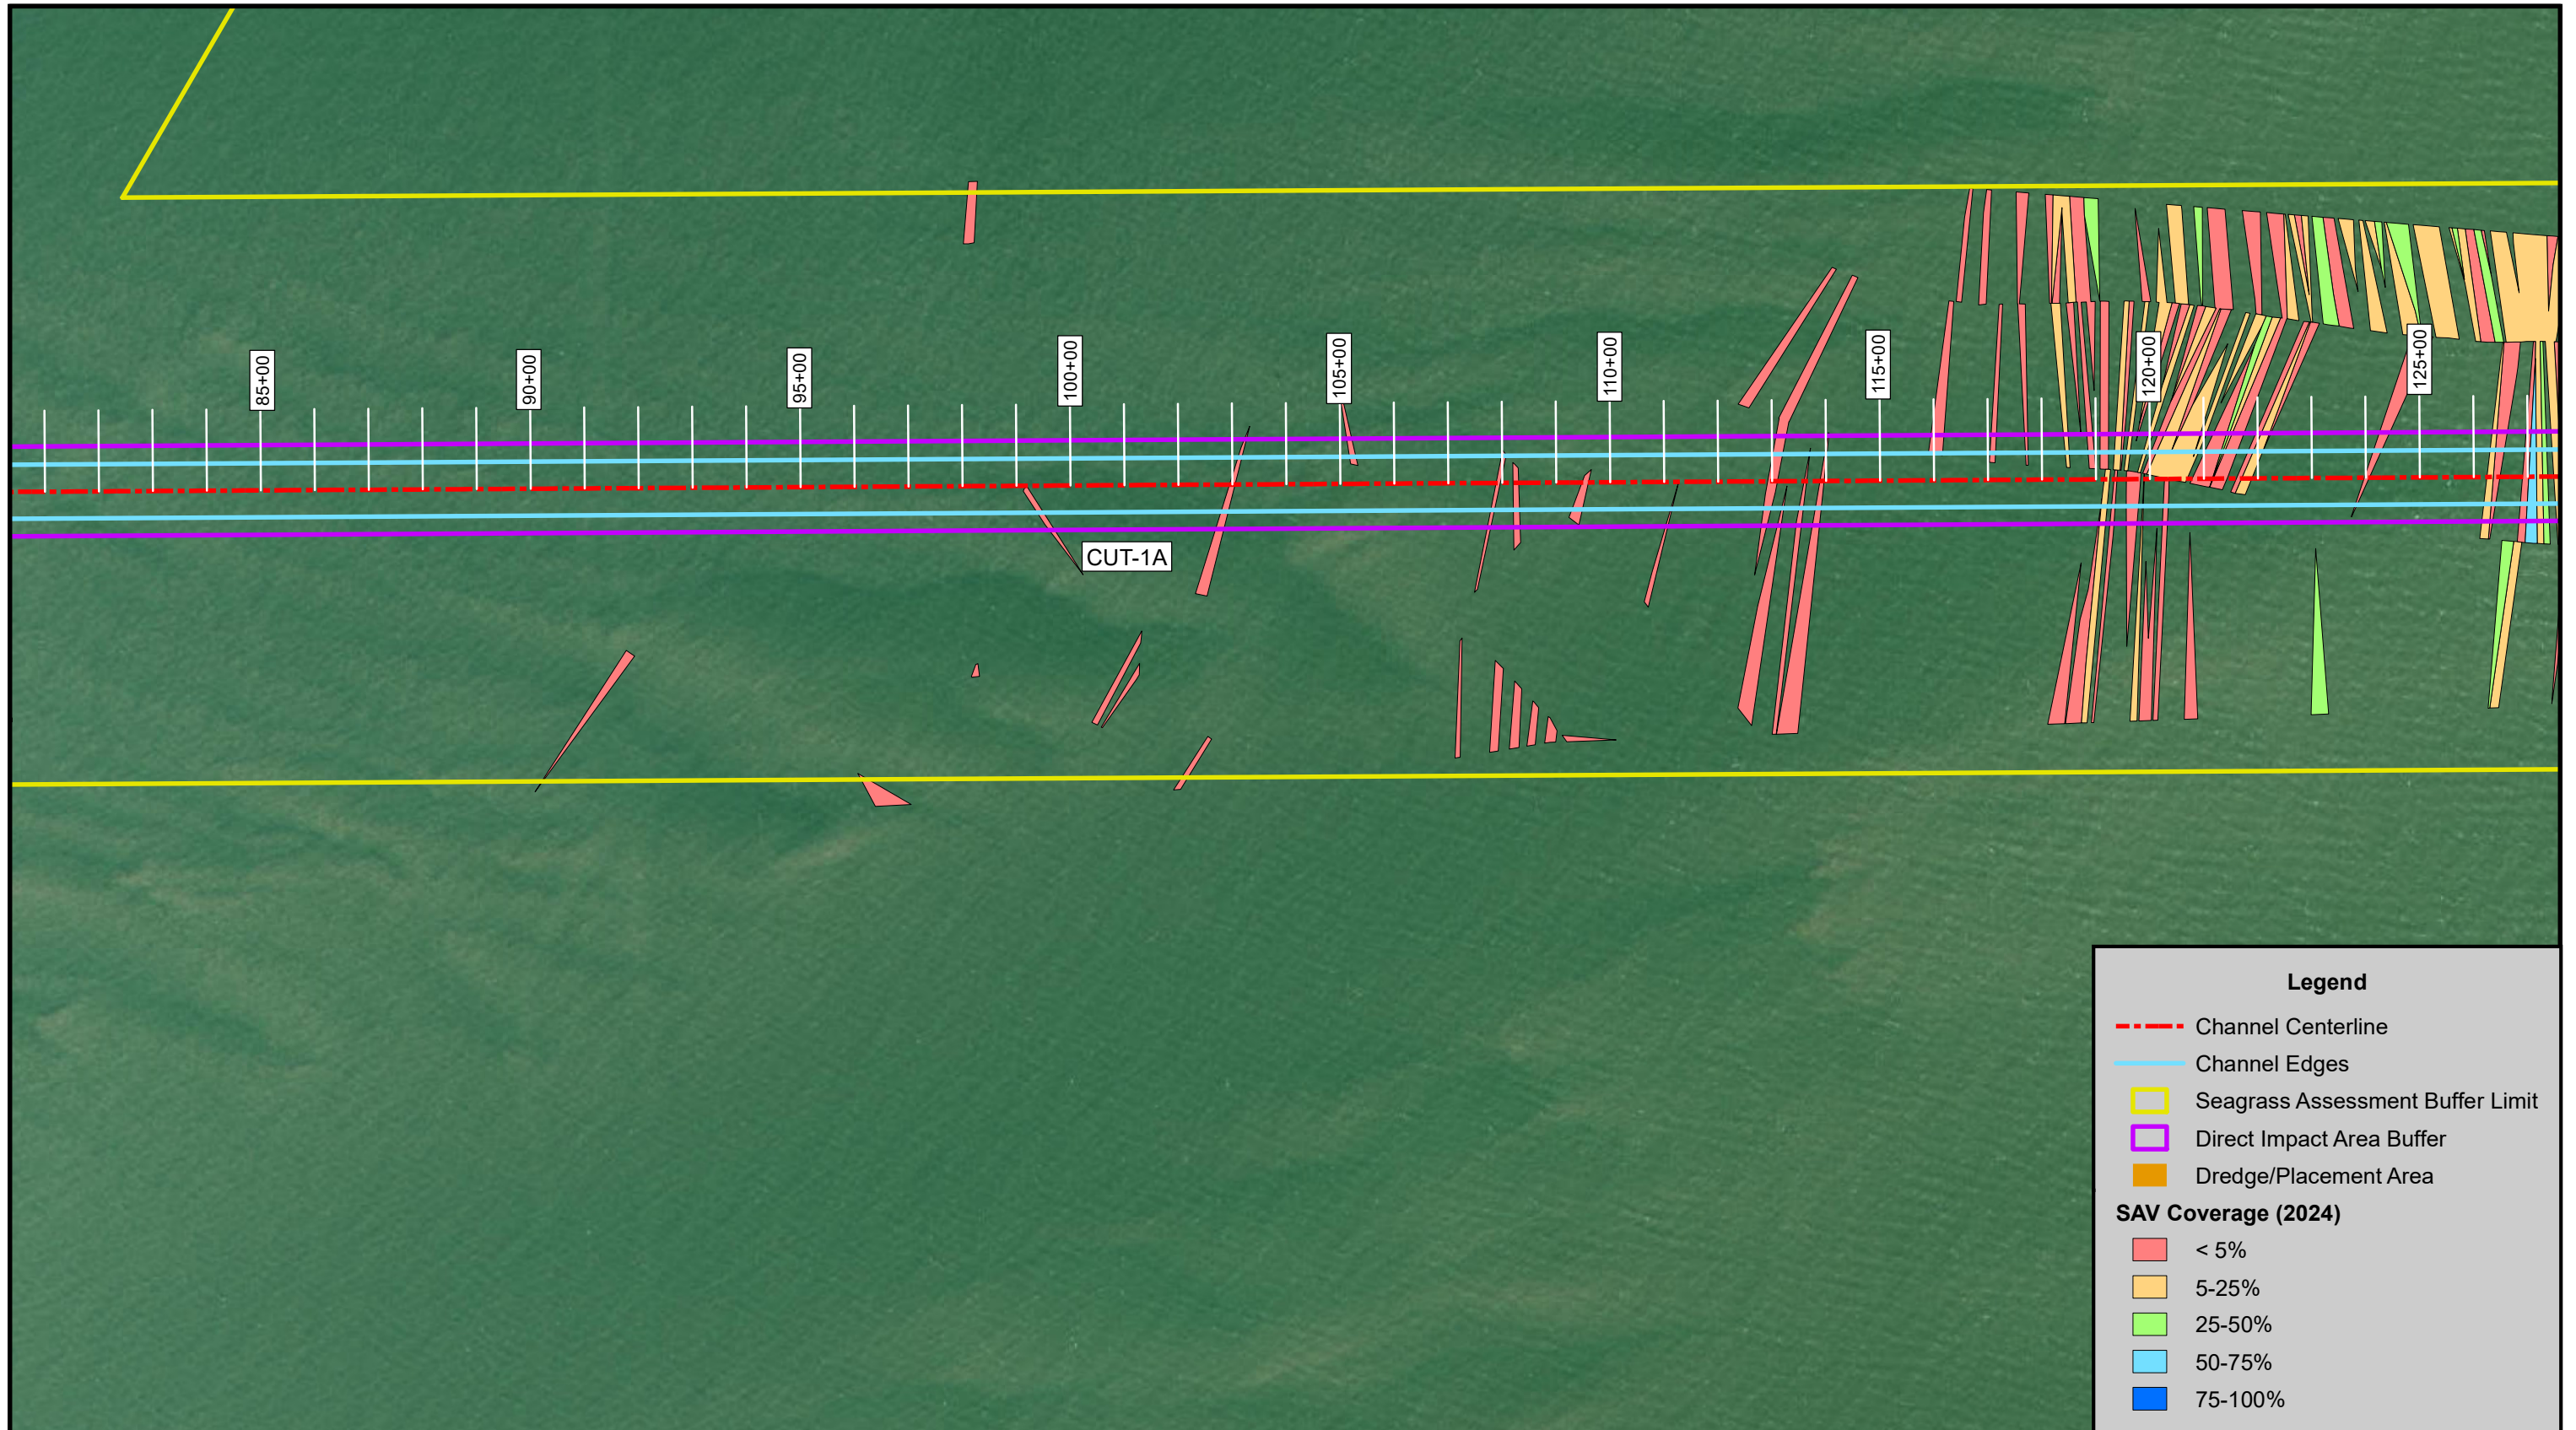
Figure 39.
 New SAV Locations (Coverage)
 Anclote / GIWW
 Submerged Aquatic Vegetation Resource Surveys
 Pasco / Pinellas County, Florida
 Source: Water & Air Research, Inc., 2024.

- < 5%
- 5-25%
- 25-50%
- 50-75%
- 75-100%
