COMPENSATORY MITIGATION PLAN GULF INTRACOASTAL WATERWAY (GIWW) O&M CUTS M-4, M-5, M-12, M-13, AND M-14, & LONGBOAT PASS CUTS 2 AND 3 MANATEE COUNTY, FLORIDA

**Anclote River, Florida Project and Gulf
Intracoastal Waterway (GIWW) Cut P-41
Pinellas & Pasco Counties
MAINTENANCE DREDGING AND DREDGED
MATERIAL PLACEMENT
NEPA ID: EAXX-202-00-K3P-1765294248**

**U.S. Army Corps of Engineers
JACKSONVILLE DISTRICT**

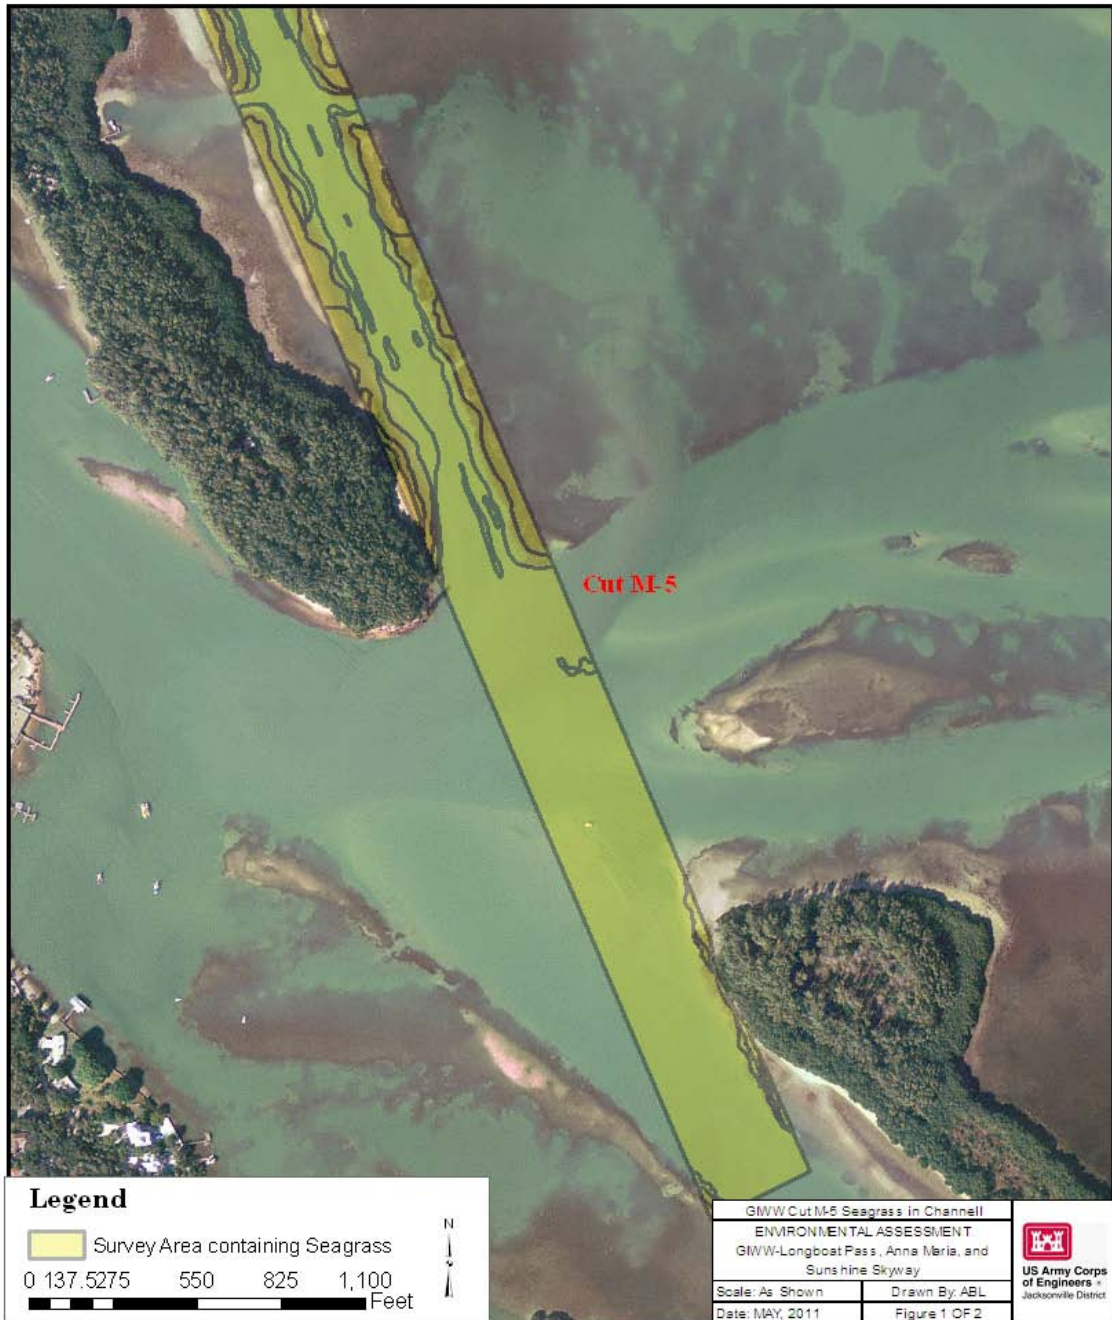
Figure 1. Seagrass beds occurring at the north end of GIWW Cut M-5 of Project Area. Note that the majority of seagrass occurs outside of the proposed dredge area in the buffer which will not be disturbed.

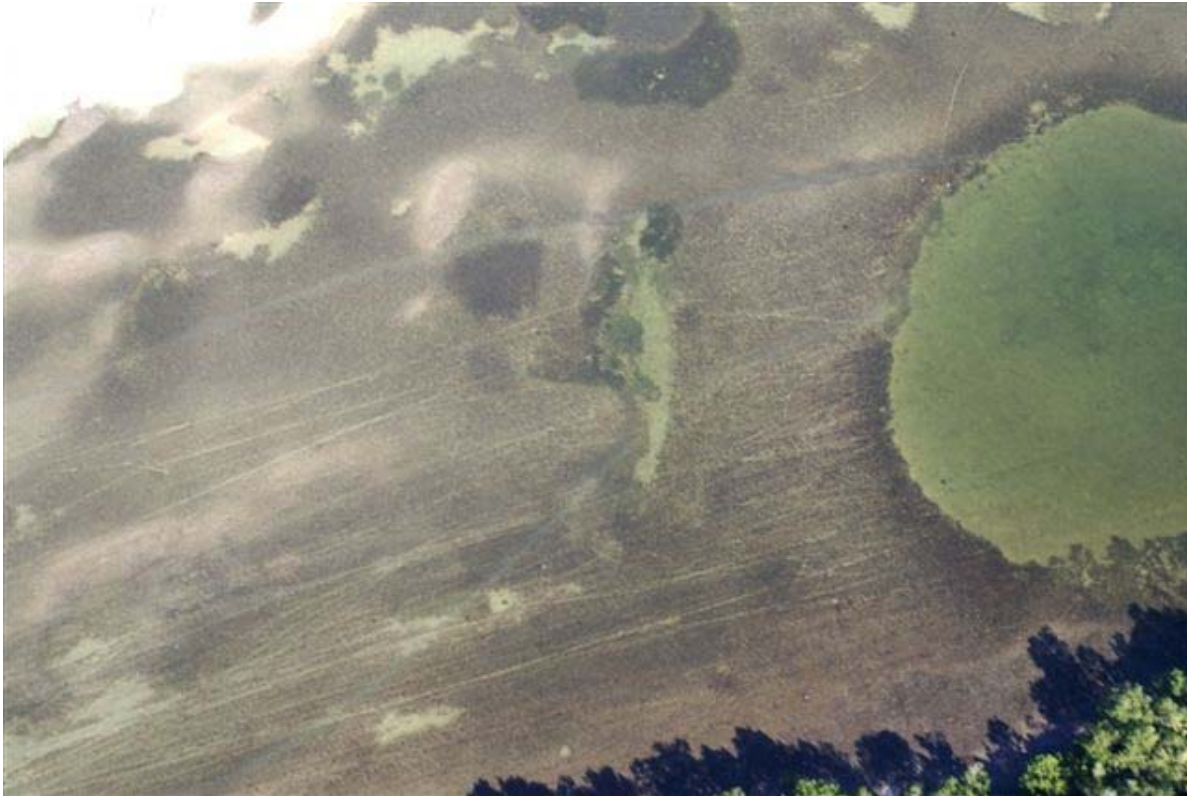
Figure 5. Detail of area within Big Pass depicting a typical zone of prop scar injury sites

Sediment replacement will be used to restore seagrass injury sites, which are characterized as below-grade unconsolidated bottom depressions. This sediment will provide stabilization to the restoration area and also topographic relief needed to achieve conditions to promote growth of shoots. The expected performance criteria for proposed substrate material will consist primarily of sand (approximately 60%), and to a lesser extent (up to 40%), silty-sand containing shell fragments or small pebbles. An upland source of acceptable material will be sought, which would include material having a similar composition from a local quarry.

Sediment Tube® technology will be employed to securely place the material into the injury locations (Seagrass Recovery, Inc website). The use of biodegradable sediment-filled mesh fabric tubes placed inside the prop scar trench is an efficient method for reducing erosion rates in injury sites while reducing turbidity
