**Miami Harbor Phase III
Federal Channel Expansion Project
Permit No. 0305721-001-BI**

**Quantitative Post-Construction Analysis for
Hardbottom Benthic Communities**

November 19, 2015

**Prepared by:
Dial Cordy and Associates Inc.
46 NE 6th Street
Miami, FL 33132**

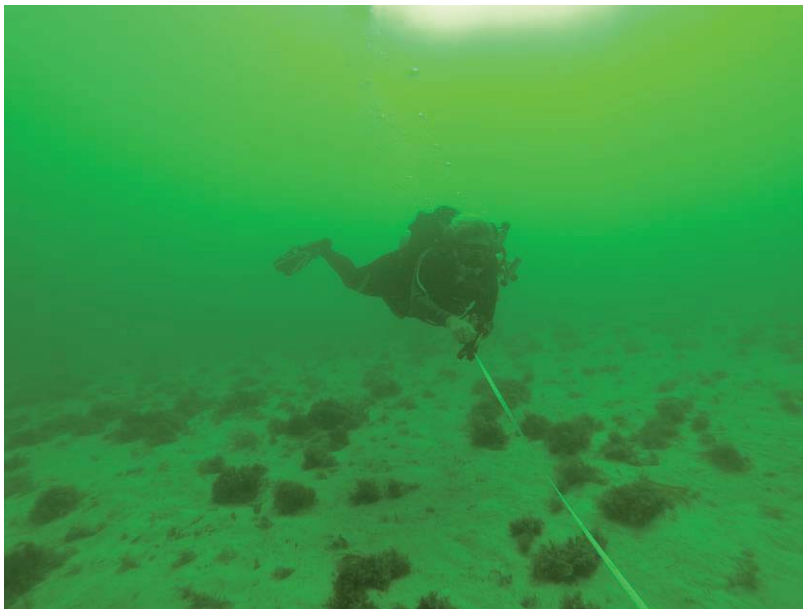
During the establishment of the monitoring stations and before baseline surveys began in 2013, scientific divers documented no hardbottom habitat at six separate locations associated with FDEP proposed site location for HBS4-CR. In order to search for hardbottom at this proposed location, divers used a 30 m transect tape radius, with one diver holding the fully extended transect tape, and the second diver swimming to the edge of visibility (~5-10 m) from the first diver. Divers then swam around each location in a circular search pattern, looking in both directions for hardbottom or signs of hardbottom. Divers covered roughly a 100 m diameter area around the proposed station location. Divers took photos at each location documenting mostly sand, as well as some attached algae and gorgonians. The buried gorgonians suggested this area may experience seasonal burial and exposure, however, in the fall of 2013 before the commencement of dredging operations; the area was completely buried in sand (Figure 2). Therefore, HBS4-CR was established in colonized pavement habitat, west of HBS3-CP, where hardbottom existed.

Figure 2. No hardbottom area at the suggested HBS4 location was found during site set-up. HBS4 had to be established in a different area.

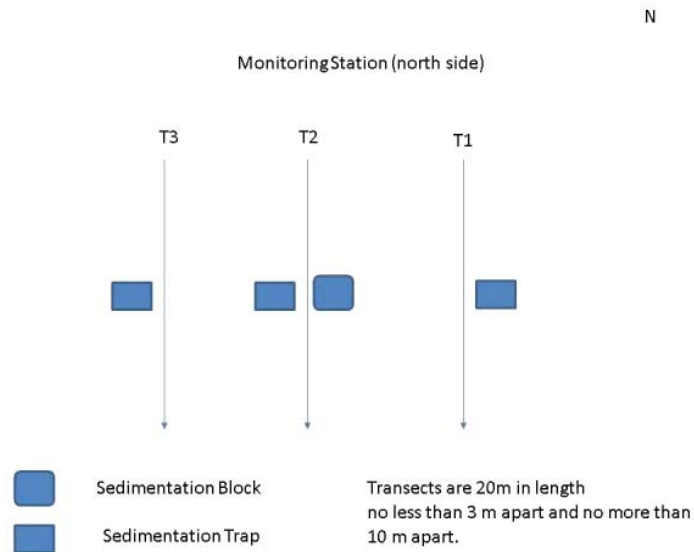
At each monitoring site, three permanent 20 m transects were established during baseline, parallel to each other in a north (0 m) to south (20m) direction. Transect number increases from east to west (1-3) at each site. Stainless steel eyebolts (3/8-in. by 8-in.) were drilled into the bottom at 0, 10, and 20 m locations along each transect. Small closed-cell foam floats coated with

Figure 3. Hardbottom monitoring site layout.

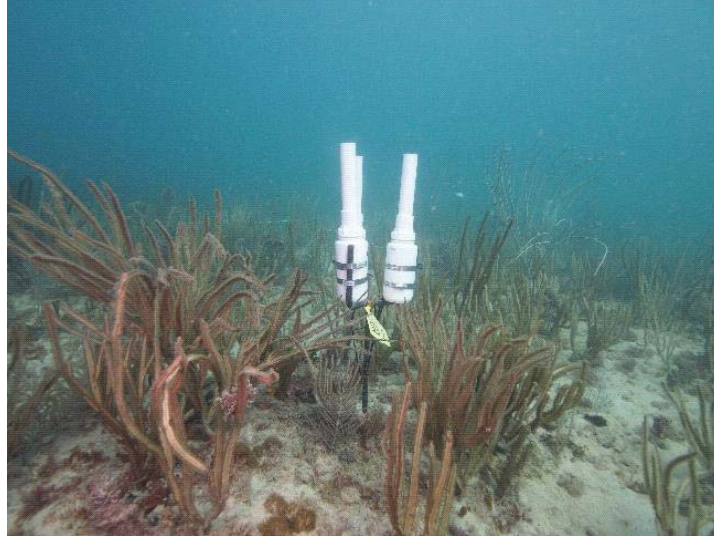
Three sediment traps (Figure 4) were placed during baseline at each of the hardbottom monitoring sites (including control sites) to allow the comparison of net sediment trap accumulation among monitoring stations and between construction monitoring sites and control monitoring sites. The sediment traps were constructed of 1 in. interior diameter x 8 in. interior length polyvinyl chloride (PVC) pipe and a 500 ml Nalgene collection jar, or similar, making modifications to best sample sedimentation within the environment, based on hydrodynamics, currents and particle size (Storlazzi et al. 2011; Figure 3). Both trap necks and jars were coated with anti-fouling paint to minimize epibiotic growth. The PVC traps with the attached jar lids were fastened to the steel sediment trap frame with hose clamps. The frames were drilled and cemented into the substrate at all hardbottom sites, and were installed to collect sediment from the water column approximately 18 inches off the bottom. Sediment traps were removed at 28-day intervals by unscrewing the Nalgene trap jars from the PVC collars and capping the jars *in situ*. New jars were installed when collections were made and a new 28-day sediment monitoring period started. Following completion of the post-construction monitoring program, all sediment traps and frames were removed.

Figure 4. Sediment traps installed at all offshore sites for environmental monitoring of hardbottom resources in Cuts 1 and 2.

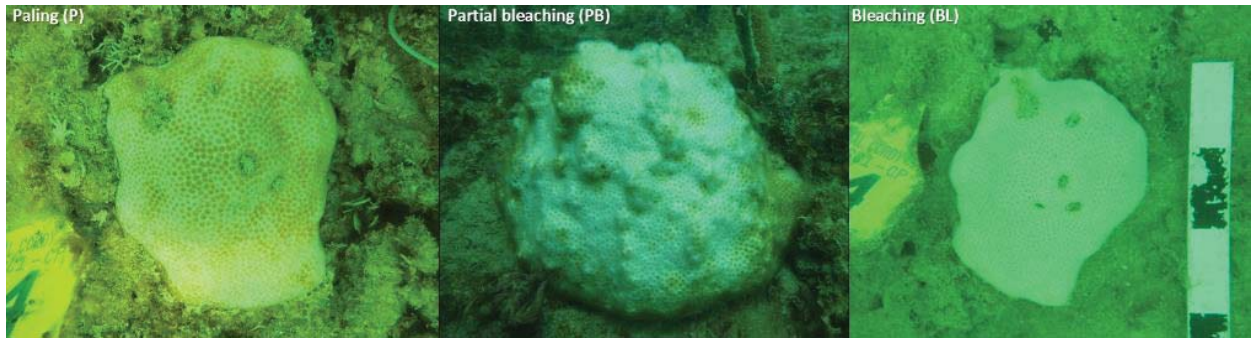
Figure 6. Photographs of bleaching conditions documented during compliance and post-construction surveys.

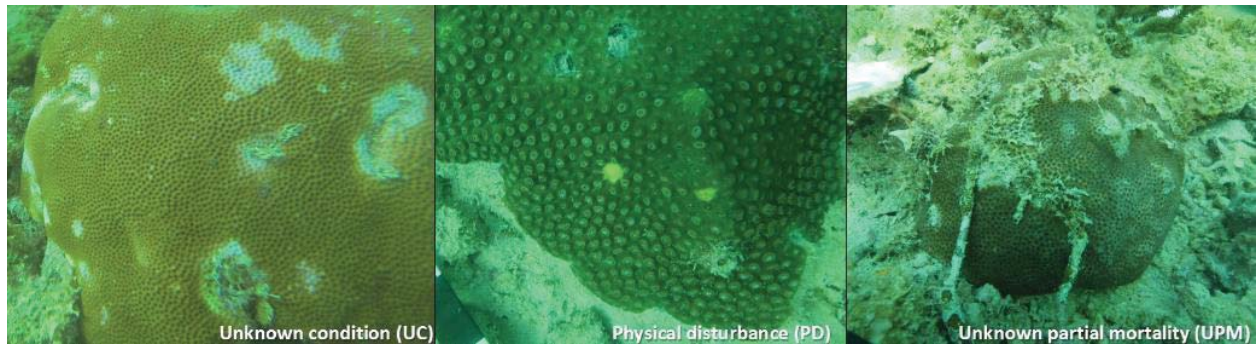
Figure 9. Photographs of stress indicators documented during compliance and post-construction surveys.

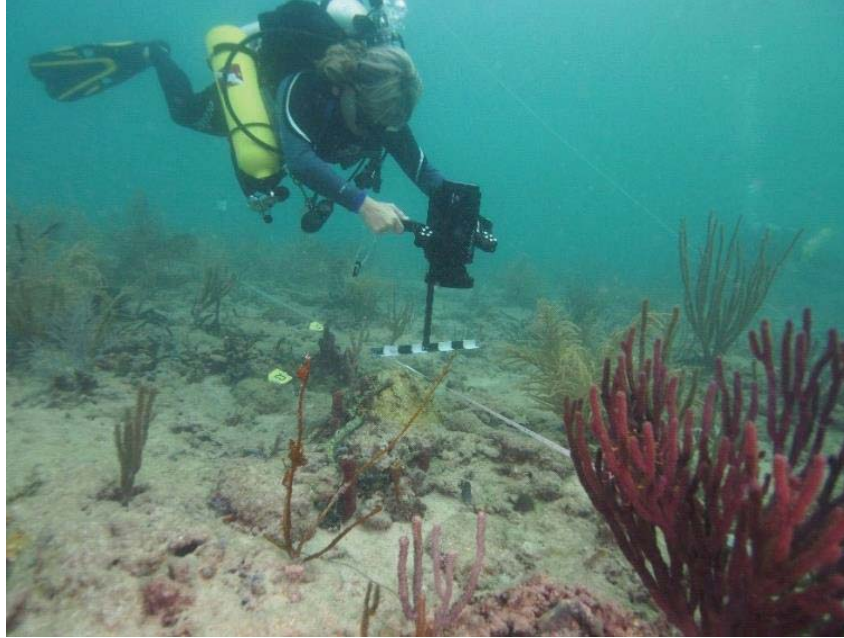
Quantitative digital video data were collected along each transect with the camera positioned 40 cm above the substrate in a vertical orientation to produce birds-eye view digital video of each transect (20 m x 0.4 m), during each compliance monitoring week and each of four weeks of post-construction surveys (Aronson et al. 1994). The video camera was equipped with a measuring bar to ensure the camera remains at 40 cm above the bottom and a scale bar was visible at the bottom of the video record at all times (Figure 11). The diver swam the camera along each transect at a speed of ~5 m per minute to insure quality still images could be extracted for point count analysis using Coral Point Count with extensions (CPCe®; Kohler and Gill 2006). This method was used to evaluate both the coral health and potential sedimentation stress during post-construction as well as functional group cover at both the channel-side sites and the control sites.

Figure 11. Scientific diver collecting video data of transects during baseline surveys. Photo taken October 24, 2013.

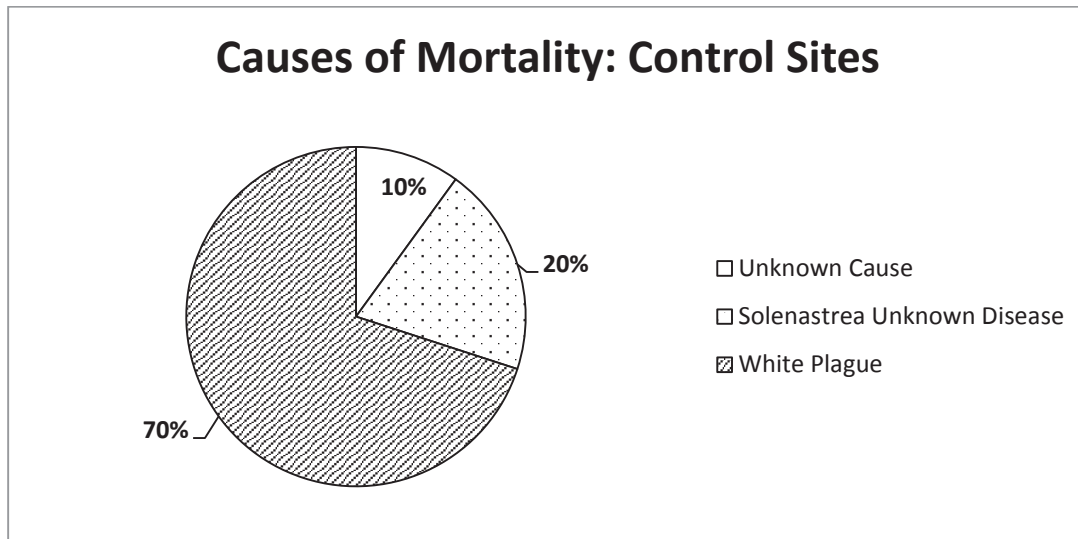
Figure 14. Percentage of causes of total scleractinian mortality across all hardbottom control sites from baseline to post-construction surveys.

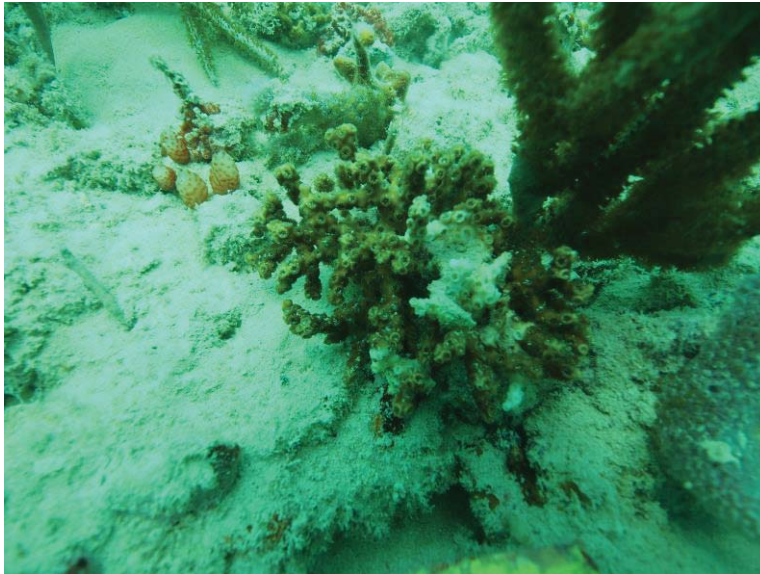
Figure 16. Image of *Oculina diffusa* “unknown” disease.

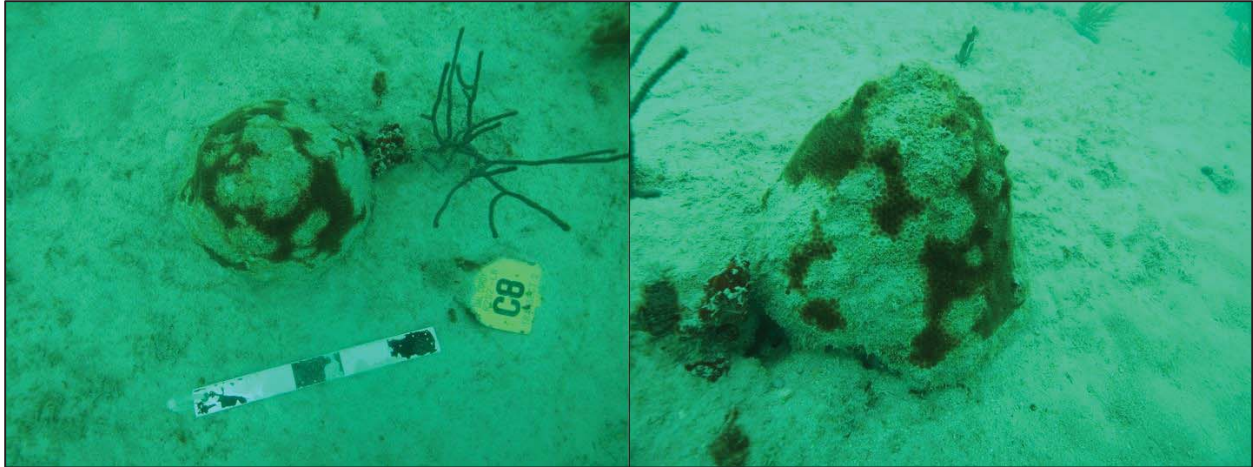
Figure 17. *S. bournoni* exhibiting unknown disease condition during compliance monitoring surveys. This colony was recorded as dead during post-construction surveys.

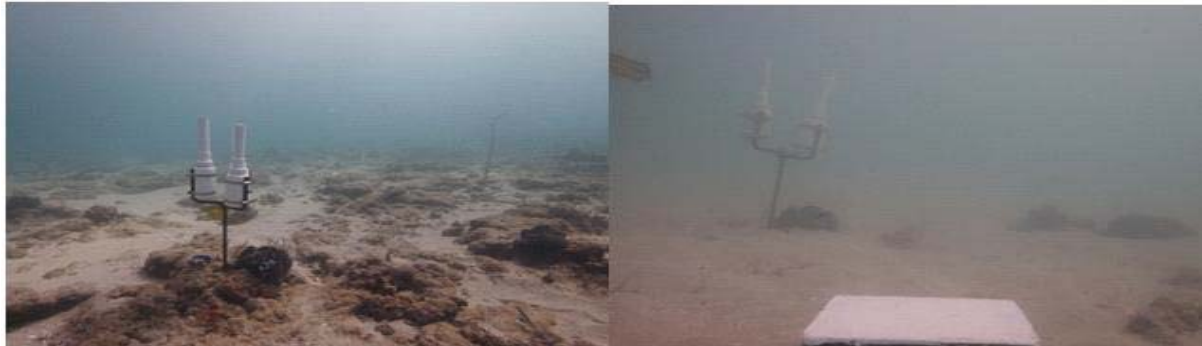
Figure 19. HBN1-CR in Week 1 of baseline and in Week 4 of baseline after burial event.
