ROD-SOF for DA Permit SAJ-1993-01395
Attachment B - Compensatory Mitigation Plan
Attachment A, Part 3 - Mitigation Categories

**SOUTH PASTURE
EXTENSION
Mosaic Fertilizer, LLC
MITIGATION
CATEGORIES**

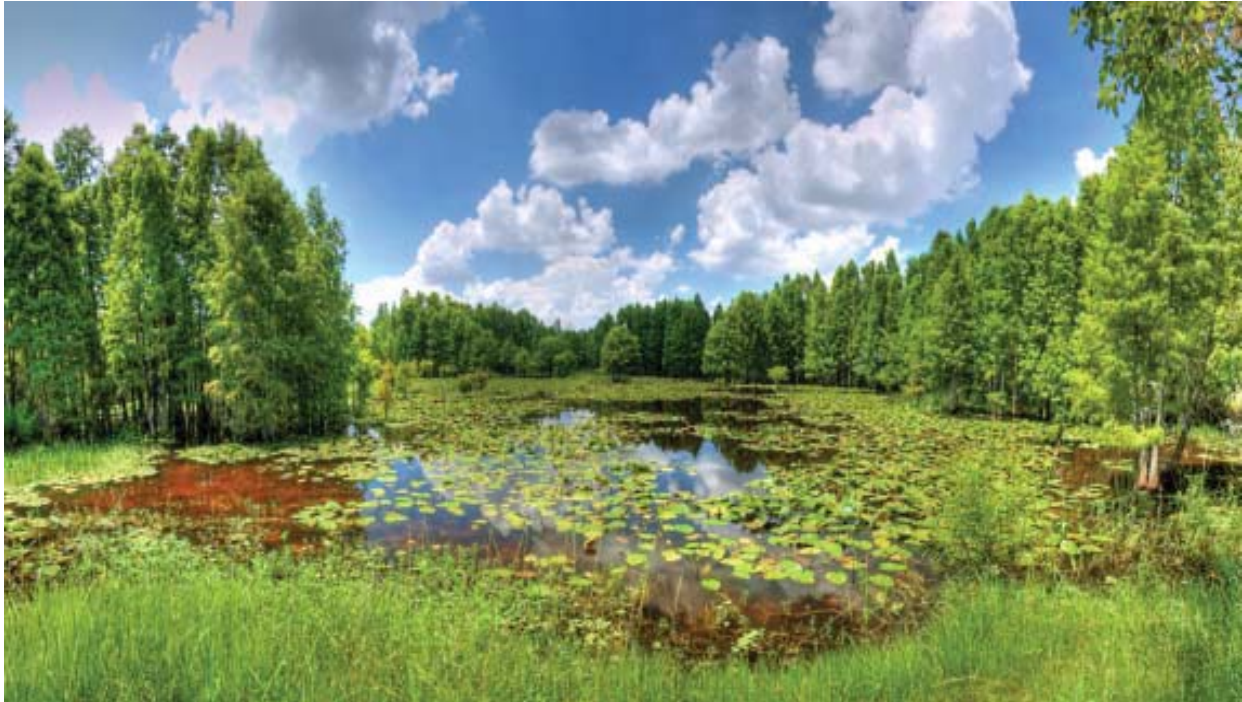
Hickey Branch, R-7 - Forested Wetland/Herbaceous Marsh Complex, 2012

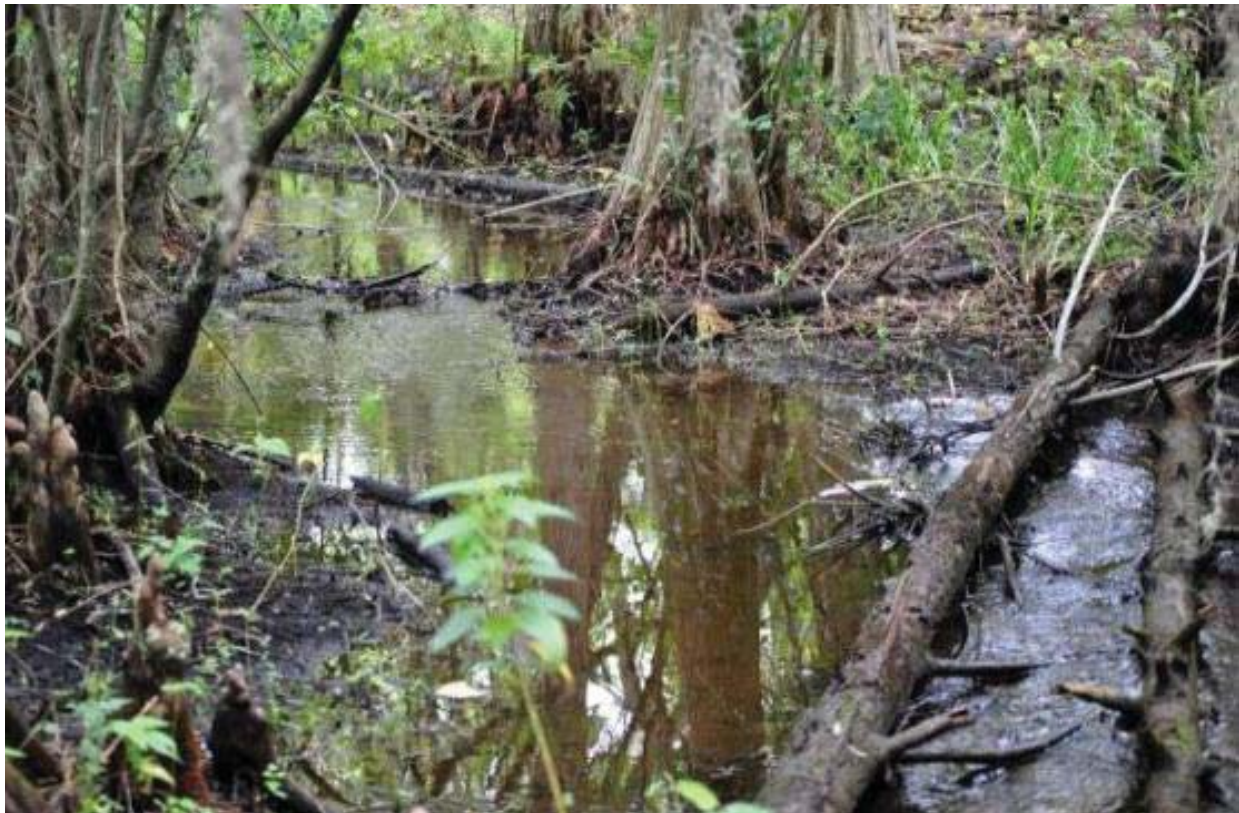
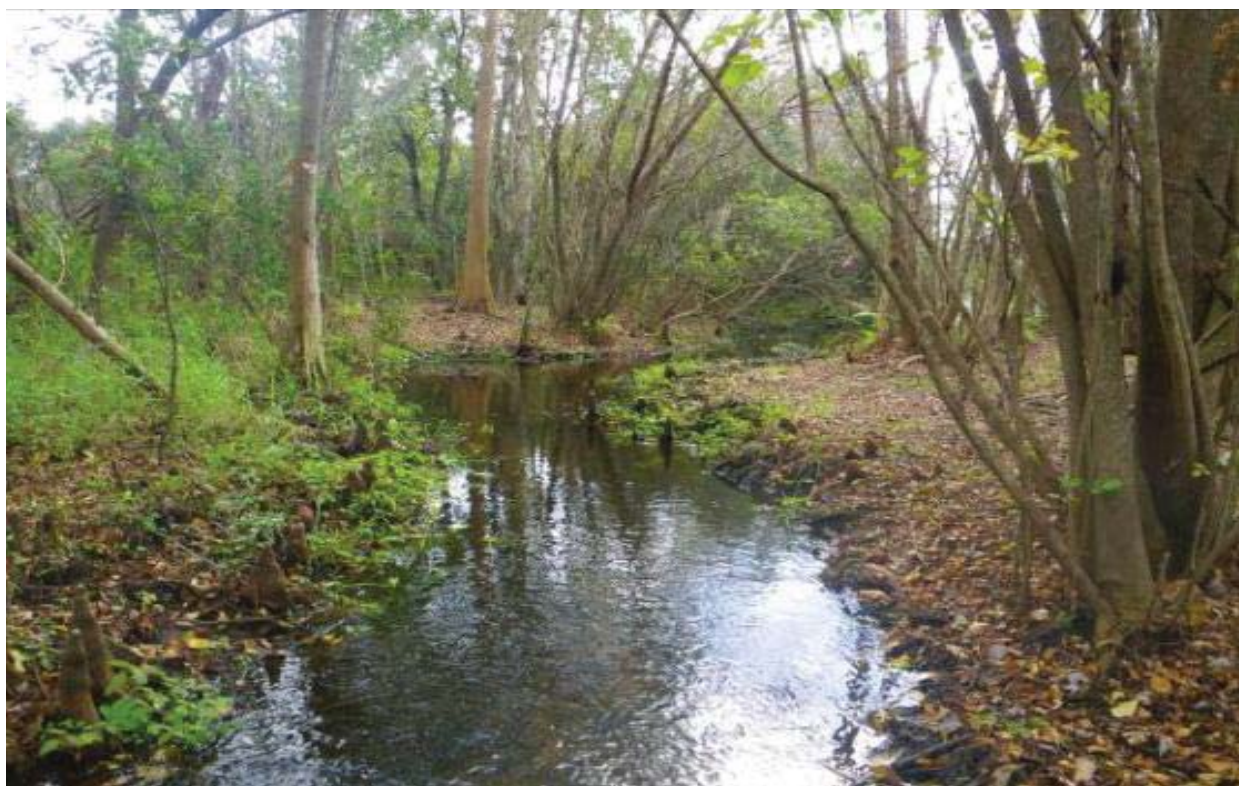
R-7 Photographs

Review of historic aerial photography indicates mining activity within the contributing basin for Hickey Branch since at least the early 1970s, if not prior. Mining activities are apparent in place of natural Hickey Branch tributaries in the vicinity of R-7 and R-10, as seen in aerials flown in late 1992; reclamation construction of the R-7 and R-10 stream valleys was completed by the late 1980s. The Hickey Branch reclamation project consisted of three phases. R-7 was the first phase and was completed in 1985, while R-10 was the third phase and was completed in 1989. The stream valleys were constructed using early stream reclamation techniques, i.e., by spreading overburden over sandy clay, and allowing the stream channels to be carved via natural hydraulic weathering processes. This technique allows the stream to self-adjust based on the valley slope and weather patterns. As early as 1995, a well-defined channel approximately 200 meters long had formed at the R-7 site (Biological Research Associates - BRA, 1995). Over time, R-7 and R-10 have developed well-defined banks lined with cypress and pop ash roots. While effective, because natural weathering can take up to 10 to 20 years to achieve channel size and shape akin to natural streams, this passive construction method is no longer endorsed by the FDEP to create stream channels.

Hickey Branch reclamation streams R-7 and R-10 have been assessed using the HA over the last 14 and 11 years, respectively. R-7's HA scores have ranged from 99 to 120, falling within the Suboptimal category, while R-10s HA scores have ranged from 107 to 129, falling within both the Optimal and Suboptimal categories. Habitat types mapped at these sites include root mats, leaf packs, large woody debris, and aquatic vegetation. Some level of habitat smothering, however, has been an issue at both sites due to the previously mentioned off-site clay settling area dam failure in 1994, which has adversely affected the area by contributing fine sediment.

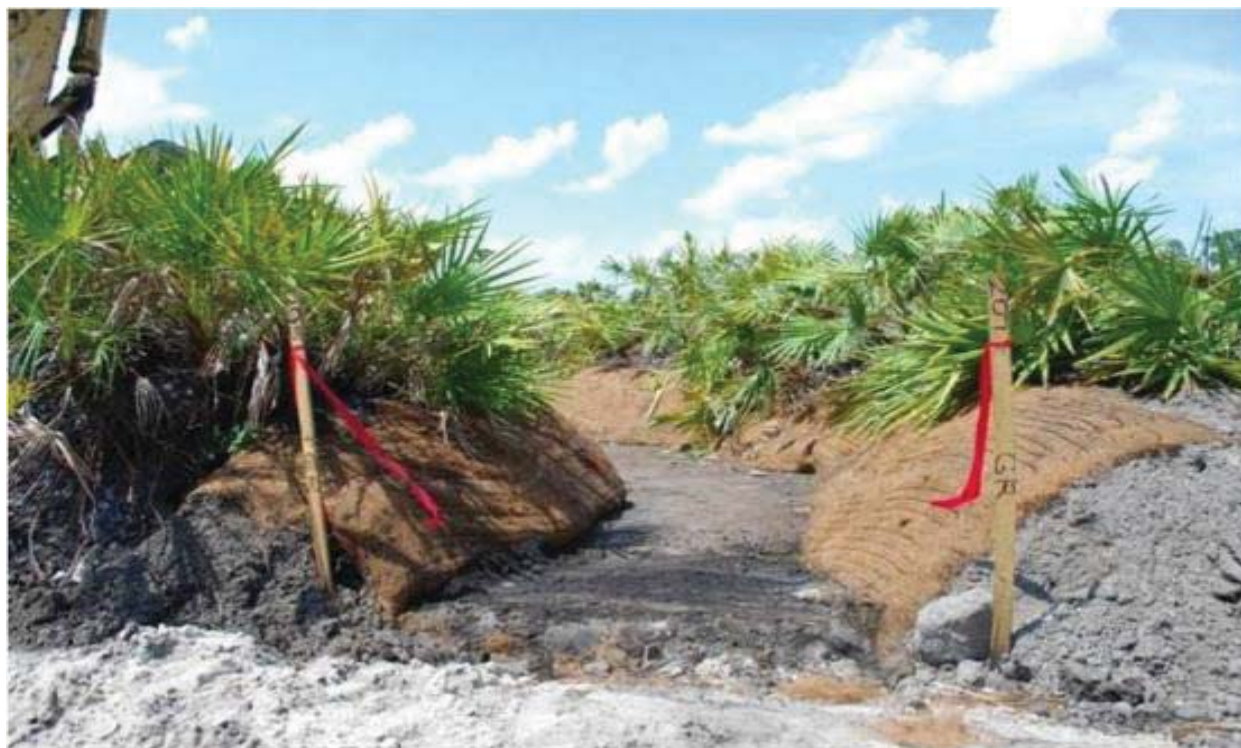
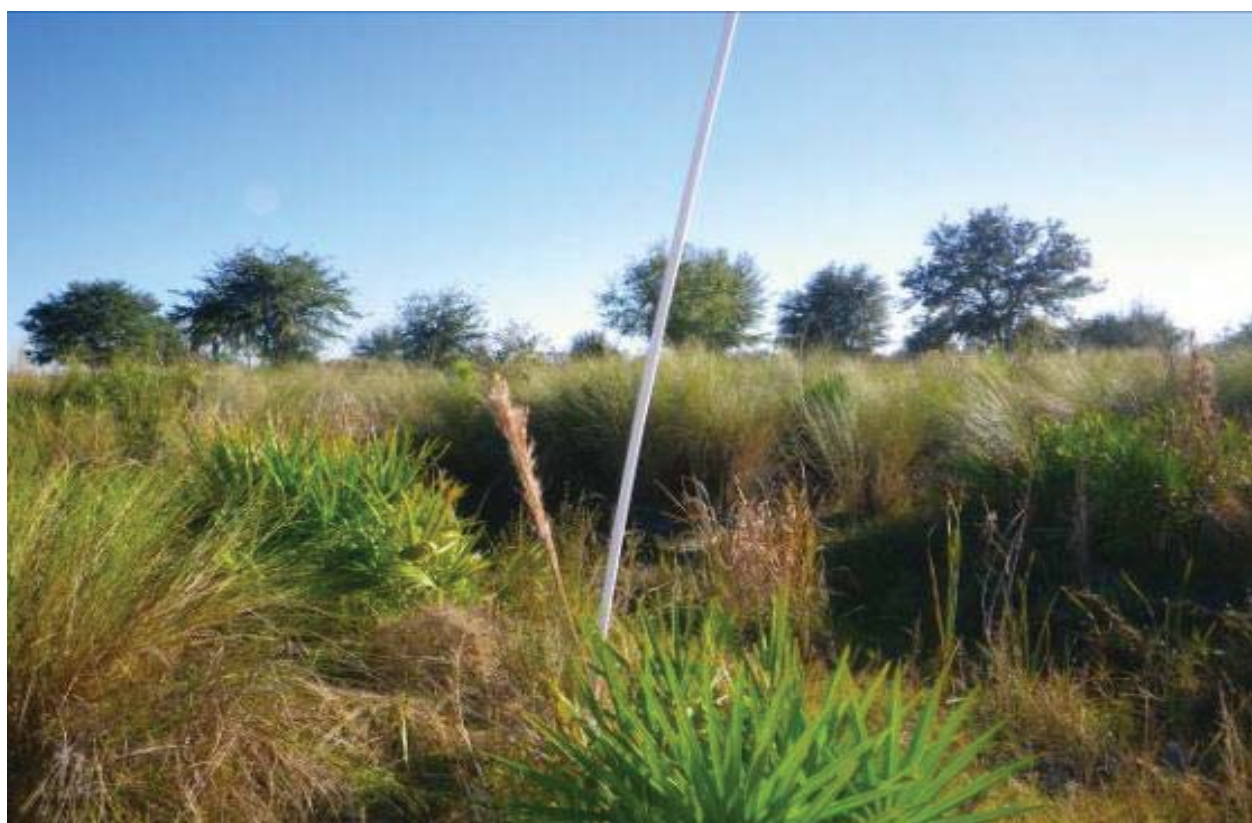
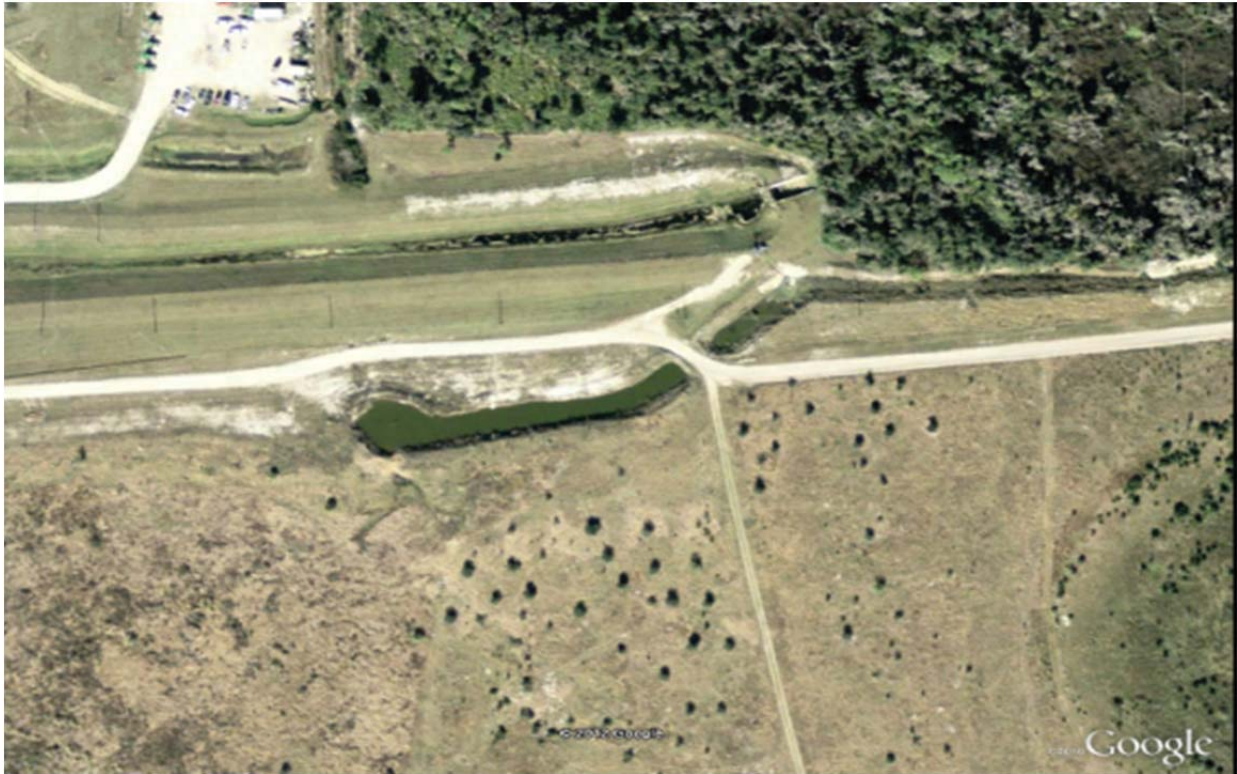
DB-5 Photographs

The 1000-foot long DB-5 stream channel was created via mechanical construction in 2009 to replace an existing ditch with a naturally meandering stream channel of appropriate size and shape connecting the headwater wetland to the downstream receiving wetland preserve. Mechanical construction is a technique by which a stream is built in accordance with a detailed plan set outlining proper stream dimension (width and depth), bend geometry, and riffle-pool sequence. Design specifications for DB-5 were based on natural channel designs derived from regional data to ensure that the stream fit its watershed (Kiefer 2010, Blanton 2008). Natural channel design approaches make sense, in part, because CF’s integrated groundwater-surface water modeling and hydrology monitoring data indicate that the surface and subsurface drainage characteristics of the post-reclamation landscape are within the natural seasonal range of fluctuations found in flatwoods-dominated physiographies typical of the region.

Soil bioengineering techniques were incorporated to approximate Florida’s vegetative conditions. A bottom-up approach was taken, in which the valley flat was first constructed at a subgrade elevation to the series of desired pool depths along the valley’s meander belt. Stream banks were then built by laying mucky mineral top soil to a height of two feet along the length of the meandering left and right banks. Constructed stream banks were then wrapped with erosion control blankets (ECB), and most of the bank length was backfilled with live saw palmetto root masses. Palmetto roots were installed not only to

provide bank stability and to hold the soil together once the ECB decomposes, but also because natural Florida headwater streams often have saw palmetto along their banks. The remaining valley flat was then filled with native sandy top soil. Last, fine to medium sandy soil was placed at the riffles and blended towards the pools. Habitat amendments such as large woody debris, v-log weirs (to induce pools), and root wads were also installed. DB-5 was built in just three weeks (eight actual construction days) and clearly demonstrates CF's ability to get properly-dimensioned streams in the ground quickly. This method is likely to be more efficient and cost-effective than hydraulic carving for stream valleys less than 1,000 feet long.

Doe Branch reclamation sites DB-2 and DB-5 are considerably younger in age (five and three years old, respectively) and have not yet been fully connected to their reclaimed watersheds. One HA has been performed at each site; however, the streams were dry at the time of sampling, and bankfull conditions were thus assumed for habitat mapping purposes. HA scores ranged from 122 to 130, falling in the Optimal category. Habitat types included snags and aquatic vegetation.

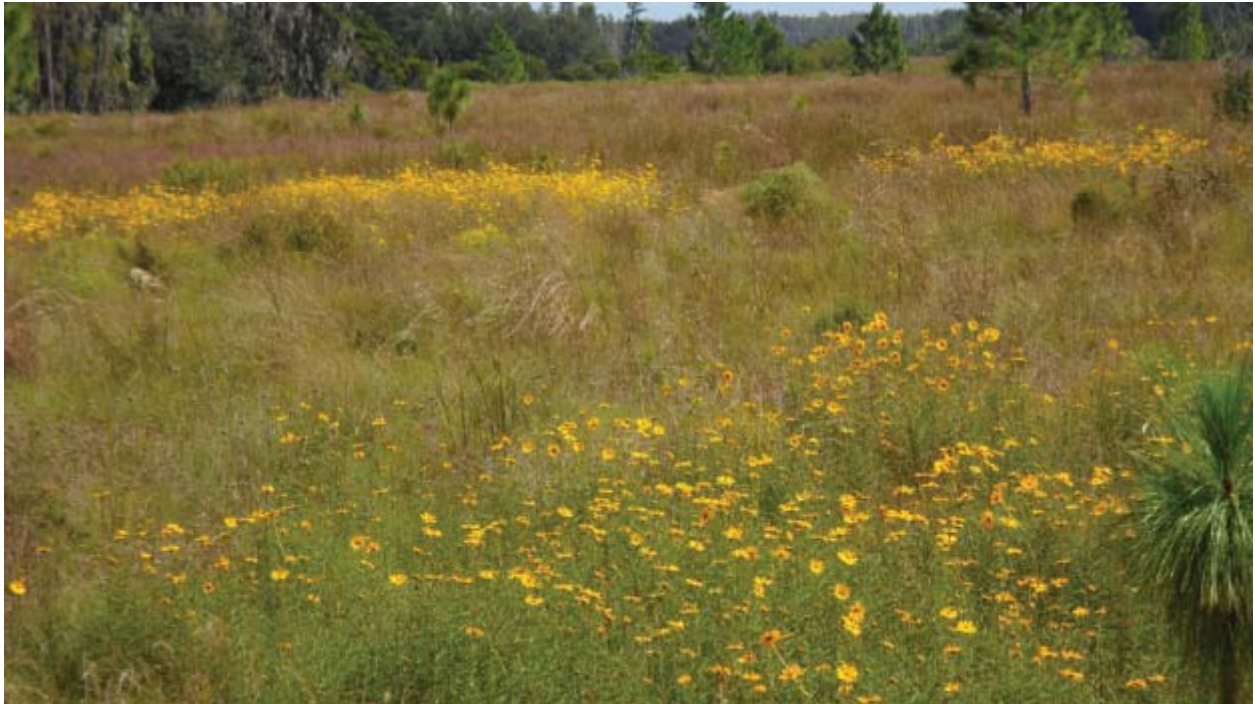
Upland enhancement, Plant City, 2012

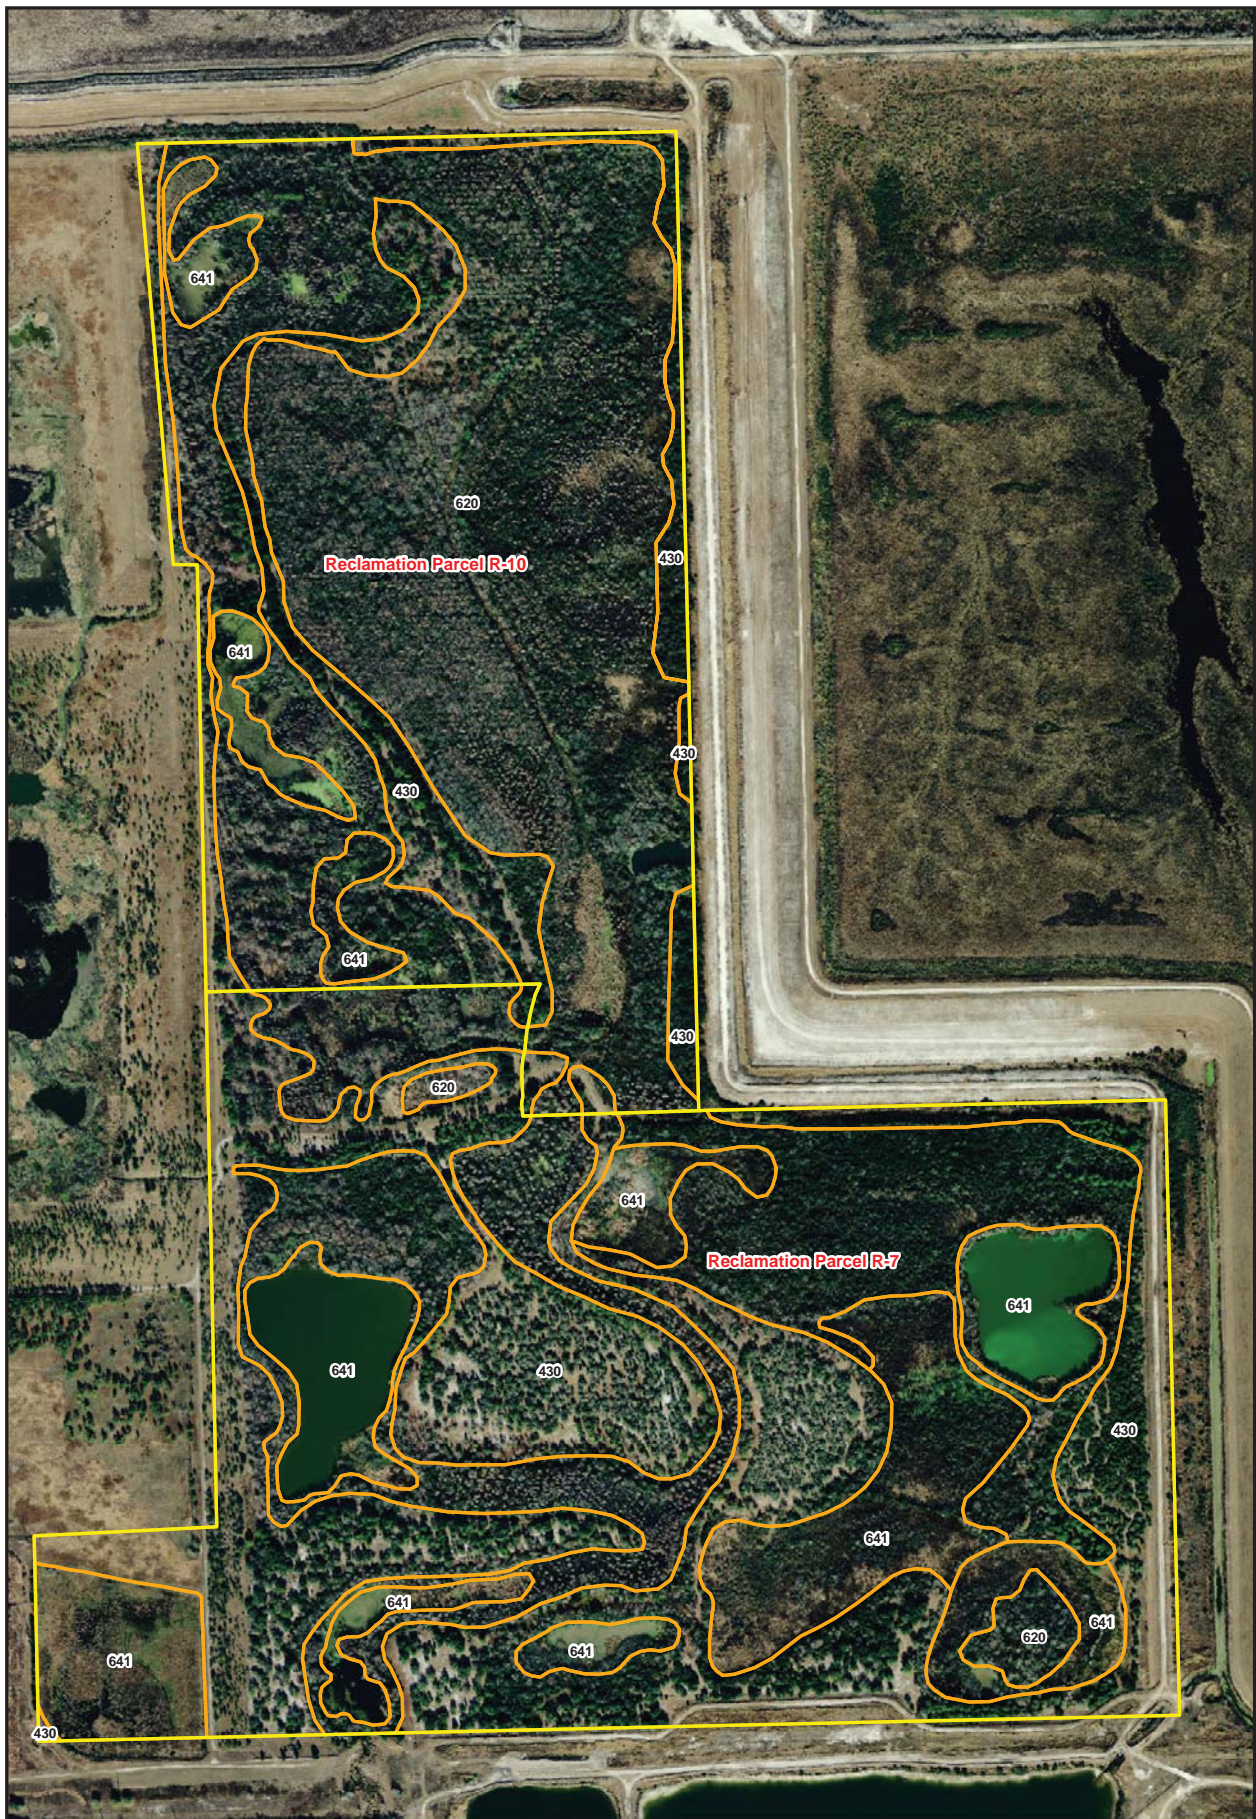
<p>Feet</p> <p>0 400</p> <p>1 in = 400 feet</p>	<p>CF INDUSTRIES INC. NORTH PASTURE R7/R10 RECLAMATION PARCELS</p>	<p> R7/R10 Reclamation Parcel Boundary</p> <p> Post Reclamation Land Use</p>	<p>N W E S</p>
<p>FLATWOODS Consulting Group</p>	<p>HARDEE COUNTY, FLORIDA</p>	<p><small>Source: 2011 SWFWMD Imagery</small></p>	<p>LAND USE MAP</p>

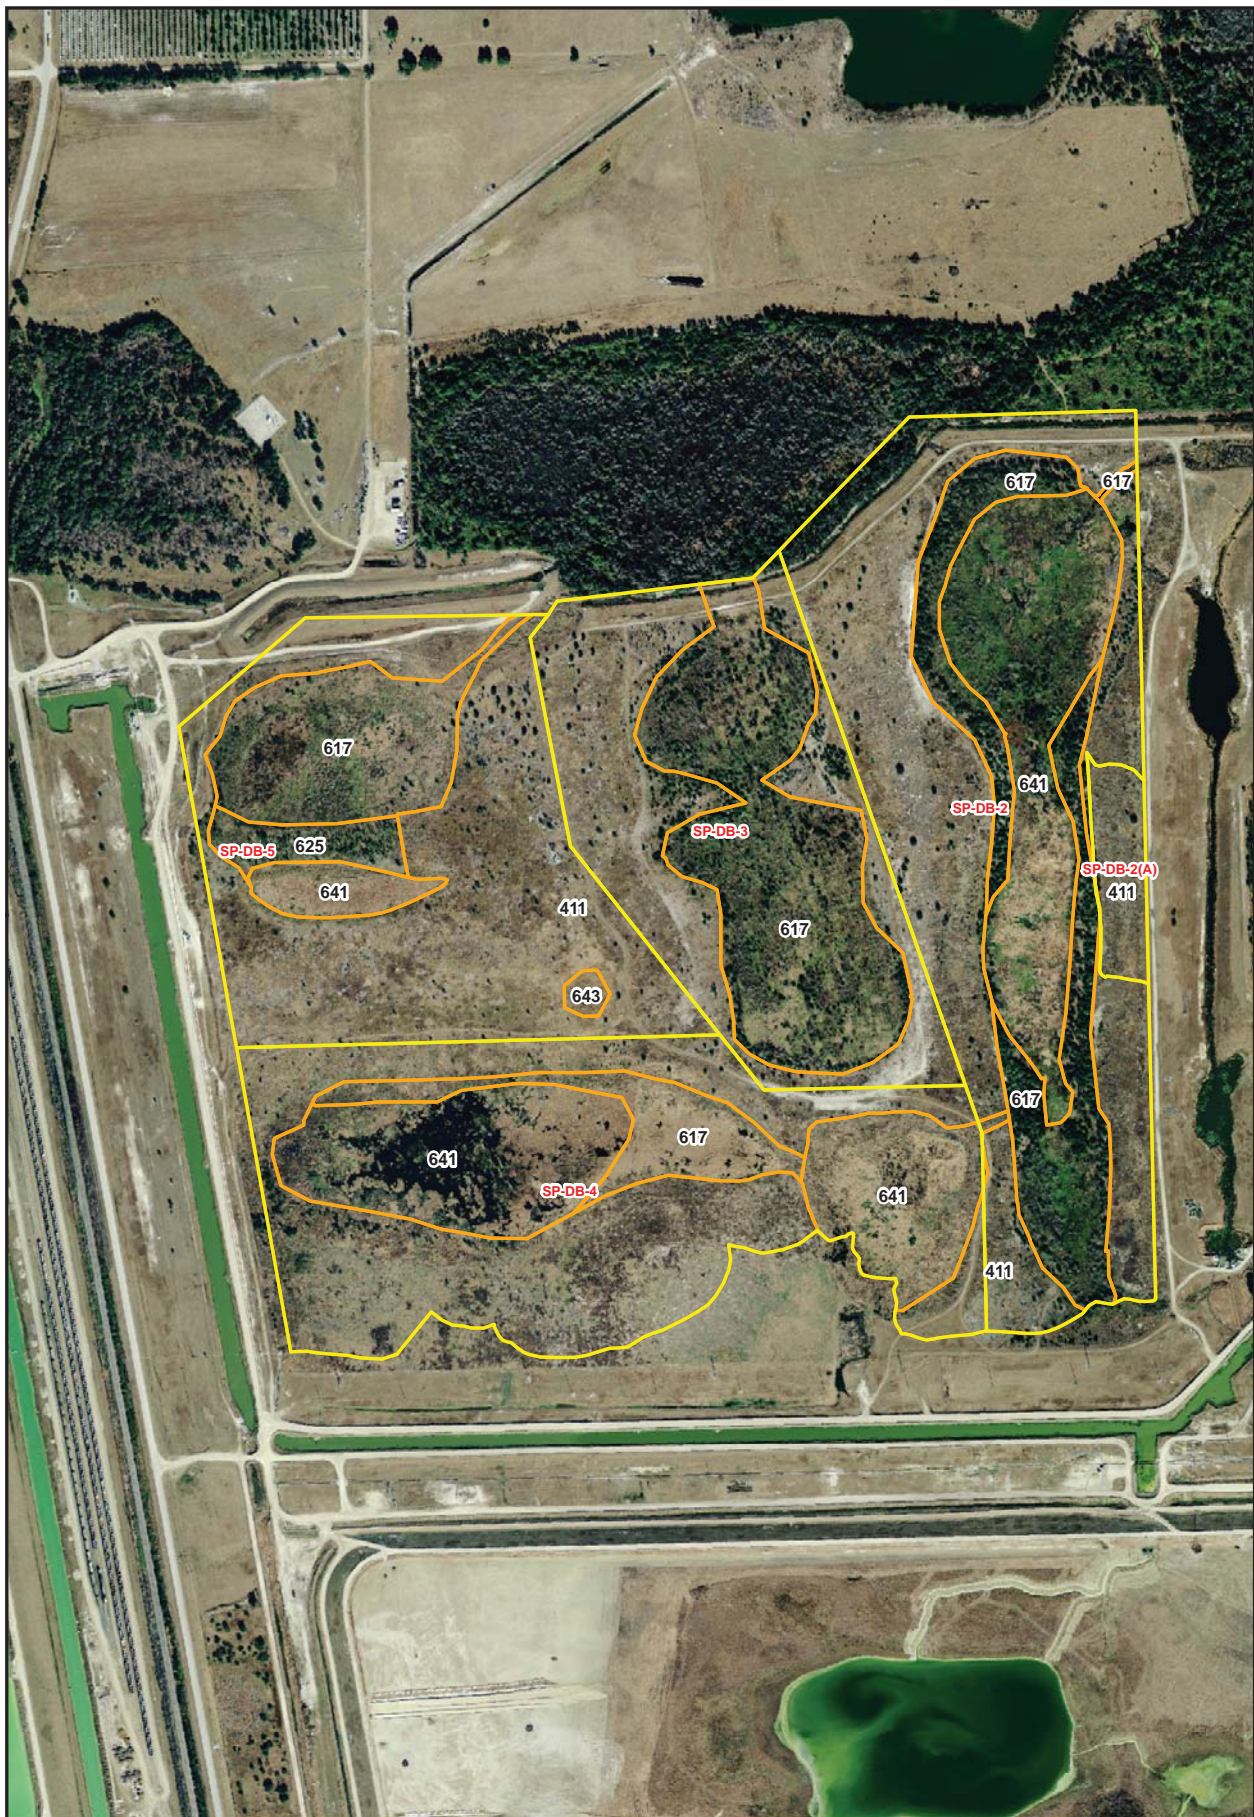
<p>Feet</p> <p>0 500</p> <p>1 in = 500 feet</p>	<p>CF INDUSTRIES INC.</p> <p>SOUTH PASTURE</p> <p>DB RECLAMATION PARCELS</p>	<p> DB Reclamation Parcel Boundary</p> <p> Post Reclamation Land Use</p>	<p>N</p> <p>W E</p> <p>S</p>
<p>FLATWOODS</p> <p>Consulting Group</p>	<p>HARDEE COUNTY, FLORIDA</p>	<p>Source: 2011 SWFWMD Imagery</p>	<p>LAND USE</p> <p>MAP</p>

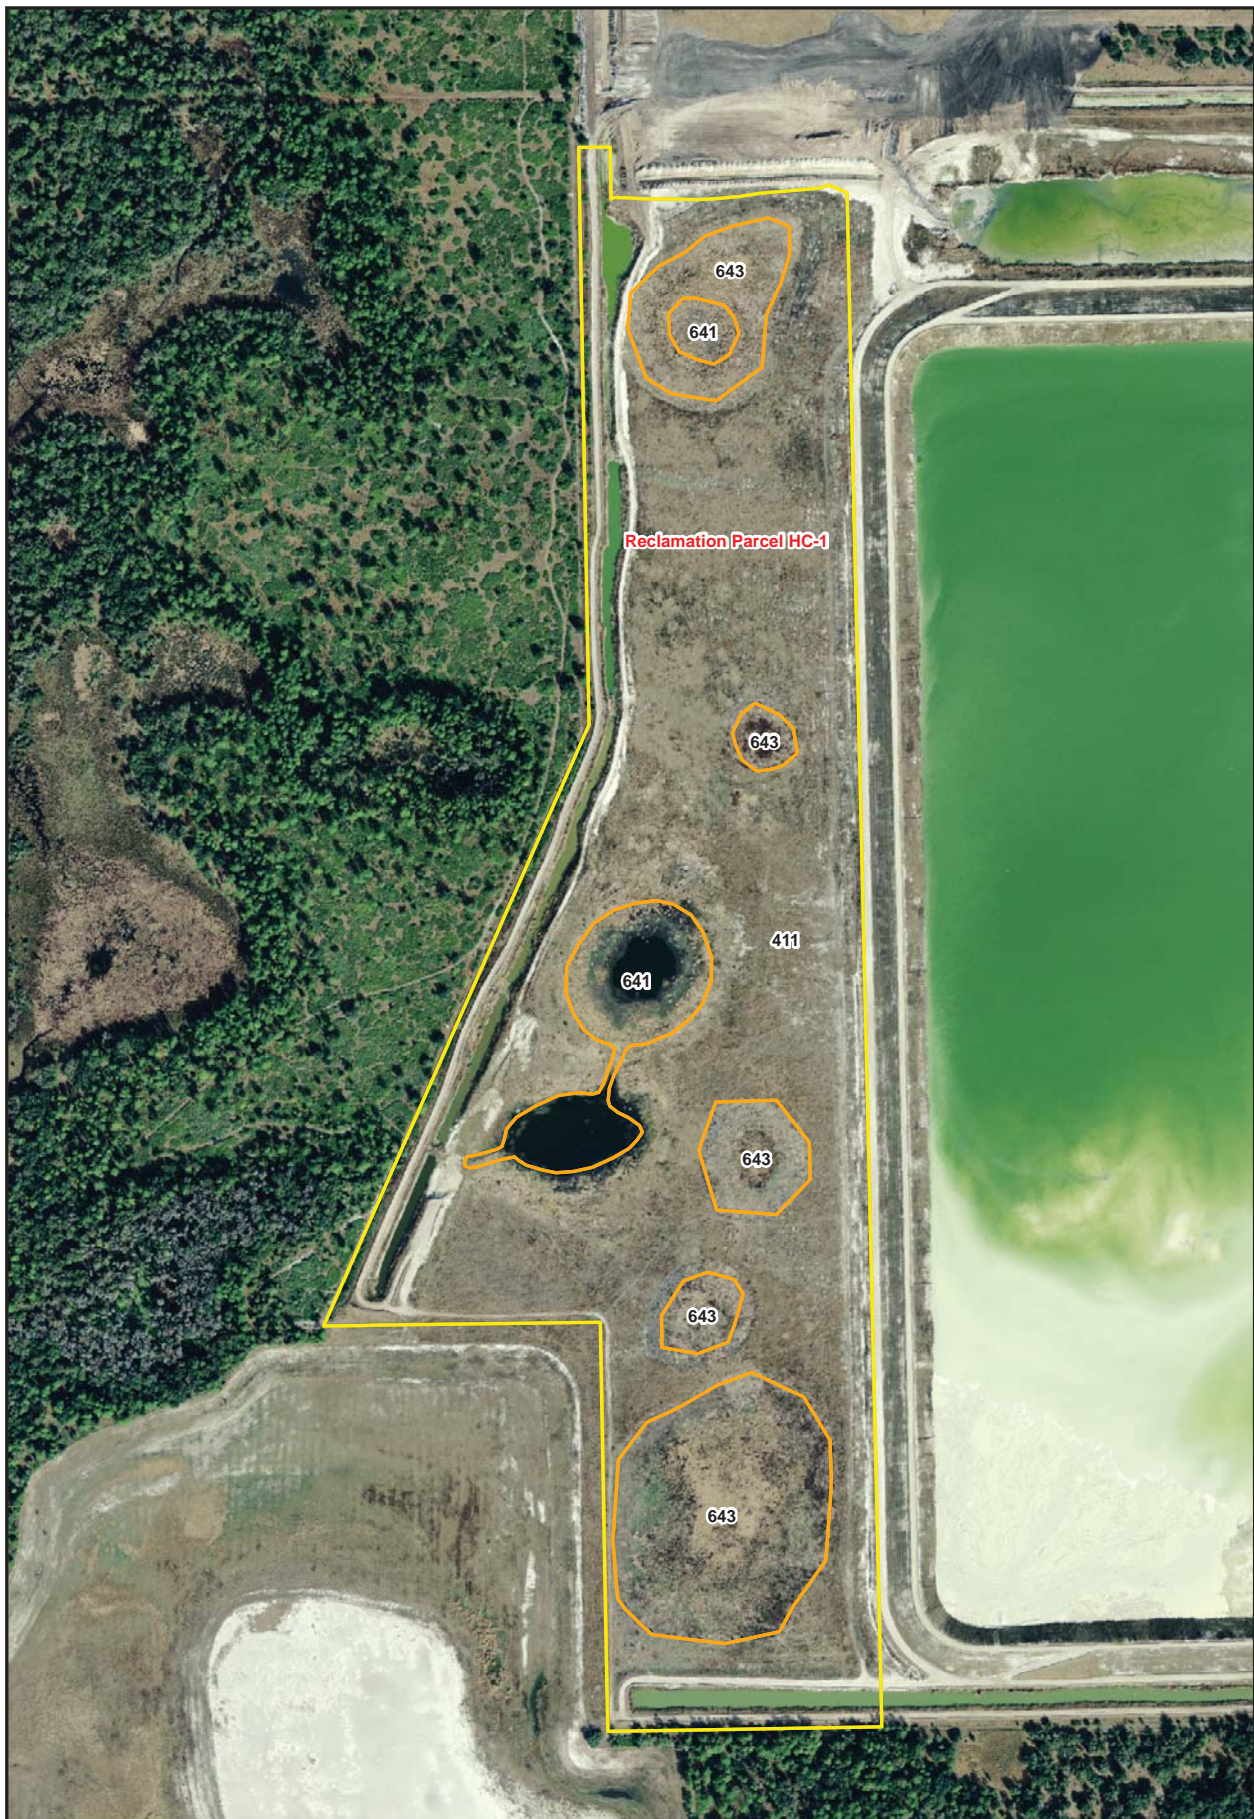
<p>Feet</p> <p>0 400</p> <p>1 in = 400 feet</p>	<p>CF INDUSTRIES INC. SOUTH PASTURE HC-1 RECLAMATION PARCELS</p>	<p> HC-1 Reclamation Parcel Boundary</p>	<p>N W — E S</p>
<p>FLATWOODS Consulting Group</p>	<p>HARDEE COUNTY, FLORIDA</p>	<p> Post Reclamation Land Use</p> <p><small>Source: 2011 SWFWMD Imagery</small></p>	<p>LAND USE MAP</p>

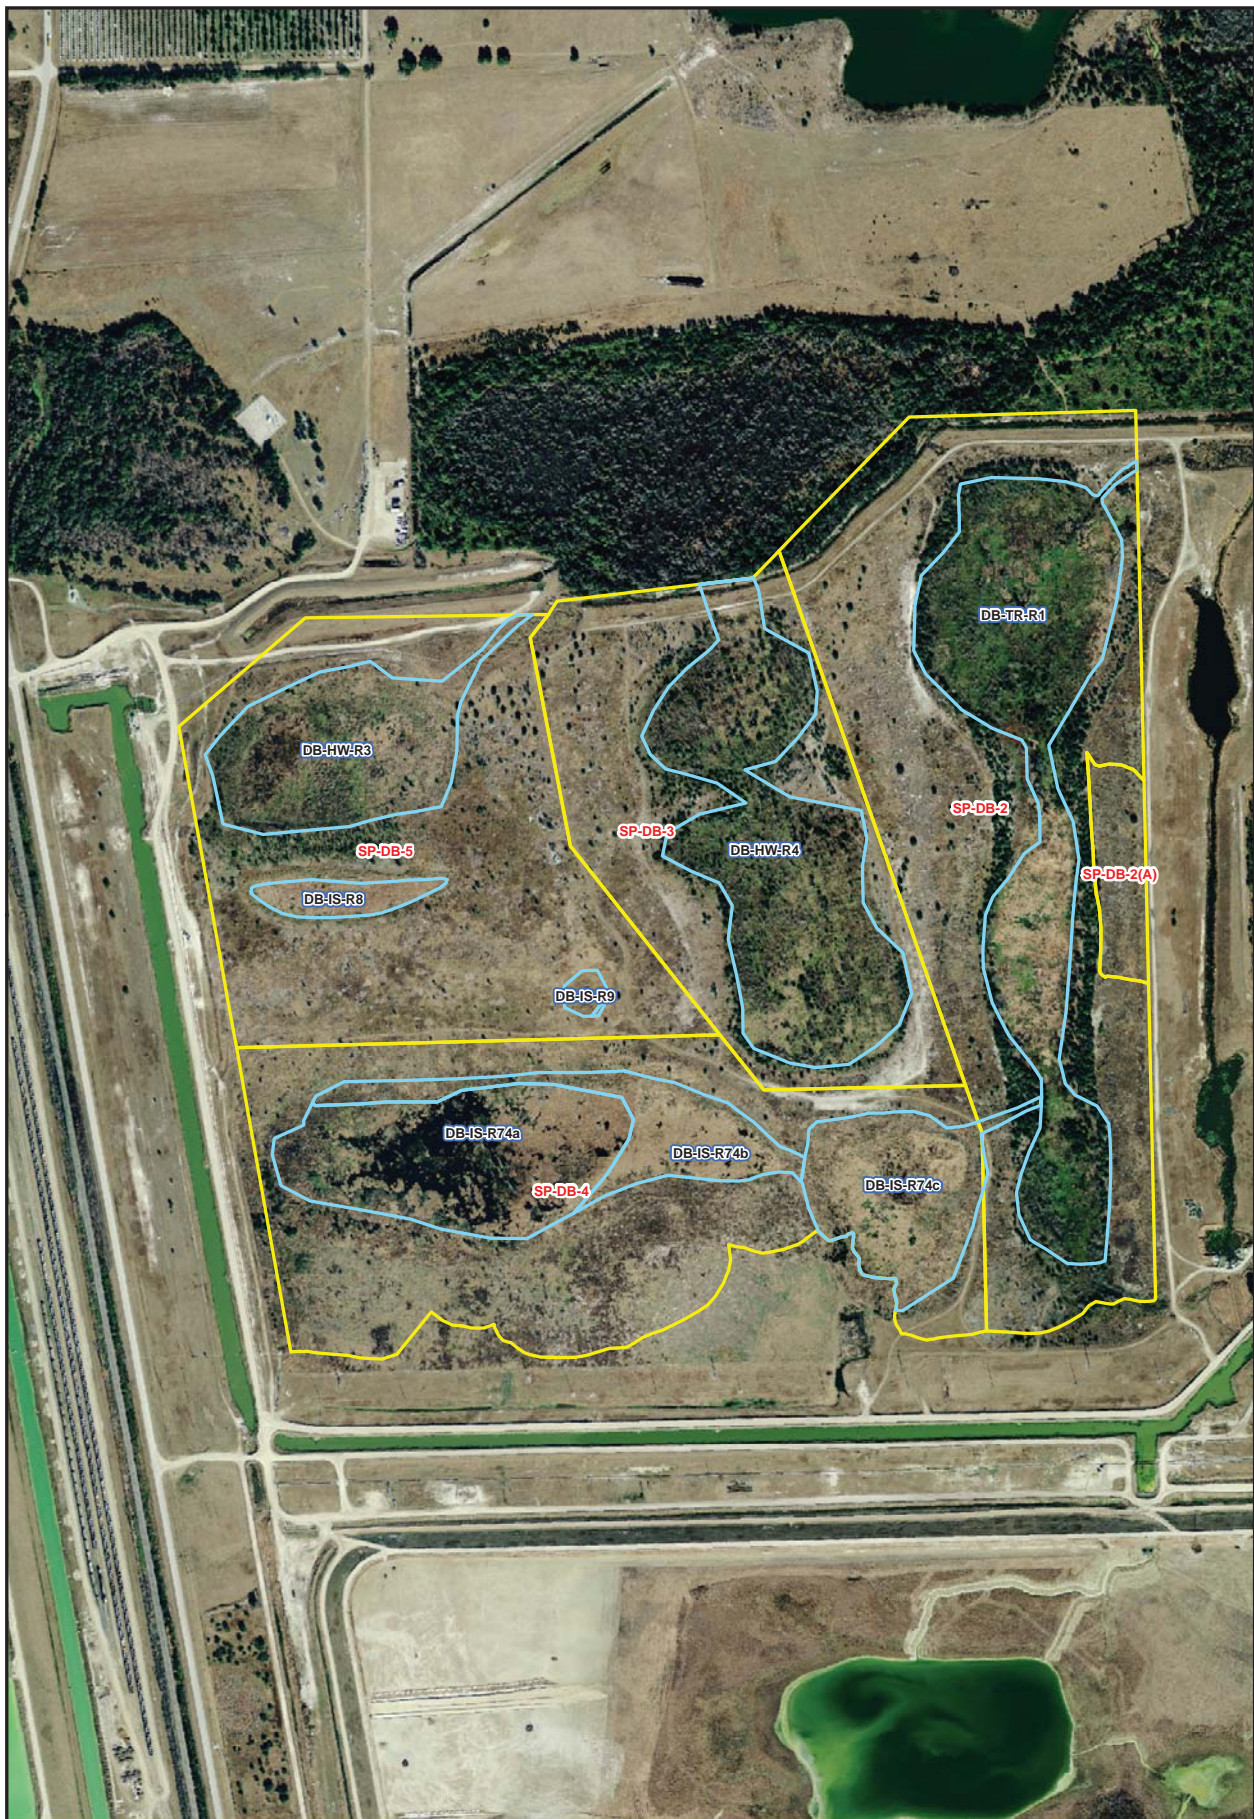
<p>Feet</p> <p>0 500</p> <p>1 in = 500 feet</p>	<p>CF INDUSTRIES INC.</p> <p>SOUTH PASTURE</p> <p>DB RECLAMATION PARCELS</p>	<p> DB Reclamation Parcel Boundary</p> <p> Reclaimed Wetland Boundary</p>	<p>N</p> <p>W E</p> <p>S</p>
<p>FLATWOODS</p> <p>Consulting Group</p>	<p>HARDEE COUNTY, FLORIDA</p>	<p>Source: 2011 SWFWMD Imagery</p>	<p>WETLAND</p> <p>MAP</p>

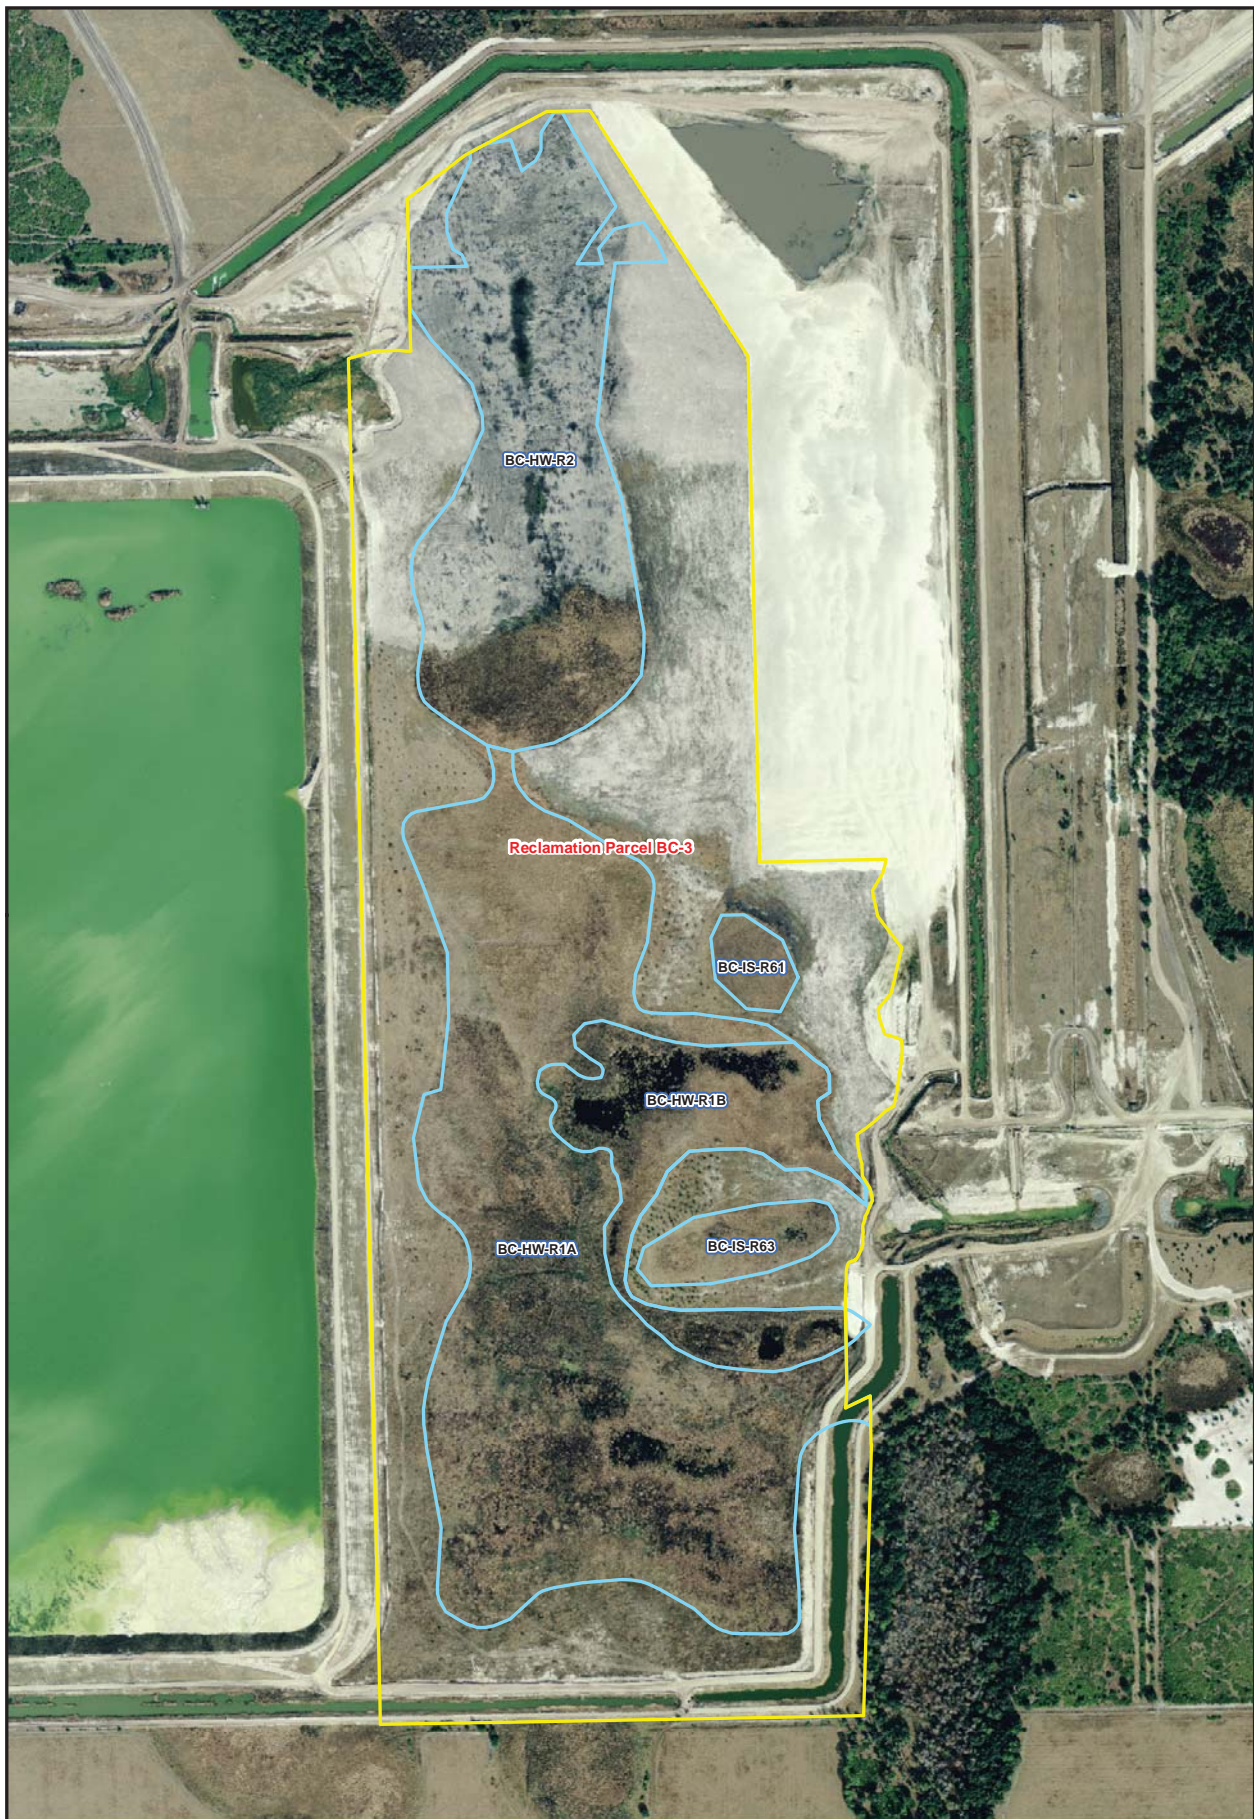
<p>Feet</p> <p>0 450</p> <p>1 in = 450 feet</p>	<p>CF INDUSTRIES INC.</p> <p>SOUTH PASTURE</p> <p>BC-3 RECLAMATION PARCEL</p>	<p> BC-3 Reclamation Parcel</p> <p> Reclaimed Wetland Boundary</p>	<p>N</p> <p>W E</p> <p>S</p>
<p>FLATWOODS</p> <p>Consulting Group</p>	<p>HARDEE COUNTY, FLORIDA</p>	<p>Source: 2011 SWFWMD Imagery</p>	<p>WETLAND</p> <p>MAP</p>

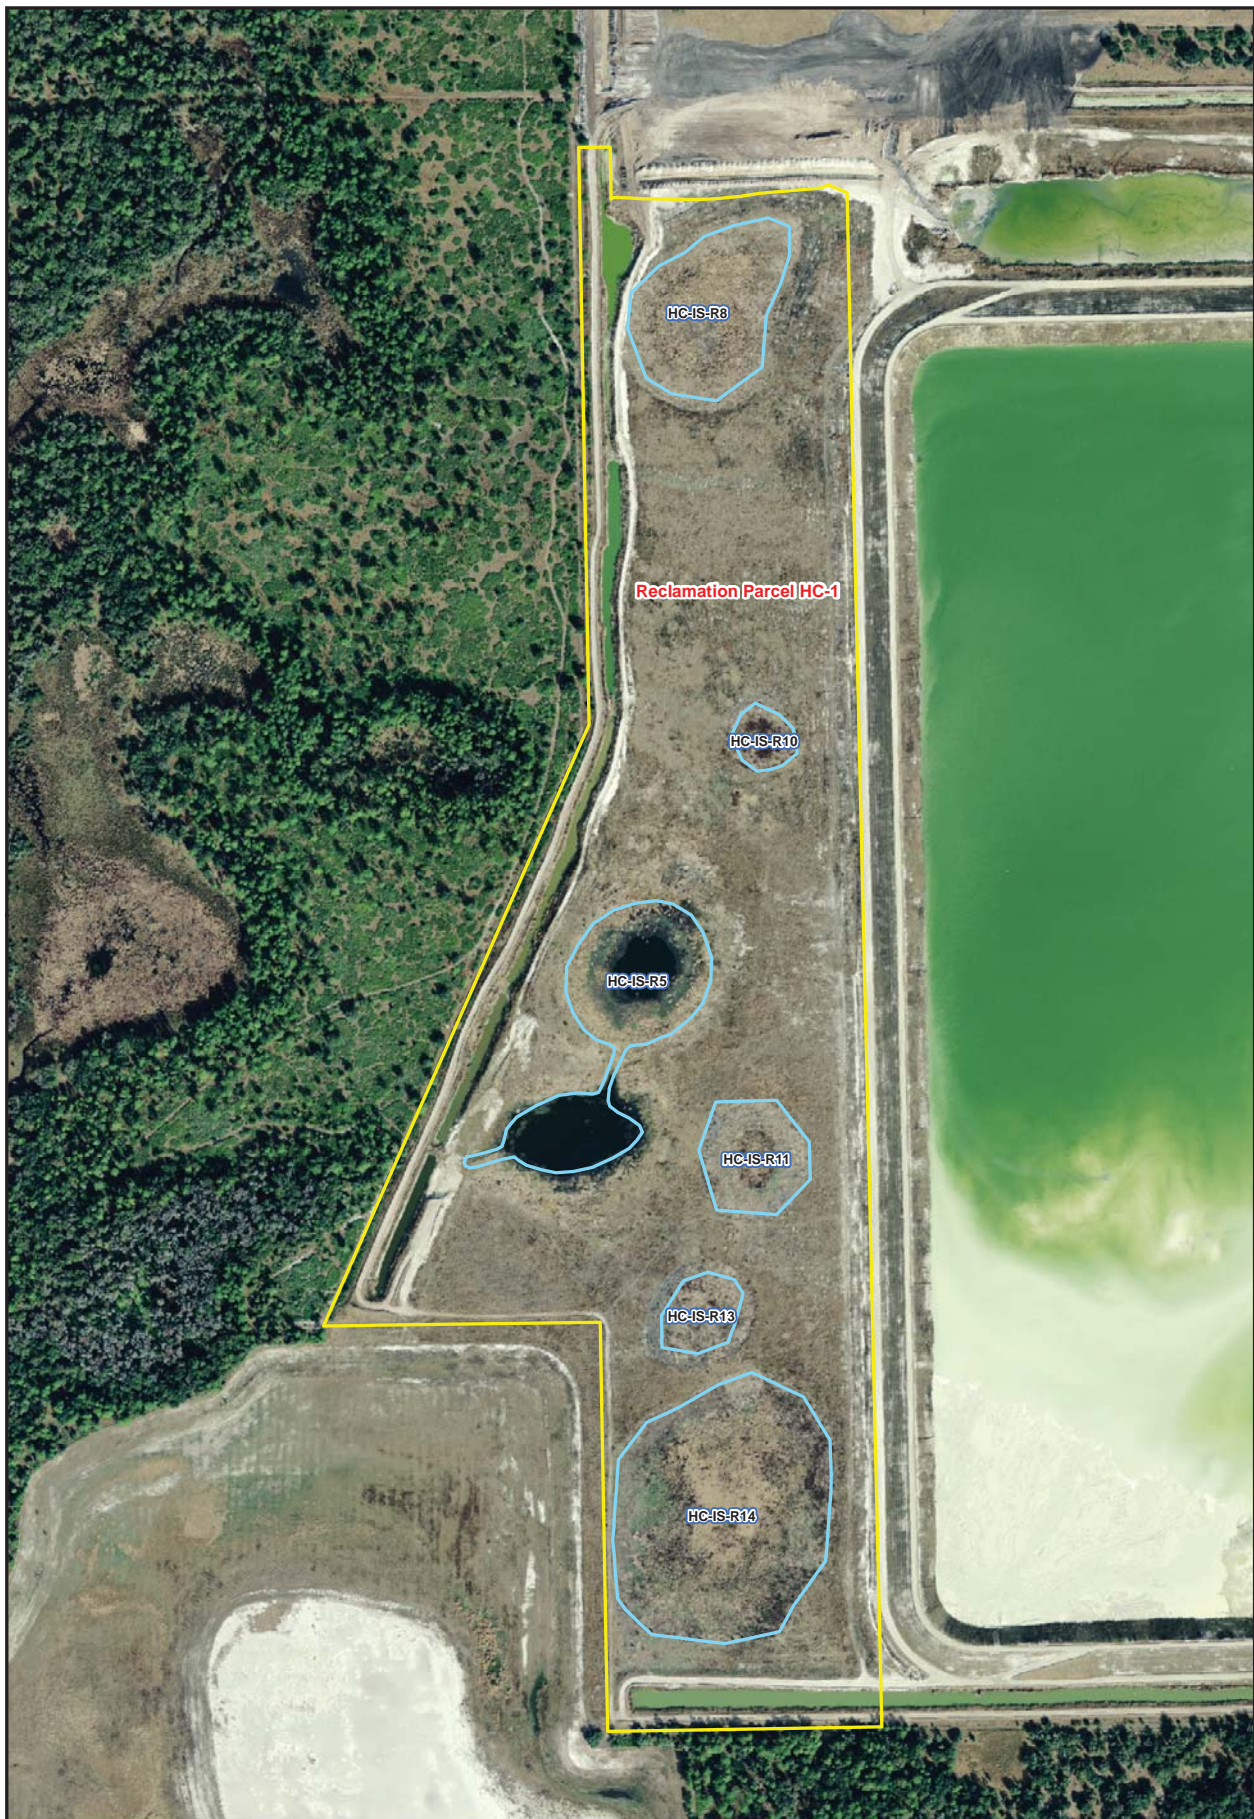
<p>Feet</p> <p>0 400</p> <p>1 in = 400 feet</p>	<p>CF INDUSTRIES INC. SOUTH PASTURE HC-1 RECLAMATION PARCELS</p>	<p> Reclaimed Wetland Boundary</p> <p> HC-1 Reclamation Parcel Boundary</p>	<p>N W E S</p>
<p>FLATWOODS Consulting Group</p>	<p>HARDEE COUNTY, FLORIDA</p>	<p>Source: 2011 SWFWMD Imagery</p>	<p>WETLAND MAP</p>
