Attachment G - Compensatory Mitigation Plan  
Attachment A, Part 2 - Stream Work Plan

**SOUTH PASTURE EXTENSION  
STREAM RESTORATION PLAN**

**CF INDUSTRIES, INC.**  
Wauchula, FL

**AMEC-BCI Engineers & Scientists, Inc.**  
2000 E. Edgewood Drive, Suite 215  
Lakeland, Florida 33803

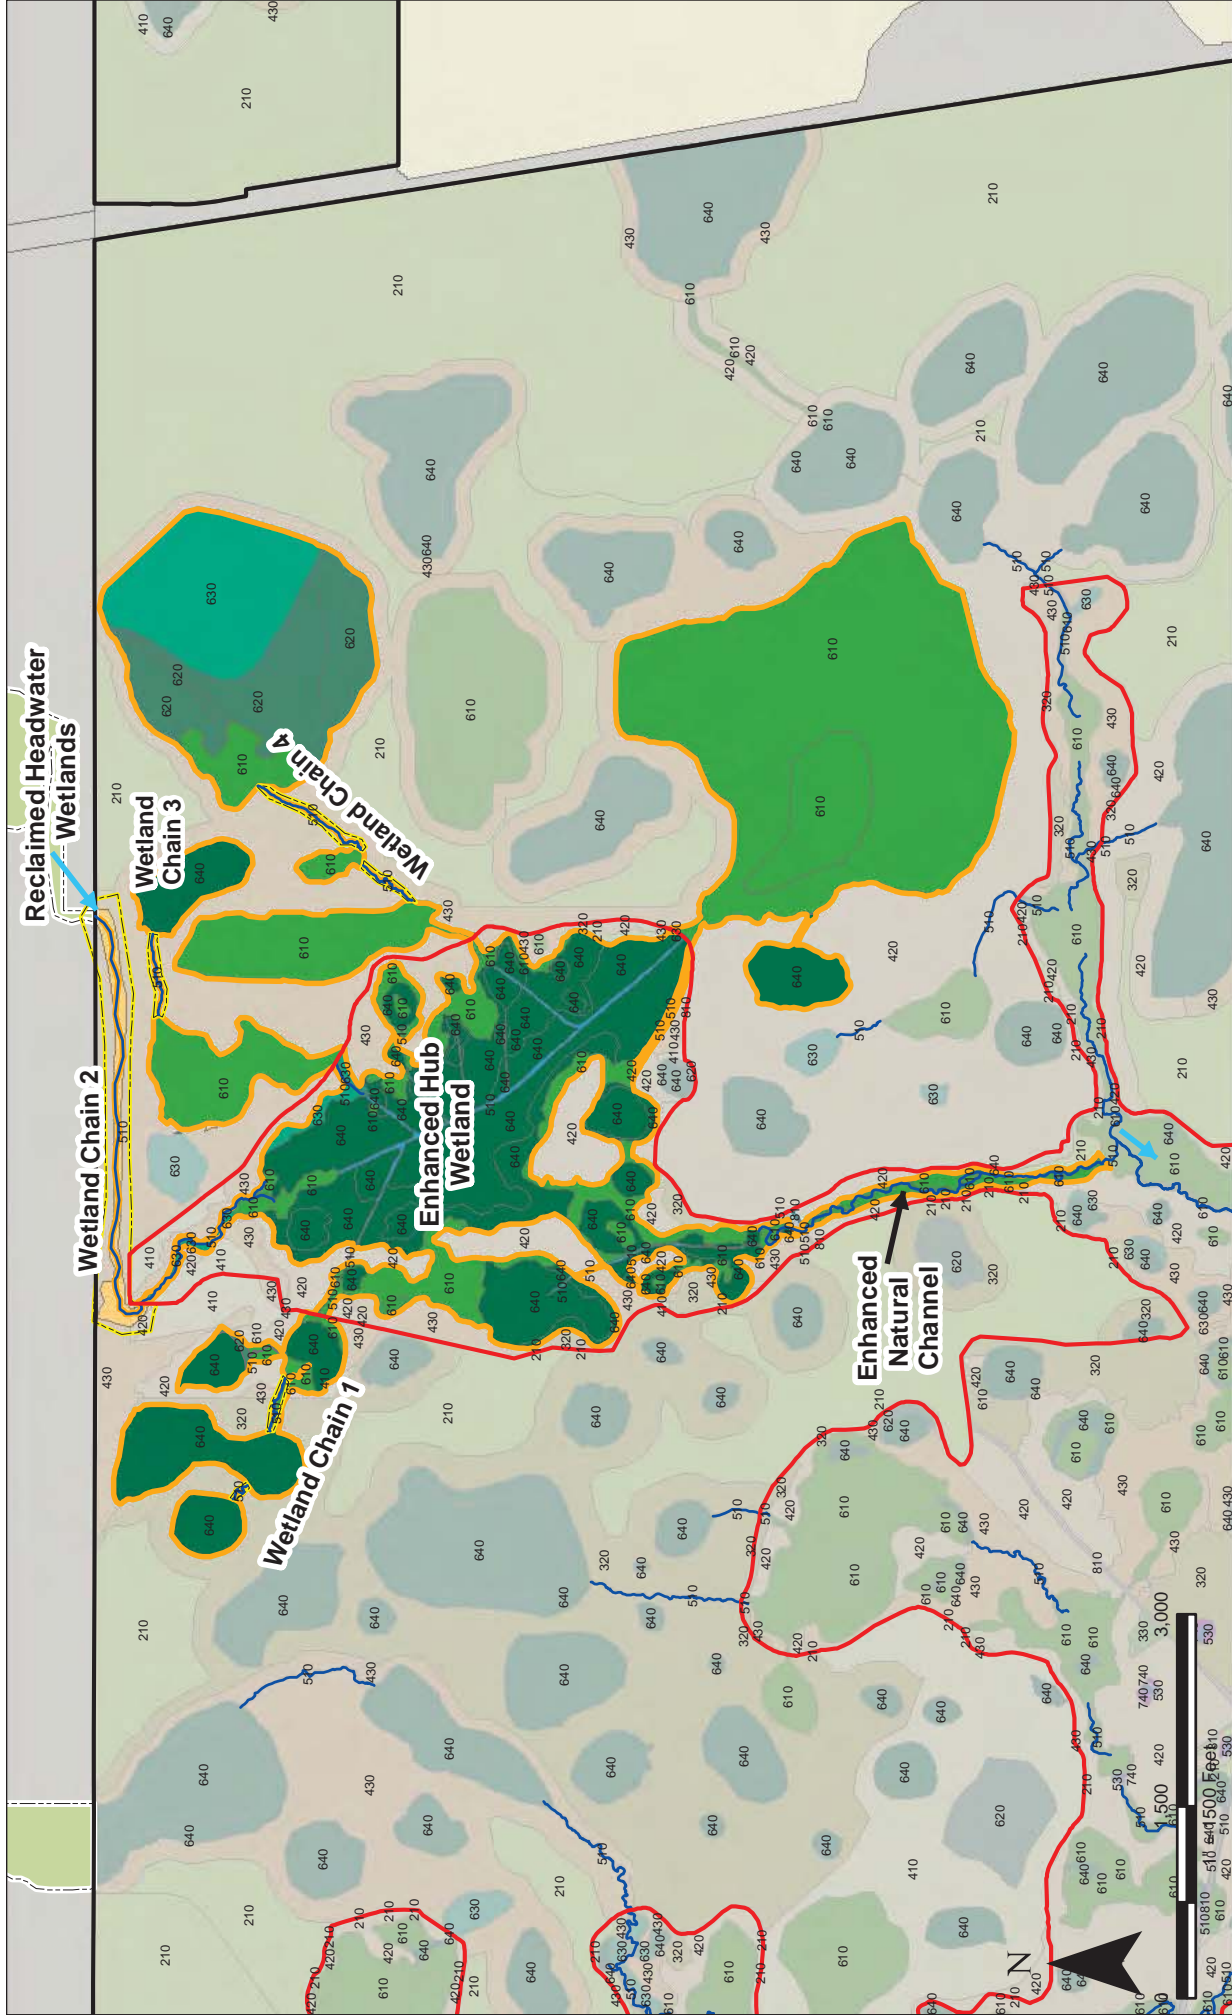
**FIGURE SRO-25**  
**POST-RECLAMATION LETTIS CREEK**  
**NORTH BRANCH**  
**SOUTH PASTURE EXTENSION**  
**HARDEE COUNTY, FLORIDA**
