APPROVED JURISDICTIONAL DETERMINATION FORM
U.S. Army Corps of Engineers

B. DISTRICT OFFICE, FILE NAME, AND NUMBER: Jacksonville District; Jasil Majors Holdings, LLC/Clearwater Reserve; SAJ-2007-01817-SCW

Clearwater Reserve Phase II
 S27 T20S R24E
 S28 T20S R24E
 Lake County, Florida

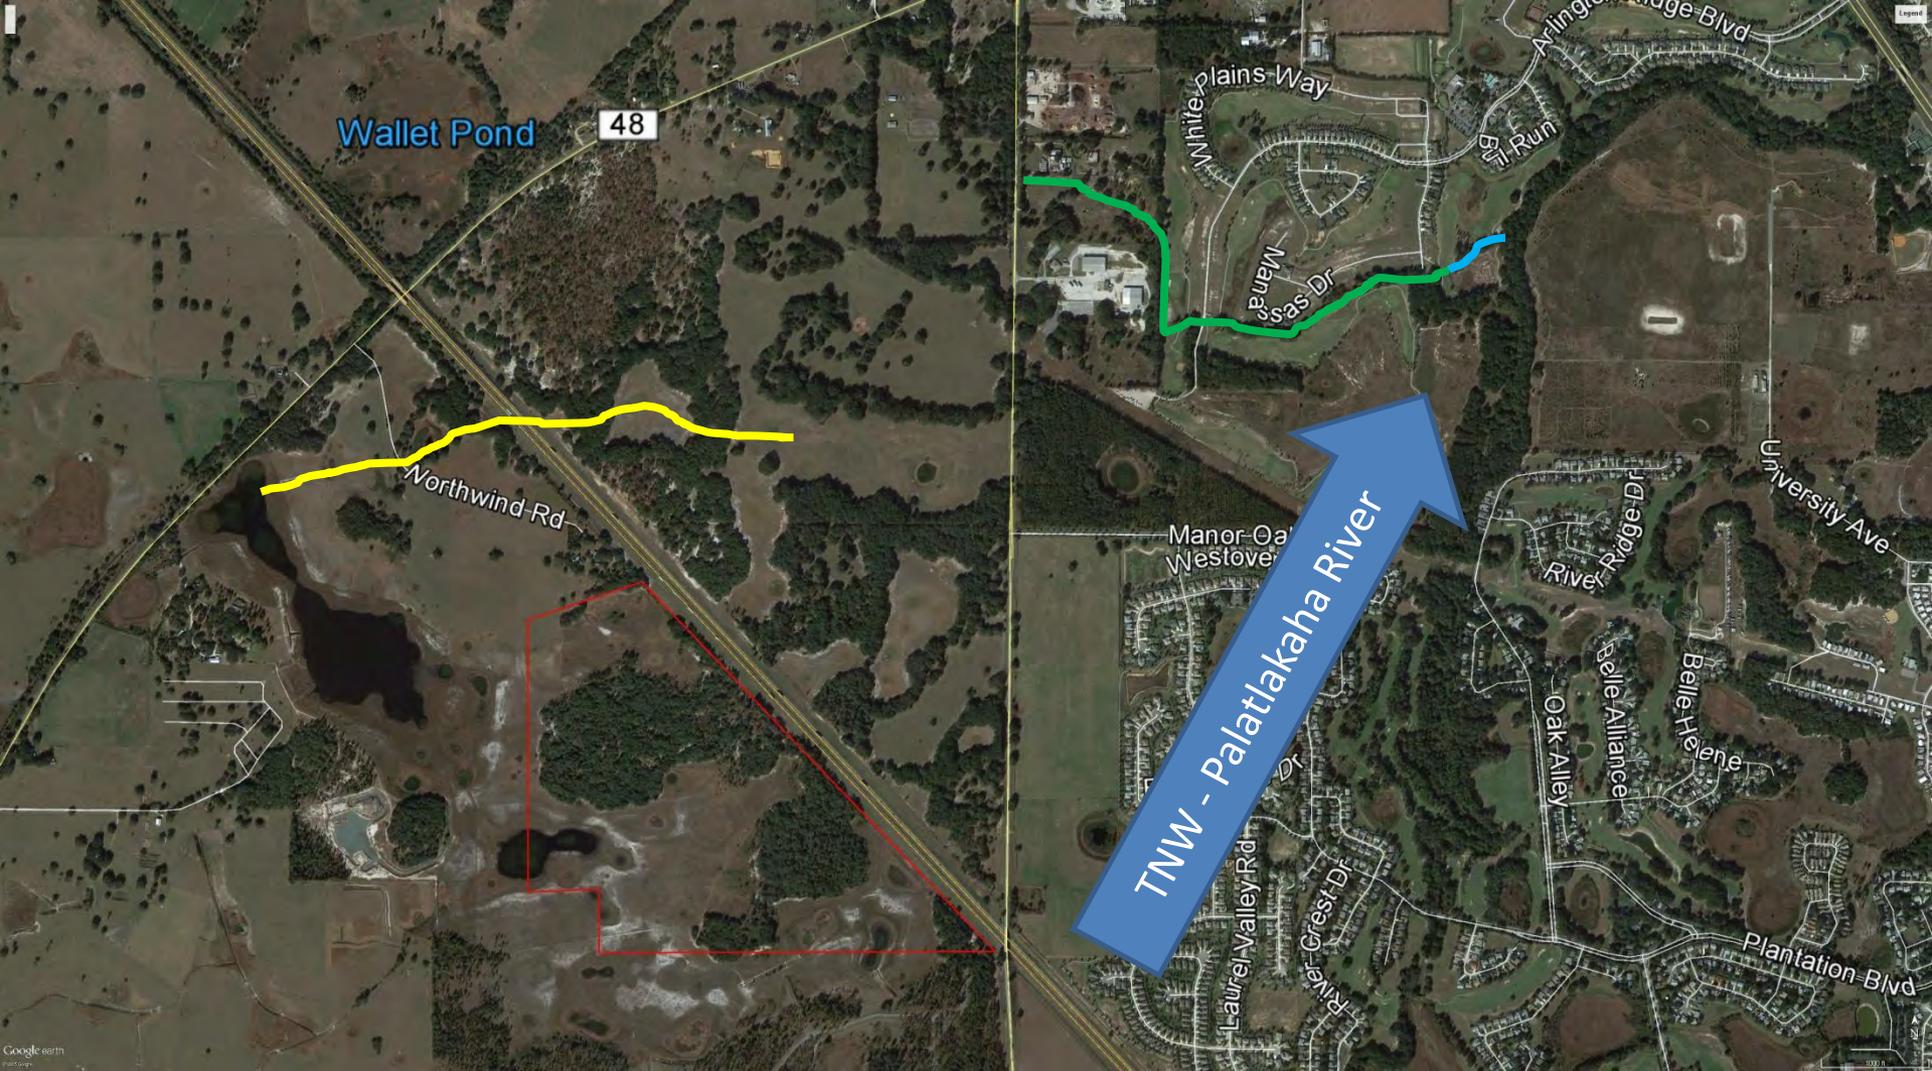
Aerial photograph from 2013. The project site is outlined in red, Ditch 1 is shown in green, Ditch 4 is shown in yellow and RPW is shown in blue.

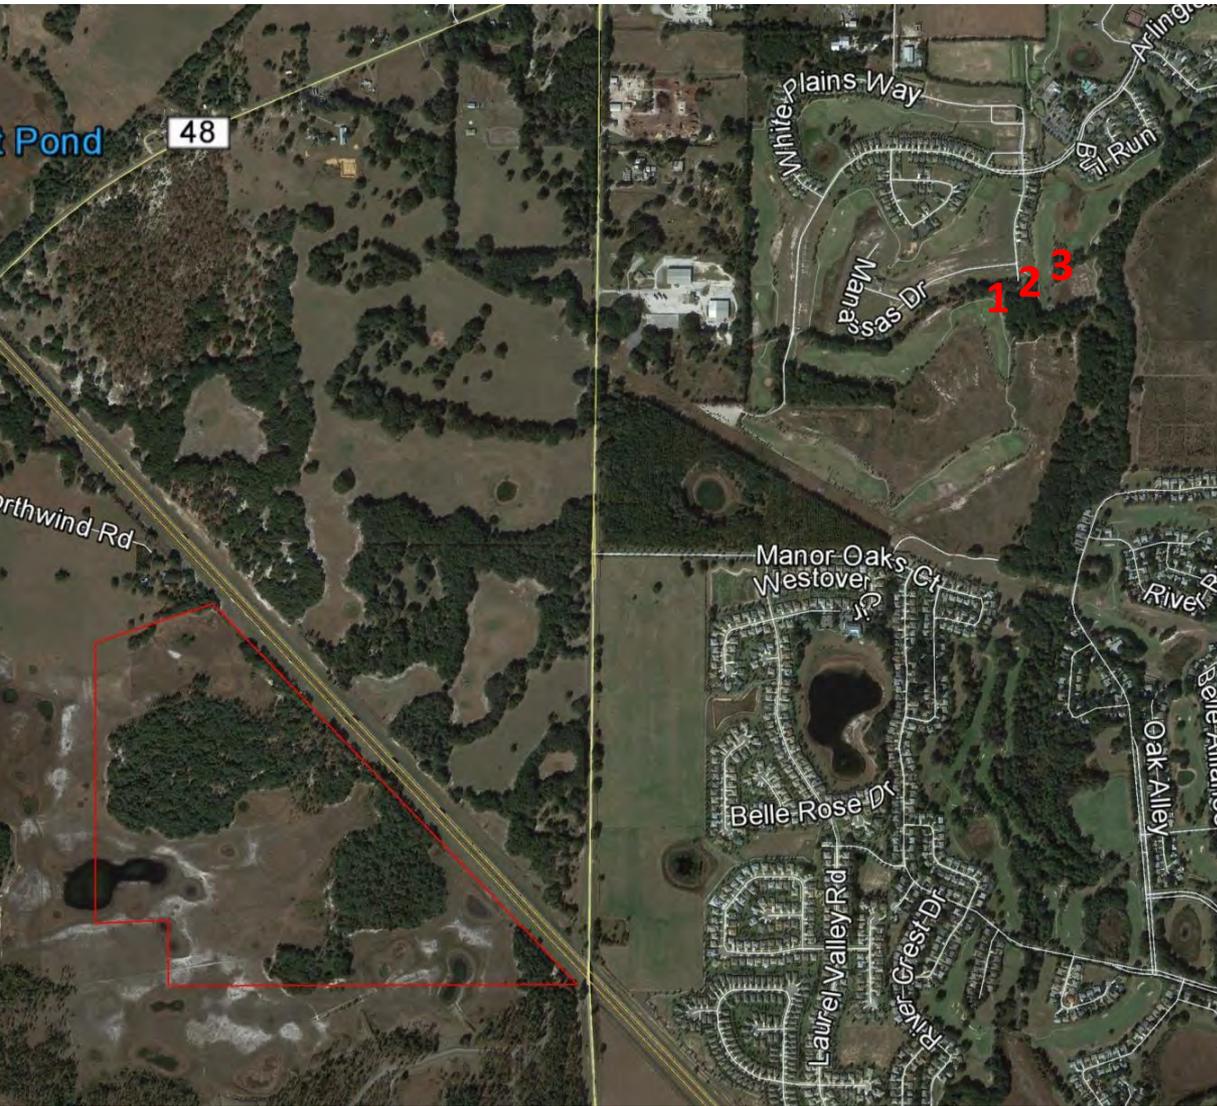
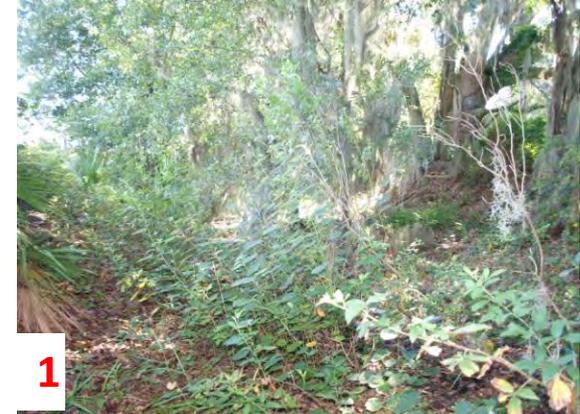
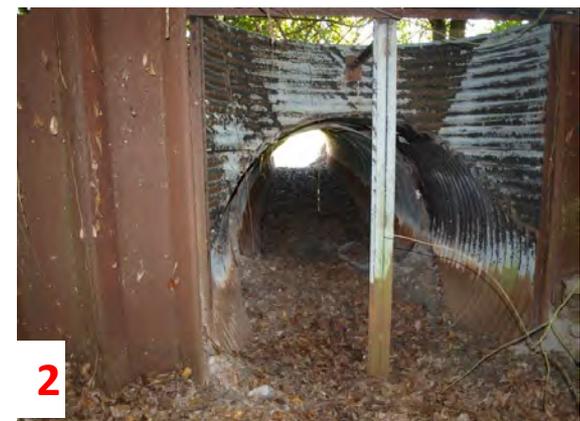
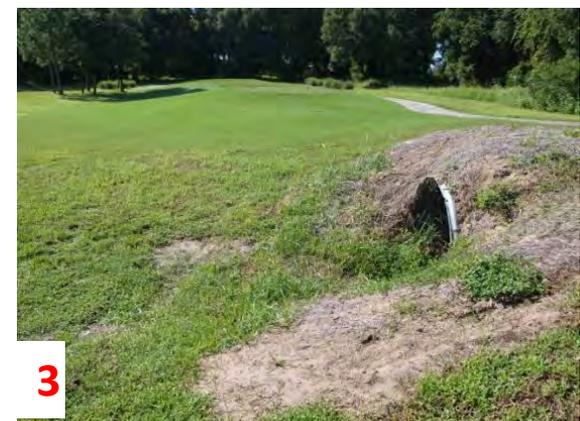
The aerial photograph is from 2013. The project site is outlined in red. Photographs 1 – 3 were taken September 17, 2015 in Ditch 1 near RPW.

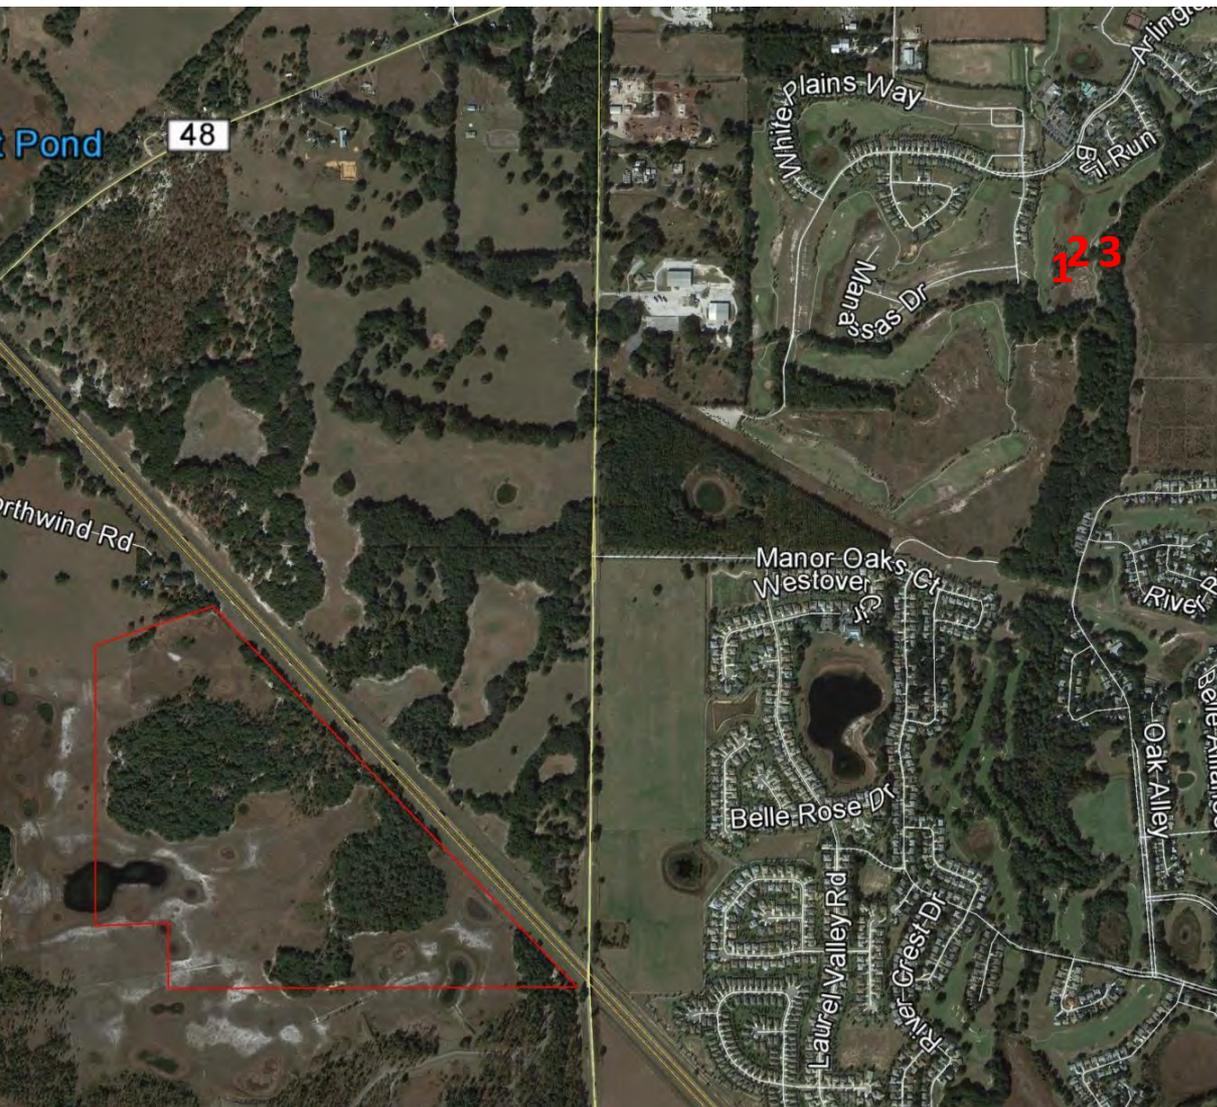
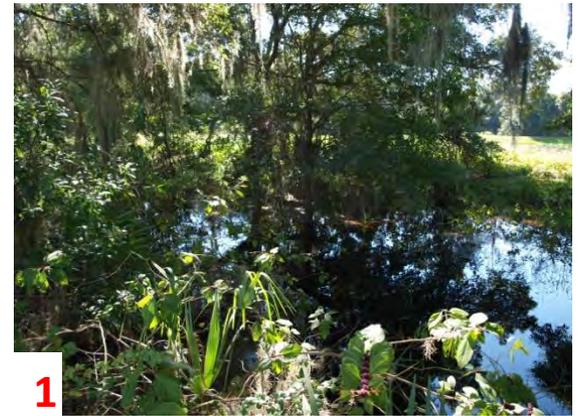
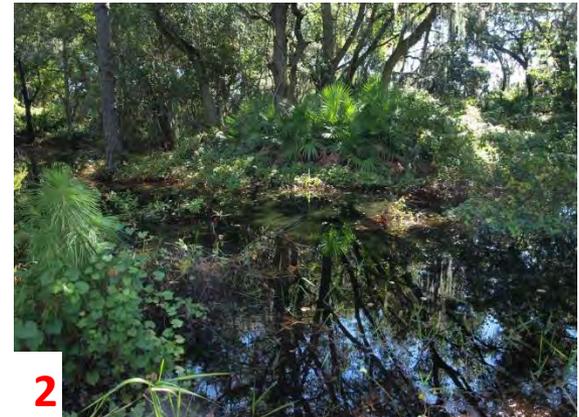
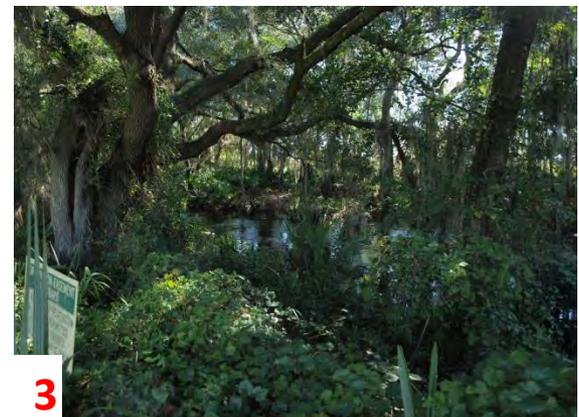
Tributary condition/stability [e.g., highly eroding, sloughing banks]. Explain: The banks of the RPW are vegetated by shrubs, vines and trees and are stable.

Characterize tributary (e.g., water color is clear, discolored, oily film; water quality; general watershed characteristics, etc.).
Explain: Water color is tannic, no oily film or algal growth observed.
Identify specific pollutants, if known: No known pollutants are present within the RPW.

The aerial photograph is from 2013. The project site is outlined in red. Photographs 1 – 3 were taken September 17, 2015 at RPW.

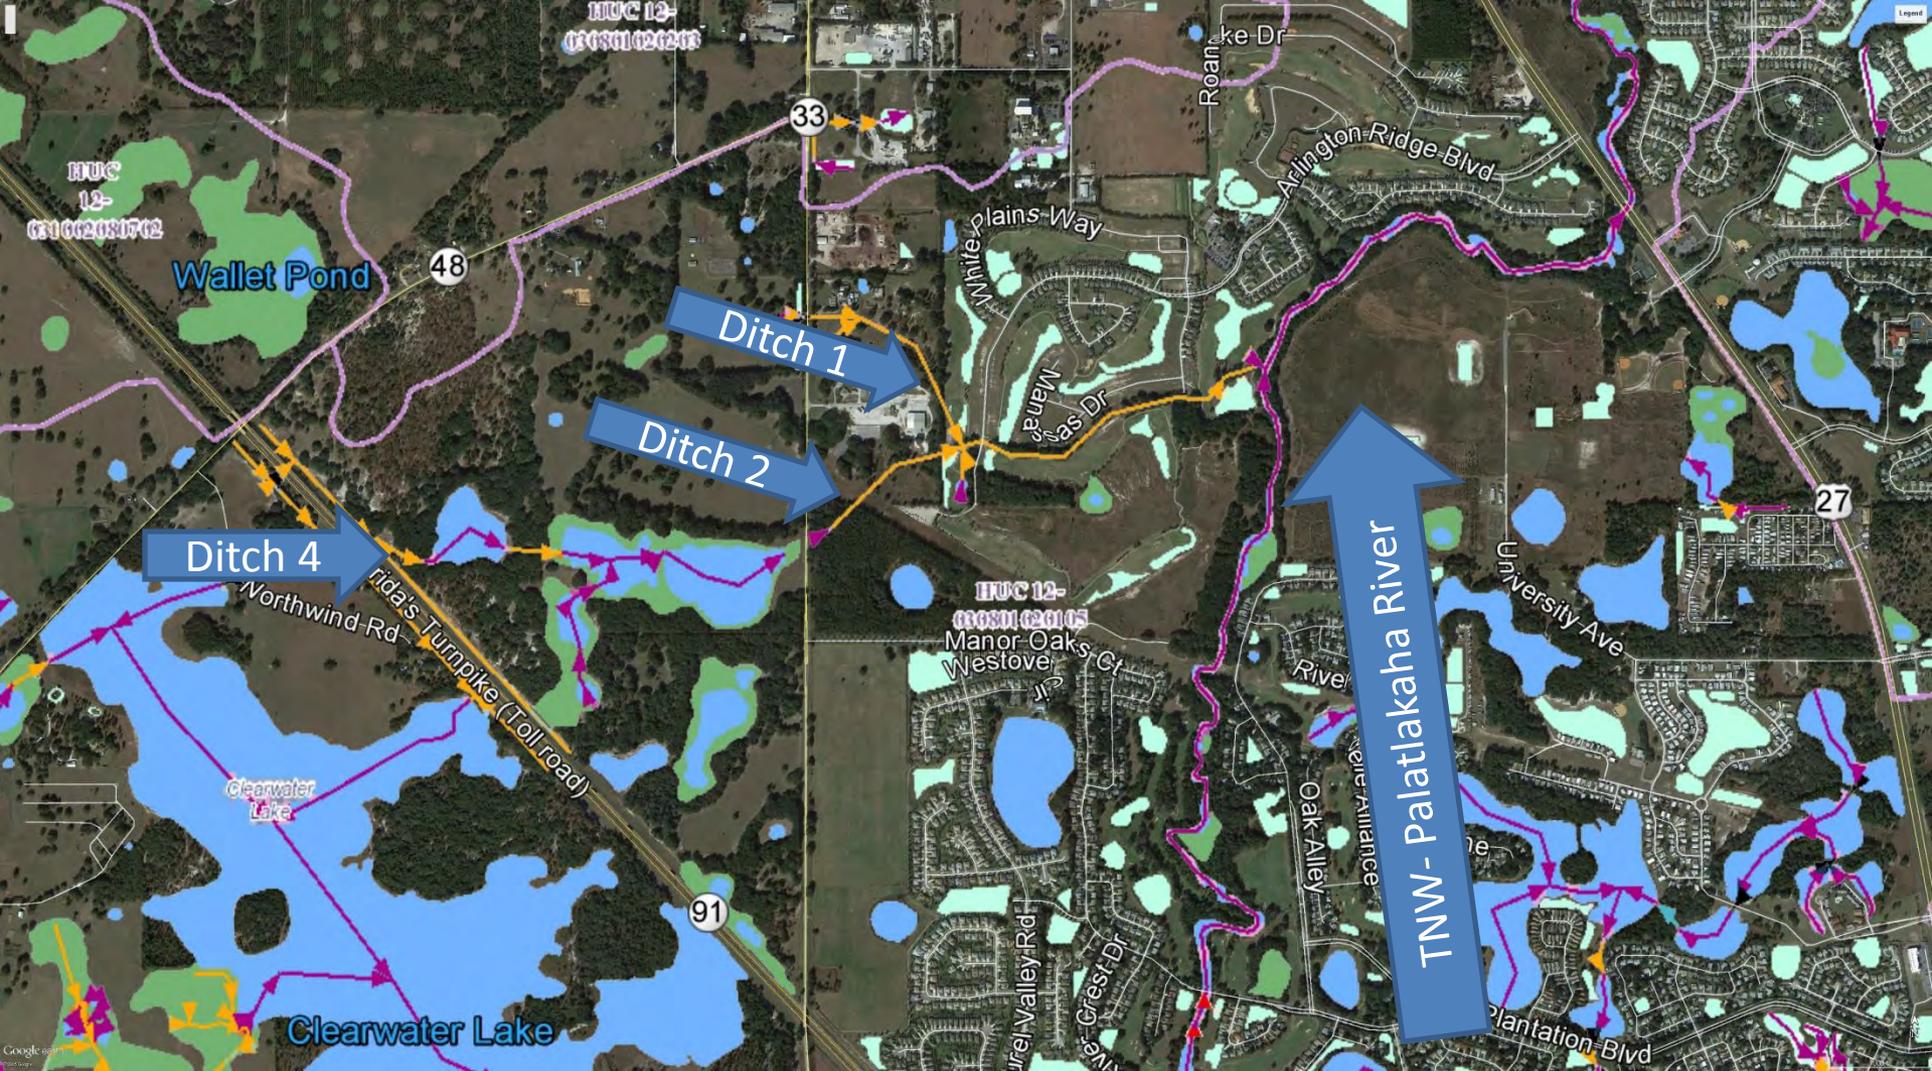
National Hydrologic Dataset showing flow pathways and NWI wetlands.

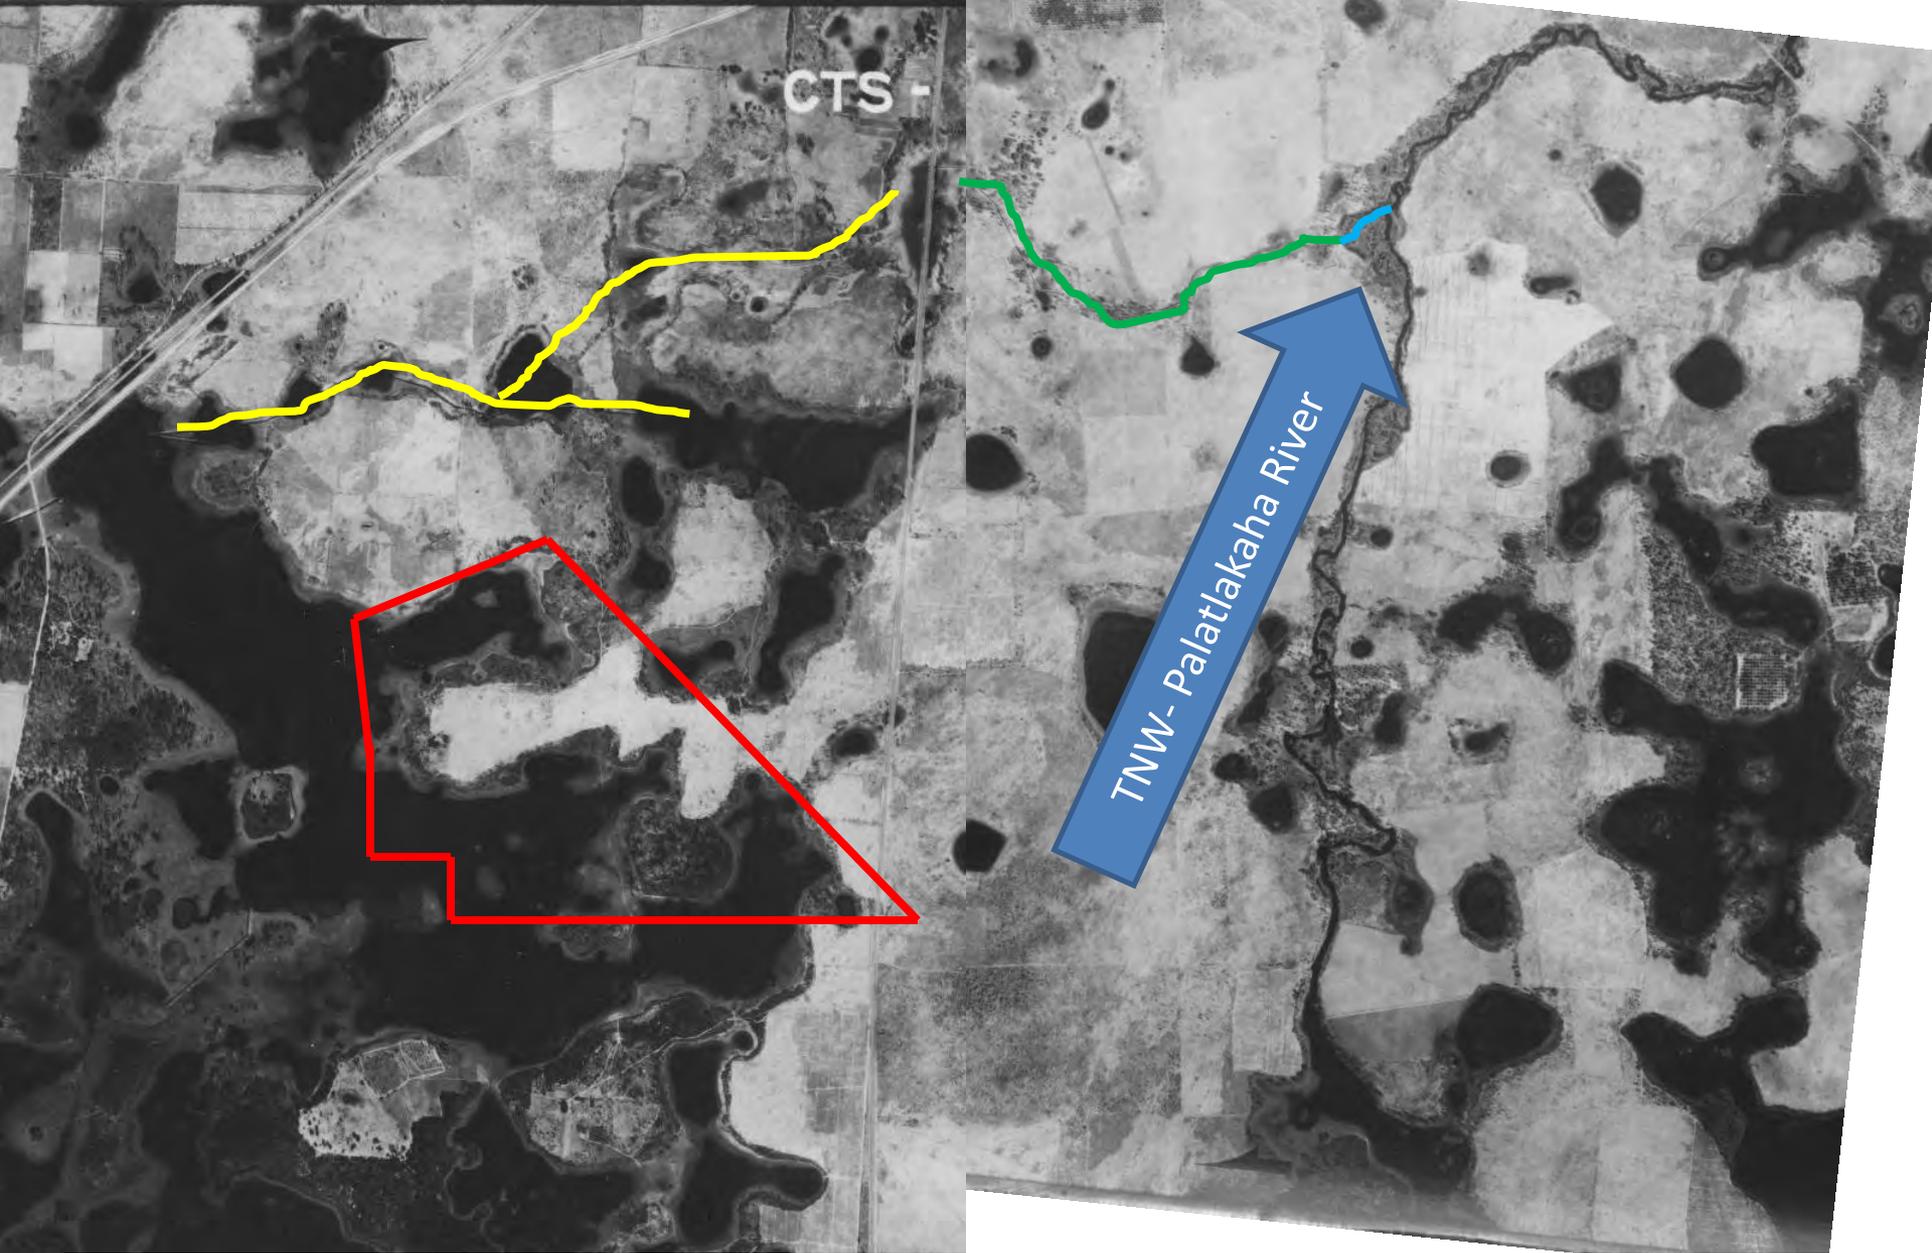
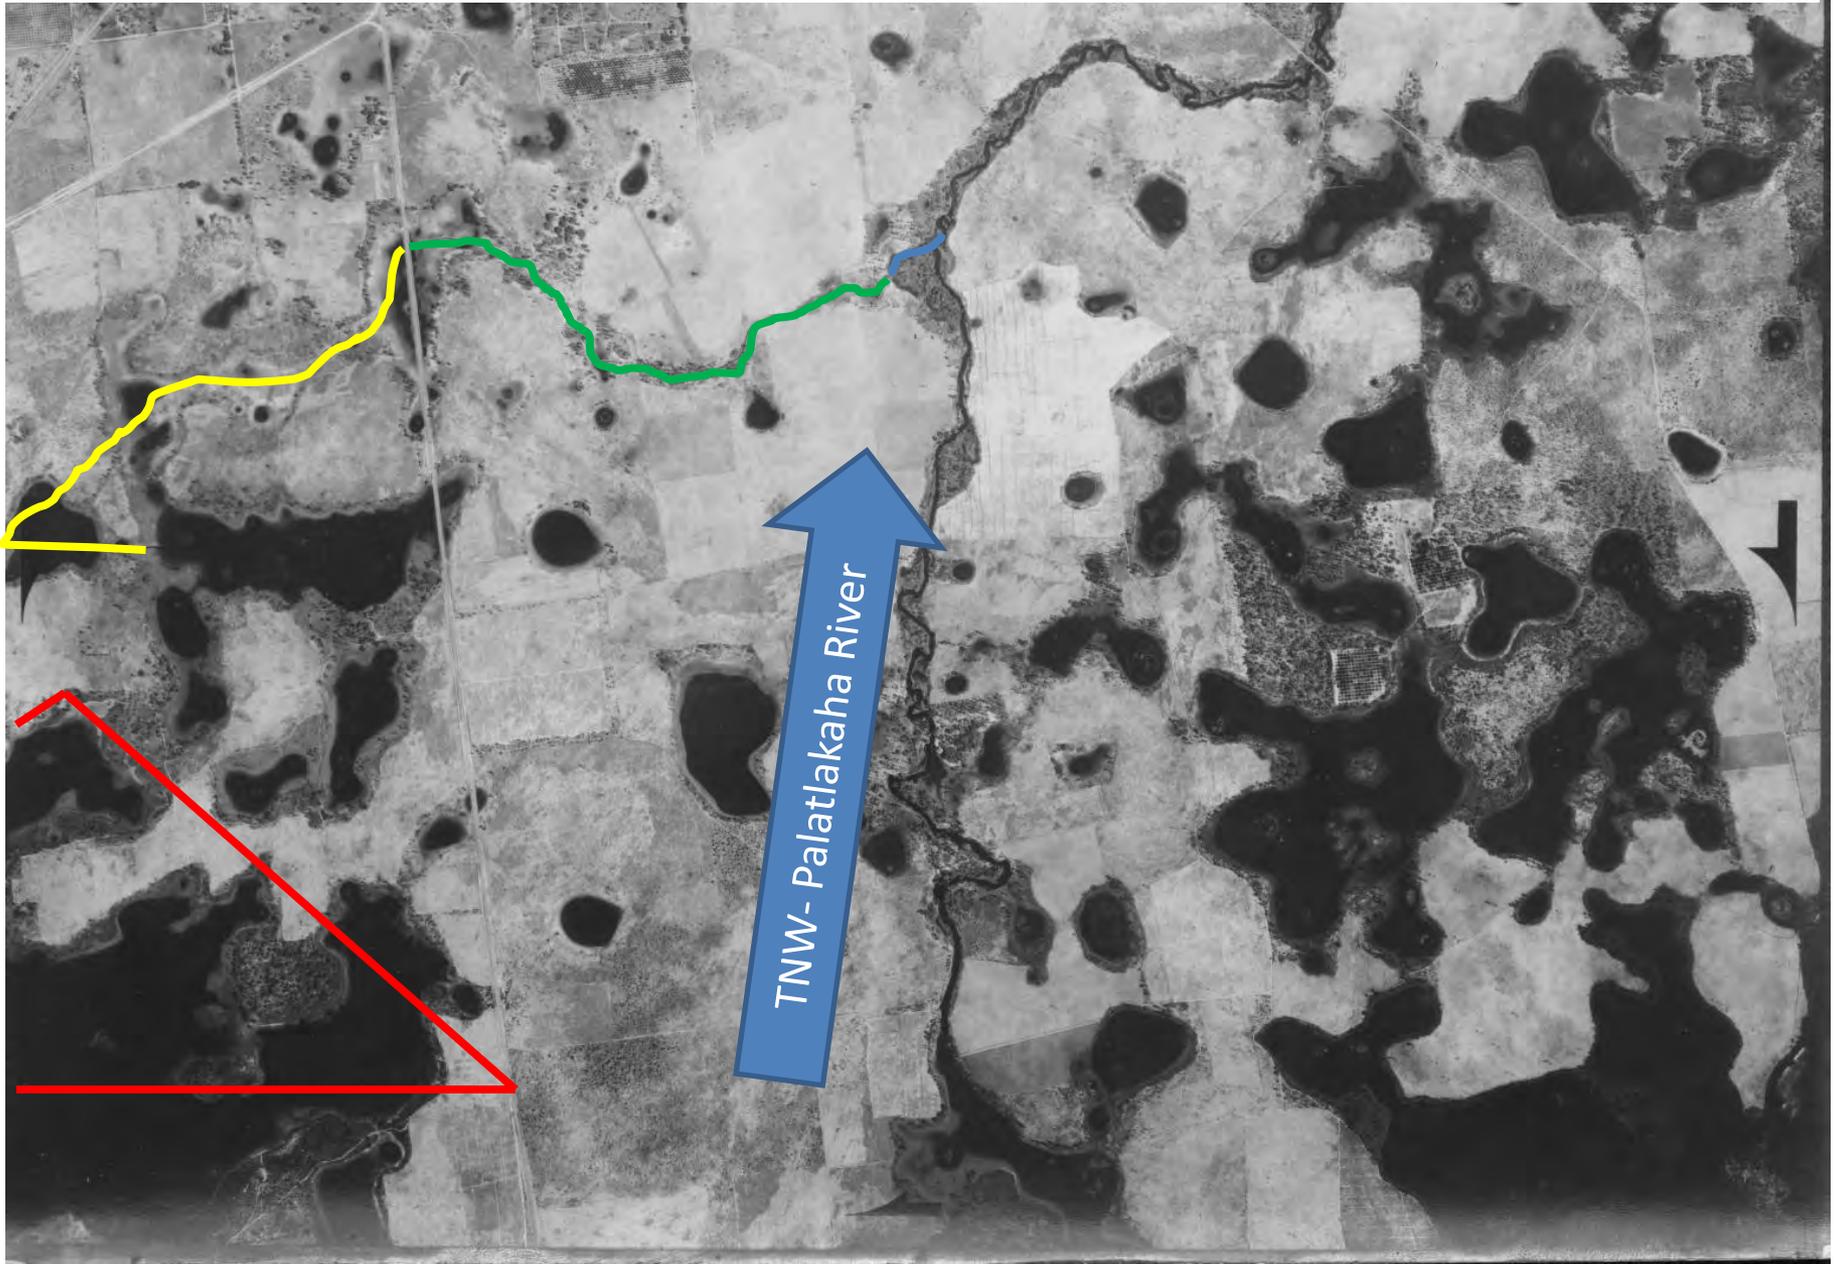
1941 Historic aerial photograph. The project site is outlined in red, Ditch 4 is shown in yellow, Ditch 1 is shown in green and RPW is shown in blue.

1941 Historic aerial photograph. The project site is outlined in red. Ditch 4 is shown in yellow, Ditch 1 is shown in green and RPW is shown in blue.

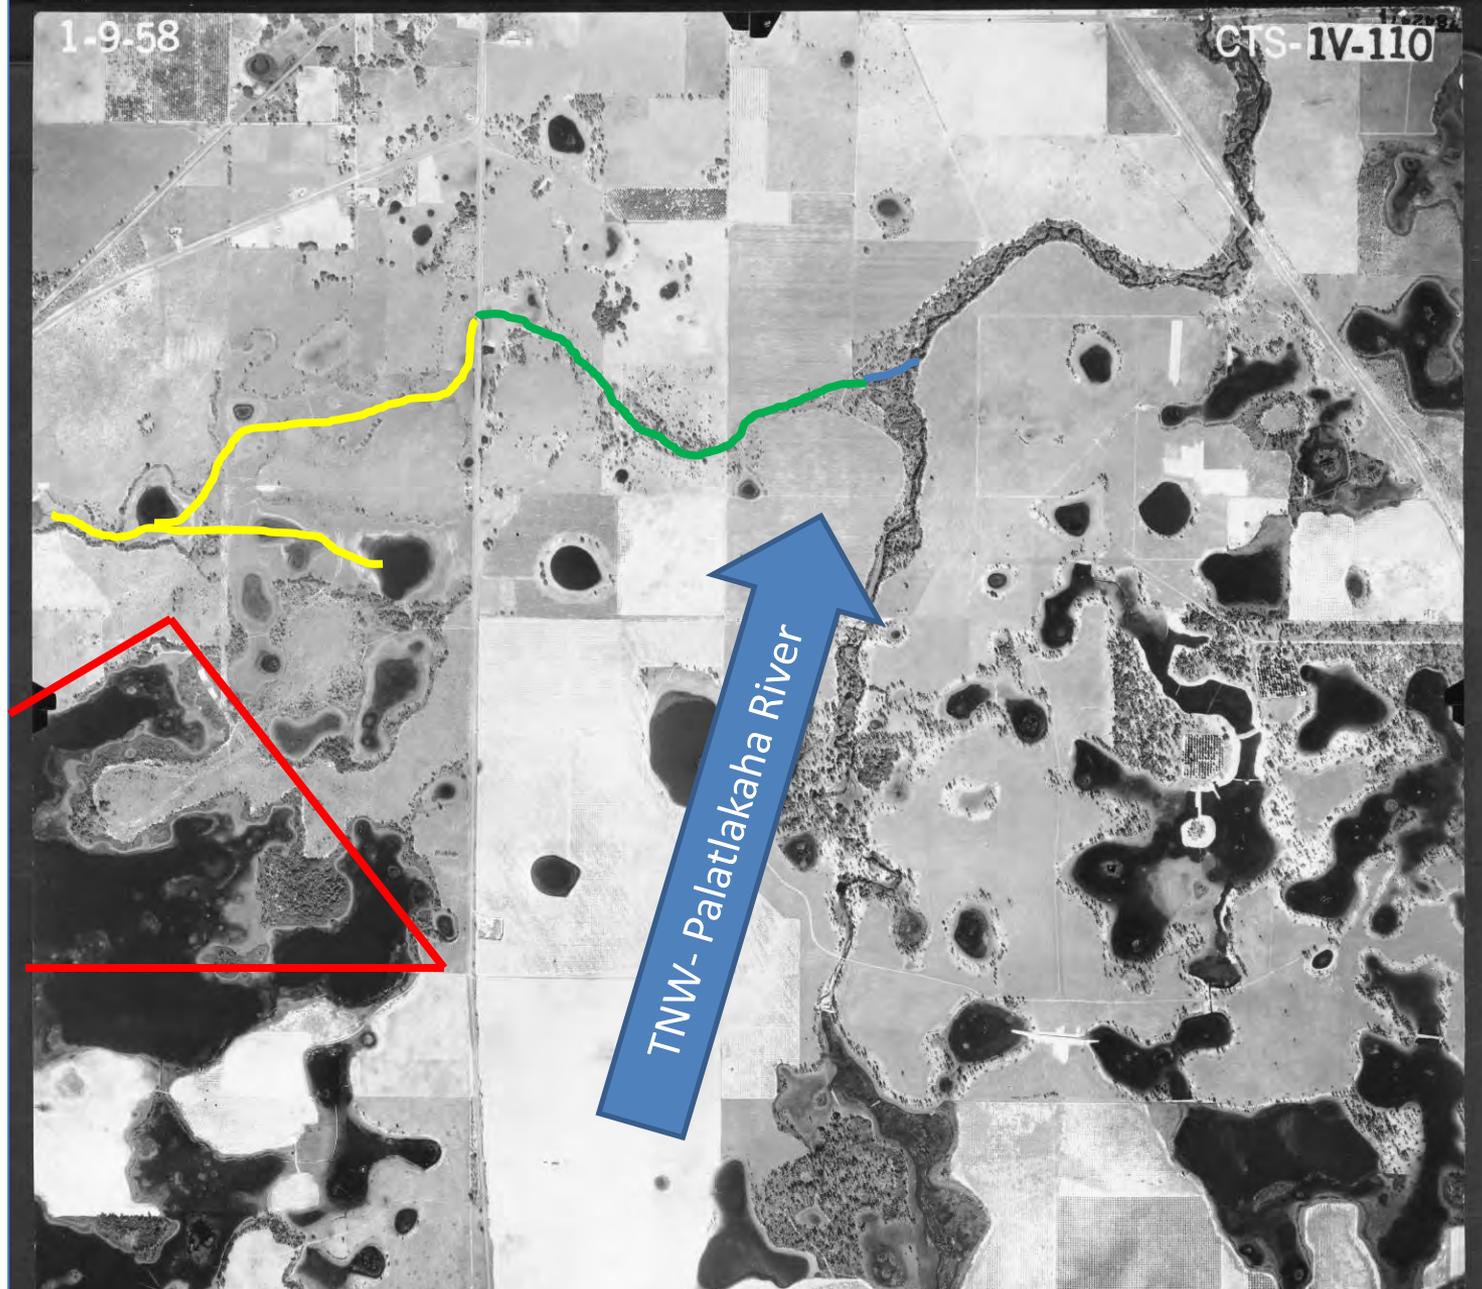
1958 Historic aerial photograph. The project site is outlined in red. Ditch 4 is shown in yellow, Ditch 1 is shown in green and RPW is shown in blue.

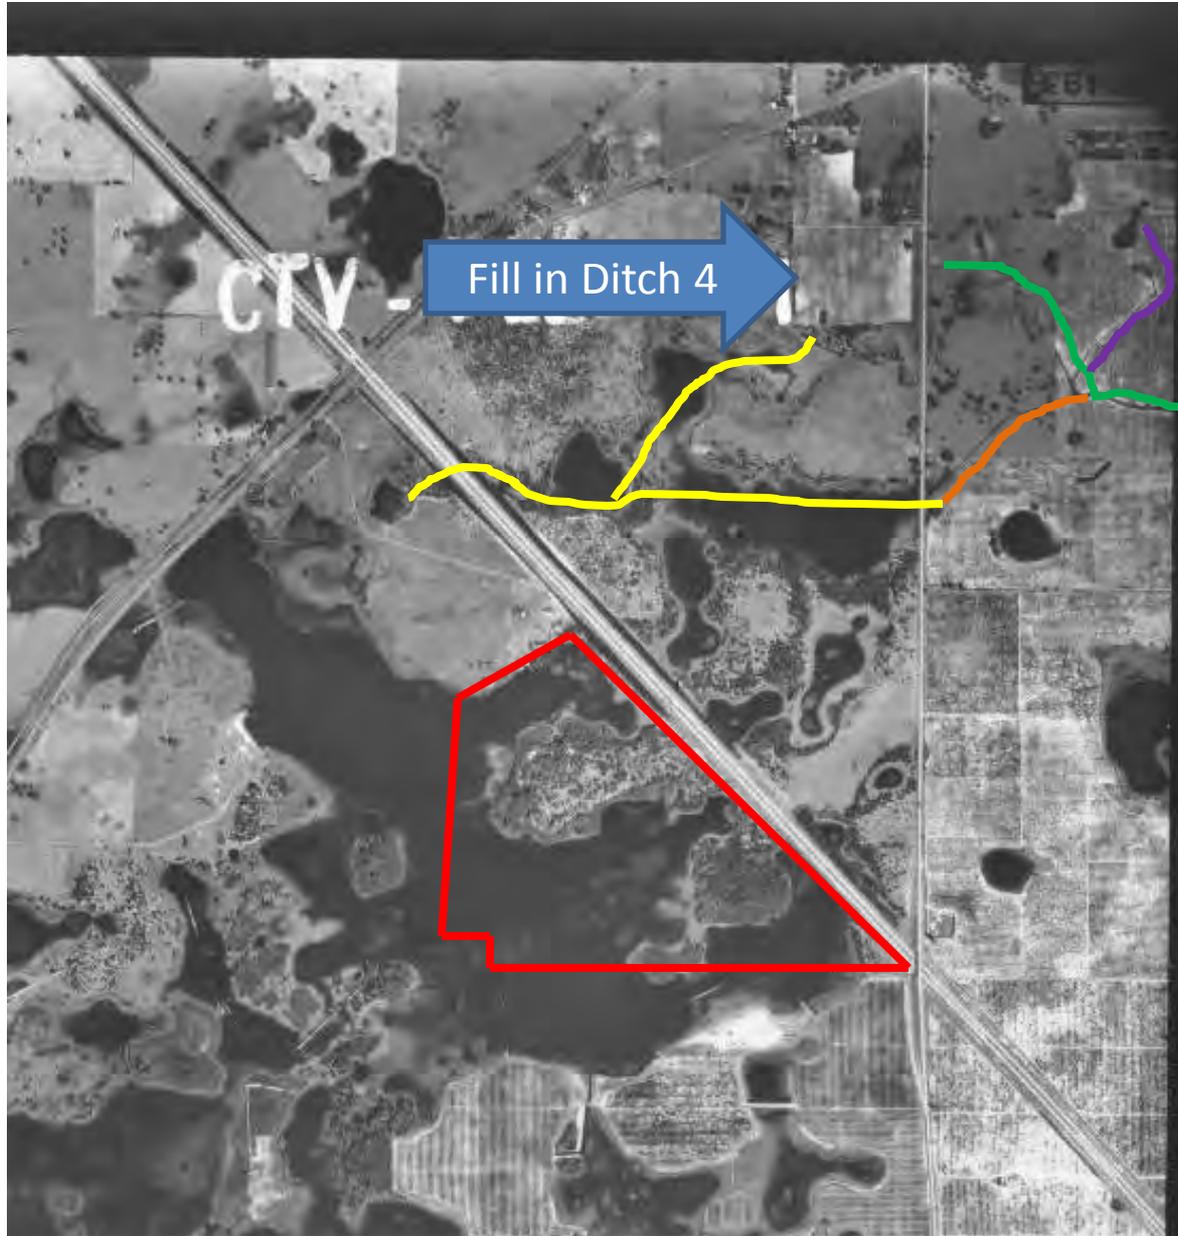
Tributary is: Natural
 Artificial (man-made). Explain:
 Manipulated (man-altered). Explain: Historic aerial photographs from 1969 indicate a ditch was excavated within the RPW.

1969 Historic aerial photograph. The project site is outlined in red, Ditch 4 is shown in yellow, Ditch 1 is shown in green, Ditch 2 is shown in orange and Ditch 3 is shown in purple.

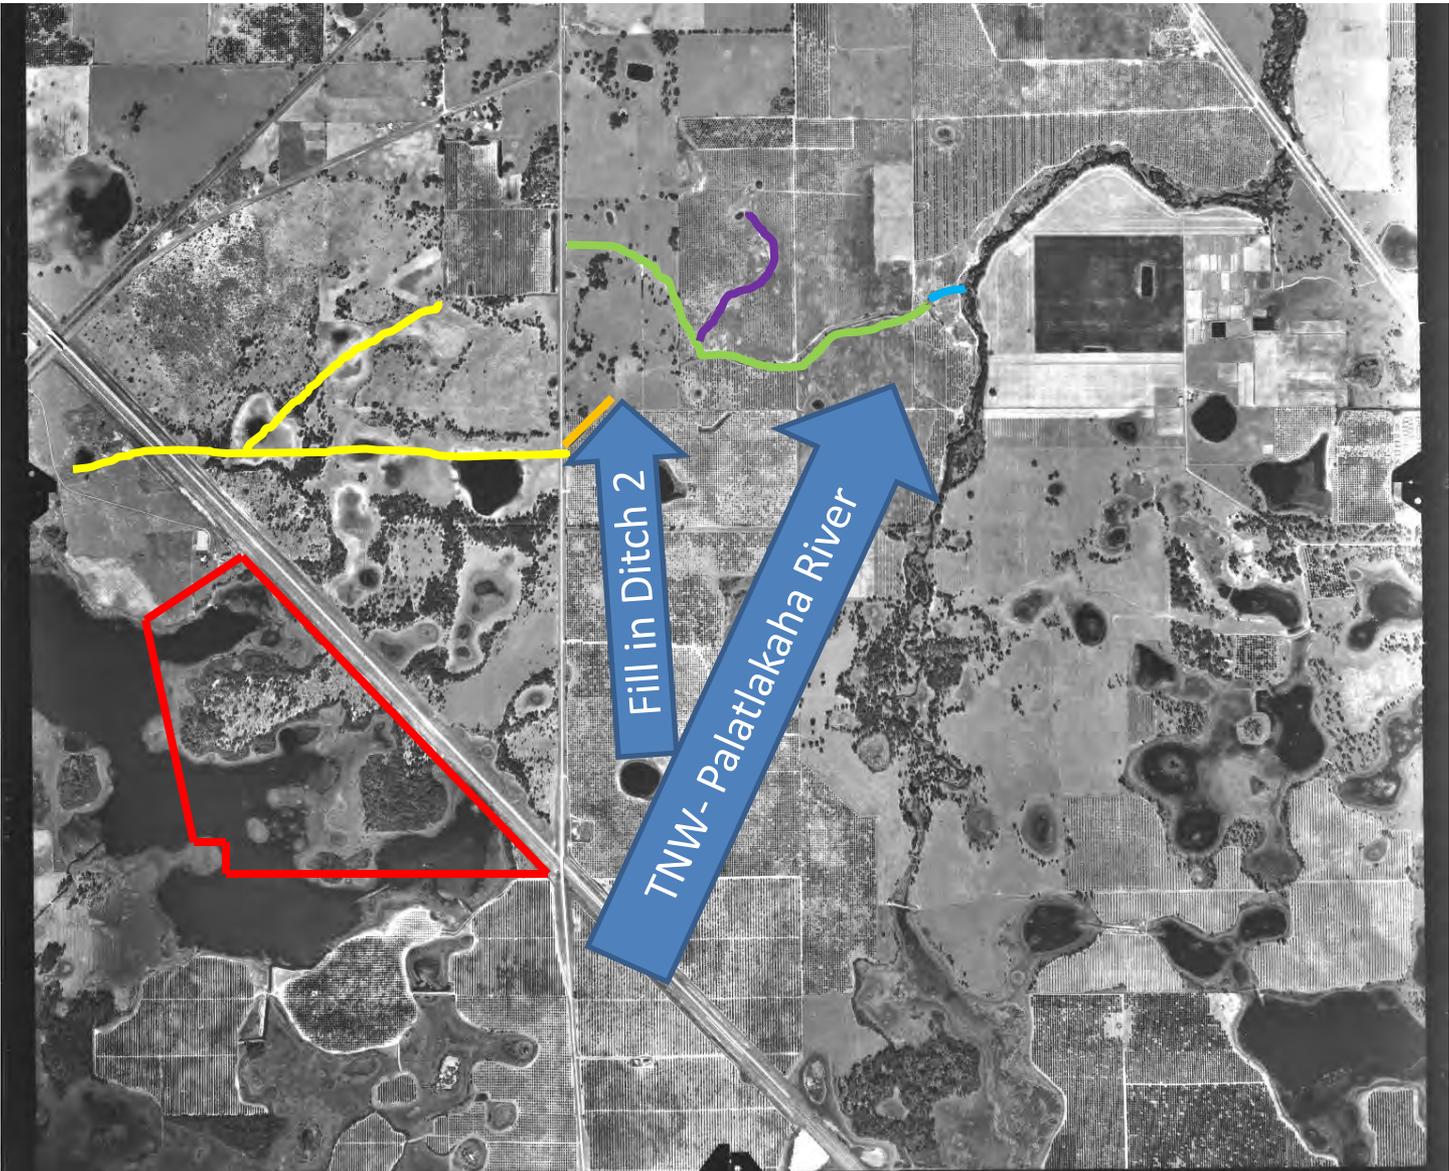
1974 Historic aerial photograph. The project site is outlined in red, Ditch 4 is shown in yellow, Ditch 1 is shown in green, Ditch 2 is shown in orange and Ditch 3 is shown in purple.

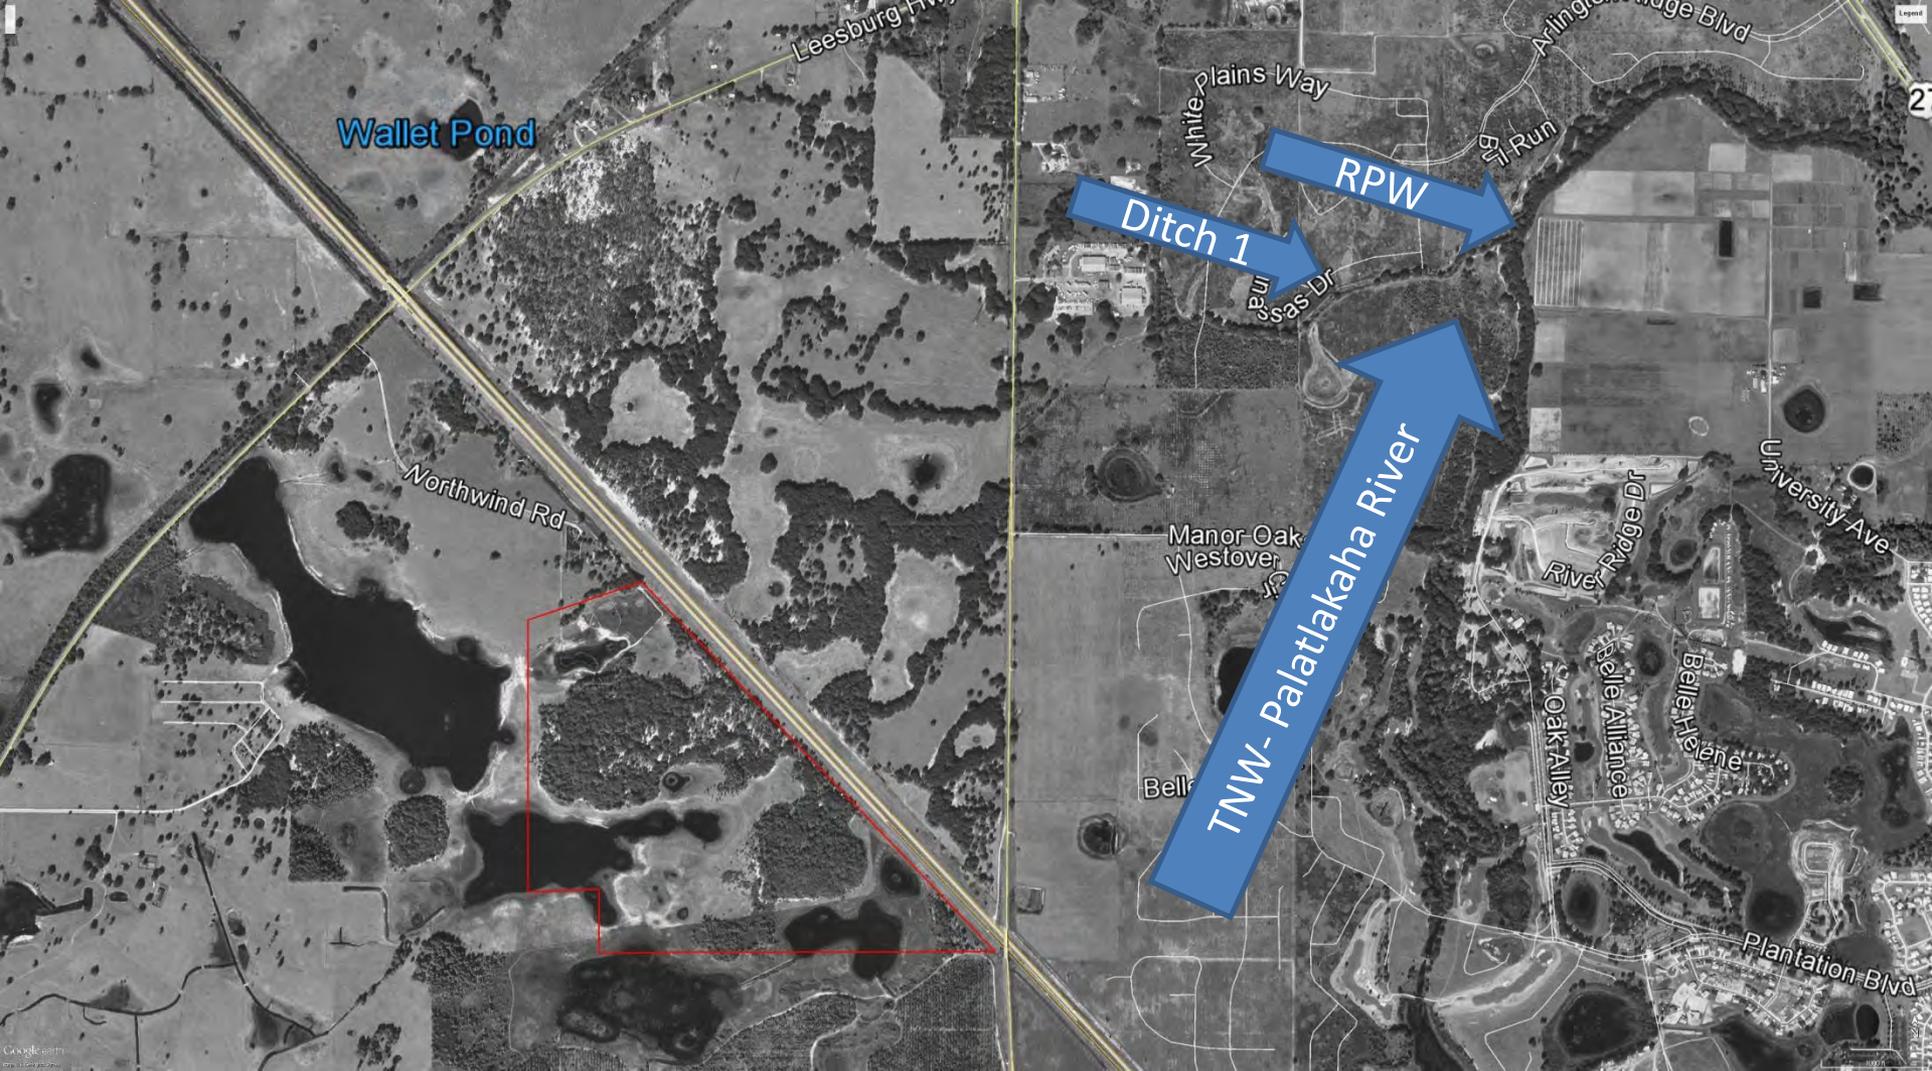
The project site is outlined in red. Aerial photograph from 1994.

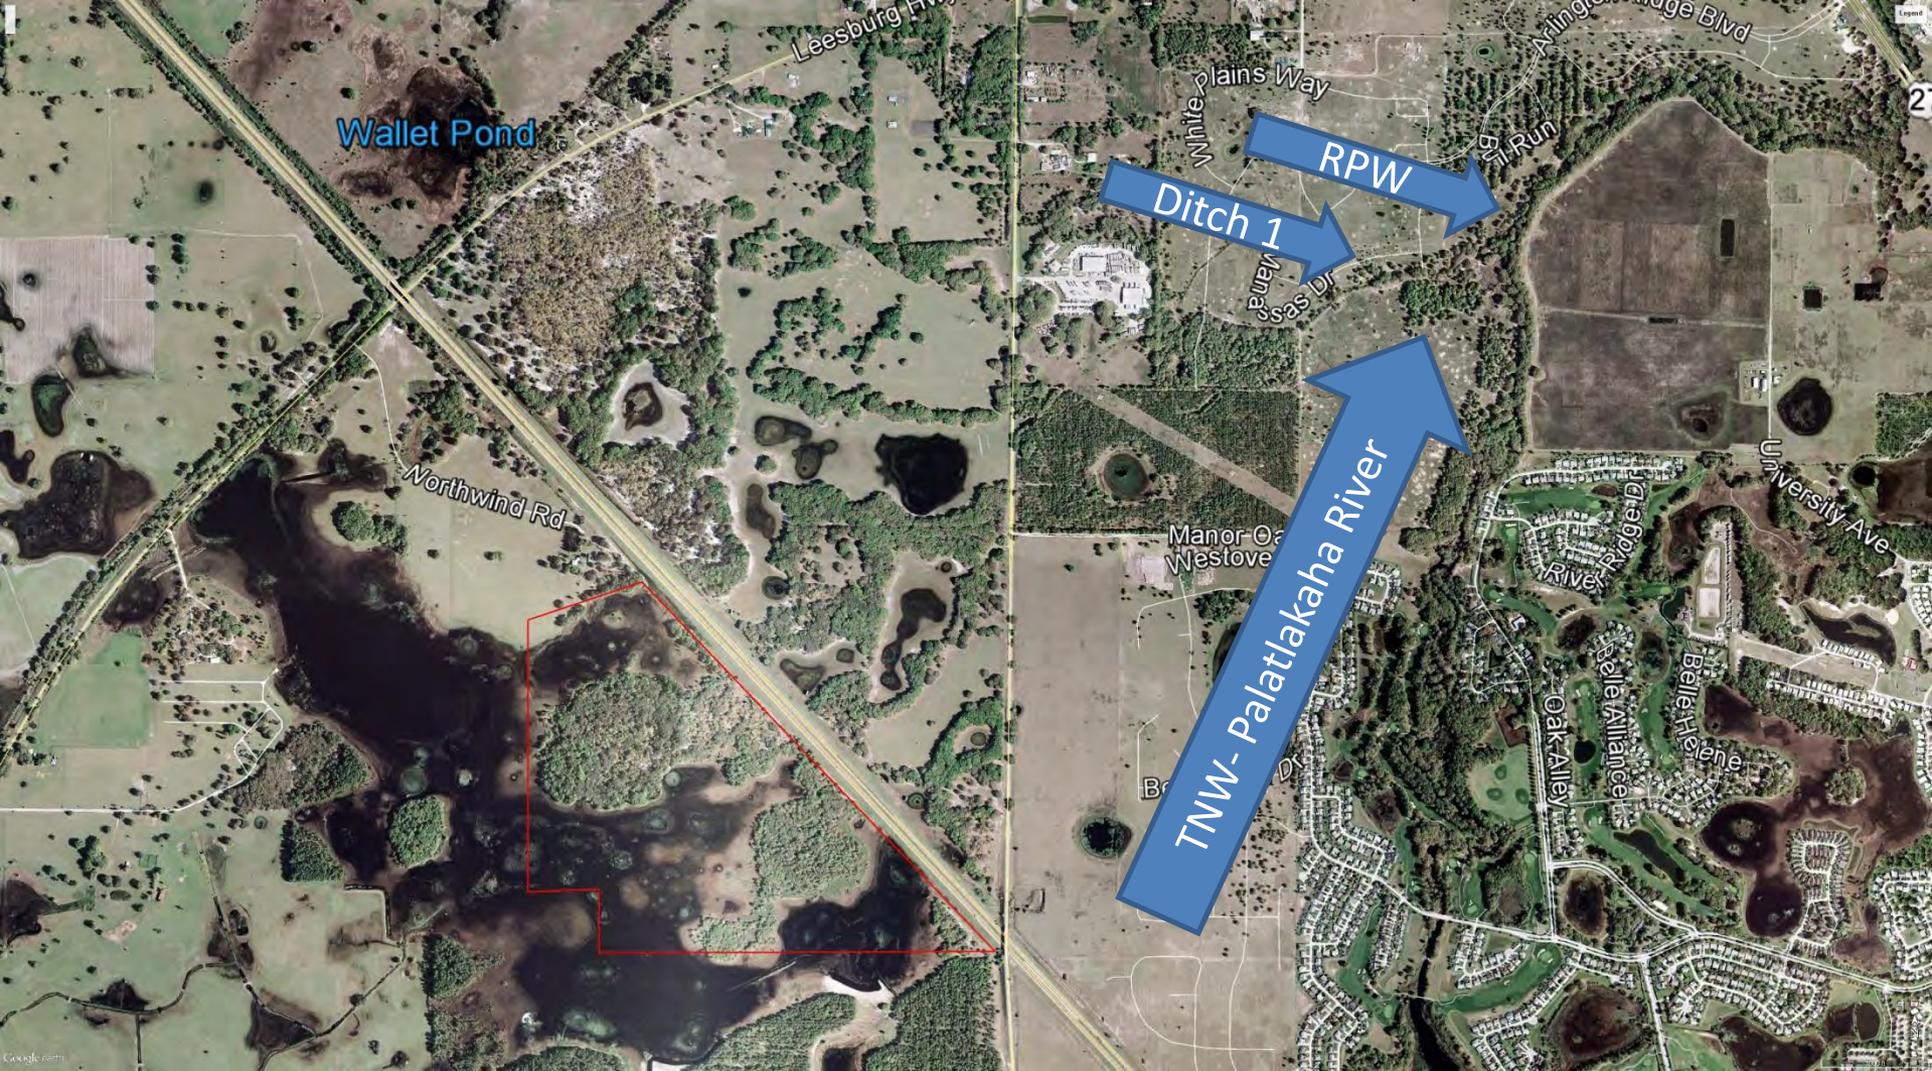
The project site is outlined in red. Aerial photograph from 2004.
