APPROVED JURISDICTIONAL DETERMINATION FORM
U.S. Army Corps of Engineers

B. DISTRICT OFFICE, FILE NAME, AND NUMBER: Jacksonville District; Jasil Majors Holdings, LLC/Clearwater Reserve; SAJ-2007-01817-SCW

Clearwater Reserve Phase II
 S27 T20S R24E
 S28 T20S R24E
 Lake County, Florida

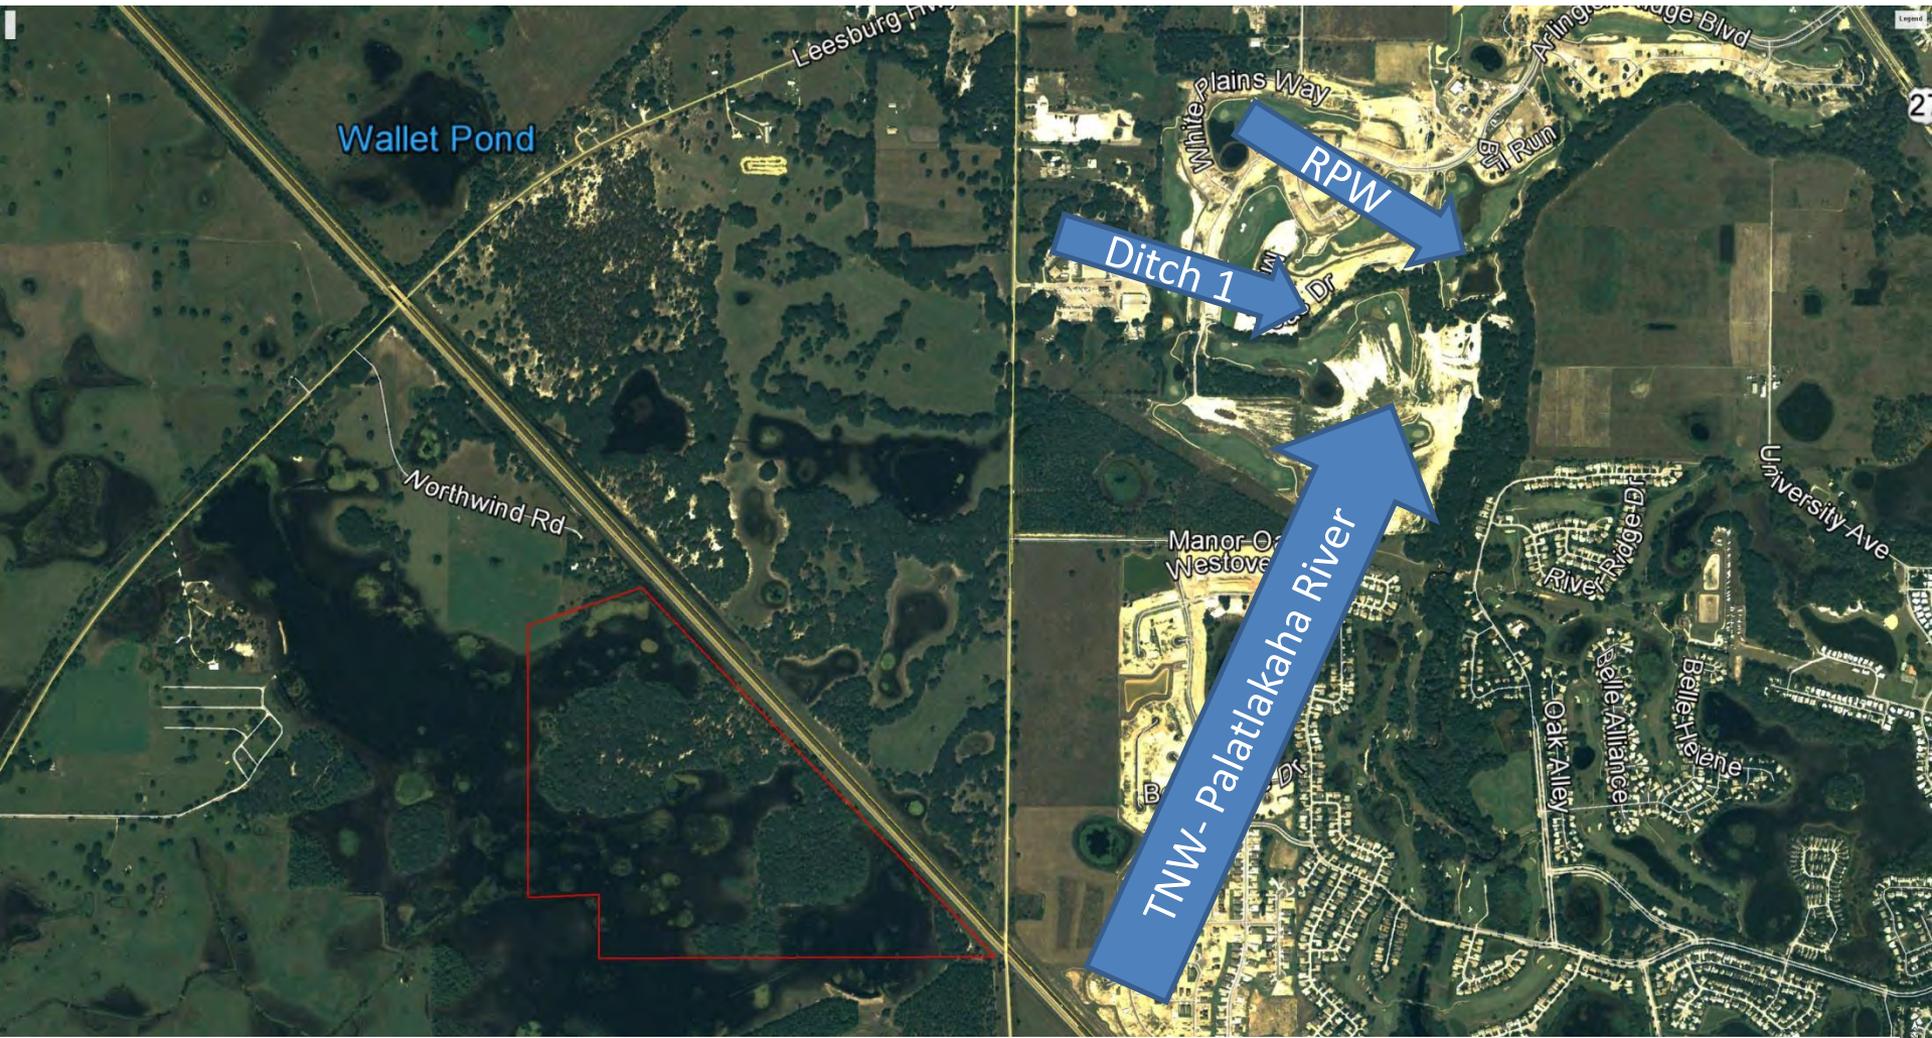
The project site is outlined in red. Aerial photograph from 2005.
