Naval Research Laboratory
Washington, DC 20375-5320 NRL/PU/6110--98-372

MTADS MAPPING AND ORDNANCE INVESTIGATION AT THE FORMER FT. PIERCE AMPHIBIOUS BASE

VERO BEACH, FLORIDA, MARCH 1998

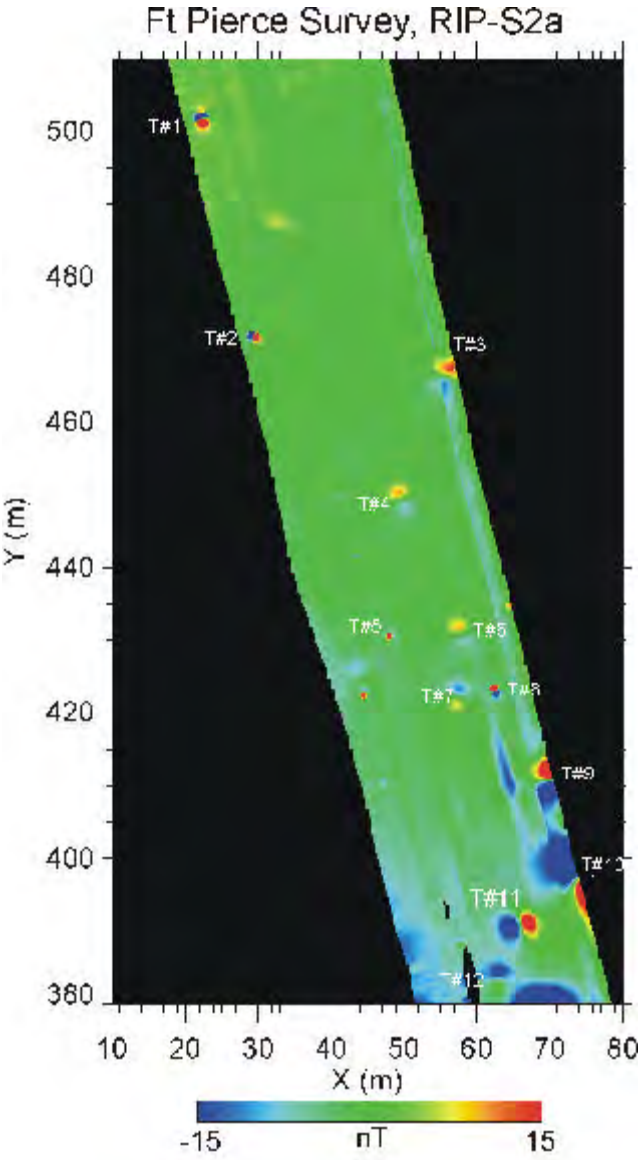
Figure 12. Dig Image showing targets selected from the north 125-meters of survey RIP-S2.

that include only M4 and M6 AT mines. About 20 targets were dug. No ordnance, or ordnance related items were discovered. This exhausted potential targets in this size range on these two sections.

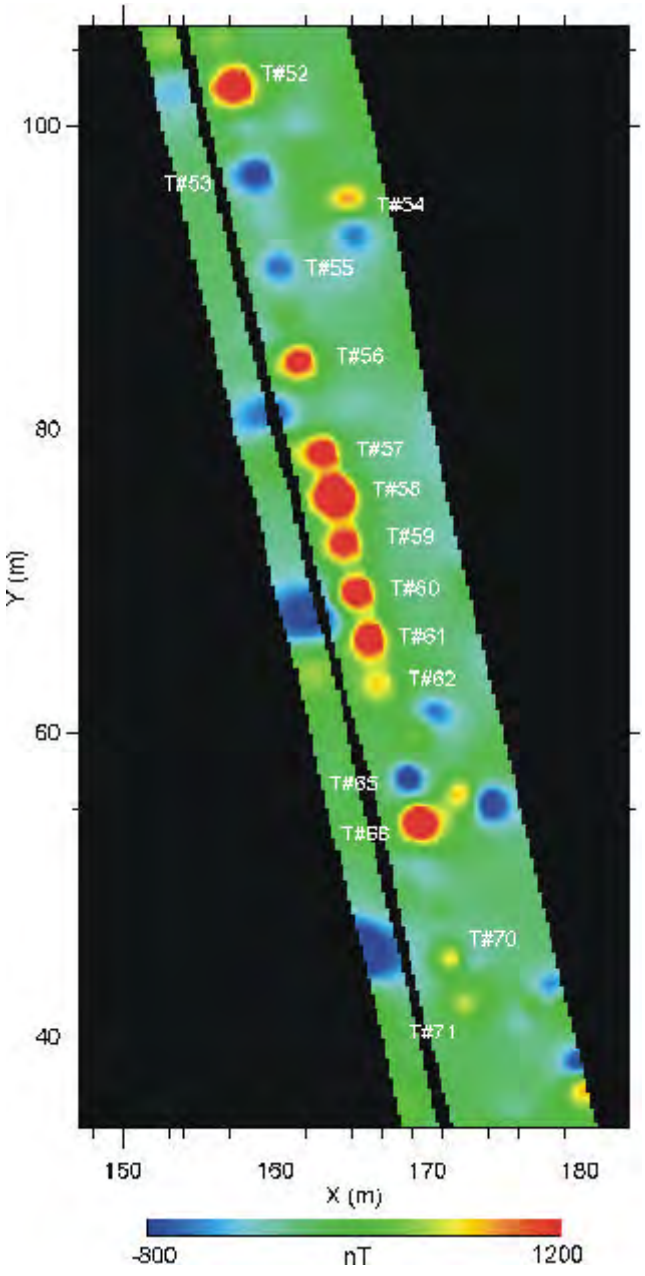
Figure 16. Magnetic anomaly image of a 35 meter long portion of RIP-S6 showing the layout of a row of beach obstacles.

The 85 remediated targets represent >18% of the total targets identified. Nineteen of the digging operations failed to locate the specified target or were abandoned because water upwelling into the holes made their completion impossible. None of the recovered items were ordnance or ordnance-related materials. The vast majority of all recovered items are materials associated with beach obstacles, primarily the horned scullys. The most massive targets were arranged in precise lines at fixed distances apart as shown in Fig. 16. All dug targets recovered fragments of

the original beach obstacles indicating that they had been explosively destroyed. It is almost certain that the explosives used were satchel charges because if the targets had been destroyed by explosive ordnance, frag and ordnance scrap would have been recovered in our operations.
