**Final
Hazardous, Toxic, and Radioactive Waste (HTRW)
Site Inspection Report
DERP-FUDS Site IO2PR006800
Former Lower Camp Debris Site
Culebra Island, Puerto Rico**

July 2012

Final
Hazardous, Toxic, and Radioactive Waste (HTRW)
Site Inspection Report
at DERP-FUDS Site IO2PR006800

Former Lower Camp Debris Site
Culebra Island, Puerto Rico

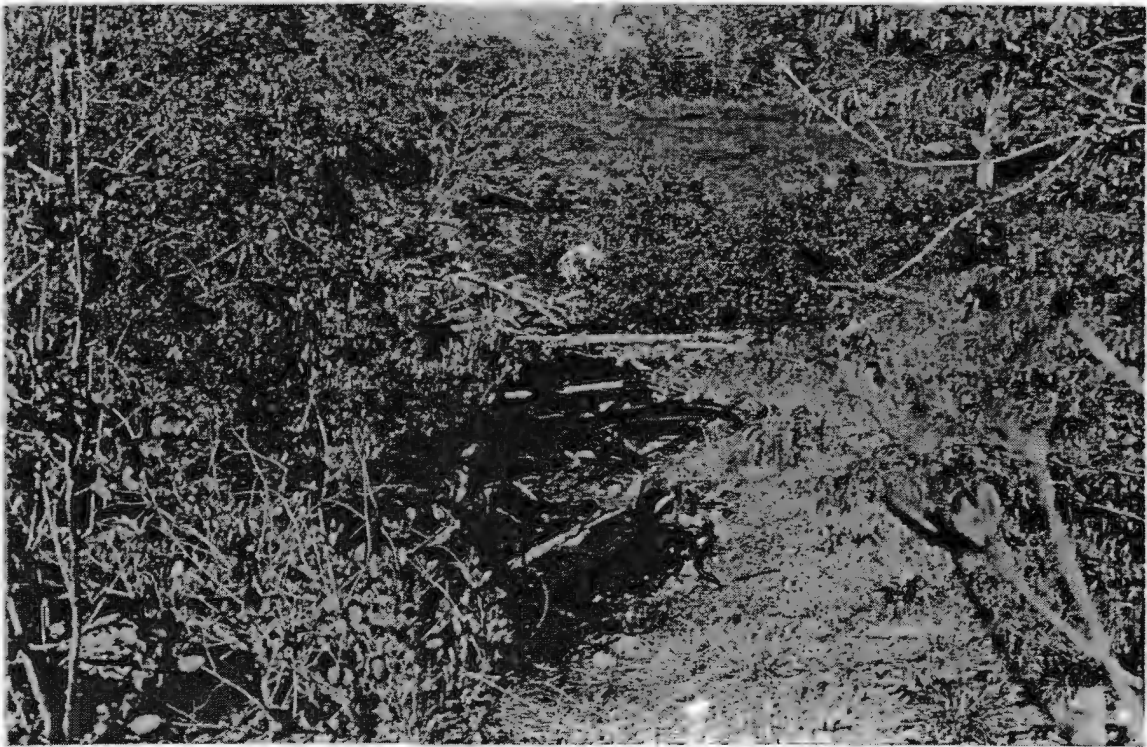
4. Culebra Island NWR (metal debris in wetland area)
