MAINTENANCE DREDGING FOR SUNSET POINT FARM LLC  
56195 OVERSEAS HIGHWAY  
MARATHON, MONROE COUNTY, FL

**MAINTENANCE DREDGE BENTHIC ASSESSMENT**  
**SUNSET POINT FARM LLC**  
**LONG POINT KEY**  
**MONROE COUNTY, FLORIDA**

December 11, 2016

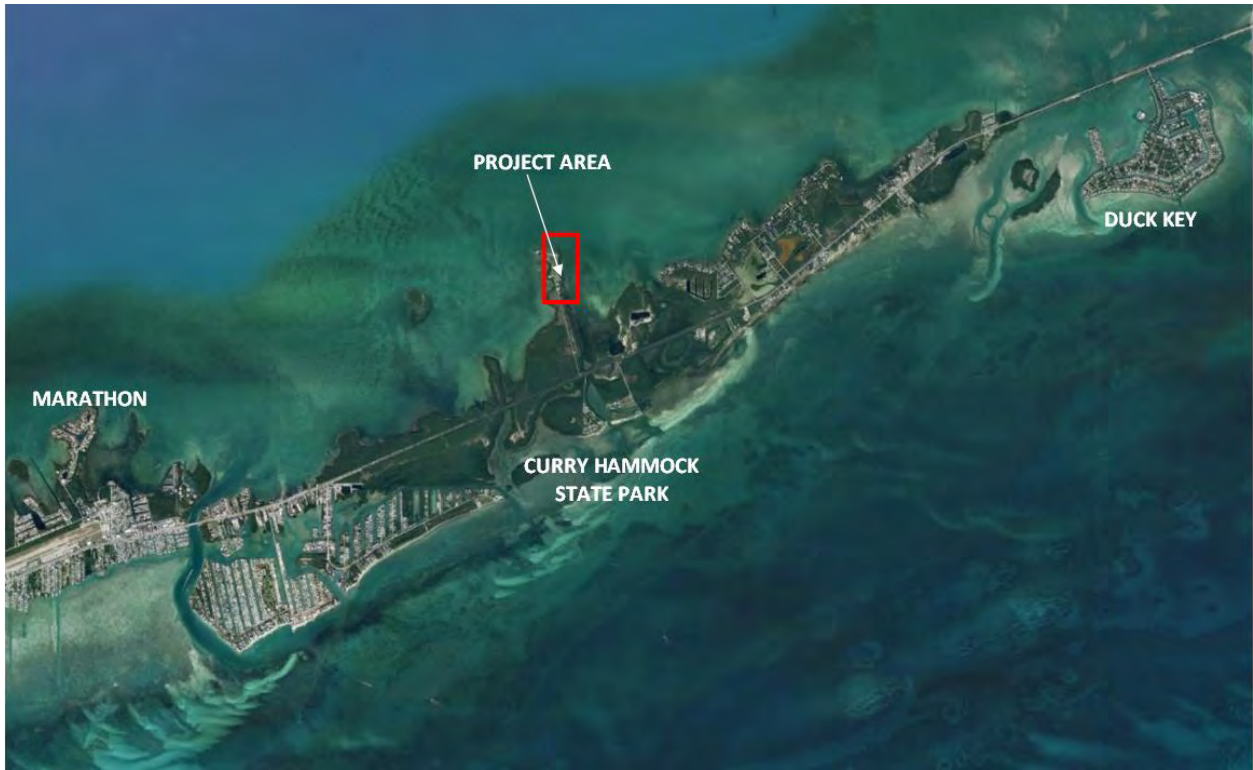
**Figure 1.** Aerial image indicating the location of proposed maintenance dredging at Sunset Point Farm LLC, Long Point Key, Monroe County, Florida.

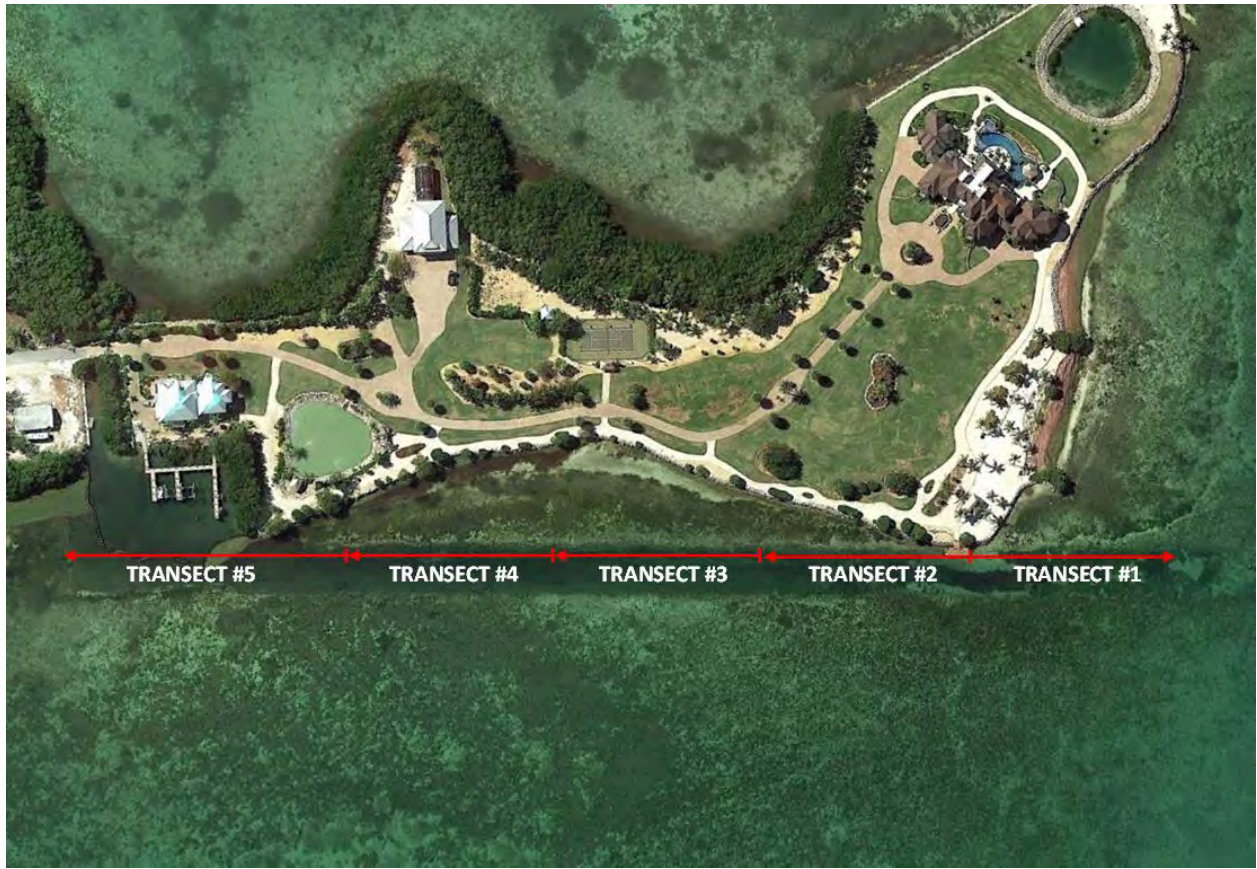
**Figure 2.** Aerial image indicating the location of the multiple 300ft primary transects deployed in order to assess the entire length of the 1500ft channel proposed for maintenance dredging at Sunset Point Farm LLC, Long Point Key, Monroe County, Florida.

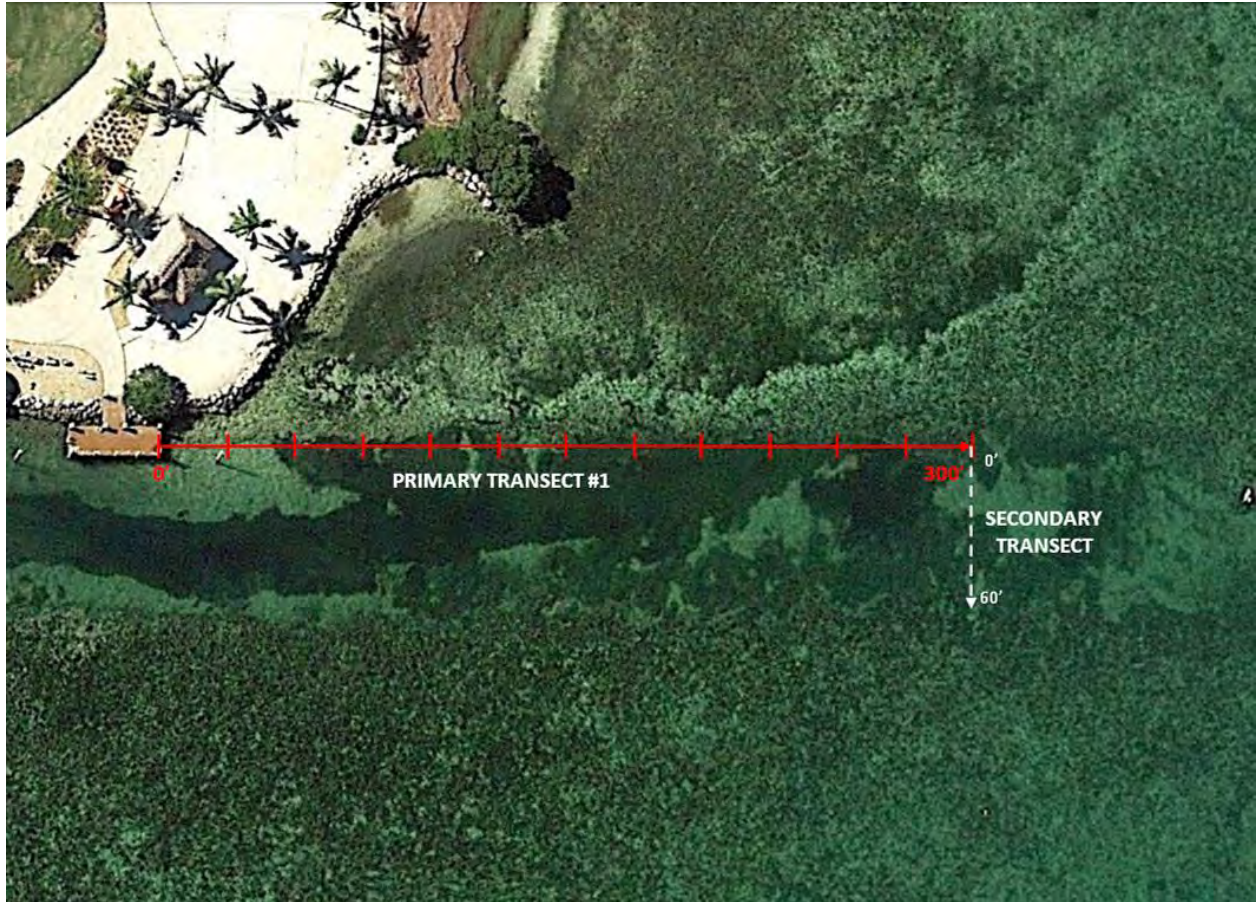
**Figure 3.** Aerial image indicating the location of primary and secondary transects deployed in order to assess each 300ft section of the channel proposed for maintenance dredging at Sunset Point Farm LLC, Long Point Key, Monroe County, Florida.
