**Hazardous, Toxic, and Radioactive Waste (HTRW)  
Site Inspection Report  
DERP-FUDS Site IO2PR006800**

**Former Lower Camp Debris Site  
Culebra Island, Puerto Rico**

December 2011

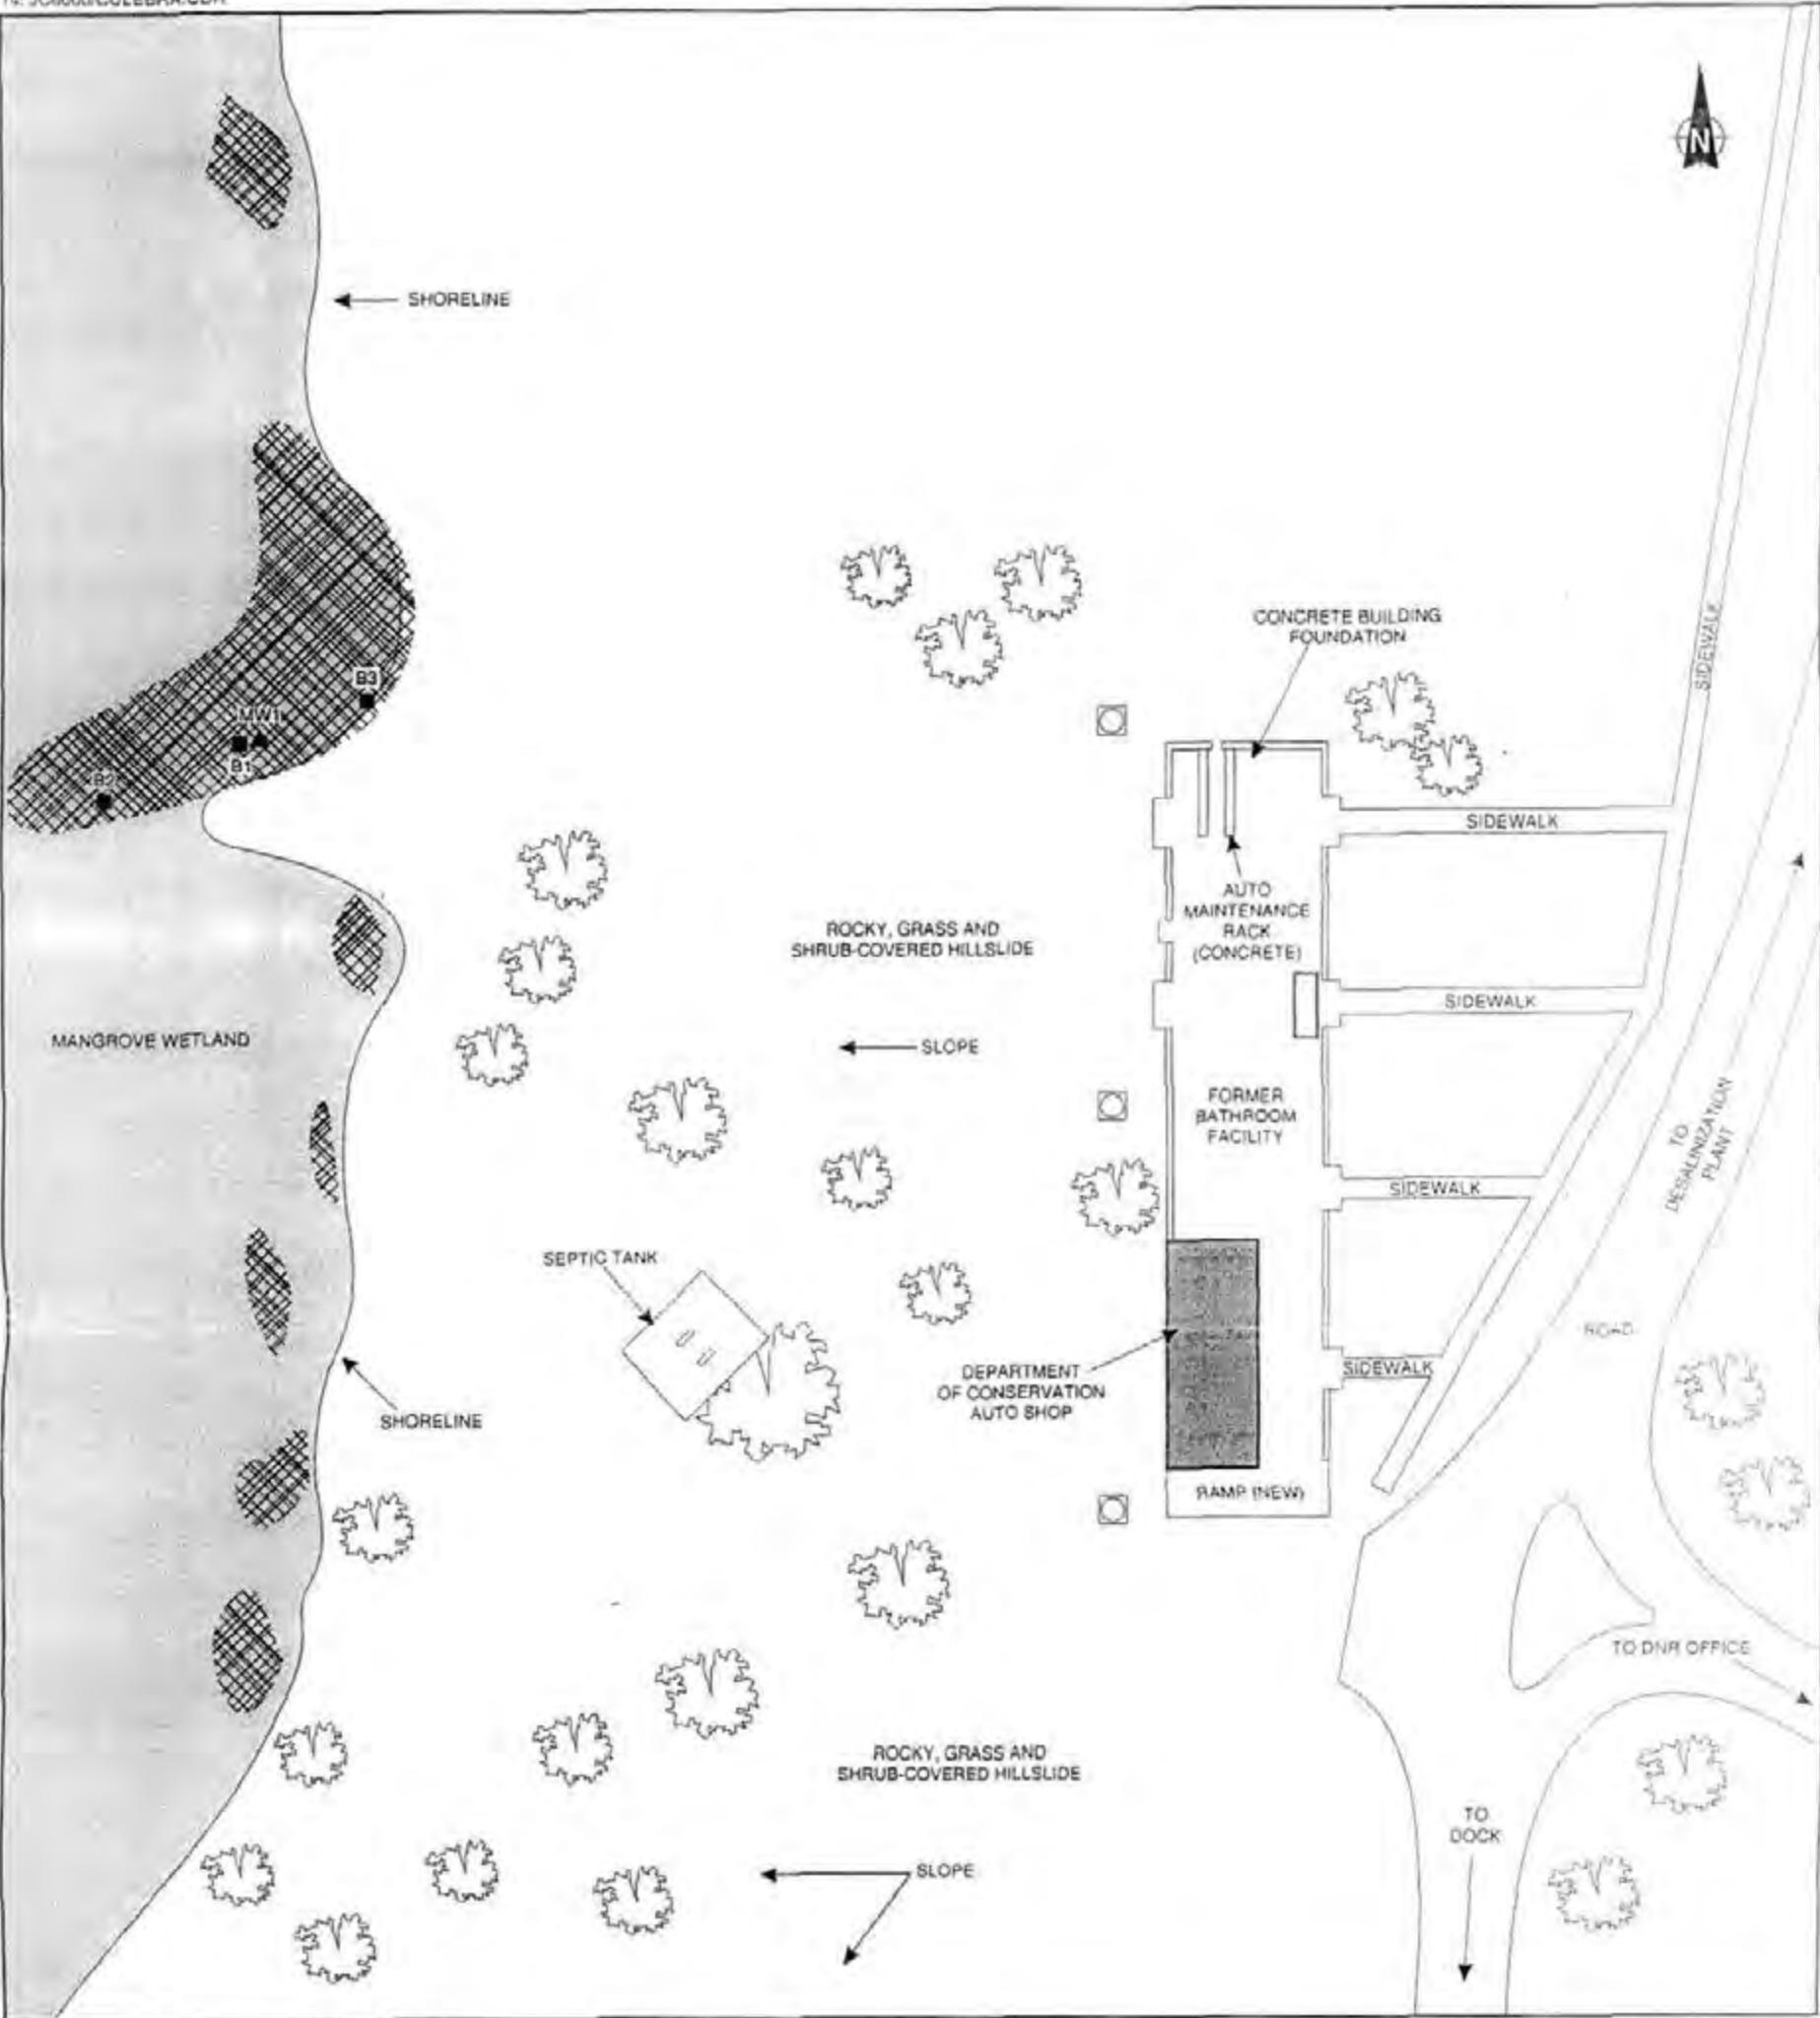
**FIGURE 1-4**  
**Site Map from 1996 Site Investigation by Ecology and Environment, Inc.**  
Former Lower Camp Debris Site  
Culebra, Puerto Rico

- Debris was scattered along approximately 400 feet of the shoreline and extended from 20 feet to 100 feet into the wetland.
- The highest concentration of debris encompassed an area of approximately 4,800 ft<sup>2</sup> (40 feet by 120 feet). The debris consists primarily of rusted metal building materials such as steel beams and reinforcing rods, corrugated steel sheeting, and bolts.

- Three soil borings (B-1, B-2, and B-3) were advanced within the wetland in an area of concentrated debris (see **Figure 1-4**). Boring B-1 was advanced to 4 feet below ground surface (bgs), and borings B-2 and B-3 were advanced to 2 feet bgs. Soil samples from the 0- to 2-foot intervals of soil borings B-1 and B-2 were collected for lithologic description, headspace screening, and chemical analysis. Composite soil samples were collected at 2-foot intervals from the ground surface to the boring completion depth. Soil samples were analyzed for the following: purgeable aromatic hydrocarbons, purgeable aromatic halocarbons, ethylene dibromide (EDB), polynuclear aromatic hydrocarbons (PAHs), total recoverable petroleum hydrocarbons (TRPHs), and eight metals (lead, arsenic, cadmium, chromium, barium, selenium, silver, and mercury).

Information regarding the type, location, and extent of debris currently at the site indicates the debris piles identified in the 1996 SI are still present, as well as an additional debris pile approximately 50 feet north of the northernmost debris pile shown on **Figure 1-4**.

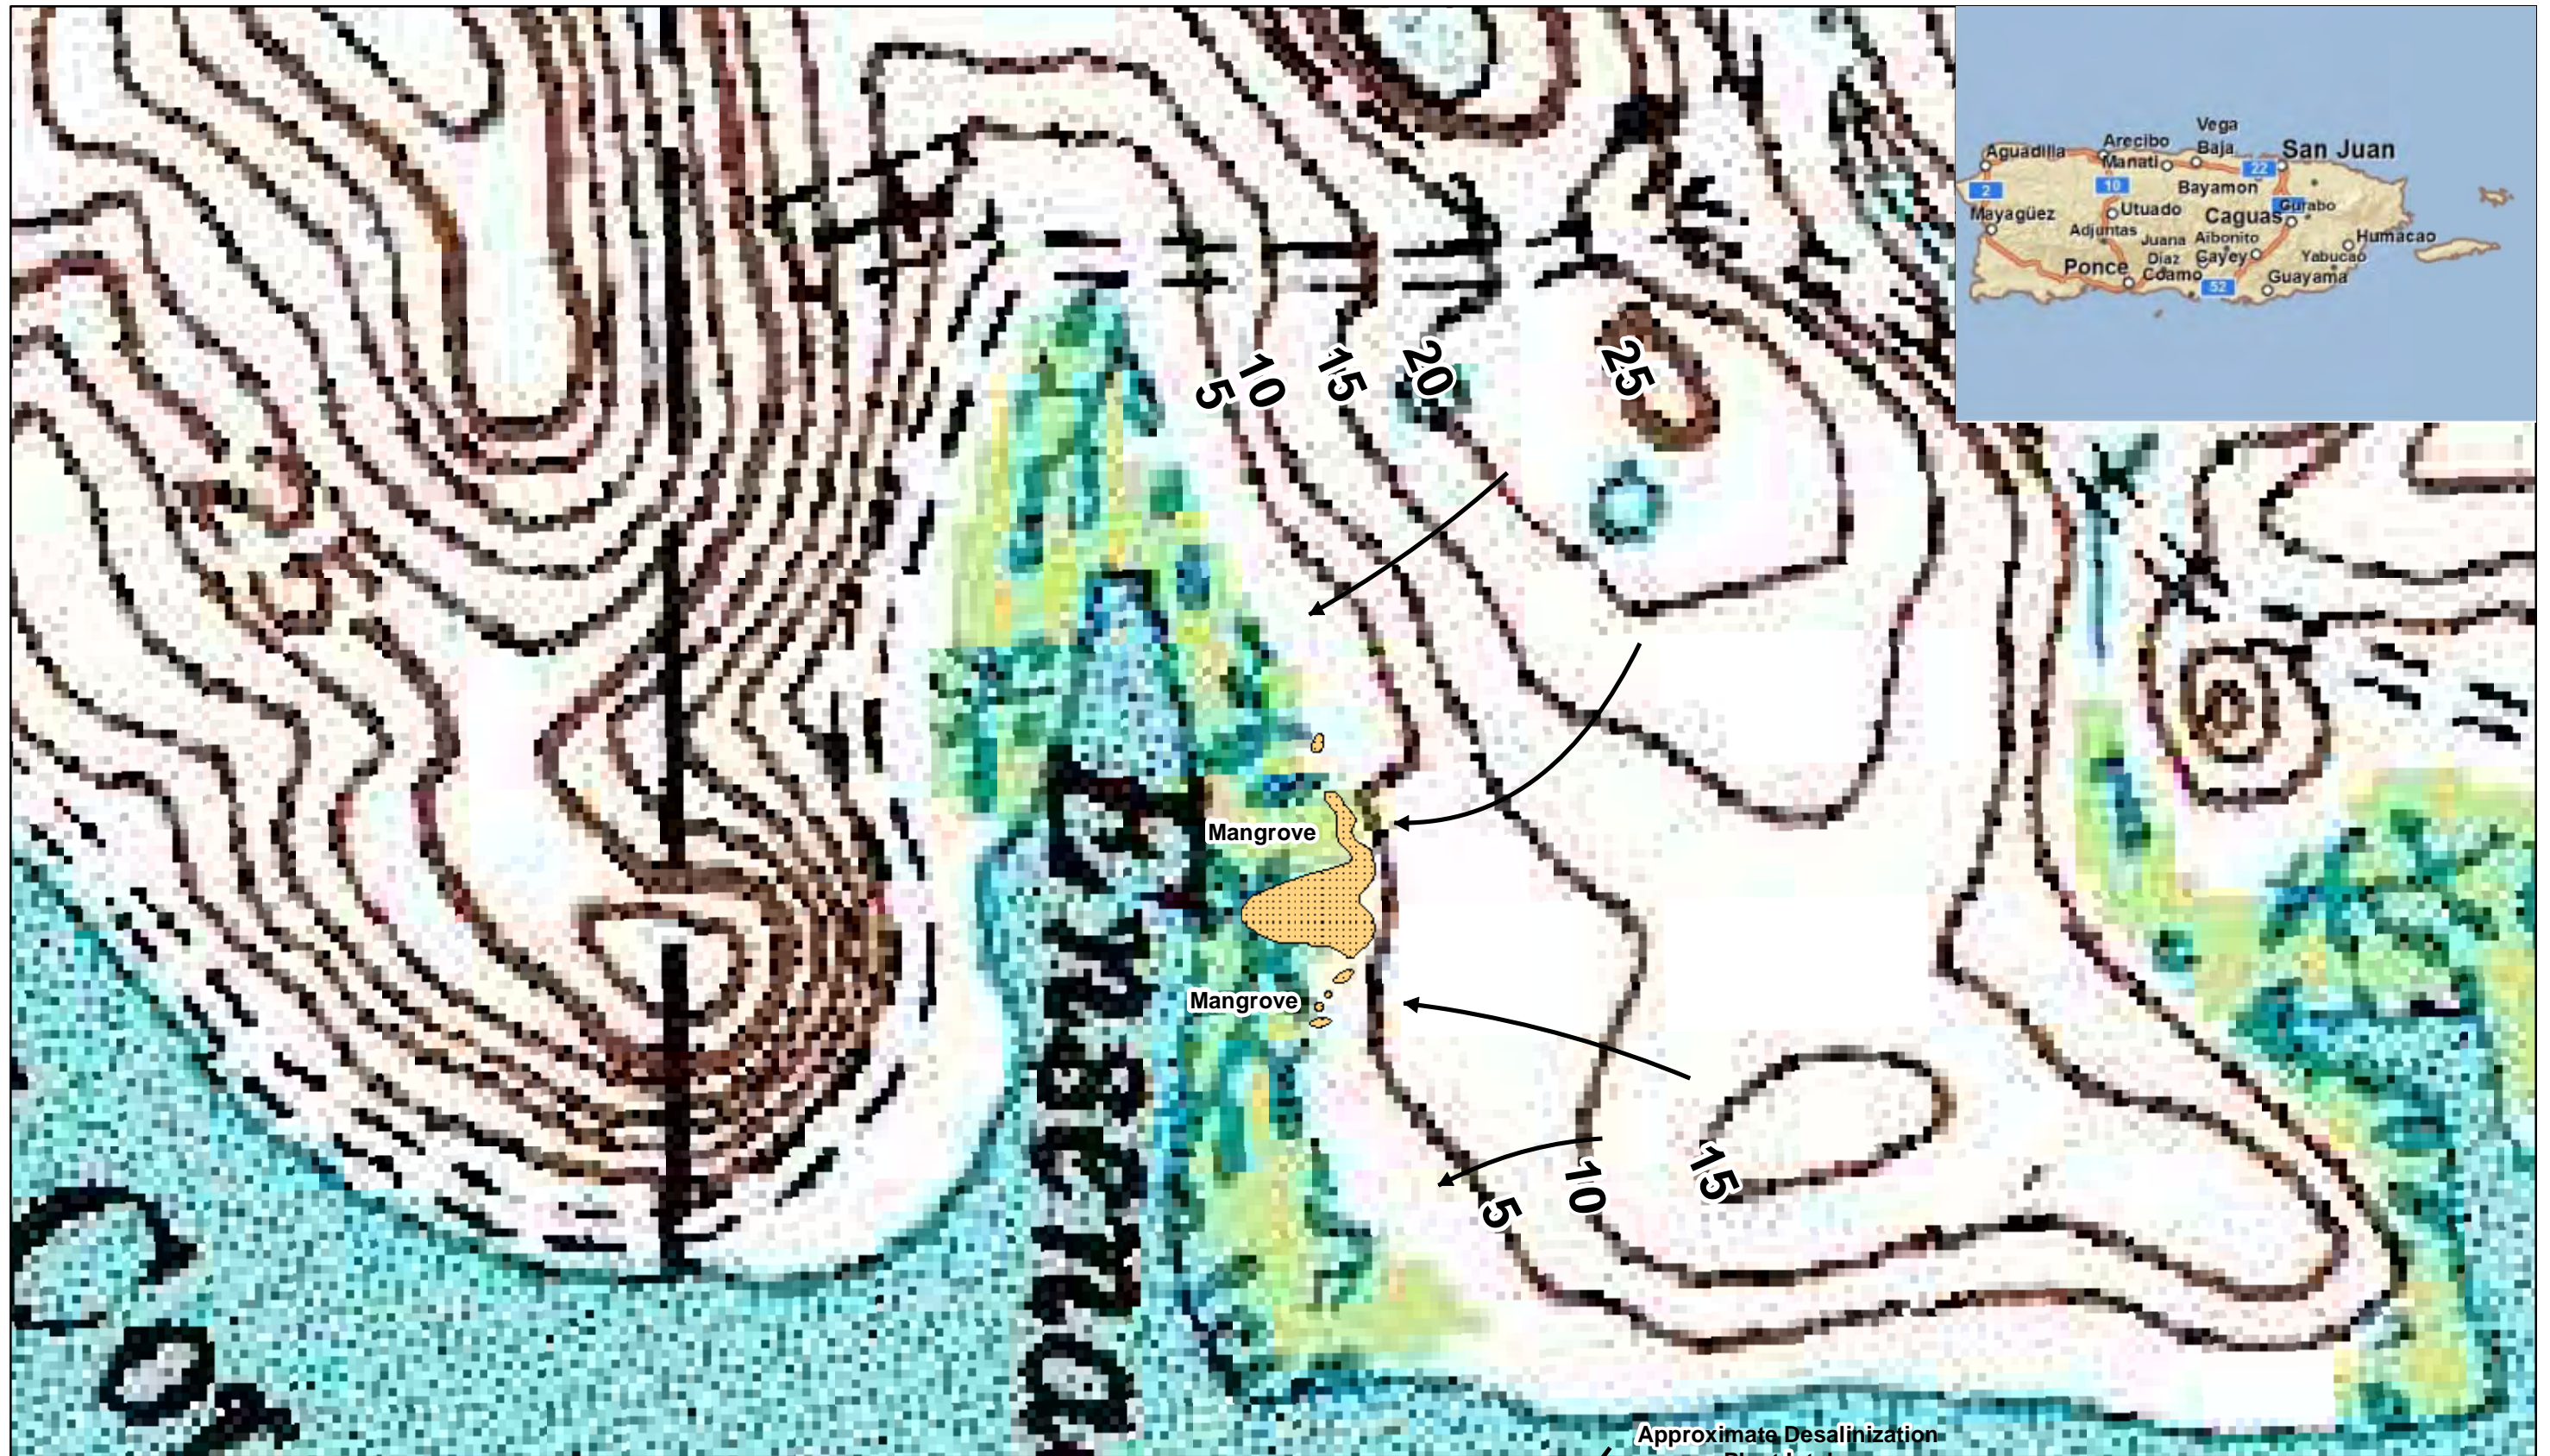
**FIGURE 3-1**  
**Site Inspection Location Map**  
 Former Lower Camp Debris Site  
 Culebra, Puerto Rico

The estimated extent of debris is located in a total area of 15,070 ft<sup>2</sup> (0.35 acre), and extends a distance of 350 feet from the southernmost to the northernmost tip of the debris field (**Figure 3-1**). The widest point of the debris field is approximately 165 feet. The debris consisted of broken bottles, building materials (i.e., bricks both broken and whole and mortar), highly deteriorated oxidized metal (i.e., pipes, beams, rods/rebar, bolts, mattress springs, cables, water valves, and cans), rusted metal walkway sheets, rusted refrigerator type appliance, rusted corrugated metal sheets, concrete stormwater pipes, old vehicle engines, a battery, tires, axles, transmissions, body frames, and broken porcelain..

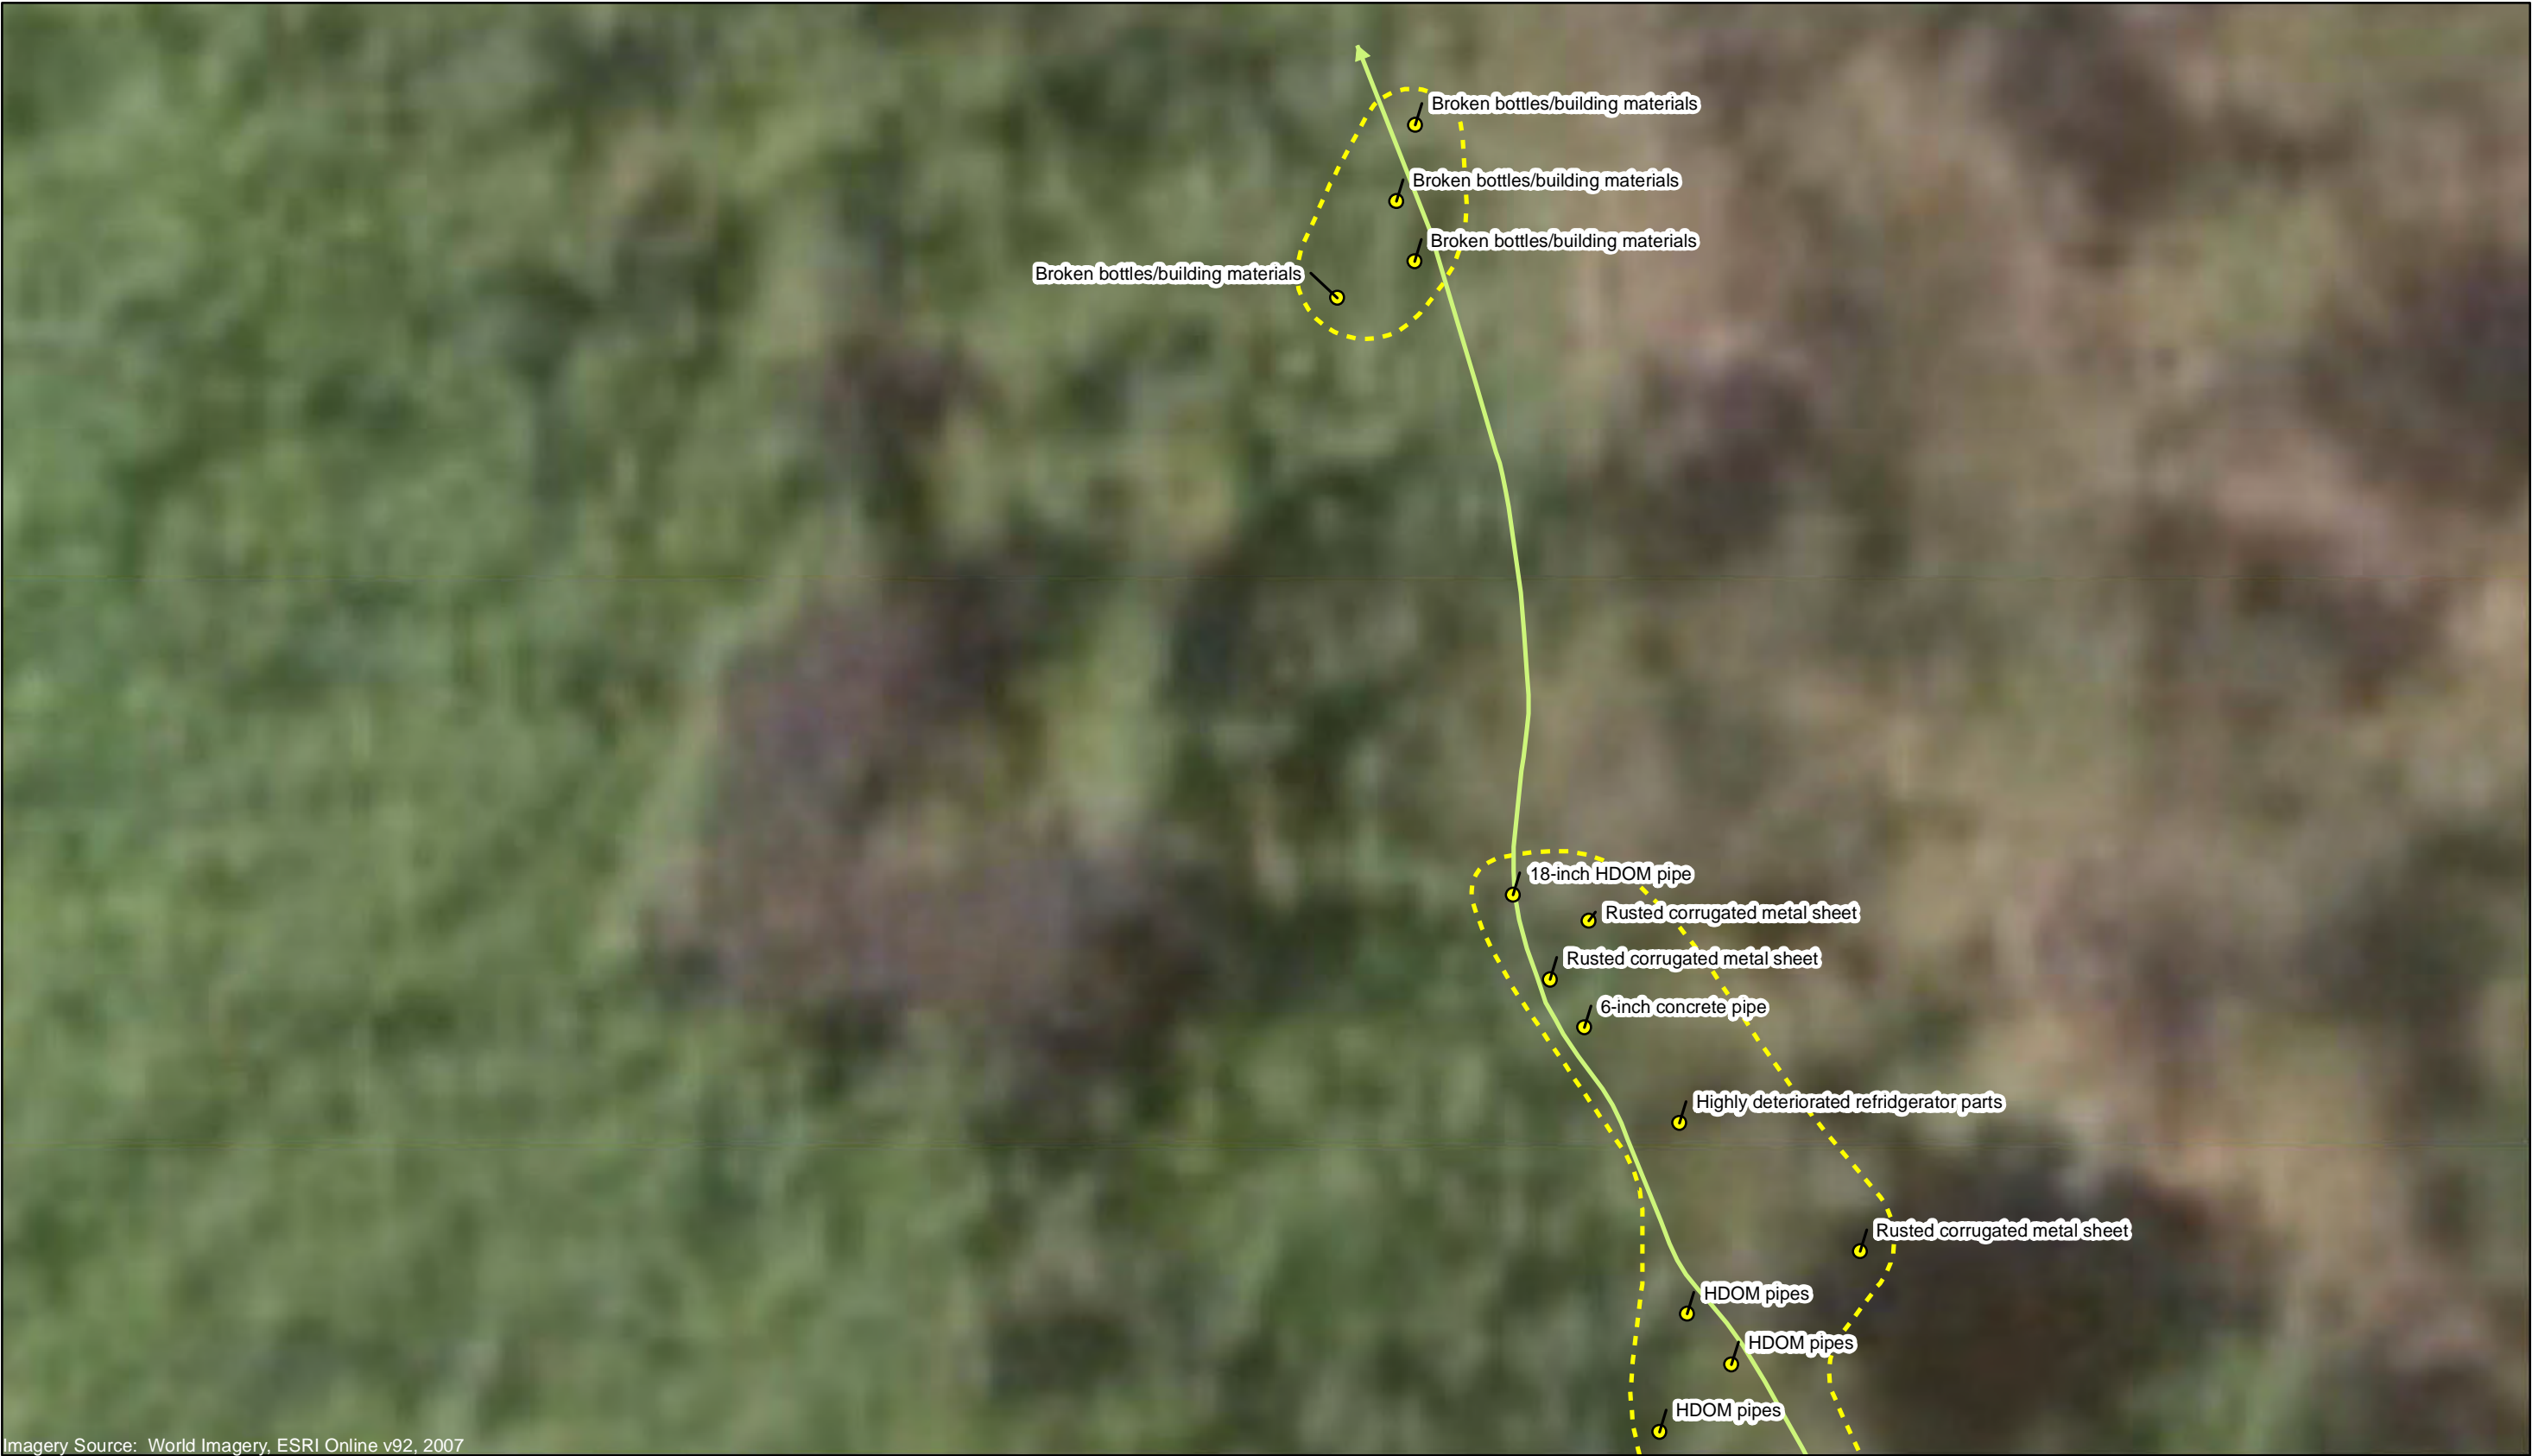
**FIGURE 3-2**  
**GPS Debris Locations - Map Area 1**  
Former Lower Camp Debris Site  
Culebra, Puerto Rico

Visual inspection of the debris areas along the shoreline of the mangrove was performed within the designated site boundary. Information regarding the type, location, and extent of debris currently at the site indicates the debris piles identified in the 1996 SI (E&E, 1996) are still present along with an additional debris pile approximately 50 feet north of the northern most debris pile shown on **Figure 1-4**. The estimated extent of surface debris is shown on **Figure 3-1**. The location and type of debris are shown on **Figures 3-2, 3-3, and 3-4**.

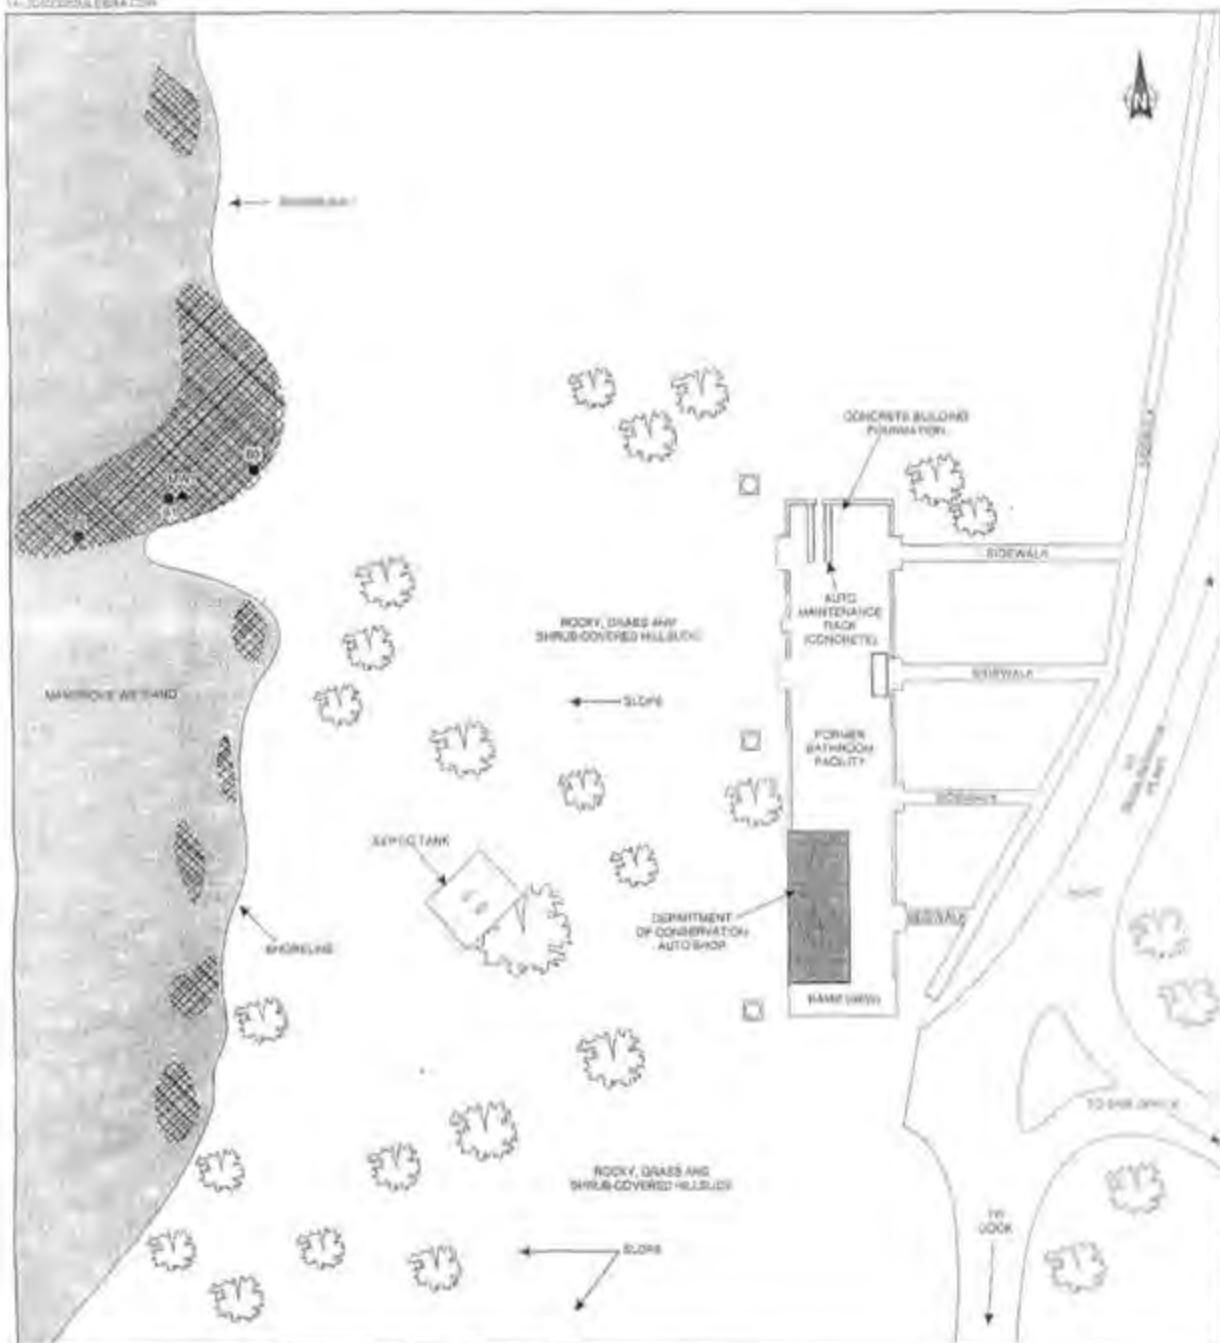
Figure 2 SITE MAP - CULEBRA ISLAND NATIONAL WILDLIFE REFUGE, CULEBRA ISLAND, PUERTO RICO

Debris is scattered along approximately 400 feet of the shoreline and extends from 20 to 100 feet into the wetland. The largest concentration of debris occupies an area approximately 120 by 40 feet (see Figure 2). The debris consists primarily of highly-rusted metal building materials such as steel beams and rods, corrugated steel sheeting and bolts. Other material observed in the wetland area includes broken glass and automobile parts. The eastern edge of the wetland area is approximately 180 feet west (downslope) of a 35 by 160-foot concrete foundation. The foundation was formerly a bathroom facility and is currently used as the Department of Conservation Automotive Maintenance facility. The hillside between the automotive maintenance facility and the wetland area is scattered with auto body parts and corrugated steel sheeting that appears relatively new (within 10 to 15 years). Figure 2 shows the site layout; photographs of the site are included as Attachment A.

A total of three borings were completed within the wetland in the area of most concentrated debris (see Figure 2). The depth to water was approximately 0.3 foot below ground surface (BGS). Boring B-1 was completed to 4 feet BGS and borings B-2 and B-3 were completed to 2 feet BGS. The lithology at each boring location from ground surface to the completion depth was characterized as black organic silt and peat. Composite samples were collected at 2 foot intervals from the surface to the completion depth of each boring (see Table 1).

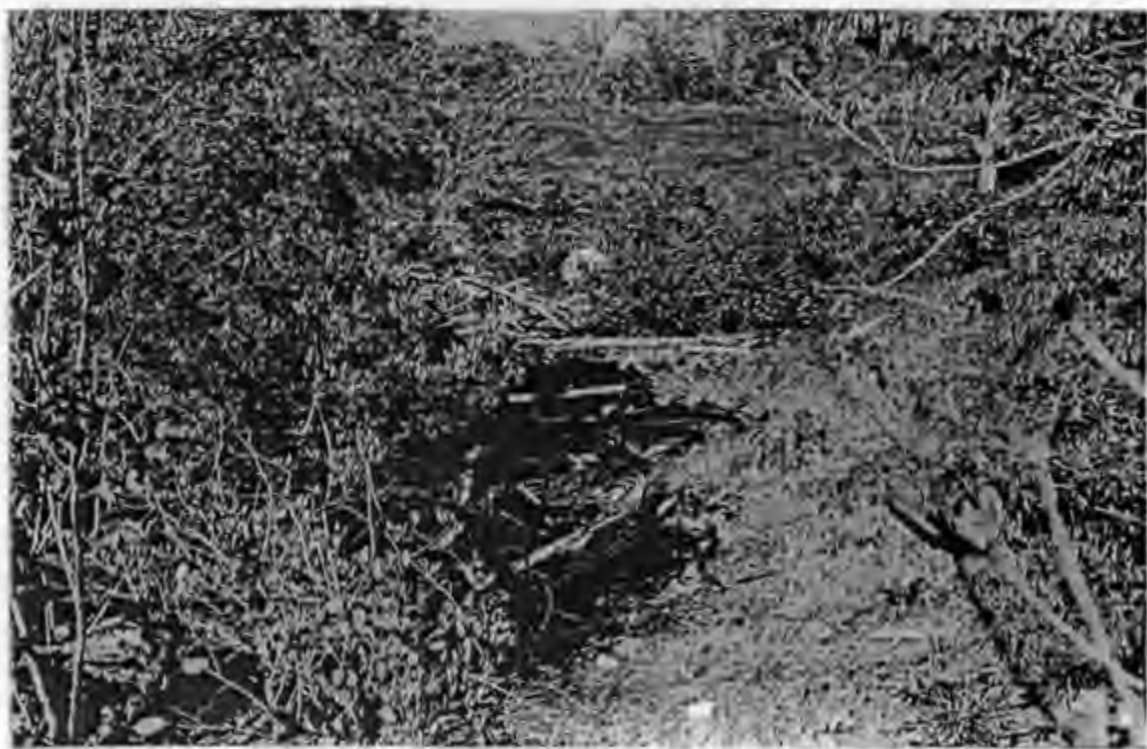
a. Culebra Island NWR (metal debris in wetland area)

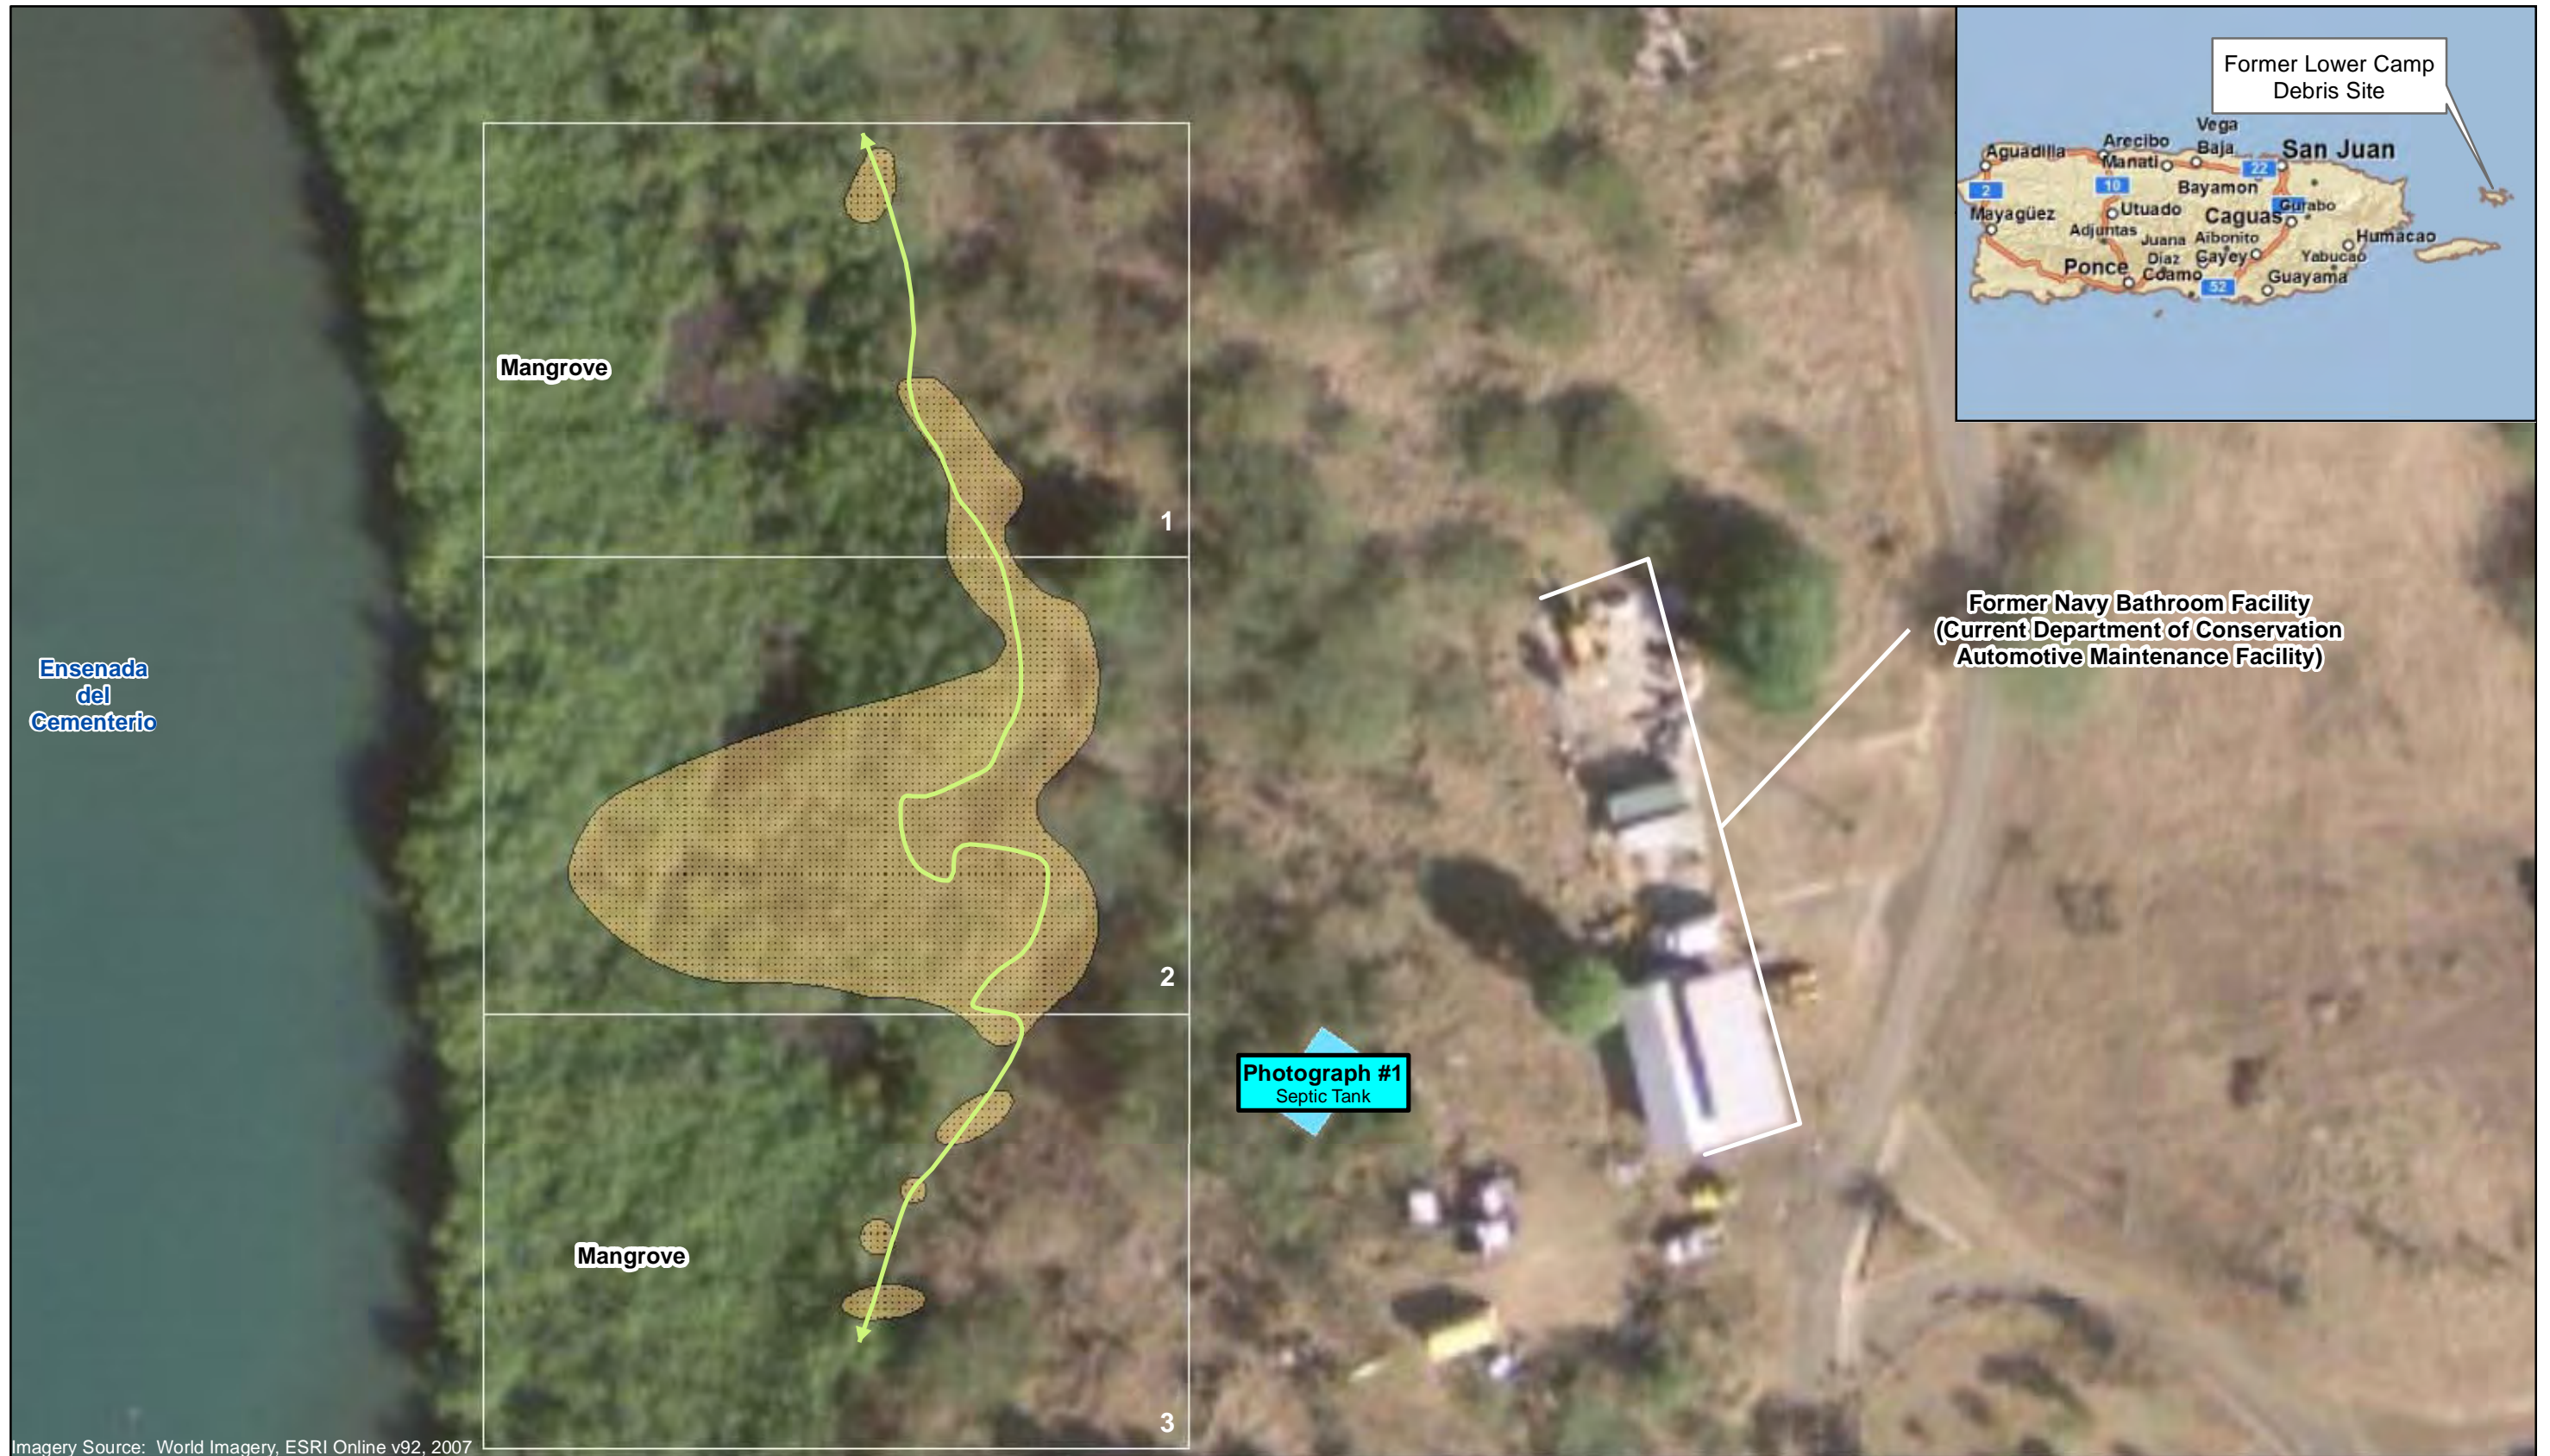
**FIGURE 1**  
**Site Inspection Location Map**  
 Former Lower Camp Debris Site  
 Culebra, Puerto Rico

Locations of existing debris – ie; tires, rusted metal framing, glass bottles, etc. were confirmed visually and locations logged in with GPS coordinates by Bryan Burkingstock on site defining the limits of each debris pile discovered. The largest pile discovered was in the mangroves even with the north end of the former fueling station.
