I. Southeast Peanut Island Wetland Habitat and Stabilization (Figures 14 and 15)

This report provides the results of engineering and environmental studies for implementing the Section 1135 Peanut Island Environmental Restoration Plan in Palm Beach County, Florida. The following page illustrates the environmental restoration components of the recommended plan. The purpose of the project is to restore the submerged shallow water habitat for fisheries and wildlife. The recommended plan consists of excavation and removal of dredged material deposits, construction of an exterior reef stabilization/breakwater, clearing and chipping of exotic vegetation, revegetation with native plant species, and the addition of recreation development features.

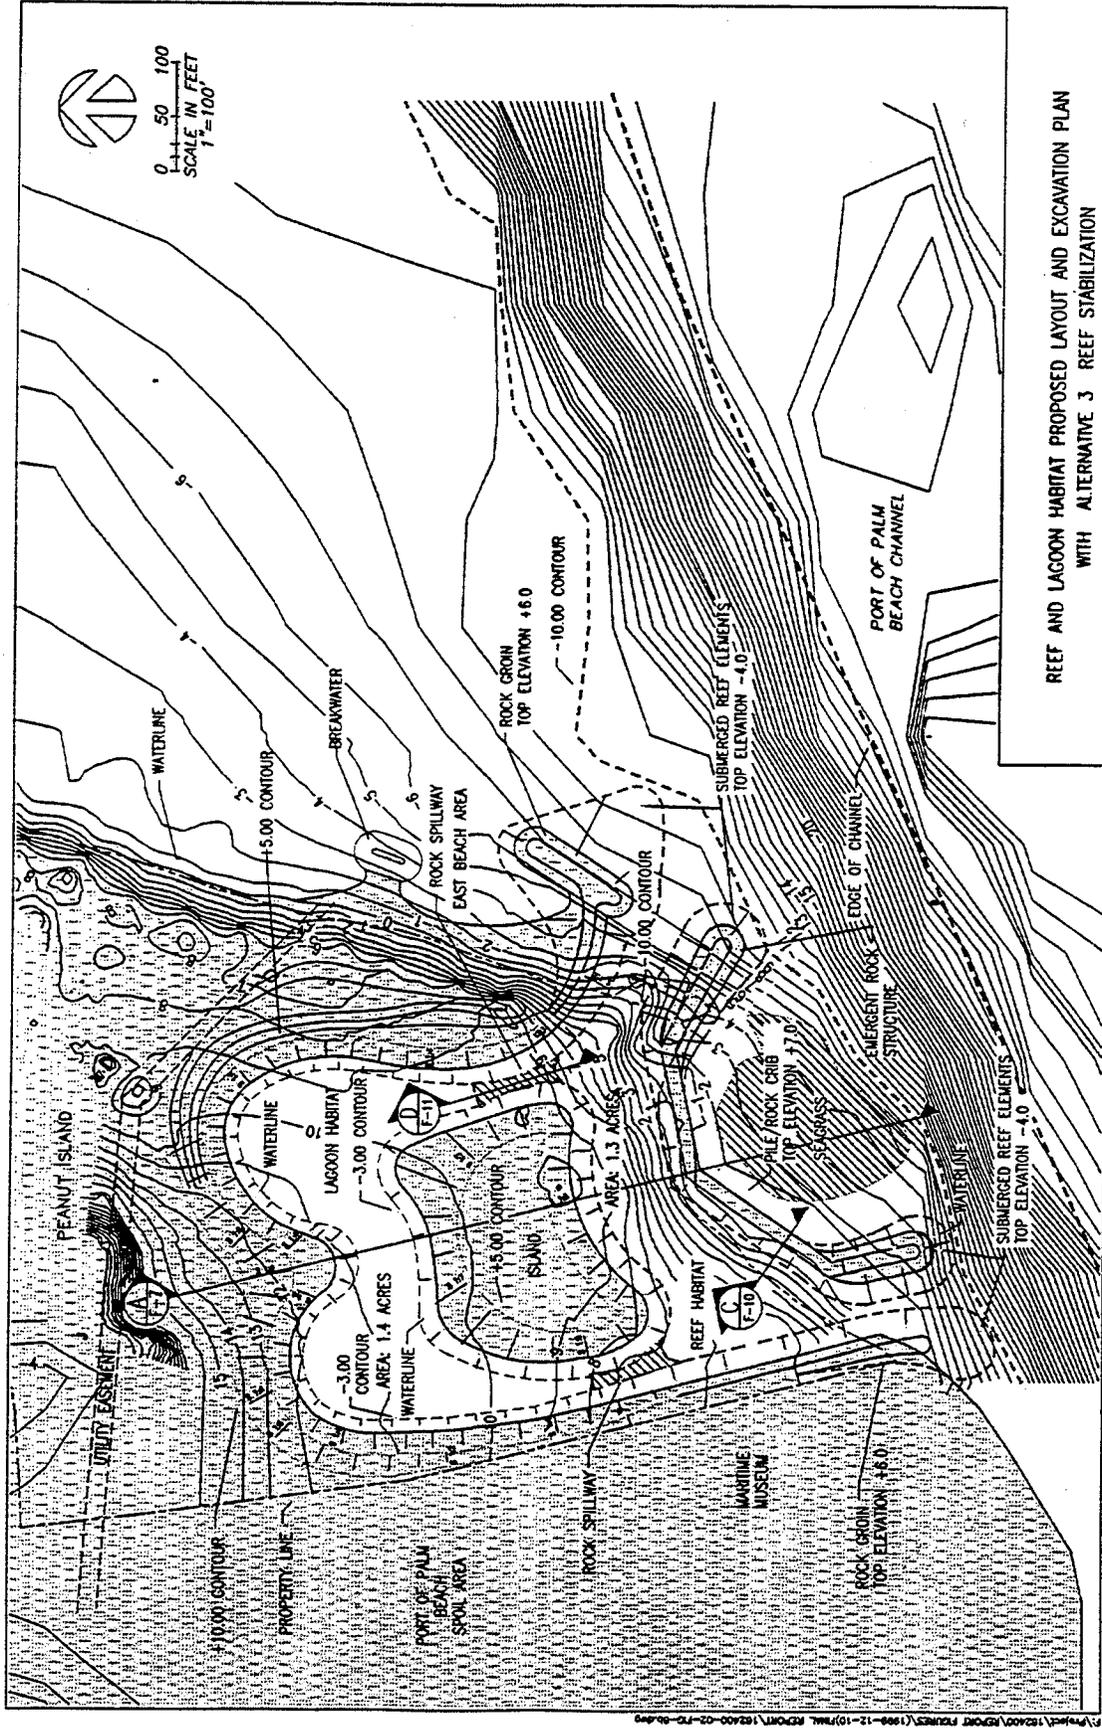
FIGURE 14. REEF AND LAGOON HABITAT PROPOSED LAYOUT AND EXCAVATION PLAN

REEF AND LAGOON HABITAT PROPOSED LAYOUT AND EXCAVATION PLAN
WITH ALTERNATIVE 3 REEF STABILIZATION

The shallow-water reef habitat has been designed for the southeast corner of the island. The reef habitat will be cut from existing upland down to an elevation of -10' NGVD and will be protected and enclosed by an exterior breakwater structure. The reef habitat will have a surface area of approximately 1.3 acres at the 0.0 NGVD waterline. The slope of the island descending into the reef habitat will be armored with limestone boulders to prevent erosion.

The reef has been located and designed to take maximum advantage of the tidal currents passing the southeastern shore of Peanut Island from Lake Worth Inlet. The tidal flow entrained by the reef habitat features will encourage species recruitment, maintain nutrient and substrate levels, and maintain acceptable water quality within the habitats. The development of a reef system to -10' NGVD will assure that hard corals will have ample area to establish above the zone affected by scouring or sedimentation. Additional rock clusters of various sizes and habitat complexion will be placed along the bottom of the shallow-water habitat, emulating natural reef conditions and promoting recruitment of fish and invertebrates. The exterior groin and breakwater features, as well as proposed interior rip-rap slope armoring, also serve the purpose of providing protection to project integrity from storm wave effects.

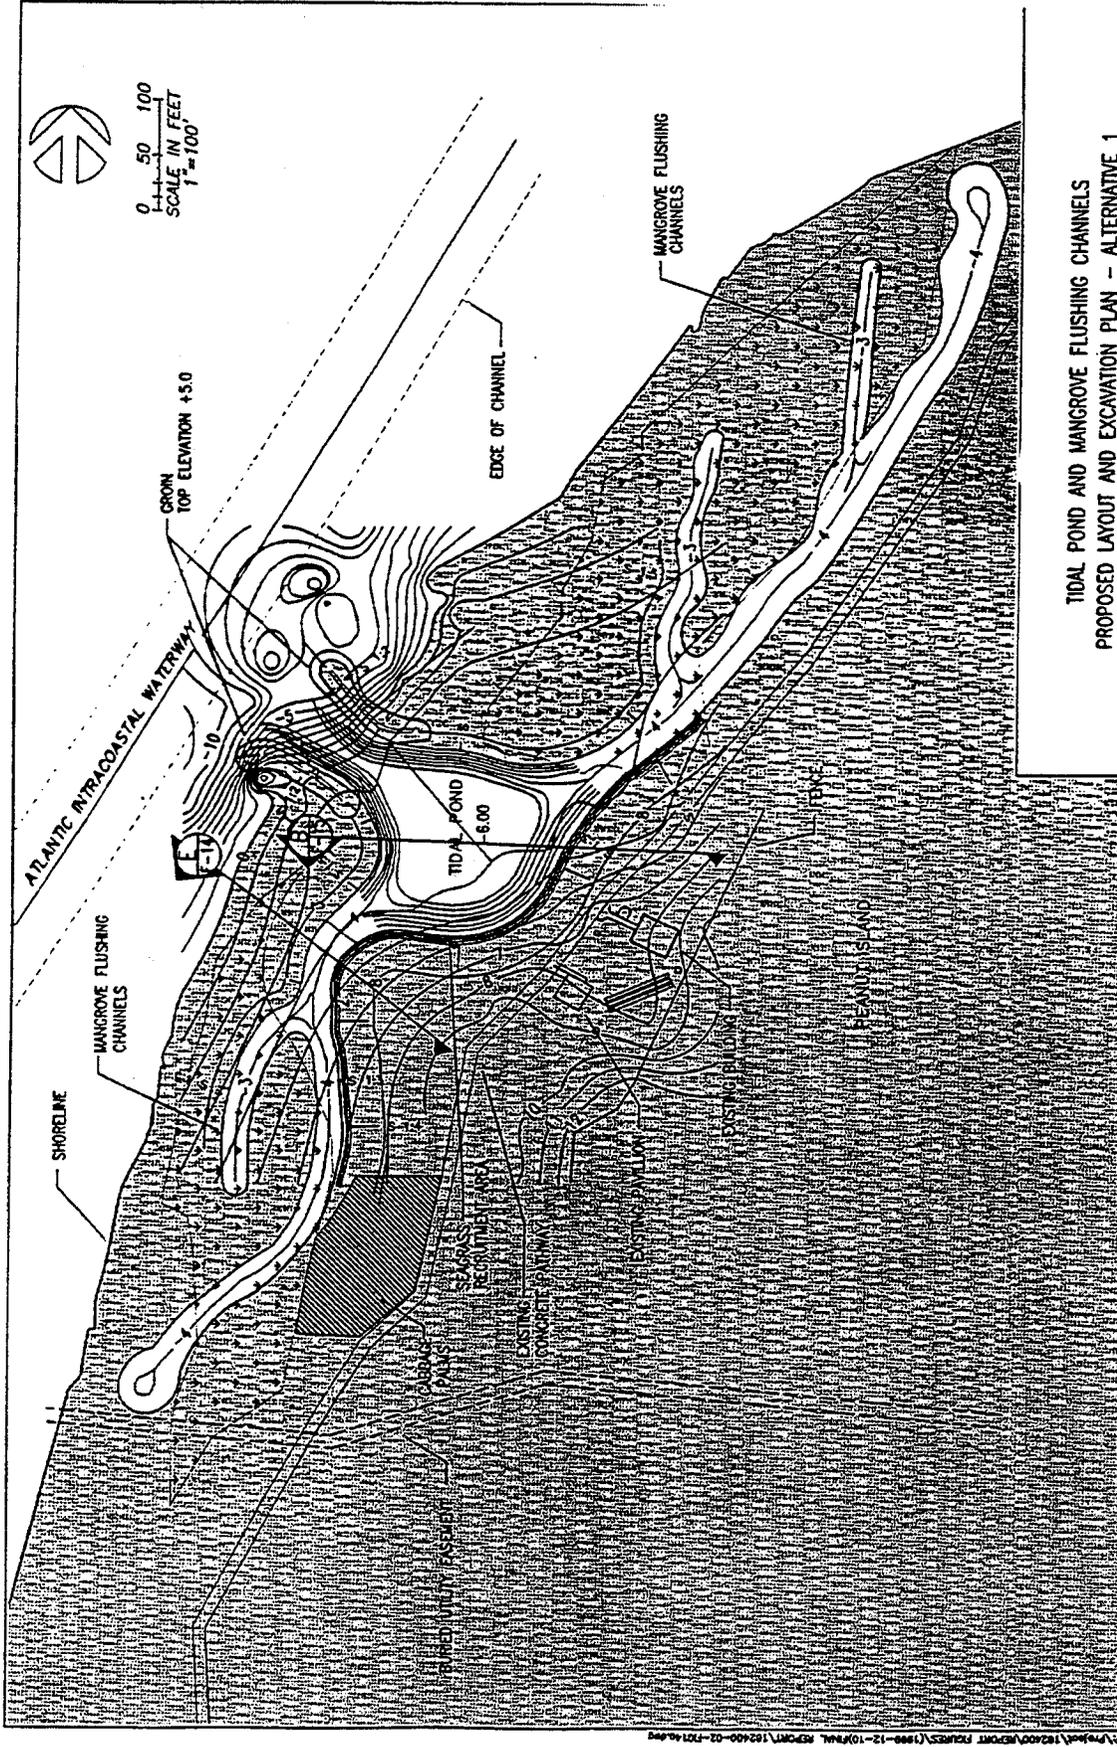
FIGURE 16. TIDAL POND AND MANGROVE FLUSHING CHANNELS

TIDAL POND AND MANGROVE FLUSHING CHANNELS
 PROPOSED LAYOUT AND EXCAVATION PLAN - ALTERNATIVE 1

II. West Peanut Island Wetland Habitat and Stabilization (Figures 16 and 17)

Restoration of existing mangroves on the west side of Peanut Island will be facilitated through the creation of a tidal pond and a series of flushing channels. The tidal pond will be excavated to a design depth of -6.0 feet NGVD and will be stabilized by two exterior groin features, which will limit sediment deposition in the tidal pond entrance and

The proposed tidal pond will work in conjunction with flushing channels to provide a connection to tidal waters for the existing mangrove community within the project area. Exotic plant and dredged material removal in the vicinity of the existing mangrove wetland will be carried out with a sensitive removal methodology insuring the protection of the existing native wetland vegetation. The system consists of two main channels, approximately 30 feet wide with a depth of -4.0 feet NGVD and smaller spur channels (-3.0 feet NGVD) cut through the impacted portions of the mangrove system.

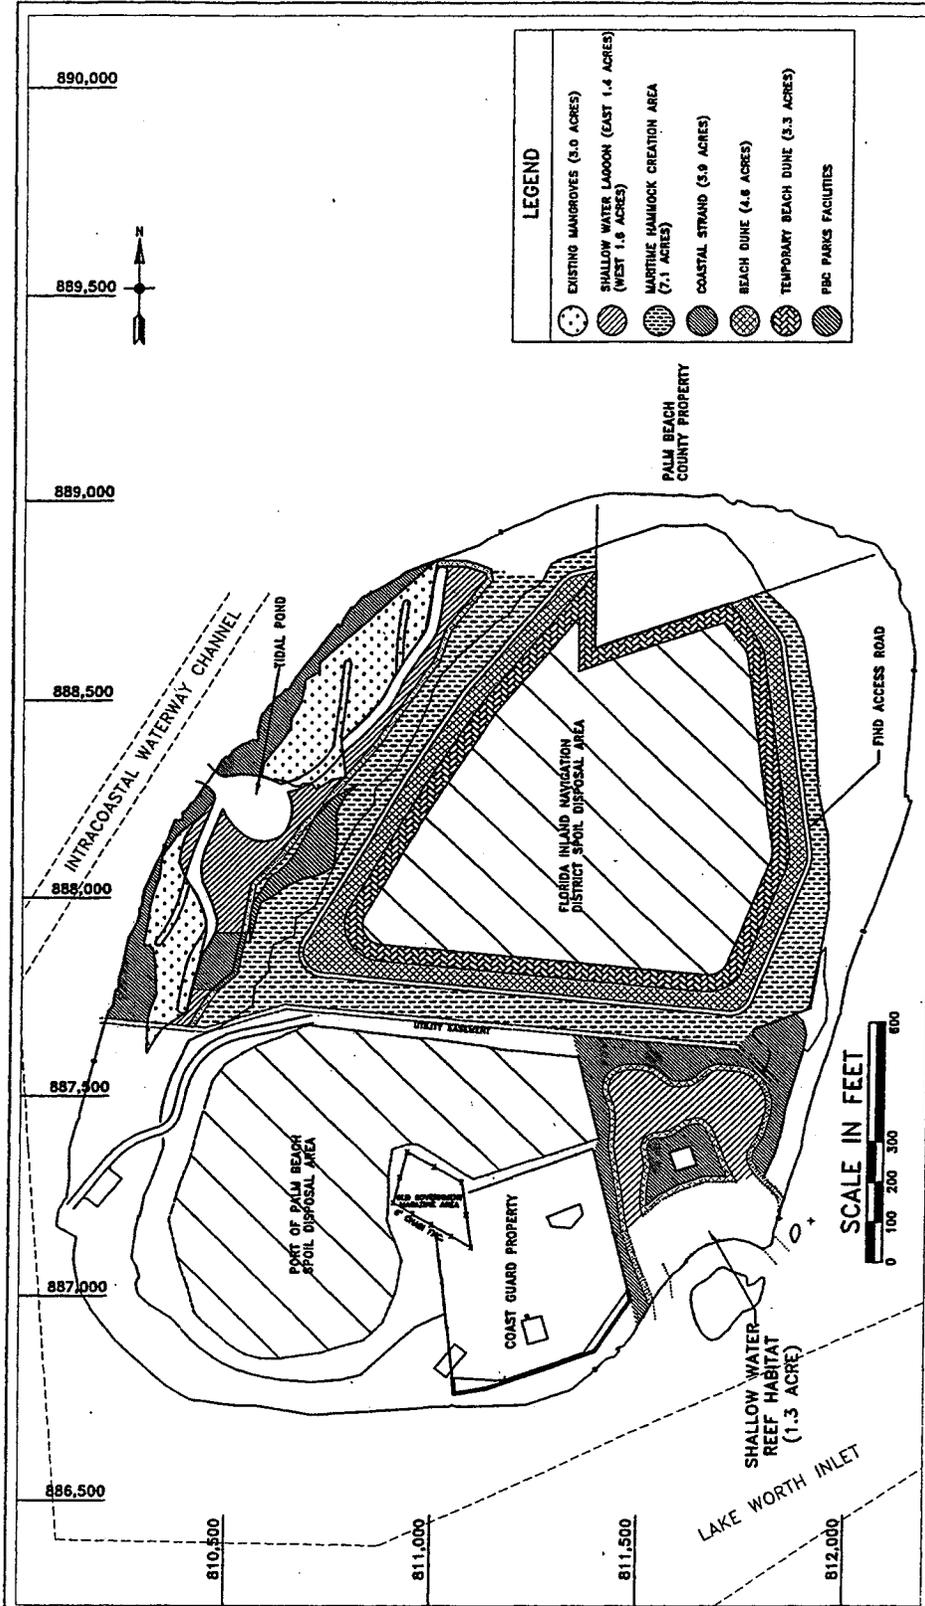
PEANUT ISLAND ENVIRONMENTAL RESTORATION RECOMMENDED PLAN

The environmental restoration will result in the creation of a 1.3 acre shallow water reef and 3.0 acres shallow-water lagoon habitat; restoration of 3.0 acres of existing mangrove habitat through the creation of an inlet, tidal pond, and flushing channels (1.5 acres). Creation of 7.1 acres of maritime hammock, 3.9 acres of Coastal Strand, 4.6 acres of Beach Dune, and 22 acres of seagrasses. The environmental restoration and recreation development features have a total estimated cost of \$5,881,608. This project will benefit reef fish, birds, invertebrates, benthic organisms, seagrasses, mangroves, and maritime hammocks. Also, this project will provide environmental education to the public and give the public an unique opportunity to experience a variety of native habitats that have been rapidly depleted in South Florida.
