Appendix A. Dam Safety Action Decision Summary (DSADS)

Herbert Hoover Dike
Dam Safety Modification Study

1. Dam Safety Action Decision Summary (DSADS)

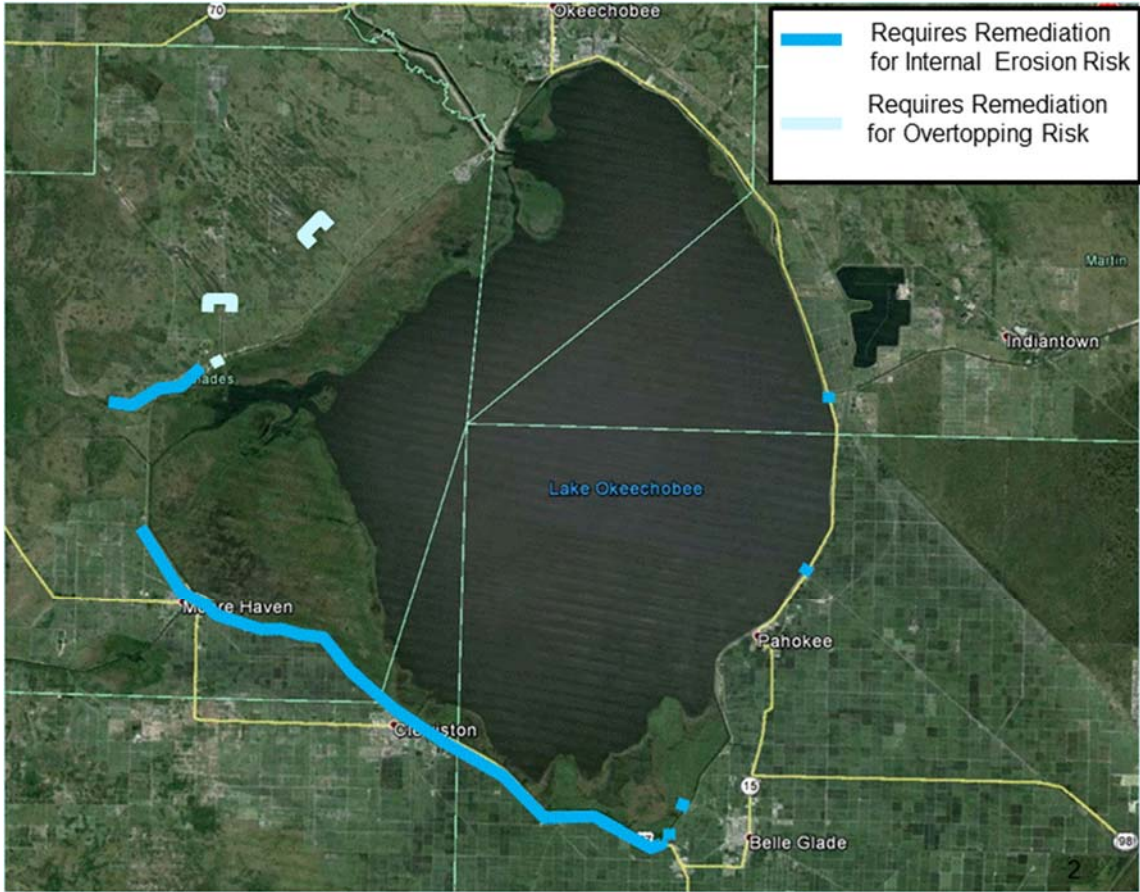
Figure 1-5: This figure portrays the locations where risks have been identified as intolerable due to combination of high probability of failure and the consequences of a failure.

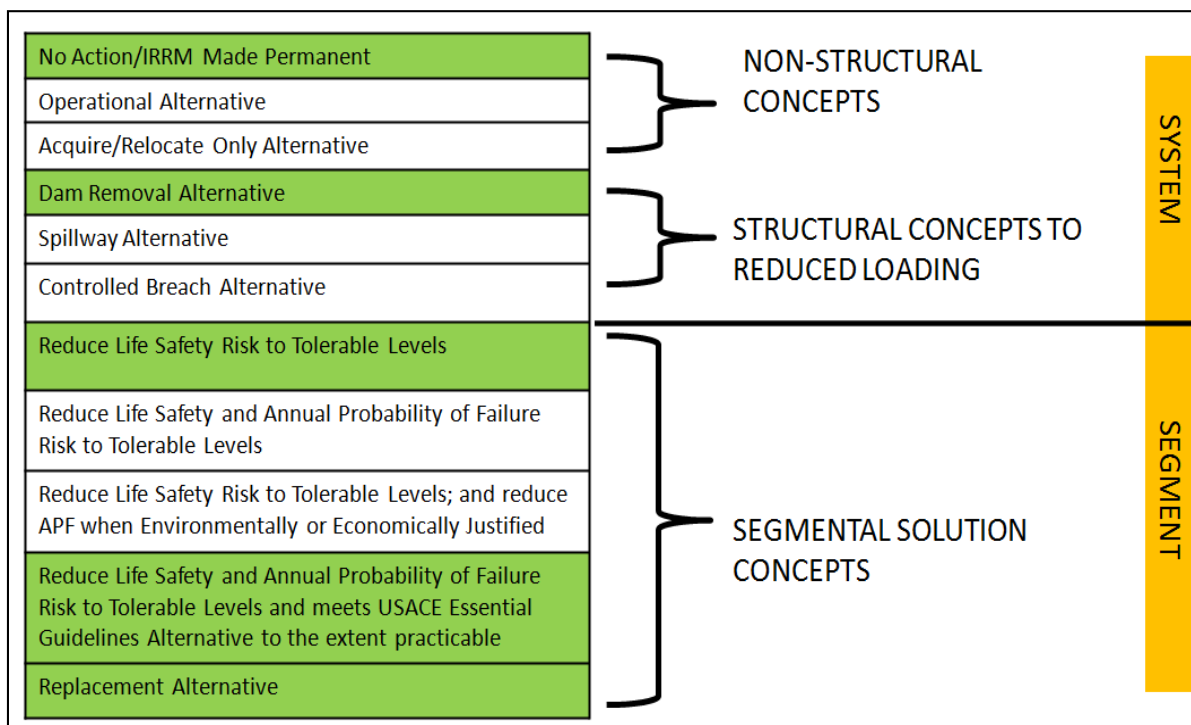
Figure 1-6: Overview of Initial Array of Alternatives

Figure 1-6 displays the initial suite of alternatives considered for remediating HHD. The alternatives shaded in green represent the five plans required to be examined in a USACE dam safety study and the alternatives shaded in white were additional alternatives identified.
