# **APPENDIX H**

## **VALUE ENGINEERING STUDY ALTERNATIVES**

**ENVIRONMENTAL ASSESSMENT FOR ST. LUCIE  
INLET, FLORIDA PROJECT - SOUTH JETTY  
REHABILITATION**

**ST. LUCIE INLET, MARTIN COUNTY, FLORIDA**

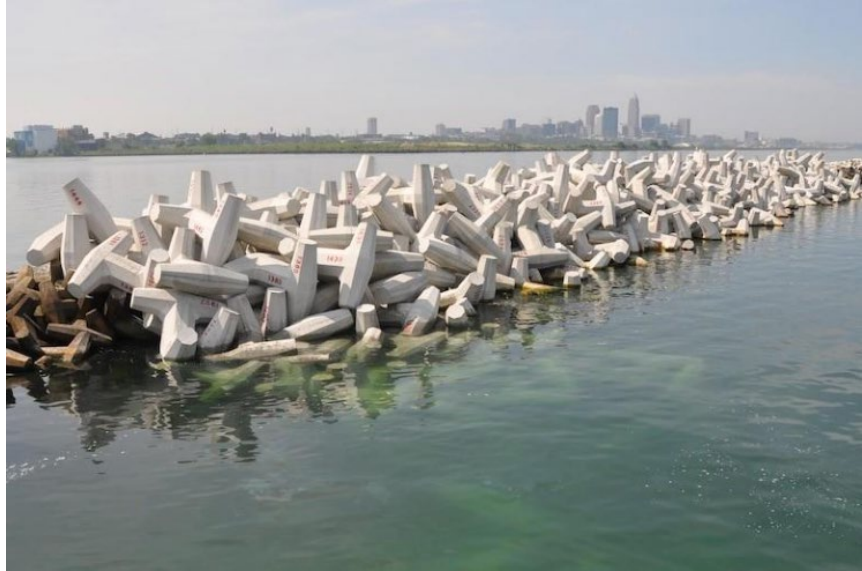
The jetty could be rehabilitated using concrete armor units instead of granite armor stone. These armor units, called dolosse, are designed for their interlocking capability rather than just weight. (See [Figure 3](#)). They are placed strategically to create a porous and resilient armor layer to dissipate wave energy. Design for use of these units is very extensive as there are strict quality control procedures for the production and installation of the units. These units also require periodic surveys and monitoring after placement in order to track their movement and verify the stability of the structure throughout its lifetime. These units have been utilized infrequently throughout the U.S., and therefore institutional knowledge is limited on their design and implementation.

**Figure 3: Concrete Armor Units (Dolosse) Implemented in Corps' Cleveland Harbor East Breakwater Project (2016)**
