APPROVED JURISDICTIONAL DETERMINATION FORM **U.S. Army Corps of Engineers**

B. DISTRICT OFFICE, FILE NAME, AND NUMBER: Jacksonville District; Walton Acquisitions, LLC/Denham Village; SAJ-2015-2703-SCW

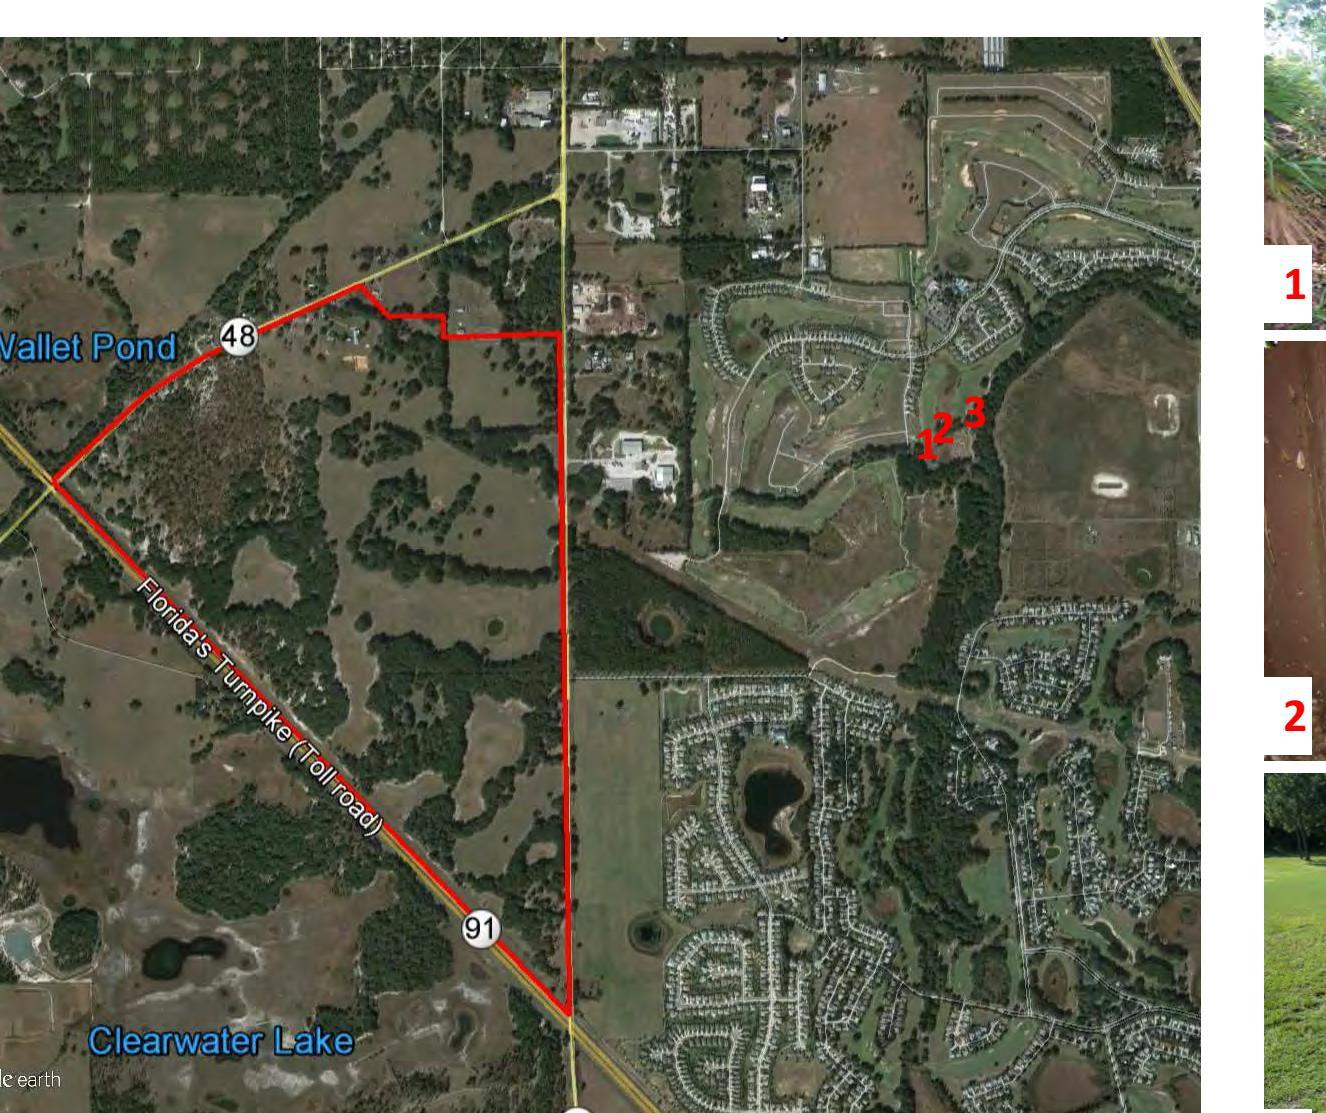
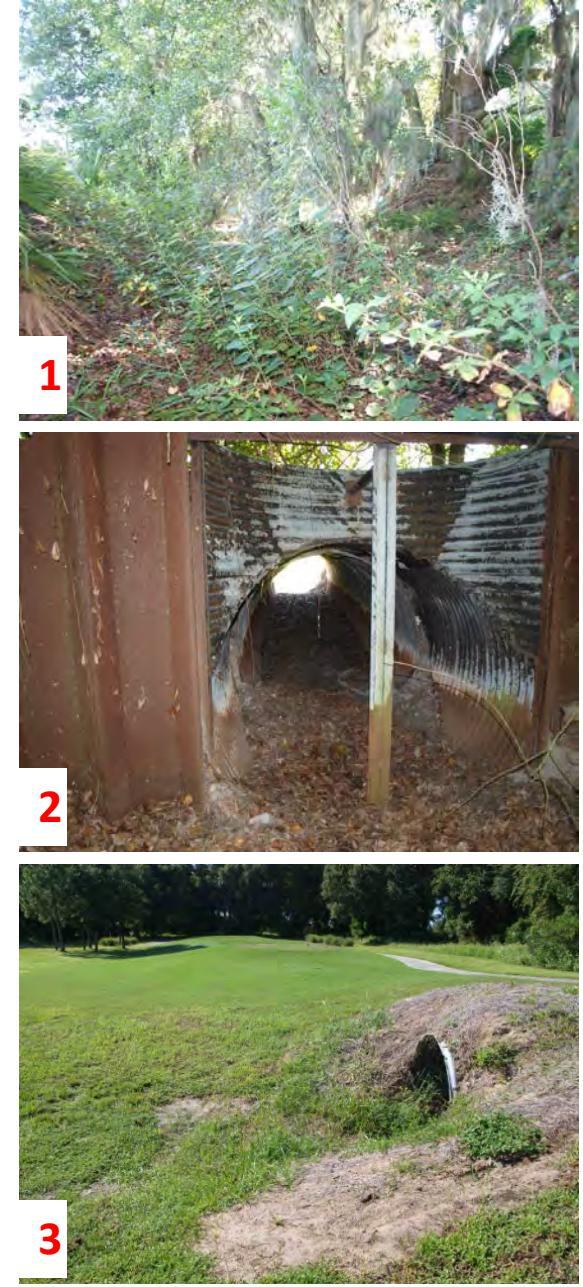
The aerial photograph is from 2013. The project site is outlined in red. Photographs 1 - 3 were taken September 17, 2015 in Ditch 1 near RPW.

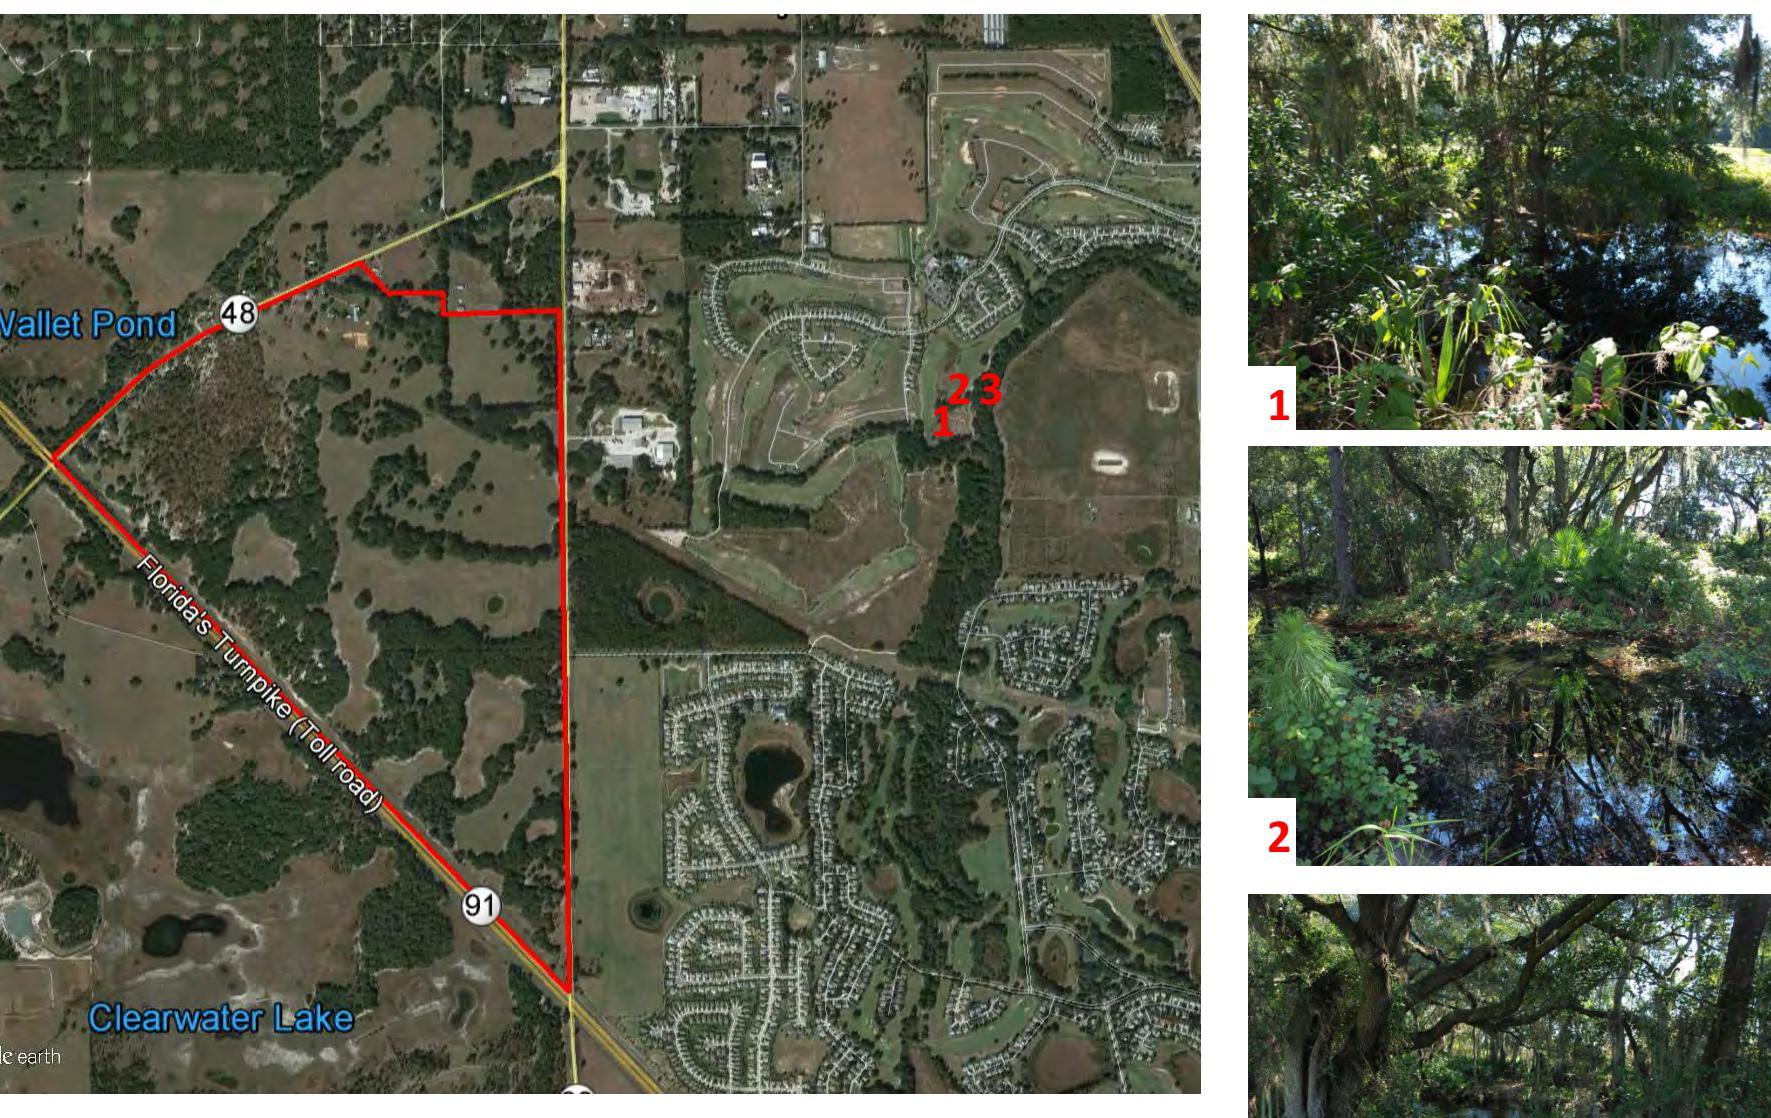
The aerial photograph is from 2013. The project site is outlined in red. Photographs 1 - 3 were taken September 17, 2015 at RPW.

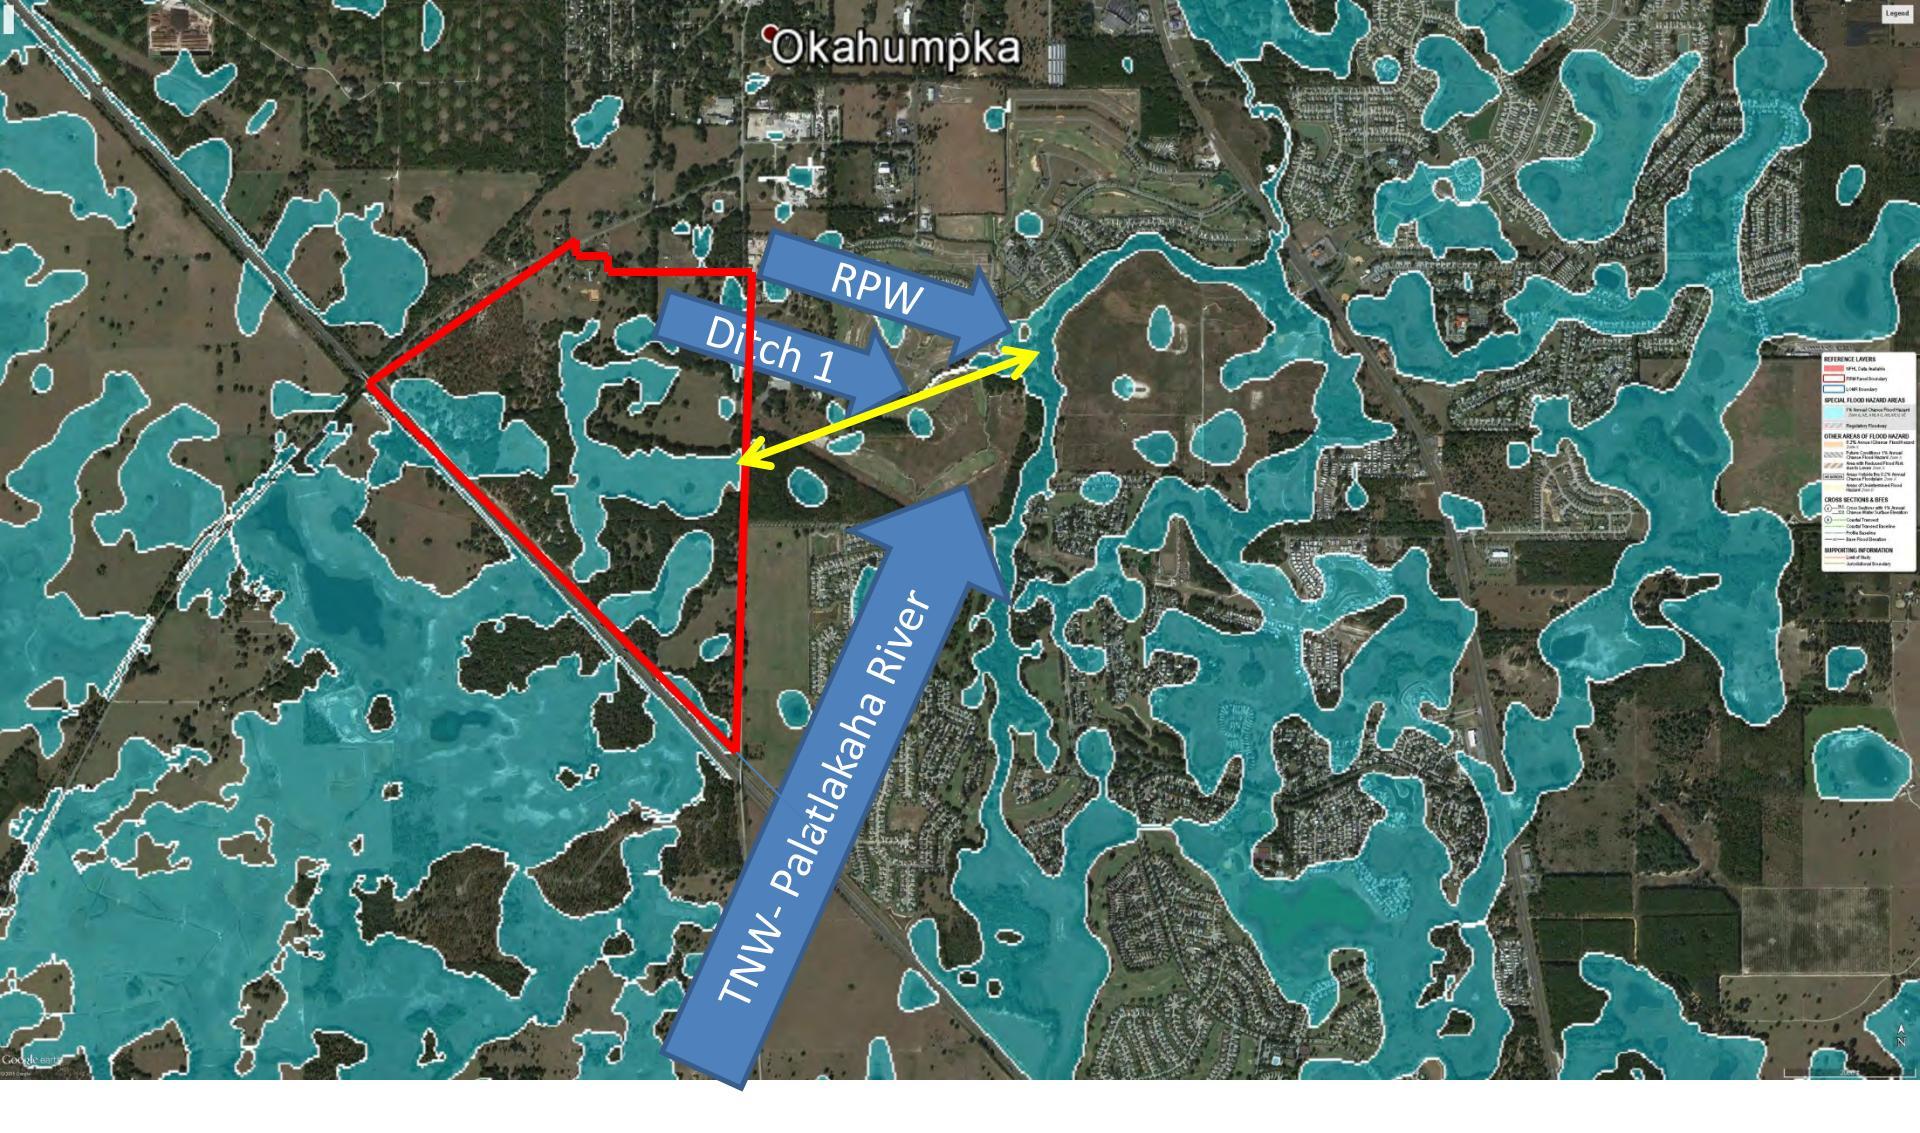
The 100 year flood zones are shown in blue. The project site is outlined in red. The yellow arrow depicts the distance from the project site to the Palatlakaha River. The distance is approximately 4,900 linear feet.

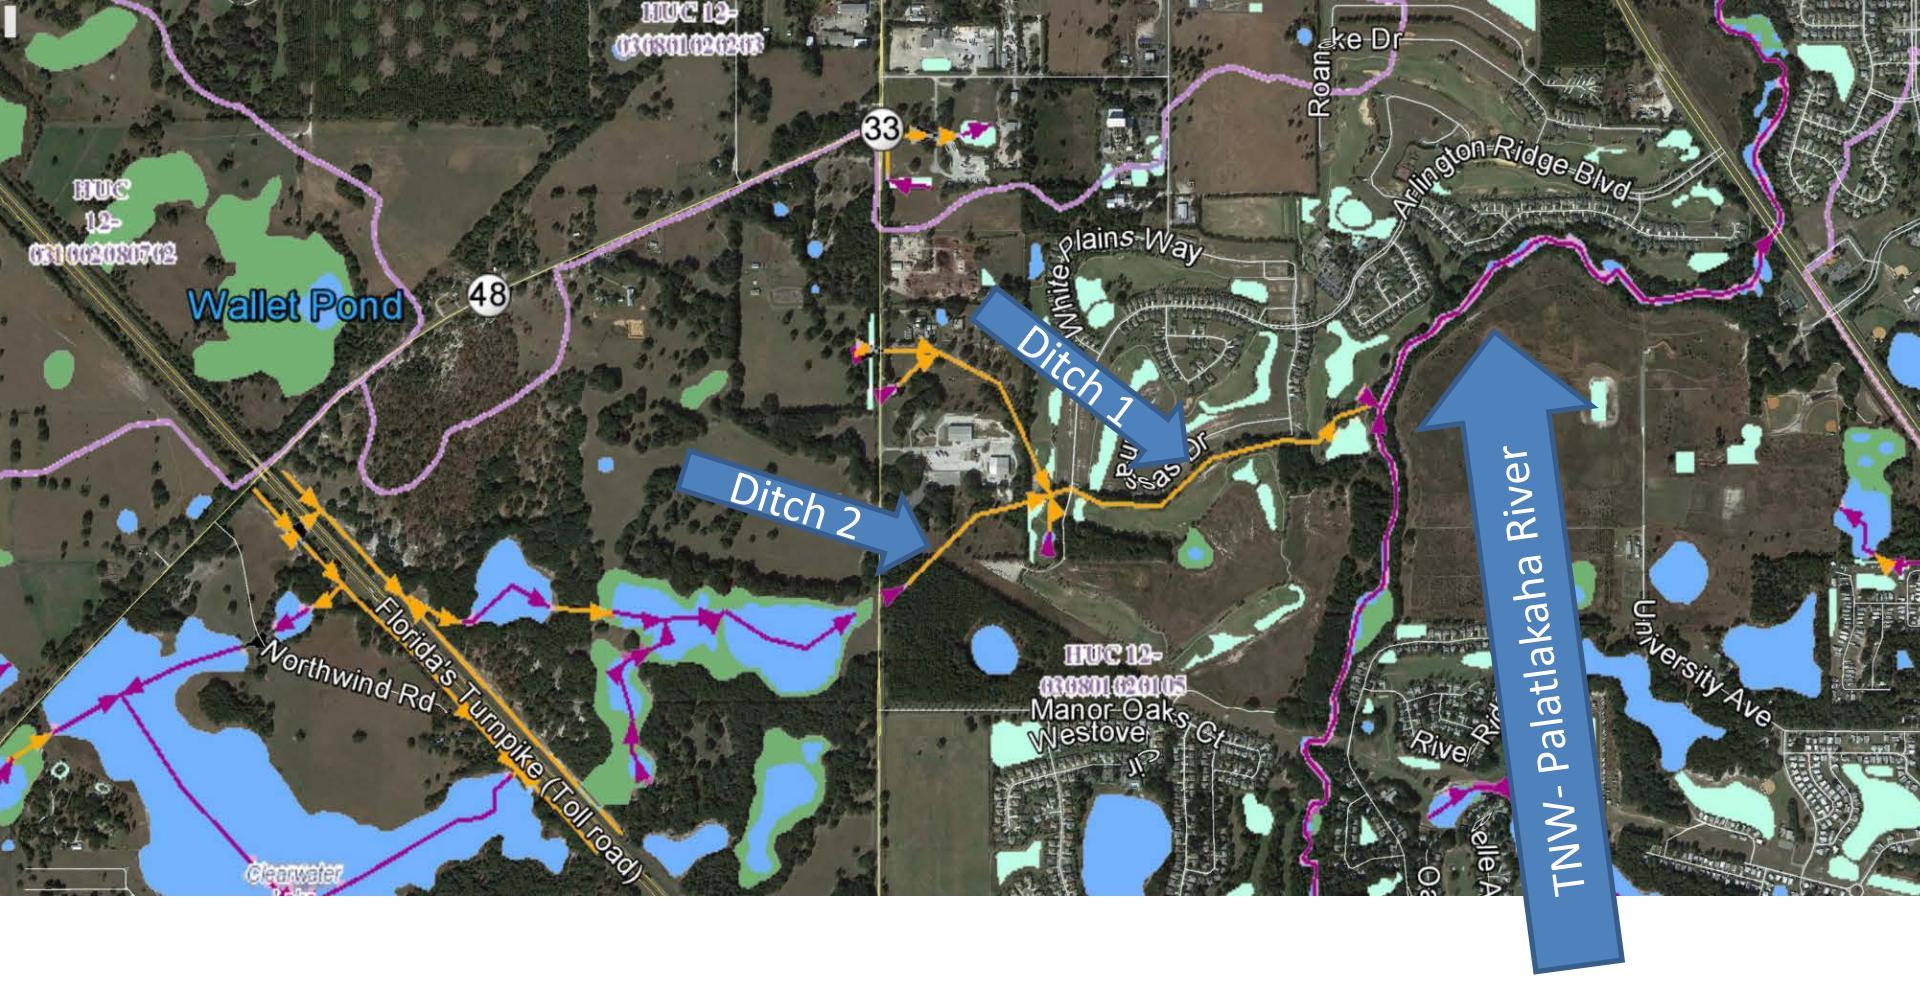
National Hydrologic Dataset showing flow pathways and NWI wetlands.

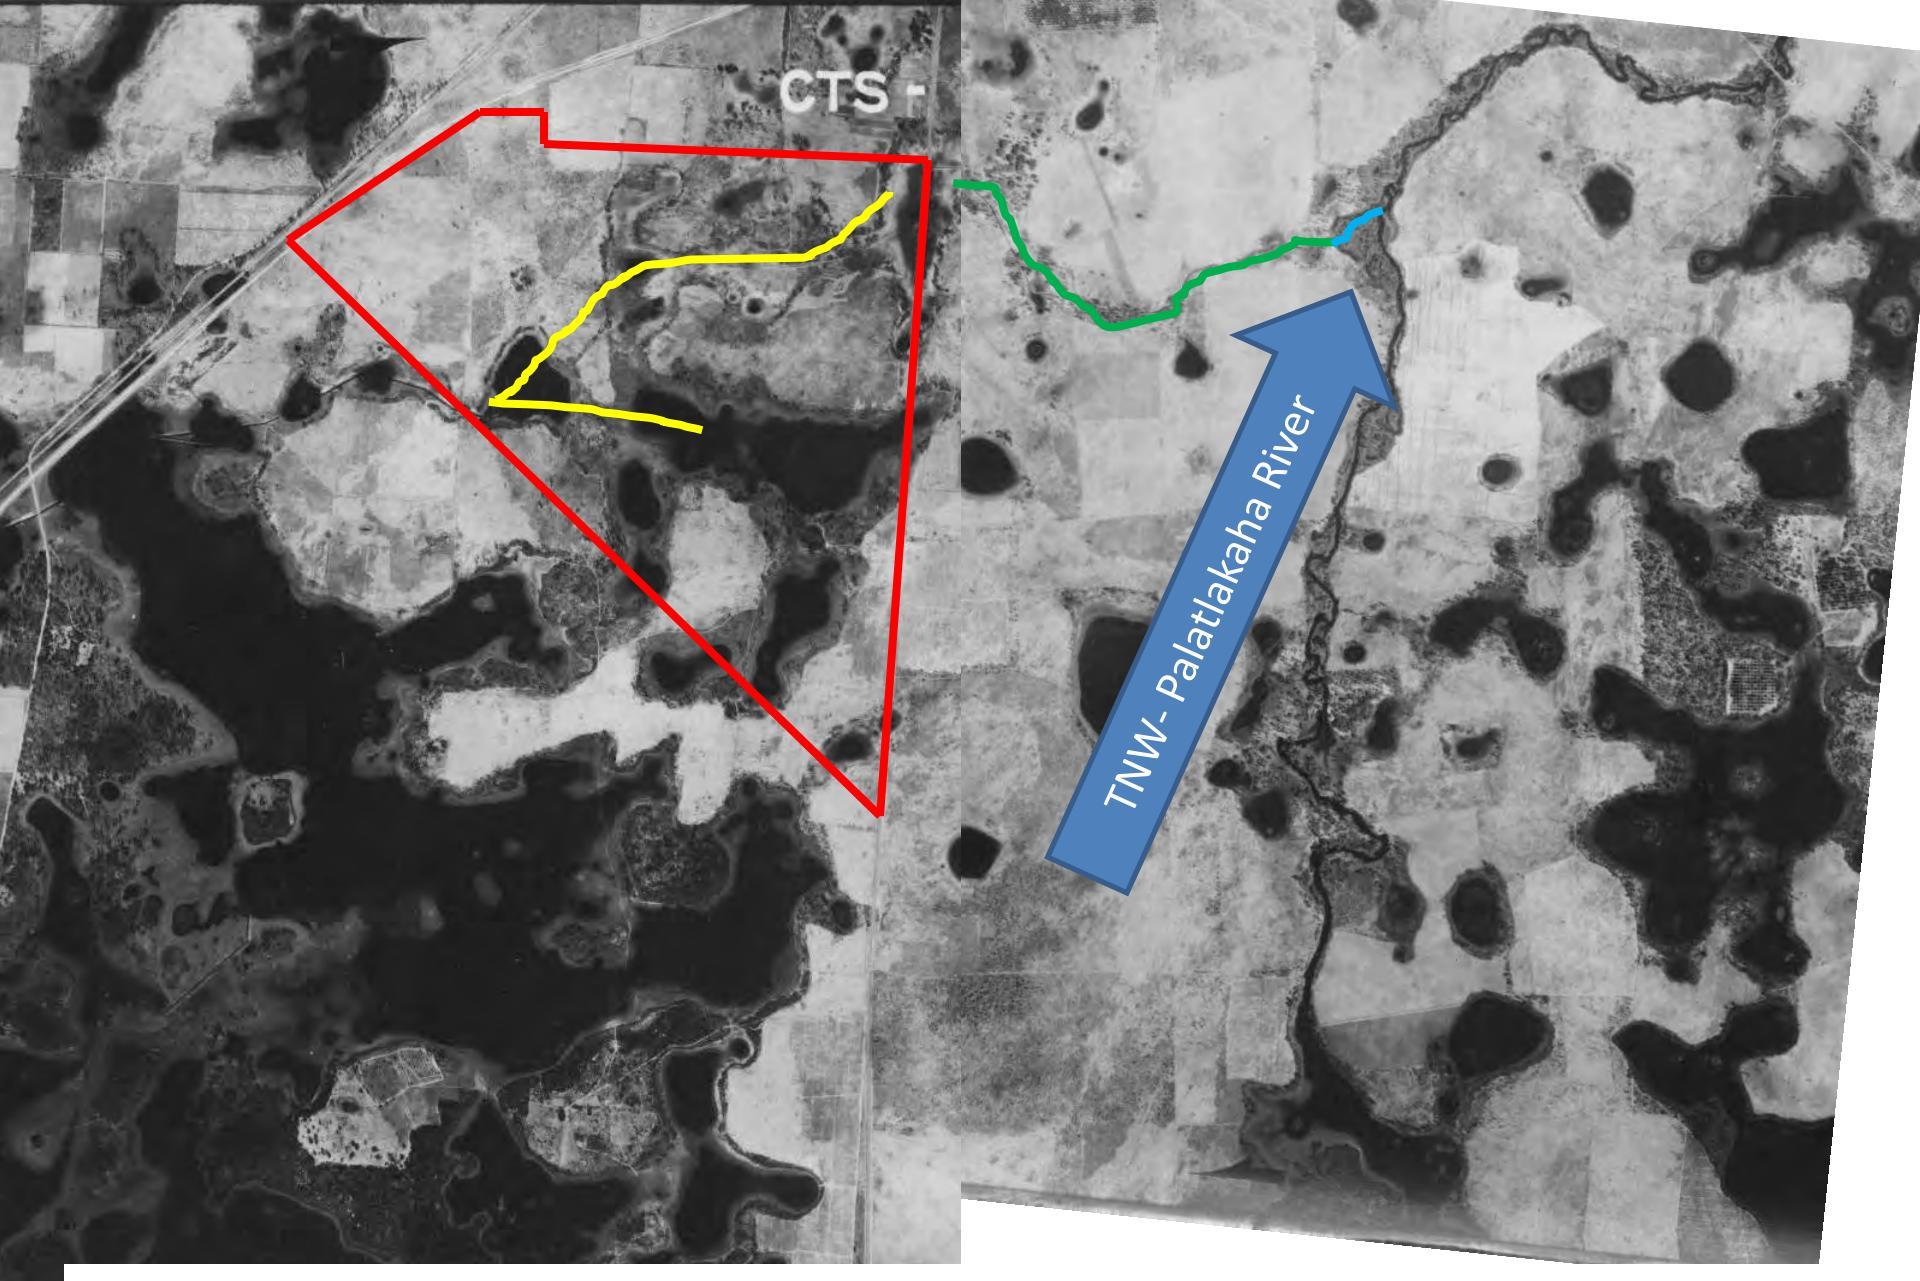
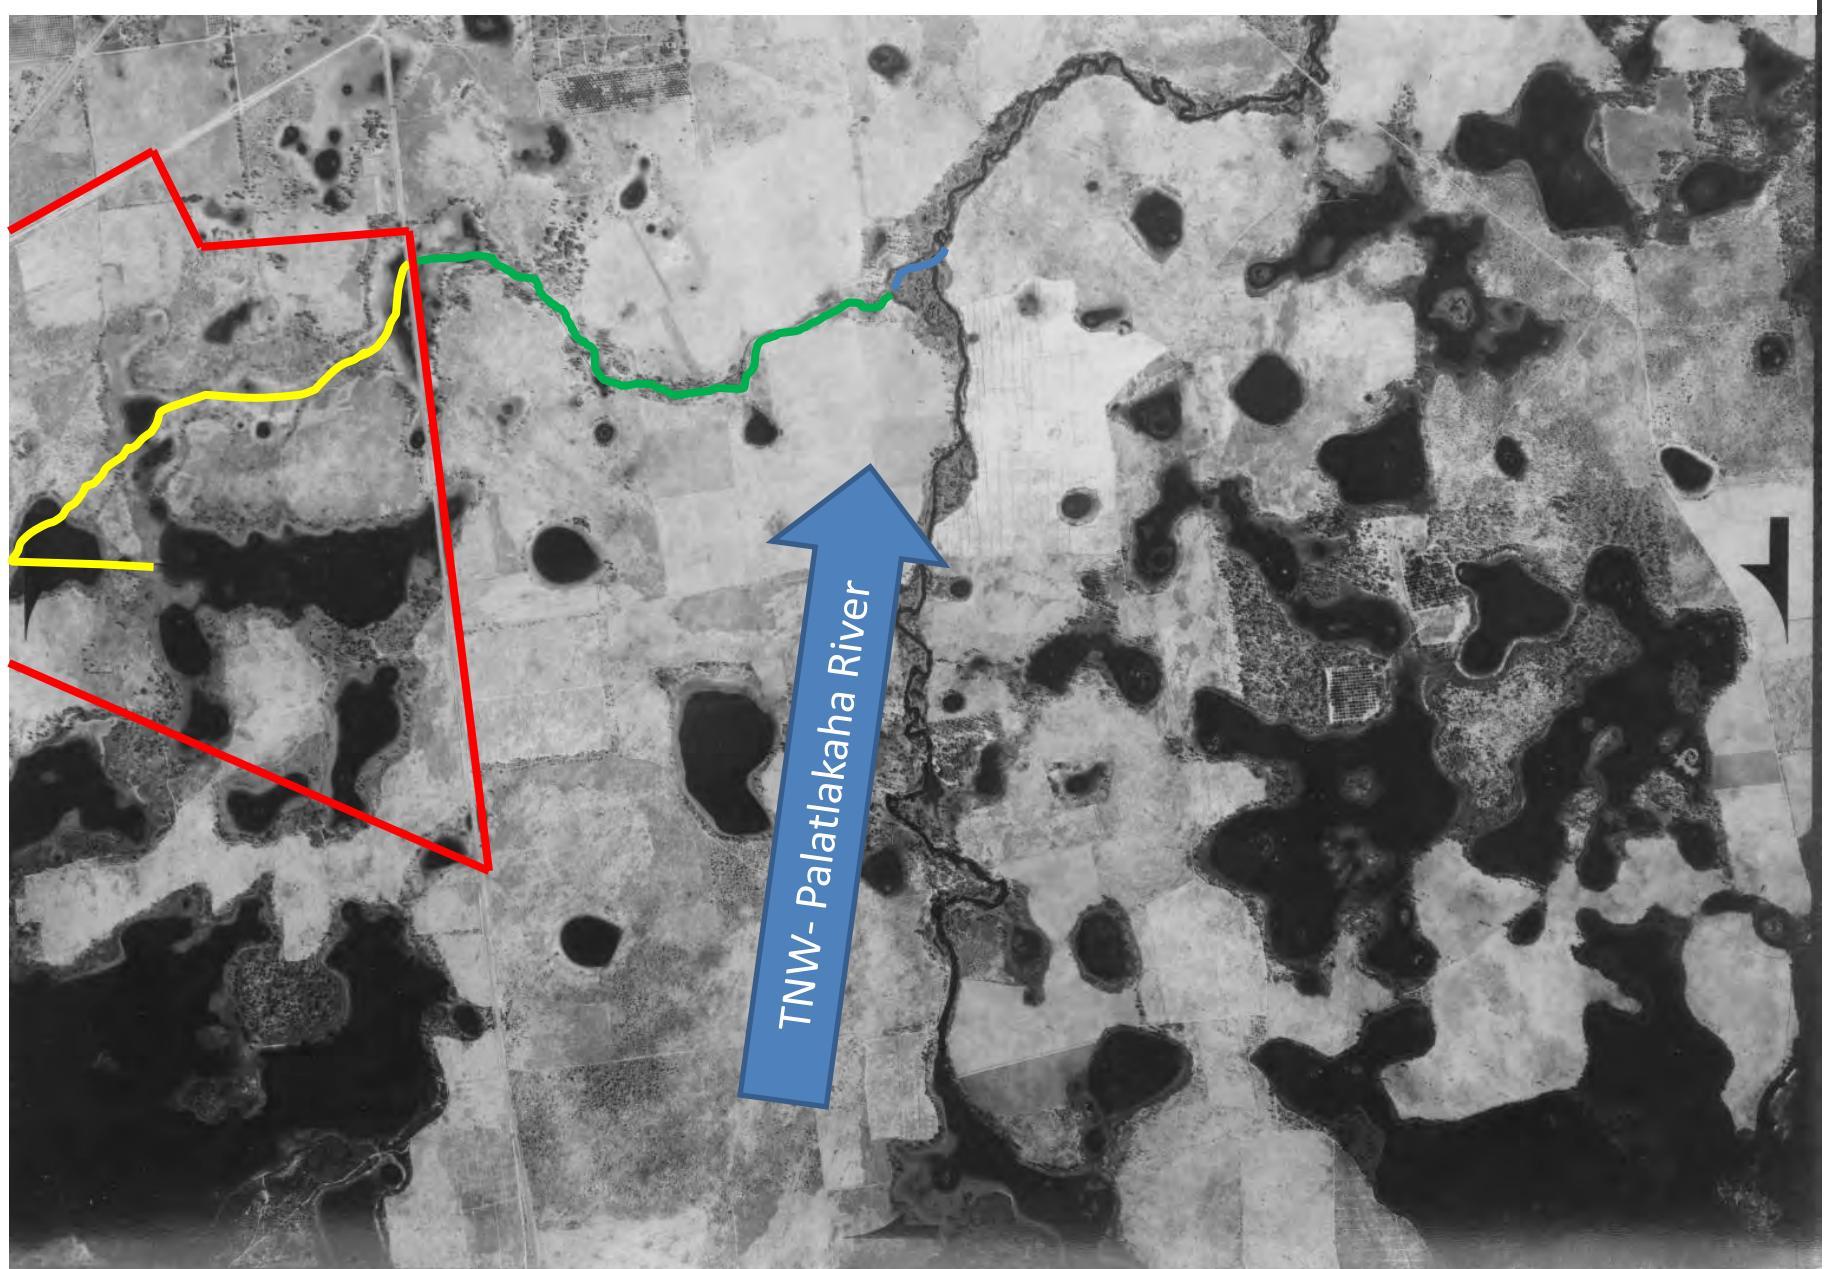
1941 Historic aerial photograph. The project site is outlined in red, Ditch 4 is shown in yellow, Ditch 1 is shown in green and RPW is shown in blue.

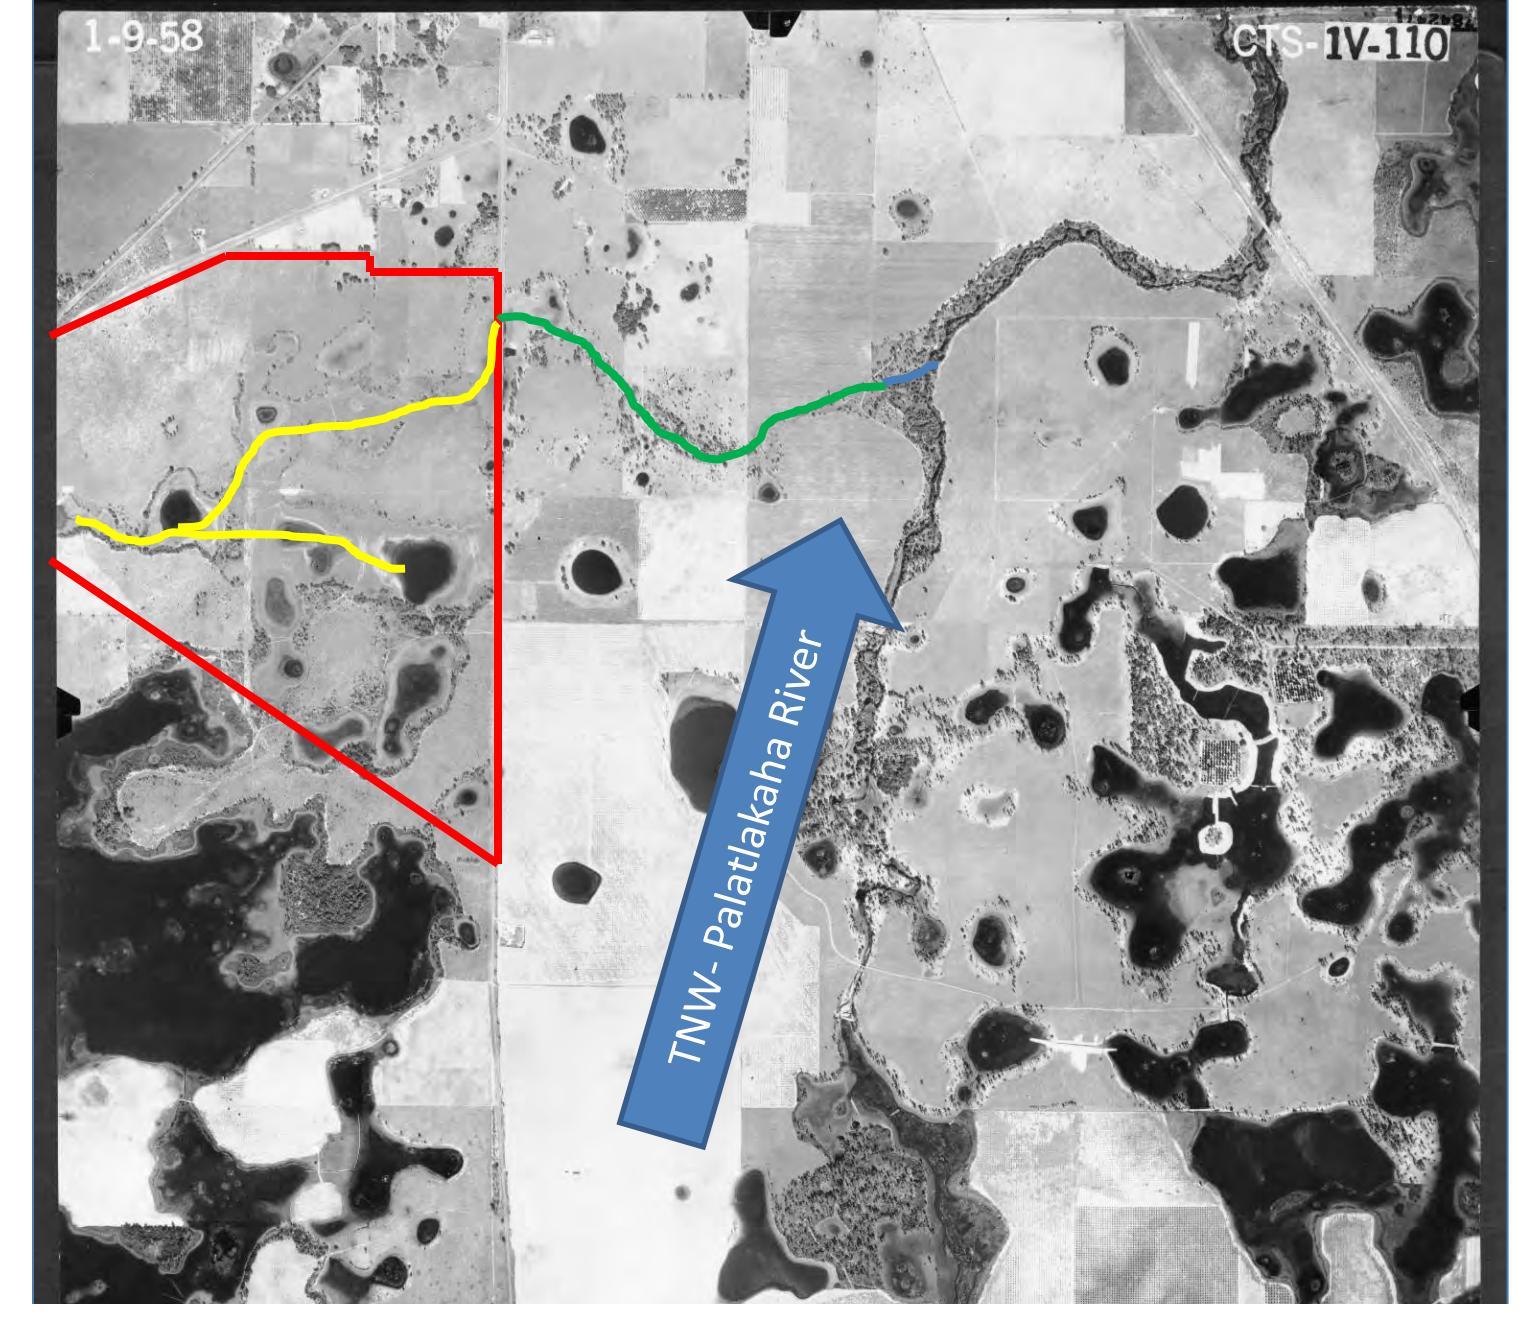
1958 Historic aerial photograph. The project site is outlined in red. Ditch 4 is shown in yellow, Ditch 1 is shown in green and RPW is shown in blue.

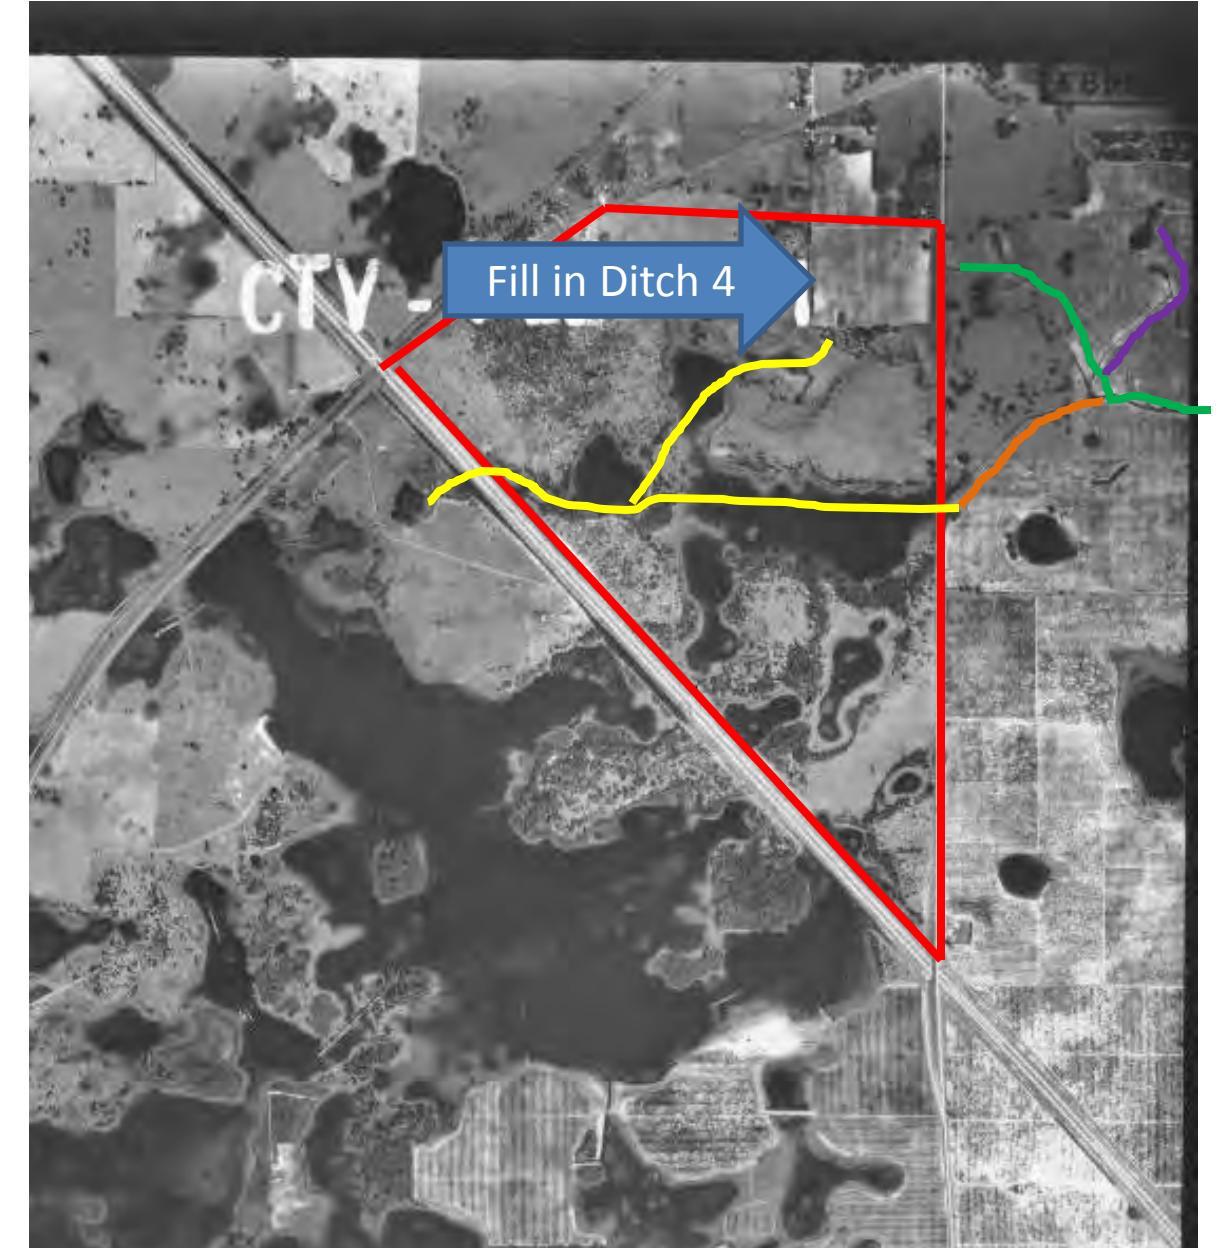
1969 Historic aerial photograph. The project site is outlined in red, Ditch 4 is shown in yellow, Ditch 1 is shown in green, Ditch 2 is shown in orange and Ditch 3 is shown in purple.

Manipulated (man-altered). Explain: Historic aerial photographs from 1969 indicate a ditch was

excavated within the RPW.

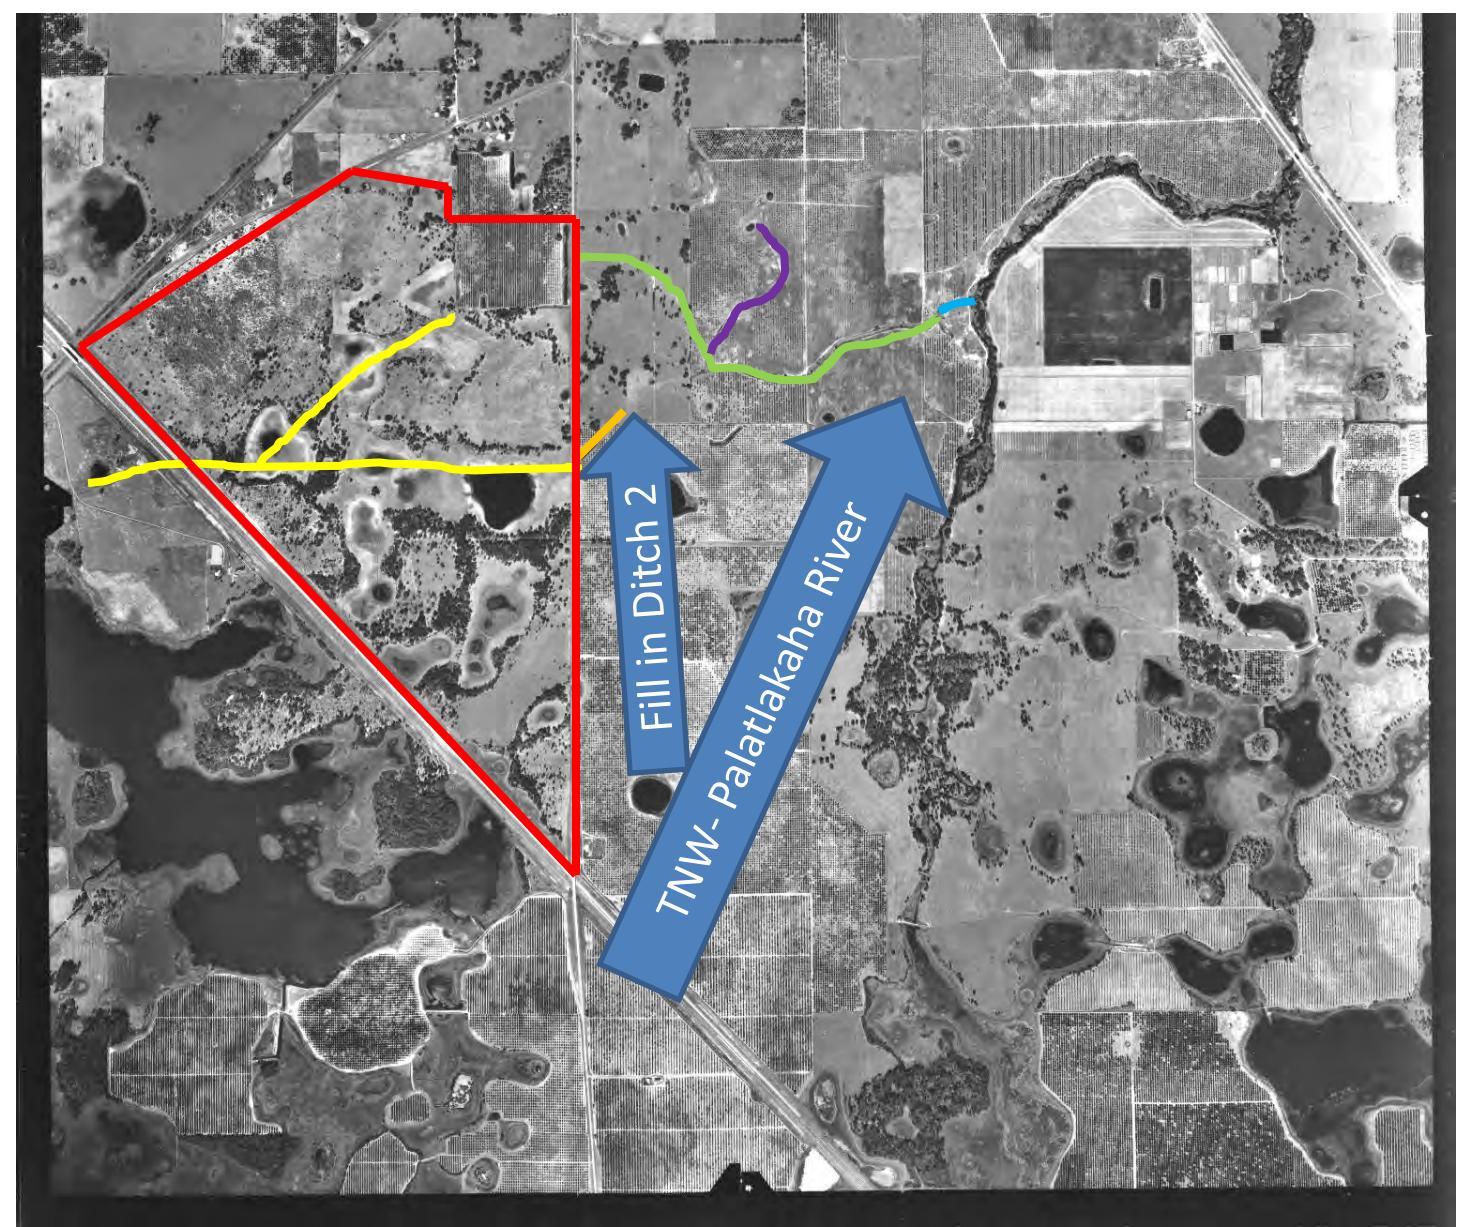
1974 Historic aerial photograph. The project site is outlined in red, Ditch 4 is shown in yellow, Ditch 1 is shown in green, Ditch 2 is shown in orange and Ditch 3 is shown in purple.

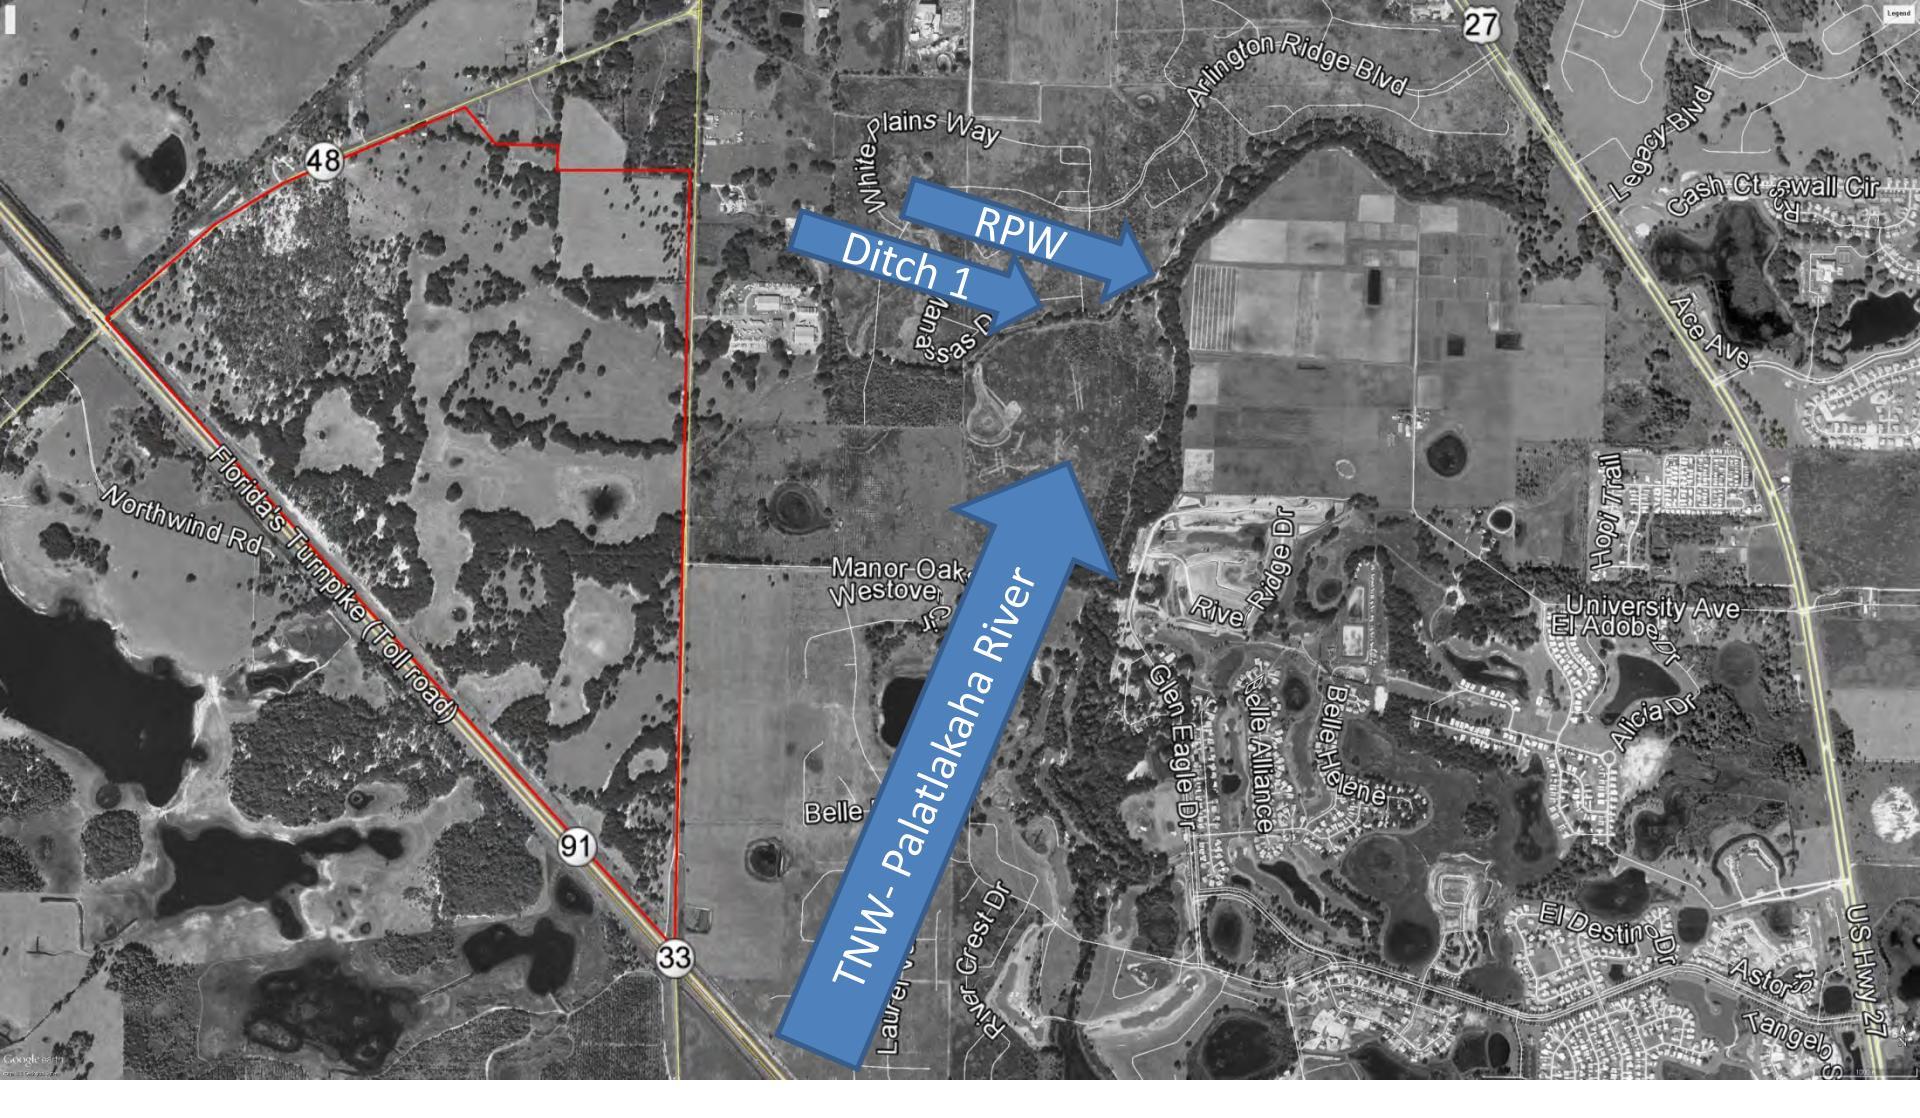
The project site is outlined in red. Aerial photograph from 1994.

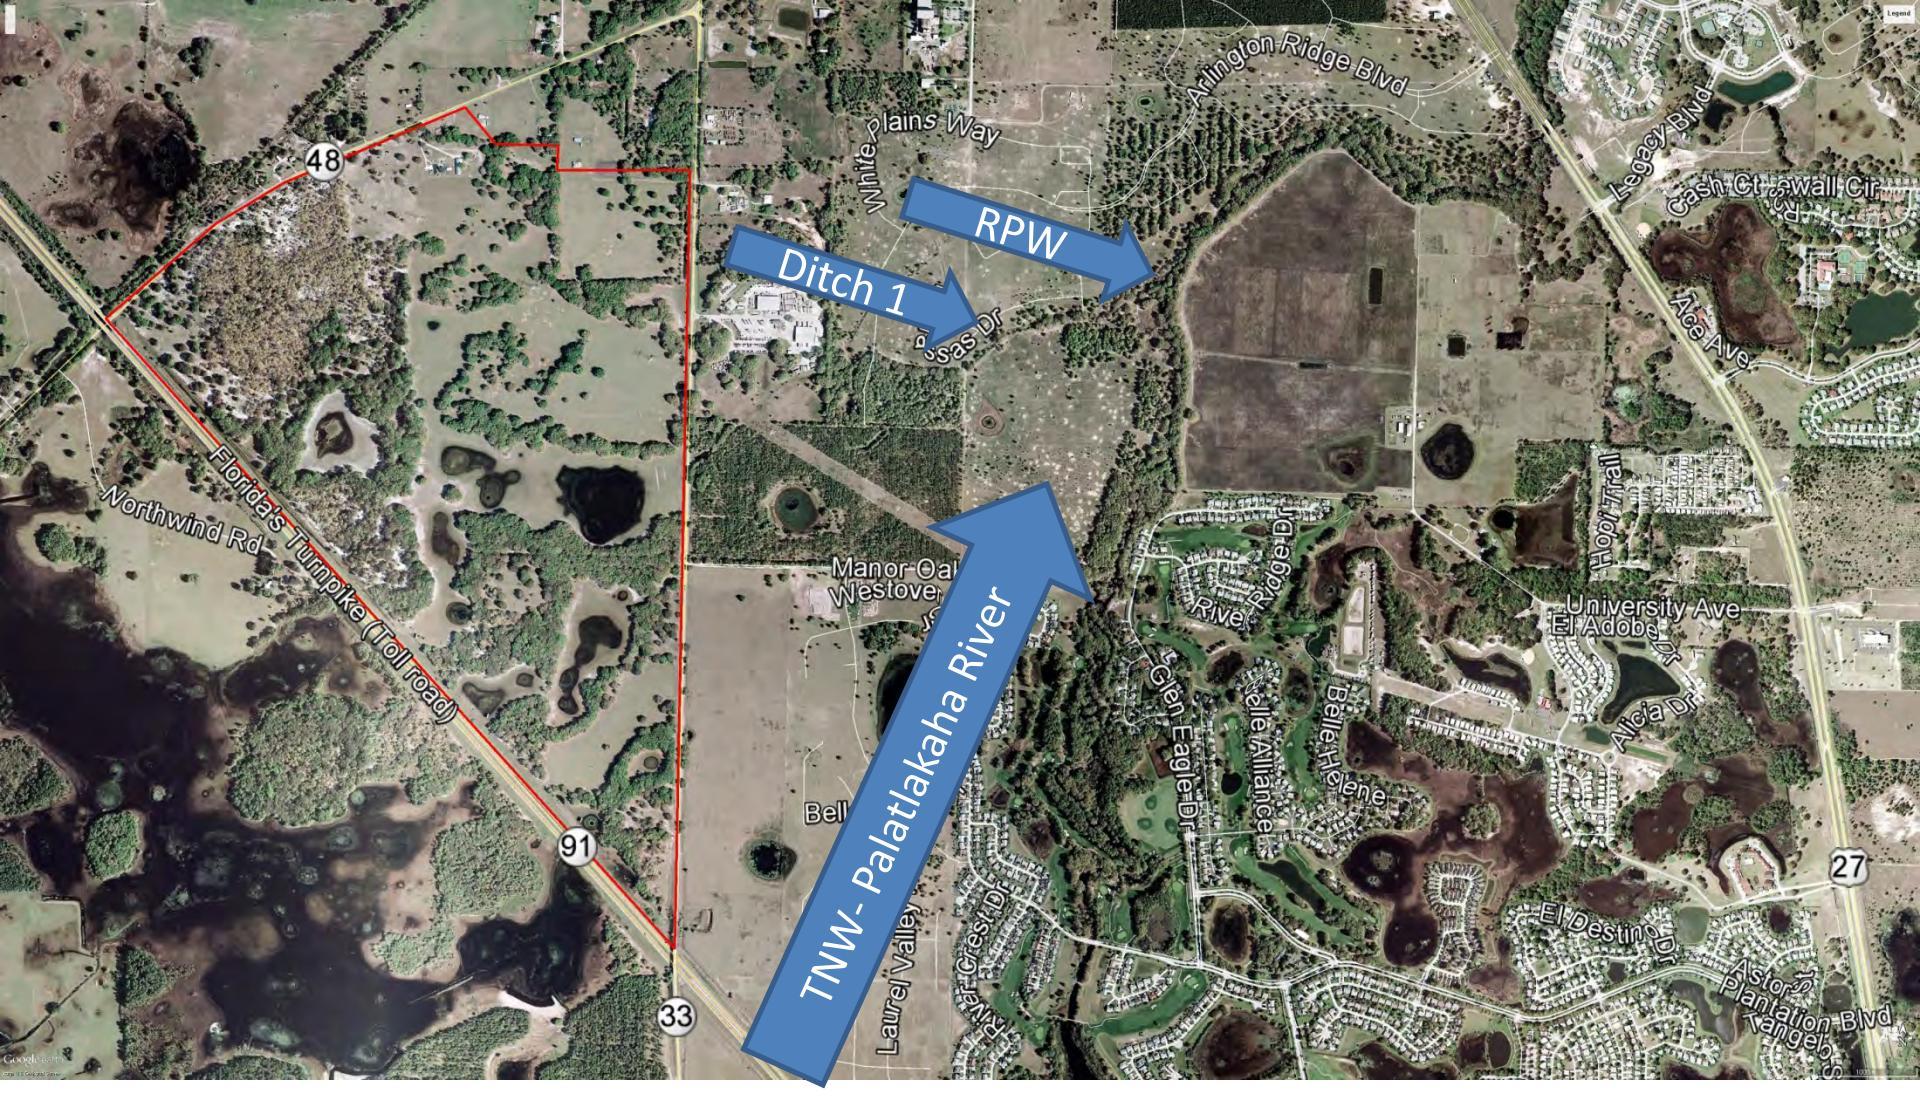
The project site is outlined in red. Aerial photograph from 2004.
