APPROVED JURISDICTIONAL DETERMINATION FORM **U.S. Army Corps of Engineers**

B. DISTRICT OFFICE, FILE NAME, AND NUMBER: Jacksonville District; Walton Acquisitions, LLC/Denham Village; SAJ-2015-2703-SCW

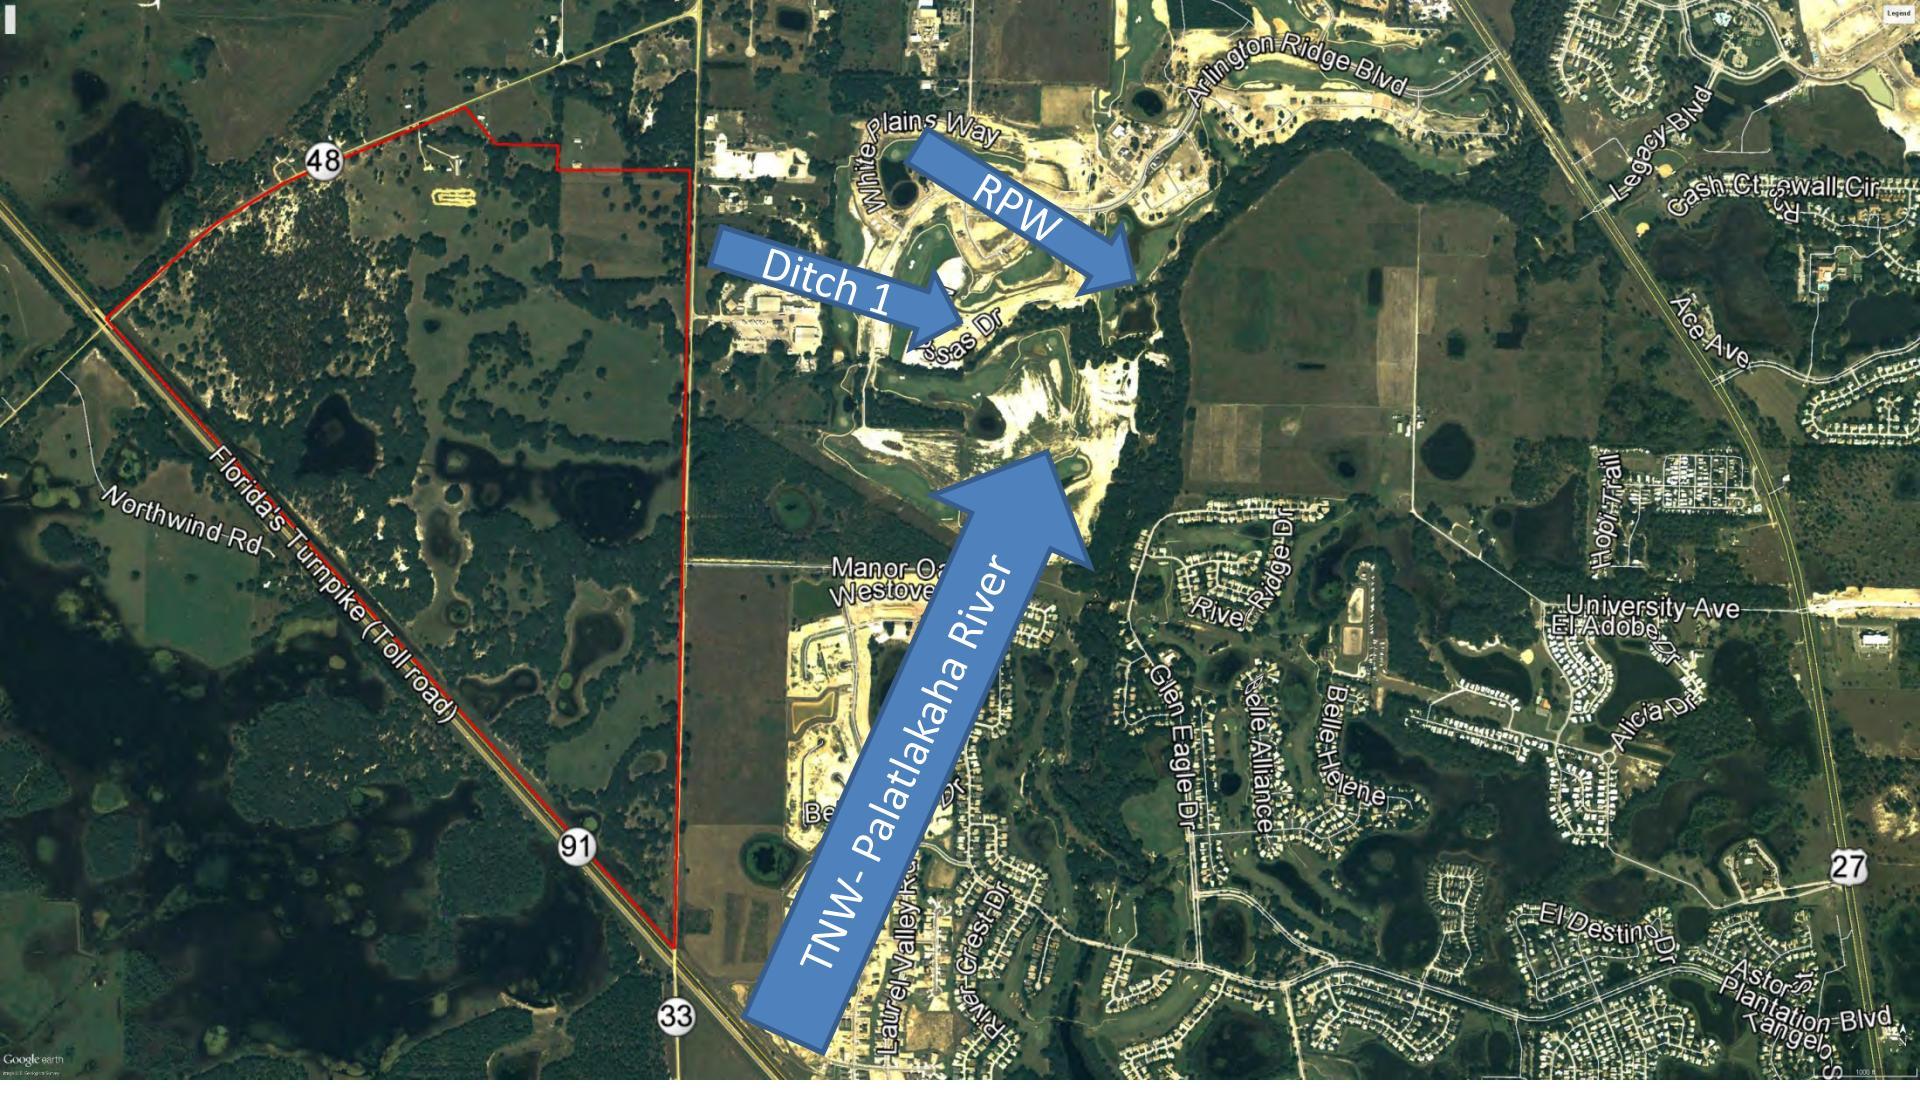
The project site is outlined in red. Aerial photograph from 2005.
