October 4, 1996

**Re: Site Investigation Report for the Culebra Island National Wildlife Refuge Site,  
Culebra Island, Puerto Rico (DERP-FUDS Site No. IO2PR006800; Contract No.  
DACW17-95-D-0010; Delivery Order No. 2)**

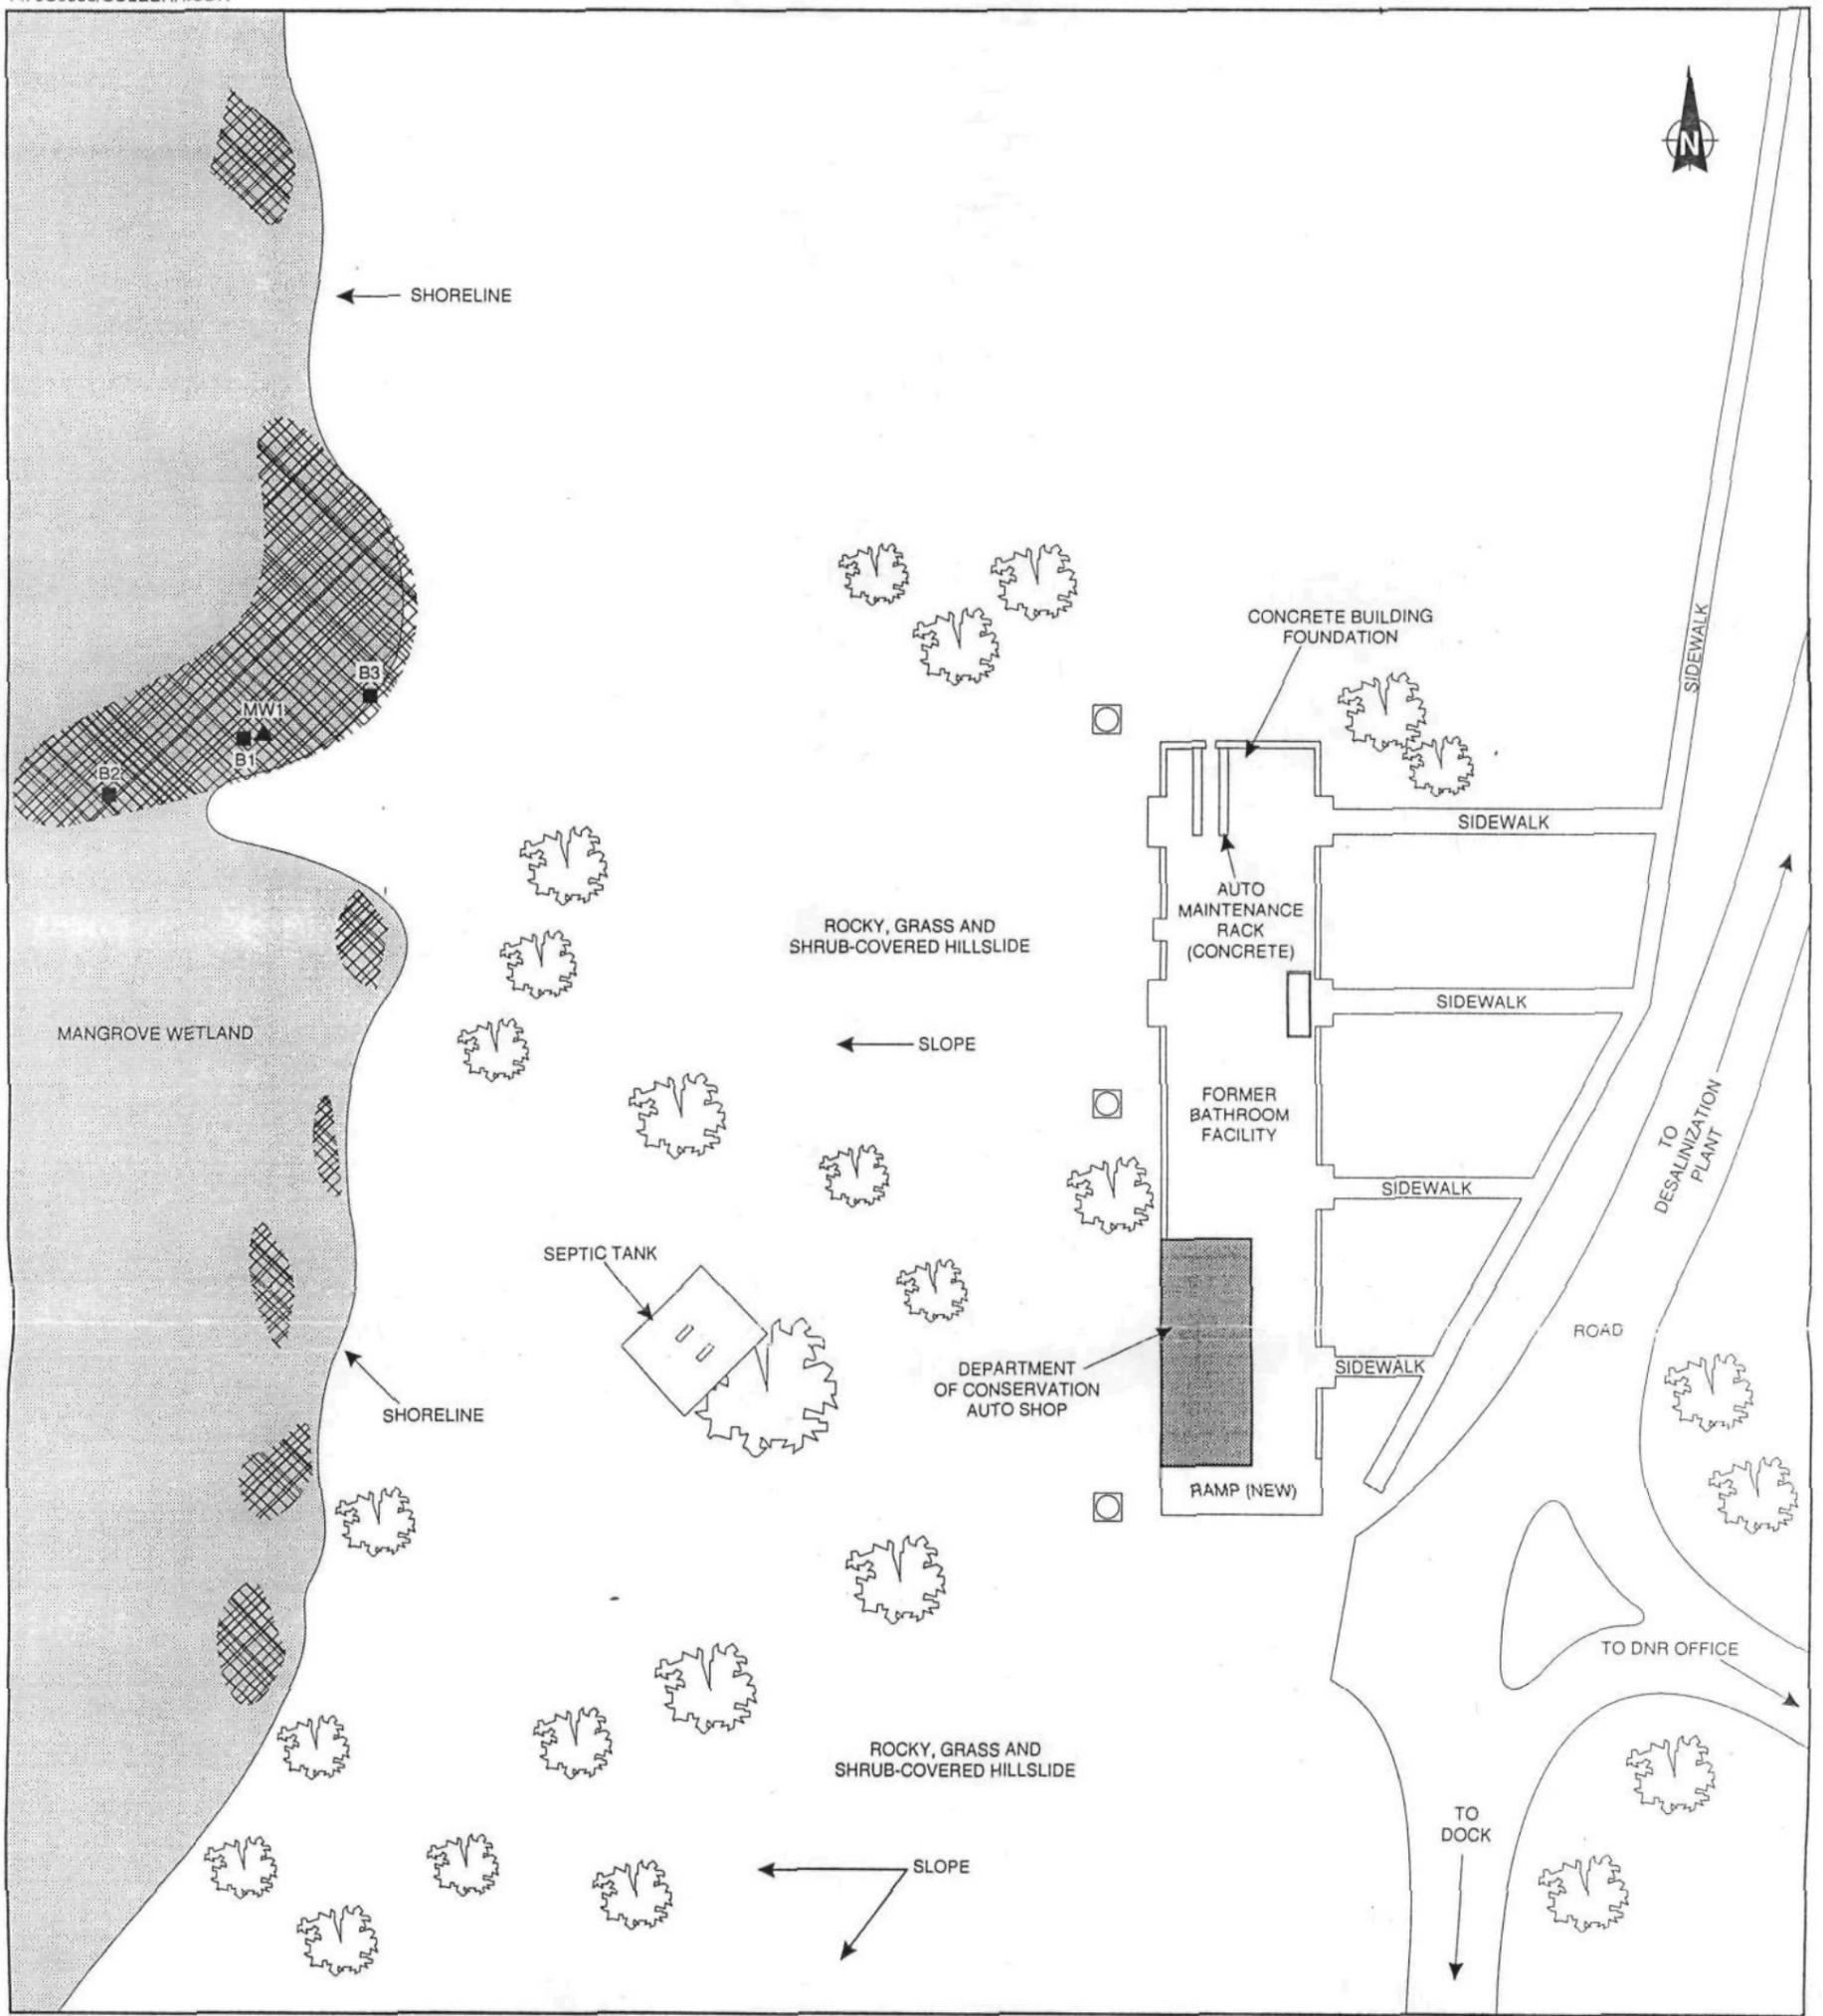
Figure 2 SITE MAP -- CULEBRA ISLAND NATIONAL WILDLIFE REFUGE, CULEBRA ISLAND, PUERTO RICO

Debris is scattered along approximately 400 feet of the shoreline and extends from 20 to 100 feet into the wetland. The largest concentration of debris occupies an area approximately 120 by 40 feet (see Figure 2). The debris consists primarily of highly-rusted metal building materials such as steel beams and rods, corrugated steel sheeting and bolts. Other material observed in the wetland area includes broken glass and automobile parts. The eastern edge of the wetland area is approximately 180 feet west (downslope) of a 35 by 160-foot concrete foundation. The foundation was formerly a bathroom facility and is currently used as the Department of Conservation Automotive Maintenance facility. The hillside between the automotive maintenance facility and the wetland area is scattered with auto body parts and corrugated steel sheeting that appears relatively new (within 10 to 15 years). Figure 2 shows the site layout; photographs of the site are included as Attachment A.

A total of three borings were completed within the wetland in the area of most concentrated debris (see Figure 2). The depth to water was approximately 0.3 foot below ground surface (BGS). Boring B-1 was completed to 4 feet BGS and borings B-2 and B-3 were completed to 2 feet BGS. The lithology at each boring location from ground surface to the completion depth was characterized as black organic silt and peat. Composite samples were collected at 2 foot intervals from the surface to the completion depth of each boring (see Table 1).

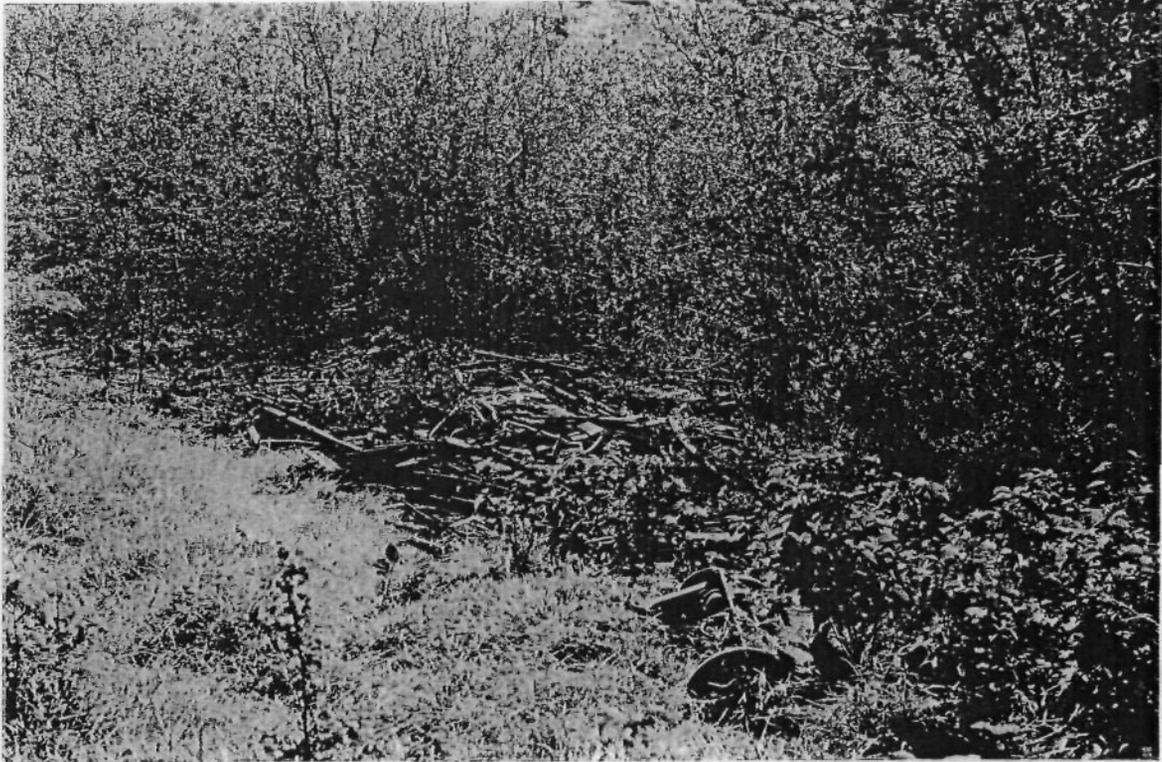
3. Culebra Island NWR (metal debris in wetland area)

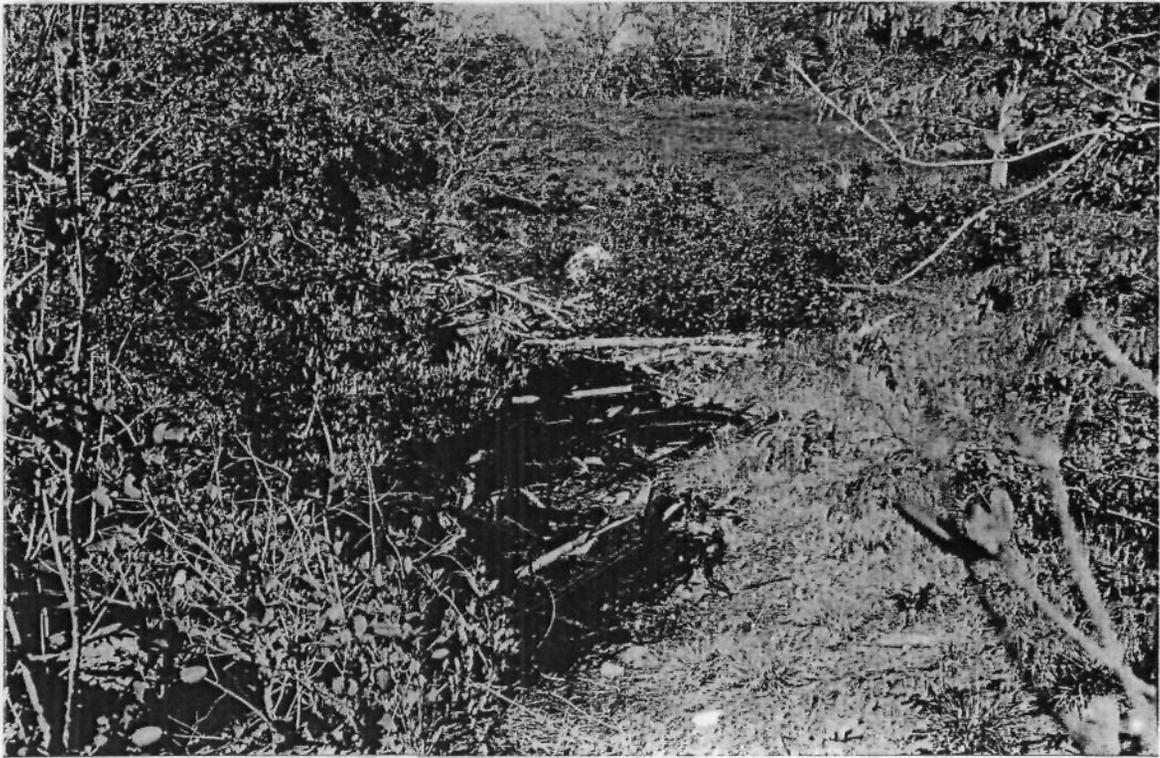
4. Culebra Island NWR (metal debris in wetland area)

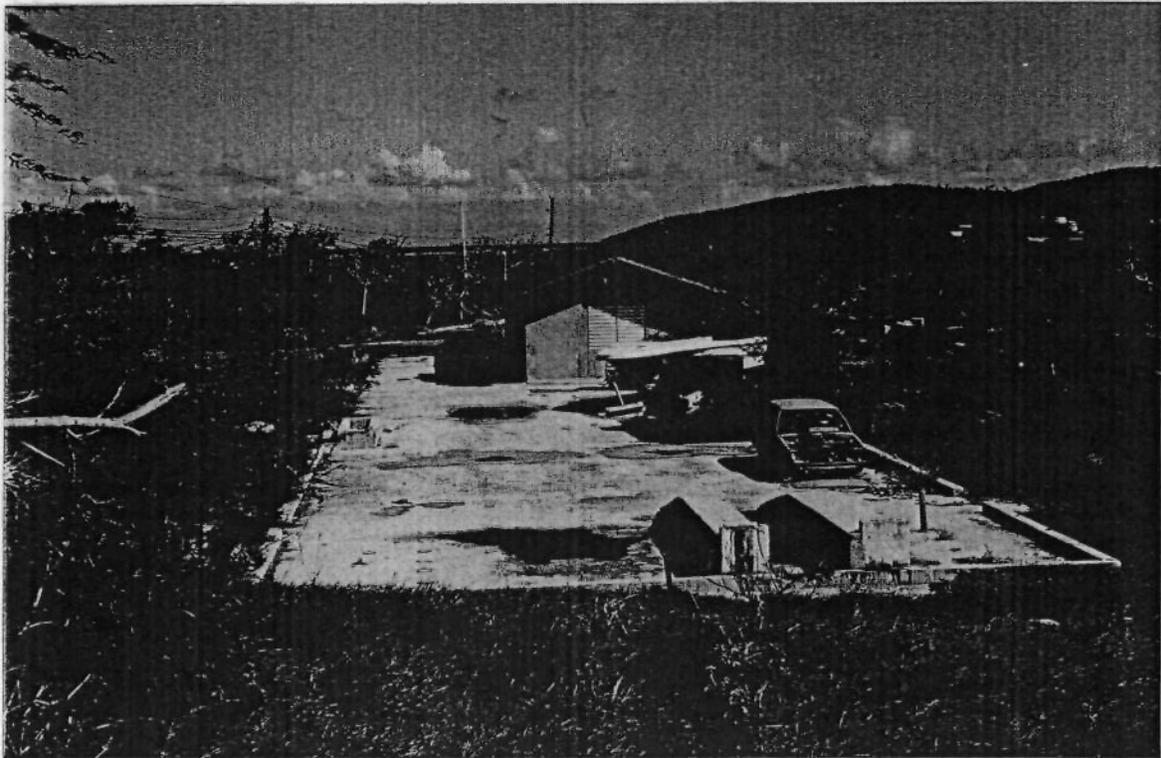
2. Culbra Island NWR (former bathroom foundation and auto shop)

From the early 1940s until 1980, the area to the east of the wetland was used as a housing facility by the U.S. Navy. The concrete foundation, currently occupied by the Department of Conservation auto shop, was previously a bathroom facility. Between the early 1940s and 1980, various materials were apparently discarded into the wetland area west of the bathroom facility. In September 1980, the Navy transferred the property to the U.S. Department of Interior, Fish and Wildlife Service, and it is now the Culebra Island National Wildlife Refuge under the control of the Puerto Rico Department of Natural Resources.
