Statewide Programmatic Biological Assessment

*Beach Placement and Shore
Protection, Coast of Florida*
June 15, 2010

U.S. Army Corps of Engineers
Jacksonville District

For Sand Placement and Shore Protection
Along the Coast of Florida

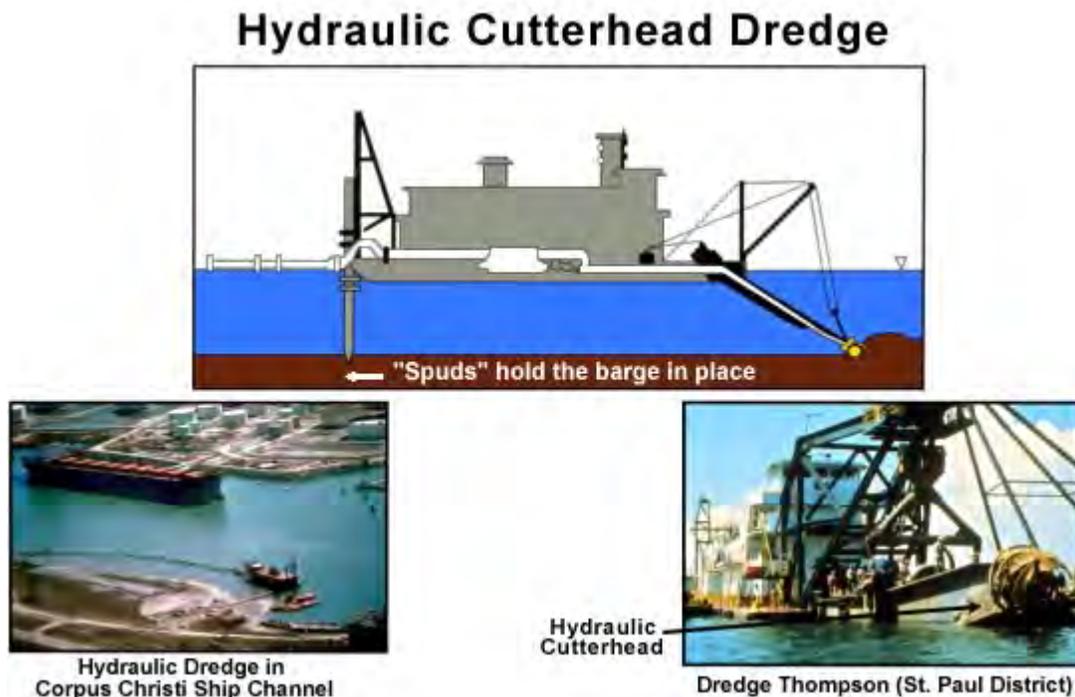
Figure 1. Cutterhead pipeline dredge schematic.

Pipeline dredges are rarely self-propelled and; therefore, must be transported to and from the dredge site. Pipeline dredge size is based on the inside diameter of the discharge pipe which commonly range from 6" to 36." They require an extensive array of support equipment including pipeline (floating, shore, and submerged), boats (crew, work, survey), barges, and pipe handling equipment. Most pipeline dredges have a cutterhead on the suction end. A cutterhead is a mechanical device that has rotating teeth to break up or loosen the bottom material so that it can be sucked through the dredge. Some cutterheads are rugged enough to break up rock for removal (Figure 1).

Cutterhead pipeline dredges work best in large areas with deep shoals, where the cutterhead is buried in the bottom. A cutterhead removes dredged material through an intake pipe and then pushes it out the discharge pipeline directly into the disposal site. Most, but not all, pipeline dredging operations involve upland disposal of the dredged material. Therefore, the discharge end of the pipeline is connected to shore pipe. When effective pumping distances to the disposal site become too long, a booster pump is added to the pipeline to increase the efficiency of the dredging operation (USACE, 1993).

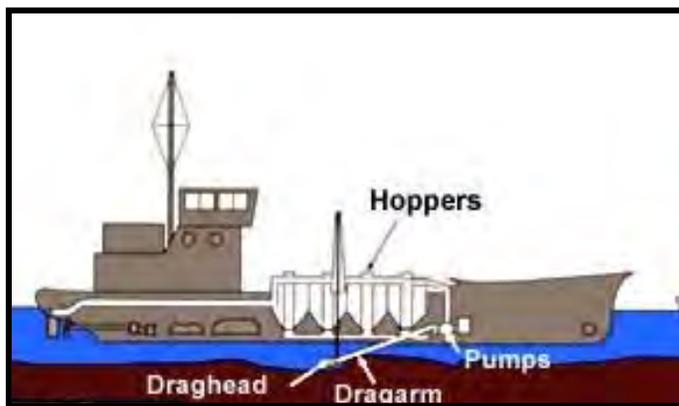
Figure 2. Hopper dredge schematic.

The hopper dredge, or trailing suction dredge, is a self-propelled ocean-going vessel with a section of the hull compartmented into one or more hoppers. Fitted with powerful pumps, the dredges suck dredged material from the channel bottom through long intake pipes, called drag arms, and store it in the hoppers. Normal hopper dredge configuration has two dragarms, one on each side of the vessel. A dragarm is a pipe suspended over the side of the vessel with a suction opening called a draghead for contact with the bottom. The dredged slurry is distributed within the vessels hopper allowing for solids to settle out and the water portion of the slurry to be discharged from the vessel during operations through its overflow system. When the hopper attains a full load, dredging stops and the ship travels to an in-water disposal site, where the dredged material is discharged through the bottom of the ship by splitting the hull. Some hopper dredges are capable of pumping the material back out of the vessel and through a series of shore-pipe to a designated disposal location (See Section 4.02).

continuously. The precision of hopper dredging is less than other types of dredges; therefore, they have difficulty dredging steep side banks and cannot effectively dredge around structures. In order to minimize the risk of incidental takes of sea turtles, the Corps requires the use of sea turtle deflecting dragheads on all hopper-dredging projects where the potential for sea turtle interactions exist. The leading edge of the deflector is designed to have a plowing effect of at least 6" depth when the drag head is being operated. Appropriate instrumentation is required on board the vessel to insure that the critical "approach angle" is attained in order to satisfy the 6" plowing depth requirement (USACE, 1993).

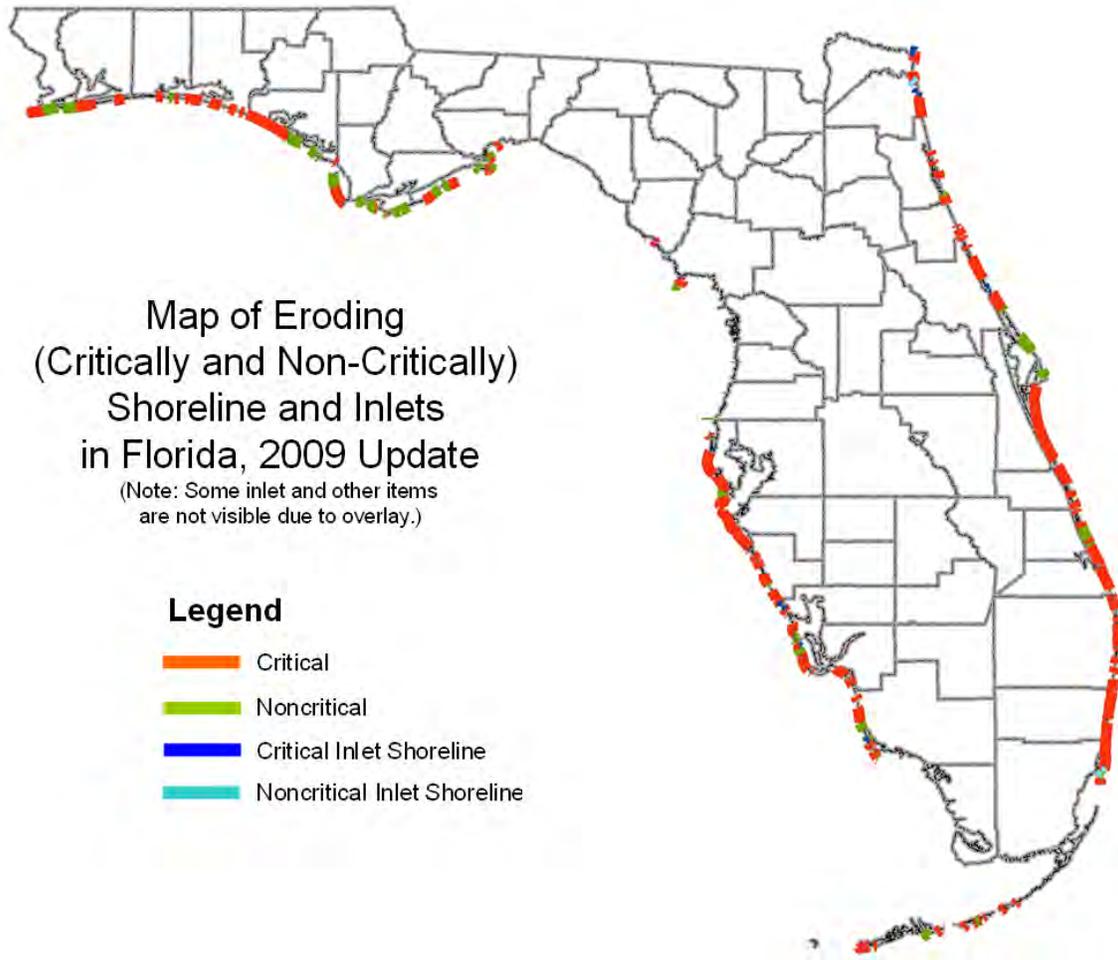
Figure 3. Erosion areas throughout the Atlantic and Gulf coasts of Florida (for more detailed information go to <http://www.dep.state.fl.us/beaches/programs/coasteng.htm>).

Between 1964 and 1998, the Florida Legislature has appropriated nearly \$200 million for beach preservation and erosion control with matching funds provided by local government and federal dollars (FCMP, 1998). While funding remains substantial, the current economic downturn has resulted in a reduction of revenues and expenditures for shore protection by the state. Depending on the shoreline protection measure utilized, the potential for habitat degradation may exist. However, for beach communities throughout the Atlantic and Gulf coasts of Florida, erosion rates are so severe that beachfront habitat is almost entirely lost and; therefore, restoration of habitat through beach management practices is becoming critical.

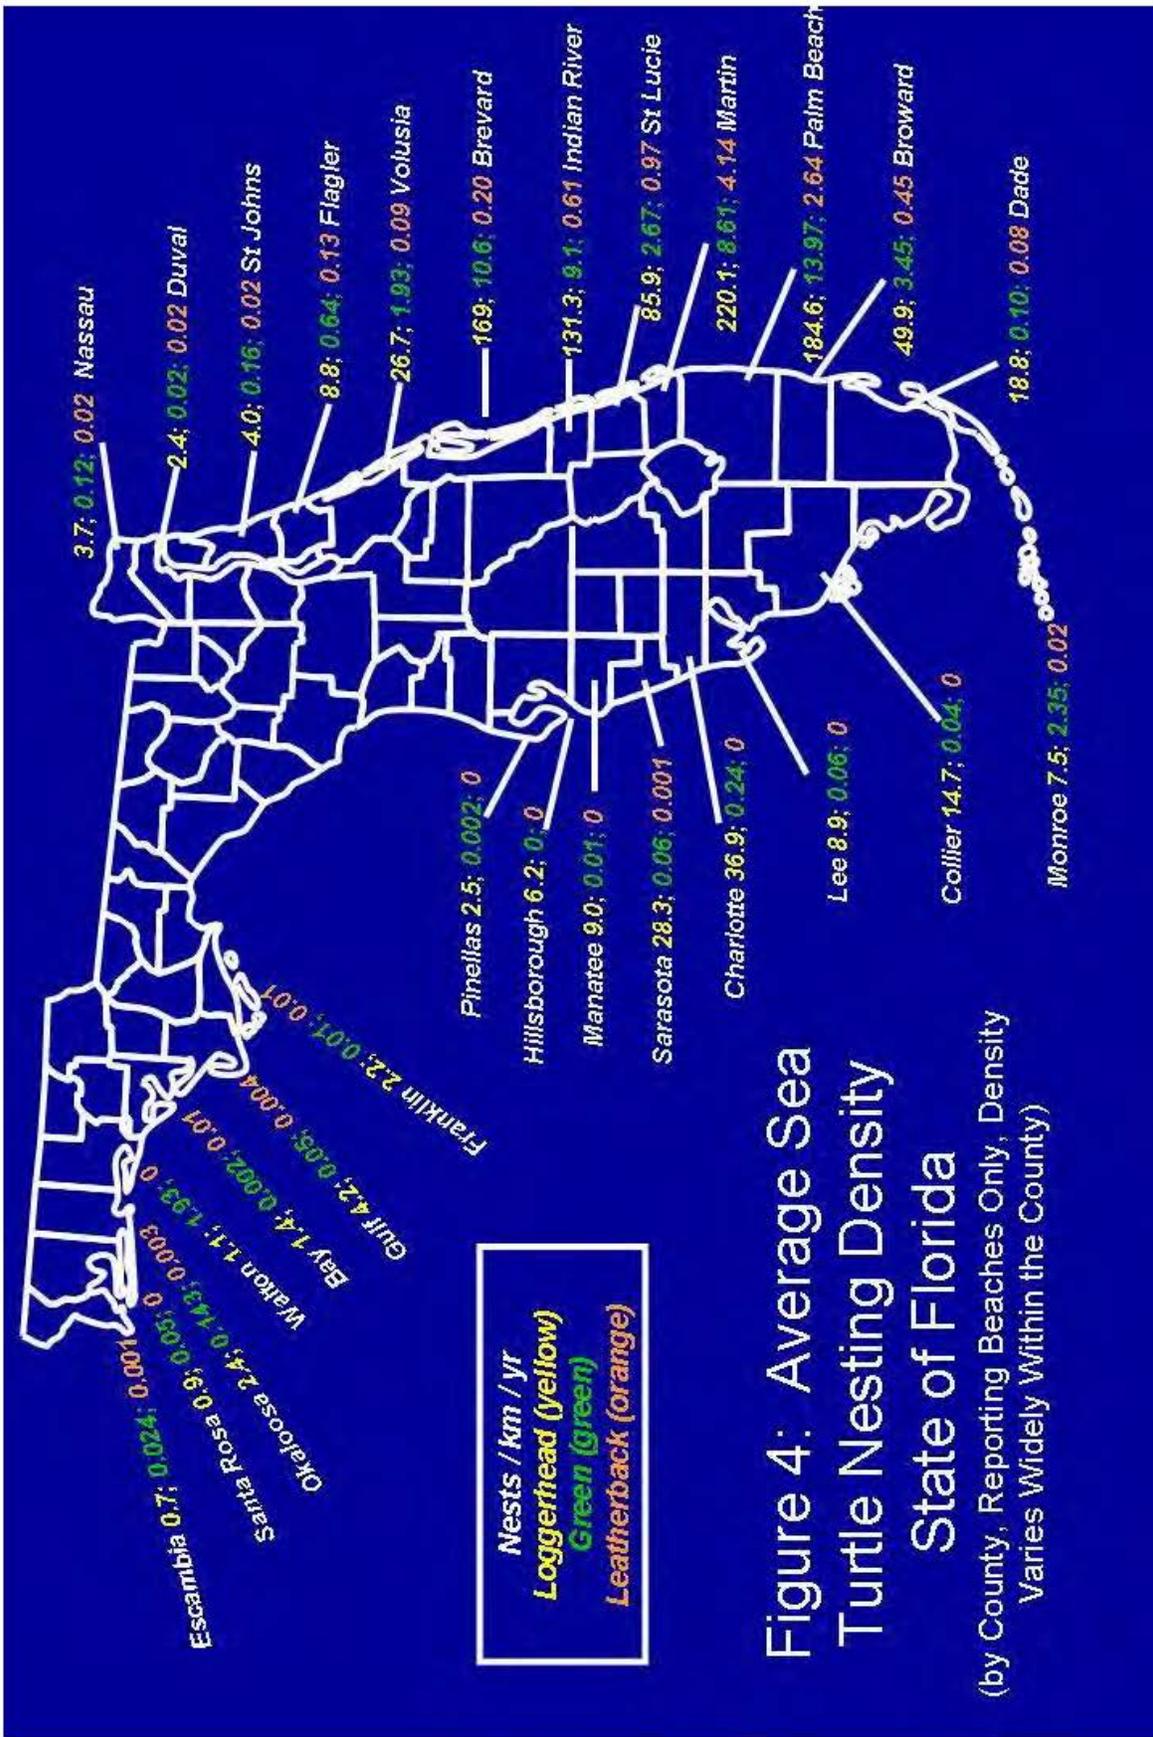
Figure 4: Average Sea Turtle Nesting Density State of Florida
 (by County, Reporting Beaches Only, Density Varies Widely Within the County)

<http://research.myfwc.com> . The average sea turtle nesting density by county (using 1988 to 2005 data) is shown in Figure 4 .

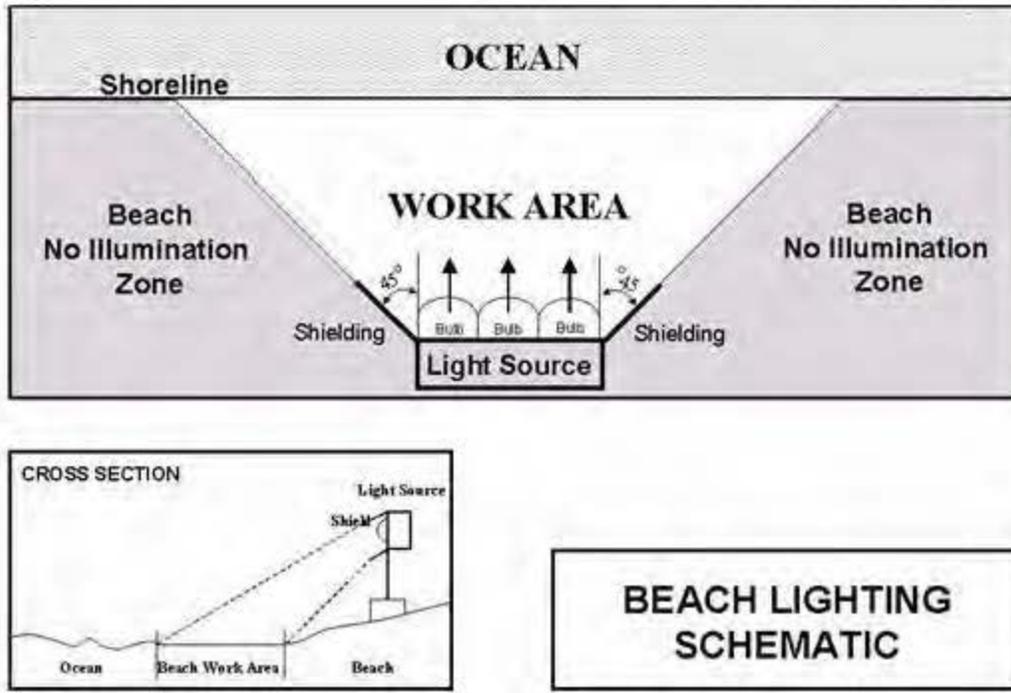
Figure 5. Beach lighting schematic identifying reduction, shielding, lowering, and appropriate placement of lights to minimize illumination of the sea turtle nesting beach and water.

If beach construction activities occur during the sea turtle nesting and hatching season, all lighting associated with project construction will be minimized to the maximum extent practicable while maintaining compliance with all Corps, U.S. Coast Guard, and OSHA safety requirements. Direct lighting of the beach and near shore waters will be limited to the immediate construction area(s). Lighting aboard dredges and associated vessels, barges, etc. operating near sea turtle nesting beaches shall be limited to the minimal lighting necessary to comply with the Corps, U.S. Coast Guard, and OSHA requirements. Lighting on offshore or onshore equipment will be minimized through reduced wattage, shielding, lowering, and/or use of low pressure sodium lights, in order to reduce illumination of adjacent beach and nearshore waters will be used to the extent practicable (Figure 5). Shielded low-pressure sodium vapor lights have been identified by the FWCC as the best available technology for balancing human safety and security, roadway illumination, and endangered species protection. They provide the most energy efficient, monochromatic, long-wavelength, dark sky friendly, environmentally sensitive light of the commercially available street lights and will be highly recommended for all lights on the beach or on offshore equipment (Gallagher, 2006).

The use of sea turtle friendly lighting has been shown to significantly improve beaches for sea turtle nesting. Implementing effective lighting ordinances or plans on major nesting beaches is a high priority for the USFWS. Therefore, in conjunction with all proposed beach projects, local lighting ordinances will be encouraged to the maximum extent practicable in order to reduce lighting impacts to nesting females and hatchlings. The applicant or local sponsor will be encouraged to work with the USFWS, local monitoring groups, and other concerned organizations to develop the best plan for each project specific environment.
