SECTION 404(b) EVALUATION

ATTACHMENT 3 – MITIGATION PLAN

**Seagrass Survey,
Federal Navigation Channel and Harbor Area,
Lake Worth Inlet, Palm Beach Harbor, FL**

FINAL REPORT

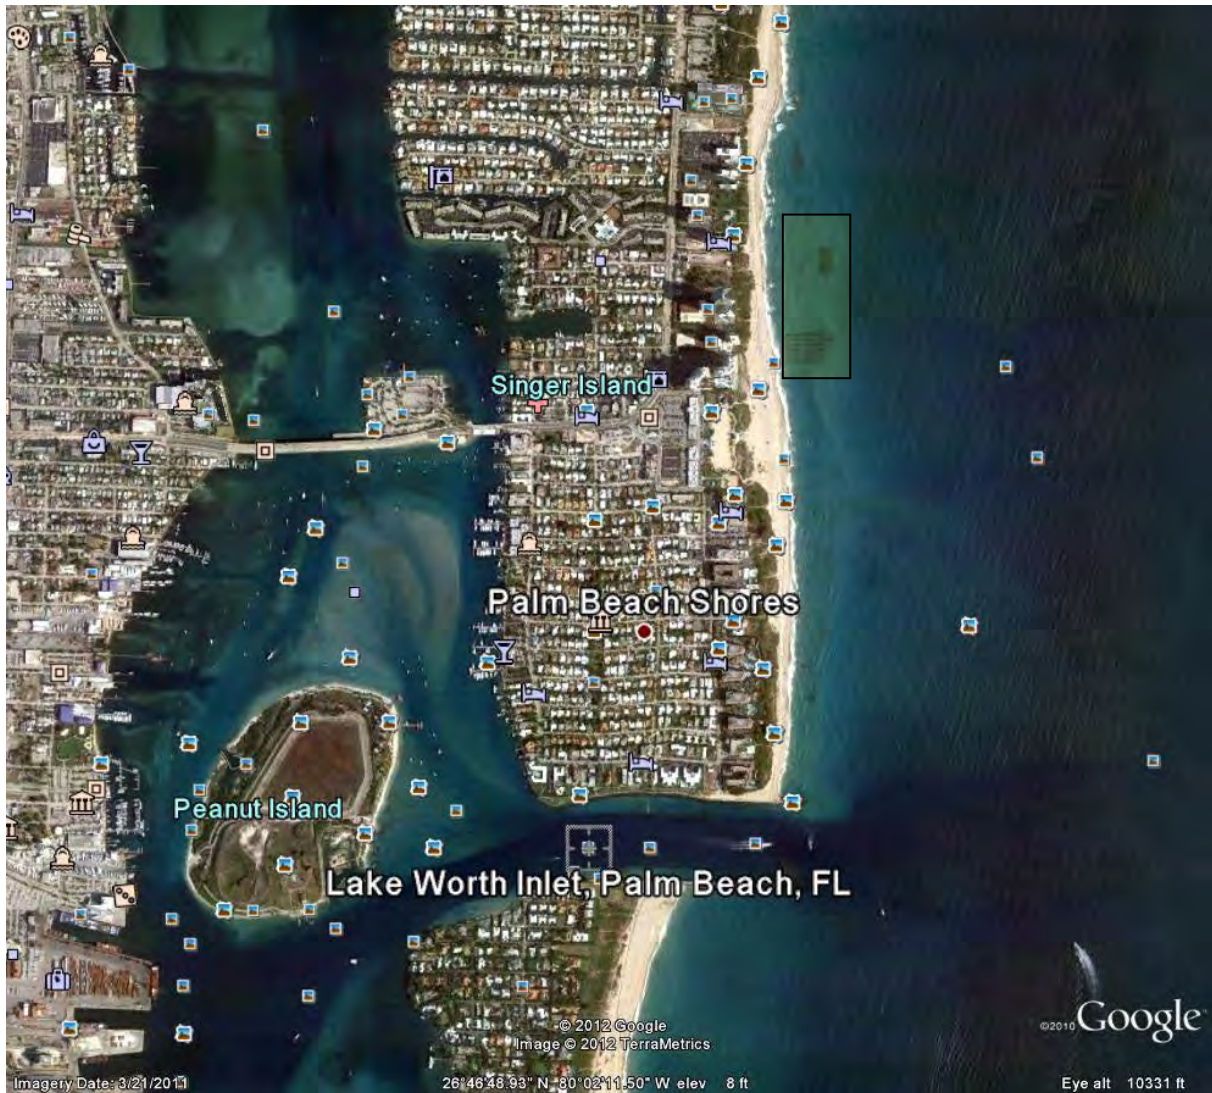
Figure 4. Proposed hardbottom mitigation site

The proposed mitigation for hardbottom impacts will be type-for-type to ensure proper species recruitment is achieved. A total of 4.9 acres of low relief-low complexity (LRLC) hardbottom will be impacted by the widening and deepening footprint and associated side slope equilibrium. To compensate for these impacts, a total of 11.25 acres of mitigation is proposed. The proposed location for mitigation of hardbottom, Singer Island Artificial Reef is found in Figure 1 and Figure 4. The Corps has the option of conducting mitigation prior to construction or simultaneously. Specific design requirements and the hardbottom design are described in this section.

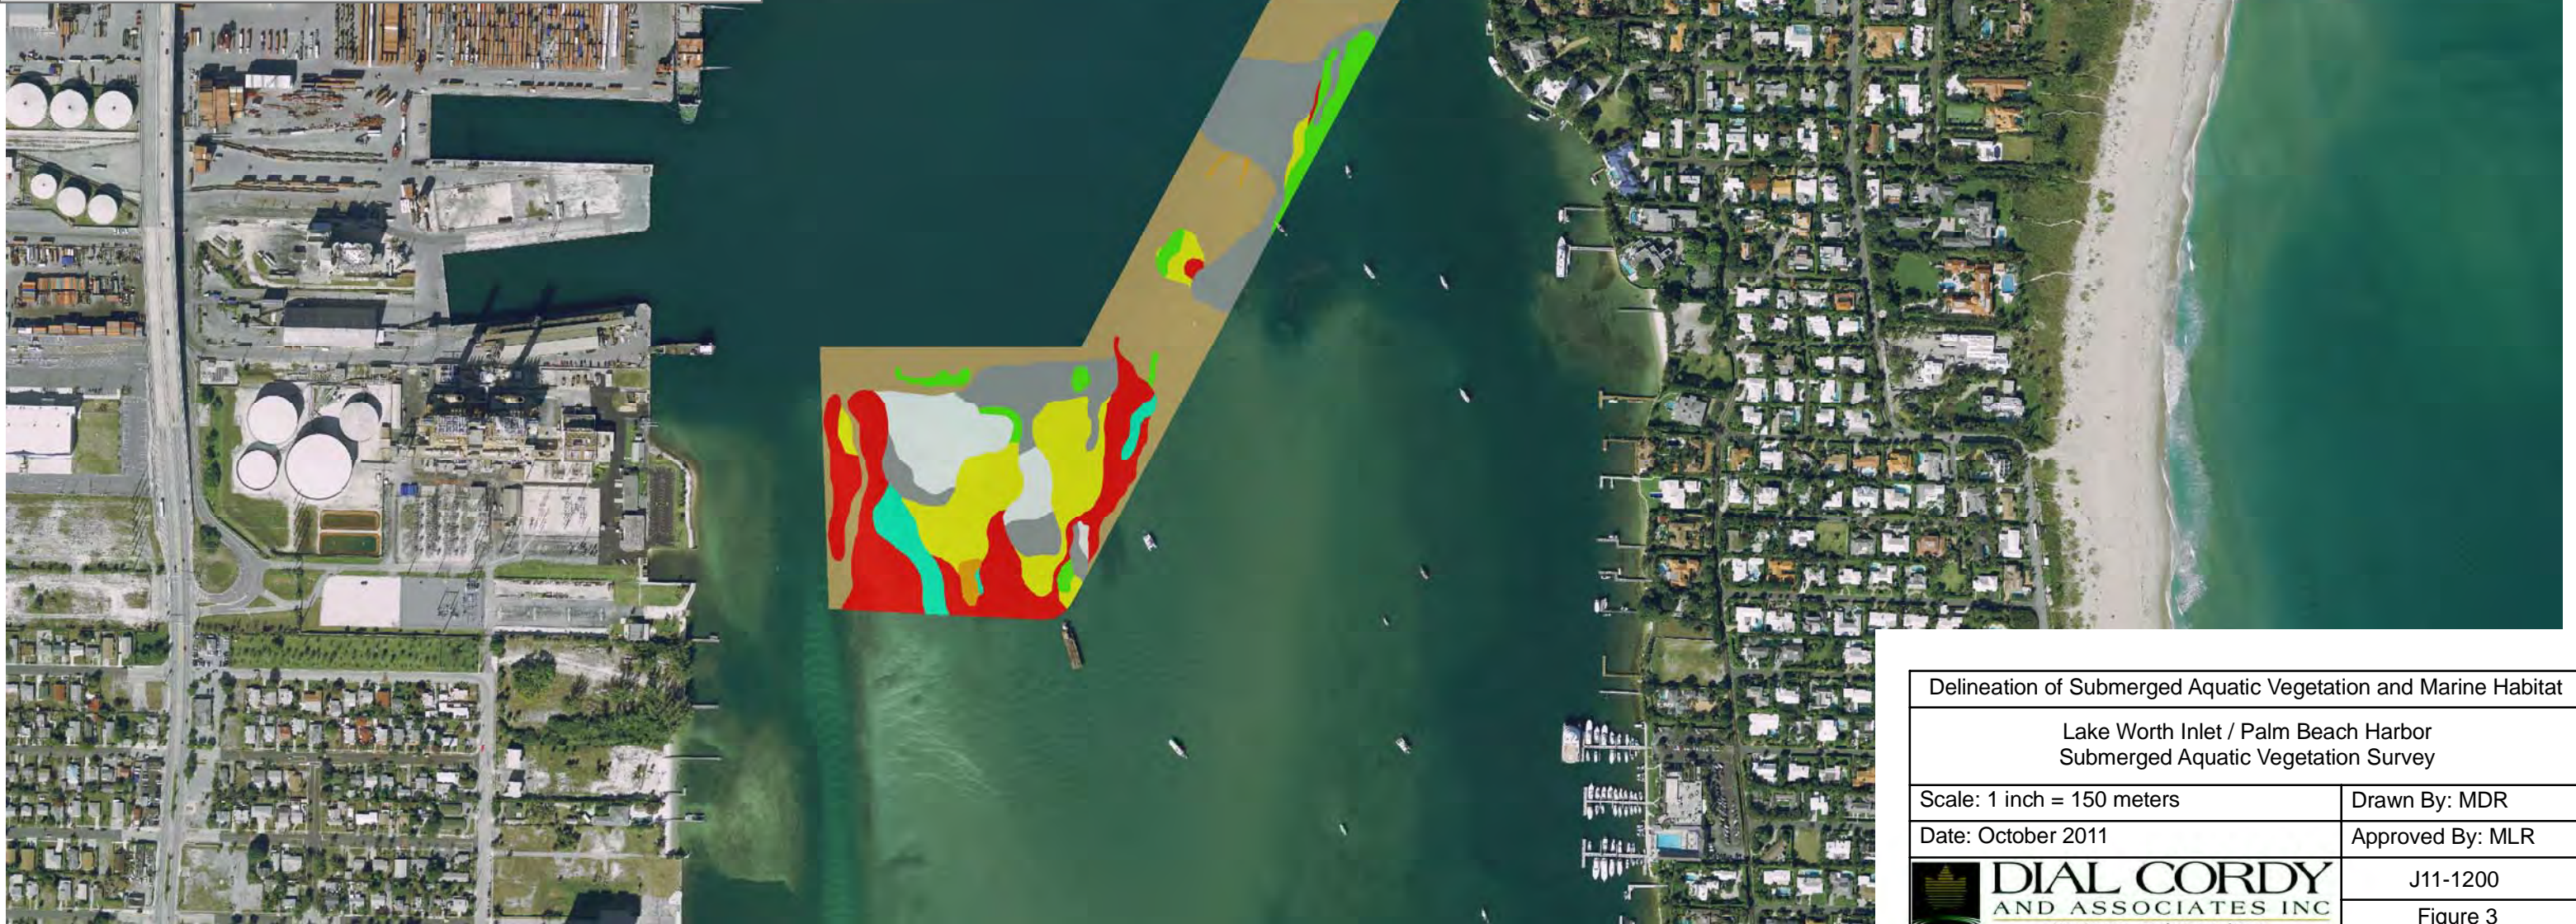
Delineation of Submerged Aquatic Vegetation and Marine Habitat

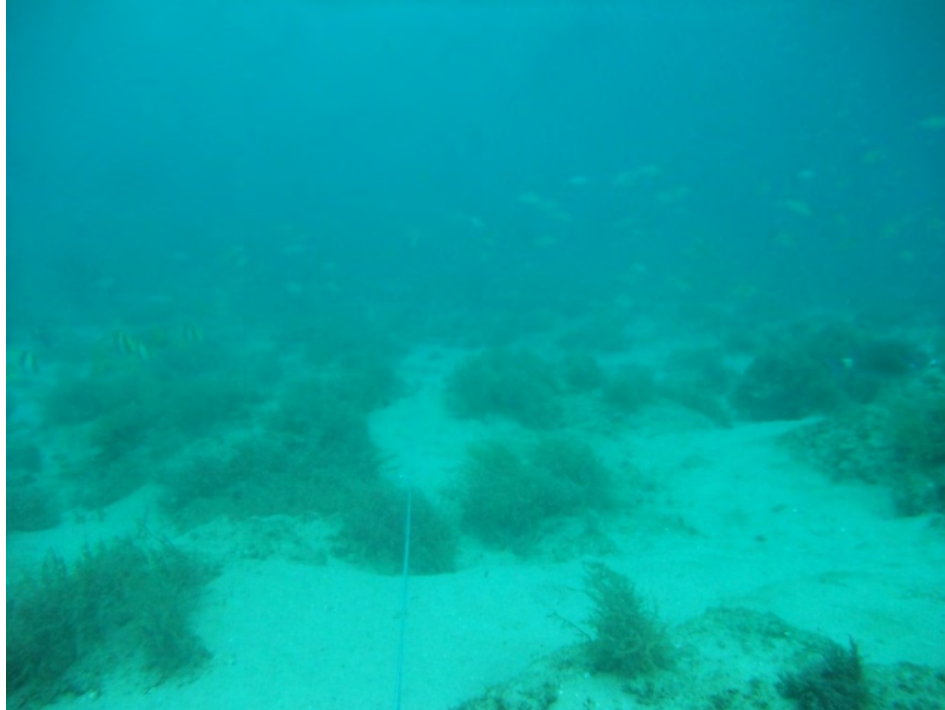
Figure 6 Sand with scattered hardbottom habitat with reef fish.

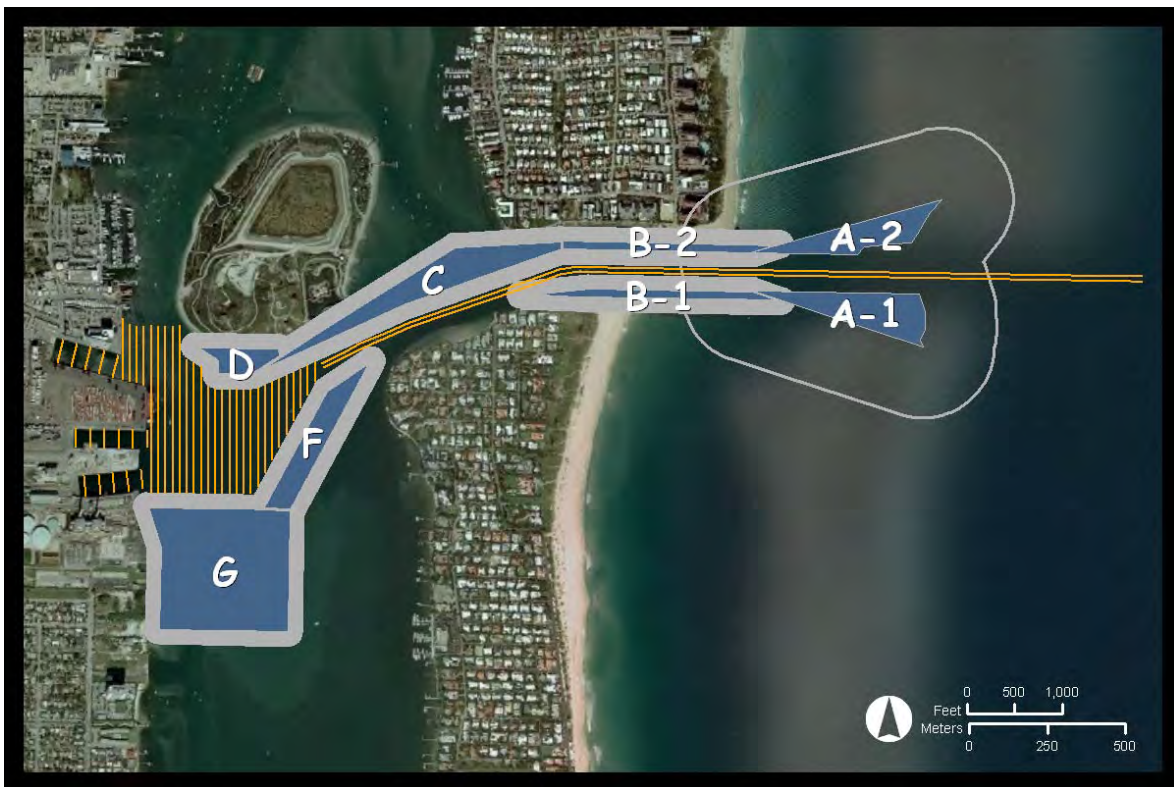
Figure 1. General location map for the Environmental Resources Report study area. Diver-investigated zones A-1 thru G (blue) with a 150-ft buffer (gray). Note the offshore 750-ft buffer (A-1 and A-2). Towed-video transects through the federal channel, turning basin, and existing berths are depicted in gold.

To encompass the proposed alternative footprints, the environmental resources survey of 2008 included an extensive diver survey of eight proposed expansion zones and towed video documentation of the existing federal channel, turning basin, and berths (**Figure 1**).

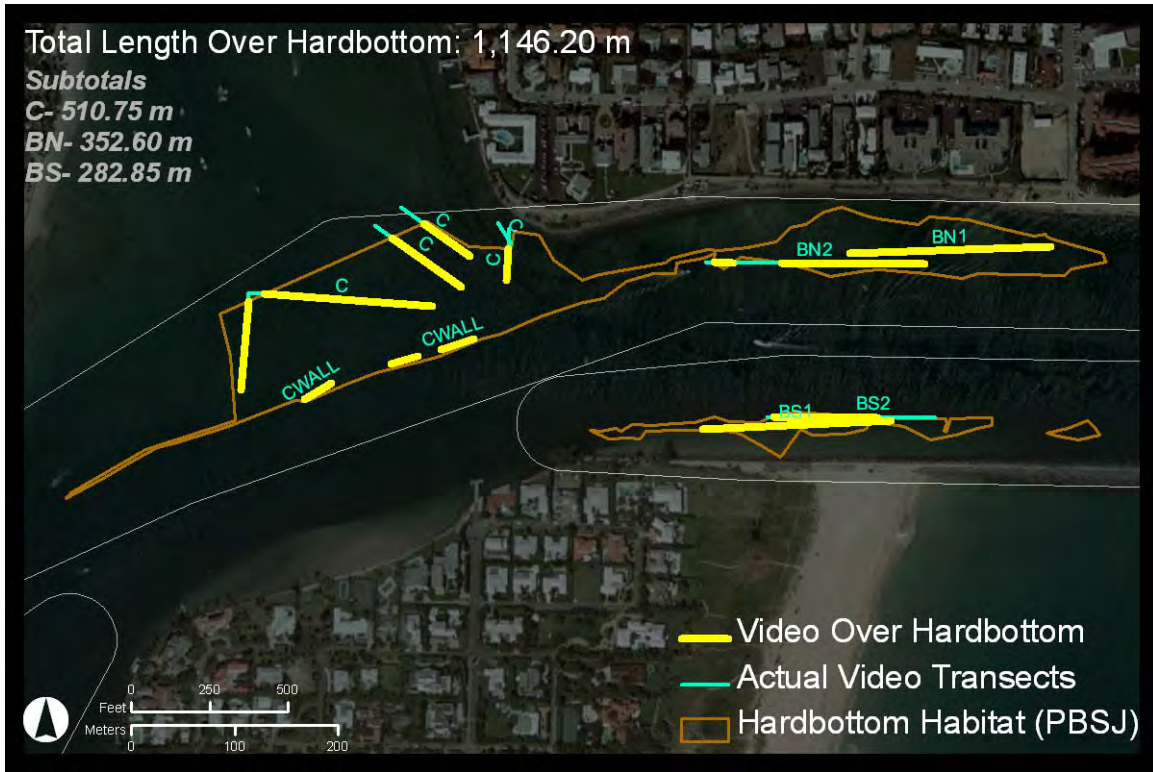
Figure 2. Dive location and interpolated distance (i.e., the straight-line distance from diver entry and exit points) for all handheld video shot within previously delineated hardbottom habitat.

(horizontal) and CWALL (vertical); B-1: BS1 (horizontal), BS2 (vertical); and B-2: BN1 (horizontal) and BN2 (vertical). These distinctions, along with the interpolated dive coverage (i.e., the straight-line distance from entry and exit points) for all handheld video dives can be seen in **Figure 2**.

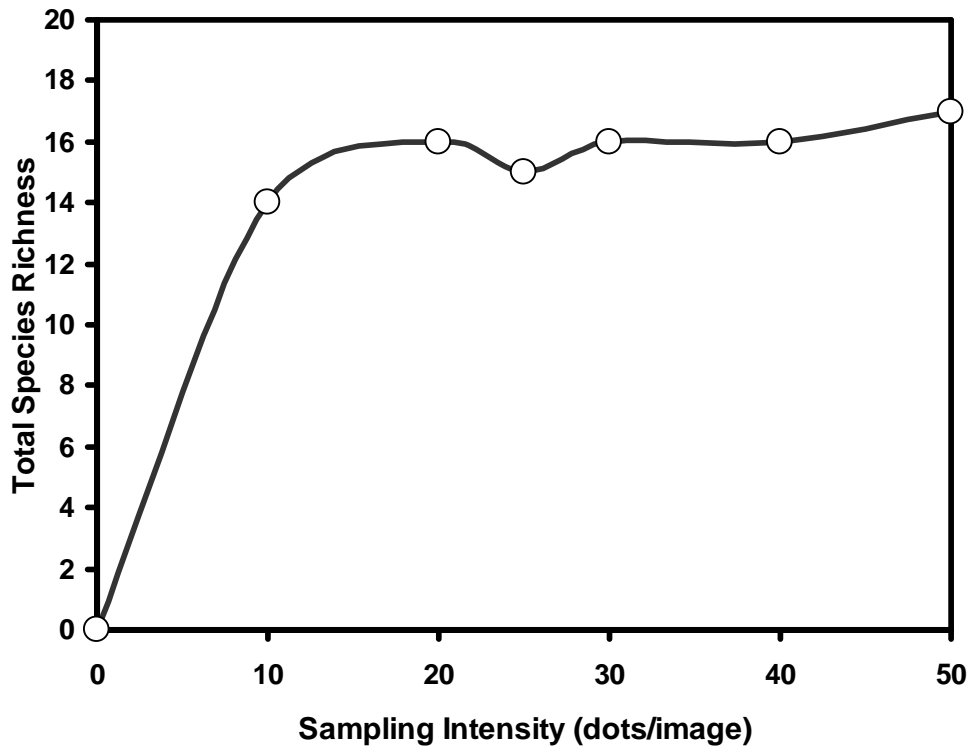
Figure 3. Species accumulation curve for 37 images repetitively analyzed using CPCe (10-50 dots per image).

To determine the dot-density needed for an adequate characterization, a single dive sequence consisting of 37 images was repetitively analyzed using successively greater dot densities (10-50 dots per image) and assessed for species accumulation. The resulting rarefaction curve is depicted in **Figure 3**. From this process, a final number of 25 dots image⁻¹ was selected for further use.

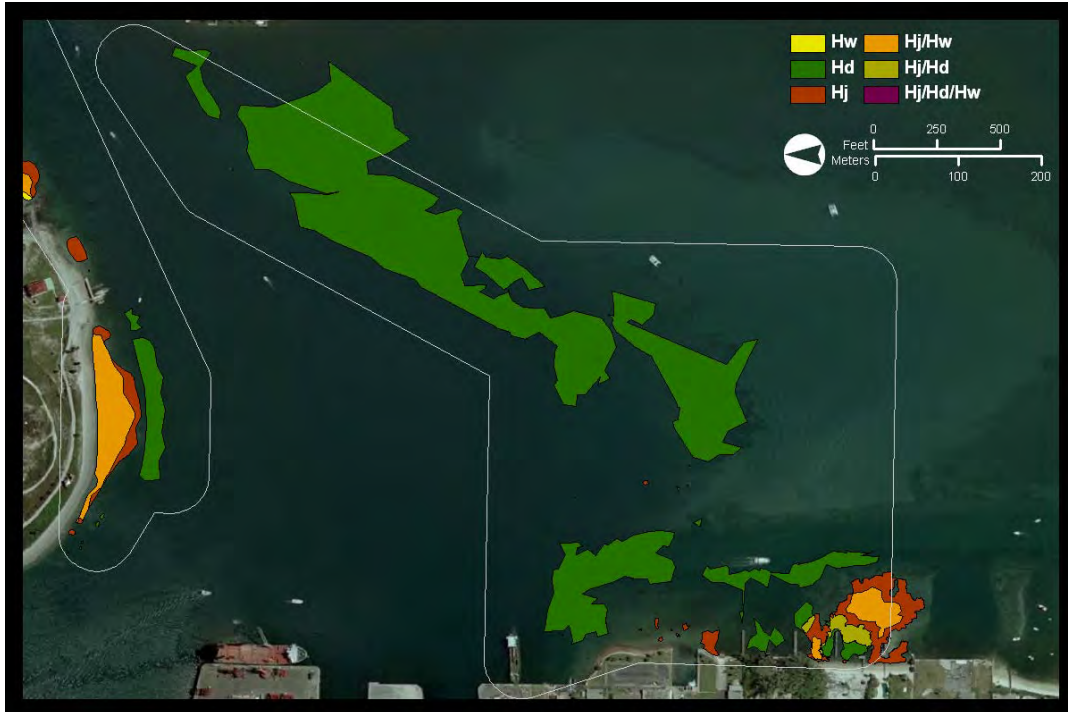
Figure 7. Location of seagrass habitat within Zones F&G. Polygonal features were located and mapped by biologists during the diver survey.

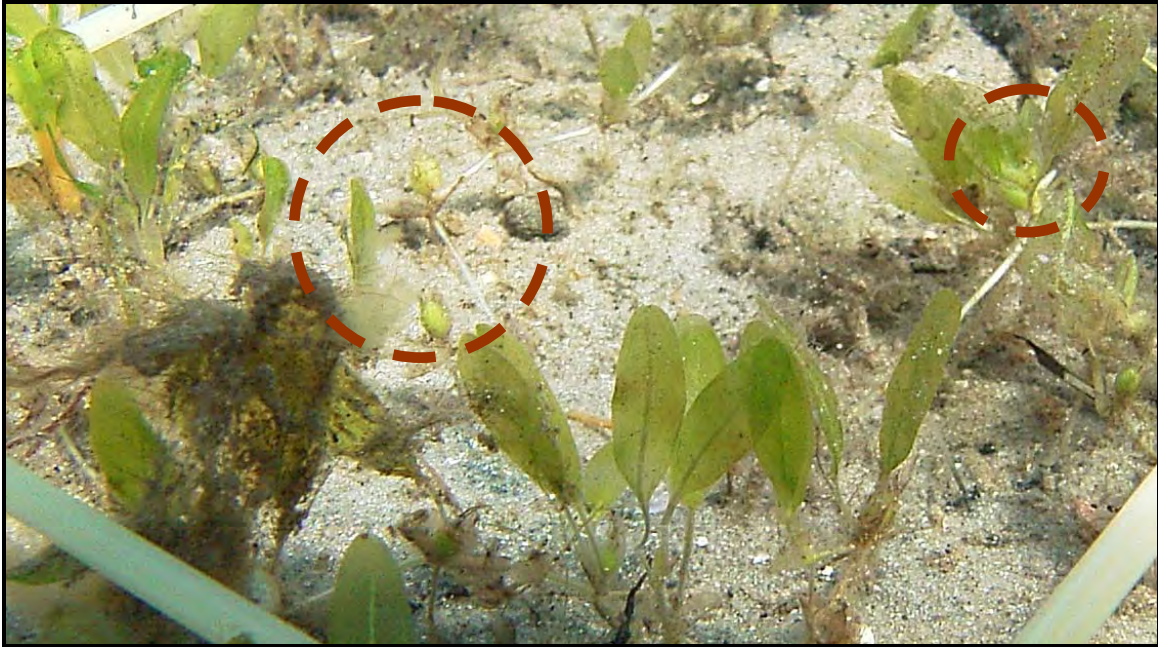
Figure 8. Photo documentation of the *H. decipiens* fruiting event observed on August 7, 2008. Image taken from quadrat #378 in Zone G. Red, dashed circles highlight visible fruits.

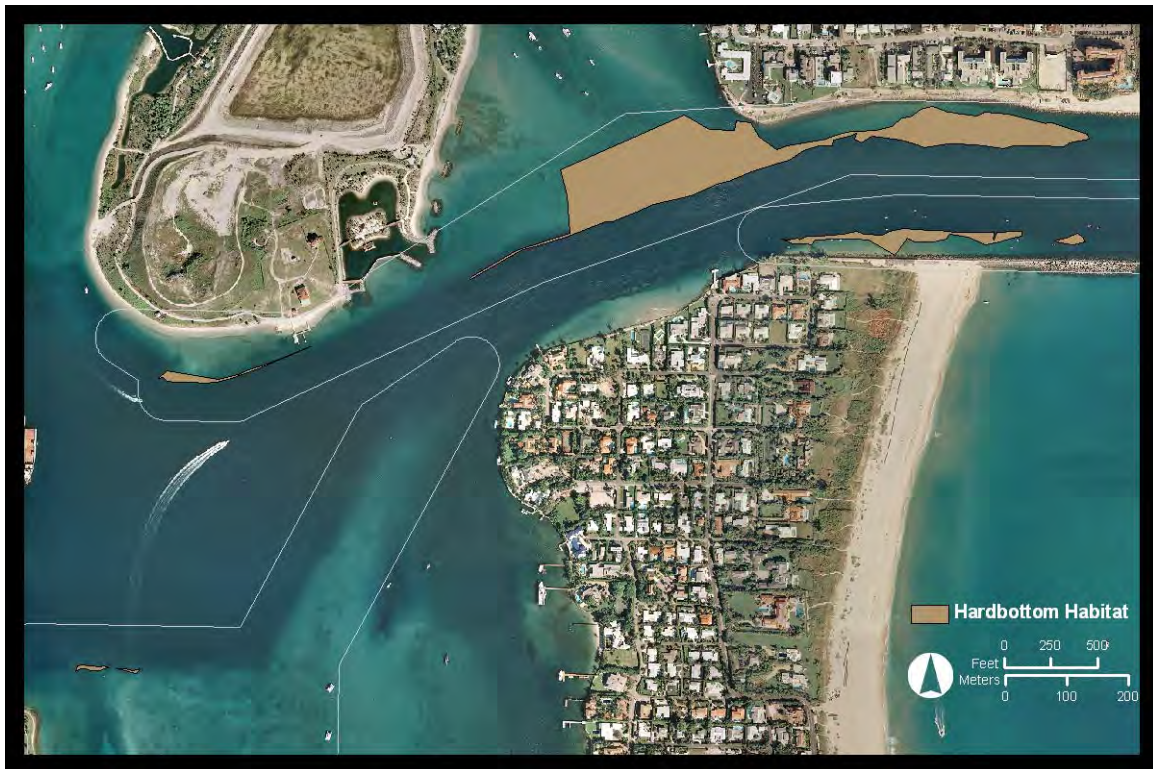
Figure 13. Location of hardbottom habitat identified during 2008 by biologists and mapped using DGPS.

Hardbottom habitat was located and mapped within 5 zones: B-1, B-2, C, D, and G (**Figure 13**). Total hardbottom areal coverage, excluding vertical surfaces, was estimated to be 14.98 acres (60,631.4-m²). Sum total coverage by zone (number of patches in parentheses) was B-1: 1.43 acres (2); B-2: 3.73 acres (1); C: 9.36 acres (1); D: 0.36 acre (1); and G: 0.10 acre (2). Individual patch sizes ranged from 0.03 to 13.09 acres, where the latter was split across Zones C and B-2 (9.36 and 3.73 acres, respectively). Zones B-1, B-2, and C were selected for further analysis (see below); however, archival video was shot for all identified areas of hardbottom.

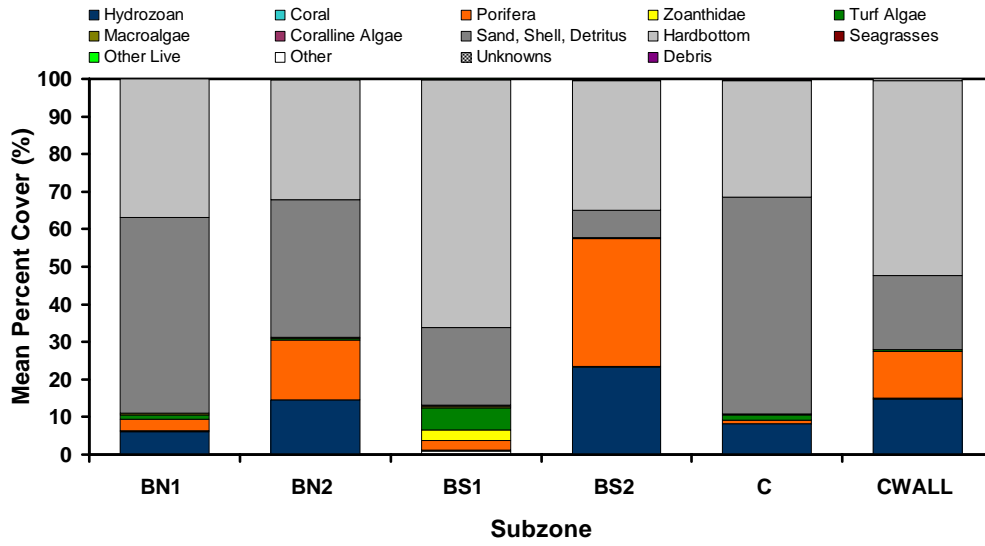
Figure 15. Mean percent cover of benthic constituents observed during the handheld video analysis. Subzone identities were as follows: B-1, BS1 and BS2; B-2, BN1 and BN2; C, C and CWALL.

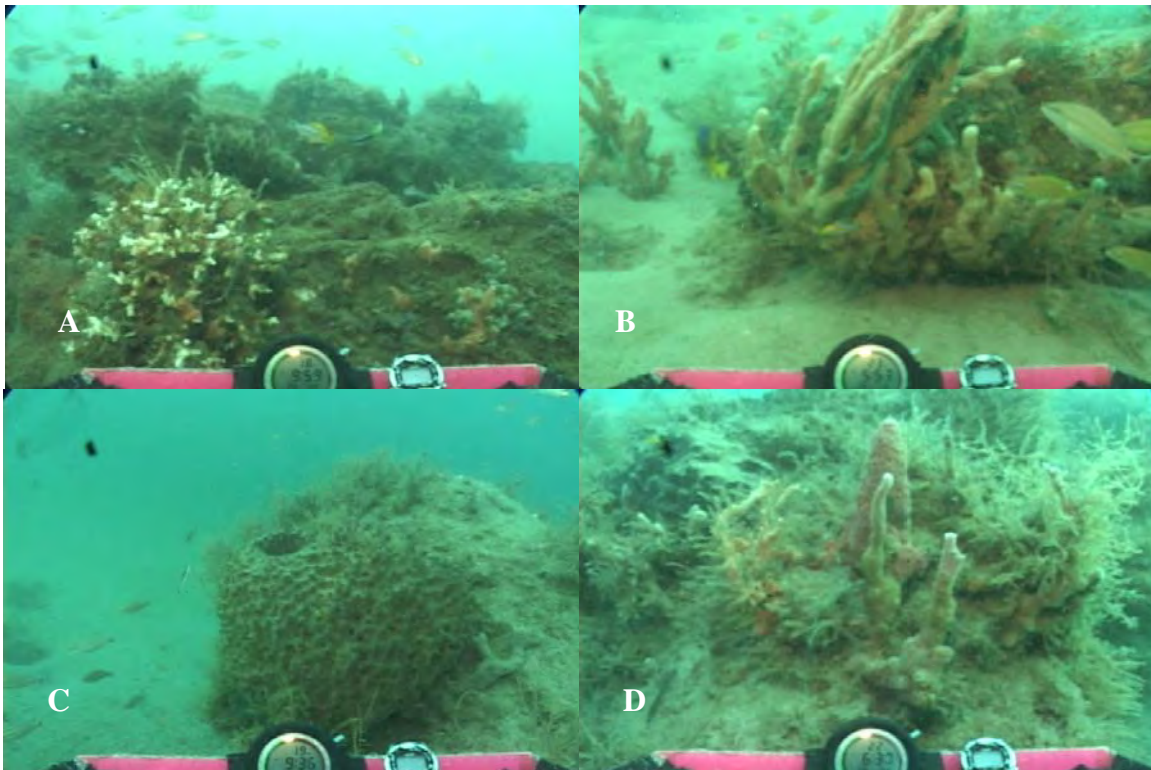
Figure 16. Hardbottom photographs captured from handheld video in zones D (A-B) and G (C-D).

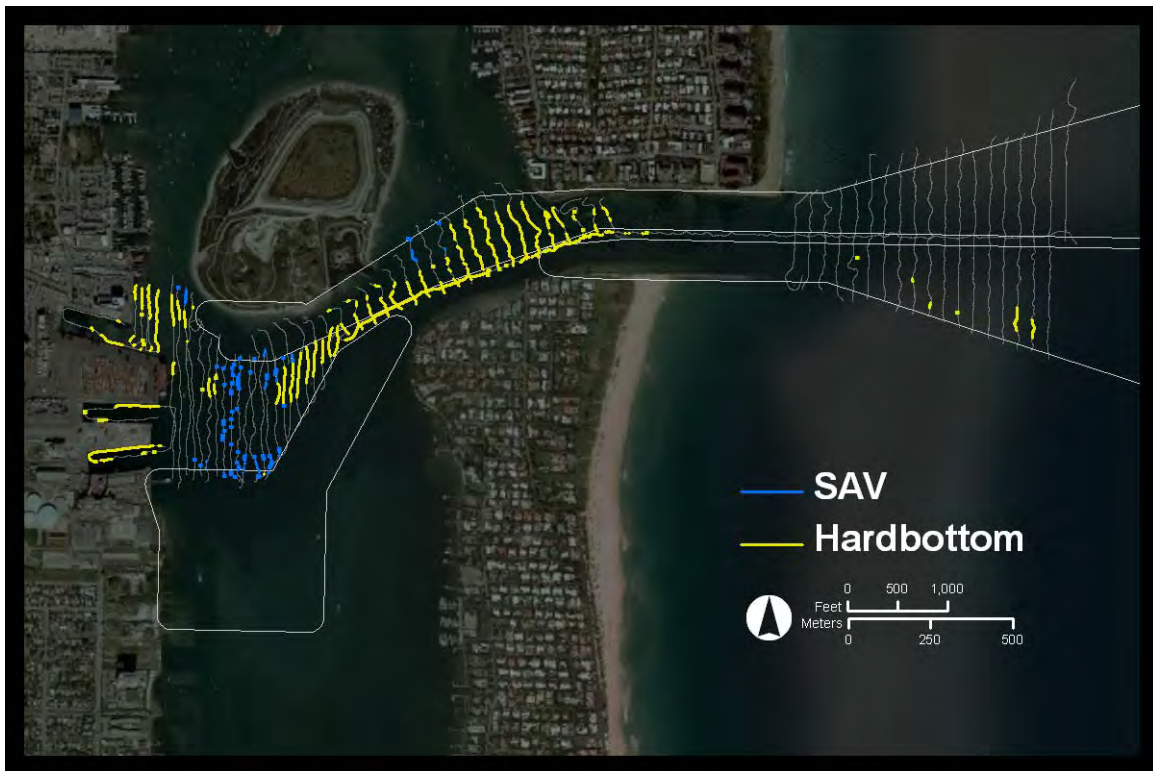
Figure 20. Location of hardbottom habitat and SAV identified from towed video in A-1, A-2, C, the turning basin, the commercial ship channel, and the berths. The yellow points/lines represent hardbottom and the blue points/lines represent SAV. Points indicate single instances of hardbottom/SAV whereas lines represent continuous hardbottom features or SAV.

Hardbottom habitat and SAV were located and mapped within A-1, A-2, C, the turning basin, the commercial ship channel, and the berths (**Figure 20**). Total hardbottom and SAV coverage (linear meters) were estimated to be 5,441.56-m and 210.93-m, respectively. **Table 4** presents the total coverage of hardbottom and SAV by survey area. Individual hardbottom areas ranged from 0.04- to 498.26-m (both in channel) while individual SAV patches ranged from 0.00- to 40.6-m (channel and C, respectively). It is important to note that the westernmost C-transects, collected in Area D, were not qualitatively analyzed as these areas were previously and thoroughly mapped via SCUBA or snorkel. Also, not all towed video was useable for qualitative analysis. In some instances, increased speed, poor visibility, or increased height off bottom made identification of benthic components difficult.

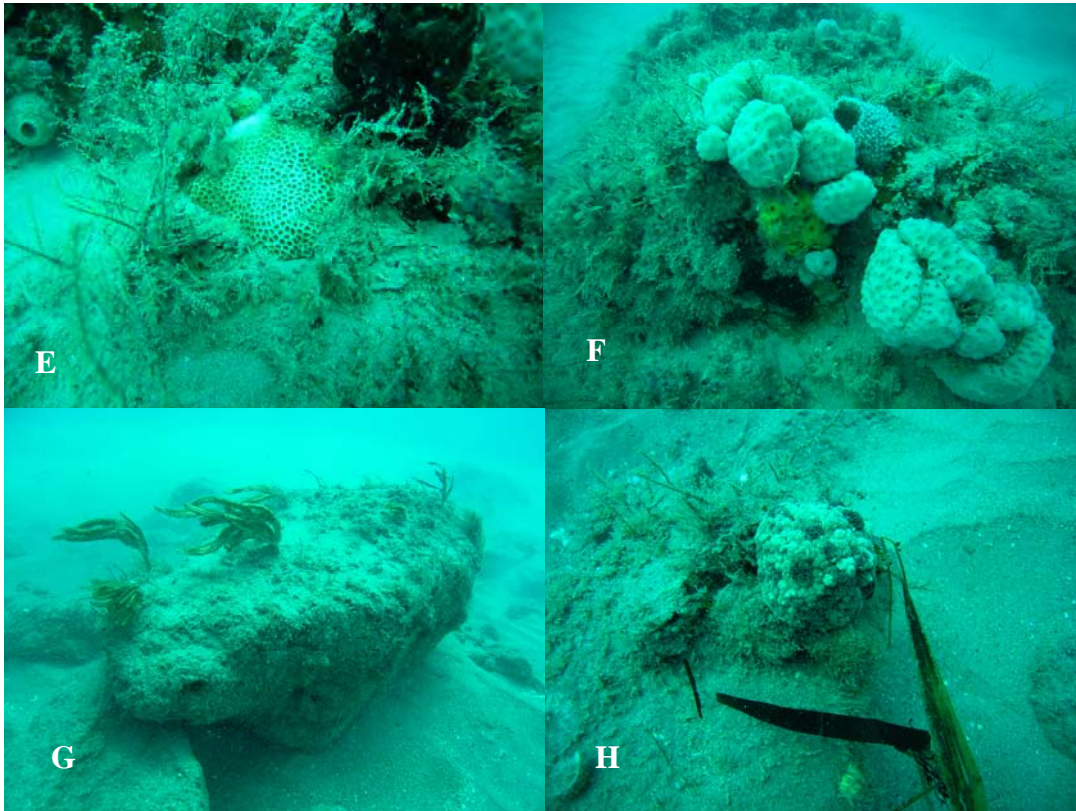
Figure 21. Subset of photographs collected in expansion zone A-1. A) Photograph of *Cliona delitrix* at site V2. B) Hardbottom community photographed at site 7. Stinging hydroids (*Macrorhynchia* spp.) located in forefront of photograph. C) Unidentifiable hydroids and lumpy sponge, *Monanchora* sp., observed at site V4. D) Colony of *Siderastrea* sp. observed at site V4. E) Variety of hydroid species, a colony of *Siderastrea* sp., and the white condominium tunicate, *Eudistoma* sp., at site V4. F) Hardbottom community photographed at site V4. Organisms photographed include the white condominium tunicate (*Eudistoma* sp.), vase sponge (possibly *Niphates* sp.), yellow, massive sponge (possibly *Aiolochoira* sp.), and a variety of hydroids, including the algae hydroid (*Thyroscyphus ramosus*). G) Large rock boulder with several gorgonians of the Genus *Pseudopterogorgia* at site V6. H) Rare in Florida, a berried anemone (*Alicia mirabilis*) photographed at site 7.

The benthic composition of expansion zones A-1 (south) and A-2 (north) consisted mostly of sediment and shell hash. Six hardbottom areas were identified from the towed video collected in expansion zone A-1. Hardbottom was not observed in A-2. A subset of hardbottom photographs collected in A-1 are presented in **Figure 21**.

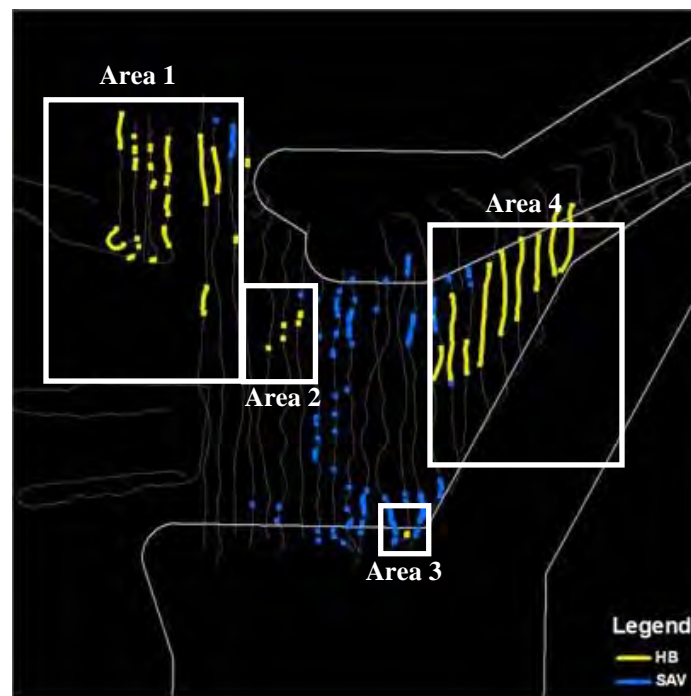
Softbottom was the major benthic habitat in the turning basin; however, hardbottom and SAV were also observed. Hardbottom was defined as a solid substrate that provides anchorage for sessile or semi-sessile organisms (e.g., corals, gorgonians, sponges, macroalgae, hydroids, etc.). The hardbottom within the turning basin was grouped into 4 areas (**Figure 22**).

Figure 22.	Four areas of hardbottom located in the turning basin.	3-21
Figure 23.	Hardbottom images captured from towed video within Area 1. A) Transect 122: rocks colonized by turf algae, hydroids, sponges, and gorgonians. B) Transect 123: rock boulders colonized by turf algae, hydroids, and sponges. Note fish school below video overlay. C) Transect 126: rock rubble and small rocks colonized by hydroids and turf algae.	3-21
Figure 24.	Hardbottom image captured from towed video within Area 2. Transect 118: small rocks with attached turf algae and hydroids.	3-22
Figure 25.	Hardbottom images captured from towed video within Area 3. Transect 111: two concrete blocks colonized by sponges, hydroids, and turf algae.	3-22
Figure 26.	Hardbottom images captured from towed video in Area 4. Small to large rocks colonized by turf algae and hydroids. Photographs captured from transects 102 (A), 101 (B), and 107 (C).	3-22

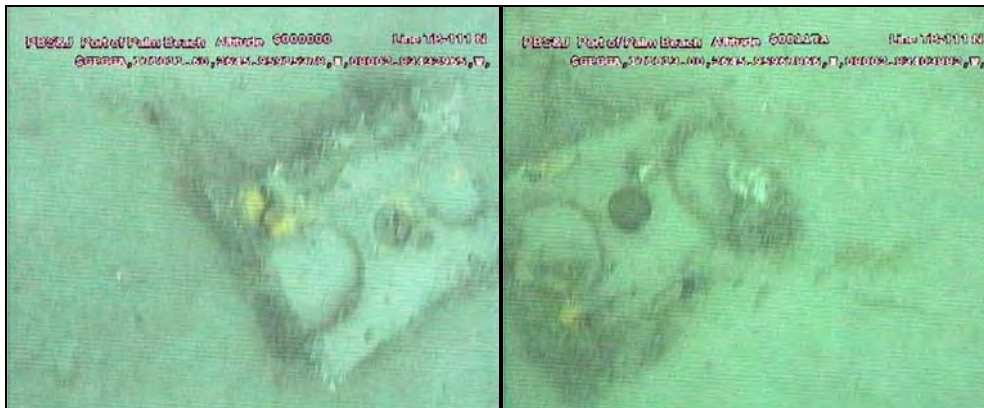
Figure 25. Hardbottom images captured from towed video within Area 3. Transect 111: two concrete blocks colonized by sponges, hydroids, and turf algae.

Area 3: A single hardbottom point located on the southern boundary of the turning basin. Hardbottom consisted of two concrete blocks (debris) colonized by sponges, hydroids, and turf algae (**Figure 25**).

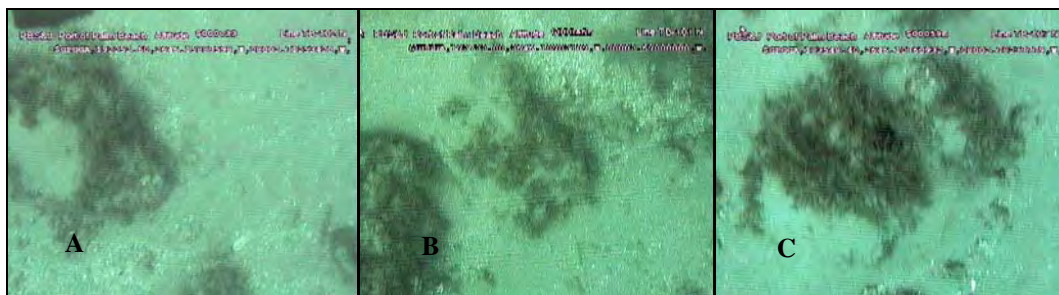
Figure 26. Hardbottom images captured from towed video in Area 4. Small to large rocks colonized by turf algae and hydroids. Photographs captured from transects 102 (A), 101 (B), and 107 (C).

Area 4: Large hardbottom area located on the northeastern side of the turning basin. Hardbottom characterized by scattered, small to large rocks with attached turf algae, hydroids, and sponges (**Figure 26**).
