**APPENDIX E. FISH AND WILDLIFE COORDINATION ACT  
AND ENDANGERED SPECIES ACT COMPLIANCE**

Herbert Hoover Dike  
**Dam Safety Modification Study**

**Draft Interim Fish and Wildlife Coordination Act Report**  
**Herbert Hoover Dike Dam Safety Modification Study**

**COMPLETE INITIATION PACKAGE**

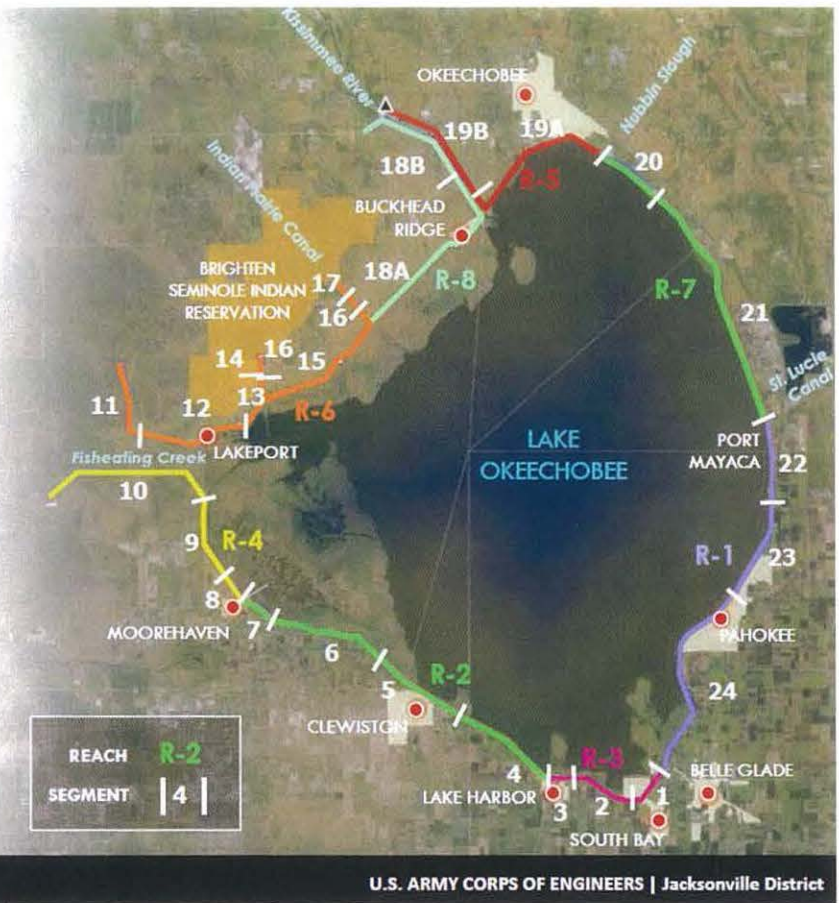
Figure 1. Herbert Hoover Dike Dam Safety Modification Study Area.

- Reaches and Segments used in plan formulation

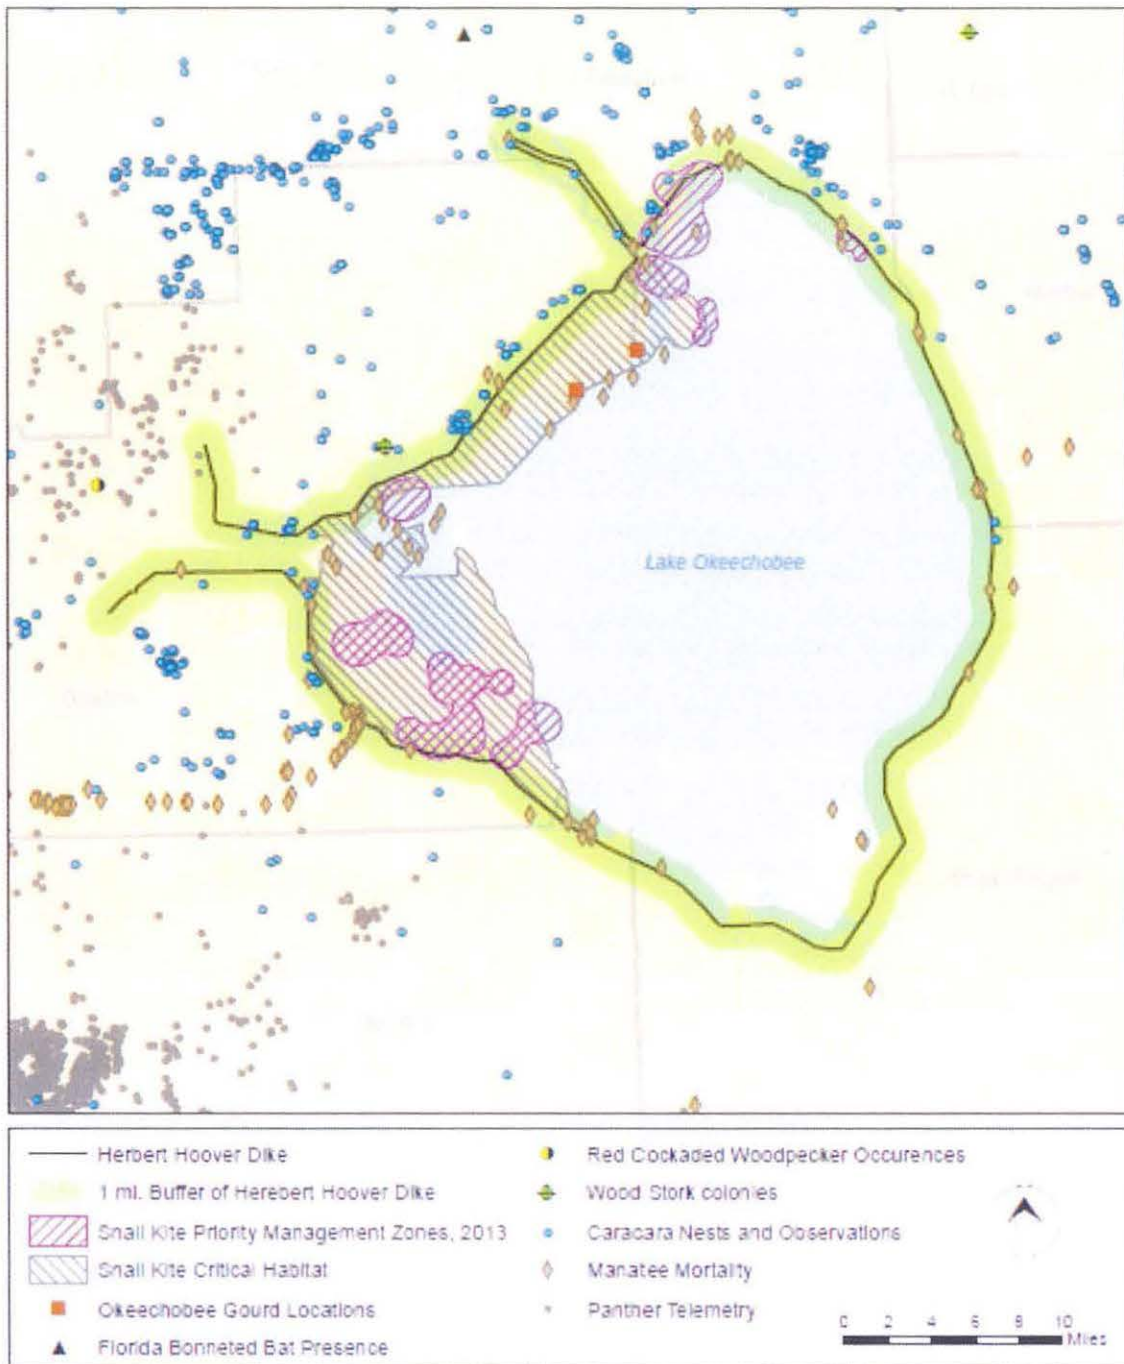
Figure 2. Herbert Hoover Dike Listed Species and Critical Habitat.

The endangered Everglade snail kite (federally listed in 1967) is nomadic throughout south Florida, seeking suitable wetland habitat for nesting and foraging. Critical habitat was designated for the Everglade snail kite in 1977 (Figure 2). Everglade snail kites are food specialists, preying on apple snails (*Pomacea paludosa*) which live in long hydroperiod, freshwater wetlands with emergent vegetation. The Everglade snail kite has experienced population fluctuations associated with both man-induced and natural hydrologic influences. Water management actions that affect hydrology and water quality are important human-controlled factors in the recovery of the Everglade snail kite. The Everglade snail kite occurs in the Everglades, Lake Okeechobee, Kissimmee River, Caloosahatchee River, and the upper St. Johns River watersheds which have all experienced habitat degradation due to urban development and agricultural activities (Service 1999).

Everglade snail kites are known to nest in the DSMS area (Figure 3). Everglade snail kite critical habitat in Lake Okeechobee is located in the western parts of Glades and Hendry Counties (Figure 2), extending along the western shore to the east of the levee system and the undiked high ground at Fisheating Creek, and from the Hurricane Gate at Clewiston northward to the mouth of the Kissimmee River, including all the spike rush (*Eleocharis* sp.) flats of

are located to the west of Lake Okeechobee (Figure 2). There have been no confirmed sightings in recent years, although panthers could potentially range along the HDD.

Audubon's crested caracara nest on and adjacent to the HHD (Figure 2). Surveys should be conducted prior to the initiation of construction and during construction, per the Service's Audubon's Crested Caracara Conservation Guidelines and Audubon's Crested Caracara Nesting Survey Protocol, at HHD construction sites to determine if caracaras are present in the project area. Since the final proposed action may produce noise above ambient levels, mufflers and sound dampening equipment would be required during construction. Human activities should be limited in the 985-foot primary management zone around any active caracara nests. Use of chemicals toxic to wildlife and construction activities lacking visual screening and above-ambient noise levels would be limited in the 985 to 4,920-foot secondary management zone around active caracara nests. Monitoring for caracaras during the nesting season

The DSMS area overlaps with a wood stork Core Foraging Area. Wood storks are known to forage within the toe ditch adjacent to the HDD, but have not been documented nesting in the DSMS area (Figure 2). The final proposed action may produce noise above ambient levels; therefore, mufflers and sound dampening equipment should be required during construction. Preconstruction surveys should be completed prior to the initiation of construction activities. Should an unexpected wood stork colony become established near the study/project site, human activities should be limited in the 1,500-foot primary management zone around active wood stork colonies (all nest trees plus a 100-foot buffer). Use of chemicals toxic to wildlife and construction activities lacking visual screening and above ambient noise levels should be limited in the 1,300 to 2,500-foot secondary management zone around active wood stork colonies.

West Indian manatees occur in Lake Okeechobee (Figure 2). The final proposed action may produce noise above ambient levels. Preconstruction surveys should be completed to ensure that no manatees are harmed or harassed during construction. In the event of cofferdam construction, surveys should also be conducted during construction and installation of the cofferdams to determine if manatees are present in the area of construction. The installation of cofferdams would prevent manatees from entering the construction zone and should prevent any disturbance to the manatees. Manatee protection grates with openings no greater than 8 inches by 8 inches should be installed on all replacement culverts to prevent manatees from accessing culvert structures. Additionally, to avoid and minimize adverse effects during construction activities, the Corps should implement the construction conservation measures outlined in *Standard Manatee Conditions for In-Water Work* (FWC 2011).

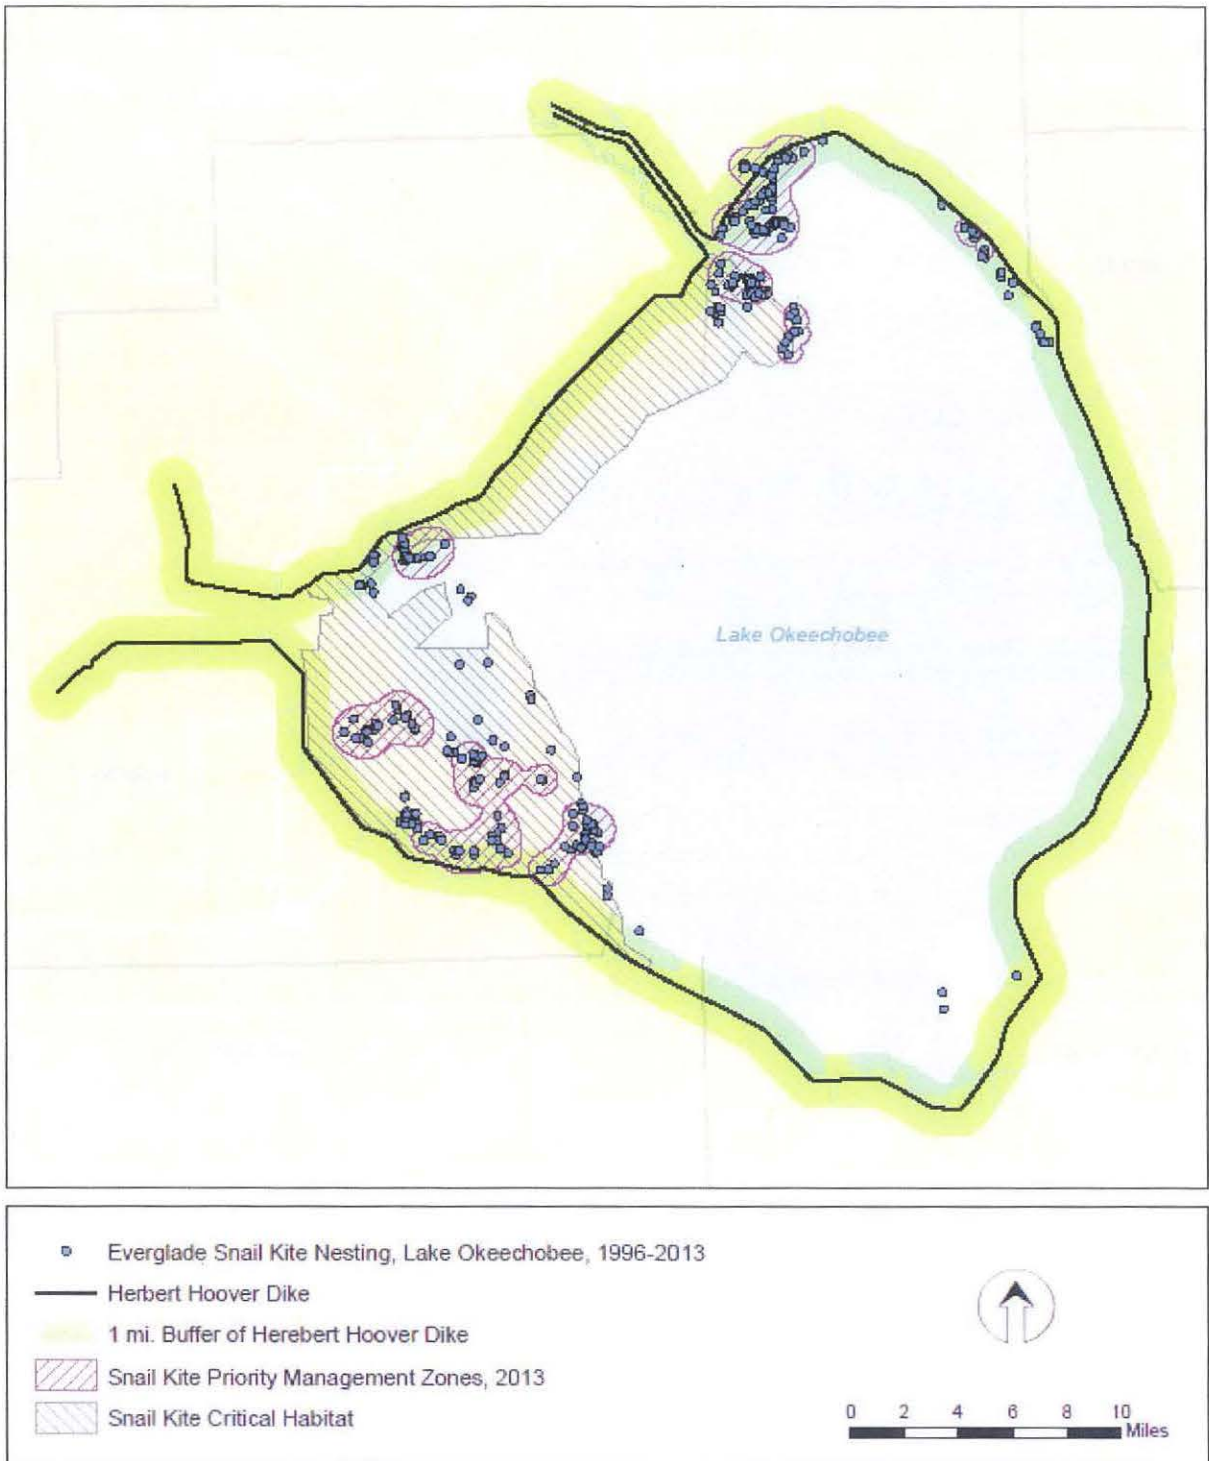
**Figure 3.** Everglade Snail Kite Nest Locations (1996-2013).

Everglade snail kite nesting is prominent in the DSMS area and could be affected by construction operations associated with HHD. Critical habitat for the snail kite is also found within the DSMS area. Everglade snail kites are known to nest within the western littoral zone of Lake Okeechobee (Figure 3), and snail kites are known to forage within the Lake Okeechobee littoral zone.

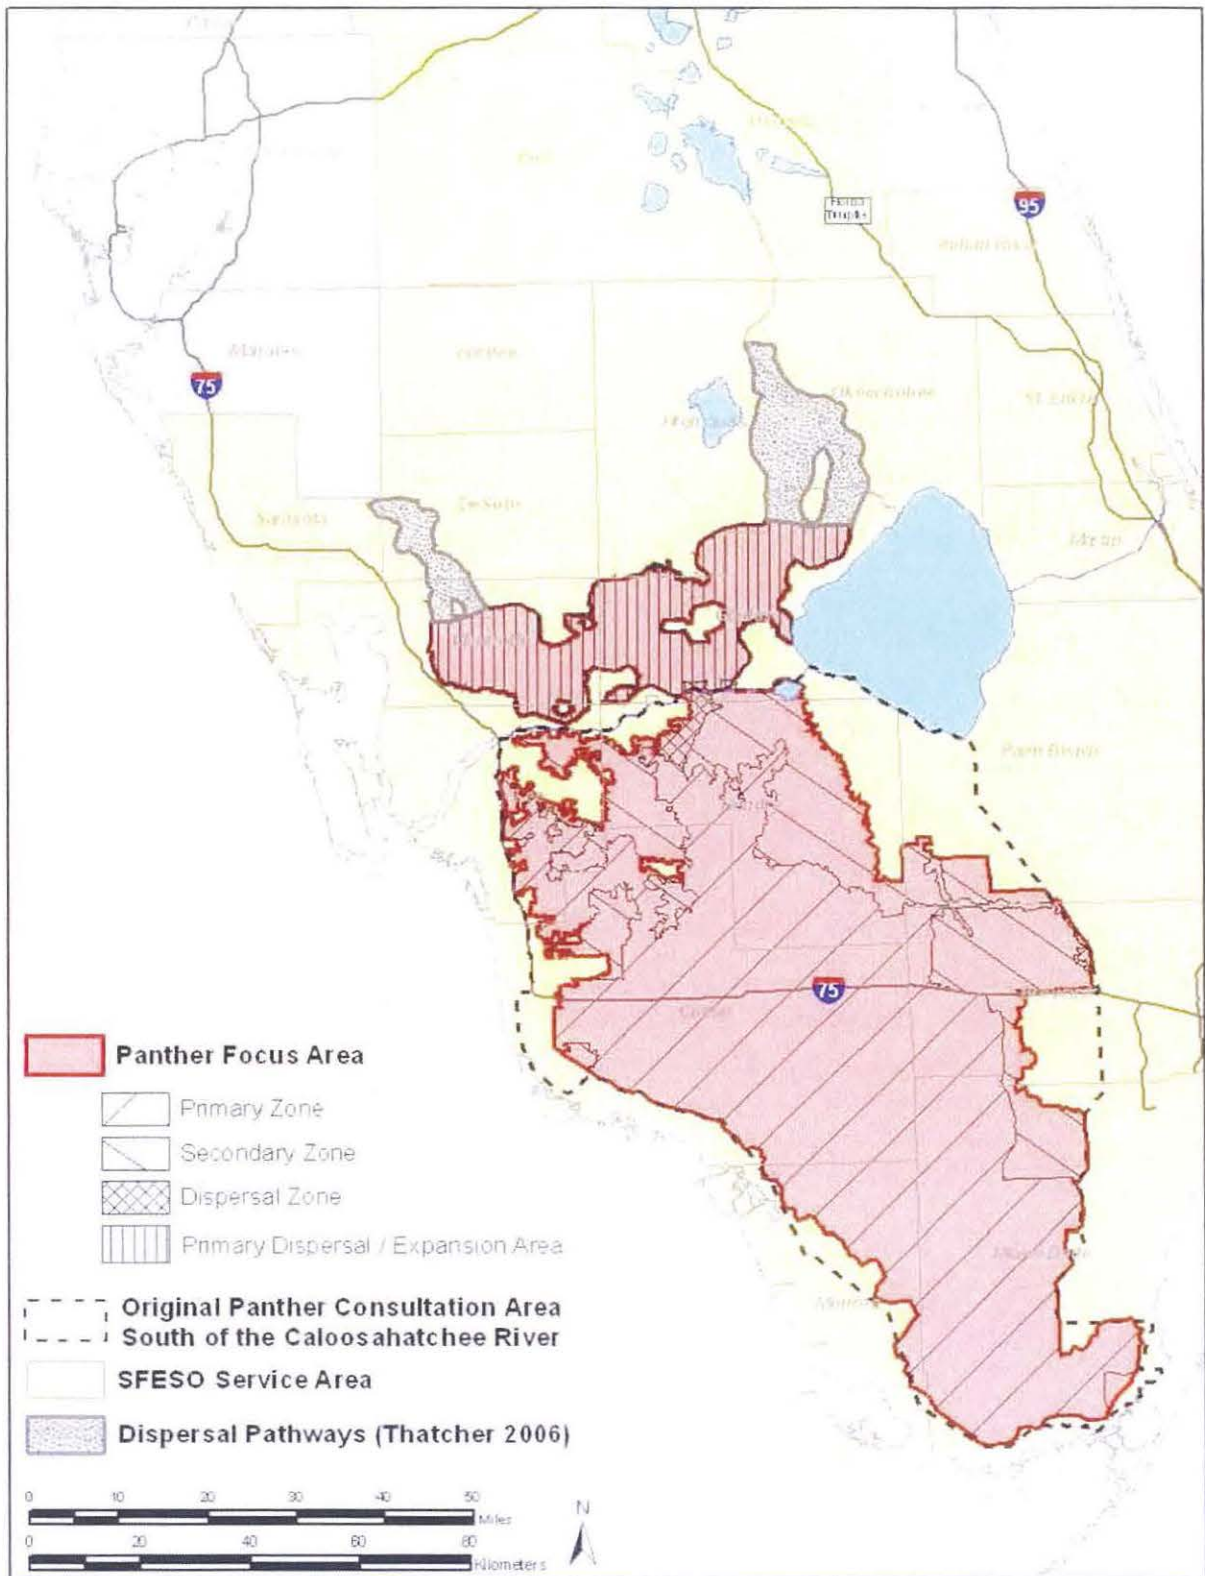
**Figure 4.** Florida Panther Focus Area.

Florida panther habitat in the DSMS area includes habitat designated as secondary zone and primary dispersal/expansion area (Figure 4) in the Landscape Conservation Strategy for the Florida Panther in south Florida (Kautz et al. 2006). The primary zone is considered to be the most important area needed to support a self-sustaining panther population. Environmental factors affecting the panther include: habitat loss and fragmentation, contaminants, prey availability, human-related disturbance and mortality, disease, and genetic erosion (Dunbar 1993).

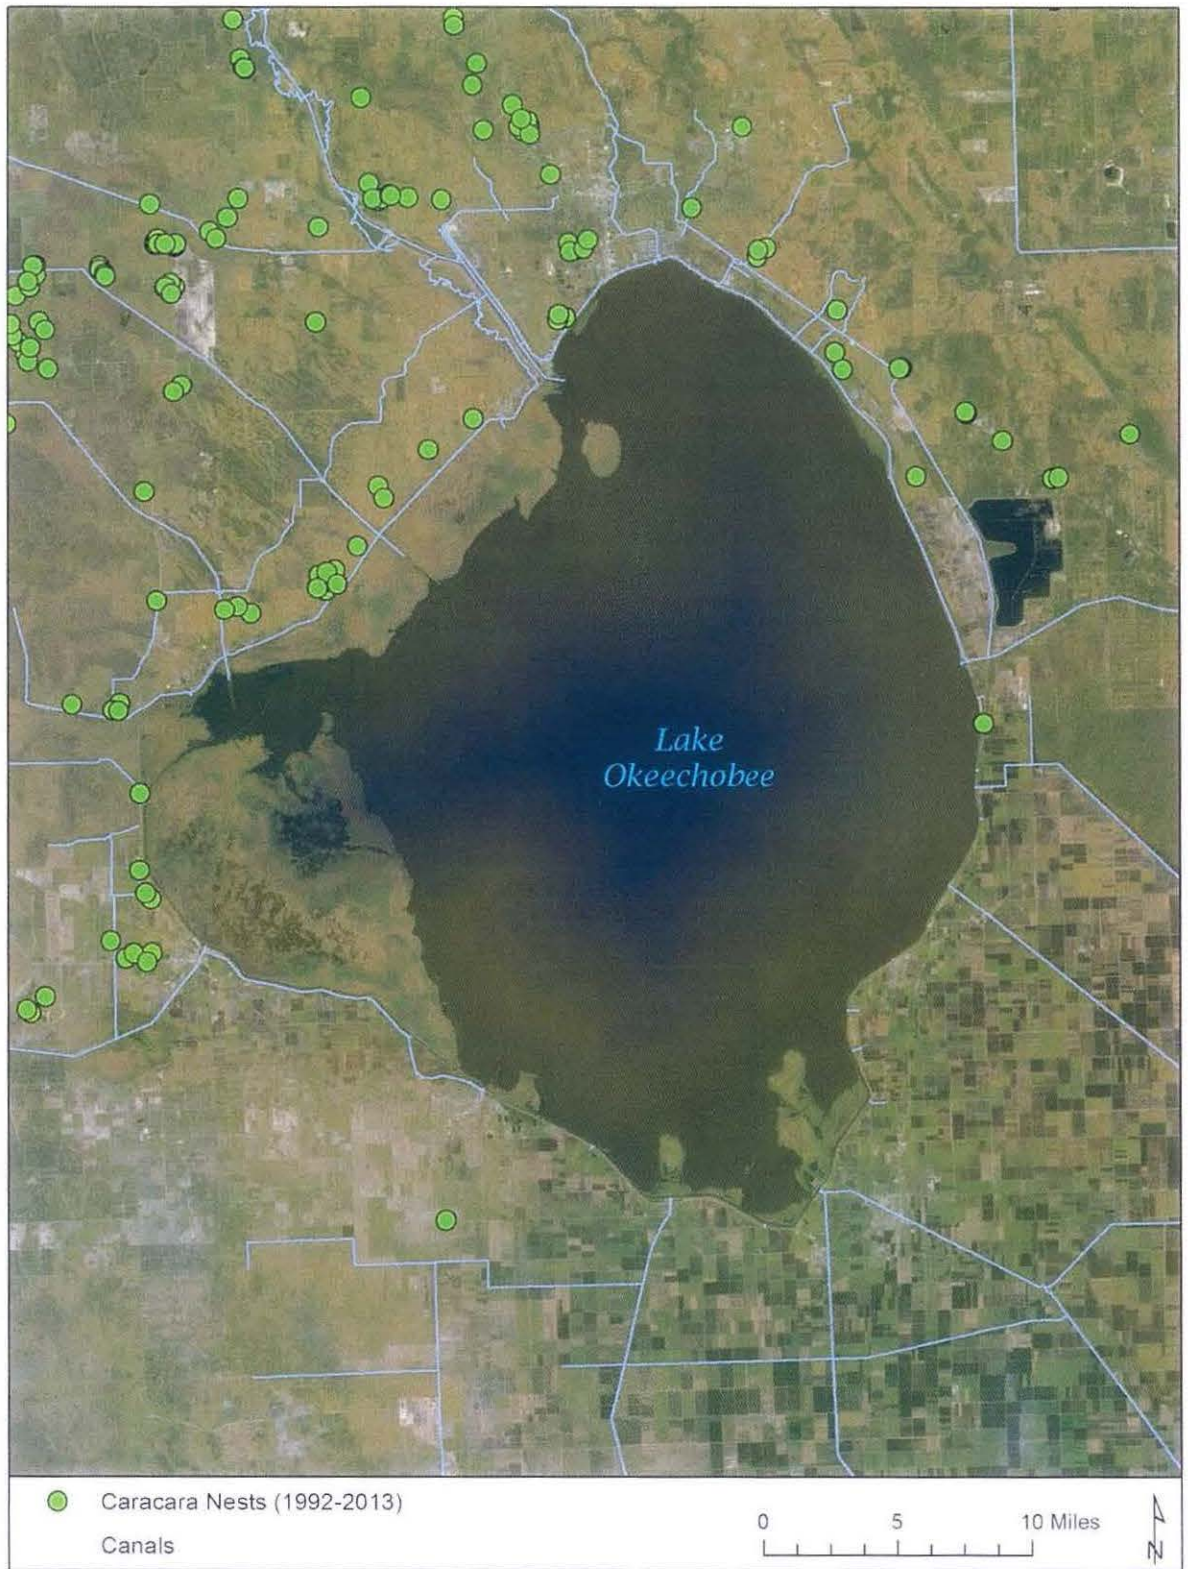
**Figure 5.** Caracara Nest Locations (1992-2013).

Figure 5 shows the location of caracara nests in the DSMS area from 1992 to 2013. Although caracaras do show some nest site fidelity, they change nest trees more readily than bald eagles. The Corps has previously committed to conducting nesting surveys in the typical nesting season ahead of anticipated work on HHD in a given year. The reaches of HHD along the western, northern, and northeastern shores of Lake Okeechobee are likely to have nesting and foraging caracaras in or adjacent to construction sites. Nesting would occur often, but not always, in a cabbage palm that would be on adjacent lands outside of the Federal right of way. However, we recommend that any cabbage palms in the right of way or any that may be affected by placement of staging areas be left undisturbed by construction even if these are not known to be active nest trees. Caracaras may select from several potential nest trees within their territories, and signs of previous nests may not be readily prominent in the sometimes dense crown. Figure 6 shows telemetry points for a caracara at the Lakeside Ranch Stormwater Treatment Area. The central cluster of points was around the nest tree, and although this may be far enough from the base of the HHD to avoid disturbance, the nest could have been placed in a given year within the territory closer to the HHD. These data also demonstrate what we have also casually observed; caracaras commonly forage or rest on the crest of the HHD, and the avoidance of harassment should be part of the educational program for workers.

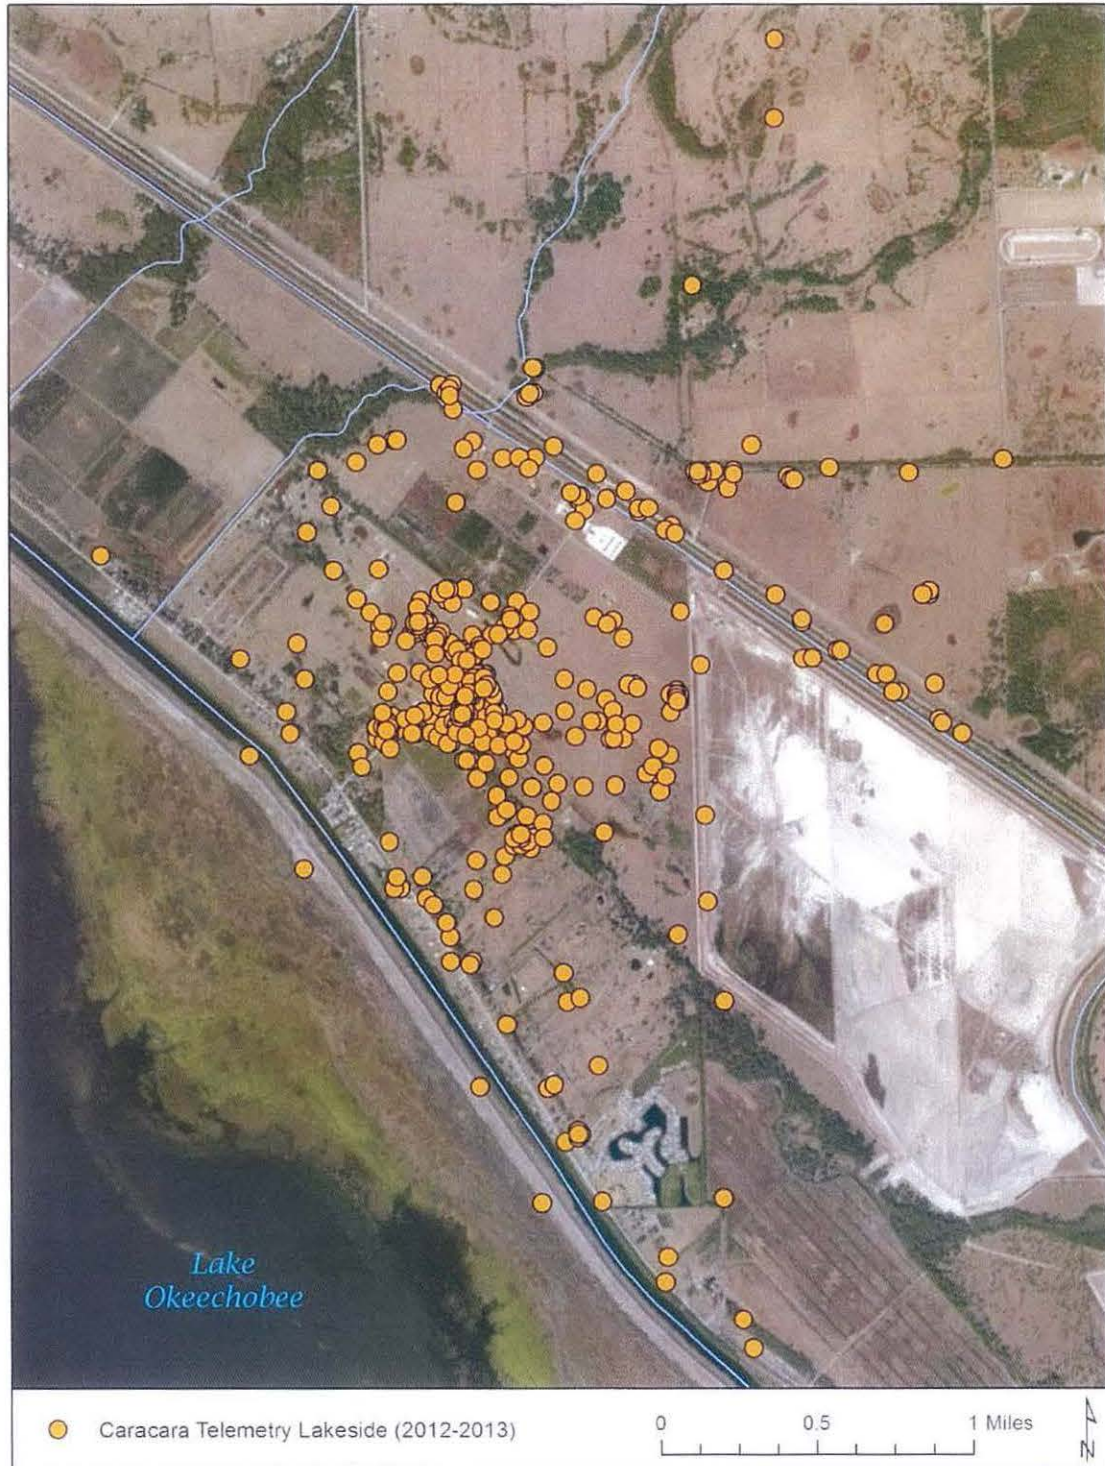
**Figure 6.** Caracara Telemetry Points (2012-2013).

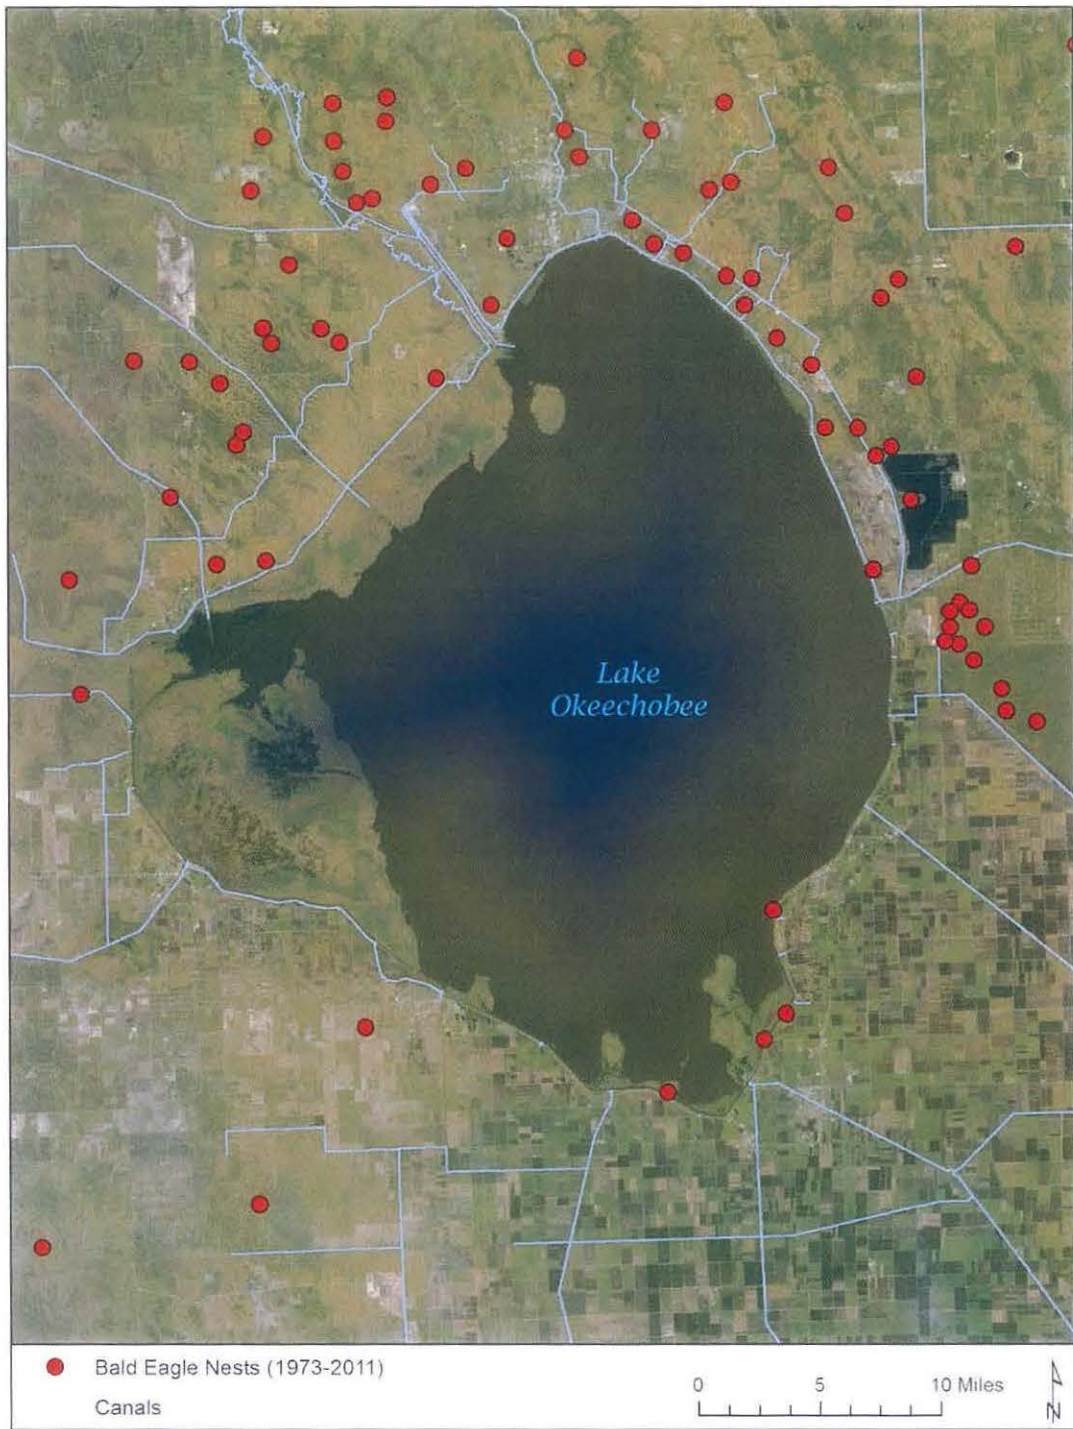
**Figure 6.** Bald Eagle Nest Locations (1973-2011).

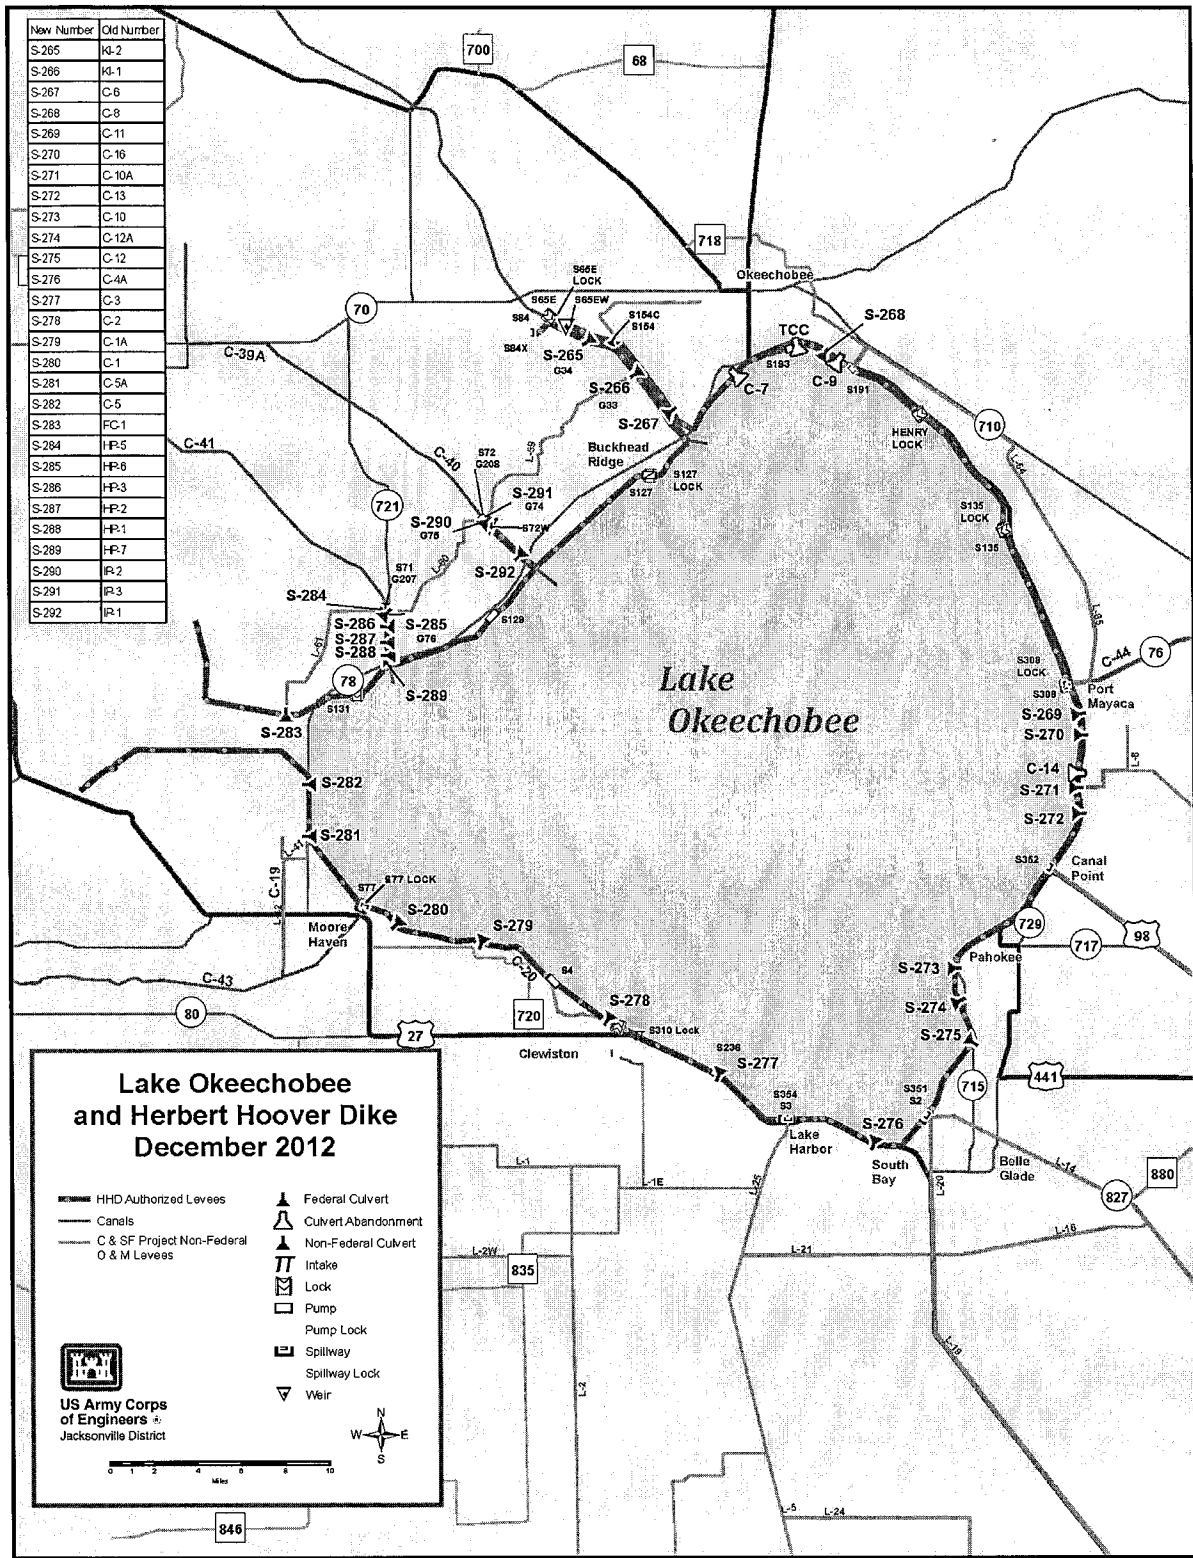
Figure 1. HHD Project Area

The HHD is approximately 143 miles long and spans the following five counties around the perimeter of Lake Okeechobee: Glades, Hendry, Martin, Okeechobee, and Palm Beach (Figure 1 enclosed). Lake Okeechobee is the third largest lake by land area in the United States and a component of the Central and Southern Florida Flood Control Project. The lake has a surface area of approximately 730 square miles and drains an area to the north and west totaling approximately 5,600 square miles of lands with major inflows coming from the Kissimmee River and Fisheating Creek.

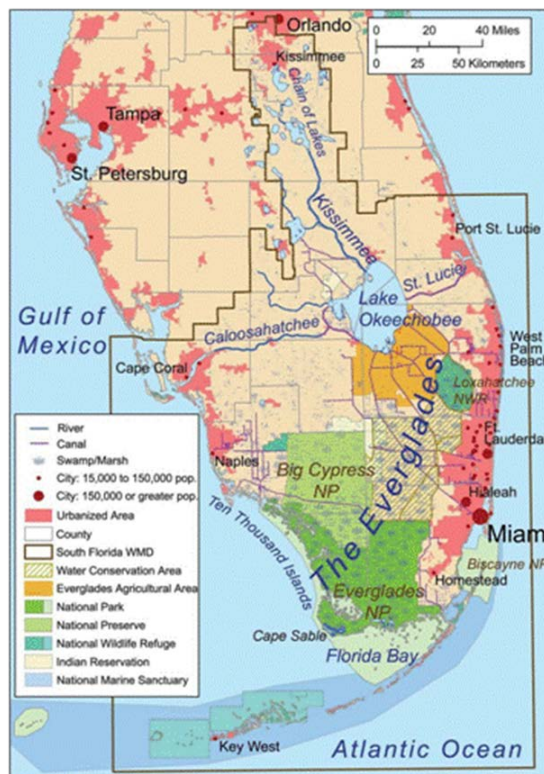
**Figure 1-1. Herbert Hoover Dike Location Map, Herbert Hoover Dike Surrounds Lake Okeechobee**

The proposed action, to be discussed in an upcoming draft Environmental Impact Statement (EIS), is to implement measures to reduce the risk of failure of the Herbert Hoover Dike (HHD) system (**Figure 1-1**). The EIS will be available for public review on December 24, 2015.

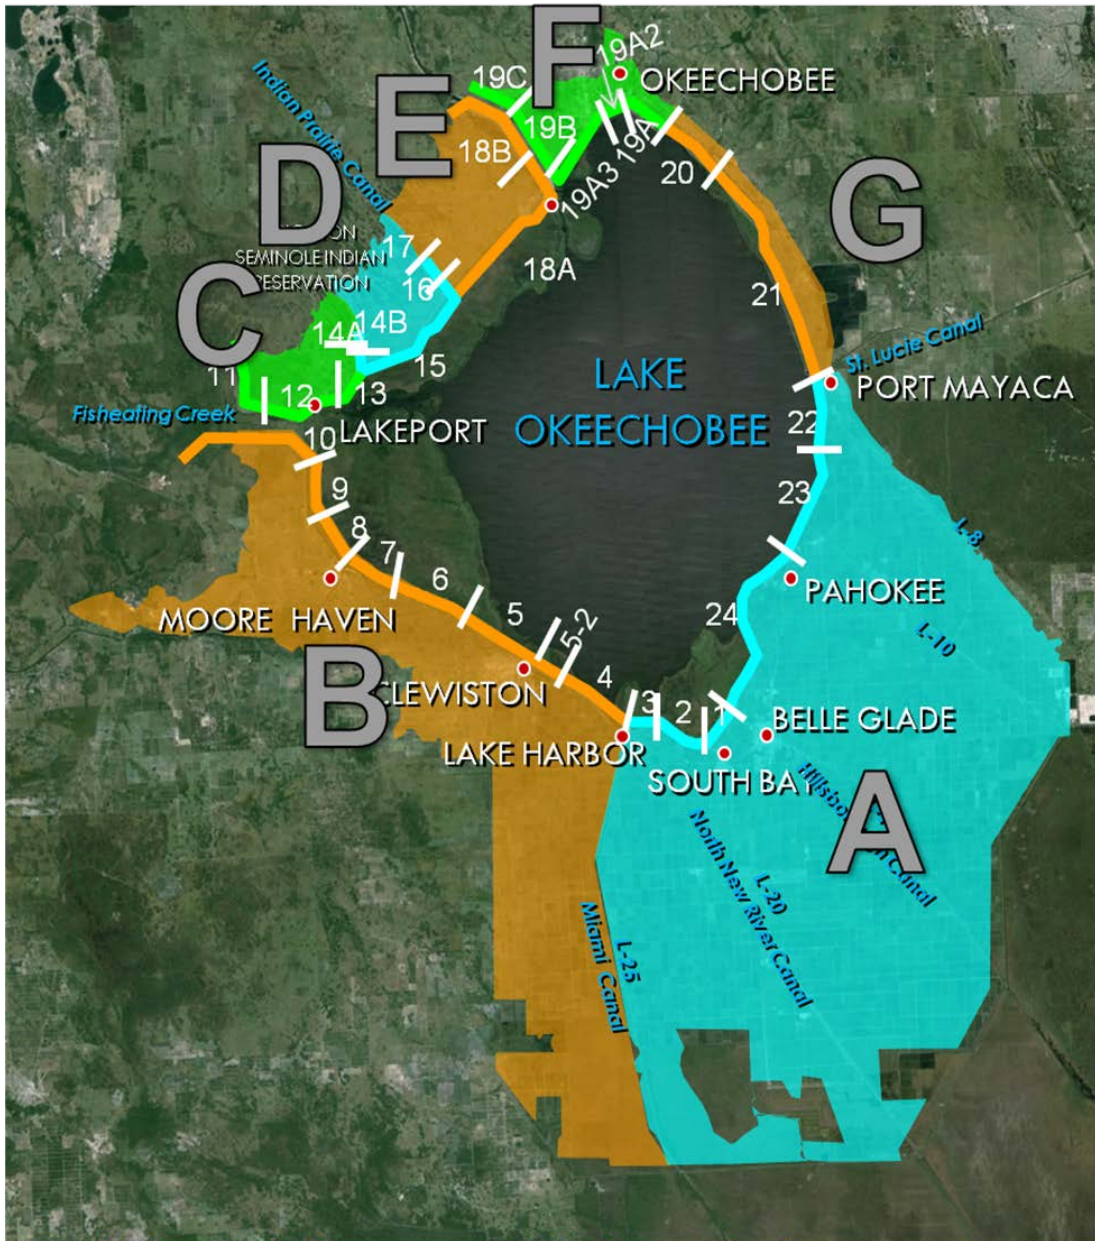
Figure 1-1-2. HHD Common Inundation Zones and Segments

Within the Dam Safety Modification Study, the use of 8 Reaches to delineate HHD has been substituted with seven Common Inundation Zones (CIZ), and then further delineations of segments within CIZs (**Figure 1-2**). These seven CIZs reflect downstream areas where similar inundation or flooding will occur from a breach anywhere within that zone.

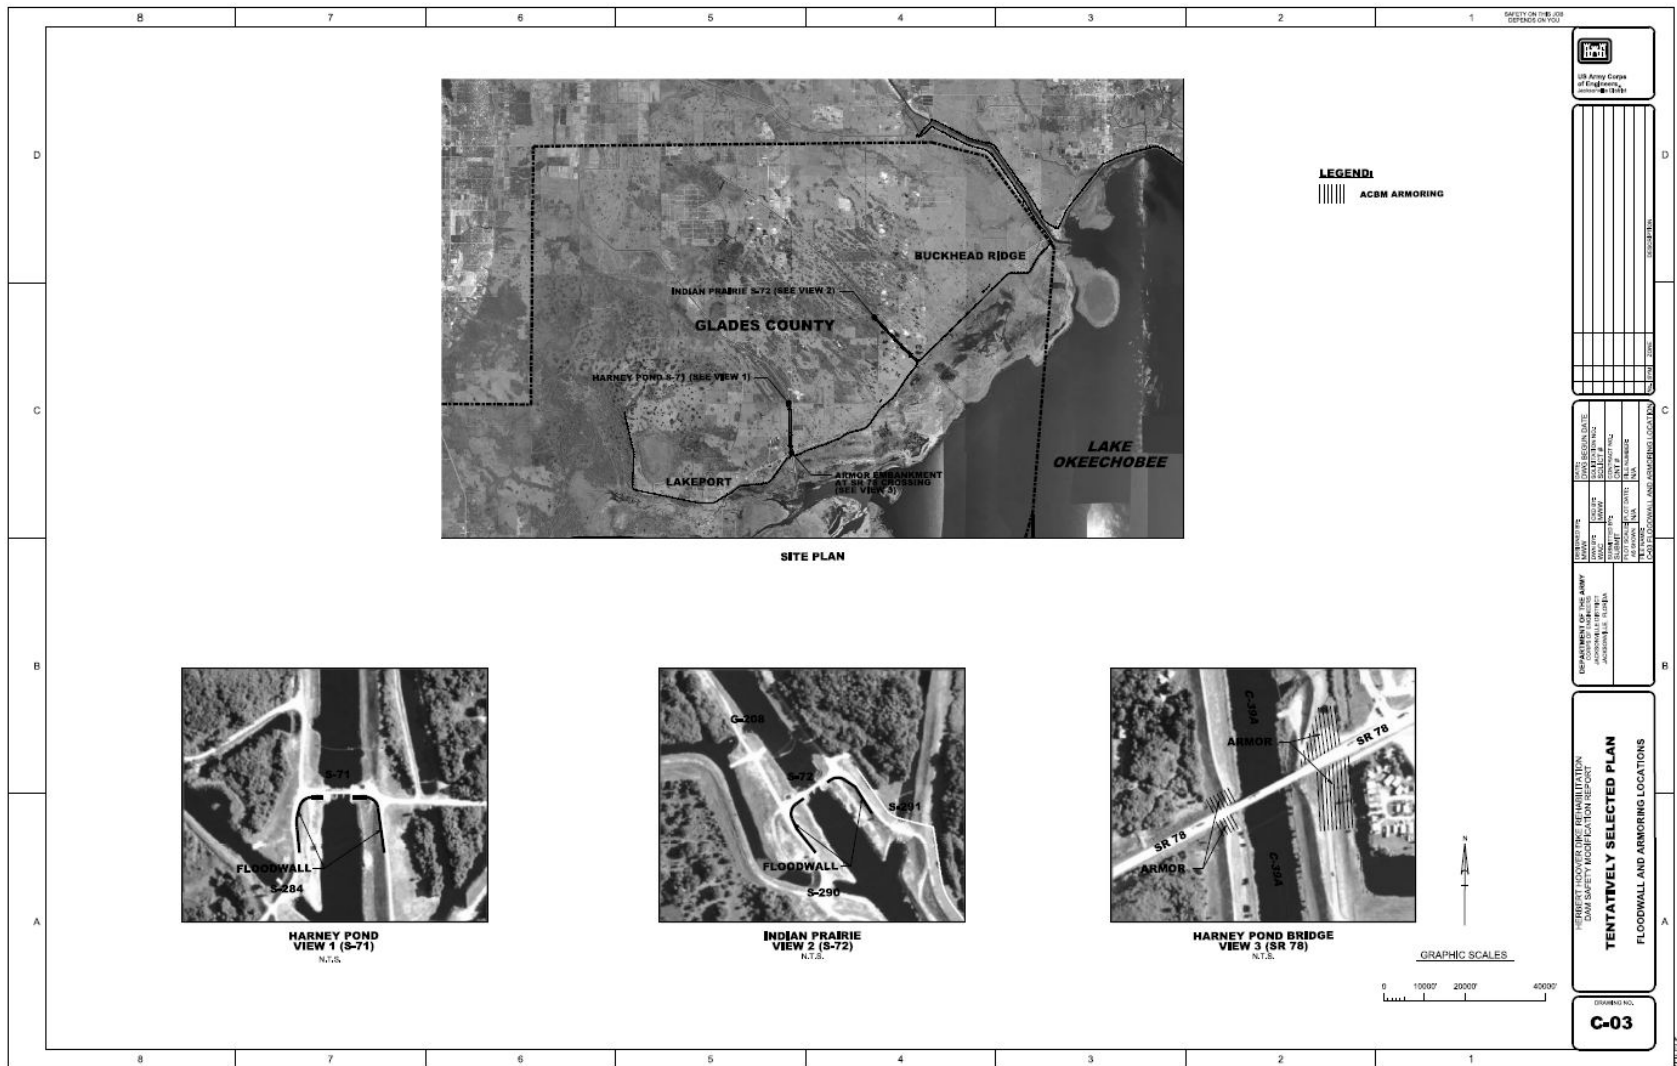
Figure 1-4. Limits of ACB armoring.

S-71 and S-72 are structures located on the Harney Pond Canal and Indian Prairie Canal. They are nearly identical in design and construction and are the terminus of HHD to the north. At these locations, the HHD earthen embankment drops down in elevation to meet the service platform of each structure. A similar situation occurs at the intersection of SR-78 Bridge and Harney Pond canal. The embankment drops down in elevation to meet the bridge abutment. A floodwall ranging in height from 1 to 6 feet or embankment armoring would be constructed adjacent to these structures.

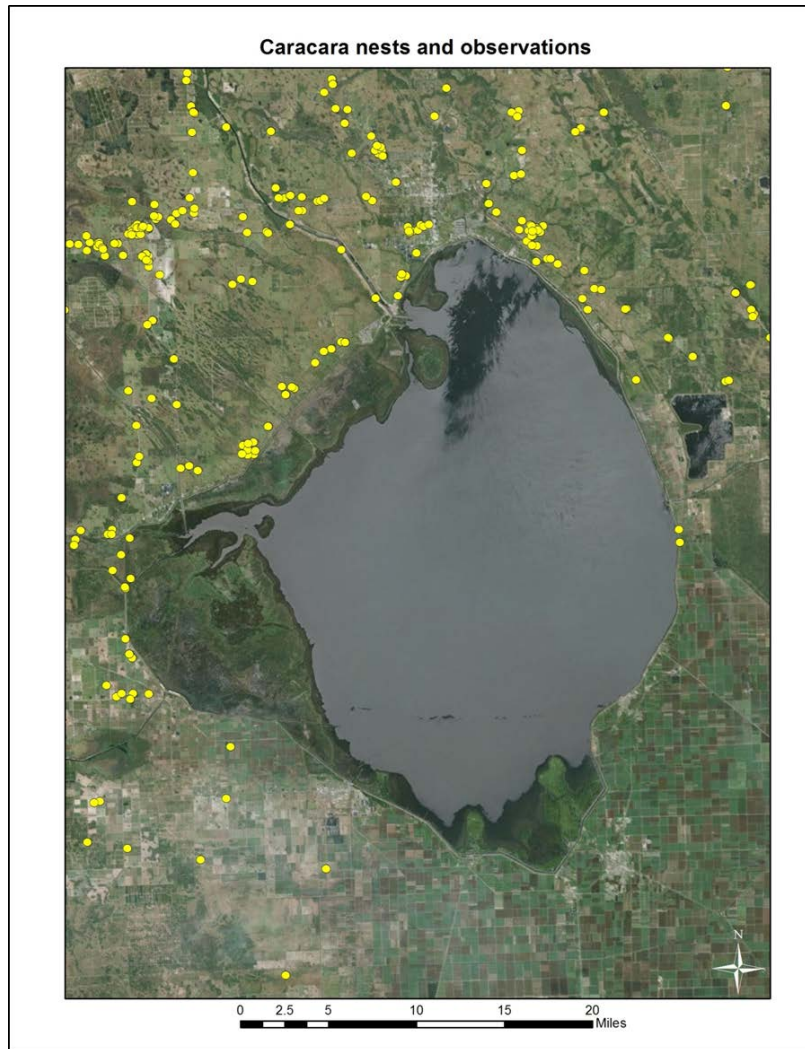
**Figure 2-1. Caracara nests and observations (from 1992-2014) around Lake Okeechobee. Source: USFWS 2015**

The caracara is an opportunistic feeder, taking prey items such as insects, small reptiles and amphibians, and small mammals. Eggs and carrion are also included in the diet of caracaras. Foraging for food takes place in early morning and late afternoon. Caracaras often walk through pastures searching for prey items, particularly after disturbance such as mowing or plowing. Caracaras have also been observed feeding in recently burned areas. Hunting takes place from conspicuous perches or while in flight. Once prey is sighted, the caracara flies to the ground and walks up to prey item (Morrison 1996, Morrison 2001). The caracara is known to occur in the vicinity of the HHD and Fisheating Creek (USFWS produced map 2015). Audubon's crested caracara have been documented to nest near the project area, specifically nests have been reported south of Port Mayaca outside of the Federal right-of-way. Additionally, it is possible that nests could be found in other areas within the project area. Caracara nests around Lake Okeechobee are shown in **Figure 2-1**.

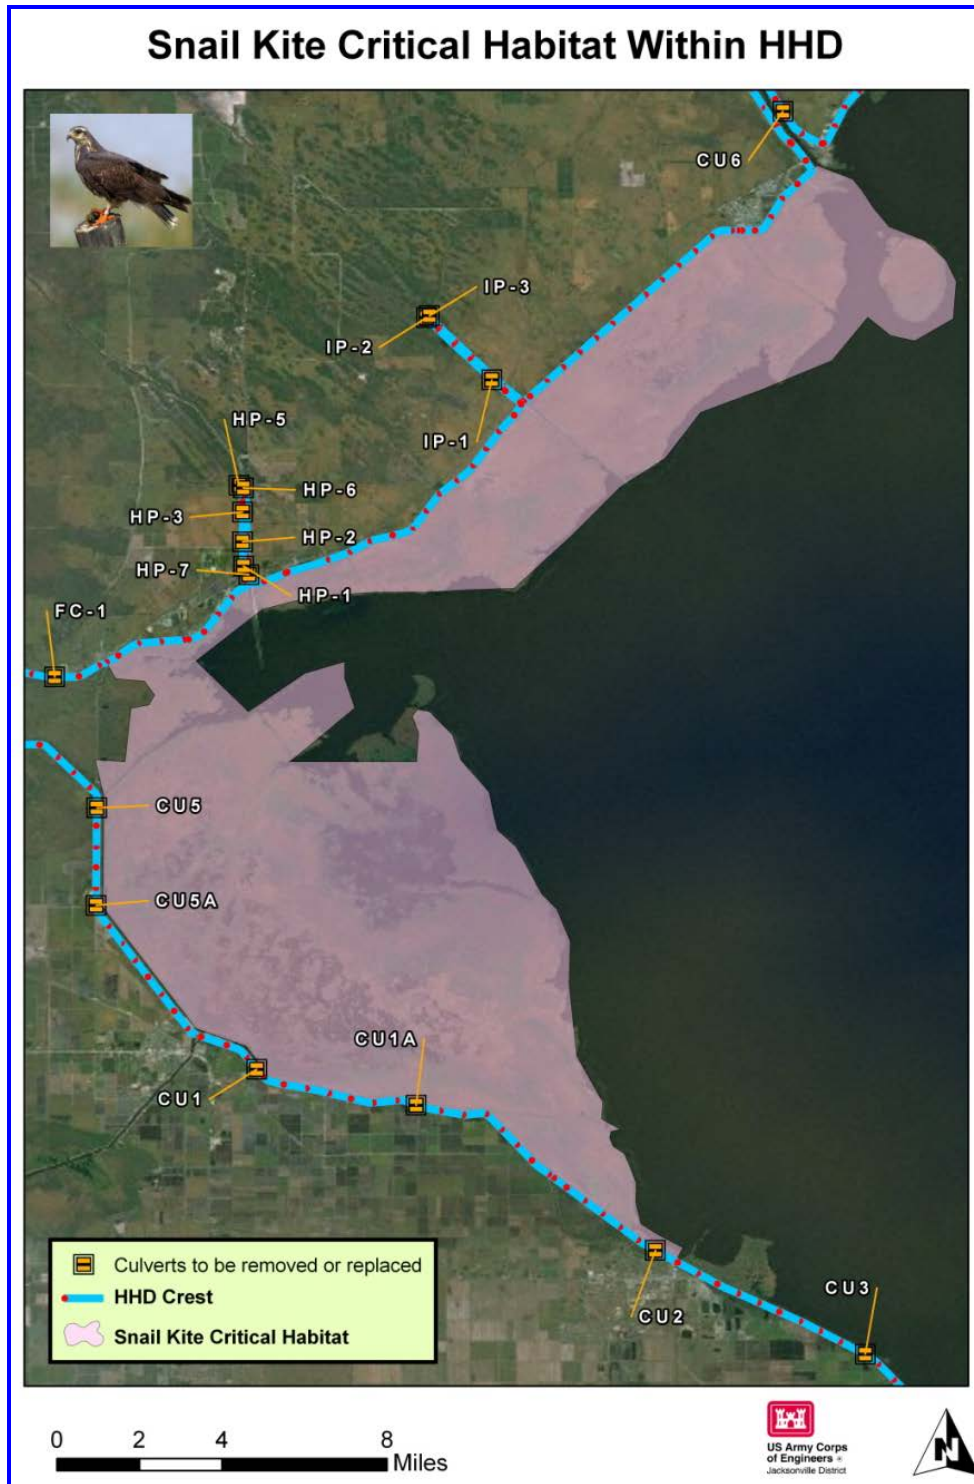
Figure 2-2. Snail Kite Critical Habitat located in Lake Okeechobee

Based on the description in the Federal Register (1977), snail kite critical habitat in Lake Okeechobee is located in the western parts of Glades and Hendry Counties, extending along the western shore to the east of the dike system and the undiked high ground at Fisheating Creek, and from the Hurricane Gate at Clewiston northward to the mouth of the Kissimmee River, including all the spike rush (*Eleocharis* sp.) flats of Moonshine Bay, Monkey Box, and Observation Shoal, but excluding the open water north and west of the northern tip of Observation Shoal north of Monkey Box and east of Fisheating Bay. Critical habitat for the snail kite includes the southwest and western shore of Lake Okeechobee from Clewiston to the Kissimmee River (excluding deep open water). In the project area, this critical habitat includes the area along the HHD in CIZ B and C (**Figure 2-2**).
