**APPENDIX E. FISH AND WILDLIFE COORDINATION ACT  
AND ENDANGERED SPECIES ACT COMPLIANCE**

Herbert Hoover Dike  
**Dam Safety Modification Study**

**Draft Interim Fish and Wildlife Coordination Act Report**  
**Herbert Hoover Dike Dam Safety Modification Study**

**COMPLETE INITIATION PACKAGE**

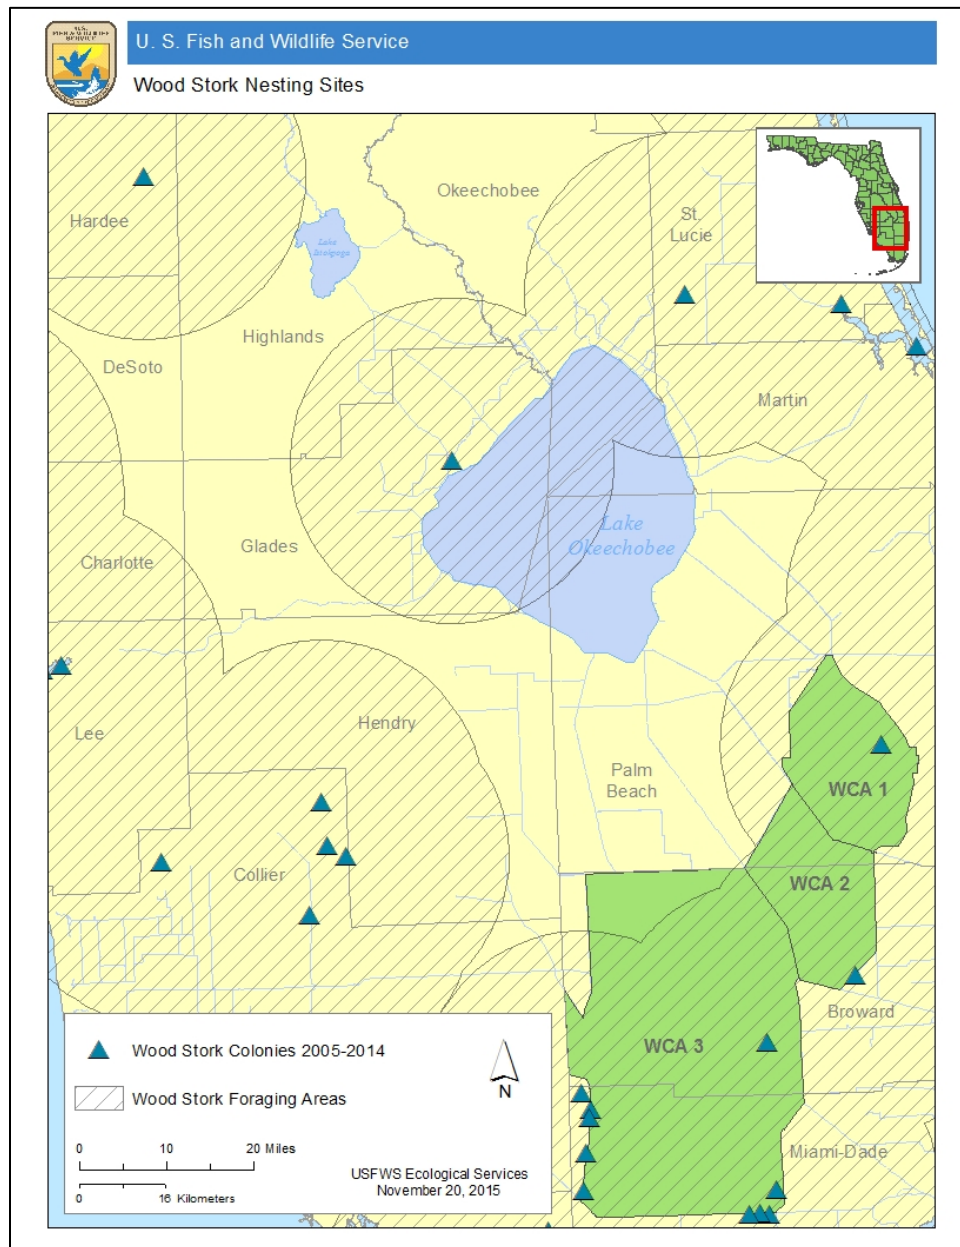
Figure 2-3. Wood stork colonies near HHD and Lake Okeechobee. Source: USFWS 2015

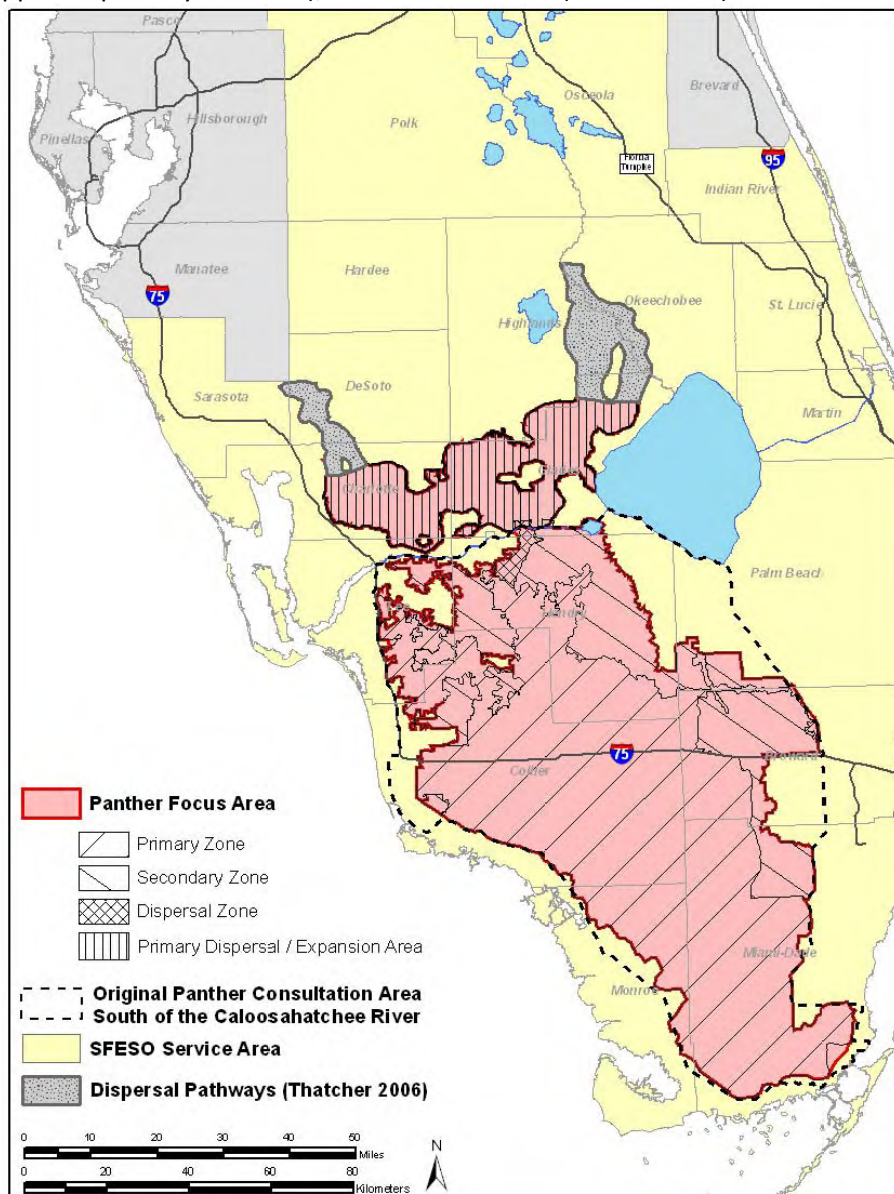
Figure 2-4. Florida panther zones in South Florida.

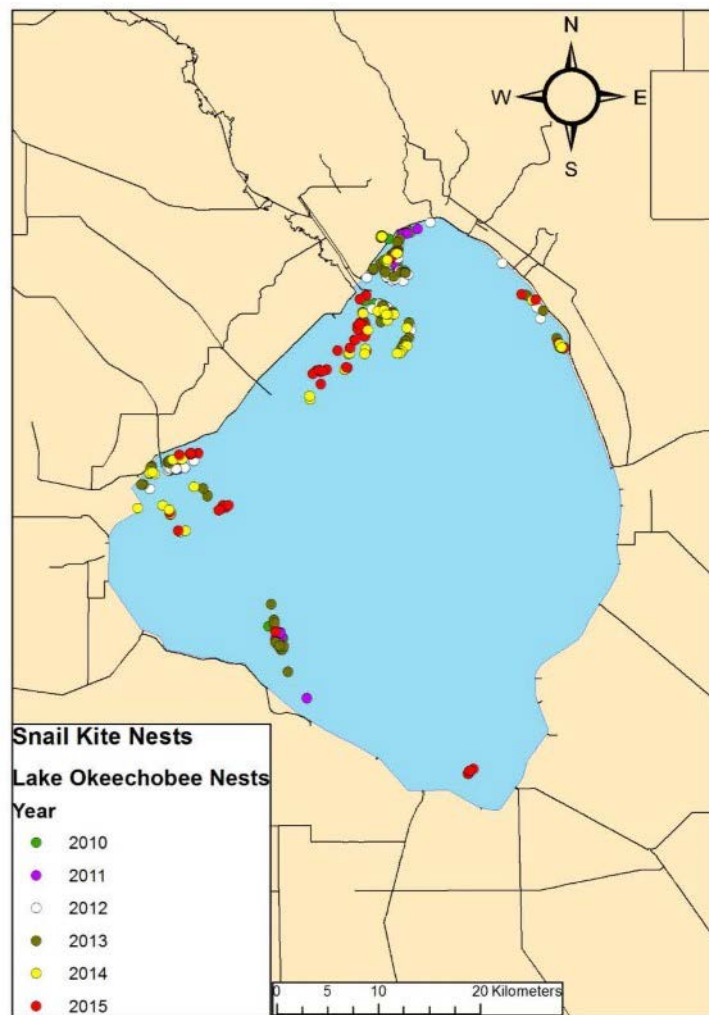
**Figure 2-5. Snail kite nest locations from 2010-2015 (\*active nests only). Source: USFWS 2015 \*Active = only nests where eggs or nestlings were observed.**

Everglade snail kites are known to nest near the project area (see **Figure 2-5** for known nesting locations). In addition to nesting, snail kites forage within the Lake Okeechobee southwestern littoral zone. The proposed action may produce noise above ambient levels, however, mufflers and sound dampening equipment would be required during construction. Preconstruction surveys would be completed prior to the initiation of construction activities. Monitoring kites during the nesting season (January through June) within the 500 ft no activity zone of active snail kite nests will ensure the action will not increase noise above ambient levels within nest protection areas of active snail kite nests. A 1640 ft buffer (Secondary Priority Management Zone) will be established as necessary around active nests.

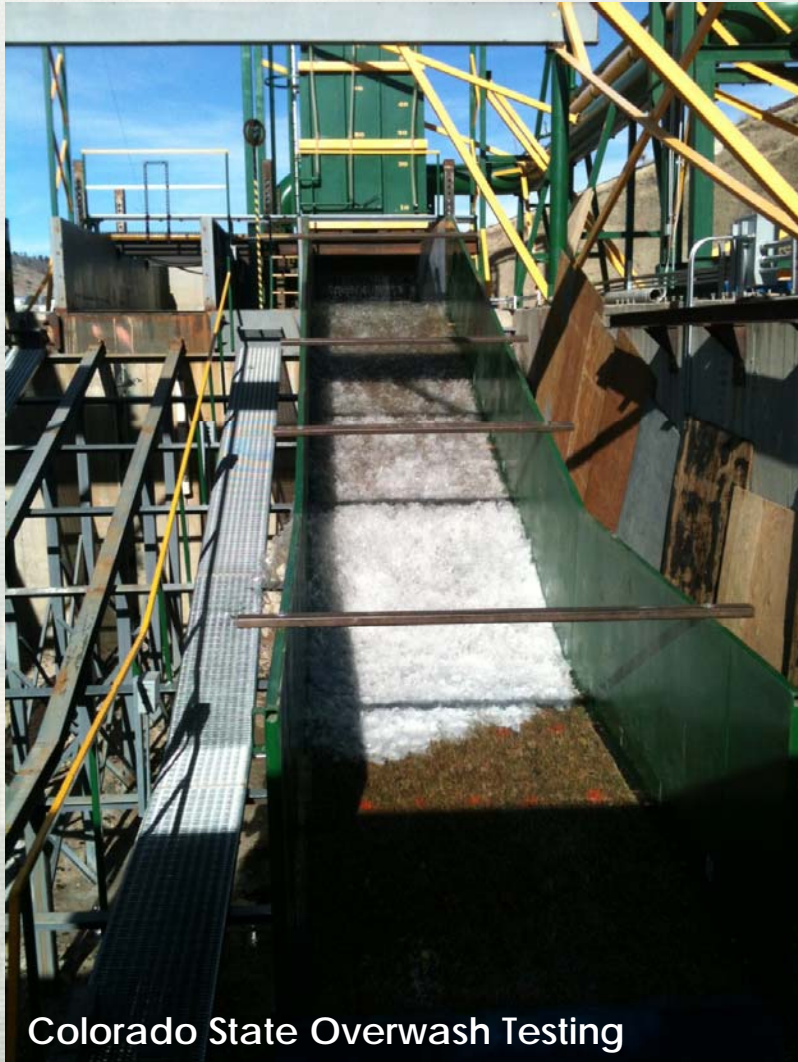
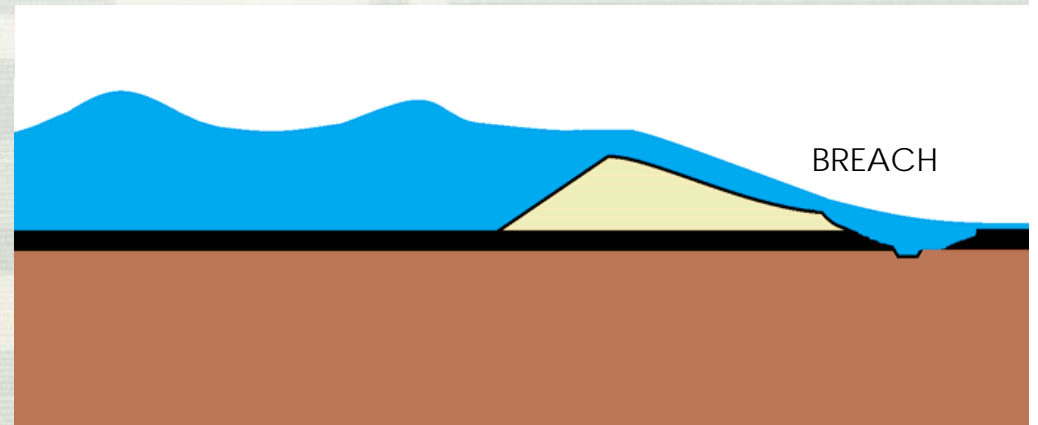
# WHAT IS OVERWASH & OVERTOP?

- Water from Lake Okeechobee going over the top of the dike due to wind and waves during storm events
  - Causes erosion of embankment

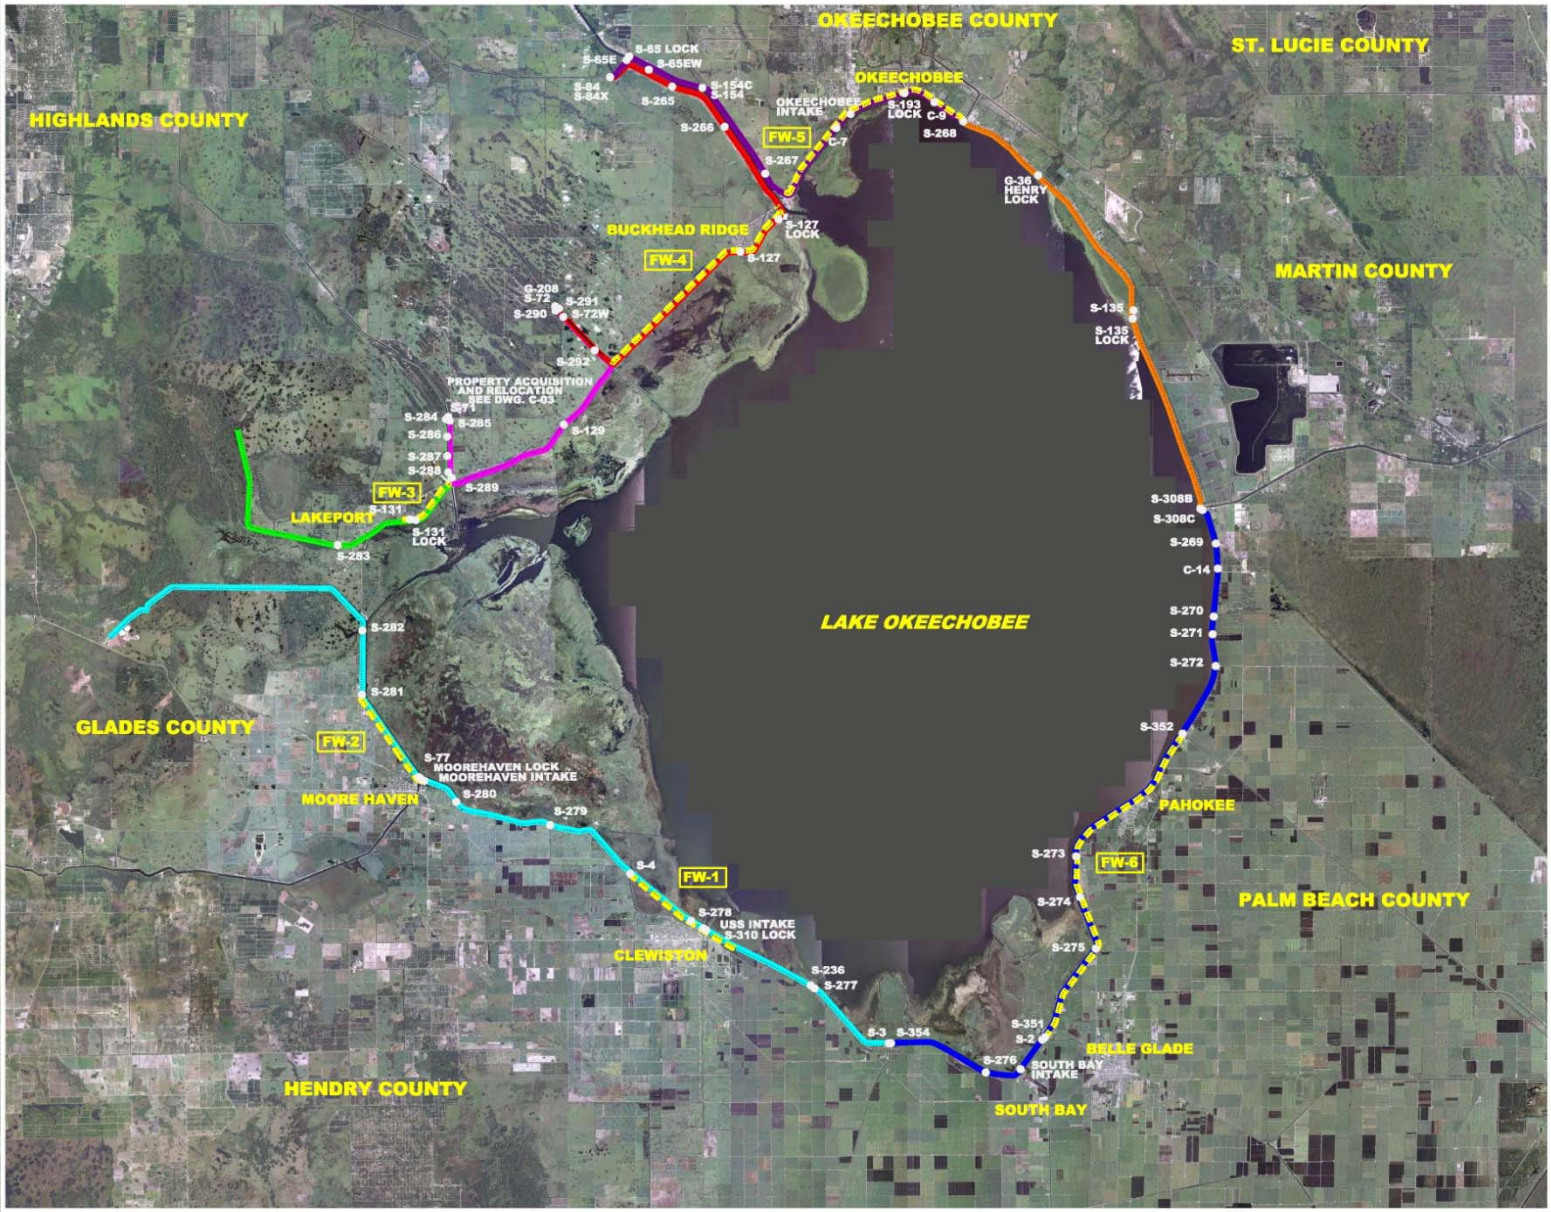
- ZONE-A
- ZONE-B
- ZONE-C
- ZONE-D
- ZONE-E
- ZONE-F
- ZONE-G
- COUNTY LINE
- - - - - FLOODWALL
- S-280 ● STRUCTURE LOCATION

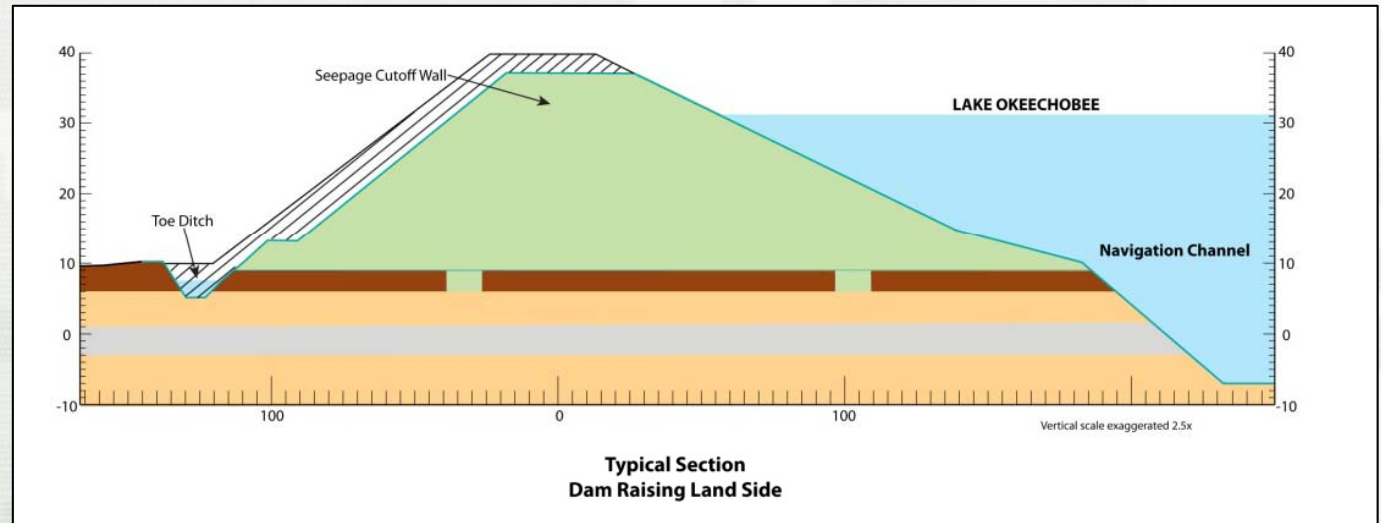
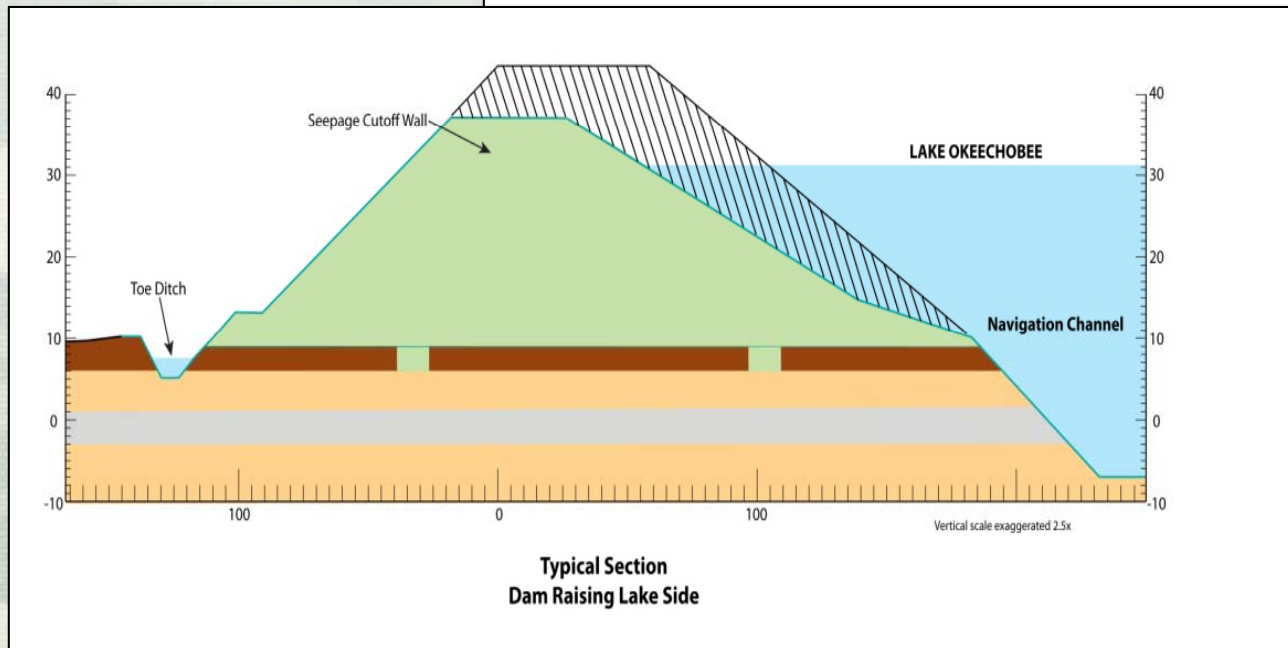
# OVERWASH/OVERTOP OPTION- RAISE EMBANKMENT

- NOTES**
1. Elevations are in NAVD (88)
  2. Actual geologic conditions will vary per location.
  3. Embankment geometry, typography and hydrophy is generalized and will vary by segment.
