**Dade County
1980-1992
Bakers Haulover Inlet**

Plate 13. Baker Haulover - Government Cut Reach Problem Identification & Plan Formulation April 1996

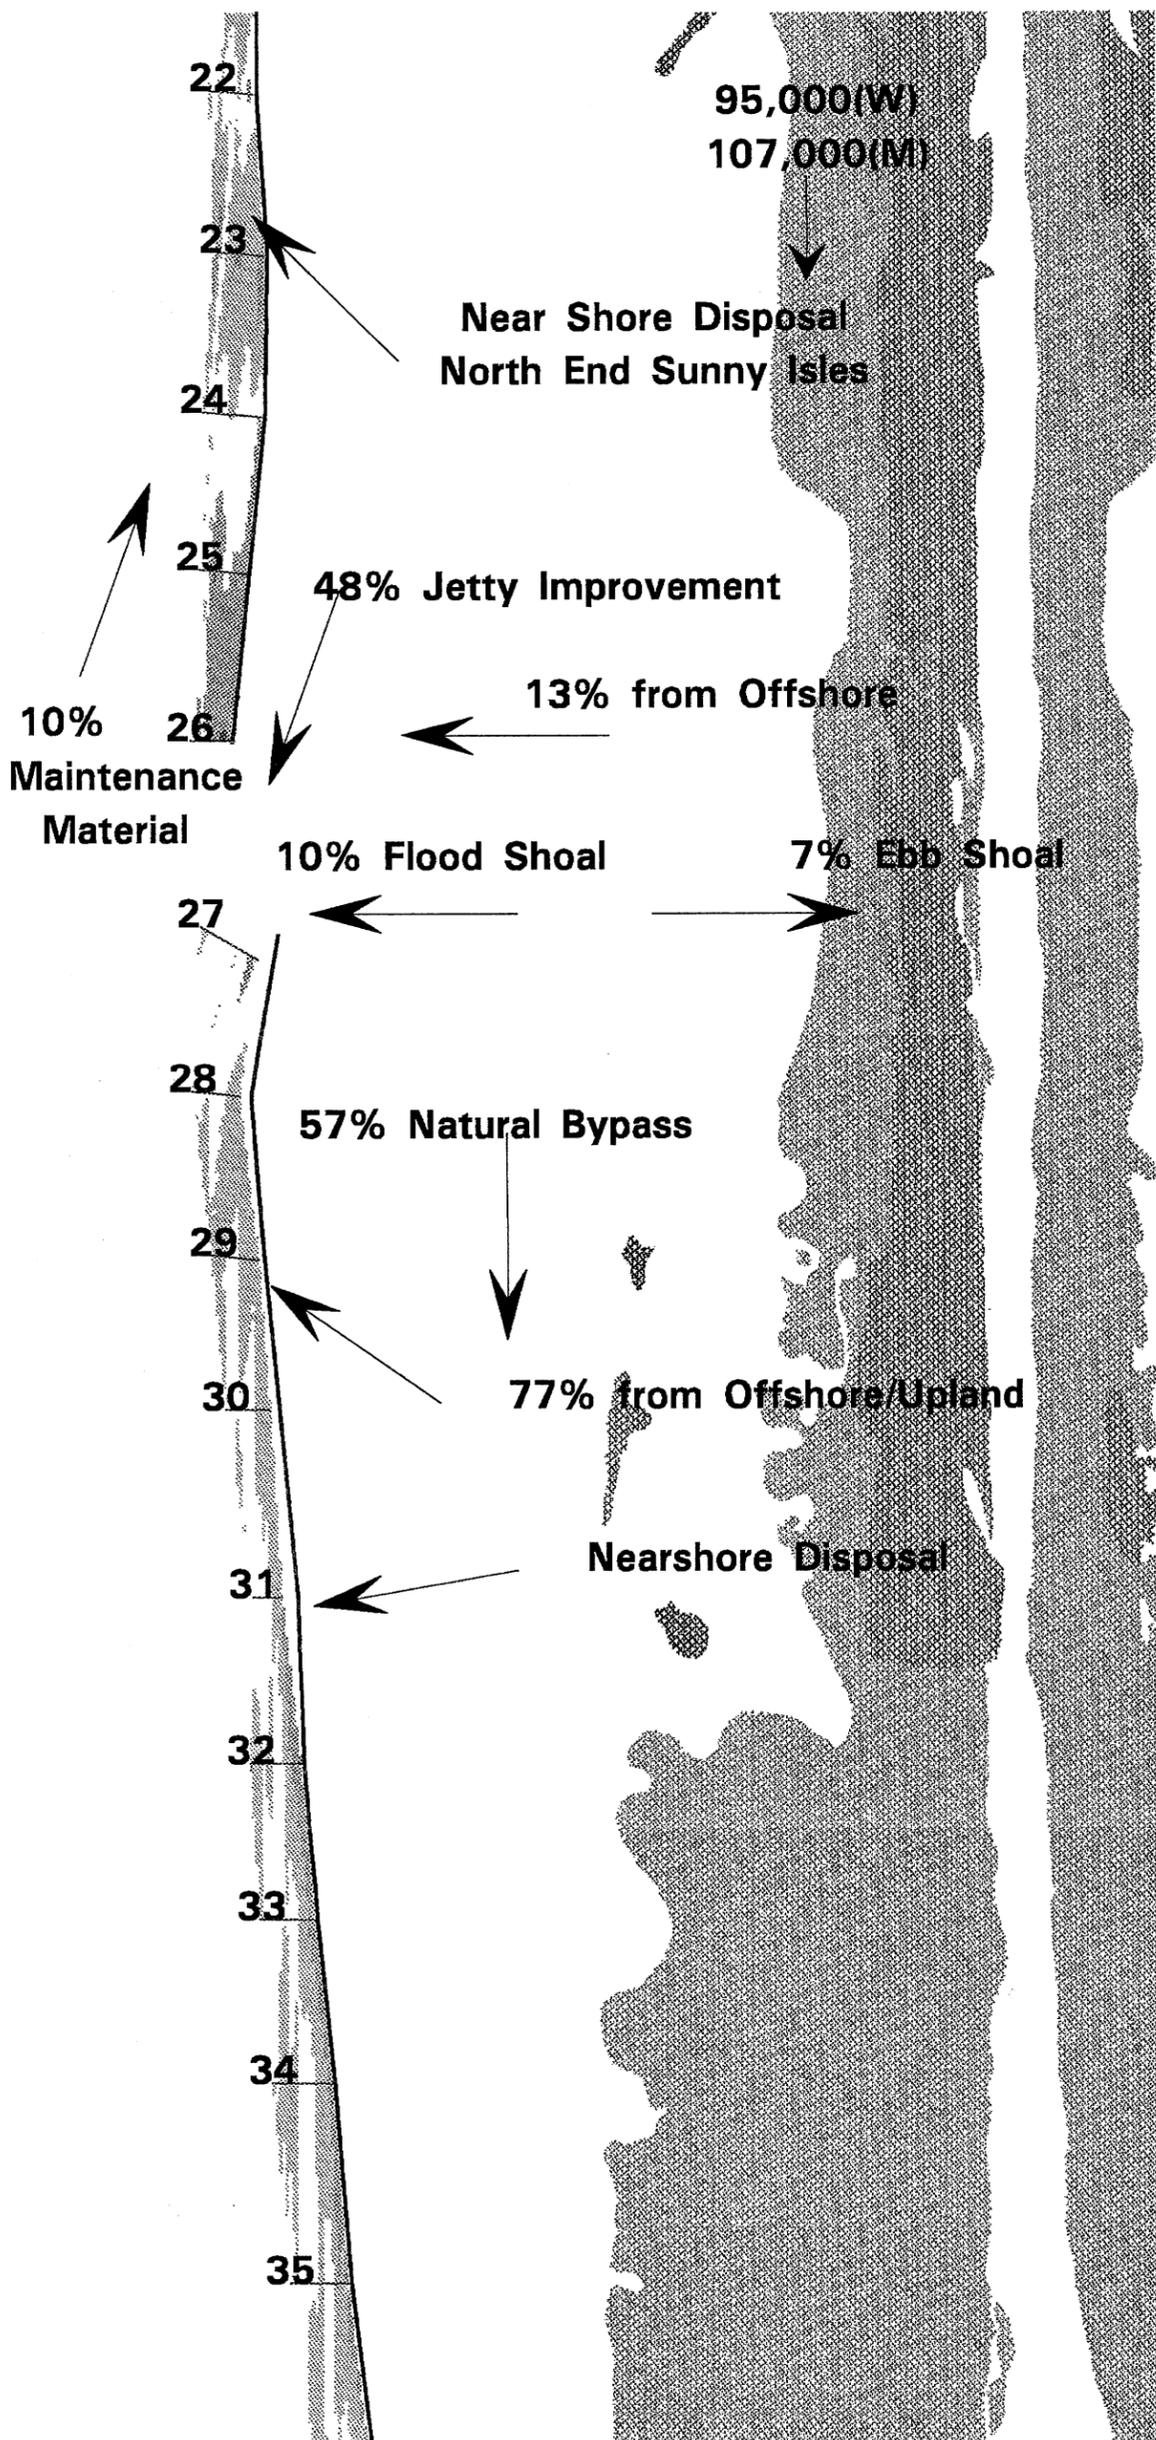
Plate 12. Bakers Haulover Inlet Sediment Budget

**Elevation Change
(Feet)**

**Hardbottom
Classification**

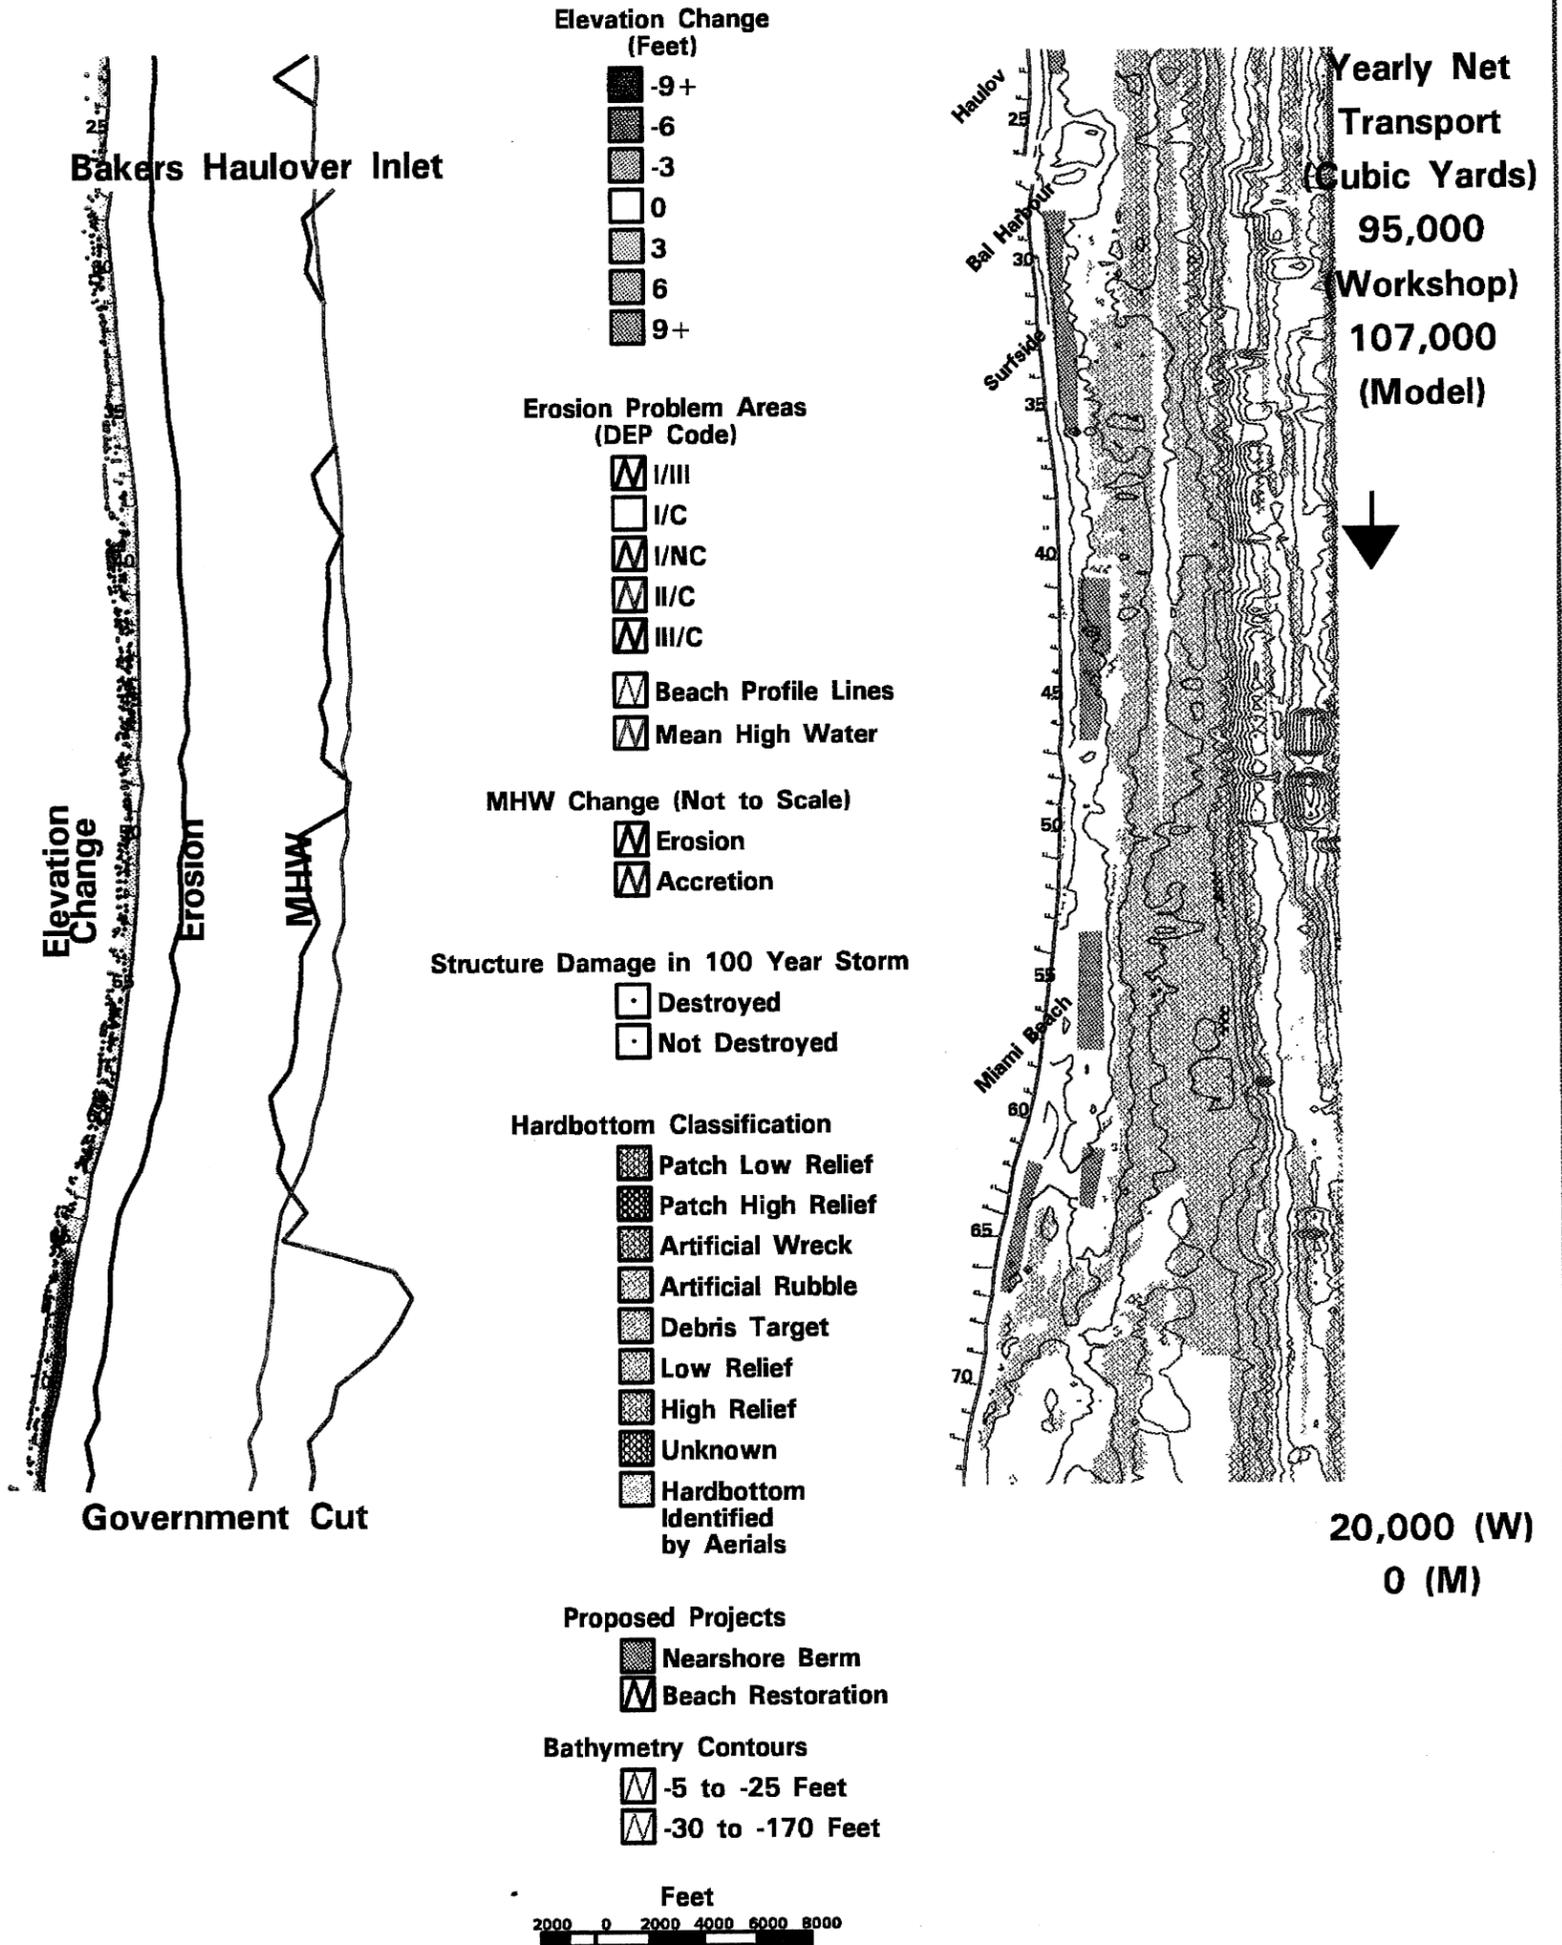
Dade County 1980-1992 Bakers Haulover Inlet to Government Cut

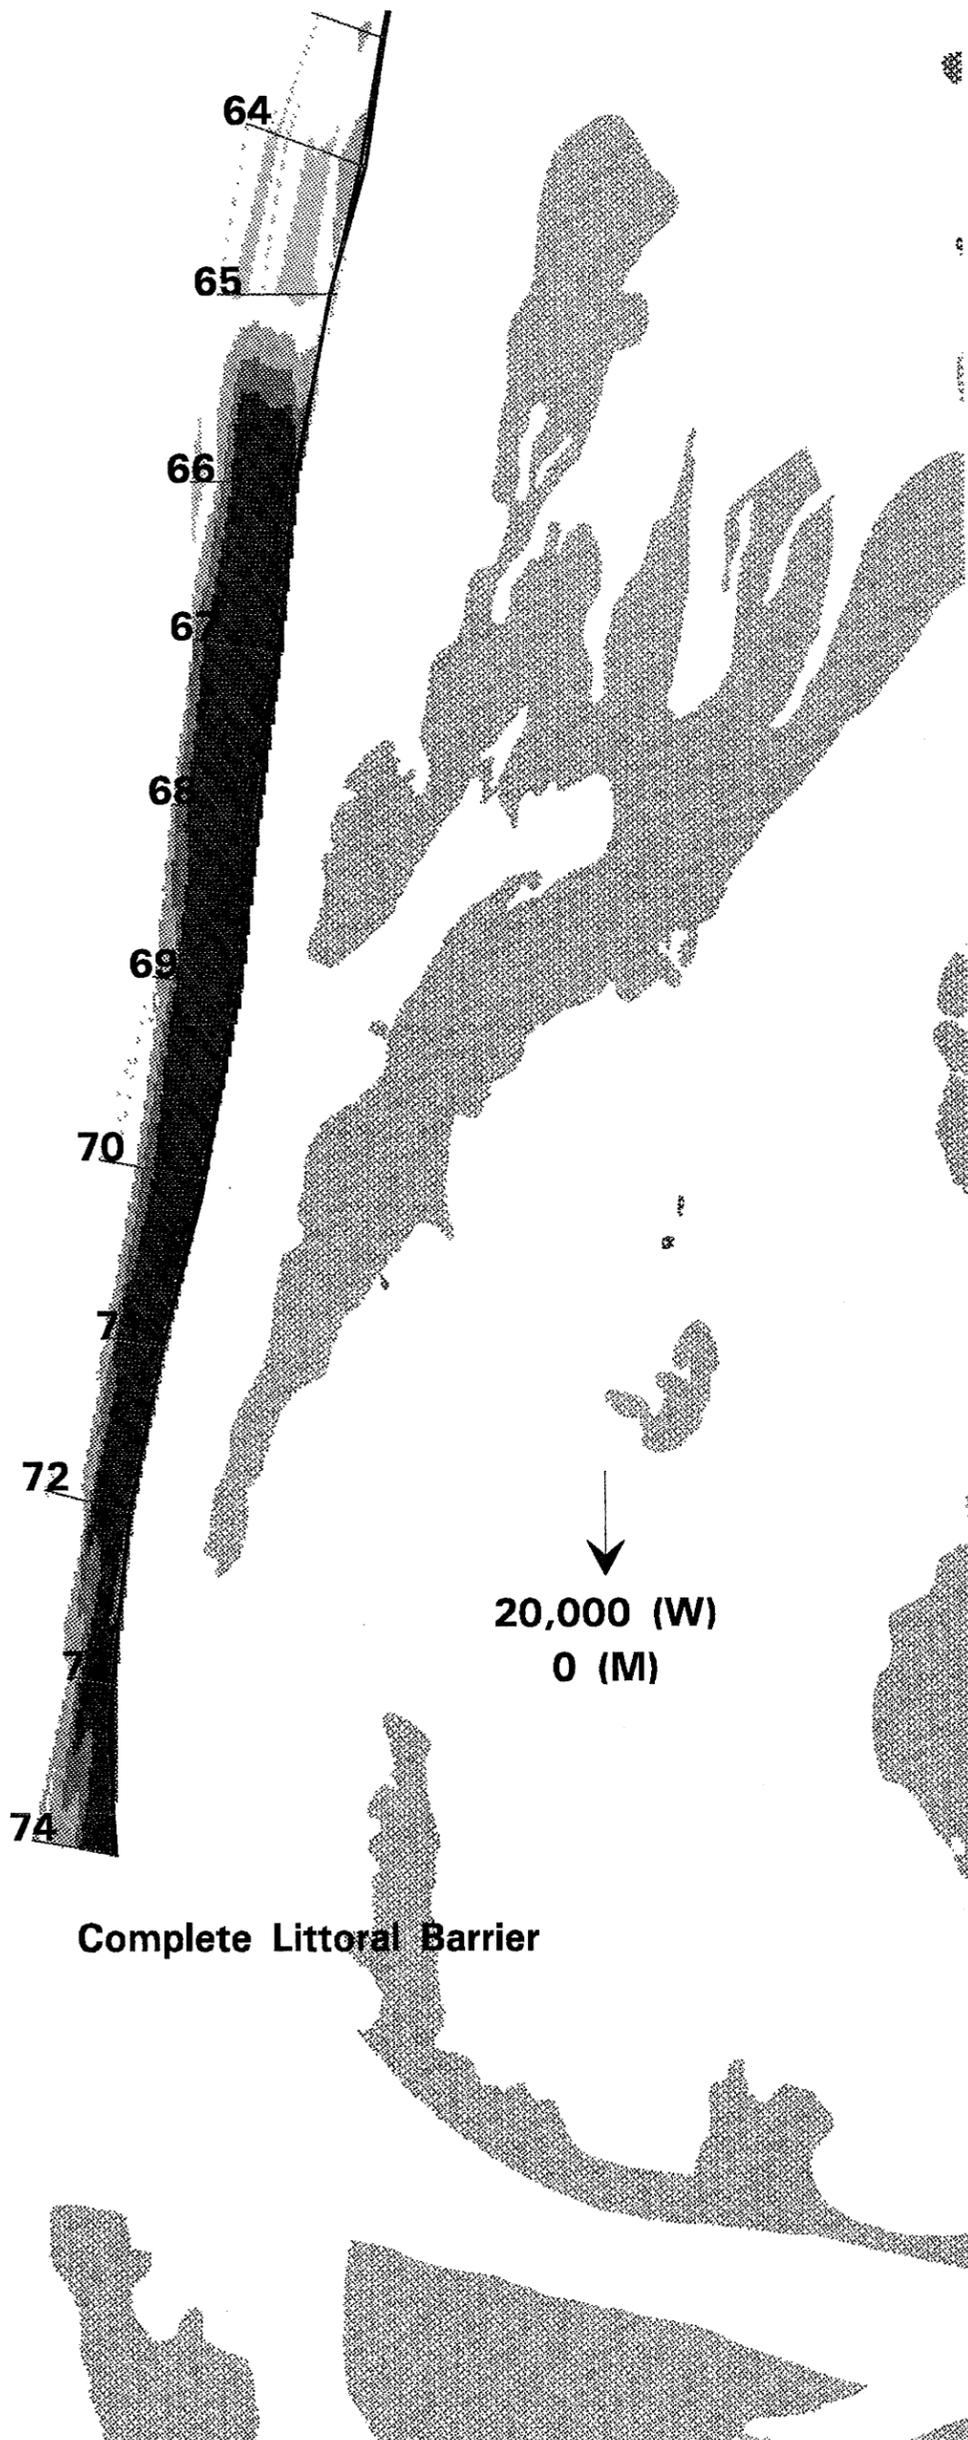
Plate 14. Government Cut Inlet Sediment Budget

**Dade County
1980-1992
Government Cut**

**Elevation Change
(Feet)**

**Hardbottom
Classification**

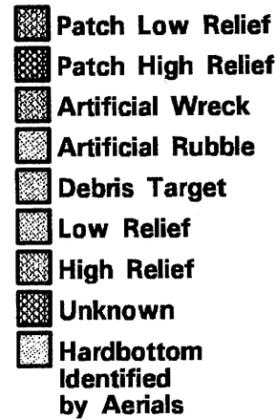
Dade County 1980-1992 Government Cut to Cape Florida

Elevation Change (Feet)

Erosion Problem Areas (DEP Code)

MHW Change (Not to Scale)

Structure Damage in 100 Year Storm

Hardbottom Classification

Proposed Projects

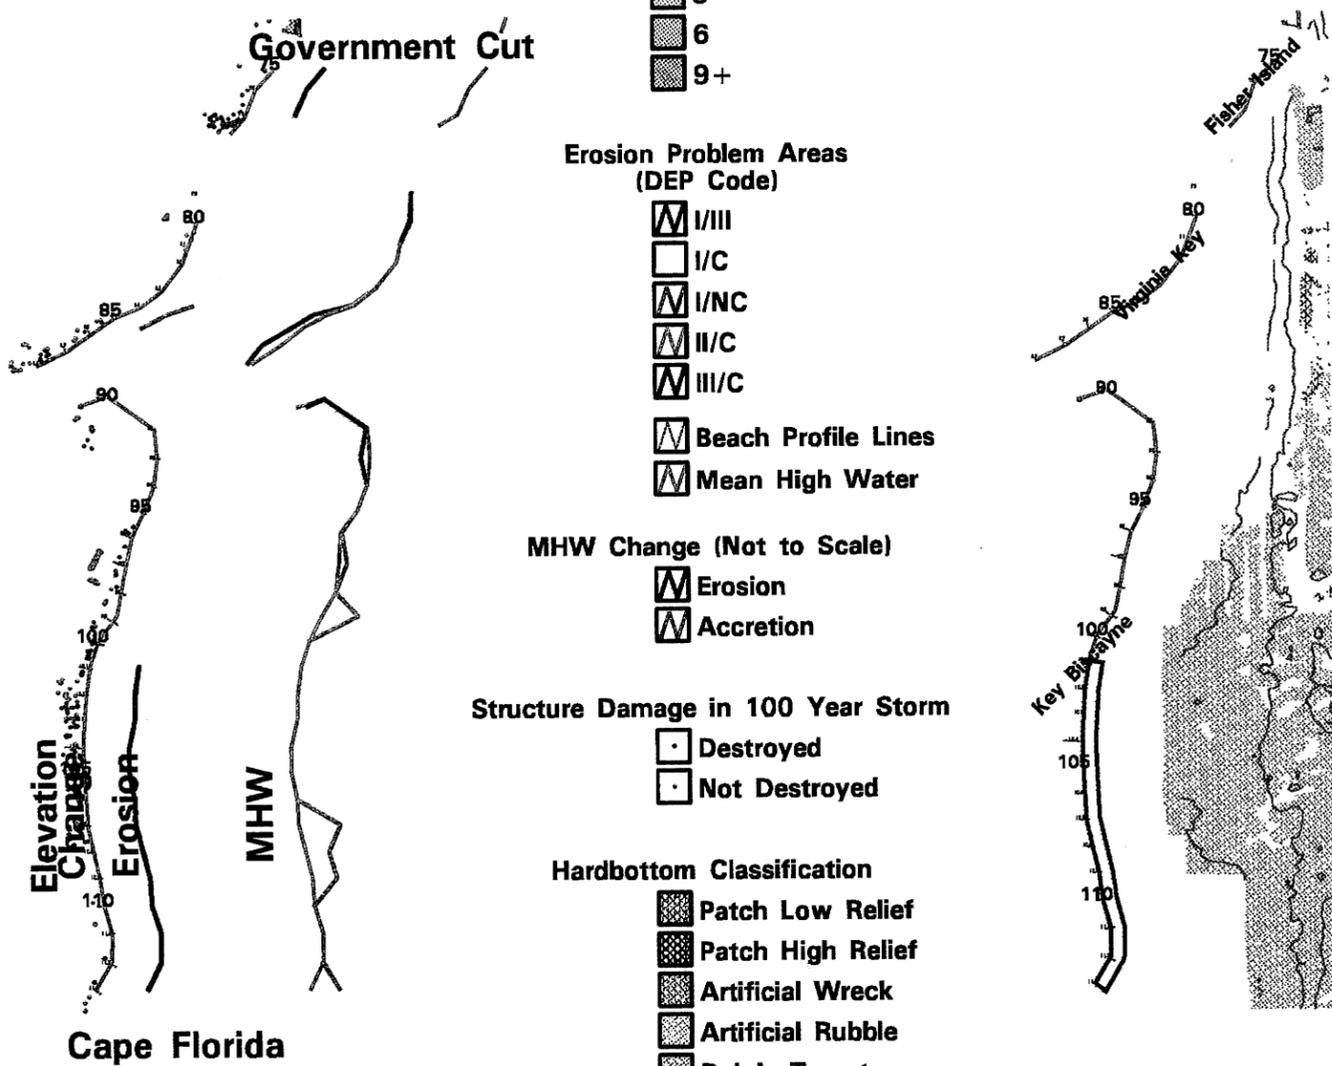
Bathymetry Contours
