APPENDIX E
Environmental Baseline Study

**Environmental Baseline Study
Miami Harbor
General Reevaluation Report**

**Revised
November 2001**

**Prepared for
Jacksonville District
U.S. Army Corps of Engineers
400 West Bay Street
Jacksonville, FL 32202**

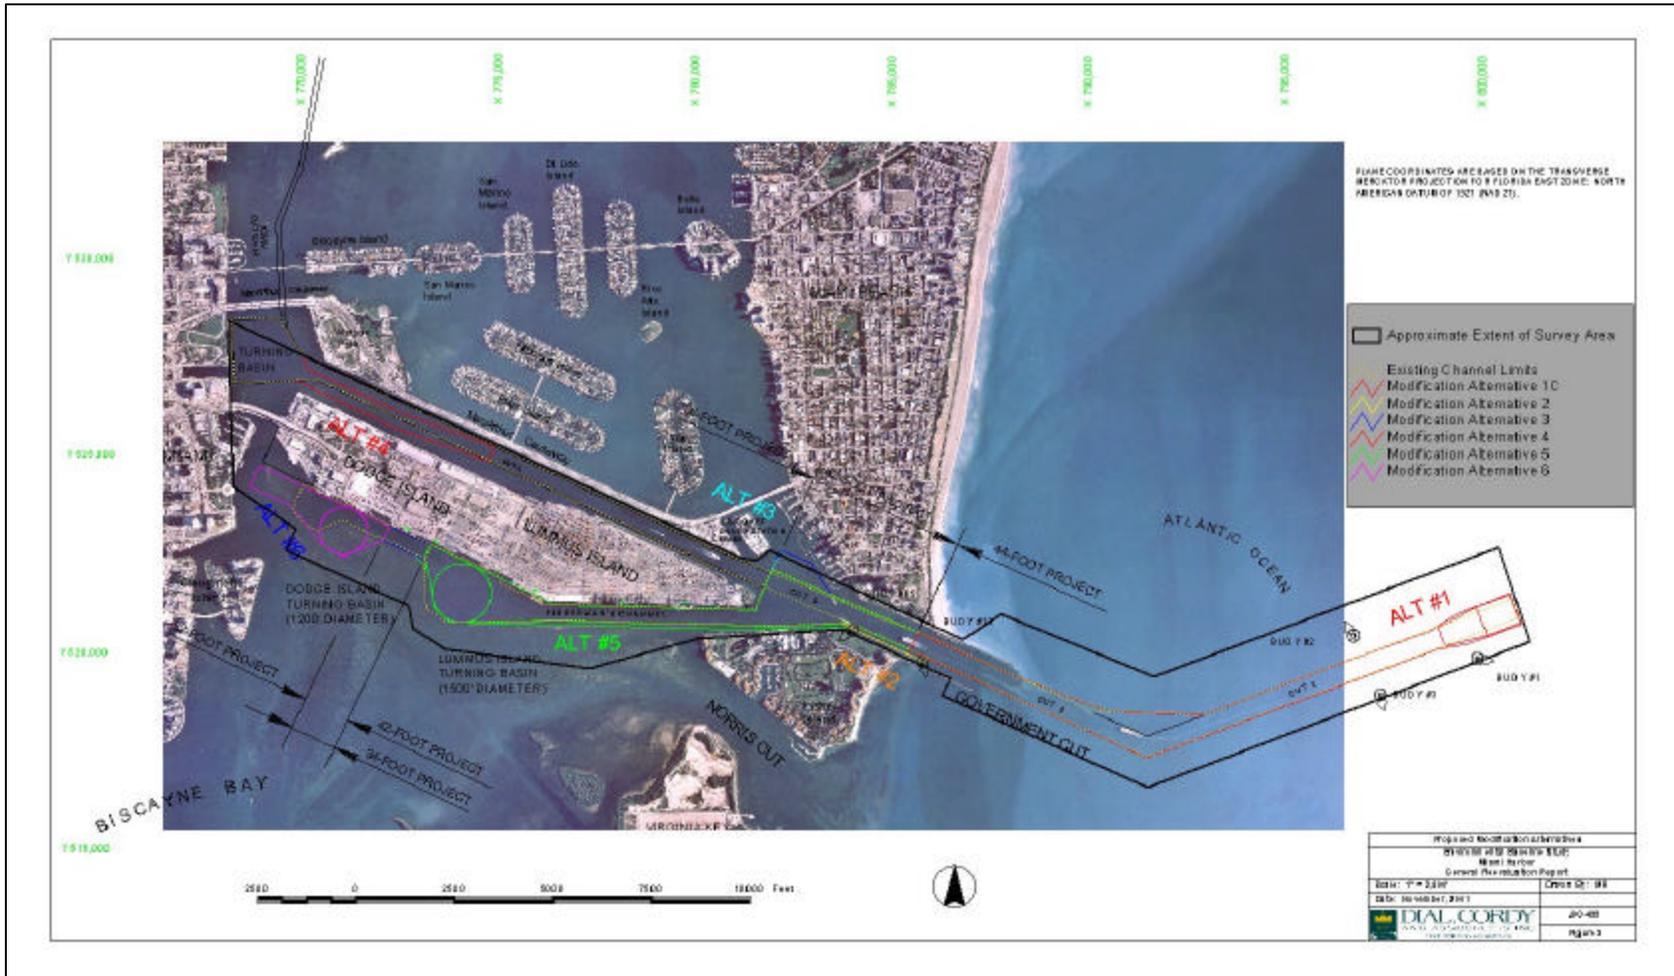
Figure 2 Proposed Modification Alternatives

No Action Plan	Port would continue operation under the existing conditions.
Alternative 1	Widen seaward portion of cut-1 from 500 feet to 800 feet and deepen Cut-1 and Cut-2 from existing depth of 44 feet to a depth of 52 feet.
Alternative 2	Add turn widener between Buoy #13 and Buoy #15 and deepen from existing depth of 42 feet to a depth of 50 feet.
Alternative 3	Expand Fisher Island turning basin and deepen from existing depth of 42 feet to a depth of 50 feet.
Alternative 4	Relocate the western end of the main channel to allow for additional cruise ship berths.
Alternative 5	Widen Fisherman's channel approximately 100 feet to the south and deepen from current depth of 42 feet to a depth of 50 feet. Deepening would include Cut-3, station 0+00 to Cut-3 station 42+00

Alternative 6	Deepen Dodge Island Cut and the proposed 1200-foot diameter turning basin from 32 and 34 feet to 36 feet and relocate western end of Dodge Island cut to accommodate proposed Port expansion.
---------------	---

Proposed preliminary modification alternatives are summarized in Figure 2. A description of the proposed modification alternatives is as follows:

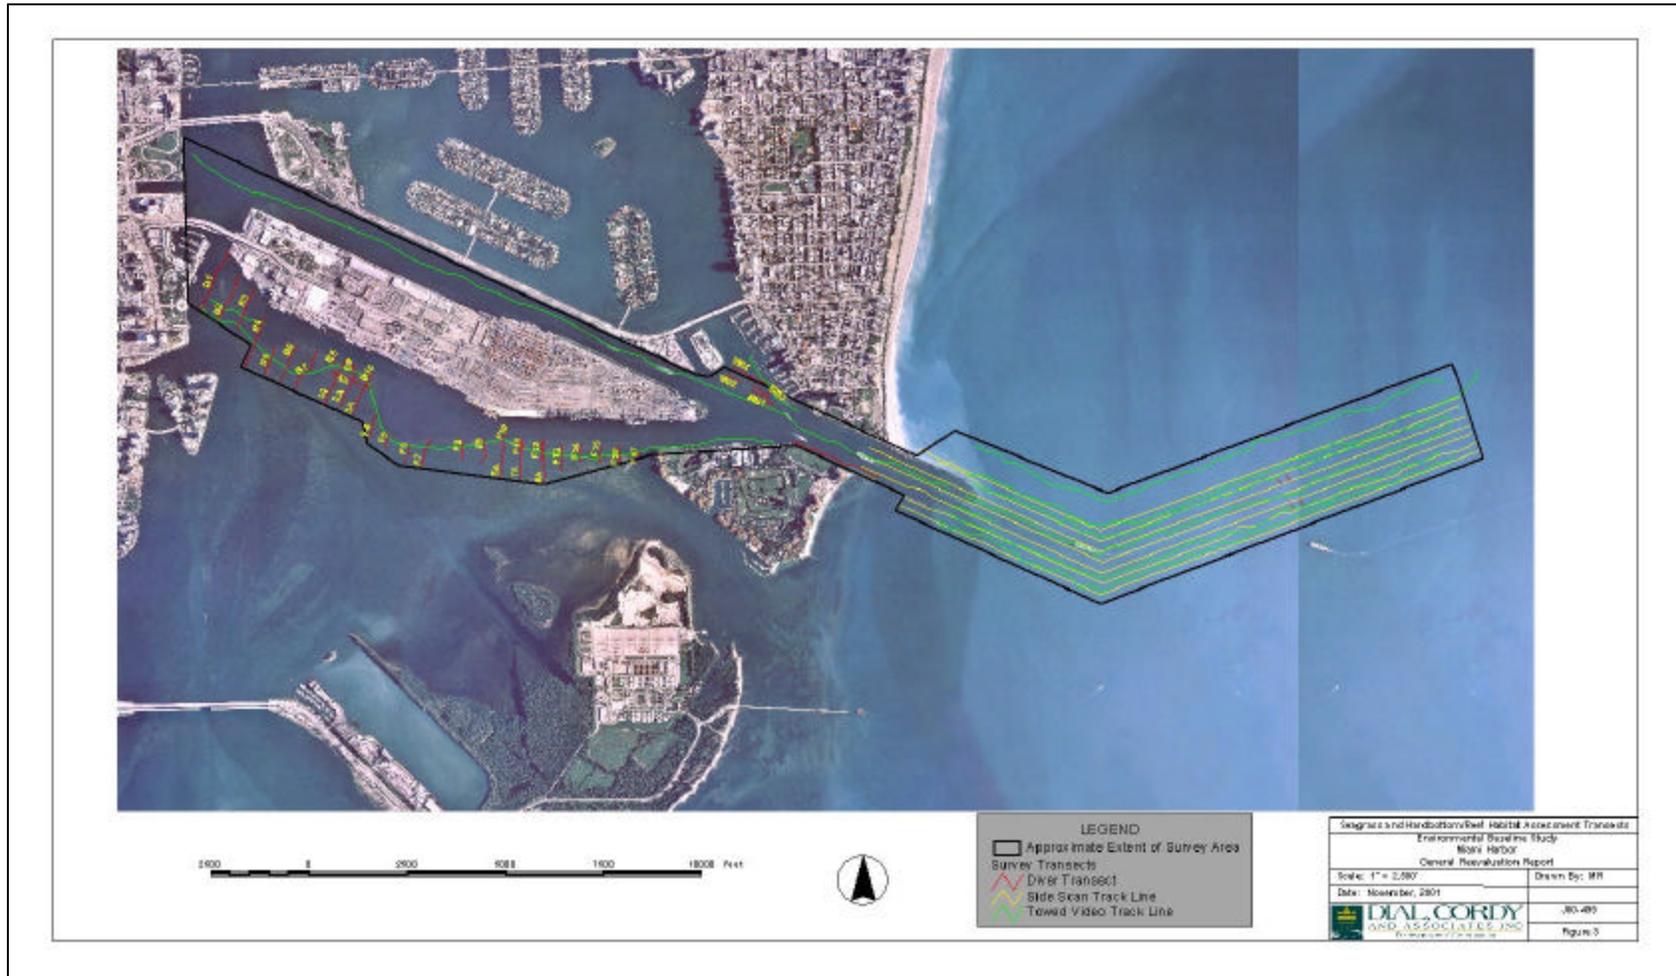
Figure 3 Seagrass and Hardbottom/Reef Habitat Assessment Transects

Survey transects within the study area included the area 400 feet south of Fisherman's Channel, including the area within the CWA, the area adjacent to the Coast Guard Station, the Entrance Channel, and the area 500 feet north and south of the offshore channel (Figure 3).

Marine seagrass was mapped along 35 transects within the designated project study area by locating the end positions of the transects using Differential Global Positioning System (DGPS), laying a weighted line marked in one meter increments from the shore, and then conducting a visual diver survey along the weighted line to document seagrass distribution and occurrence from the shore to the edge of channel. Seagrass habitat and bottom type observed while crossing each transect were noted. Divers drift dove to the next transect, and if any seagrass was found between transects, a DGPS position at the start and end of the grass bed was recorded and the width of the grass bed estimated. Information recorded on seagrass habitat type and distribution was transferred from field logs and entered into a spreadsheet. Table 1 lists a description of habitat classifications used for mapping purposes. This approach allowed a visual representation of species' associations and occurrences across the shelf, channel, and slope as compared with bottom depth. Maps were produced for all stations surveyed that had seagrass present. A GIS map (ArcView) and database were created to illustrate seagrass distribution throughout the study area.

reef habitats along transects on each side of the entrance channel (Figure 3). Side-scan sonar imaging (Klein 590TM) was also utilized to map the hardbottom and reef habitat features offshore. Side-scan, video and field data collected was used to assess the accuracy of existing maps of coral reef and nearshore hardbottom habitats within the study area. A revised resource map was prepared based on remote surveys conducted and existing resource maps.

Marine seagrass species observed within the study area included *Halodule wrightii*, *Halophila decipiens*, *Syringodium filiforme* and *Thalassia testudinum*. Of the 35 transects surveyed (Figure 3), marine seagrass species were observed at 25 transects. A summary of occurrence records for each transect where seagrass is found in Table 3. Seagrass occurrence in these areas consisted of mixed Submerged Aquatic Vegetation (SAV) with *H. decipiens* and *H. wrightii*, mixed SAV with *H. wrightii*, and *T. testudinum*, mixed SAV of *T. testudinum* and *S. filiforme*, mixed beds of all species and, monospecific beds of *T. testudinum*, and monospecific beds of *H. decipiens*. No *H. johnsonii* was observed while surveying the 35 transects.

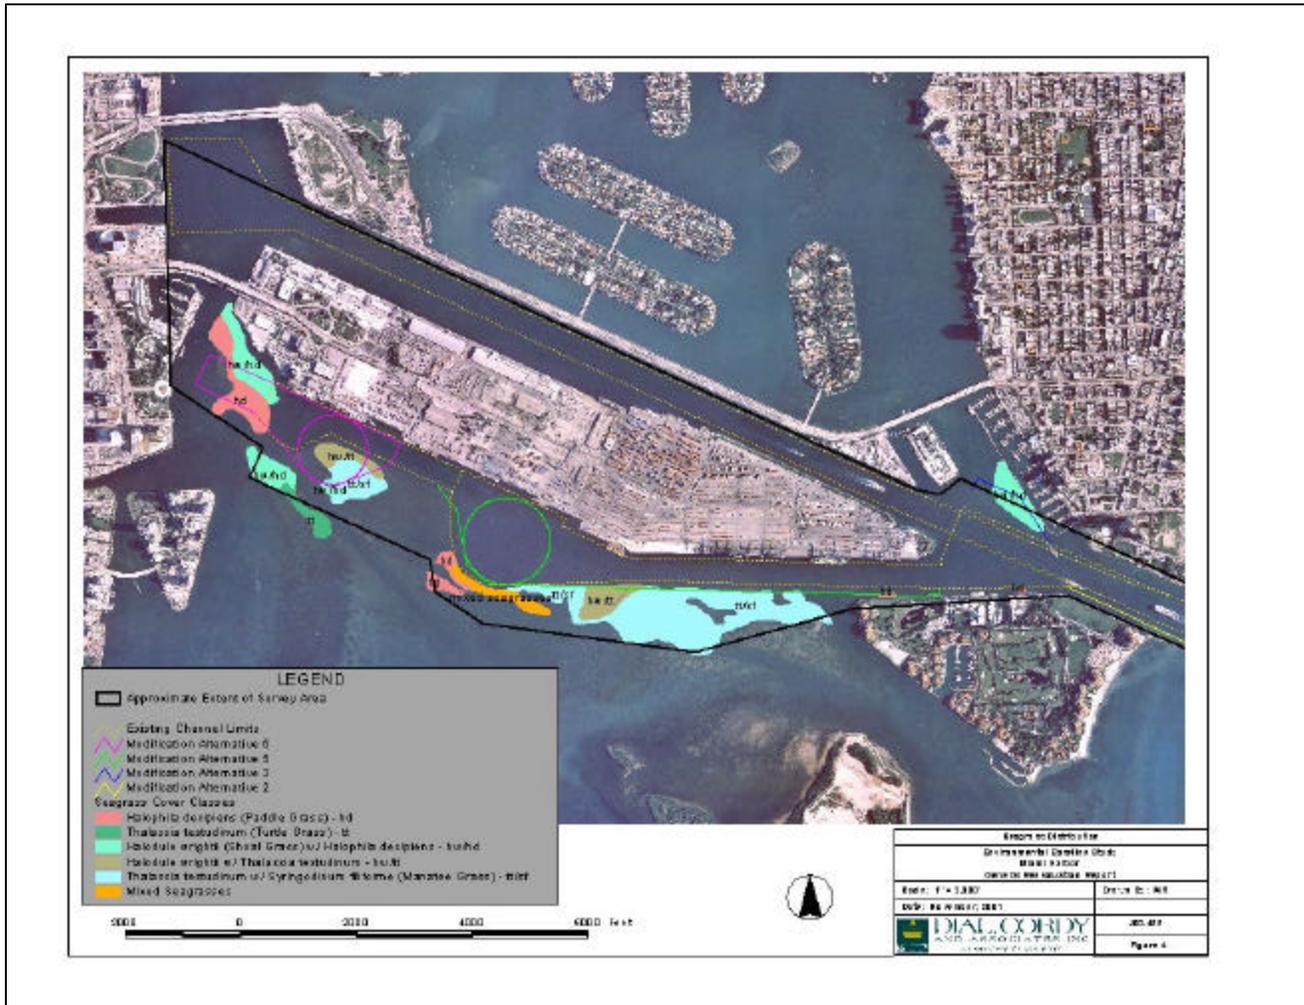
Figure 4 Seagrass Distribution

Seagrass habitat cover type, abundance, and density for the study area are described below. Distribution and occurrence observations range from approximately 400 feet south of Fisherman's Channel, including the area of the CWA, and the area adjacent to the Coast Guard Station north of the entrance channel at the southern tip of Miami Beach (Figure 4).

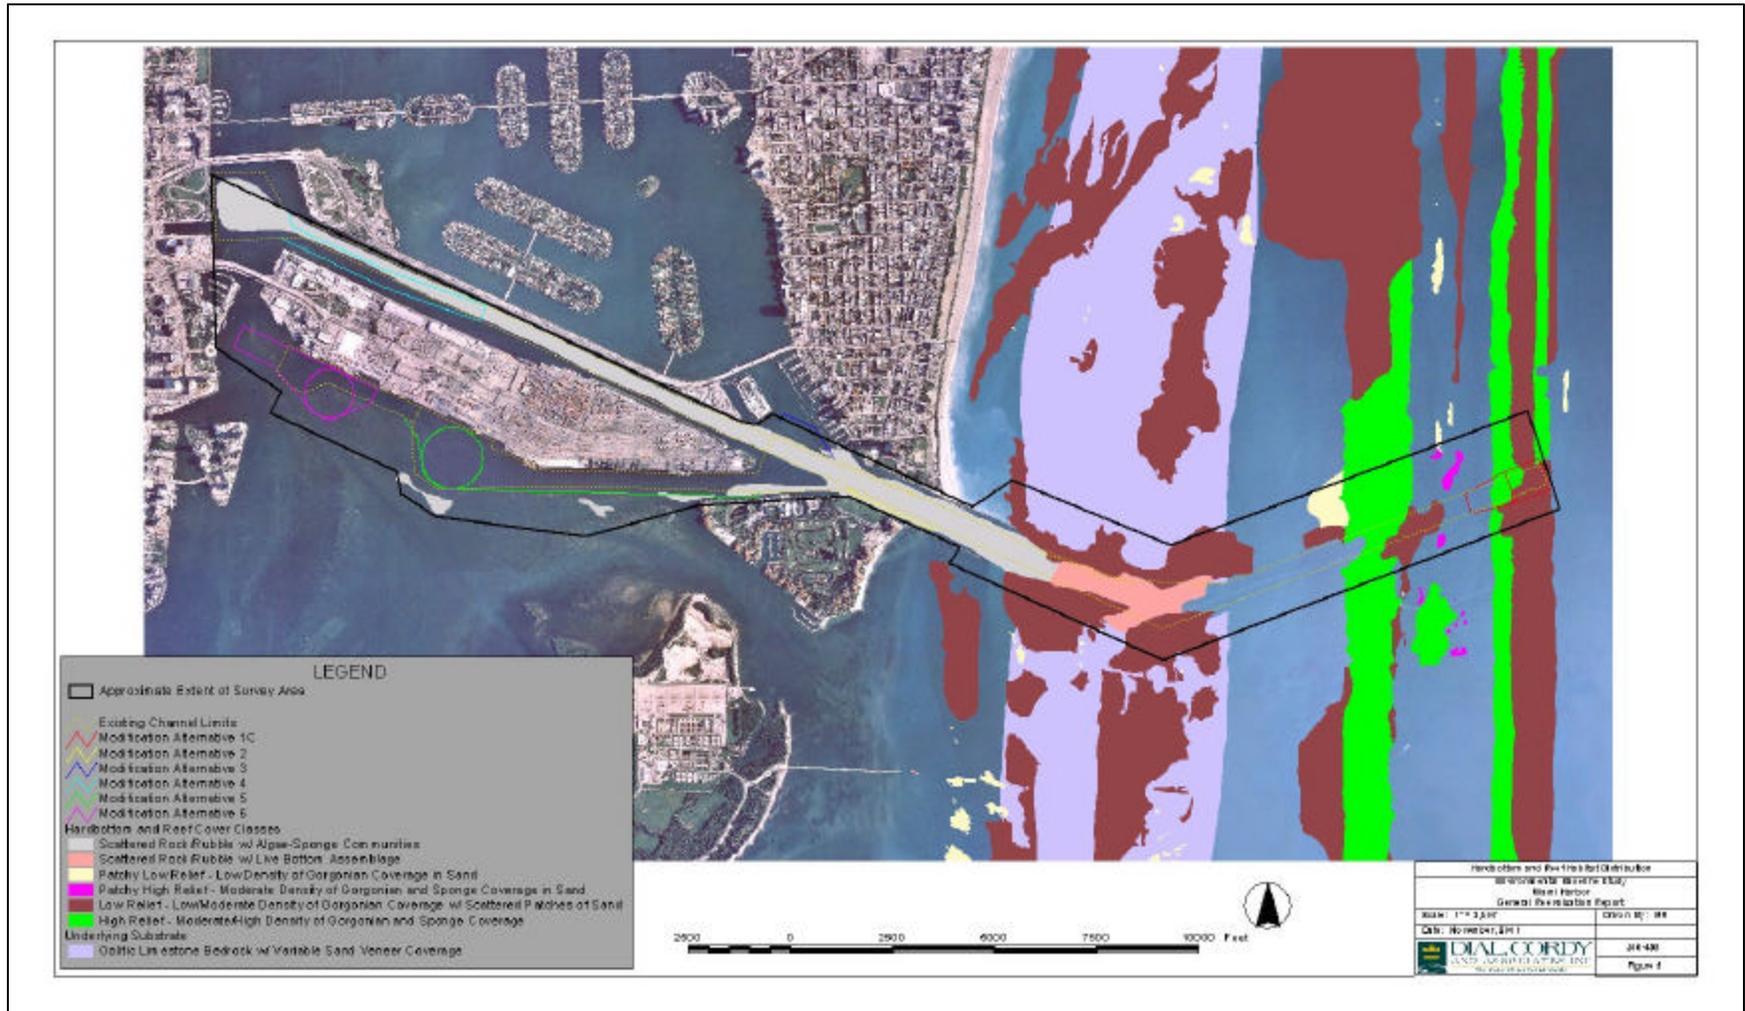
Figure 5 Hardbottom and Reef Habitat Distribution

Hardgrounds associated with the project area include a nearshore hardbottom area and three additional parallel reef tracts that run generally north/south (Figure 5). The hardbottom zone nearest to shore exists in a physically stressed environment, and involves the Miami Oolite Formation (Hoffmeister et al., 1967). Offshore from this nearshore hardbottom area, there are three parallel reef tracts (Duane and Meisburger, 1969). The first reef occurs approximately 100 to 2000 feet from shore, the second reef is located 3,000 to 6,000 feet offshore, and the third reef is approximately 8,000 feet or more offshore. There is an extensive sand area located between the second and third reef lines. The area between the first and second reef lines is characterized by small isolated hermatypic coral heads and interspersed coral rubble, with areas of open sand (see Appendix C for additional side scan data). Resources found within the Main Channel included scattered low- and high-relief reef, with its characteristic biota, but largely comprised softbottom and rock/rubble habitat. The areas of scattered rock/rubble within the channel do exhibit some sponge and coral growth, although, this habitat is not of the same quality as areas of hardbottom outside of the channel. The channel hardbottom is rock/rubble exposed from prior dredging events, and was colonized after previous dredging activities.

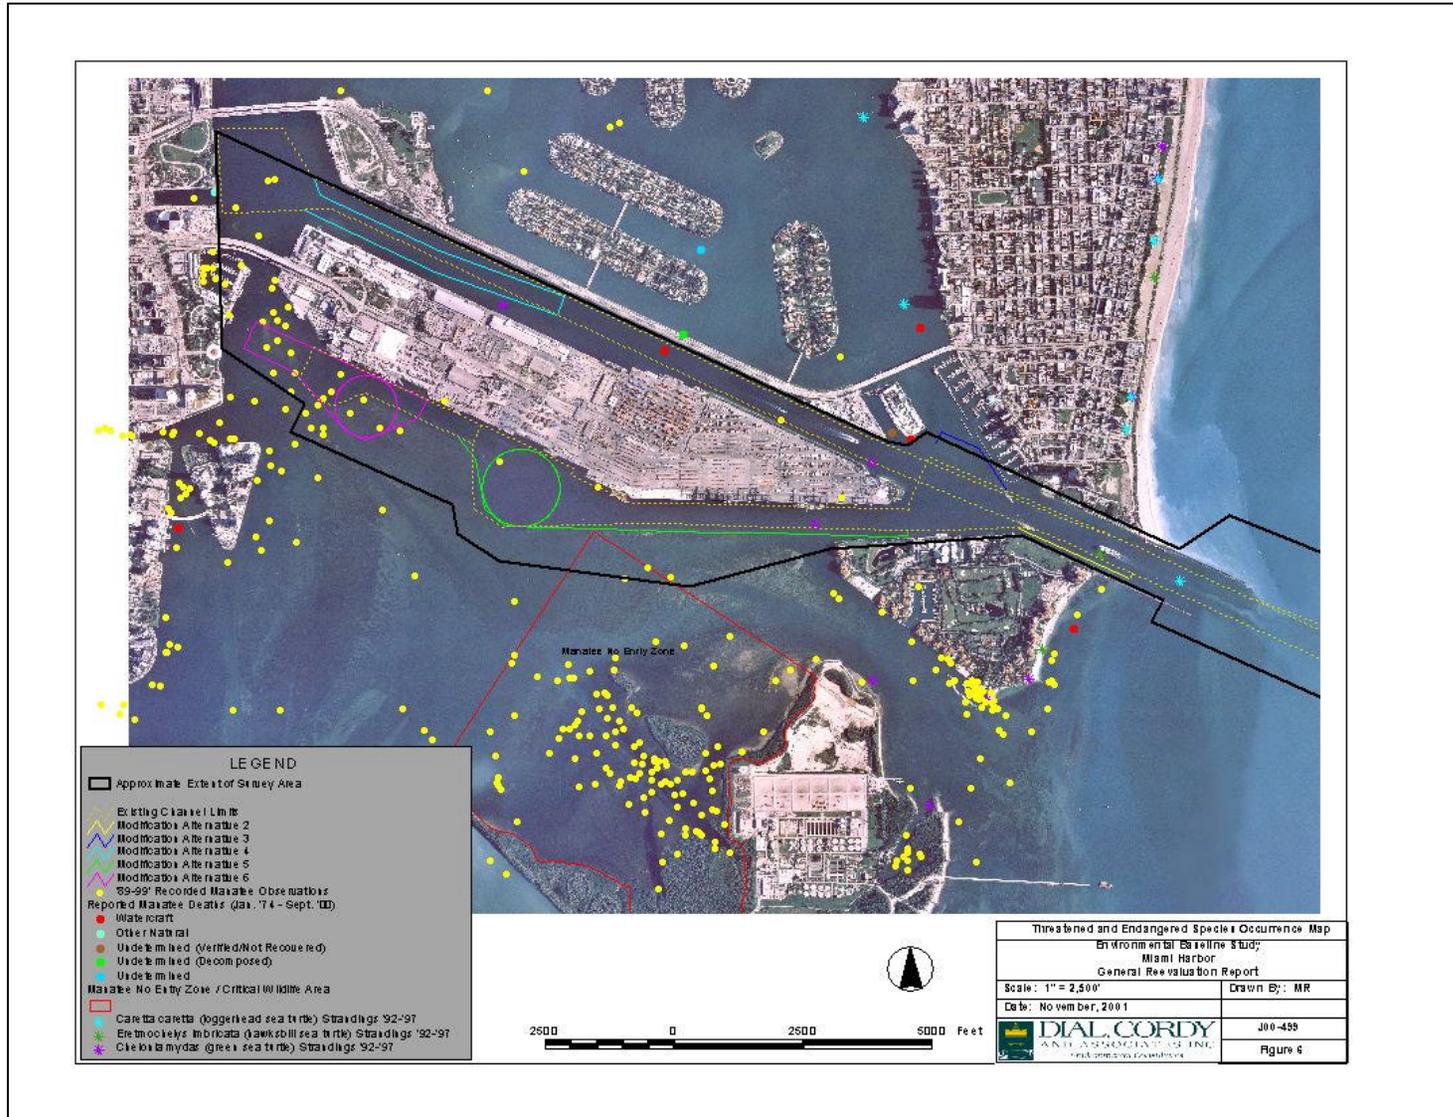
Figure 6 Threatened and Endangered Species Occurrence Map

Within Miami-Dade County there exist both permanent and transient populations of manatees. Surveys show that during the winter months when temperatures drop, manatees from north Florida and also Miami-Dade County will migrate to the Florida Power and Light (FPL) power plant at Port Everglades (USGS 2000). During the summer months when the water warms, manatees return to the counties to the north and south to forage and reproduce. Telemetry and aerial surveys (Figure 6) confirm manatees are present within Miami-Dade County all year (Miami-Dade County 1999a, USGS 2000).

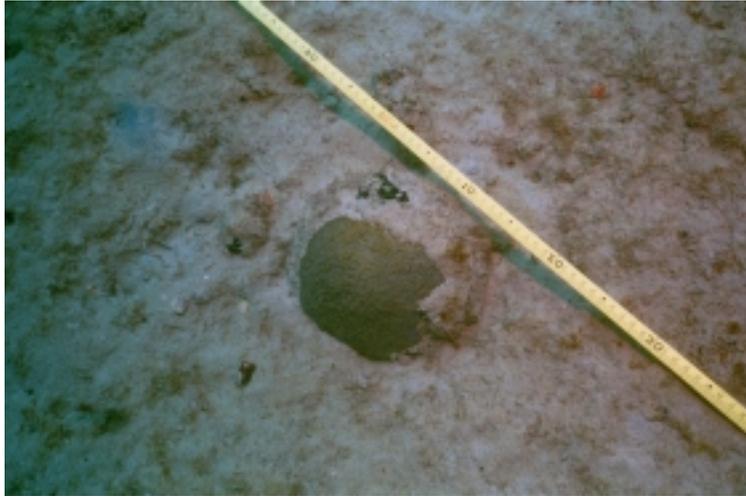
Photo 1: Star mountain coral along mid reef transect north of entrance channel.

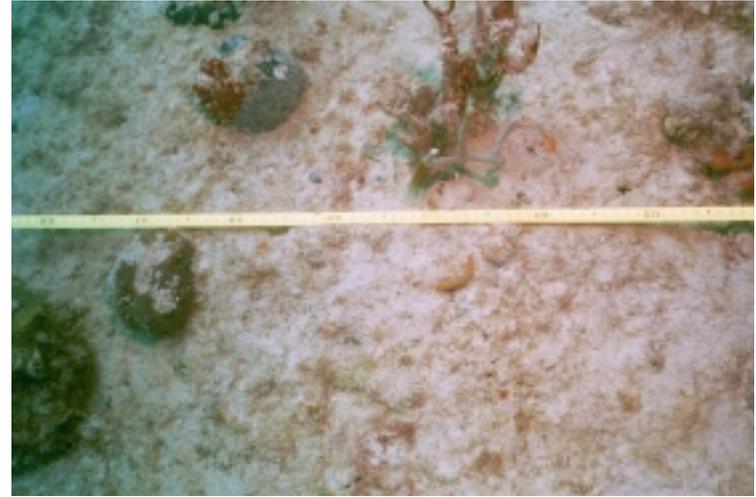
Photo 2: Coral and algae representative of mid reef north of channel.

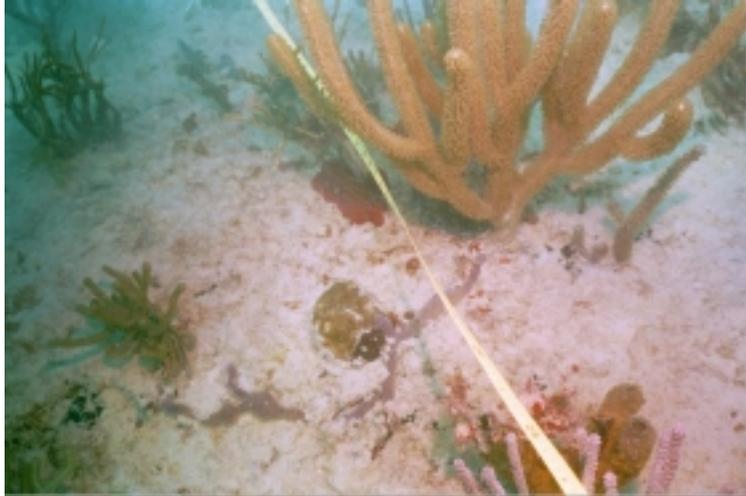
Photo 3: Gorgonian and sponge assemblage along mid reef tract north of entrance channel.

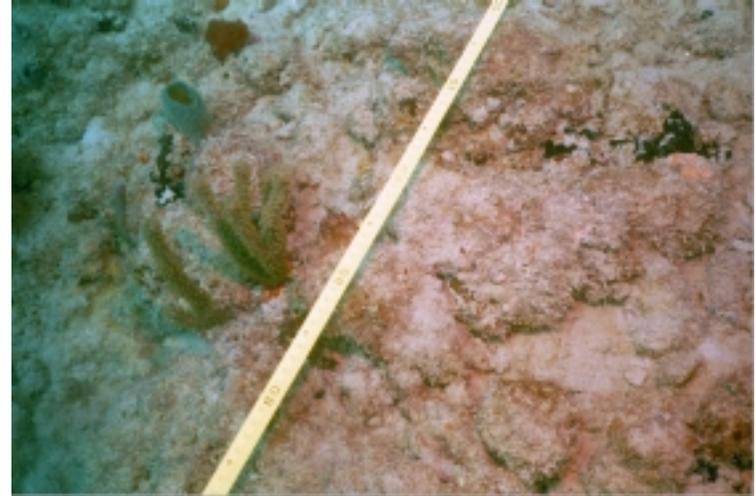
Photo 4: Hardbottom and octocorals along transect.

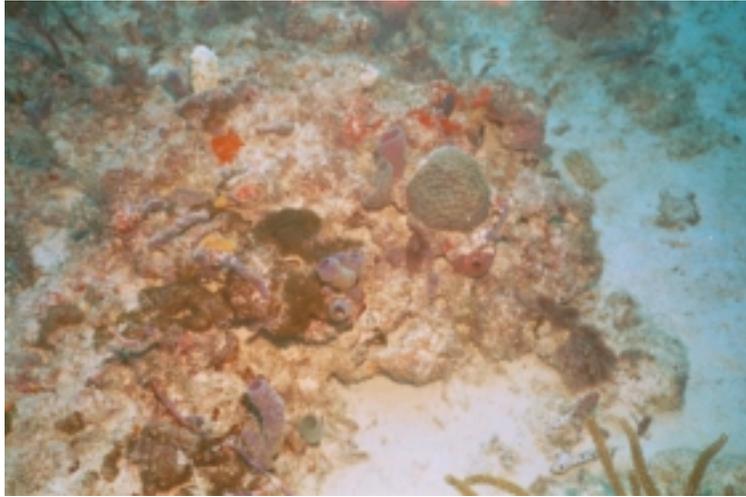
Photo 1: Coral and sponge growth representative of outer reef area.

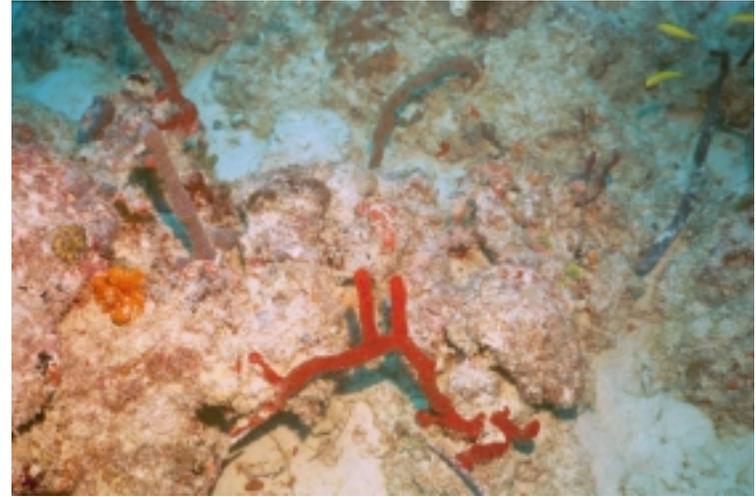
Photo 2: Rope sponge, boring sponge and gorgonians on outer reef.

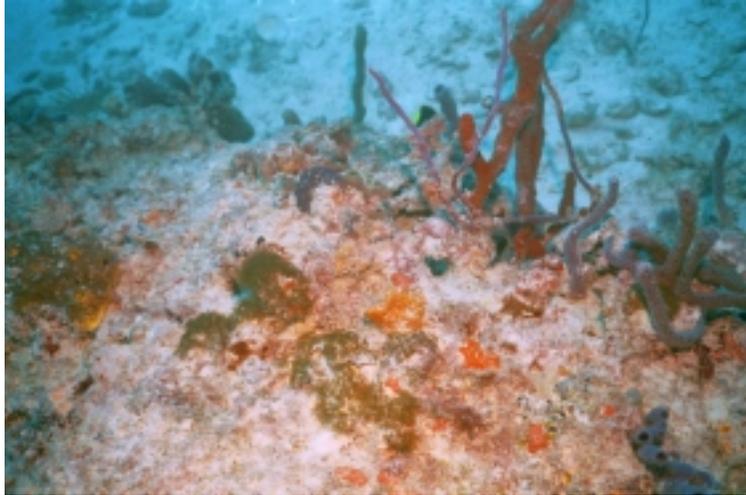
Photo 3: Representative coral, sponge and octocorals along outer reef transect.

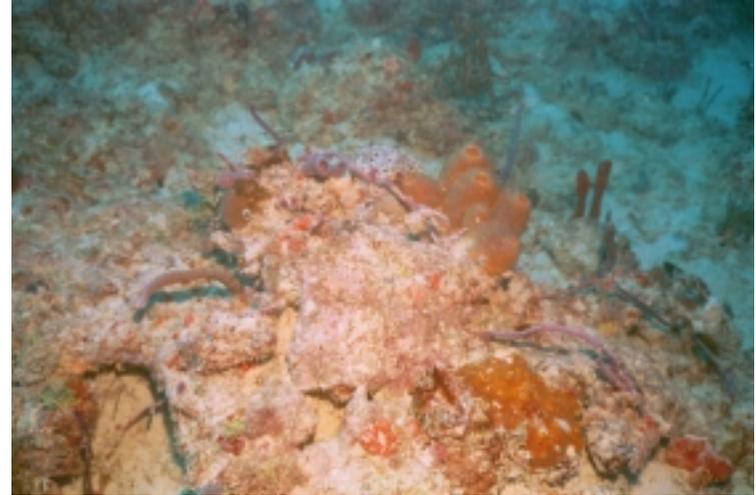
Photo 4: Sponge and algae community along transect, outer reef.

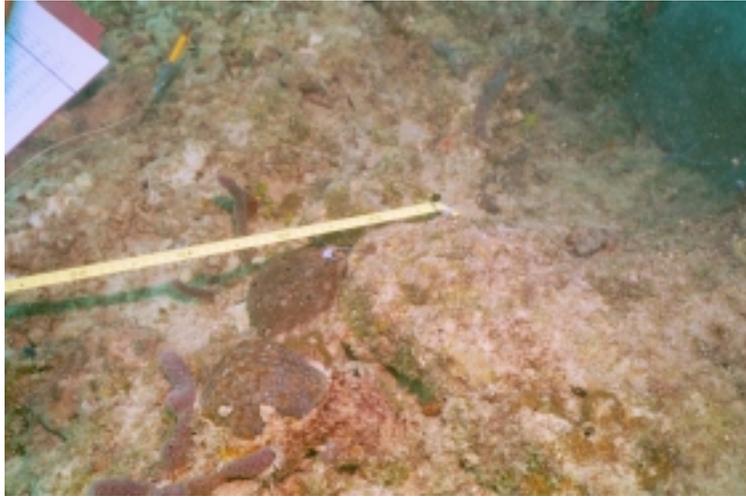
Photo 1: Beginning of transect showing hard coral and sponge growth.

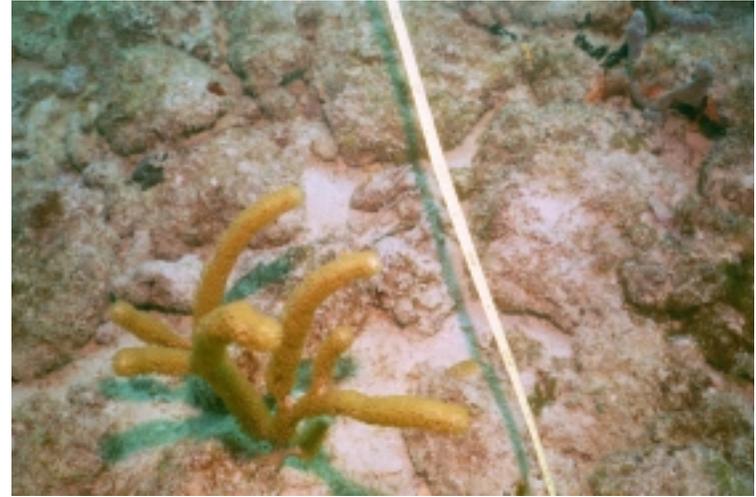
Photo 2: Transect line with representative octocoral and algae community.

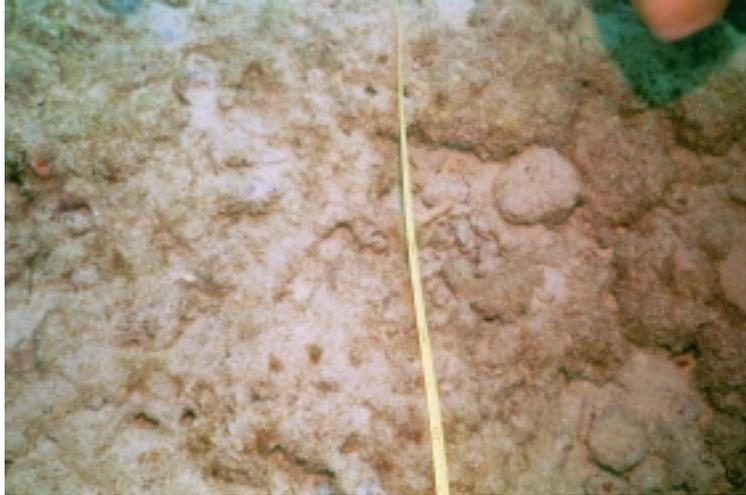
Photo 3: Hardbottom area along mid reef transect.

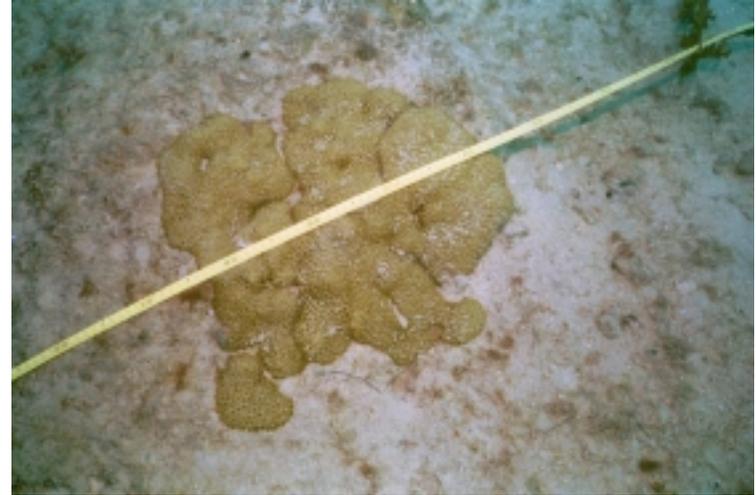
Photo 4: Hard coral growth representative of mid reef transect.
