**Final
Hazardous, Toxic, and Radioactive Waste (HTRW)
Site Inspection Report
DERP-FUDS Site IO2PR006800
Former Lower Camp Debris Site
Culebra Island, Puerto Rico**

July 2012

Final
Hazardous, Toxic, and Radioactive Waste (HTRW)
Site Inspection Report
at DERP-FUDS Site IO2PR006800

Former Lower Camp Debris Site
Culebra Island, Puerto Rico

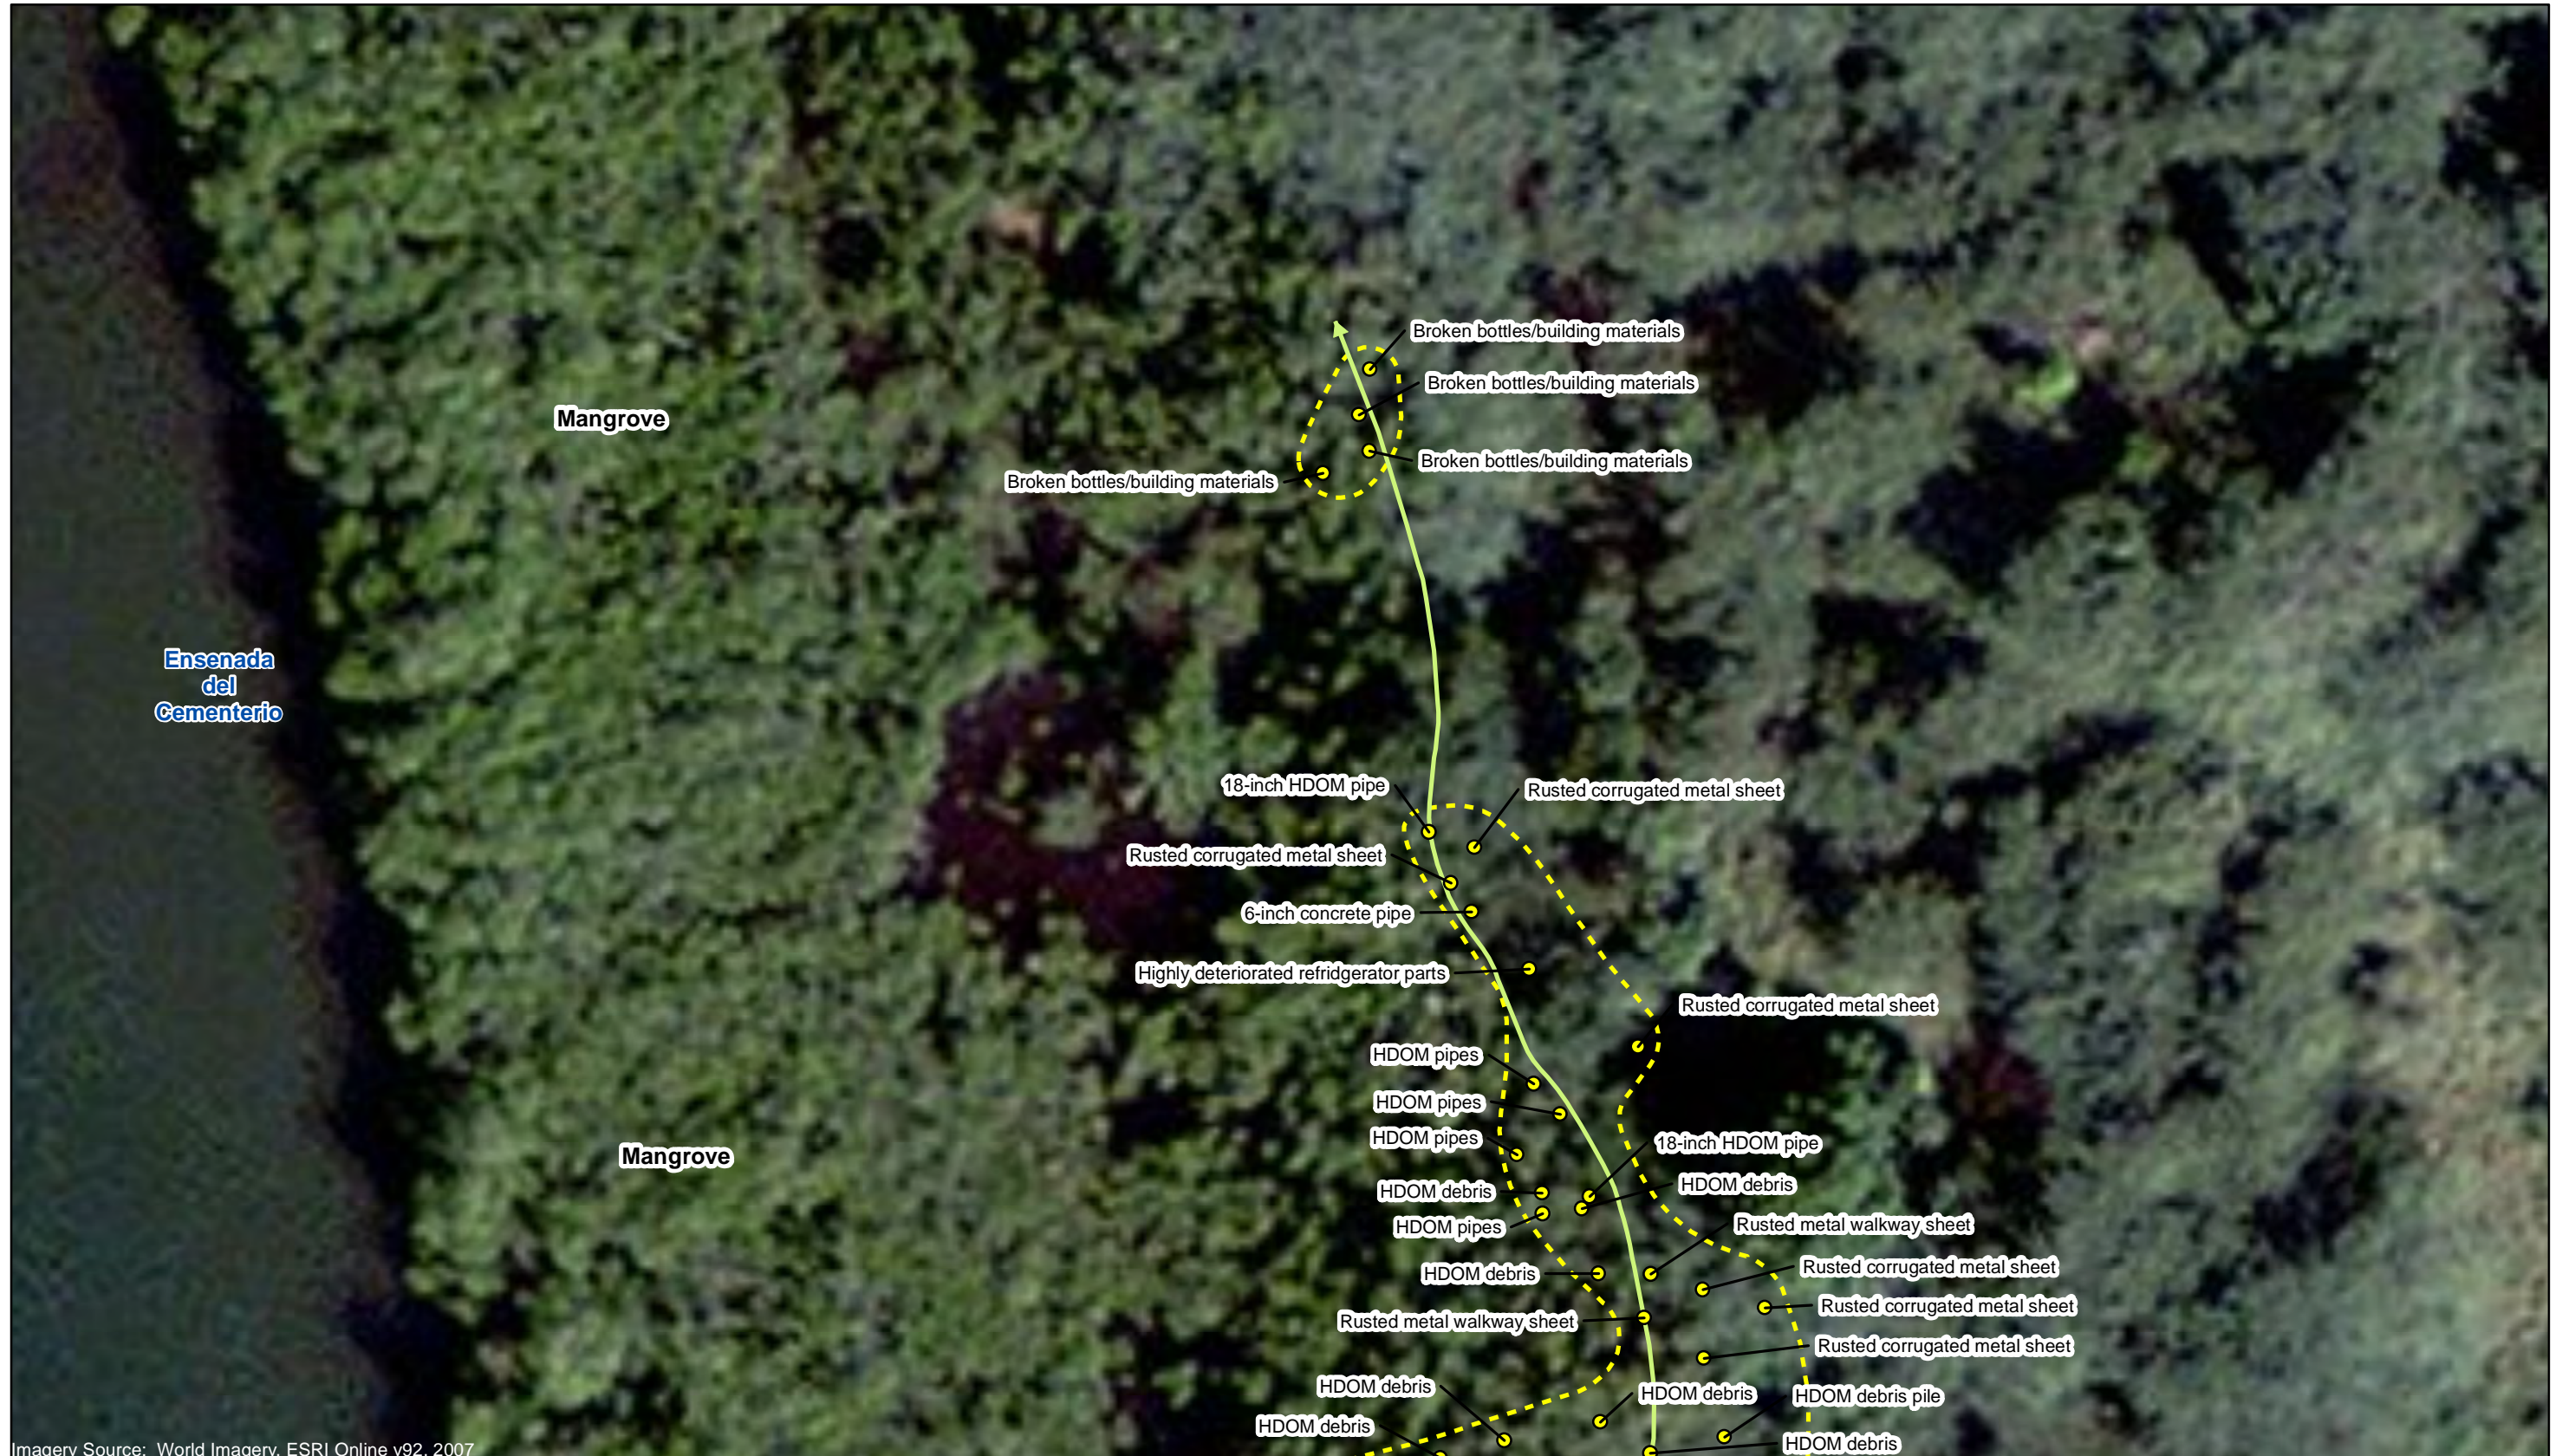
FIGURE 3-1
Site Inspection Location Map
 Former Lower Camp Debris Site
 Culebra, Puerto Rico

The estimated extent of debris is located in a total area of 15,070 ft² (0.35 acre), and extends a distance of 350 feet from the southernmost to the northernmost tip of the debris field (**Figure 3-1**). The widest point of the debris field is approximately 165 feet. The debris consisted of broken bottles, building materials (i.e., bricks both broken and whole and mortar), highly deteriorated oxidized metal (i.e., pipes, beams, rods/rebar, bolts, mattress springs, cables, water valves, and cans), rusted metal walkway sheets, rusted refrigerator type appliance, rusted corrugated metal sheets, concrete stormwater pipes, old vehicle engines, a battery, tires, axles, transmissions, body frames, and broken porcelain..

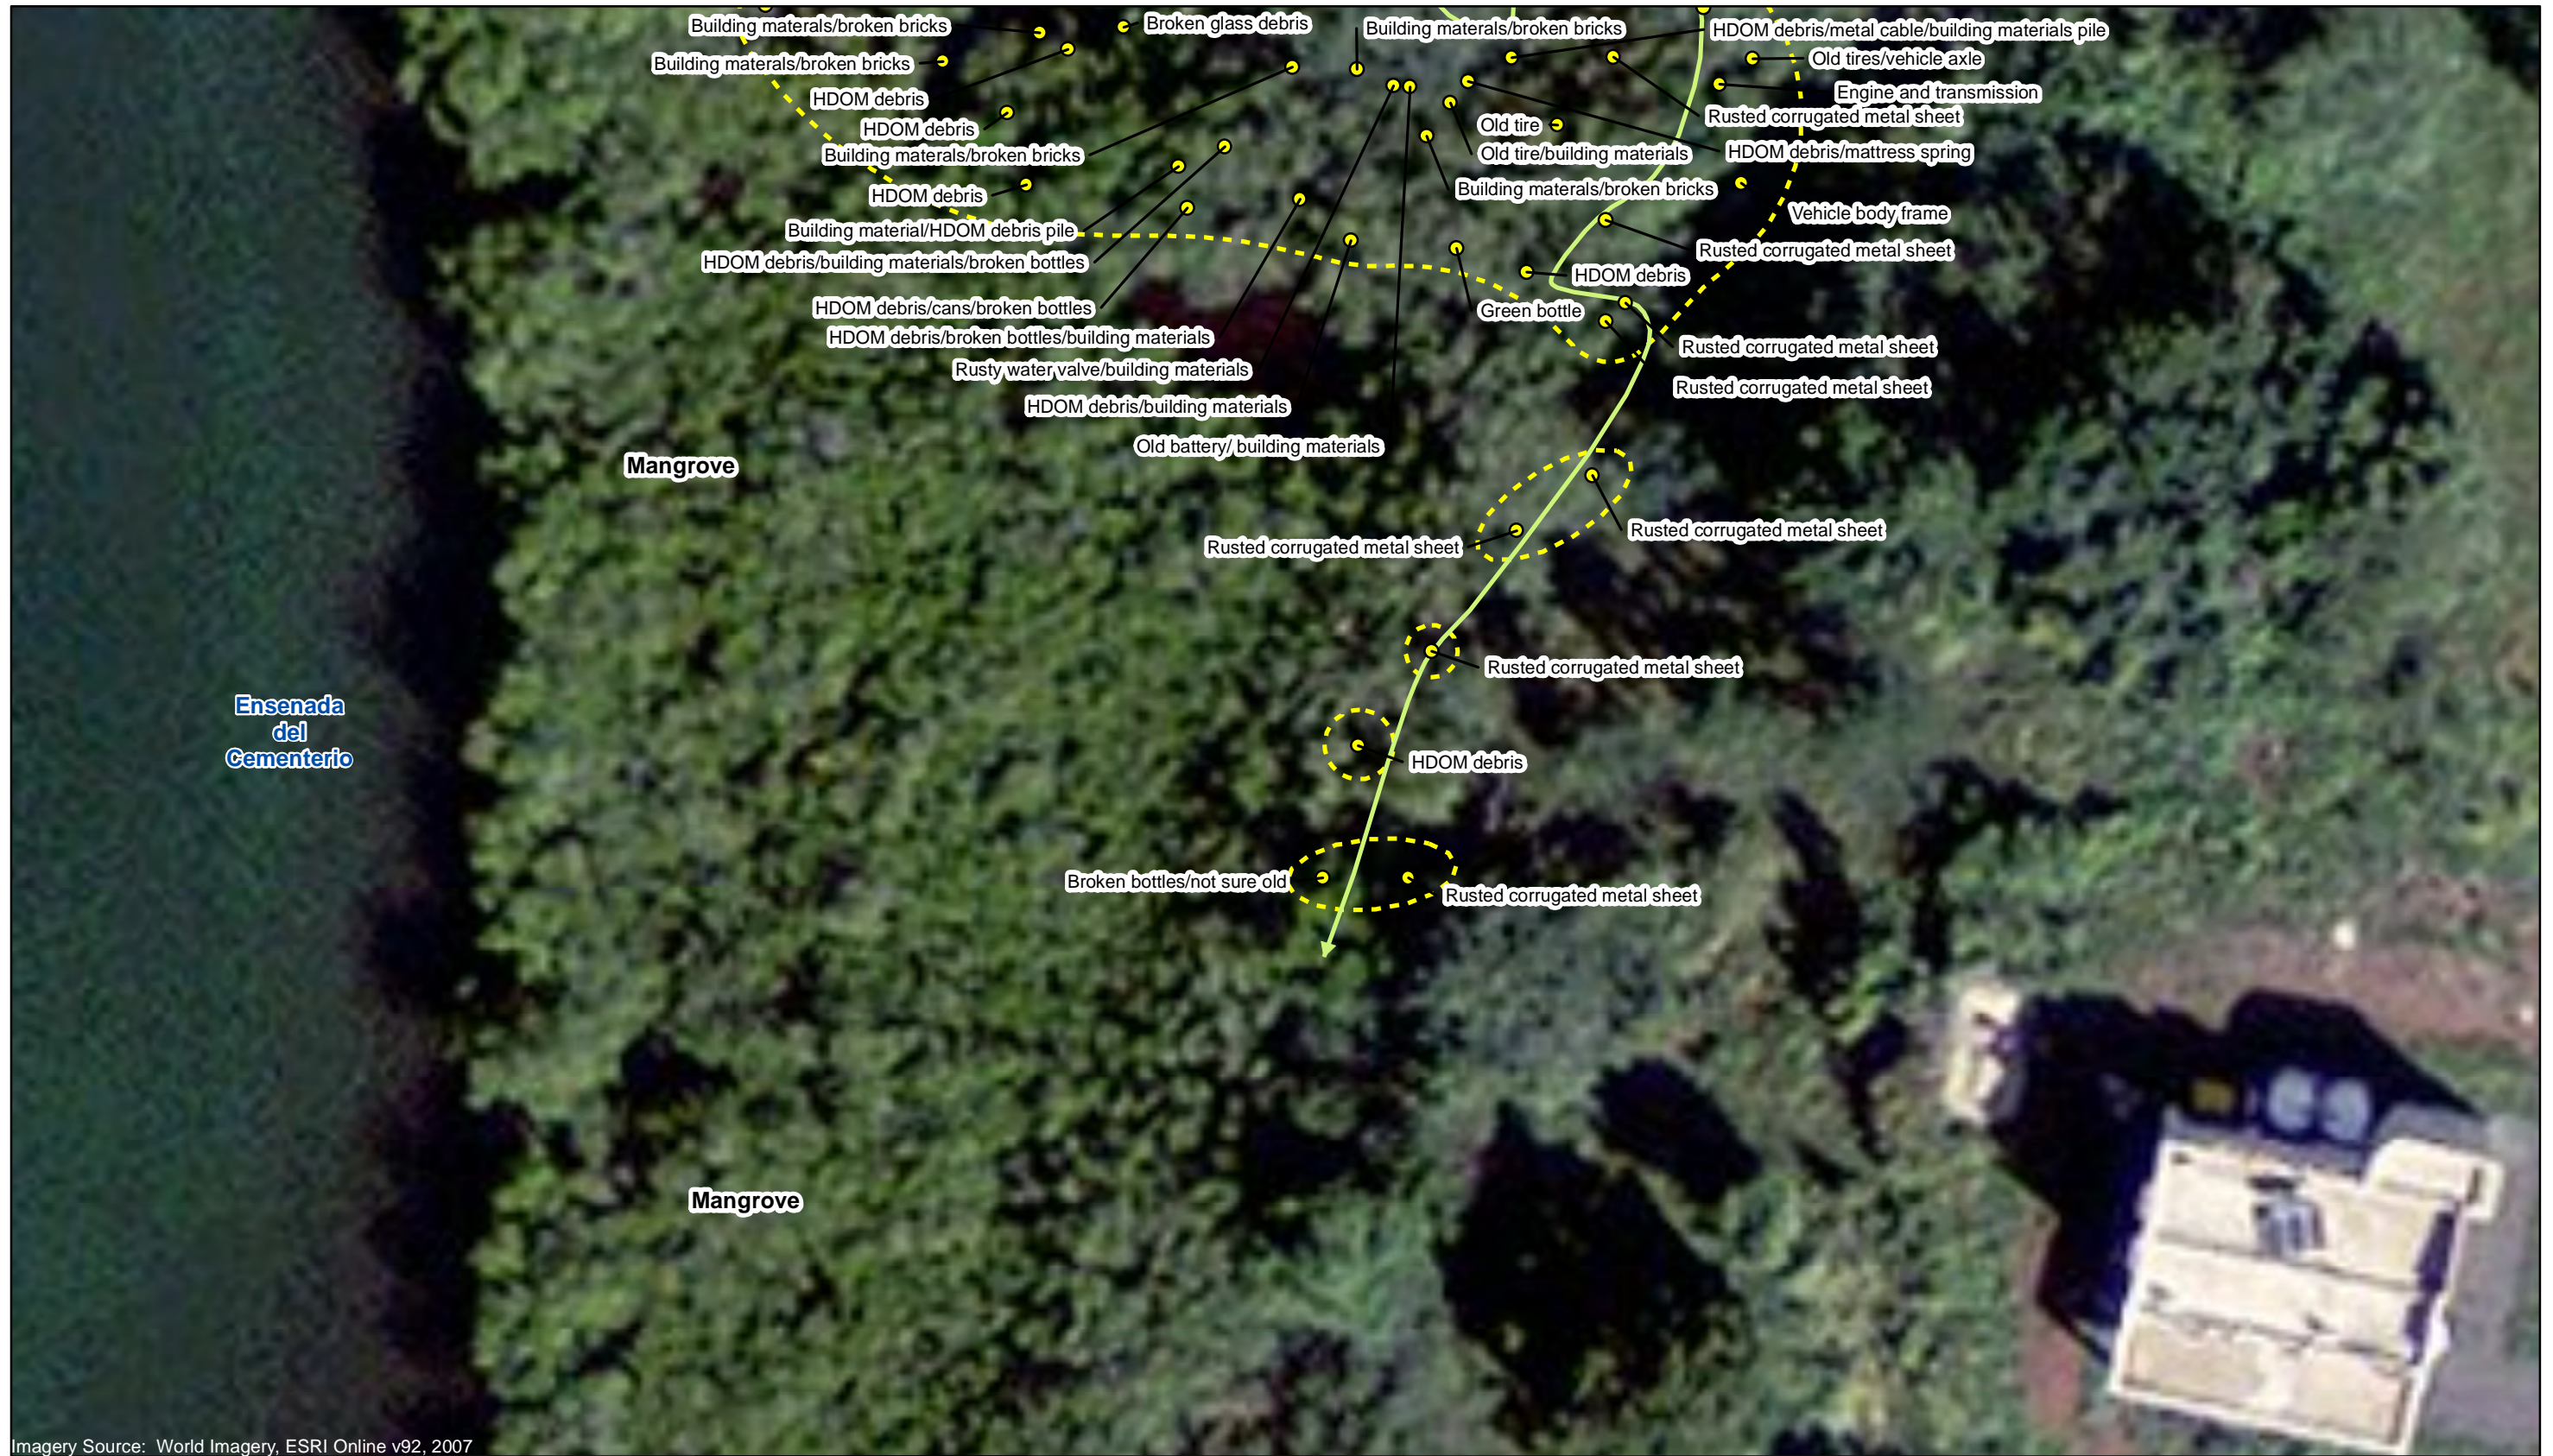
FIGURE 3-2
GPS Locations - Map Area 1
 Former Lower Camp Debris Site
 Culebra, Puerto Rico

Visual inspection of the debris areas along the shoreline of the mangrove was performed within the designated site boundary. Information regarding the type, location, and extent of debris currently at the site indicates the debris piles identified in the 1996 SI (E&E, 1996) are still present along with an additional debris pile approximately 50 feet north of the northern most debris pile shown on **Figure 1-4**. The estimated extent of surface and partially buried debris is shown on **Figure 3-1**. The location and type of debris are shown on **Figures 3-2, 3-3, and 3-4**.
